Stewart, Rebecca@Waterboards

Mr. Ralph:

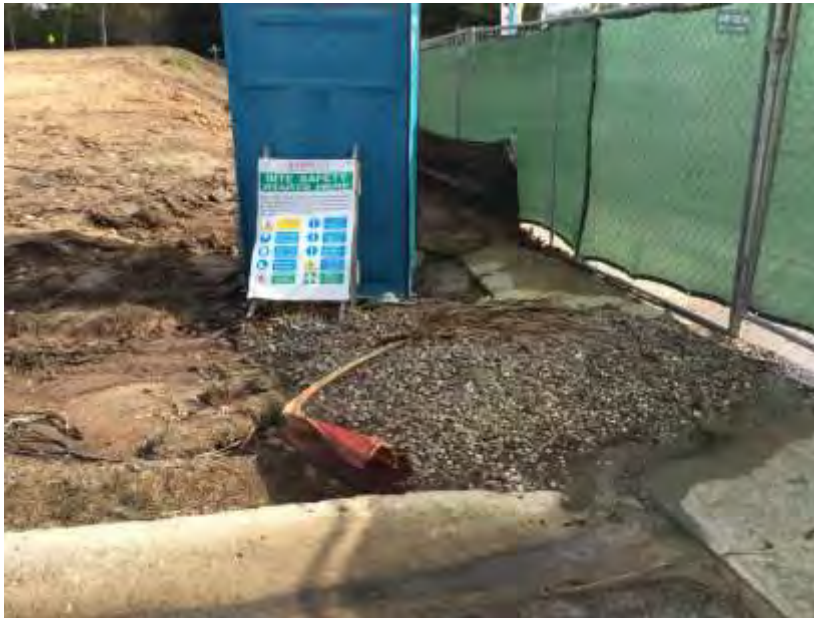
Facility: La Jolla del Rey Phase 1
Inspection Date: 12/4/2014

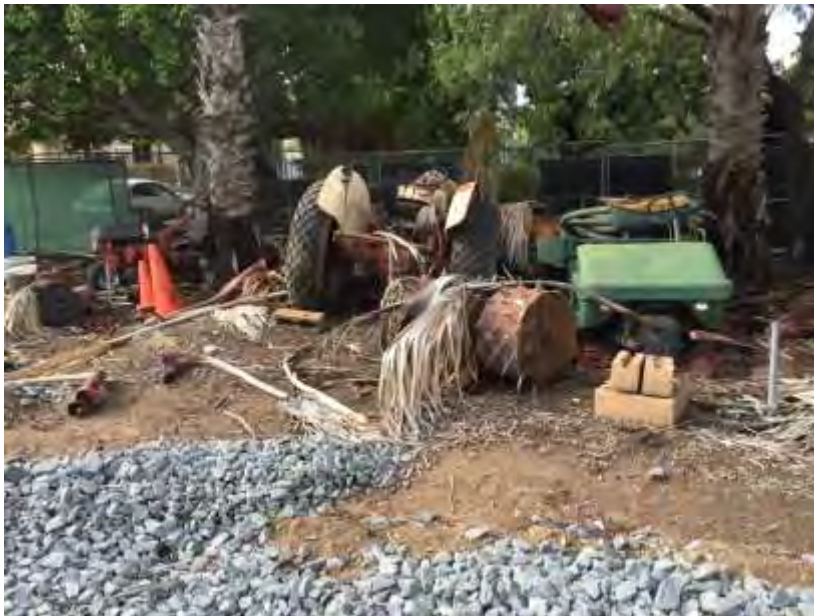
Photo 1 shows sanitation facilities (i.e. portable toilet) located next to site boundary with evidence of runoff flowing through location, and lack of perimeter sediment controls. Evidence of erosion and sediment transport through location and discharge of sediment and storm water from area without perimeter controls.

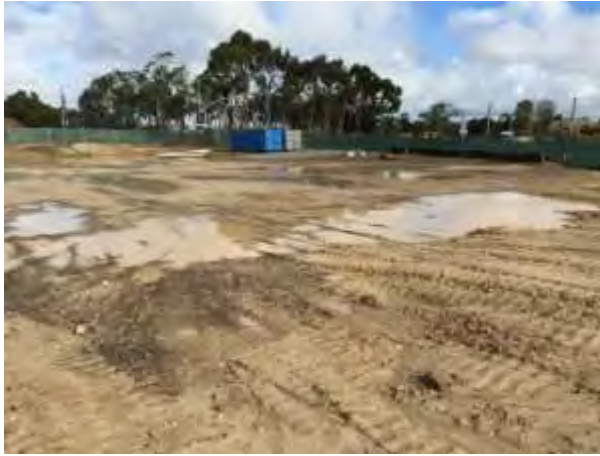
Facility: La Jolla del Rey Phase 1
Inspection Date: 12/4/2014
