Second Annual Mitigation Monitoring Report for the

# Tijuana River Valley Channel Maintenance Mitigation Project

DECEMBER 2015

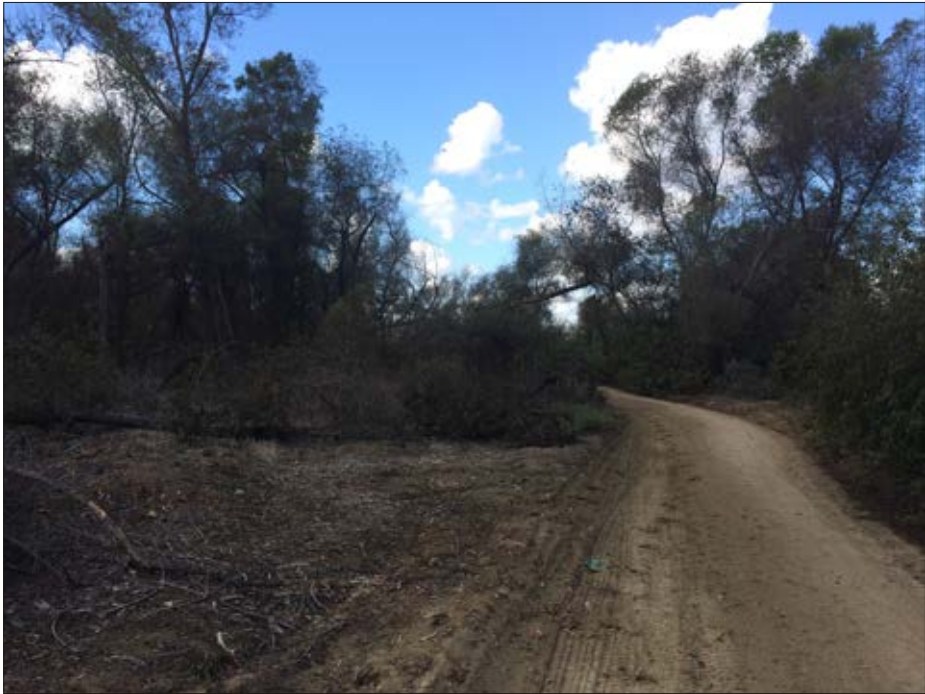
Photo Point 1 (November 4, 2015)

| Photo Point # | Date | Time | Coordinates (Lat/Long,) | Direction | Location Description | Notes/Conditions |
|---|---|---|---|---|---|---|
| PP-1 | 11/4/15 | 1044 | 117° 5' 18.73" W<br>32° 33' 03.70" N | N | View of out-of-channel mitigation area along access road. | Area which received recent invasive non-native removal and control. |

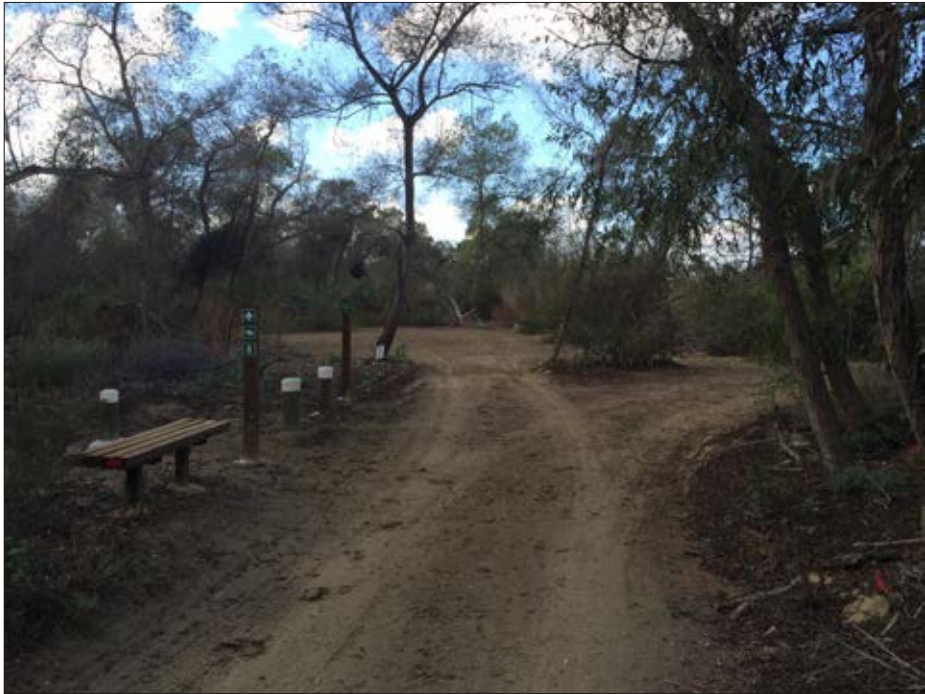
Photo Point 2 (November 4, 2015)

| Photo Point # | Date | Time | Coordinates (Lat/Long,) | Direction | Location Description | Notes/Conditions |
|---|---|---|---|---|---|---|
| PP-2 | 11/4/15 | 1050 | 117° 5' 20.71" W<br>32° 33' 06.58" N | NW | View of out-of-channel mitigation area along access road at horse trail crossing at northern end of site. | Area which received recent invasive non-native removal and control. |

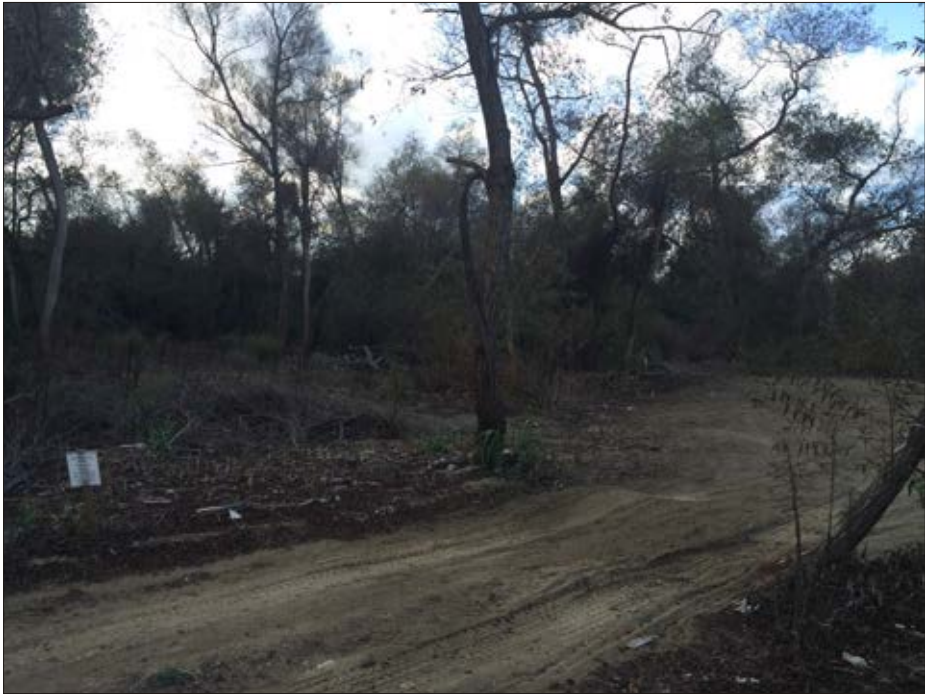
Photo Point 3 (November 4, 2015)

| Photo Point # | Date | Time | Coordinates (Lat/Long,) | Direction | Location Description | Notes/Conditions |
|---|---|---|---|---|---|---|
| PP-3 | 11/4/15 | 1051 | 117° 5' 20.99" W<br>32° 33' 06.83" N | W | View of out-of-channel mitigation area along access road at horse trail crossing at northern end of site. | Area which received recent invasive non-native removal and control. |

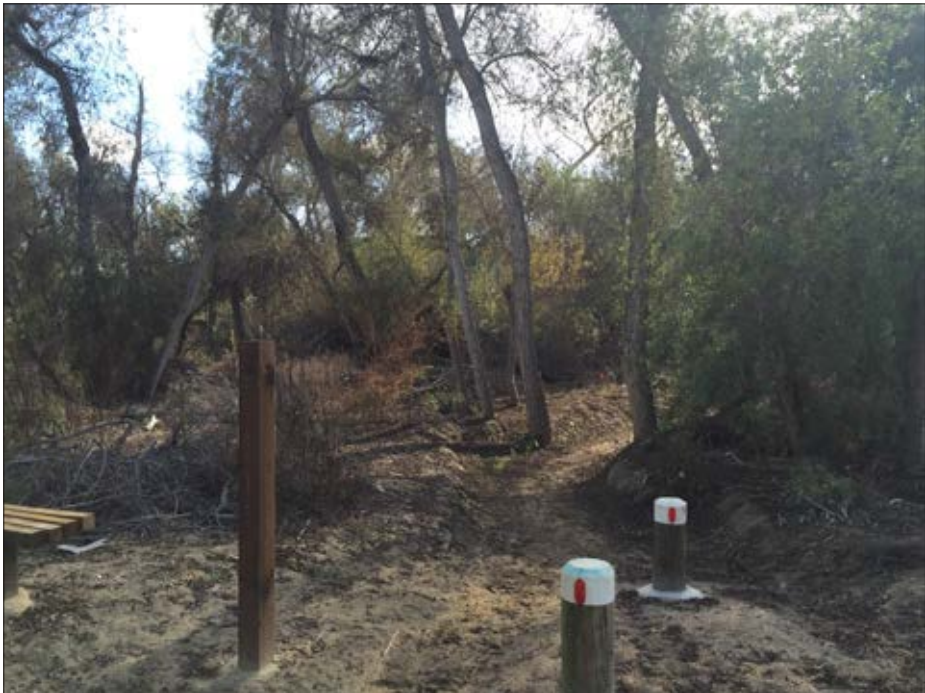
Photo Point 4 (November 4, 2015)

| Photo Point # | Date | Time | Coordinates (Lat/Long,) | Direction | Location Description | Notes/Conditions |
|---|---|---|---|---|---|---|
| PP-4 | 11/4/15 | 1052 | 117° 5' 21.12" W<br>32° 33' 06.91" N | W | View of out-of-channel mitigation area looking down the horse trail at cleared area. | Area which received recent invasive non-native removal and control. |

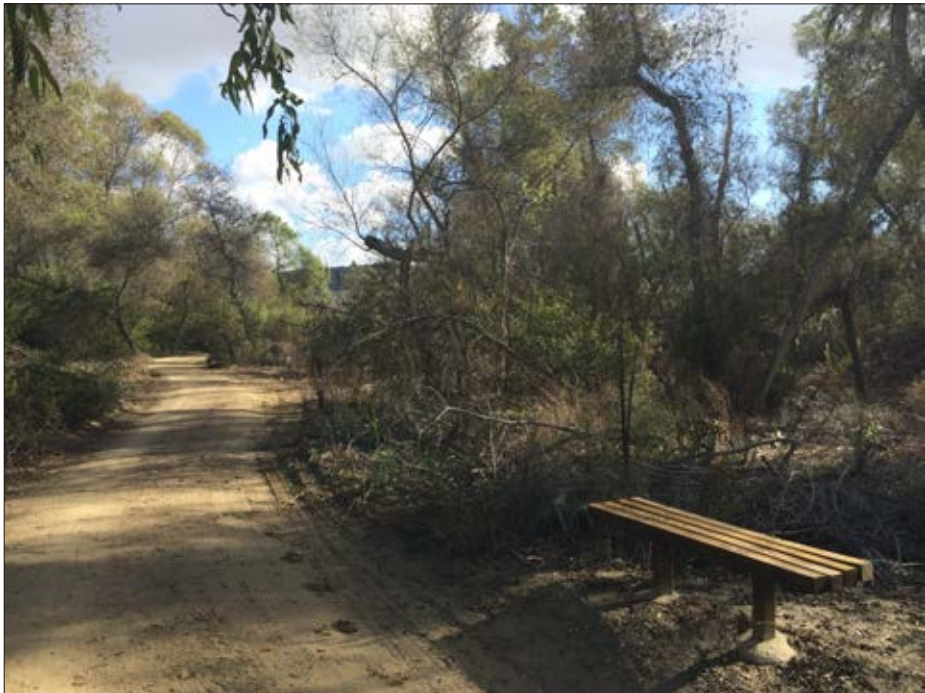
Photo Point 5 (November 4, 2015)

| Photo Point # | Date | Time | Coordinates (Lat/Long,) | Direction | Location Description | Notes/Conditions |
|---|---|---|---|---|---|---|
| PP-5 | 11/4/15 | 1053 | 117° 5' 21.12" W<br>32° 33' 06.91" N | S | View of out-of-channel mitigation area looking south along access road at cleared area. | Area which received recent invasive non-native removal and control. |

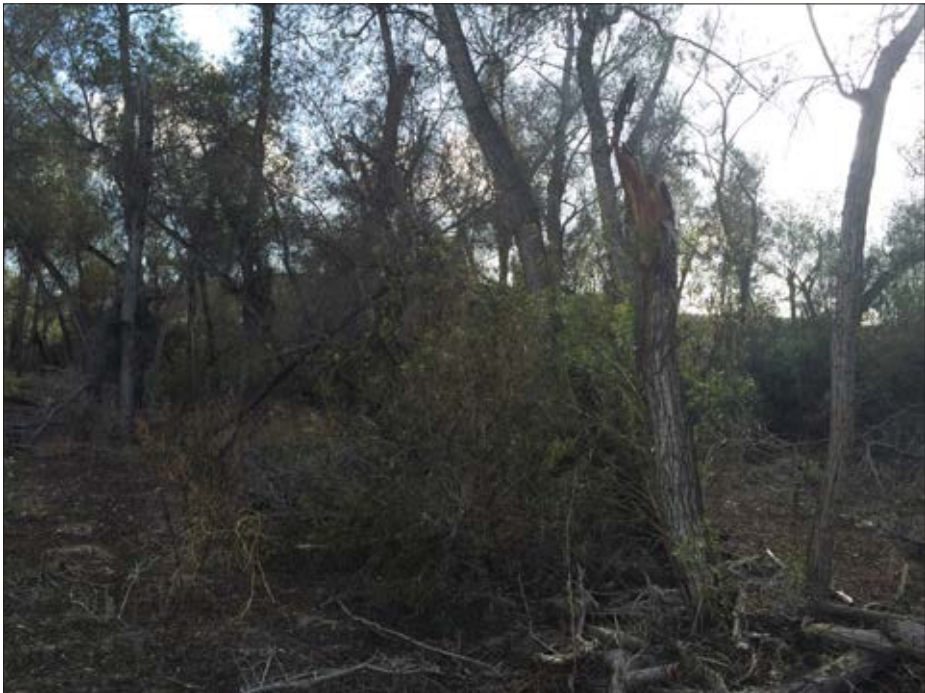
Photo Point 6 (November 4, 2015)

| Photo Point # | Date | Time | Coordinates (Lat/Long,) | Direction | Location Description | Notes/Conditions |
|---|---|---|---|---|---|---|
| PP-6 | 11/4/15 | 1049 | 117° 5' 20.44" W<br>32° 33' 06.19" N | SW | View of out-of-channel mitigation area looking southwest at cleared area. | Area which received recent invasive non-native removal and control. |

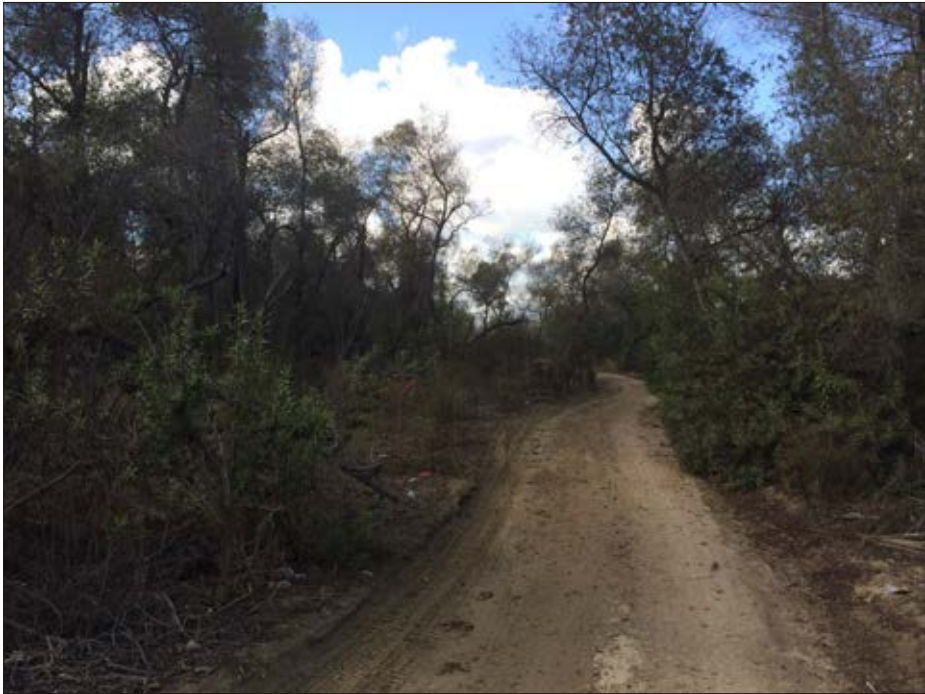
Photo Point 7 (November 4, 2015)

| Photo Point # | Date | Time | Coordinates (Lat/Long,) | Direction | Location Description | Notes/Conditions |
|---|---|---|---|---|---|---|
| PP-7 | 11/4/15 | 1047 | 117° 5' 19.62" W<br>32° 33' 05.62" N | N | View of out-of-channel mitigation area looking north at cleared area along access road. | Area which received recent invasive non-native removal and control. |

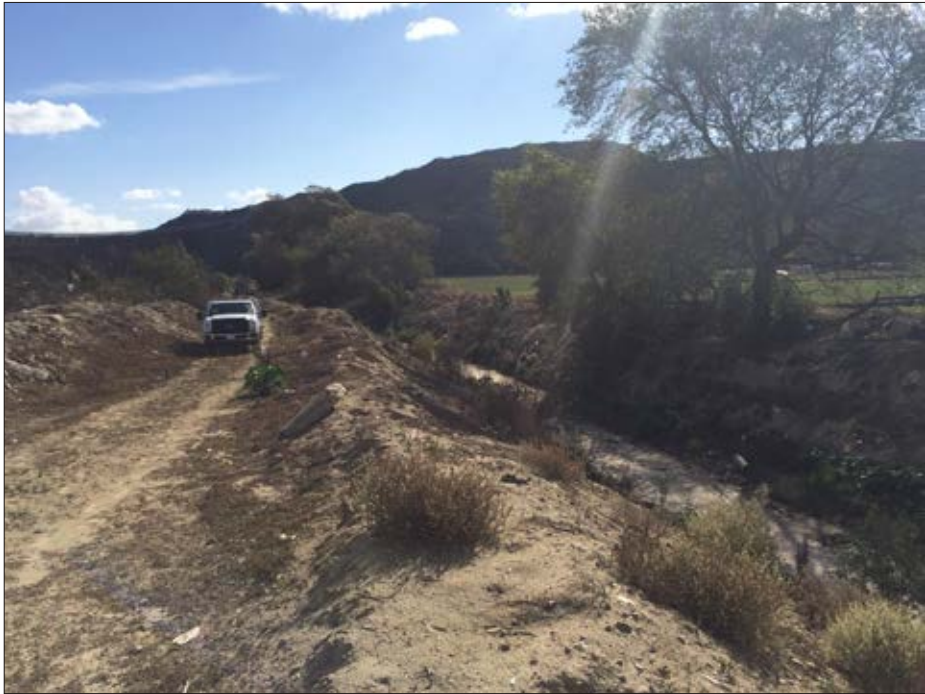
Photo Point 8 (November 4, 2015)

| Photo Point # | Date | Time | Coordinates (Lat/Long,) | Direction | Location Description | Notes/Conditions |
|---|---|---|---|---|---|---|
| PP-8 | 11/4/15 | 1111 | 117° 5' 17.71" W<br>32° 32' 47.05" N | SW | View of both the Smuggler's Gulch channel and the out-of-channel mitigation area looking southwest. | Area which received recent invasive non-native removal and control, as well as the Smuggler's Gulch channel which was dredged. |

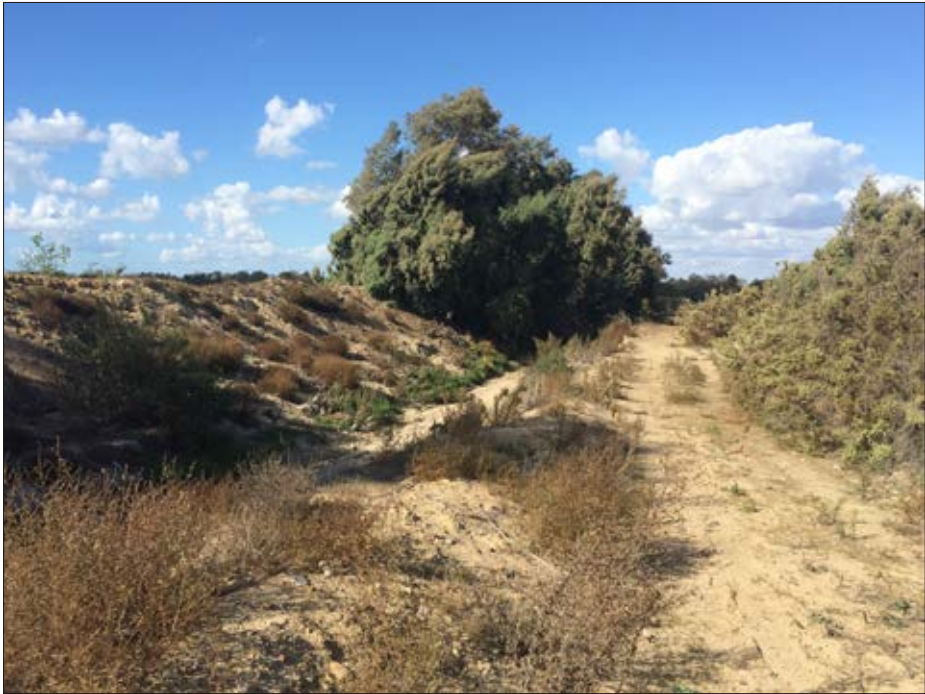
Photo Point 9 (November 4, 2015)

| Photo Point # | Date | Time | Coordinates (Lat/Long,) | Direction | Location Description | Notes/Conditions |
|---|---|---|---|---|---|---|
| PP-9 | 11/4/15 | 1115 | 117° 5' 17.59" W<br>32° 32' 40.42" N | NW | View of both the Smuggler's Gulch channel and the out-of-channel mitigation area looking northwest. | Area which received recent invasive non-native removal and control, as well as the Smuggler's Gulch channel which was dredged. |

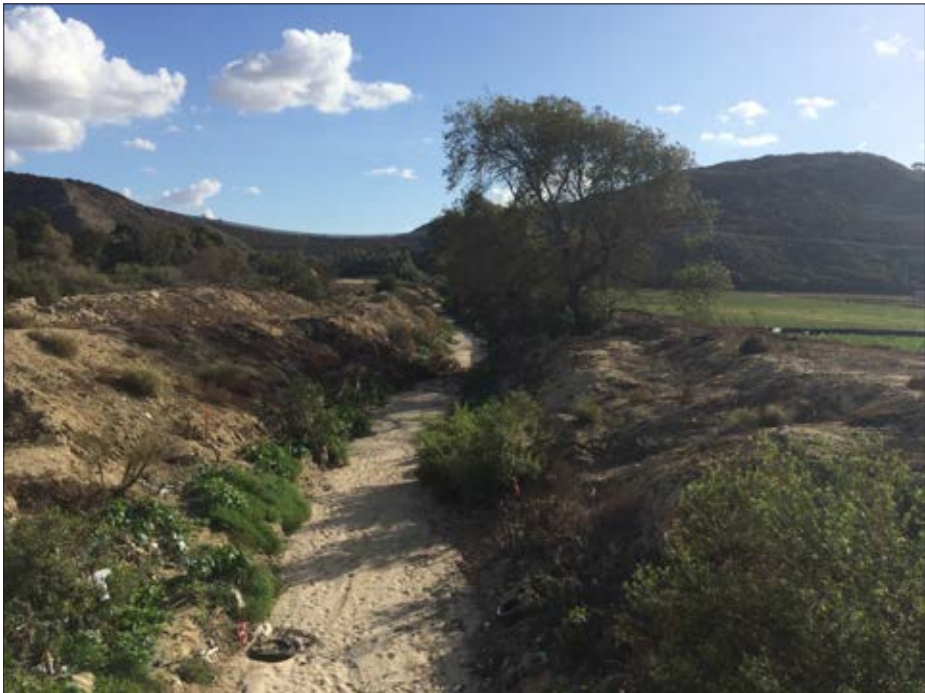
Photo Point 10 (November 4, 2015)

| Photo Point # | Date | Time | Coordinates (Lat/Long,) | Direction | Location Description | Notes/Conditions |
|---|---|---|---|---|---|---|
| PP-10 | 11/4/15 | 1105 | 117° 5' 18.29" W<br>32° 32' 53.15" N | S | View of Smuggler's Gulch channel with out-of-channel treatment areas on banks looking south. | Area which received recent invasive non-native removal and control, as well as the Smuggler's Gulch channel which was dredged. |

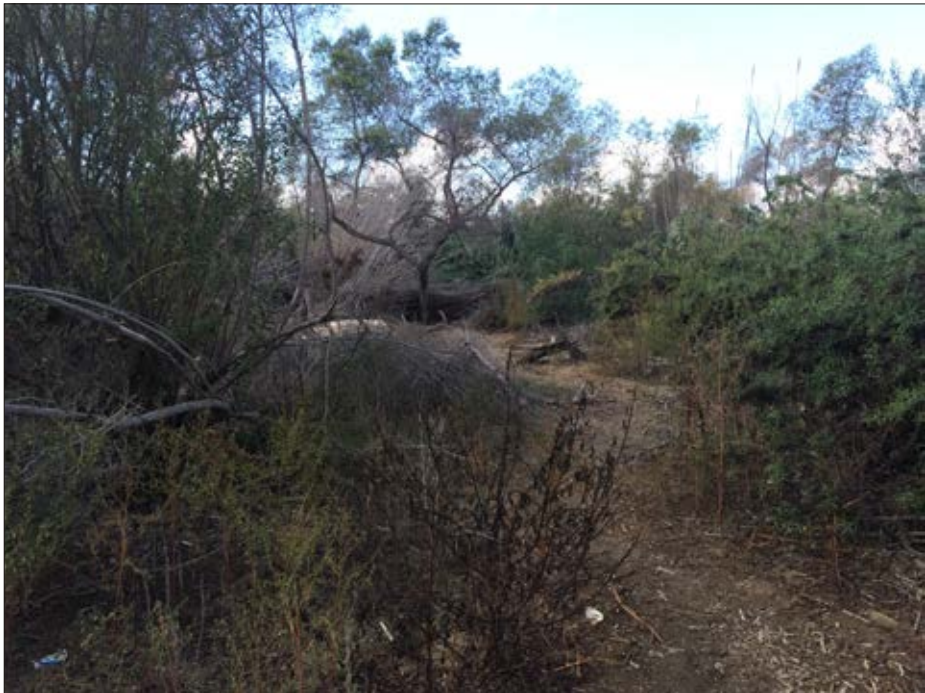
Photo Point 11 (November 4, 2015)

| Photo Point # | Date | Time | Coordinates (Lat/Long,) | Direction | Location Description | Notes/Conditions |
|---|---|---|---|---|---|---|
| PP-11 | 11/4/15 | 1036 | 117° 5' 25.91" W<br>32° 33' 08.95" N | W | View of northwestern most end of the out-of-channel mitigation area looking west along the pilot channel. | Area which received recent invasive non-native removal and control. |

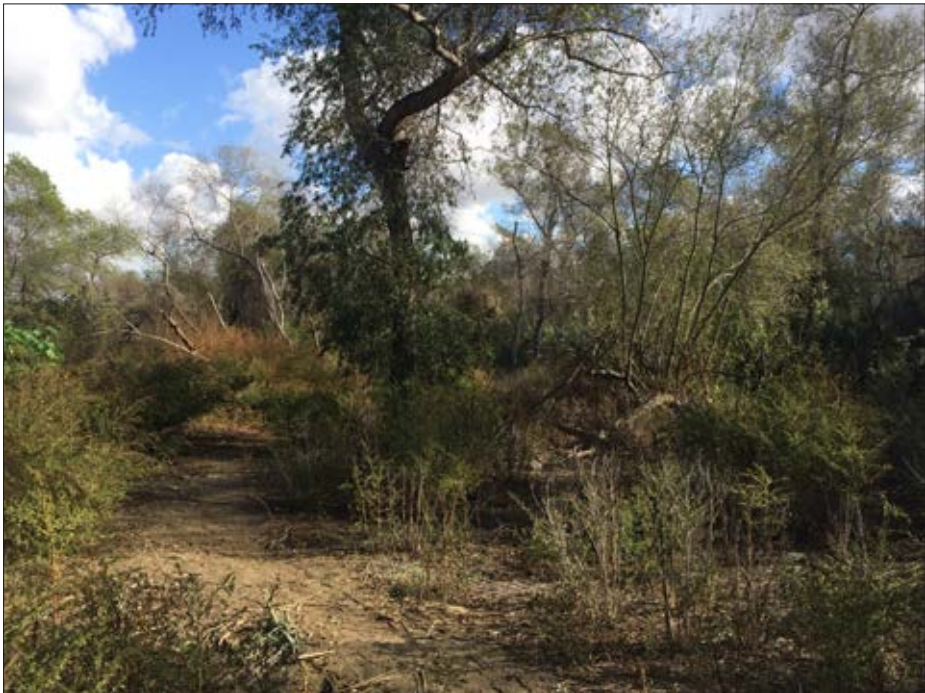
Photo Point 12 (November 4, 2015)

| Photo Point # | Date | Time | Coordinates (Lat/Long,) | Direction | Location Description | Notes/Conditions |
|---|---|---|---|---|---|---|
| PP-12 | 11/4/15 | 1036 | 117° 5' 25.91" W<br>32° 33' 08.95" N | SE | View of northwestern most end of the out-of-channel mitigation area looking southeast along the pilot channel. | Area which received recent invasive non-native removal and control. |

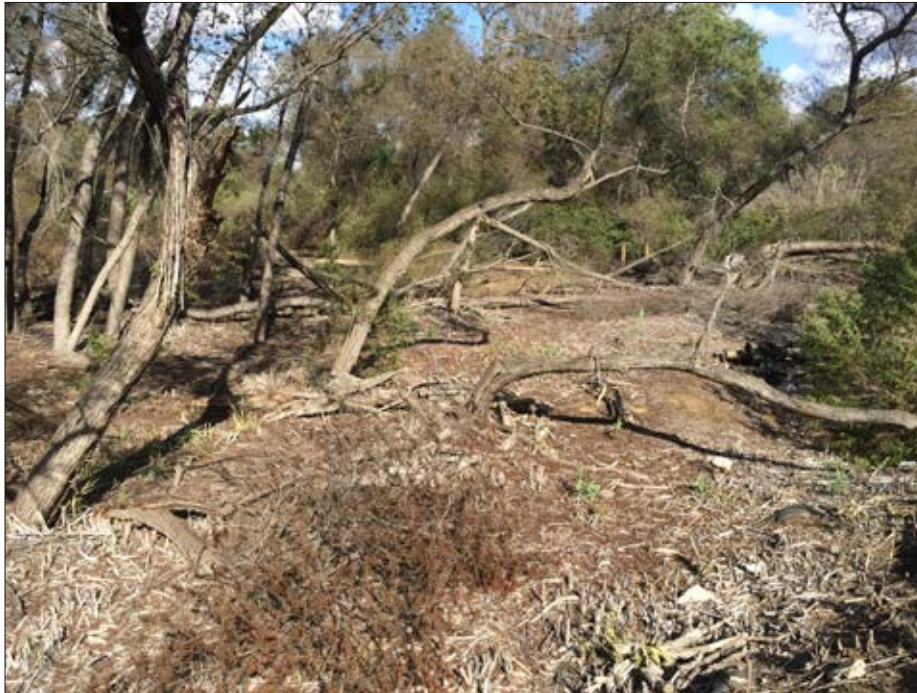
**Photo Point 13 (November 4, 2015)**

| Photo Point # | Date | Time | Coordinates (Lat/Long,) | Direction | Location Description | Notes/Conditions |
|---|---|---|---|---|---|---|
| PP-13 | 11/4/15 | 1057 | 117° 5' 18.29" W<br>32° 32' 53.15" N | NE | View of out-of-channel mitigation area looking northeast from the berm running along the southern side of the site. | Area which received recent invasive non-native removal and control. |

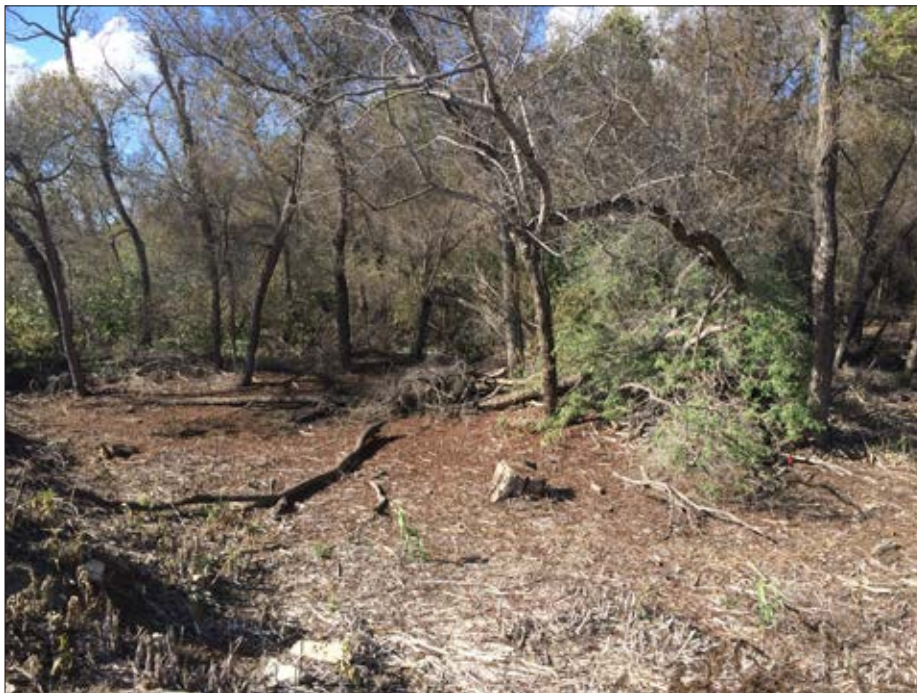
**Photo Point 14 (November 4, 2015)**

| Photo Point # | Date | Time | Coordinates (Lat/Long,) | Direction | Location Description | Notes/Conditions |
|---|---|---|---|---|---|---|
| PP-14 | 11/4/15 | 1057 | 117° 5' 18.29" W<br>32° 32' 53.15" N | NW | View of out-of-channel mitigation area looking northwest from the | Area which received recent invasive non-native removal and control. |
