10
11 IN THE MATTER OF:) **DECLARATION OF BEN ANDERSON**
12 ADMINISTRATIVE CIVIL LIABILITY COMPLAINT) **IN SUPPORT OF SAN ALTOS –**
13 No. R9-2015-0110) **LEMON GROVE, LLC’S LEGAL AND**
AGAINST SAN ALTOS – LEMON GROVE, LLC) **TECHNICAL ARGUMENTS AND**
14) **ANALYSIS IN OPPOSITION TO**
15) **ADMINISTRATIVE CIVIL LIABILITY**
16) **COMPLAINT NO. R9-2015-0110**
17)
18)
19)
20)
21)
22)
23)
24)
25)
26)
27)
28)

Subject: PIN: SM-828060:wchiu

This letter will serve as San Altos-Lemon Grove, LLC's ("LLC") response to the Notice of Violation No. R9-2014-0153 issued by the San Diego Water Board on December 19, 2014. The LLC takes its responsibilities under Order No. 2009-0009-DWR seriously and has made a determined effort to correct any deficiencies at the construction site and employ the most effective Best Management Practices available. We have employed three different contractors with over 1,400 man hours including Saturdays and Sundays, associated BMP equipment and material and management for the project. To date the costs exceed \$ 60,000 in an effort to remedy deficiencies on the site since the rain events in early December. While we understand that money spent is not a measure of eff

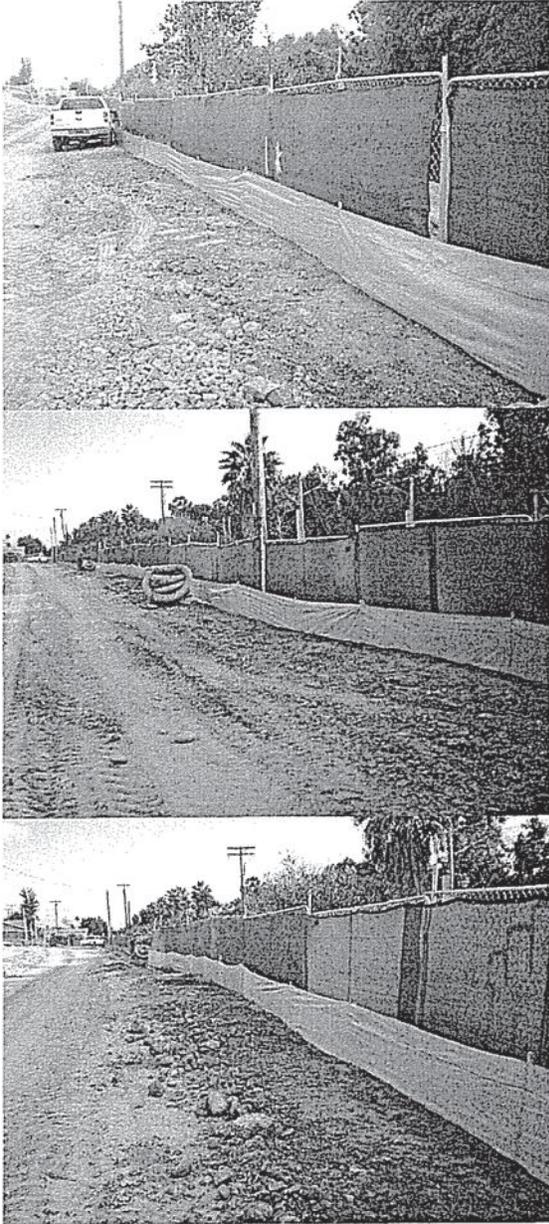
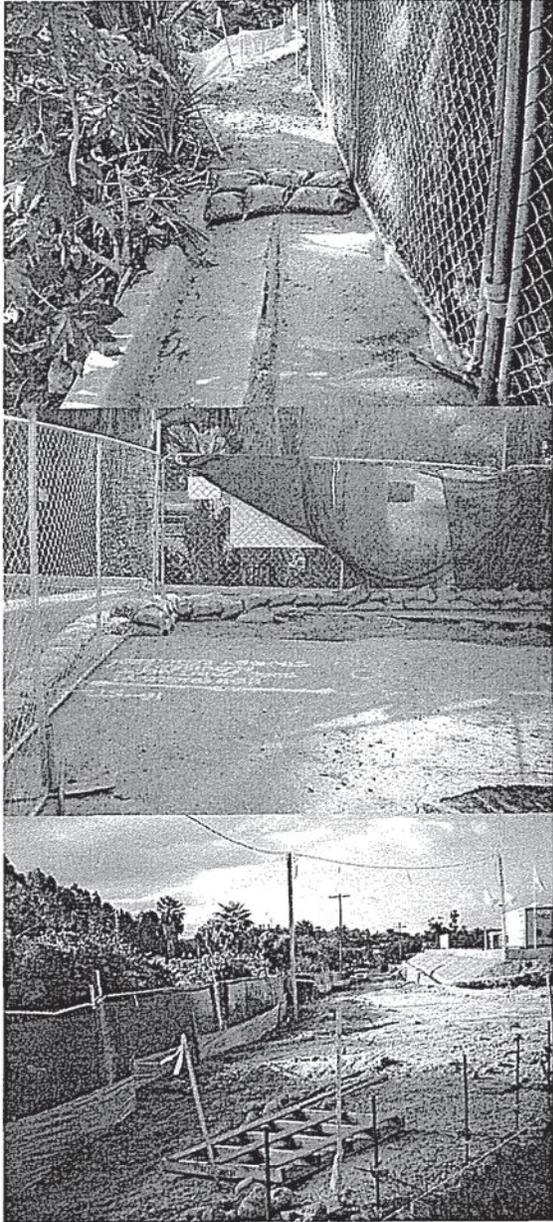
6: Failure to Implement Adequate Perimeter Sediment Controls

Observation: On December 4, 2014, the San Diego Water Board inspected the Valencia construction site (WDID 937C369143). San Altos Lemon Grove LLC is the Legally Responsible Person (LRP) enrolled under the Construction General Permit (CGP) for the site. On December 4 and 11, 2014, the City of Lemon Grove documented unauthorized discharges of sediment and sediment-laden storm water from the site due to inadequate implementation of best management practices (BMPs). On December 15, 2014, the San Diego Water Board inspector observed evidence of sediment discharged from the site due to inadequate and ineffective implementation of BMPs, constituting an unauthorized discharge of sediment from the site. See attached December 15, 2014 Facility Inspection Report Photos 9 through 12 and Attachments.

not established or maintained to sufficiently control erosion and sediment discharges from the site. See attached December 15, 2014 Facility Inspection Report Photos 9 through 14.

These photos show the implementation of perimeter sediment controls and run-on/runoff controls to prevent discharges of sediment from the site.

Response: We repaired and supplemented the perimeter silt fence and gravel bags on the southern and eastern perimeters. Additionally, we have

implemented additional gravel bags crossing graded streets at the project entries providing additional containment. Lastly, we have stockpiled straw wadde and gravel bags at the entries for pre rain staging.

Response: See response No. 1. Specifically, improved run-on and runoff controls were installed San Altos entry, Akins entry, and 69th Street & Broadway locations.

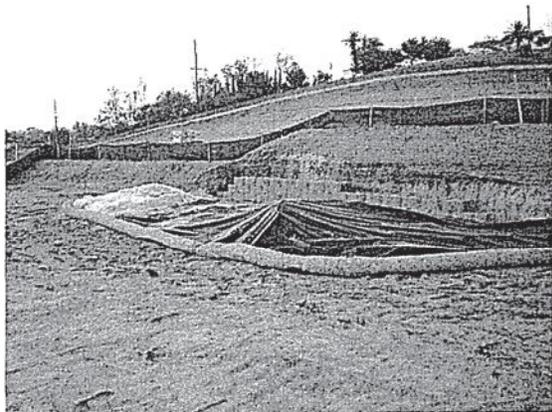
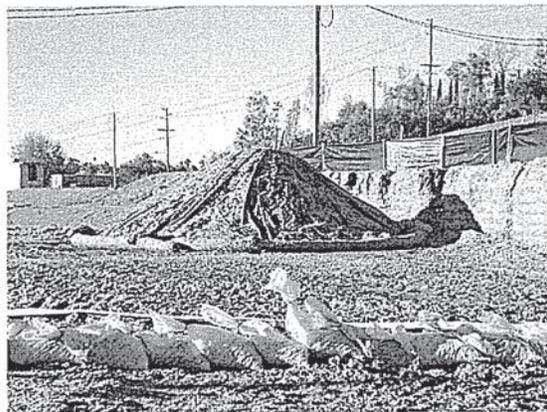
3: Soil Stockpiles

These photos show material stockpiles with cover, berm, or containment to prevent erosion and sediment transport

Response: All existing covered stockpiles were enhanced with the straw waddle and gravel bags at the perimeter of the stockpiles.

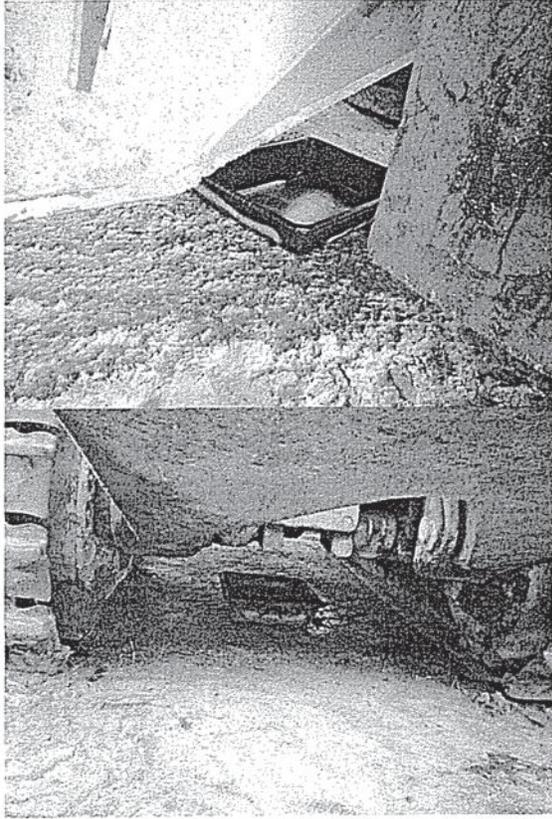
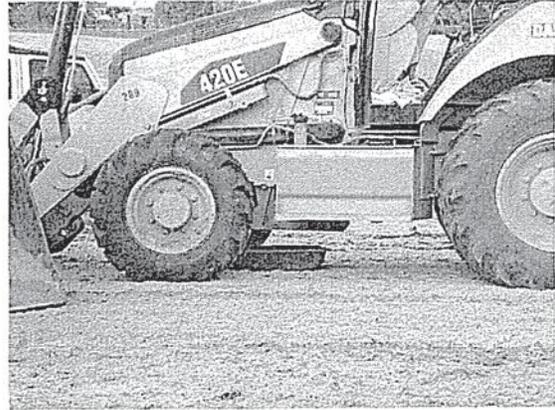
4: BMP's for Vehicle Storage and Maintenance

- a. **Pursuant to Provision X and Section B.3.a of Attachment D of State Water Board Order No. 2009-0009-DWQ:** Risk Level 2 dischargers are required to prevent oil, grease, or fuel to leak in to the ground, storm drains or surface waters.
- b. **Pursuant to Provision X and Section B.3.b of Attachment D of State Water Board Order No. 2009-0009-DWQ:** Risk Level 2 dischargers are required to place all equipment or vehicles, which are to be fueled, maintained and stored in a designated area fitted with appropriate BMPs.
- c. **Observation:** During the December 15, 2014 inspection, the San Diego Water Board inspector observed several construction vehicles stored without appropriate BMPs to prevent oil, grease or fuel to leak in to the ground, storm drains or surface waters. See attached December 4, 2014 Facility Inspection Report Photos 2 and 3.

Photos with vehicles stored with appropriate BMP's

Response: Owner met with all contractors immediately after December 15, 2014 on site meeting. Contractors were notified that under no circumstances that equipment may be parked drain pans. Contractors are now required to park in identified specific areas provided by project management. Project management providing daily inspection regarding drain pans.

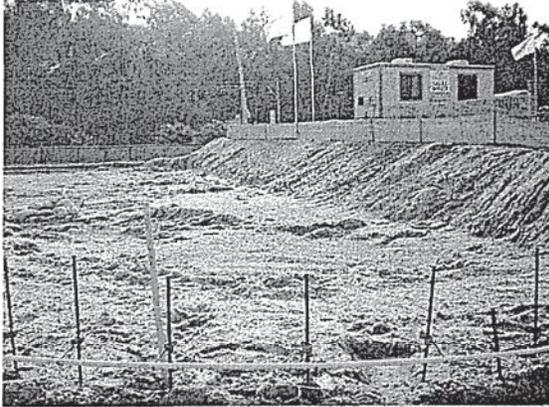
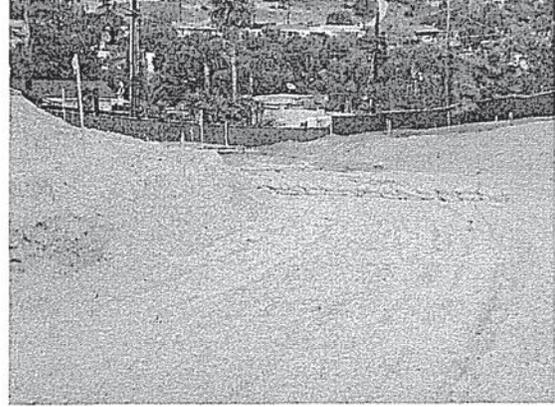
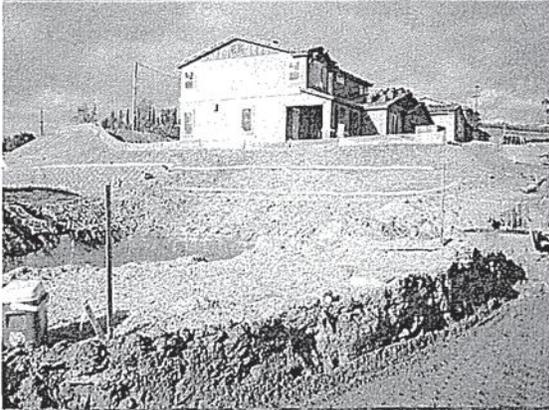
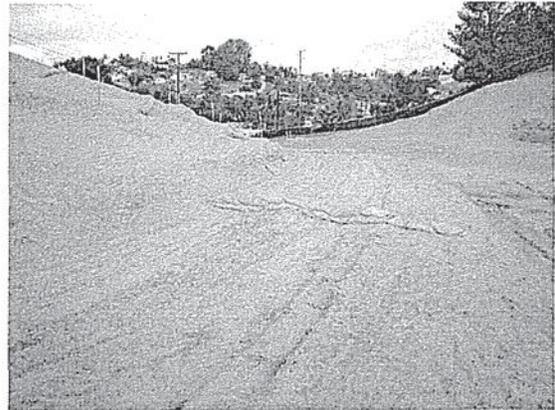
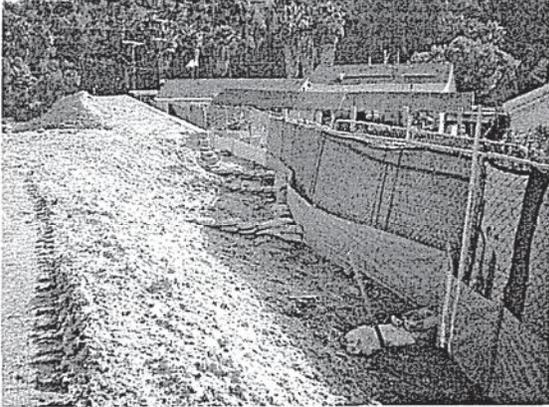
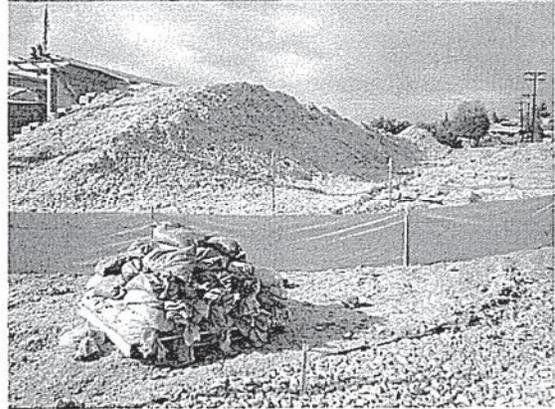
5: Erosion Control for Inactive Areas

- a. **Pursuant to Provision X and Section D.2 of Attachment D of State Water Board Order No. 2009-0009-DWQ:** Risk Level 2 dischargers shall provide effective soil cover for inactive areas and all finished slopes, open space, utility backfill, and completed lots.
- b. **Observation:** During the December 15, 2014 inspection, the San Diego Water Board inspector observed several completed building pads and slopes on the site that appeared to be inactive, or could be scheduled to be inactive, without effective soil cover or other BMPs that could prevent erosion. Evidence of erosion and sediment transport due to lack or erosion control measures for inactive areas were observed throughout the site during the inspection. See attached December 15, 2014 Facility Inspection Report Photos 4 through 7.

Photos of completed pads or slopes with effective soil cover or other BMP's to prevent erosion

Response: Rills have been repaired in active and in active areas. Straw waddle has been installed in areas where required or necessary. Active and inactive areas were hydro seeded where necessary. Silt fencing and gravel bagging of inactive areas or completed lots has been implemented and will be ongoing when areas become inactive.

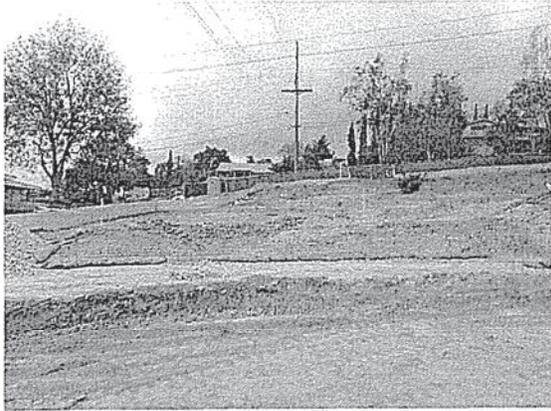
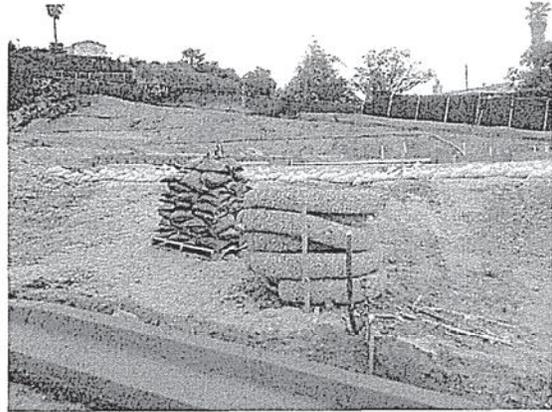
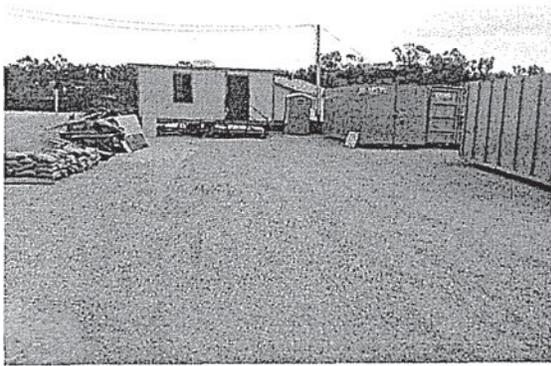
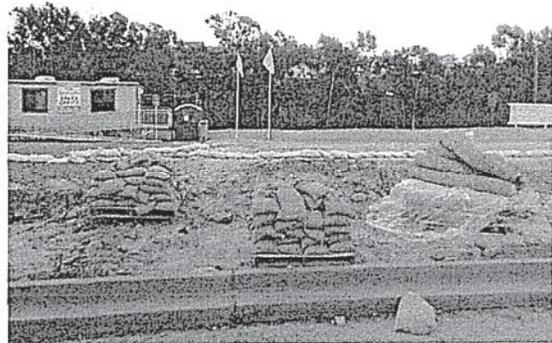
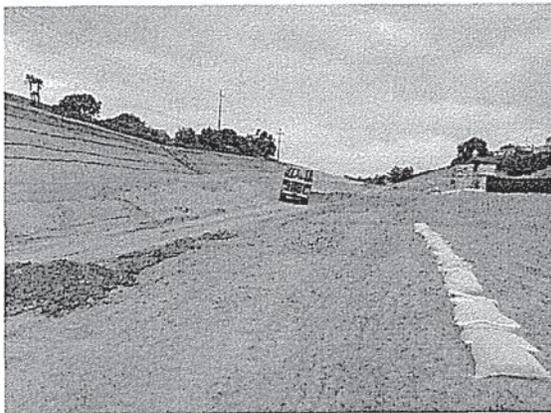
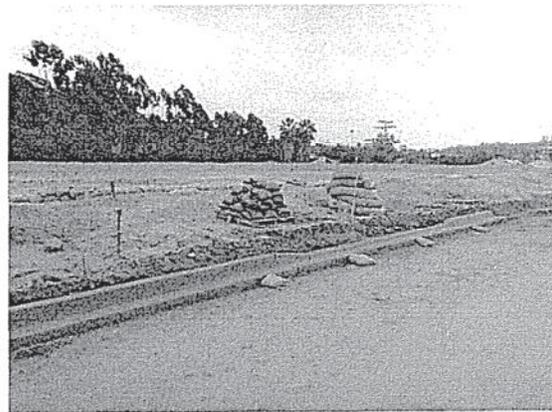
7: Failure to Implement Adequate Controls for Active Areas

b. **Observation:** During the December 15, 2014 inspection, the San Diego Water Board inspector observed several active areas of the site that did not have appropriate erosion control BMPs in place or ready to be deployed. See attached December 15, 2014 Facility Inspection Report Finding 4 and Photo 8.

Photos of active areas with appropriate erosion control BMP's in place or ready to be deployed

Response: See response to No. 5. Additionally, deployment of straw waddle and gravel bags has been placed in strategic areas in the project ready for deployment prior to rain events.
