Stream Health Assessment and Index Development in Malibu Creek

November 30, 2004
Shelley Luce and Mark Abramson
Heal the Bay

Sponsored by the California Coastal Conservancy and the SMBRC

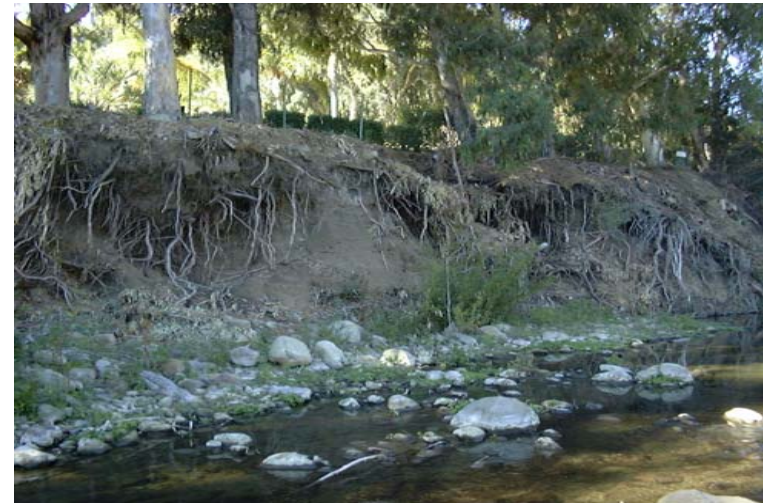
Unstable Stream Banks

Stream Walker mapping unstable stream bank and associated field sheet.

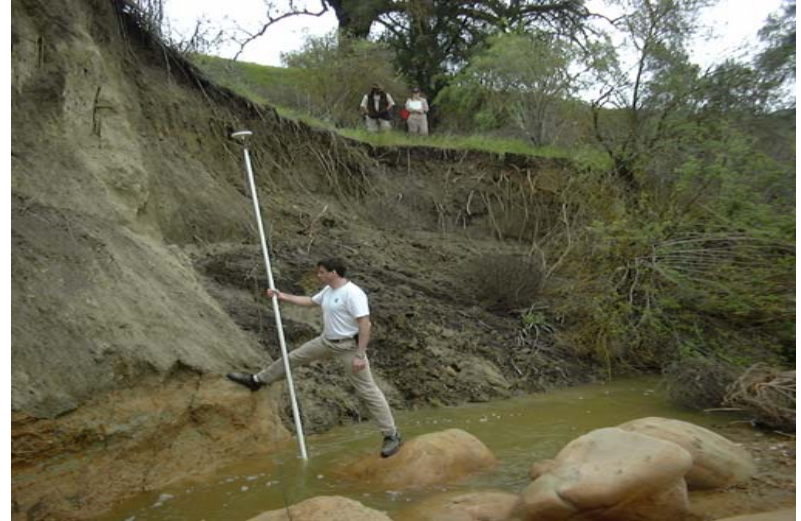
**Unstable stream banks: 18.7
(27%)** linear miles of eroding stream
banks

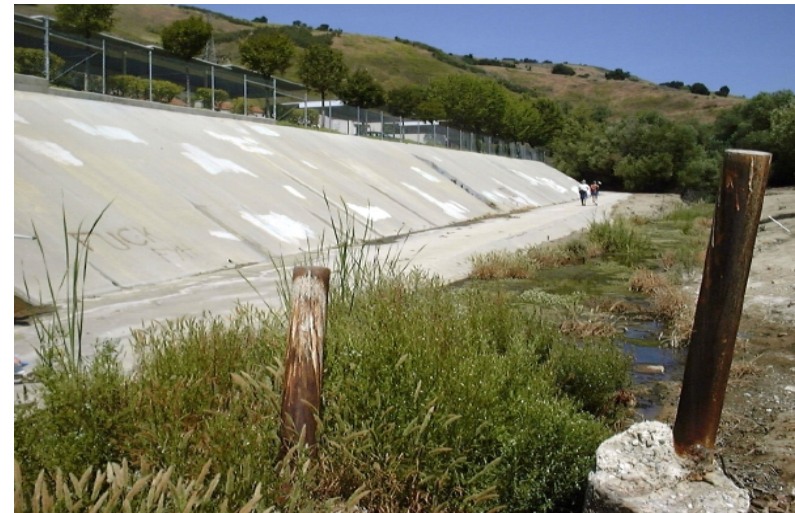
**Streambank Modifications: 19.8
(28%)** linear stream miles are
armored

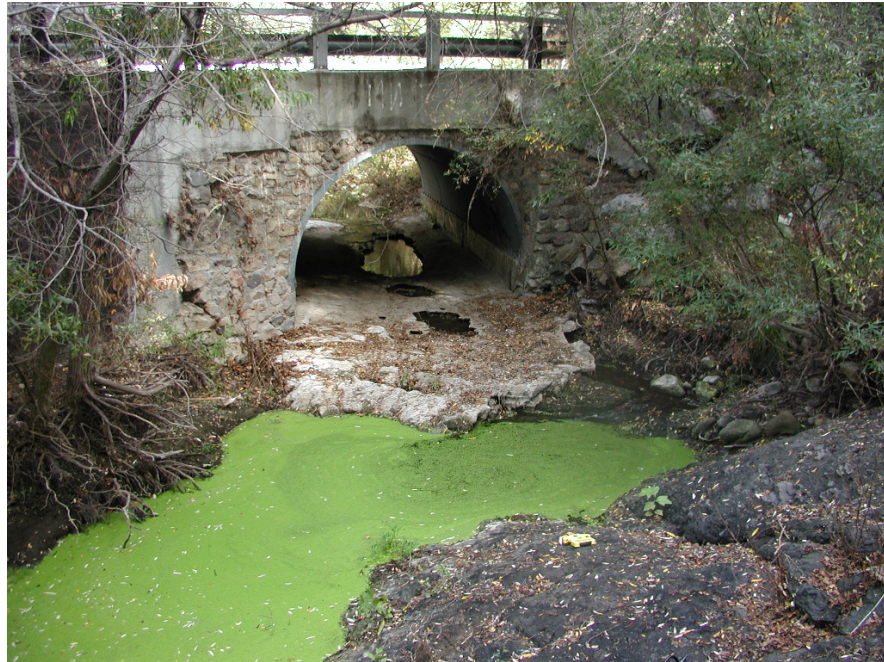
171 separate fish barriers

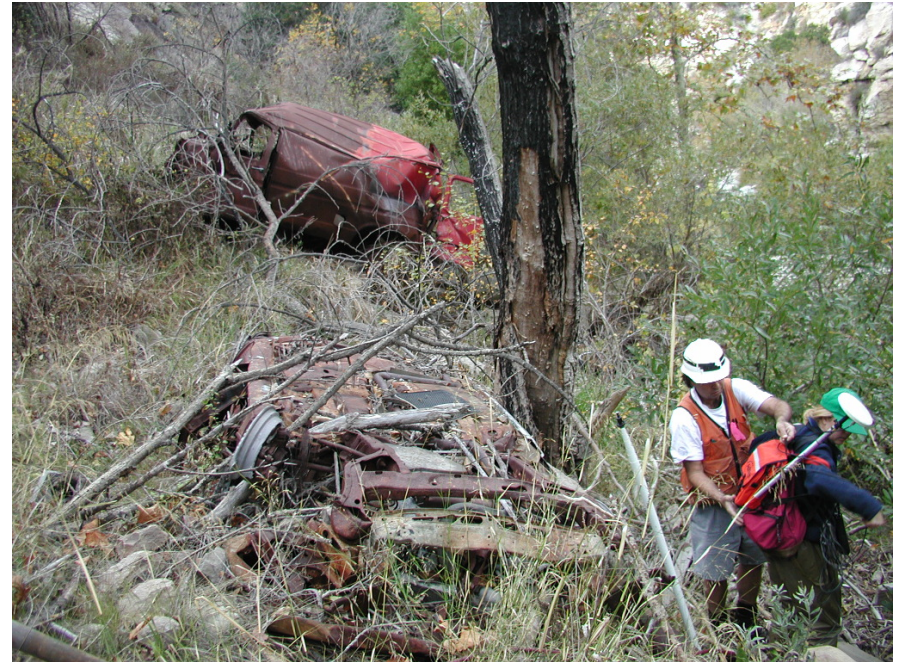
636 illegal dump sites

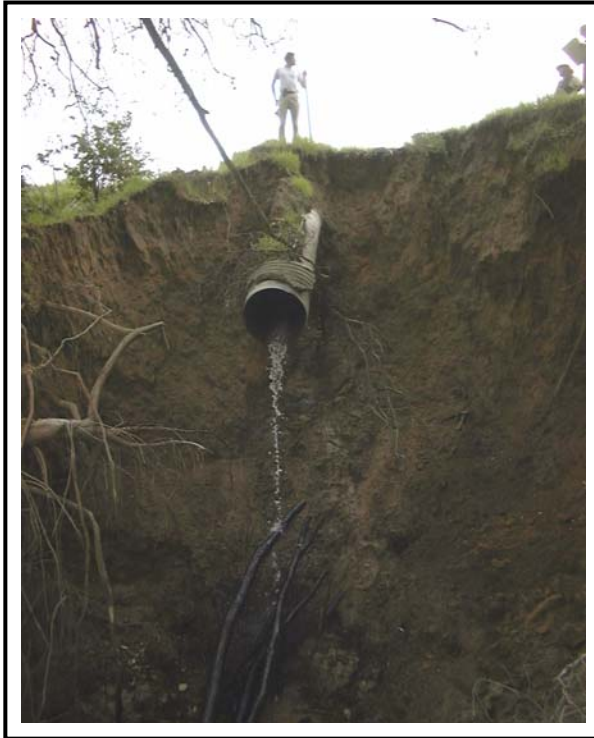
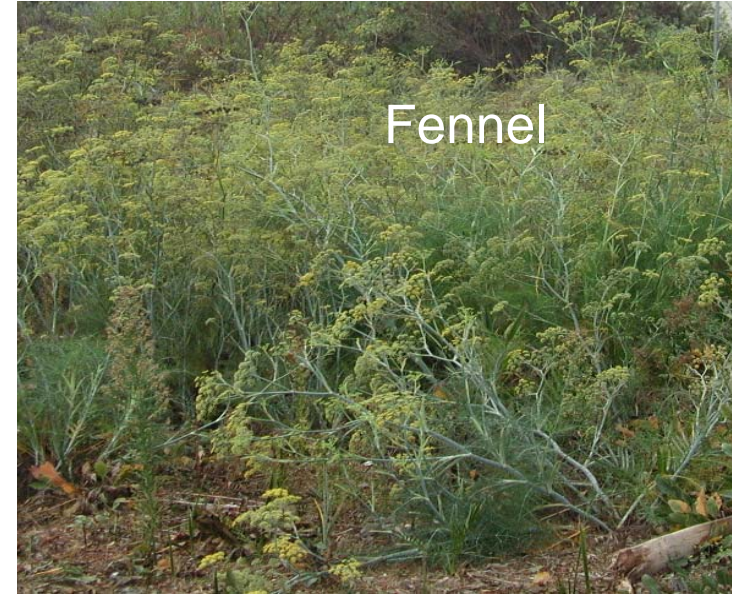
- **Invasive Vegetation: 16.9 (24%)** linear miles of riparian zone impaired
- **20** different types of invasive veg

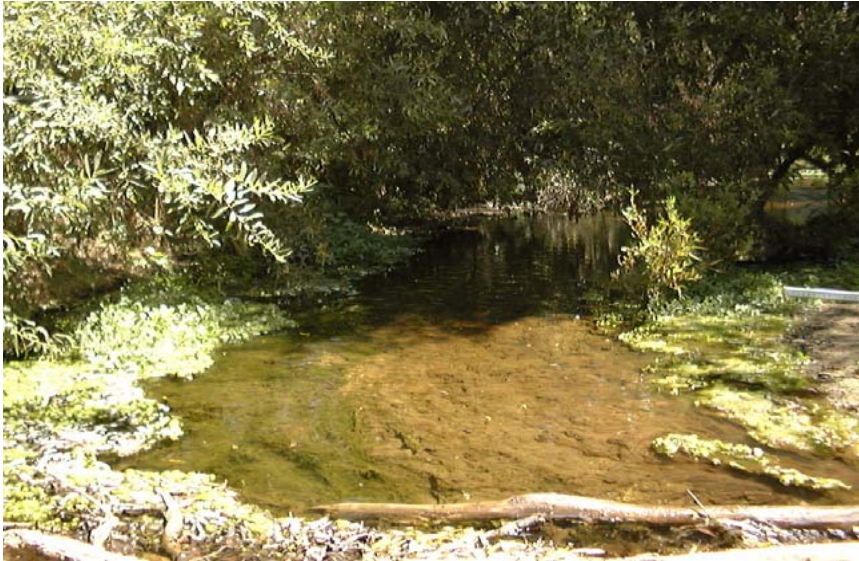
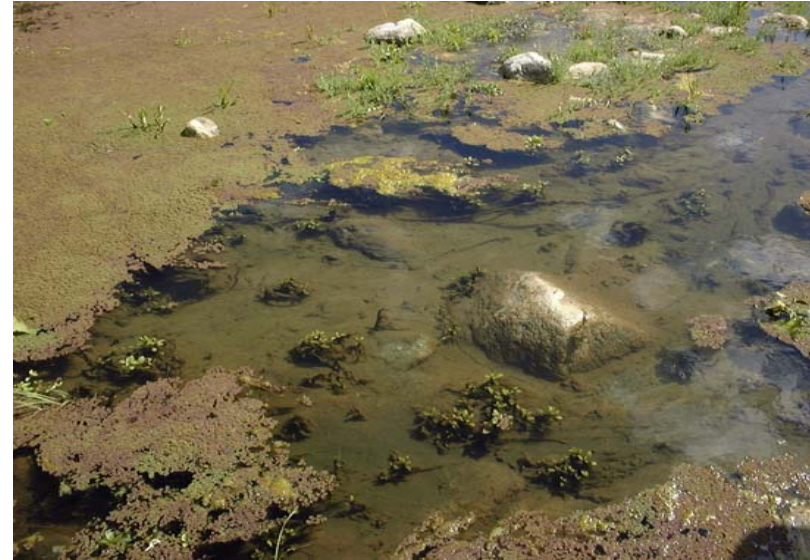
- **736** discharge points mapped, many causing bank erosion

- **21.7** linear miles (**30.8%**) of streams impaired by algae
- **22.1** linear miles (**31.3 %**) of streams impaired by sediment
