REDWOOD CREEK POOL COVER PROJECT

California Department of Fish and Game

FG-1251

FINAL REPORT

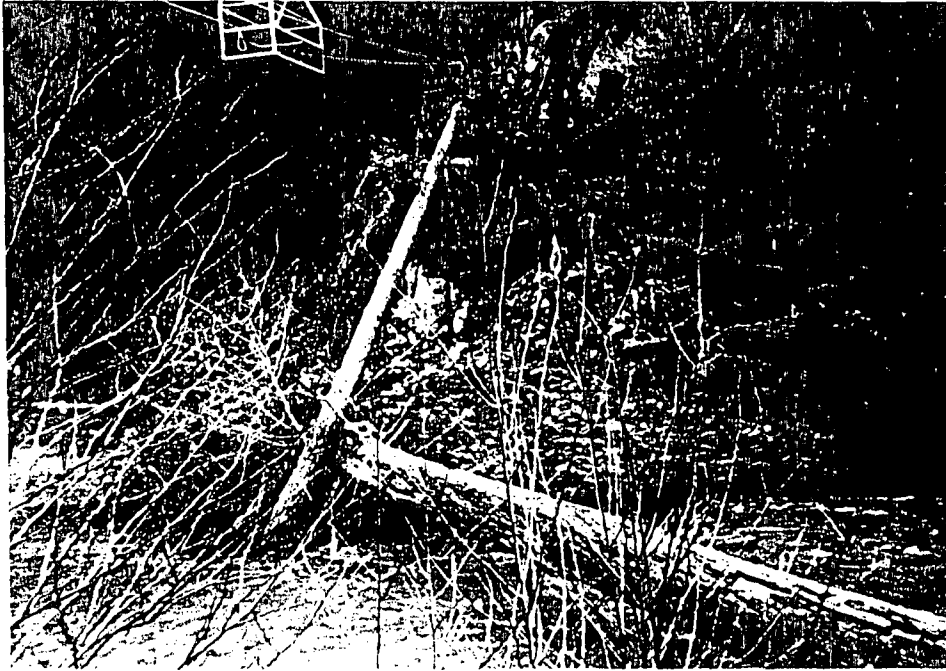
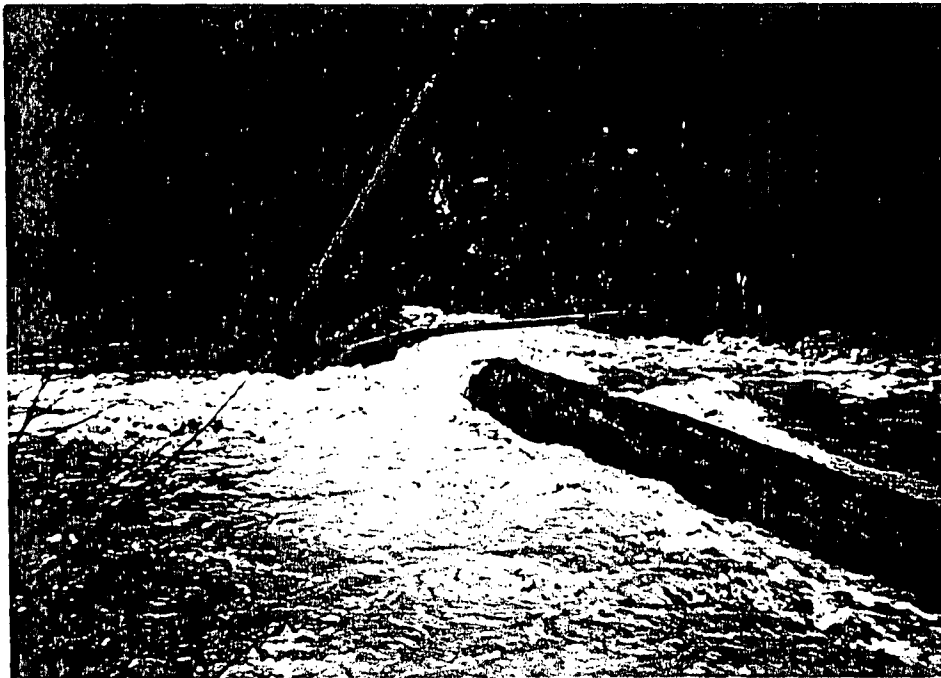
FIGURE #3

Structure photographs (Two upper photo's at 800 CFS flow. Two lower photo's same sites at 4,000 CFS flow.)
