REDWOOD CREEK SUMMER STEELHEAD RECOVERY PROJECT

FINAL REPORT

Contract # FG 7058 IF

**California Department of Fish and Game
Inland Fisheries Division
1997/1998 Fishery Restoration Grants Program**

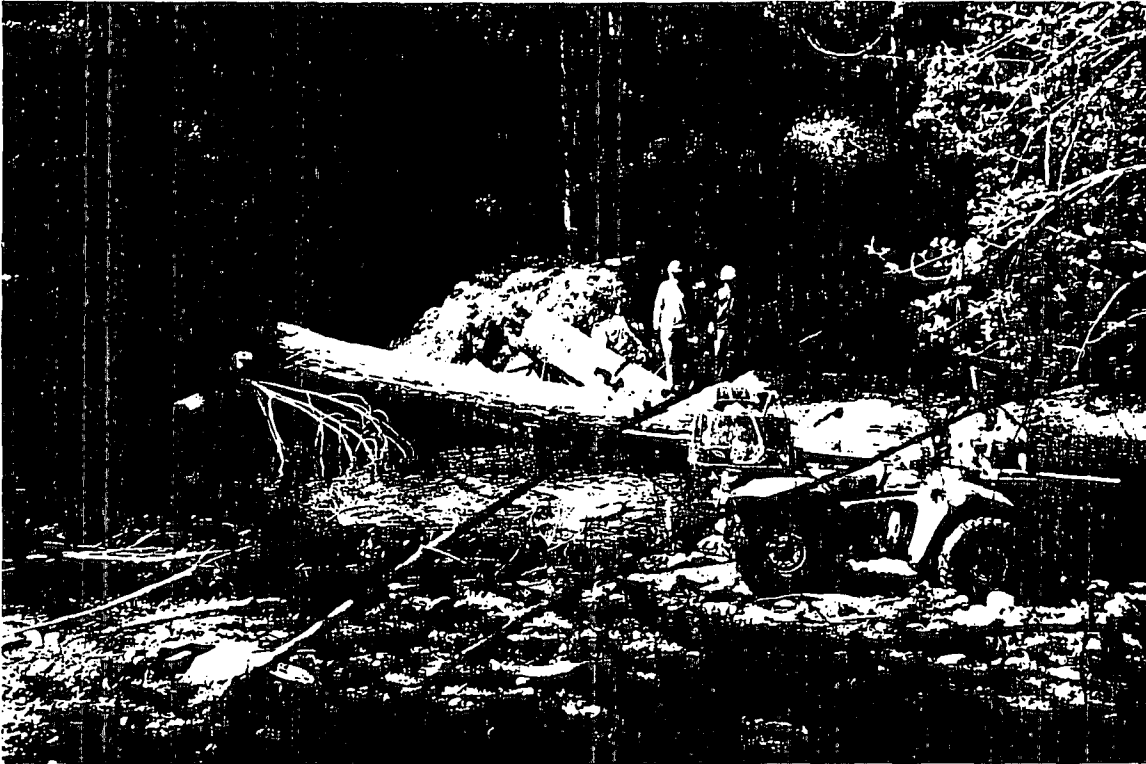
1996 completed
LWD Cover Structure

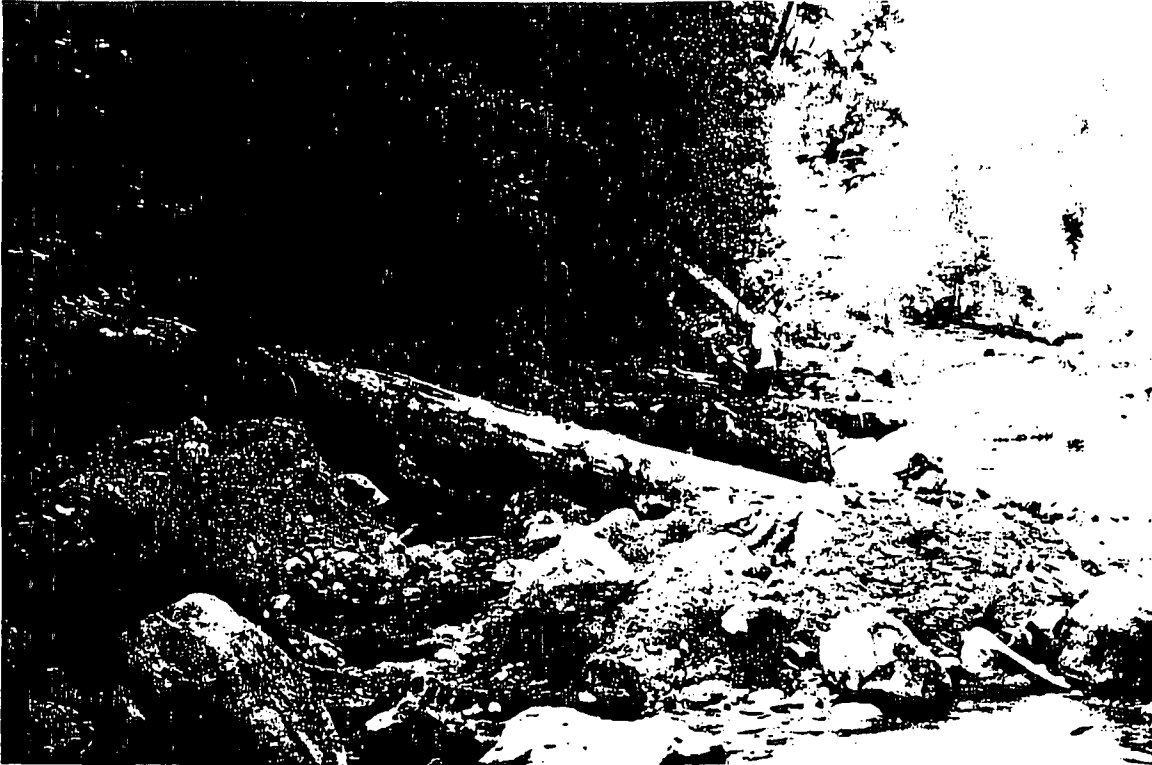
Completed LWD
Cover Structure

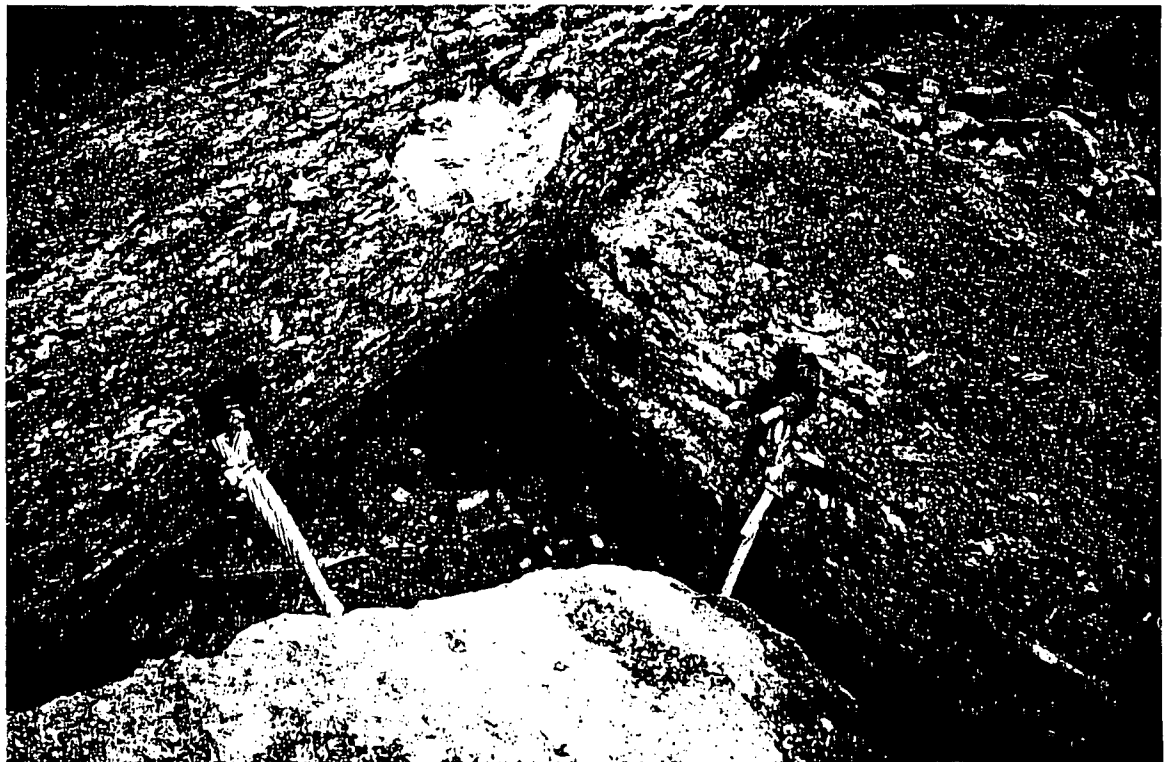
Cable eye to threaded
rebar anchors securing
LWD to boulder
