Greenwood Creek Stream Survey: Data Analysis and Recommendations

May 15, 1996

*Greenwood Creek Watershed Project
(GT-5-95-08-011)*

Prepared by Forest, Soil & Water, inc.

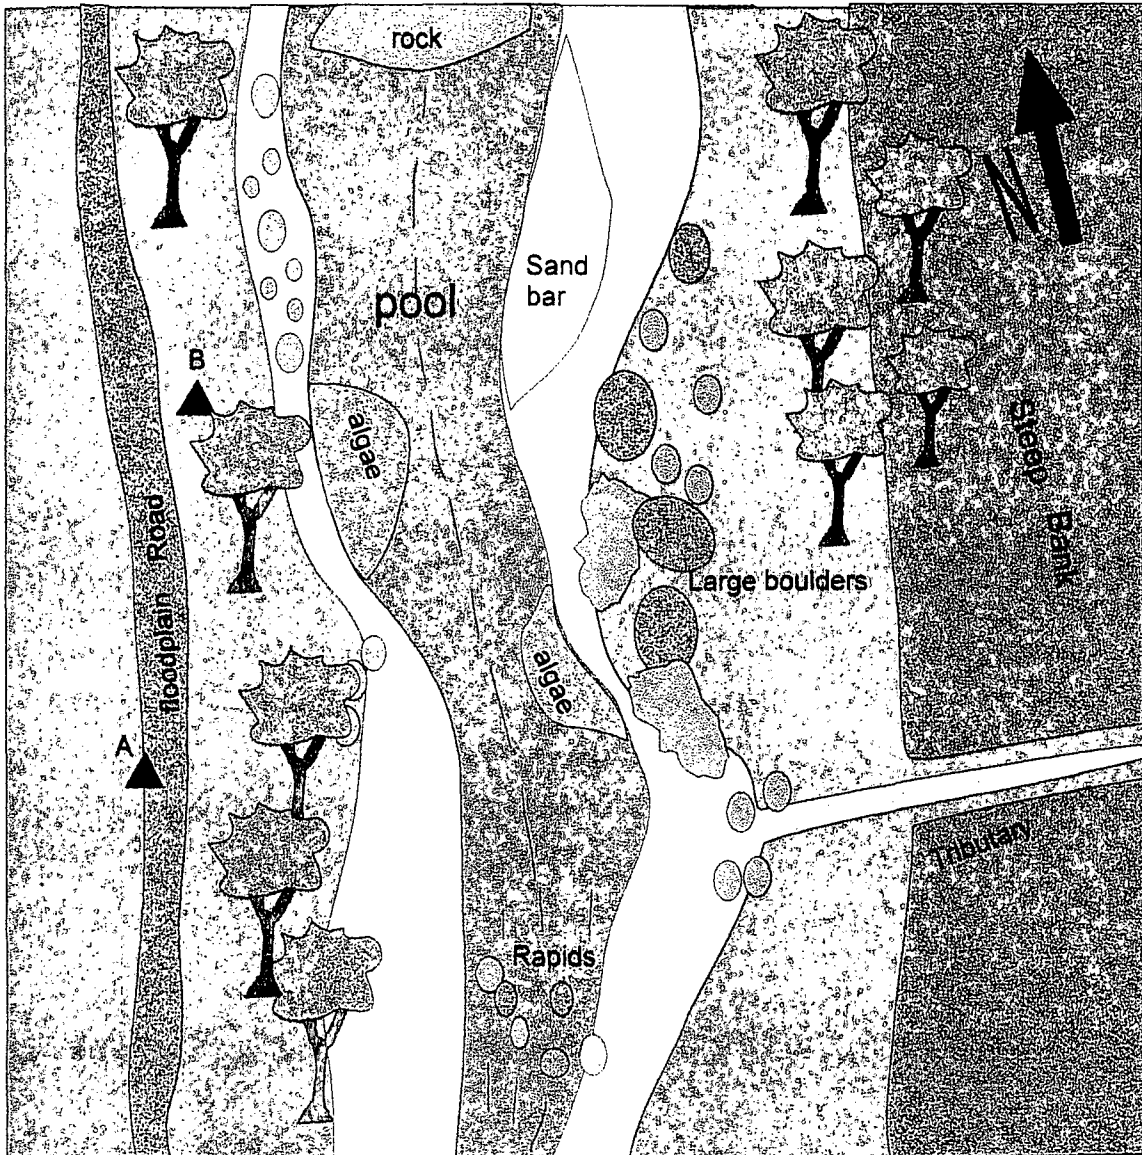
Figure 1.

1. Location: .Large cobble running creek, upstream from Commons Flat
2. Valley Morphology: constricted
3. Channel Morphology: riffle-pool-obstruction
4. Channel pattern: straight
5. Bank Morphology: ramped 75% squared 15% overhanging 15%
6. Bank condition: unvegetated 75% vegetated 30% wood or root wads 5% eroding actively contributing sediment 30%

Transect A. Active channel location 9.7 ft Alternative channel locations ____
 Edge of plain locations + 23 ft ,6. Total length of transect 29m
 Transect B. Active channel location 5.0 ft. Alternative channel locations ____
 Edge of plain location + 22, -4.3. Total length of transect 26.3

Sample no. 6 meter location 1230 -1260 scribe's name Dave date 7/23/95

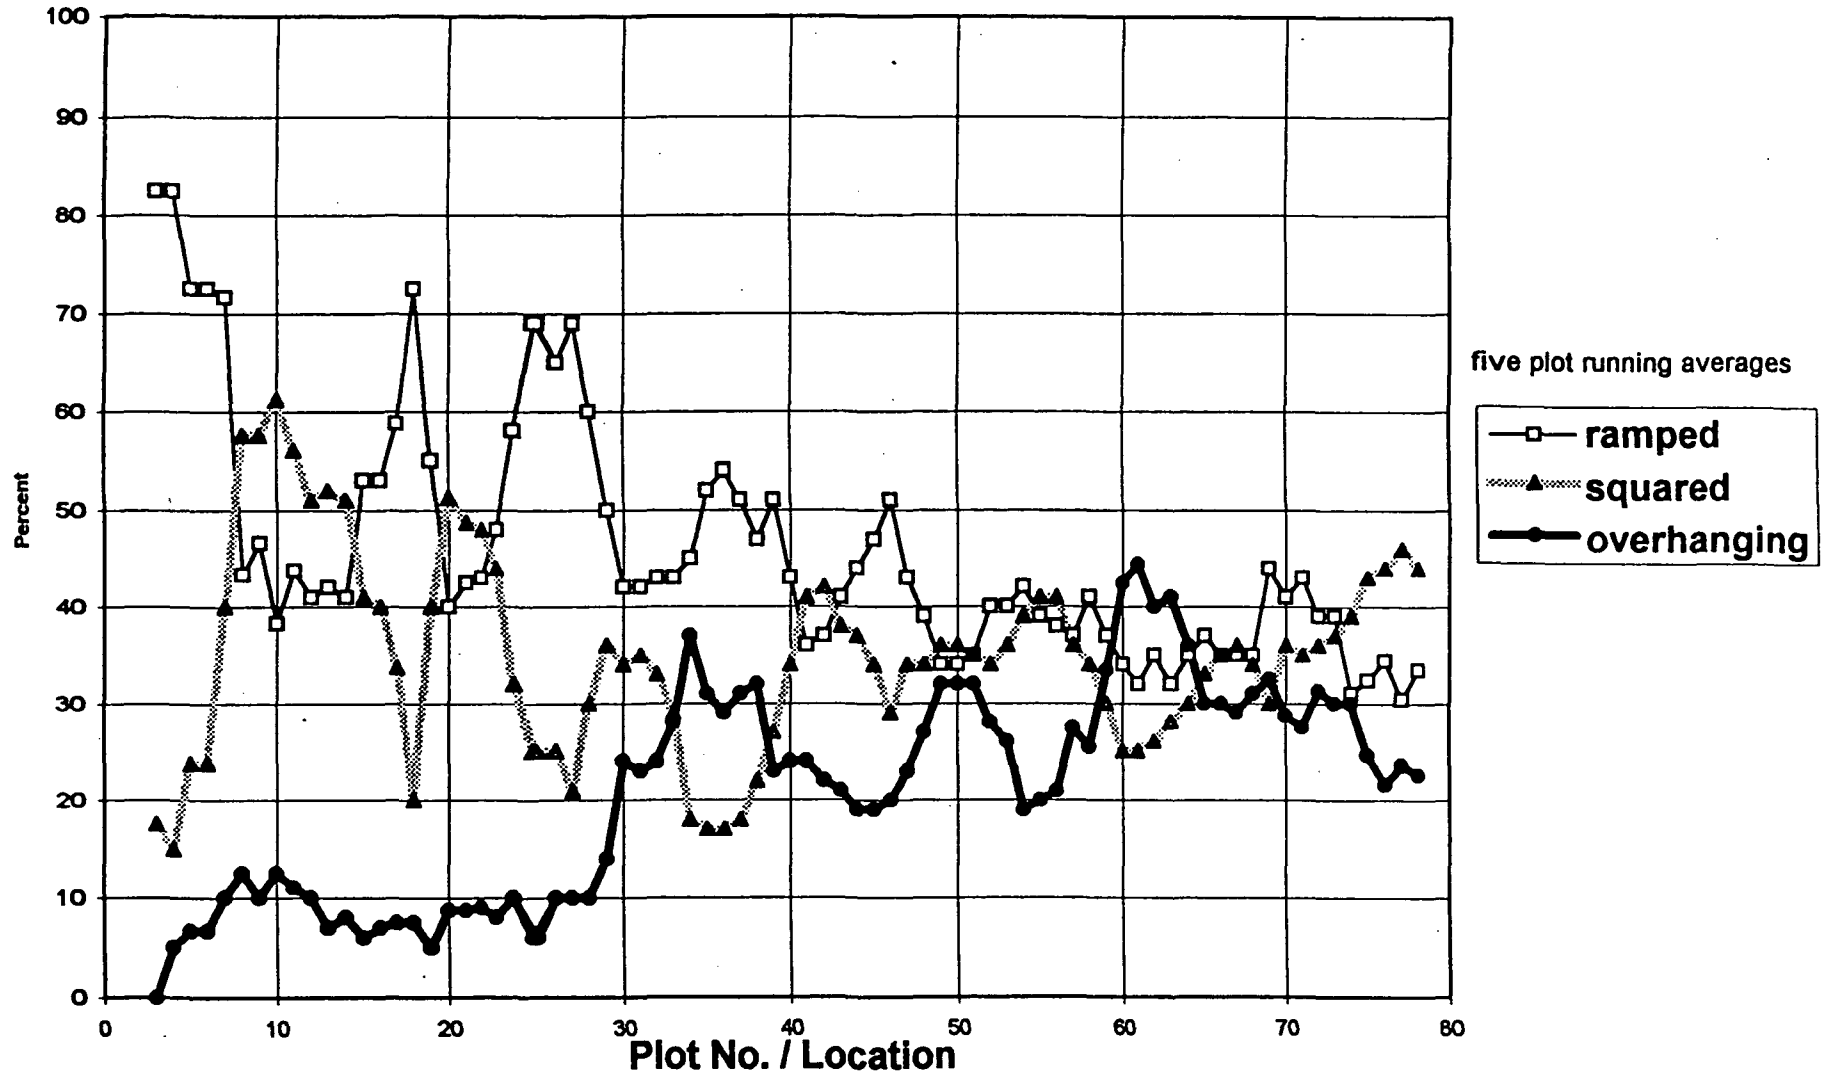
Figure 2.

Bank morphology was evaluated for each 30 meter sample reach, along both sides of the creek. Crews estimated the percent of bank that was ramped, squared or overhanging, with a sum total equal to 100%. Figure 2 shows Greenwood Creek bank morphology. Starting from the lower reaches of the creek in the broad floodplain, the banks tend to be highly ramped and/or squared. Moving upstream, from site banks get more overhanging and the distribution of bank conditions is more equally spread between the three types of morphologies (from site 50 and above).

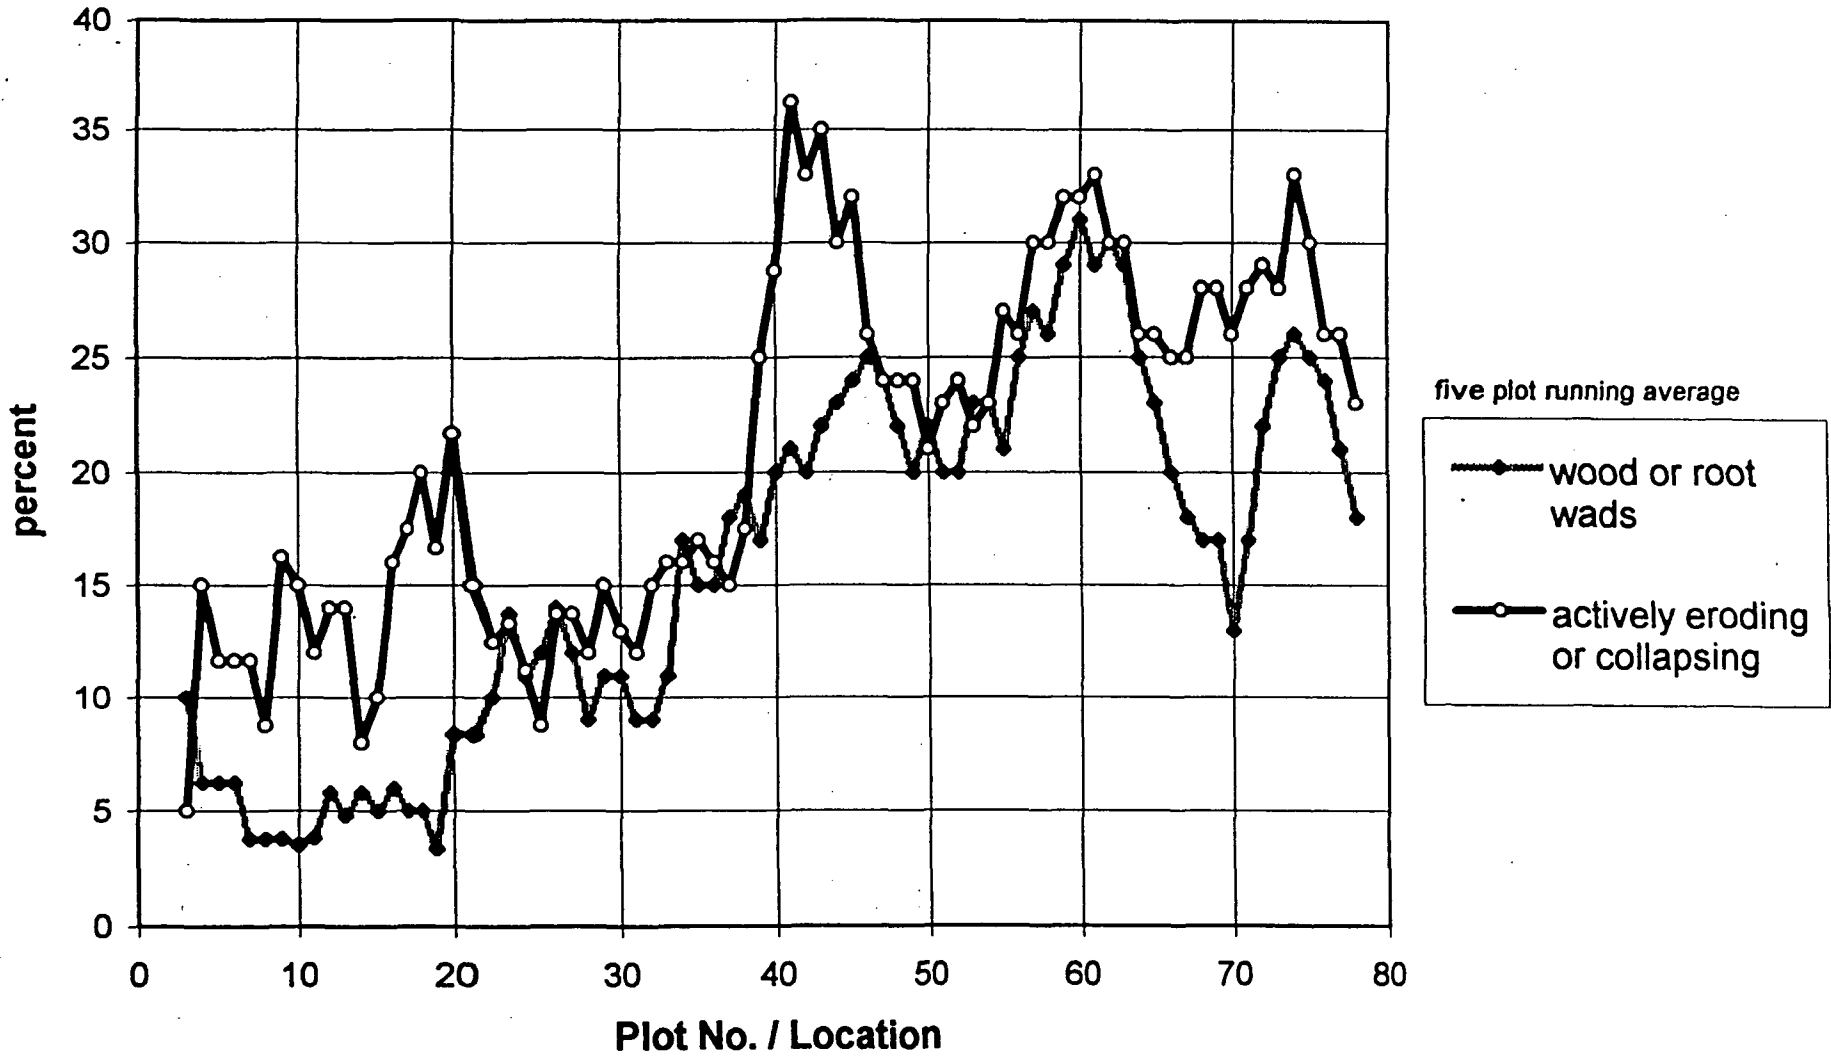
Figure 3.

Banks were also evaluated as to whether they were 1) vegetated, 2) unvegetated, 3) composed of wood or root wads and 4) actively eroding or collapsing. Figure 3 shows a running average of the distribution of bank conditions for sampled sites on Greenwood Creek. Note the higher percentages of actively eroding or collapsing banks in the upper reaches of the watershed above site #40, relative to stabilizing elements. Also note the marked peaks of collapsing banks in the vicinity of plots #16-20 and #38-43. These sites stand out as good stretches of the creek to revisit and assess for restoration and bank stabilization projects. Figure 4 shows the vegetated and unvegetated state of Greenwood Creek banks. Sample sites #12-17 show high percentages of unvegetated, squared and ramped banks and coincide with reaches of eroding banks. These sites should be revisited to evaluate potential for restoration and bank stabilization.

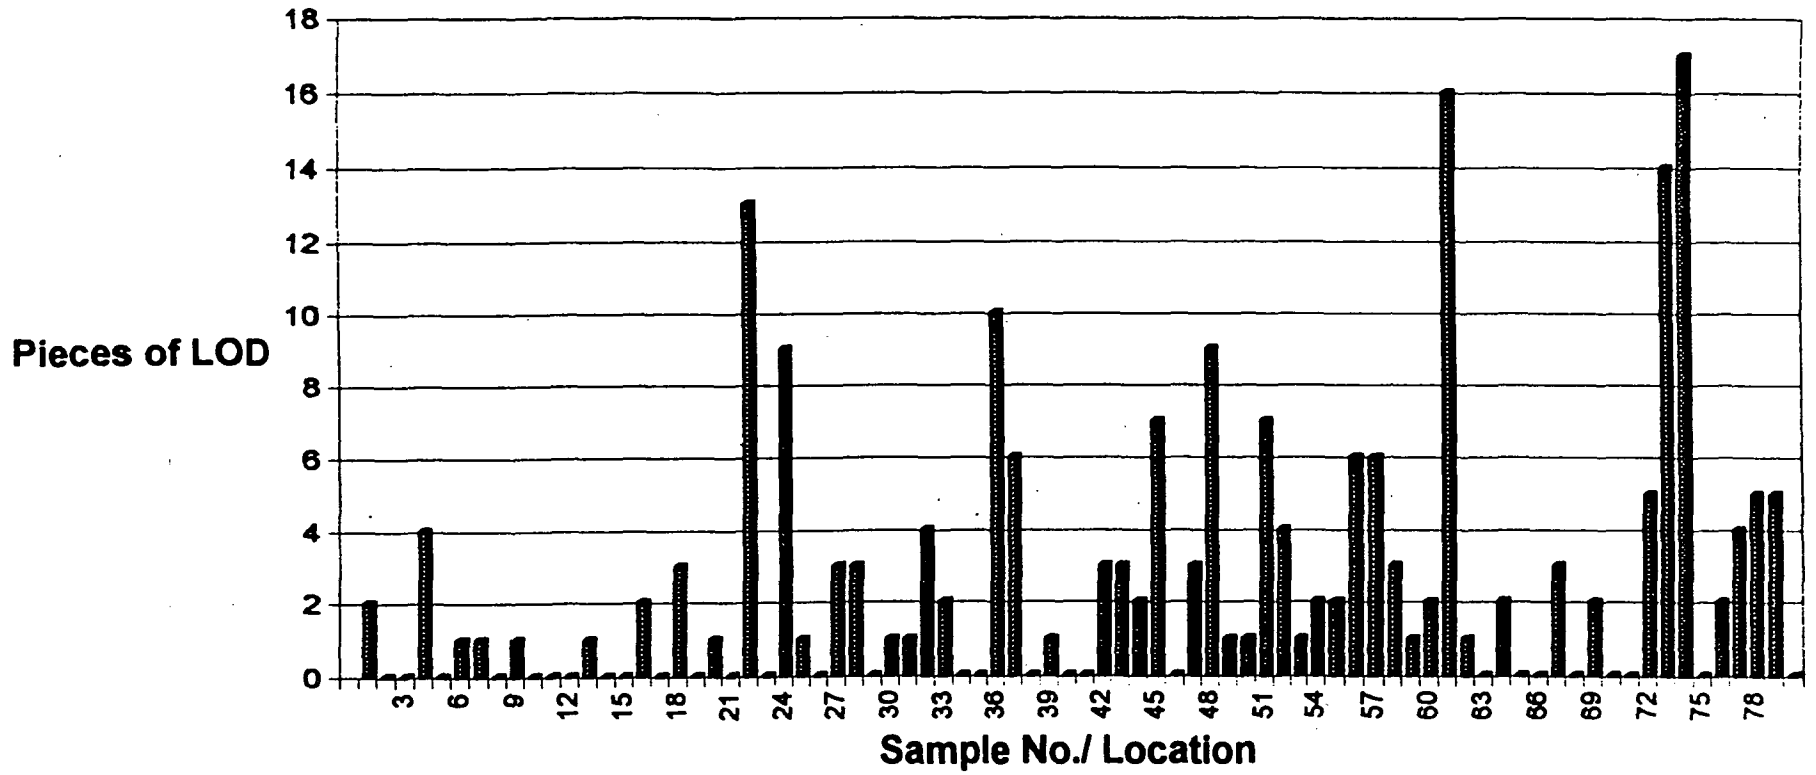
Figure 5.

For the purpose of this study, Figure 5 shows the total number of *functional* woody debris elements found within sample sites on Greenwood Creek. Amount of woody debris per sample site ranged from zero to seventeen pieces per sample plot. 66% of sampled sites had 2 or less pieces of functional LWD, and 36% of the sites had none. Only 20% of the sampled sites showed a count of five or more functional woody debris elements. This may be due to high flows moving the LWD through the system, but, as discussed below, appears to suggest a clumpy distribution in log jams.

The lower half of the creek showed significantly lower levels of LWD per sample site, with the exception of large log jams that were located in and in between plots #1 to 4. In general, woody debris amounts increase upstream, with the exception to this trend occurring in the upper reaches of the stream between plots #62-71, where LWD drops off considerably. Lower reaches between sites #5-21 and the noted upper watershed sites #62-71 would be good stream reaches to look at for possible recruitment of LWD into the channel. This can be accomplished by widening the riparian buffer zone, falling logs into the channel, and the promotion of large, recruitment conifers and hardwoods in the riparian corridor. Recruitment trees would be marked for eventual falling (natural or assisted) into the stream.

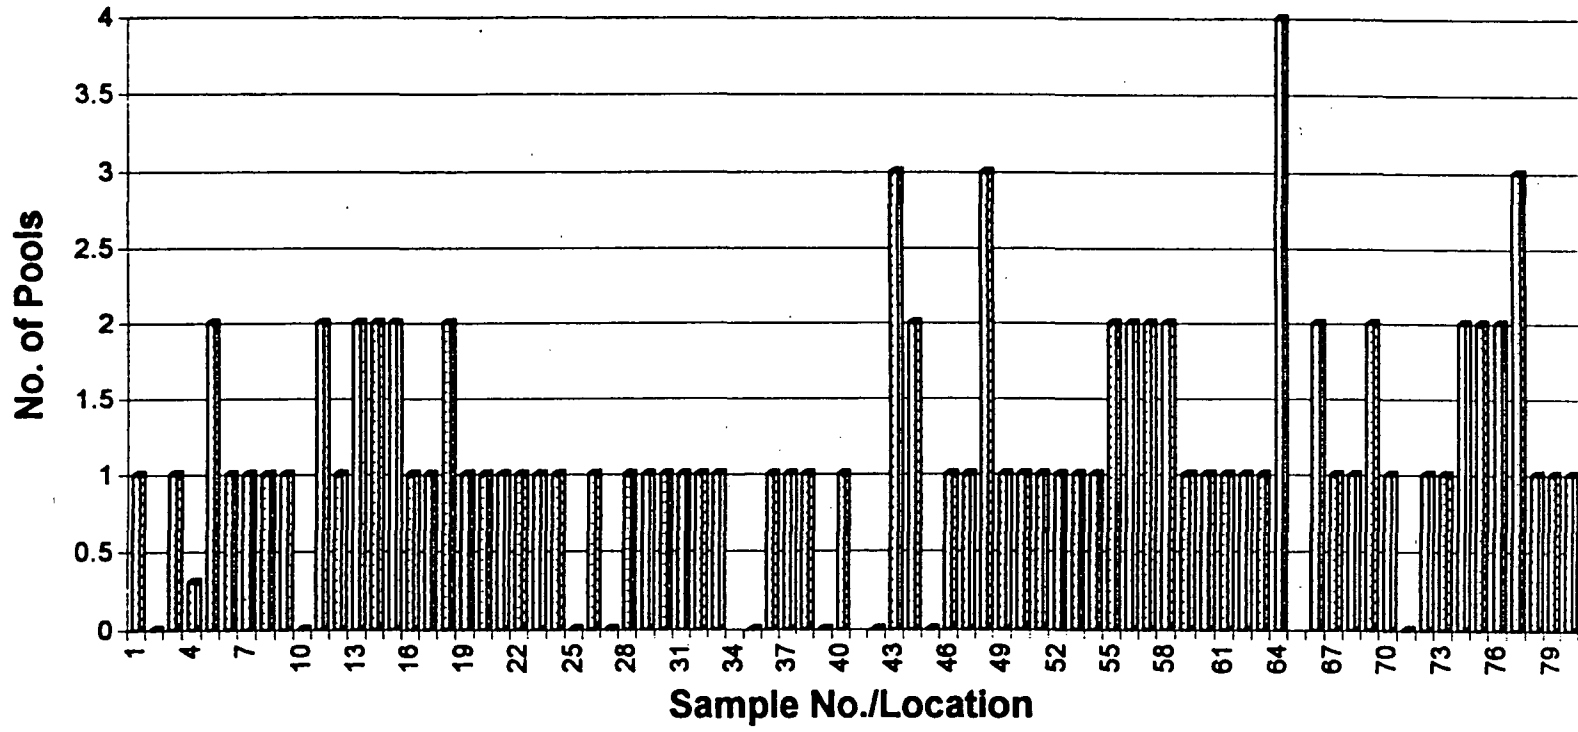
Figure 7.

Many sample sites along the entire length of Greenwood Creek had relatively few pools. 75% of the sites sampled had only one pool or less per 30 meters of stream reach, and 14% of these sites had no pools at all (Figure 7). This lack of pools may be linked to a lack of woody debris or boulders in many of the sites (Hamilton and Bergersen, 1984; FEMAT, 1993), or may be a function of the flow, the meander wavelength and the streambed materials (Leopold et al. 1964)--all directions for further research. After assessing what the 'right' number of pools are, and if they are restricted by woody debris recruitment, habitat restoration

projects on Greenwood Creek may do well to focus on recruitment and stabilization of woody debris into the stream channel to create more pool formation to increase habitat potential for fish.

The first sites which should be evaluated are in the plot #34-45 area, which should be investigated both for causes of few pools and potential for pool creation.

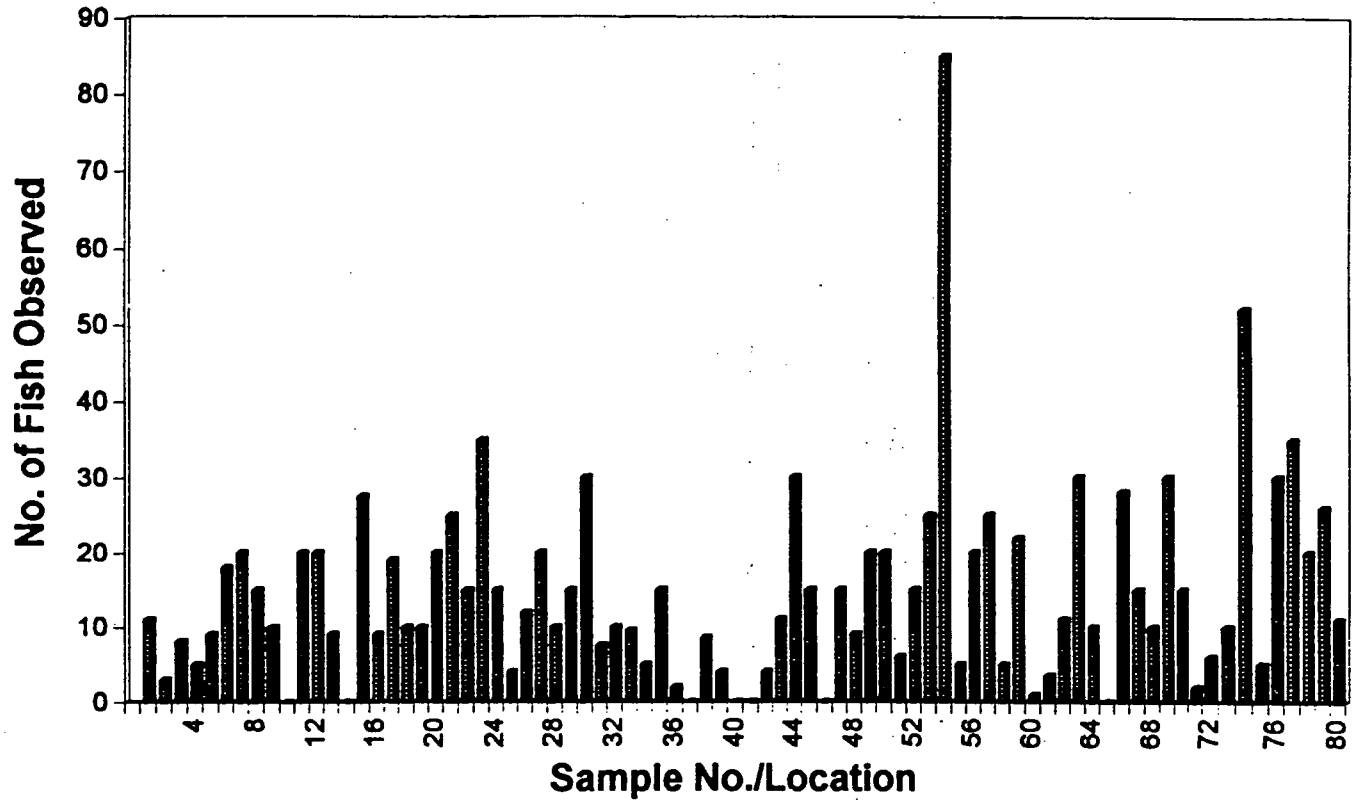
Figure 8.

A noticeable drop in fish numbers, from sites # 37-42, coincides with a large increase in collapsing banks, limited pools and almost no woody debris along that reach of the stream. This trend is best seen in Appendix B, Table 8.

Recommendations for future assessment of fish within Greenwood Creek are to get better population information using snorkel surveys, electrofishing or migrant trapping. This more intense measurement will better assess the number, species and habitats of Greenwood Creek's fish population. A fisheries specialist should be consulted on the direction and detail of survey goals and techniques.

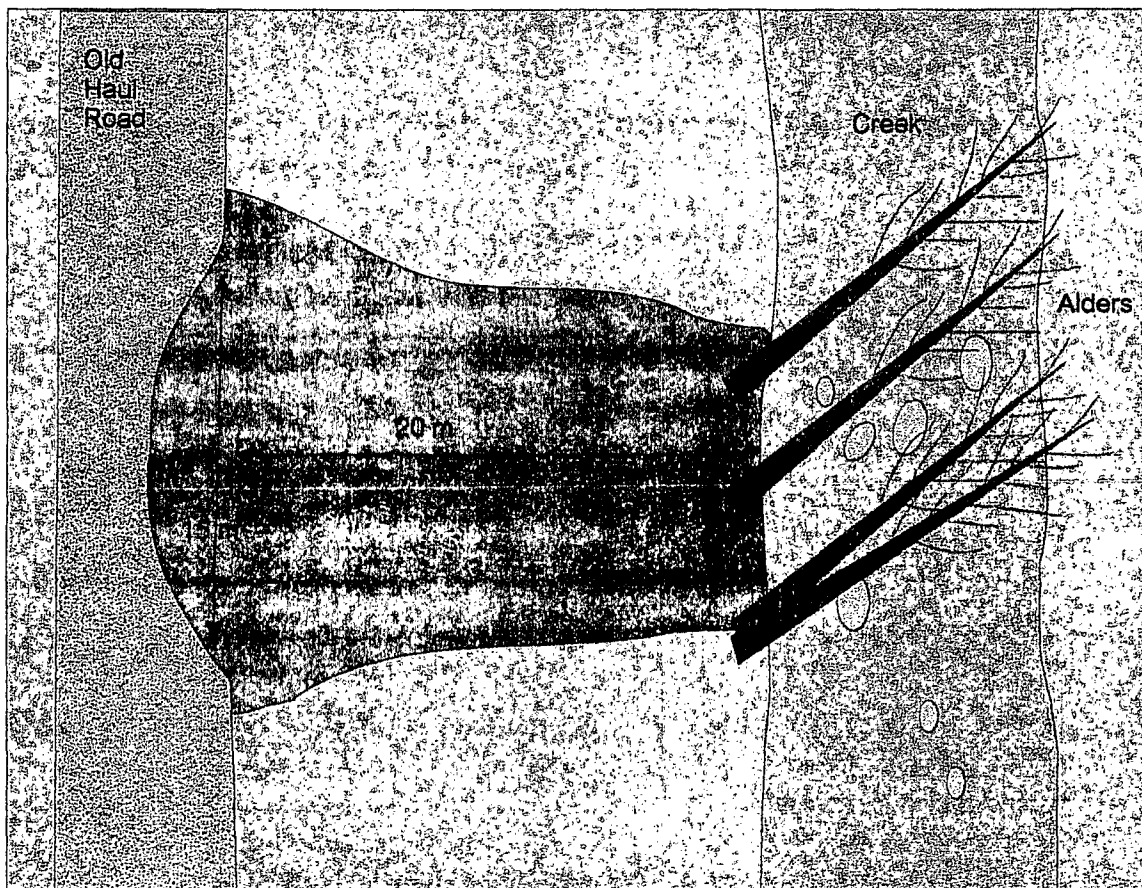
Figure 16.

Sediment Transport Corridors (STC's) are places where sediment enters the stream zone. They may be related to human activities or of natural causes. Roads, logging activities, utility right of ways, construction, and trails made by people, game, and cattle typically create STC's. Sometimes steep slopes or a high stream flow will cause banks to erode and an STC in the form of a landslide occurs. Tributaries are considered a separate category from STC's, although they do transport sediment. Figure 16 is a sample sketch of an STC created by a road

Location of Stream entry Below the "Pigeon Hole"
Facing upstream, the STC drains in from the: Left
Width 15 m. Length 20 m. Depth ?
Describe the source and/ cause:
Failed road. Not proper draining.

sample no. above 9 meter location 1890 to 1910 scribe's name Jesse date 7/25/95

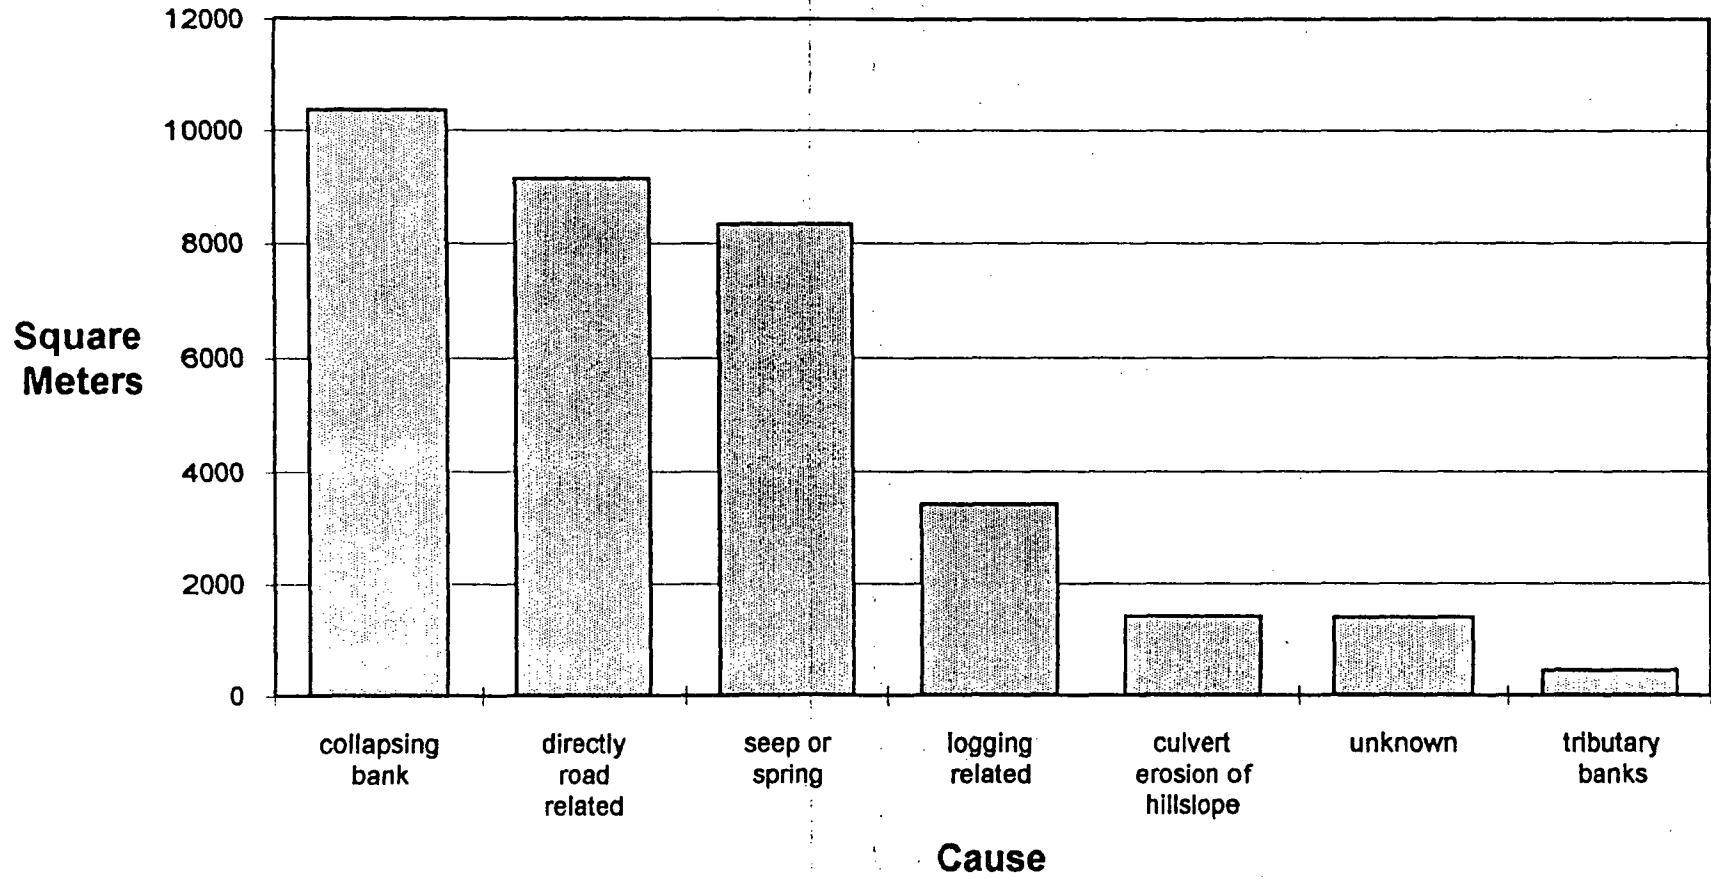
Figure 18.

Field crew were instructed to investigate STC's and follow them from the creek up to source areas. Most probable causes were noted, and are shown in Figure 18, which looks at a sum of STC area relative to cause. The largest amounts of STC area were attributed to 1) collapsing banks along the stream course, 2) roads and 3) seeps or springs. This breakdown is extremely important to consider when planning for water quality or fish habitat restoration. The reason for such high

percentages of collapsing banks, in particular, needs to be investigated. Road related STC's may be the source to reduce, because of the common interest in their repair--both road users and water users will benefit from reduced road erosion. Site specific, in-field, practical remedies need to be considered for every STC.

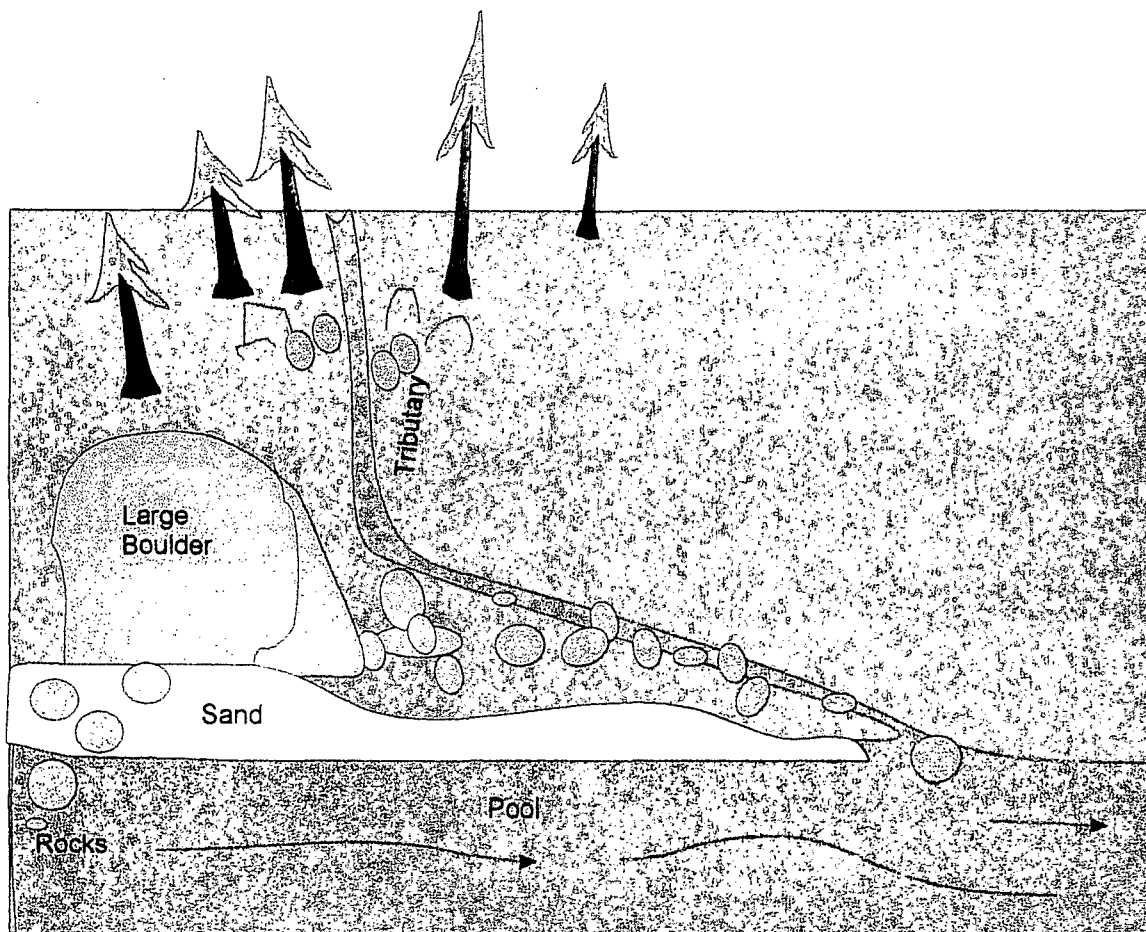
Figure 19.

Channel goes up steep bank through second growth fir and redwood. The channel feeds in behind a large cobble bar and goes underground. Water feeds into stream about 10 m. down stream.

sample no. 6+ meter location 1320 to 1330 scribe's name Dave date 7/23/95
