STREAM INVENTORY REPORT

SAN VICENTE CREEK

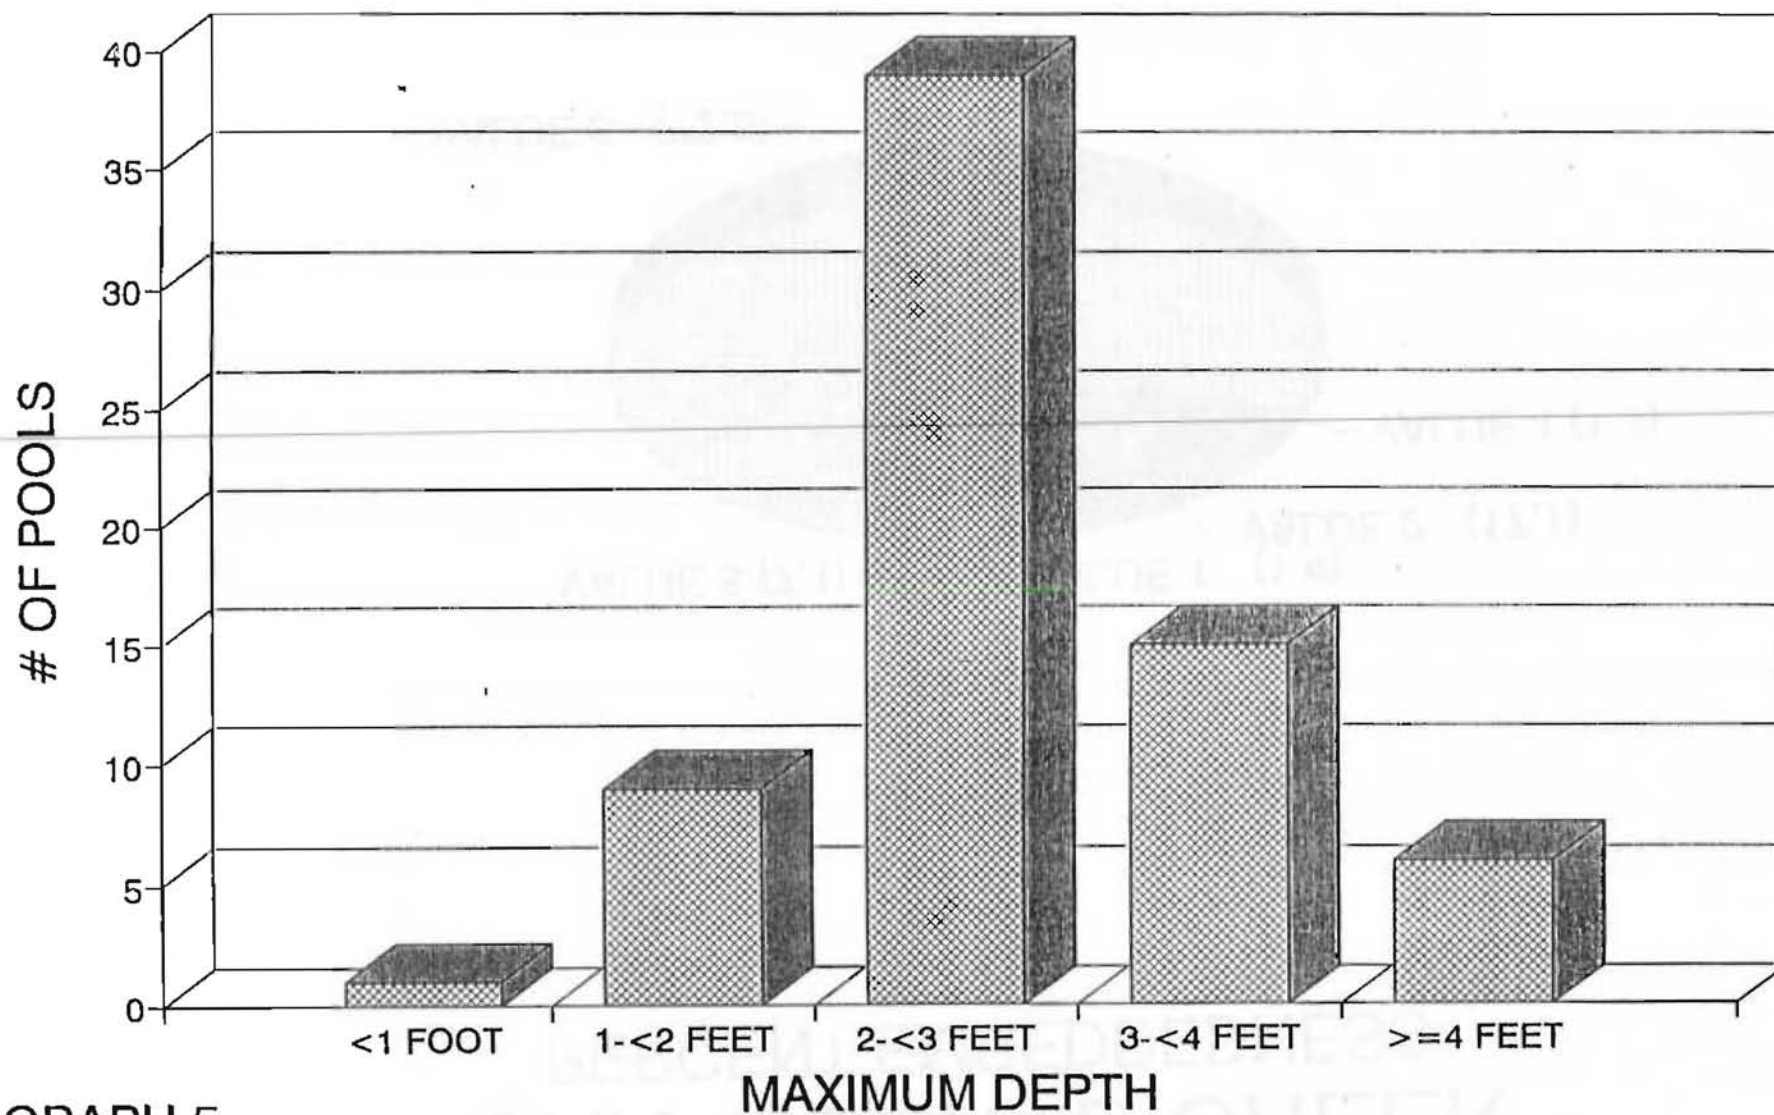
GRAPH 5

Table 4 is a summary of maximum pool depths by pool habitat types. If instream shelter is present, pool quality for salmonids will increase with depth. Twenty-one of the seventy pools (30%) had a depth of three feet or greater (Graph 5).

Flatwater habitat types comprised 76% of the total length of this survey, riffles 8%, and pools 15%. The pools are relatively shallow, with only 21 of the 70 (30%) pools having a maximum depth greater than 3 feet. In third and fourth order streams, a primary pool is defined to have a maximum depth of at least three feet, occupy at least half the width of the low flow channel, and be as long as the low flow channel width. Fallen trees, log jams, large boulders and other hard substantial elements will allow additional pools to be scoured and in the case of fallen trees and log jams, complex instream cover will also be provided.

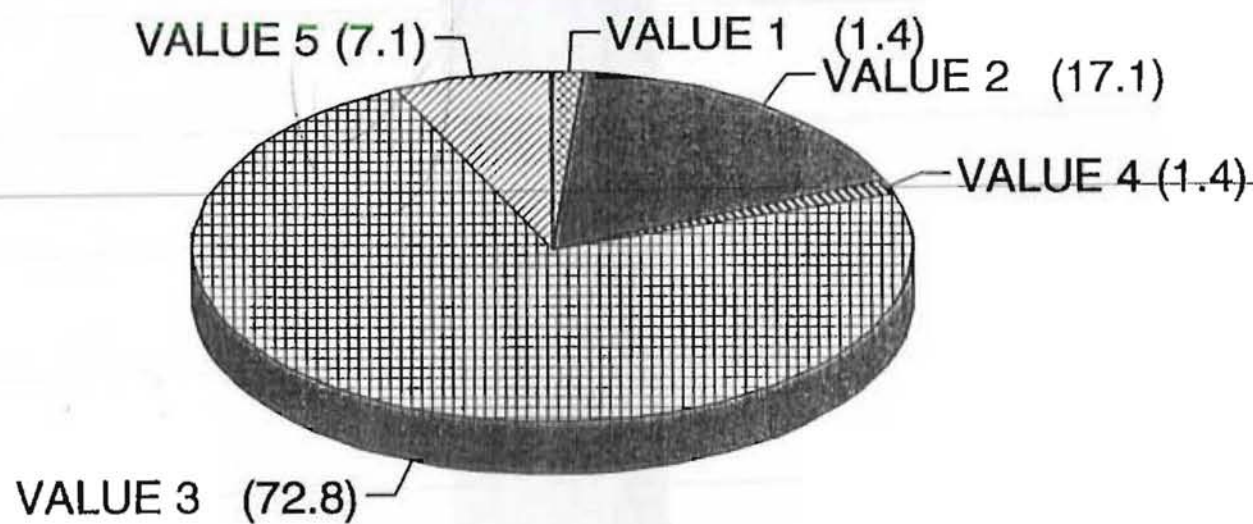
GRAPH 6

The depth of cobble embeddedness was estimated at pool tail crests. Of the 70 pool tail crests measured, 1 had a value of 1 (1.4%); 12 had a value of 2 (17.1%); 51 had a value of 3 (72.8%); 1 had a value of 4 (1.4%); and 5 (7.1%) were unsuitable for spawning (Graph 6). On this scale, a value of 1 indicates low embeddedness or a low percentage of fines at spawning sites.

Fifty-seven of the 70 pool tail-outs measured had embeddedness ratings of 3, 4, or 5. Only 1 had a 1 rating. Cobble embeddedness measured to be 25% or less, a rating of 1, indicates high quality spawning substrate for salmon and steelhead. In San Vicente Creek, sediment sources should be identified mapped and prioritized according to their potential sediment yields, and the appropriate control measures should be taken.

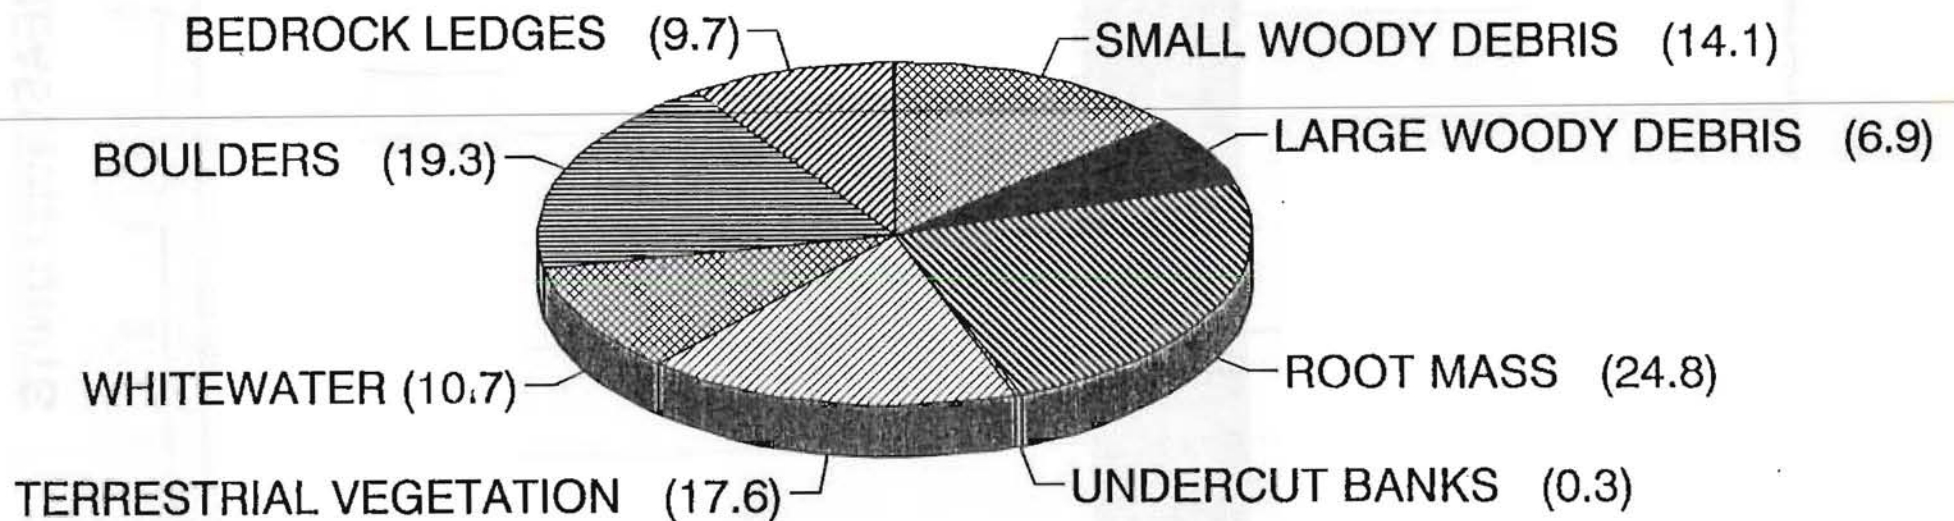
GRAPH 7

Table 5 summarizes mean percent cover by habitat type. Boulders are the dominant cover type in San Vicente Creek. Large woody debris are lacking in nearly all habitat types (Graph 7).

The mean shelter rating for pools was low with a rating of 12. The shelter rating in the flatwater habitats was slightly lower at 6. A pool shelter rating of approximately 100 is desirable. The relatively large amount of cover that now exists is being provided primarily by boulders in all habitat types. Log and root wad cover structure in pool and flatwater habitats are needed to improve both summer and winter salmonid habitat. Complex woody debris (i.e. roots, fallen trees) provides rearing fry with protection from predation, refuge from high water velocities, provides a food source and divides territorial units to reduce density related competition.

- 1) San Vicente Creek should be managed as an anadromous, natural production stream.
- 2) Increase woody cover in the pools and flatwater habitat units. Most of the existing cover is from boulders. Adding or allowing for the natural recruitment of complex woody debris (i.e. trees and logs) would provide summer and winter habitat in addition to scouring more pools.

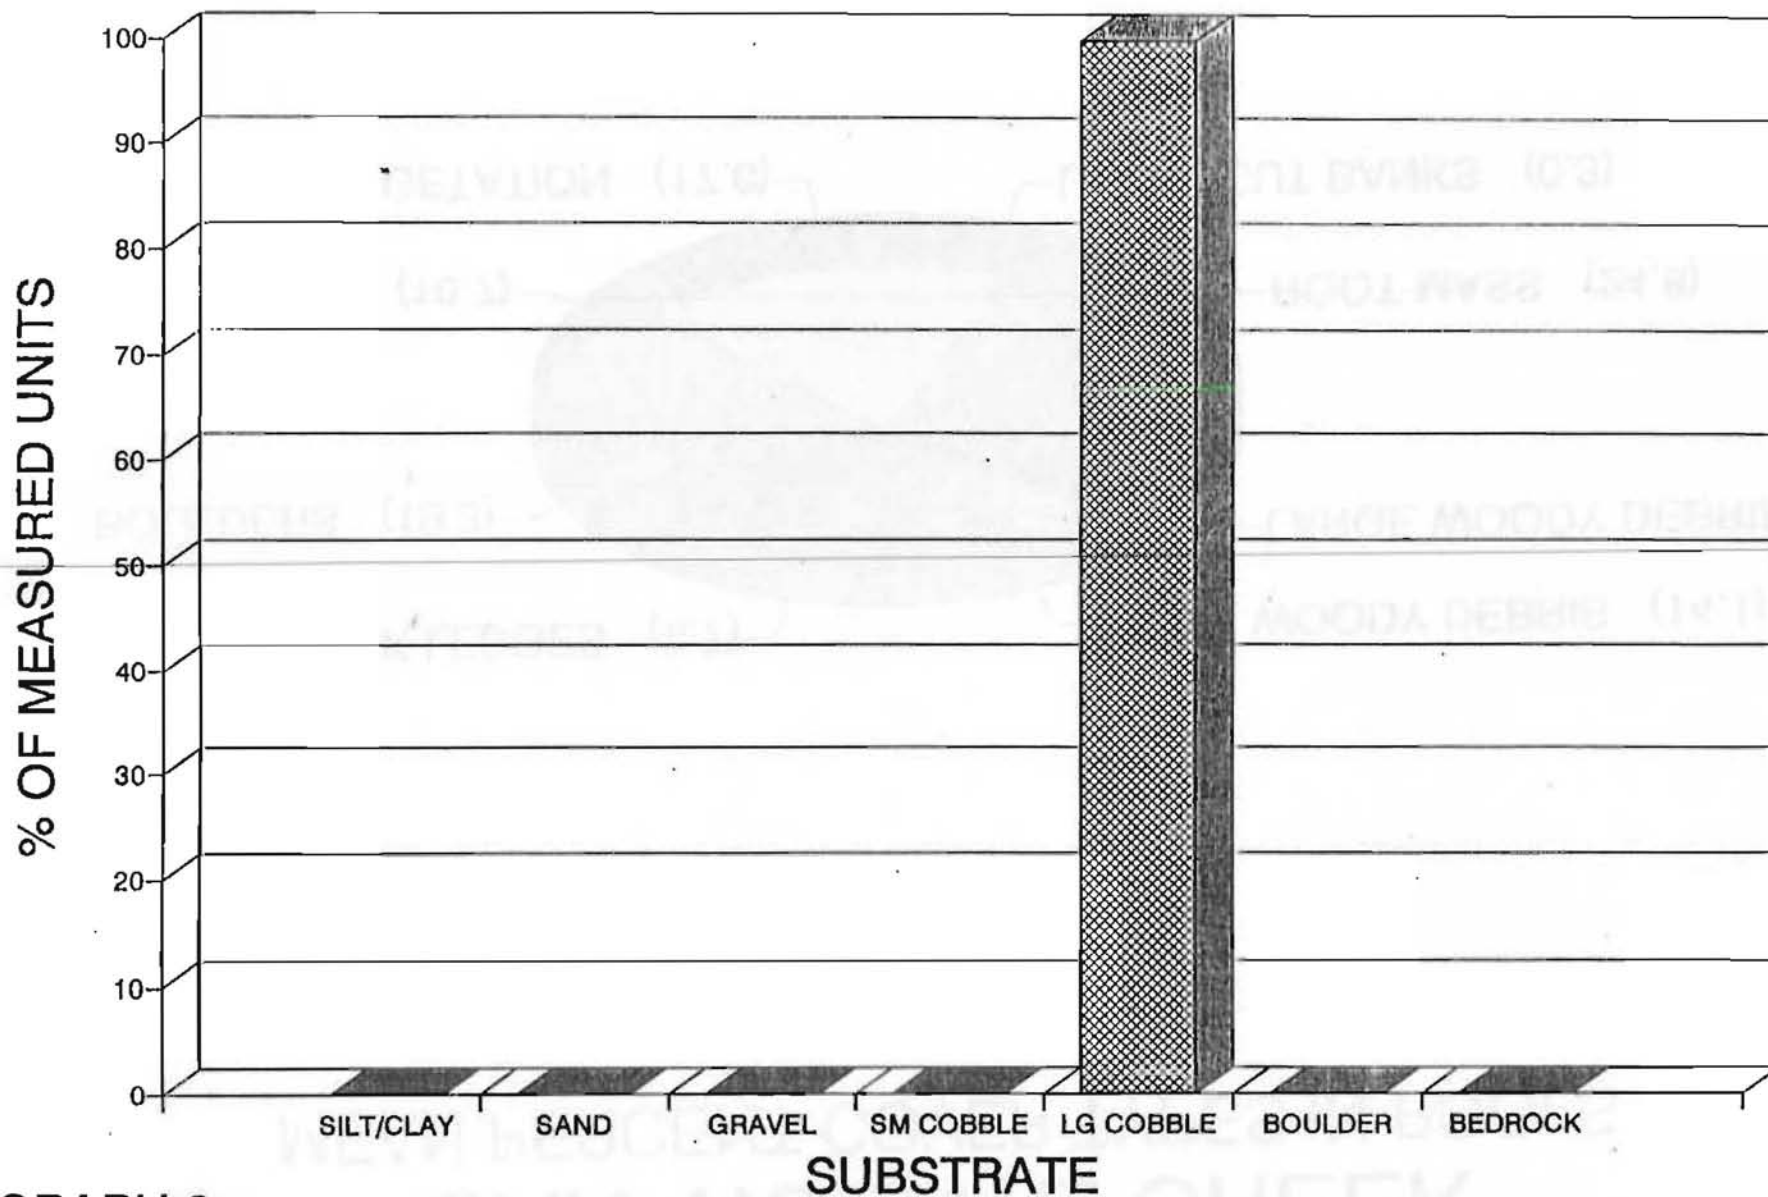
GRAPH 8

Table 6 summarizes the dominant substrate by habitat type. Large cobble was the dominant substrate observed in the two low gradient riffles measured. Large cobble was the dominant substrate observed in 4 of the 7 step runs measured (57%). Small cobble was the next most frequently observed dominant substrate type and occurred in 43% of the step runs (Graph 8).

The two low gradient riffles measured had large cobble as the dominant substrate. Large cobble was also dominant in four of the seven step runs measured. Large cobble (5.0 to 10.0 inch diameter) is considered unsuitable for spawning steelhead and coho salmon.

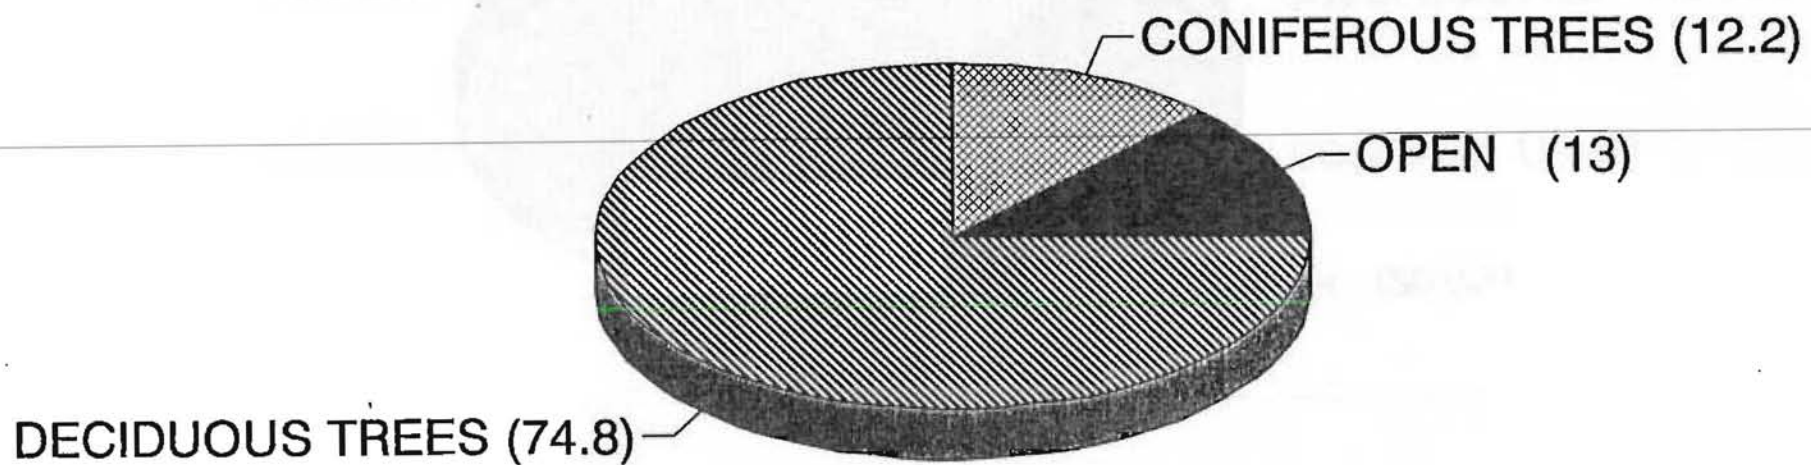
GRAPH 9

The mean percent canopy density for the stream reach surveyed was 87% of which 86% of the canopy consisted of deciduous trees and 14% were coniferous trees (Graph 9).

The mean percent canopy density for the stream was 87%. This is considered adequate canopy cover to provide the necessary shade on the stream and assure cool water for juvenile coho salmon and steelhead.

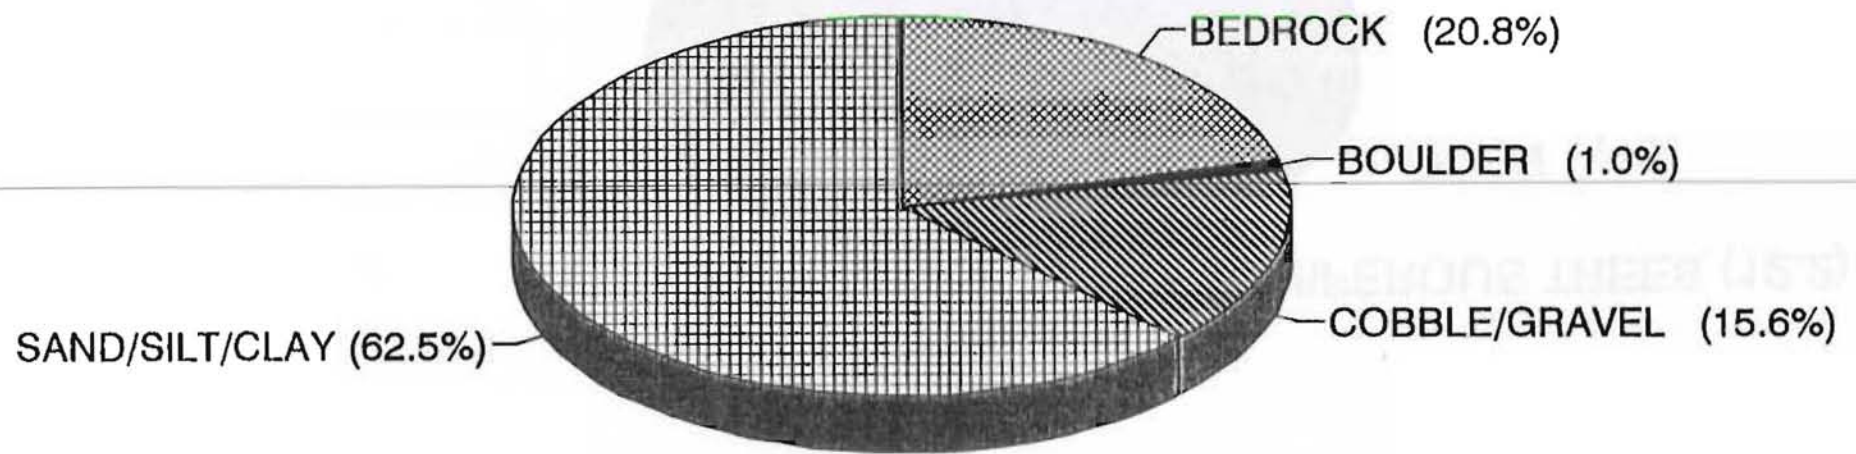
GRAPH 10

For the stream reach surveyed, the mean percent right bank vegetated was 73%. The mean percent left bank vegetated was 75.5%. The dominant elements composing the structure of the stream banks consisted of 20% bedrock, 1% boulder, 15% cobble/gravel, and 60% sand/silt/clay (Graph 10). Deciduous trees are the dominant vegetation type observed in 76% of the units surveyed. Additionally, 11% of the units surveyed had brush as the dominant vegetation type, and 1% had coniferous trees as the dominant vegetation, including down trees, logs, and root wads (Graph 11).

The percentage of right and left bank covered with vegetation was moderate at 73% and 76%, respectively. In areas of stream bank erosion or where bank vegetation is not at acceptable levels, planting endemic species of coniferous and deciduous trees, in conjunction with bank revetment, is recommended.
