**California Department of Fish and Wildlife**  
**Santa Cruz County**  
**Big Basin Coastal Watershed**  
**Stream Habitat Assessment Reports**

# **San Vicente Creek**

*Surveyed 2010*

# STREAM INVENTORY REPORT

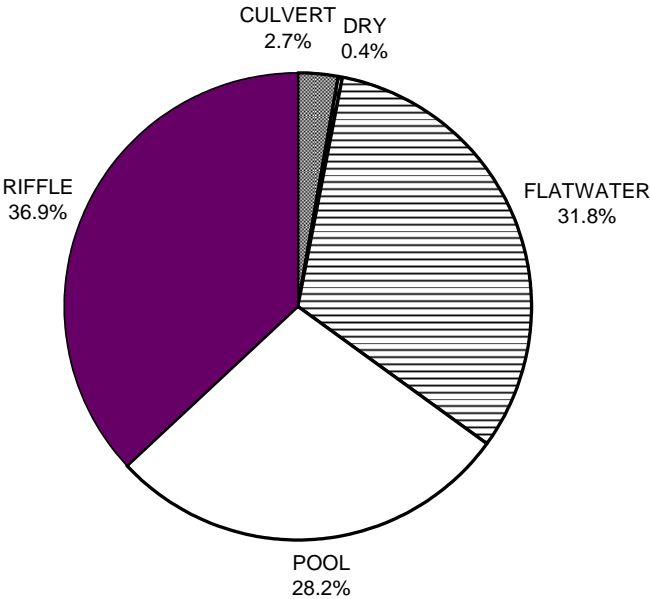
GRAPH 2

Table 1 summarizes the Level II riffle, flatwater, and pool habitat types. Based on frequency of occurrence there were 36% pool units, 35% riffle units, 27% flatwater units, 2% culvert units, and 0% dry units (Graph 1). Based on total length of Level II habitat types, there were 37% riffle units, 32% flatwater units, 28% pool units, 3% culvert units, and 0% dry units (Graph 2).

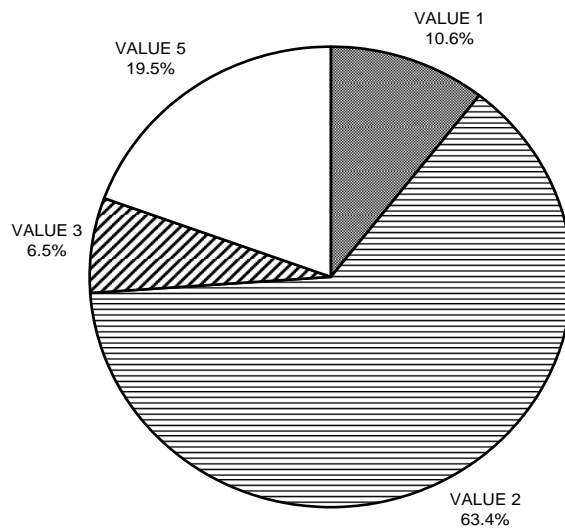
GRAPH 6

The depth of cobble embeddedness was estimated at pool tail-outs. Of the 123 pool tail-outs measured, 13 had a value of 1 (11%), 78 had a value of 2 (63%), 8 had a value of 3 (7%), 24 had a value of 5 (20%) (Graph 6). On this scale, a value of 1 indicates the best spawning conditions and a value of 4 the worst. Additionally, a value of 5 was assigned to tail-outs deemed unsuited for spawning due to inappropriate substrate such as bedrock, log sills, boulders, or other considerations.

Ninety-one of the 123 pool tail-outs measured had embeddedness ratings of 1 or 2. Eight of the pool tail-outs had embeddedness ratings of 3 or 4. Twenty-four of the pool tail-outs had a rating of 5, which is considered unsuitable for spawning. Cobble embeddedness measured to be 25% or less, a rating of 1, is considered to indicate good quality spawning substrate for salmon and steelhead. Sediment sources in San Vicente Creek should be mapped and rated according to their potential sediment yields, and control measures should be taken.

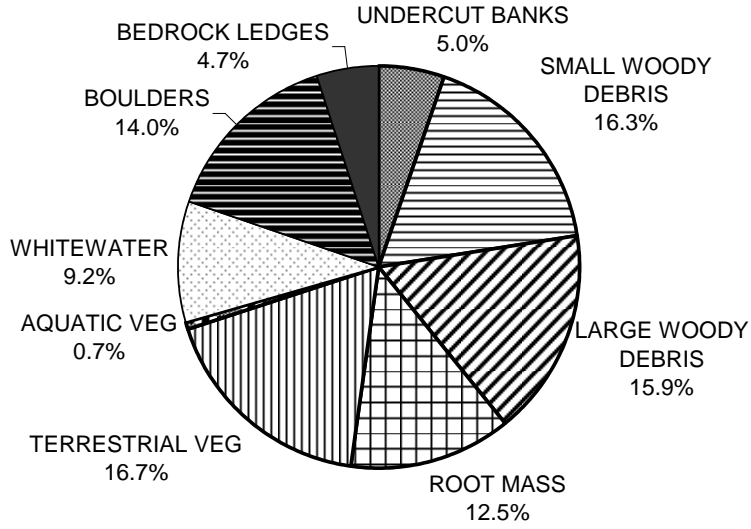
GRAPH 7

Table 5 summarizes mean percent cover by habitat type. Boulders are the dominant cover type in San Vicente Creek. Graph 7 describes the pool cover in San Vicente Creek. Terrestrial vegetation is the dominant pool cover type, followed by small woody debris.

- 1) Increase woody cover in the pools and flatwater habitat units. Most of the existing cover in the pools is from terrestrial vegetation. Adding high quality complexity with woody cover in the pools is desirable.

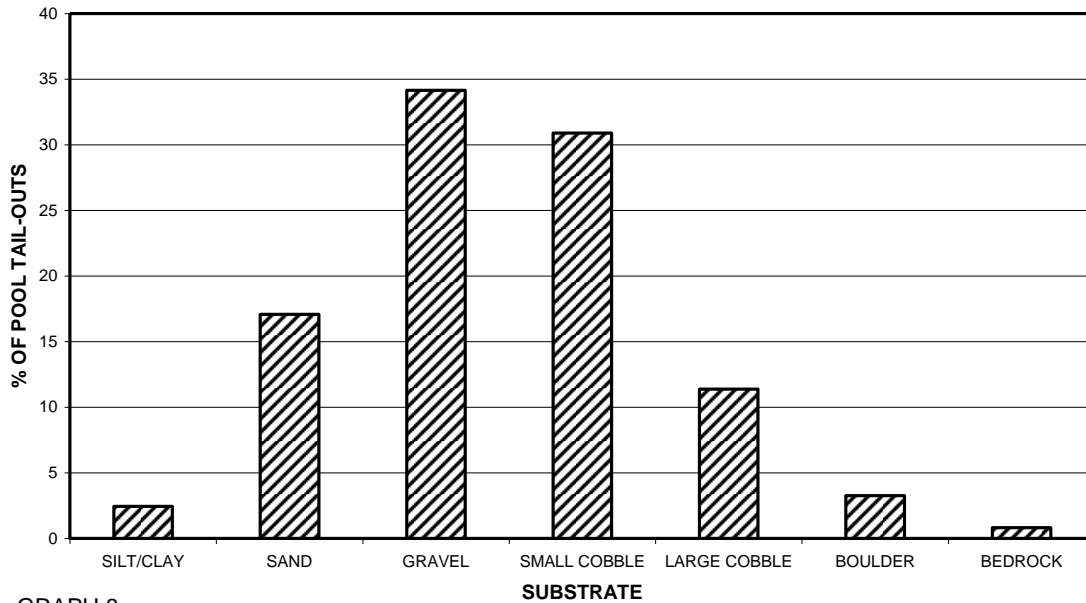
GRAPH 8

Table 6 summarizes the dominant substrate by habitat type. Graph 8 depicts the dominant substrate observed in pool tail-outs. Gravel substrate was observed in 34% of pool tail-outs; and small cobble substrate was observed in 31% of pool tail-outs.

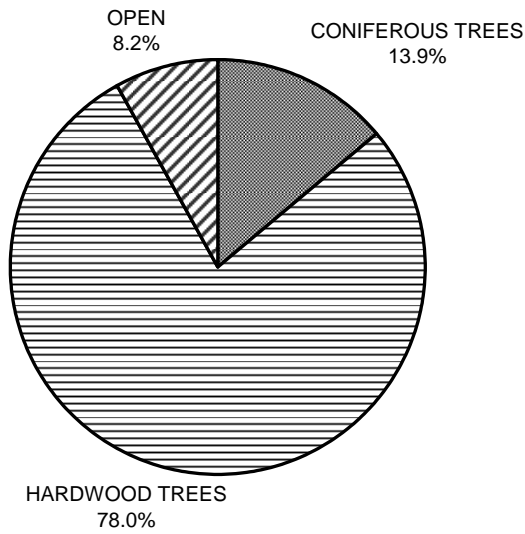
GRAPH 9

respectively. Eight percent of the canopy was open. Graph 9 describes the mean percent canopy in San Vicente Creek.
