**California Department of Fish and Wildlife**  
**Santa Cruz County**  
**Big Basin Coastal Watershed**  
**Stream Habitat Assessment Reports**

# **San Vicente Creek**

*Surveyed 2010*

# STREAM INVENTORY REPORT

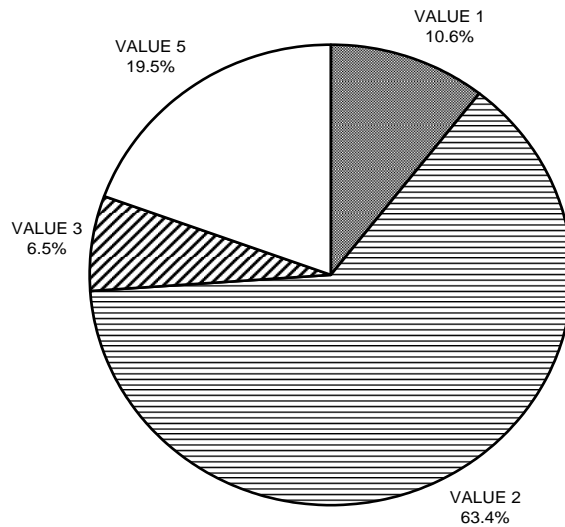
GRAPH 6

The depth of cobble embeddedness was estimated at pool tail-outs. Of the 123 pool tail-outs measured, 13 had a value of 1 (11%), 78 had a value of 2 (63%), 8 had a value of 3 (7%), 24 had a value of 5 (20%) (Graph 6). On this scale, a value of 1 indicates the best spawning conditions and a value of 4 the worst. Additionally, a value of 5 was assigned to tail-outs deemed unsuited for spawning due to inappropriate substrate such as bedrock, log sills, boulders, or other considerations.

Ninety-one of the 123 pool tail-outs measured had embeddedness ratings of 1 or 2. Eight of the pool tail-outs had embeddedness ratings of 3 or 4. Twenty-four of the pool tail-outs had a rating of 5, which is considered unsuitable for spawning. Cobble embeddedness measured to be 25% or less, a rating of 1, is considered to indicate good quality spawning substrate for salmon and steelhead. Sediment sources in San Vicente Creek should be mapped and rated according to their potential sediment yields, and control measures should be taken.

- 3) Inventory and map sources of stream bank erosion particularly in Reach 5, and prioritize them according to present and potential sediment yield. Identified sites should then be treated to reduce the amount of fine sediments entering the stream. Active and potential sediment sources related to the road system need to be identified, mapped, and treated according to their potential for sediment yield to the stream and its tributaries.
