2006 BIOASSESSMENT MONITORING PROGRAM IN LOS ANGELES COUNTY

Final Report

Los Angeles County Department of Public Works
Watershed Management Division
900 South Fremont Avenue
Alhambra, California 91803-1331

June 2007

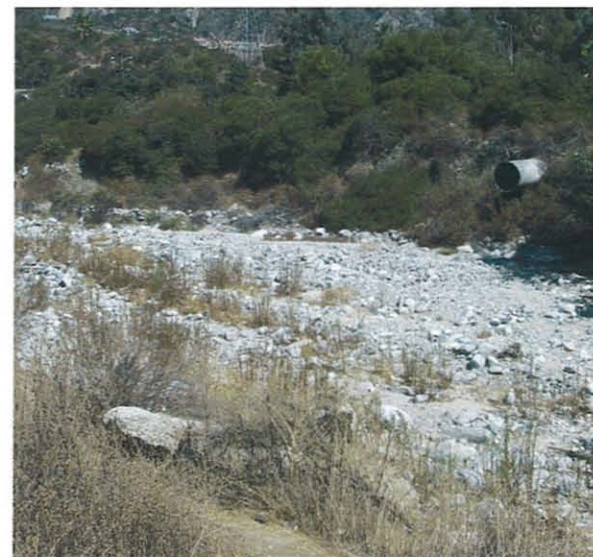
Station 10-Eaton Wash (dry)

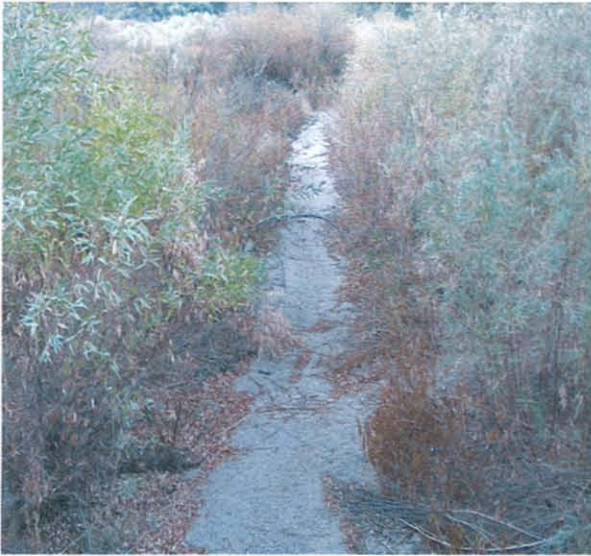
Station 20-Bouquet Canyon (dry)
