Tuolumne County Foothill Watershed Assessment . 204254

Figure 4-10

Sullivan Creek Watershed Channel Geomorphic Units and Station Locations

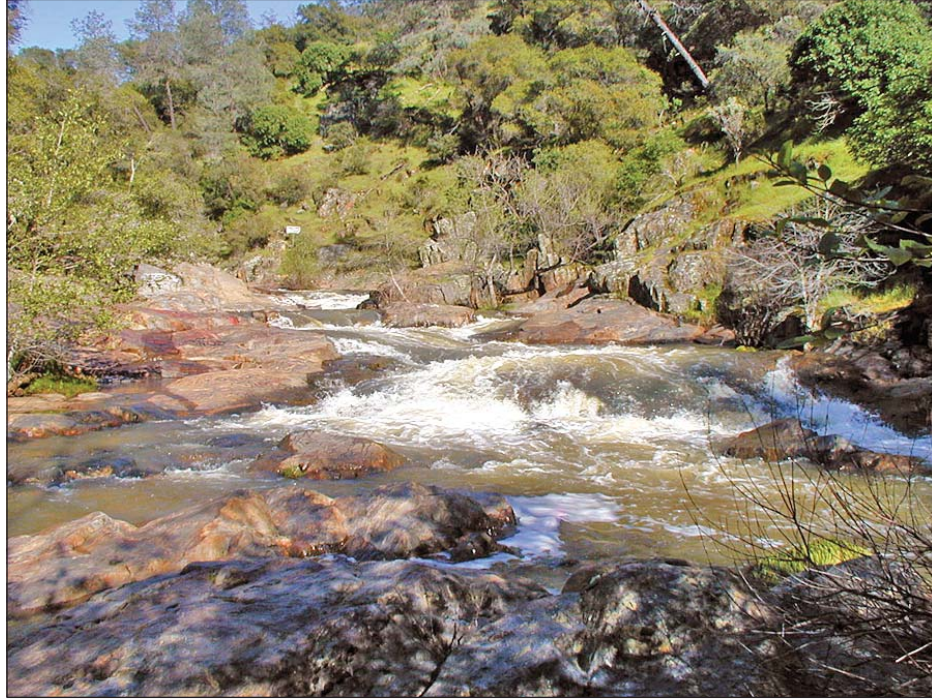
SCR-12. Sullivan Creek, above Lime Kiln Road, where the waterway has incised deeply into rocks associated with the Calaveras Complex.

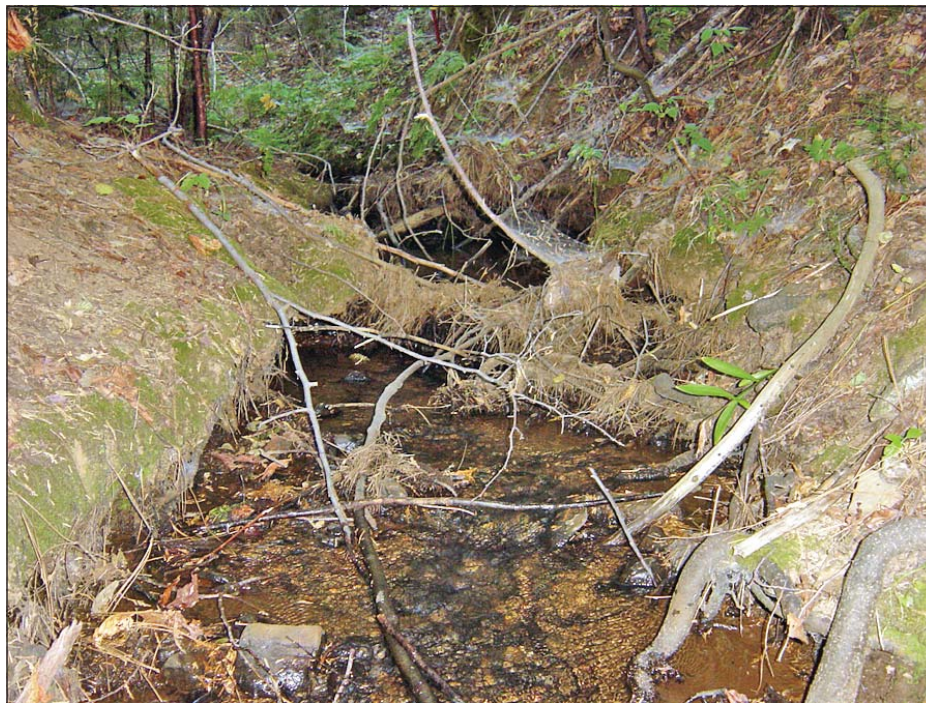
SCR-2. Sullivan Creek, near Phoenix Lake Road, exhibiting shallow slope gradient, accumulation of woody debris, and cobble-dominated bed.

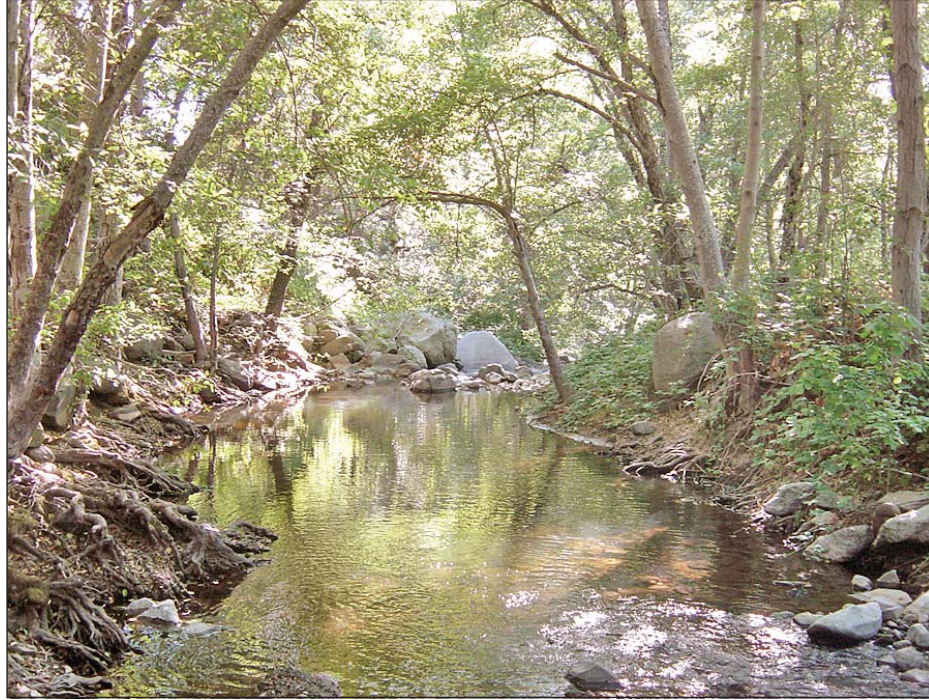
SCR-11. Sullivan Creek, downstream of Phoenix Lake. Morphology is step-pool and pool-riffle, with minimal sediment accumulation or storage in this reach.

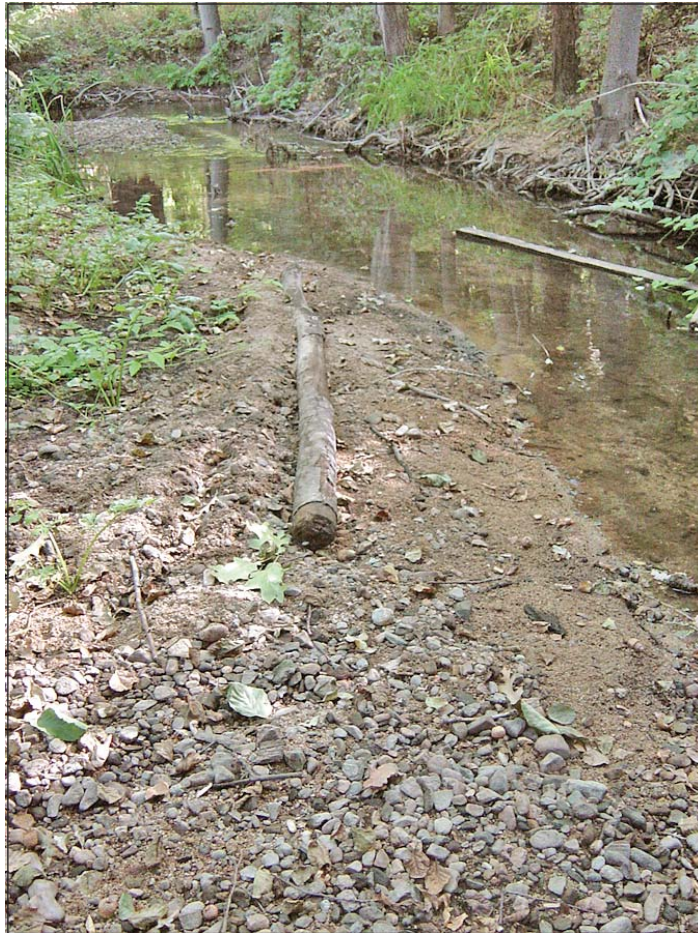
SCR-2. Downstream vantage of a low gradient reach along the mainstream of Upper Sullivan Creek. Bar formation and sand accumulation suggest this channel reach is transport limited.

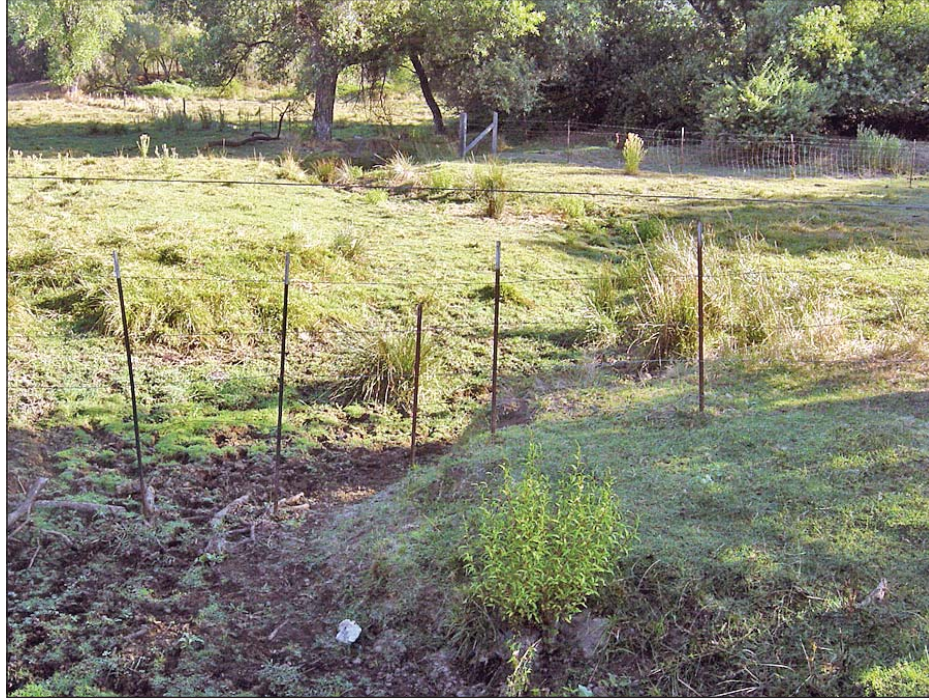
CCR-5. Tributary to Curtis Creek. Contributing drainages, downstream of Lime Kiln Road, begin to exhibit marked transitions to transport-limited waterways.

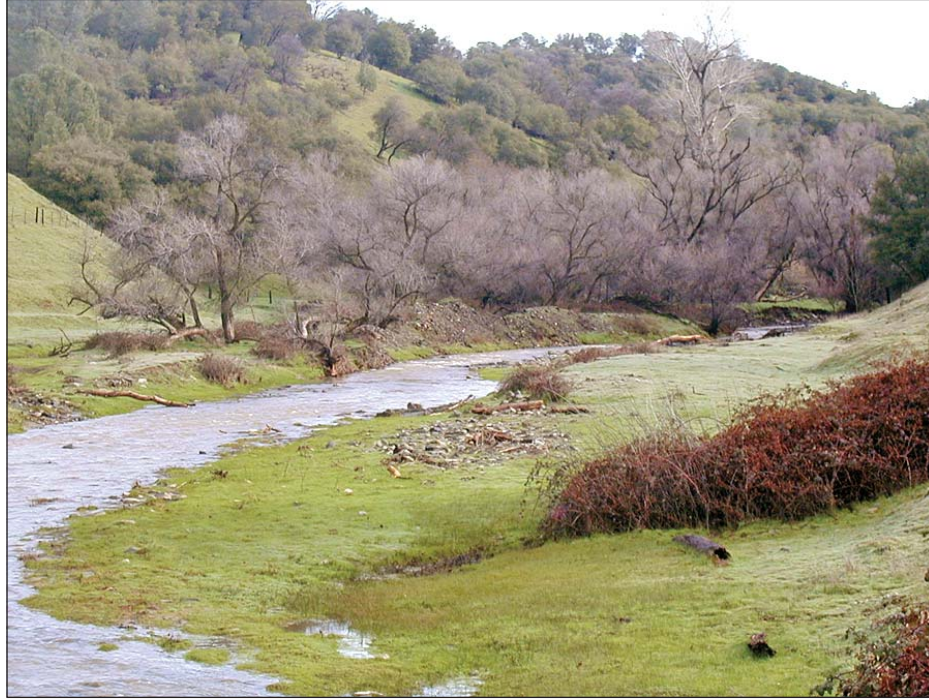
CCR-10. Lower mainstream of Curtis Creek, above Algerine Road. Floodplain and terrace development becomes more obvious at this reach.

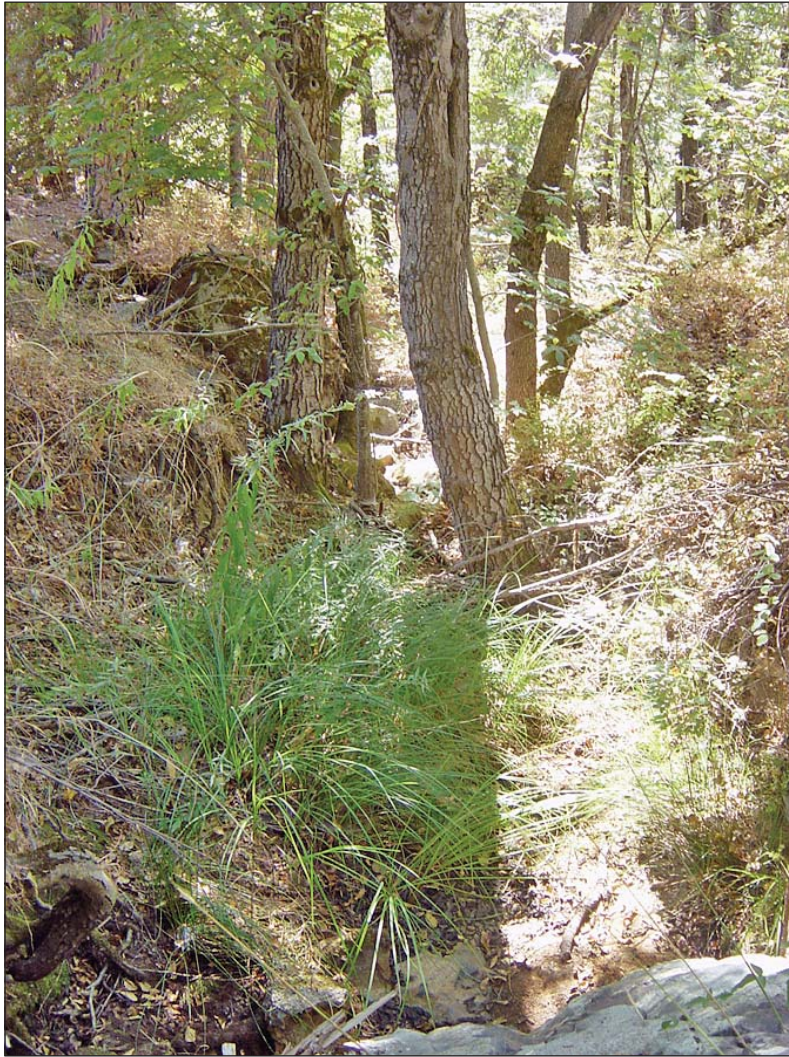
SCR-10. Looking downstream; channel morphology is cascade/step-pool. Large amounts of sediment are stored behind channel obstructions (e.g., boulders).

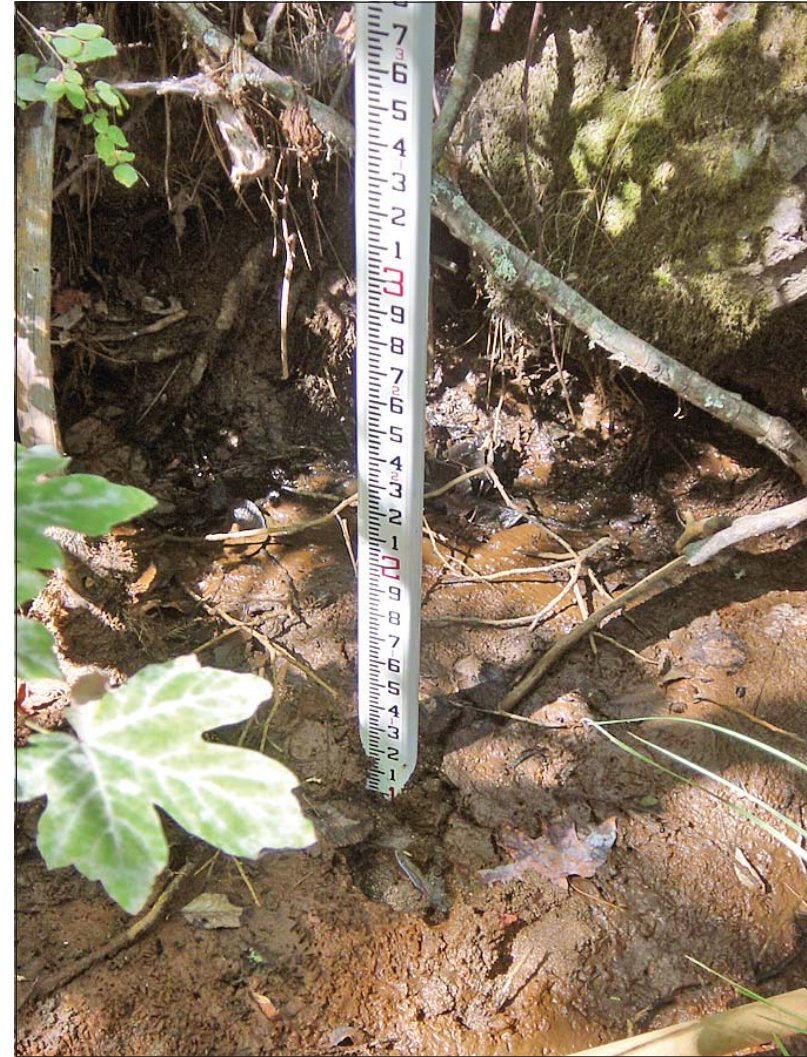
SCR-10. Close-up of silt and sand accumulation within channels; upstream of local obstructions.
