Tuolumne County Foothill Watershed Assessment . 204254

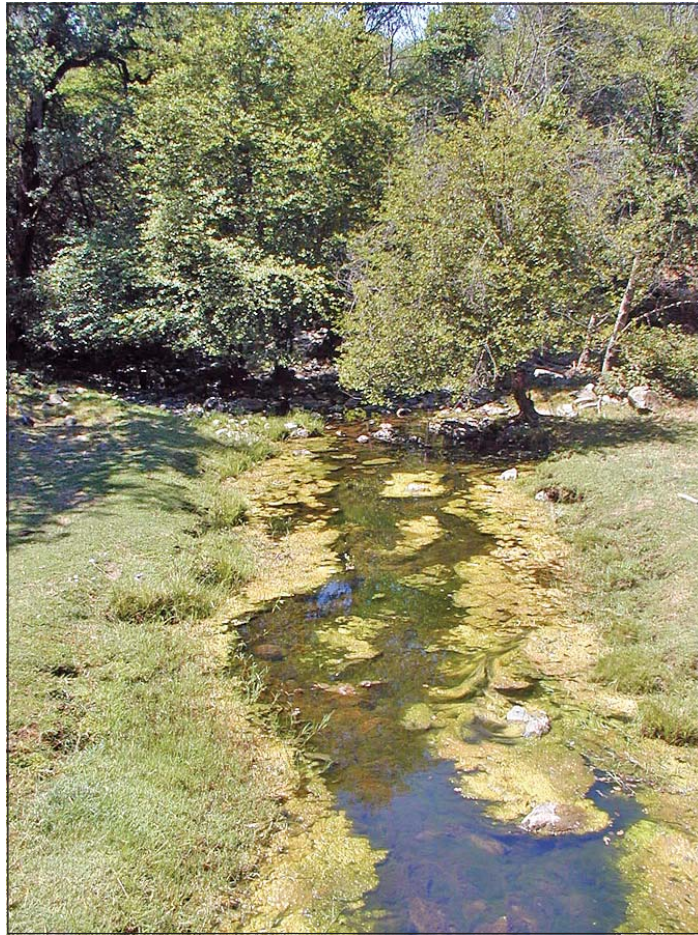
Development of an algal bloom below Lime Kiln Road on Curtis Creek.

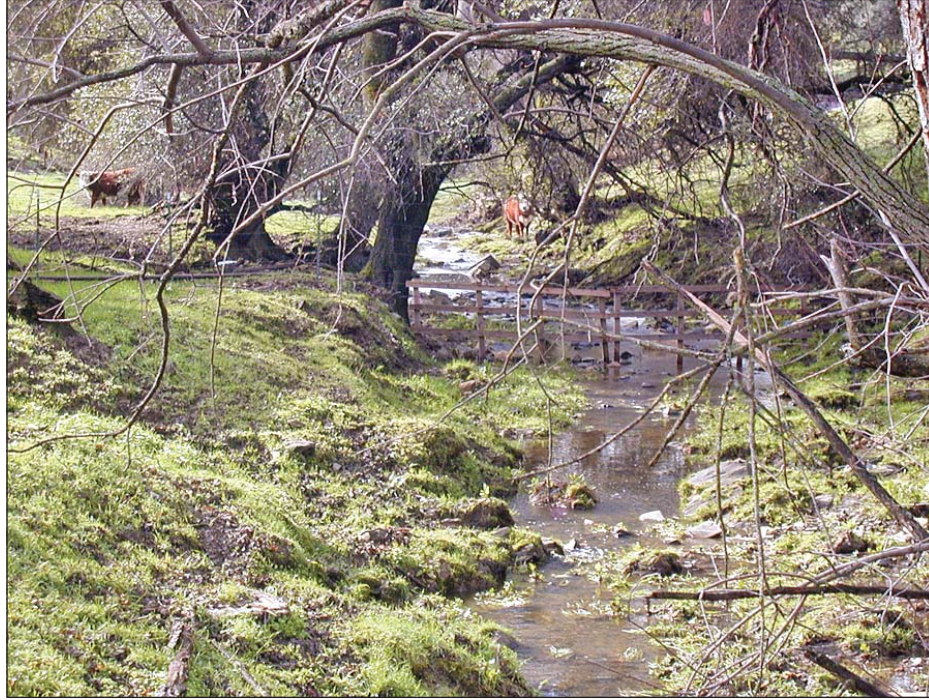
Livestock observed within a contributing drainage to Curtis Creek. Livestock waste was observed along channel banks and, in some locations, within the actual channel.
