Findings Report for Stanshaw Creek Habitat and Instream Flow Assessment

Prepared for the Karuk Tribe

Ross Taylor and Associates

January 2015

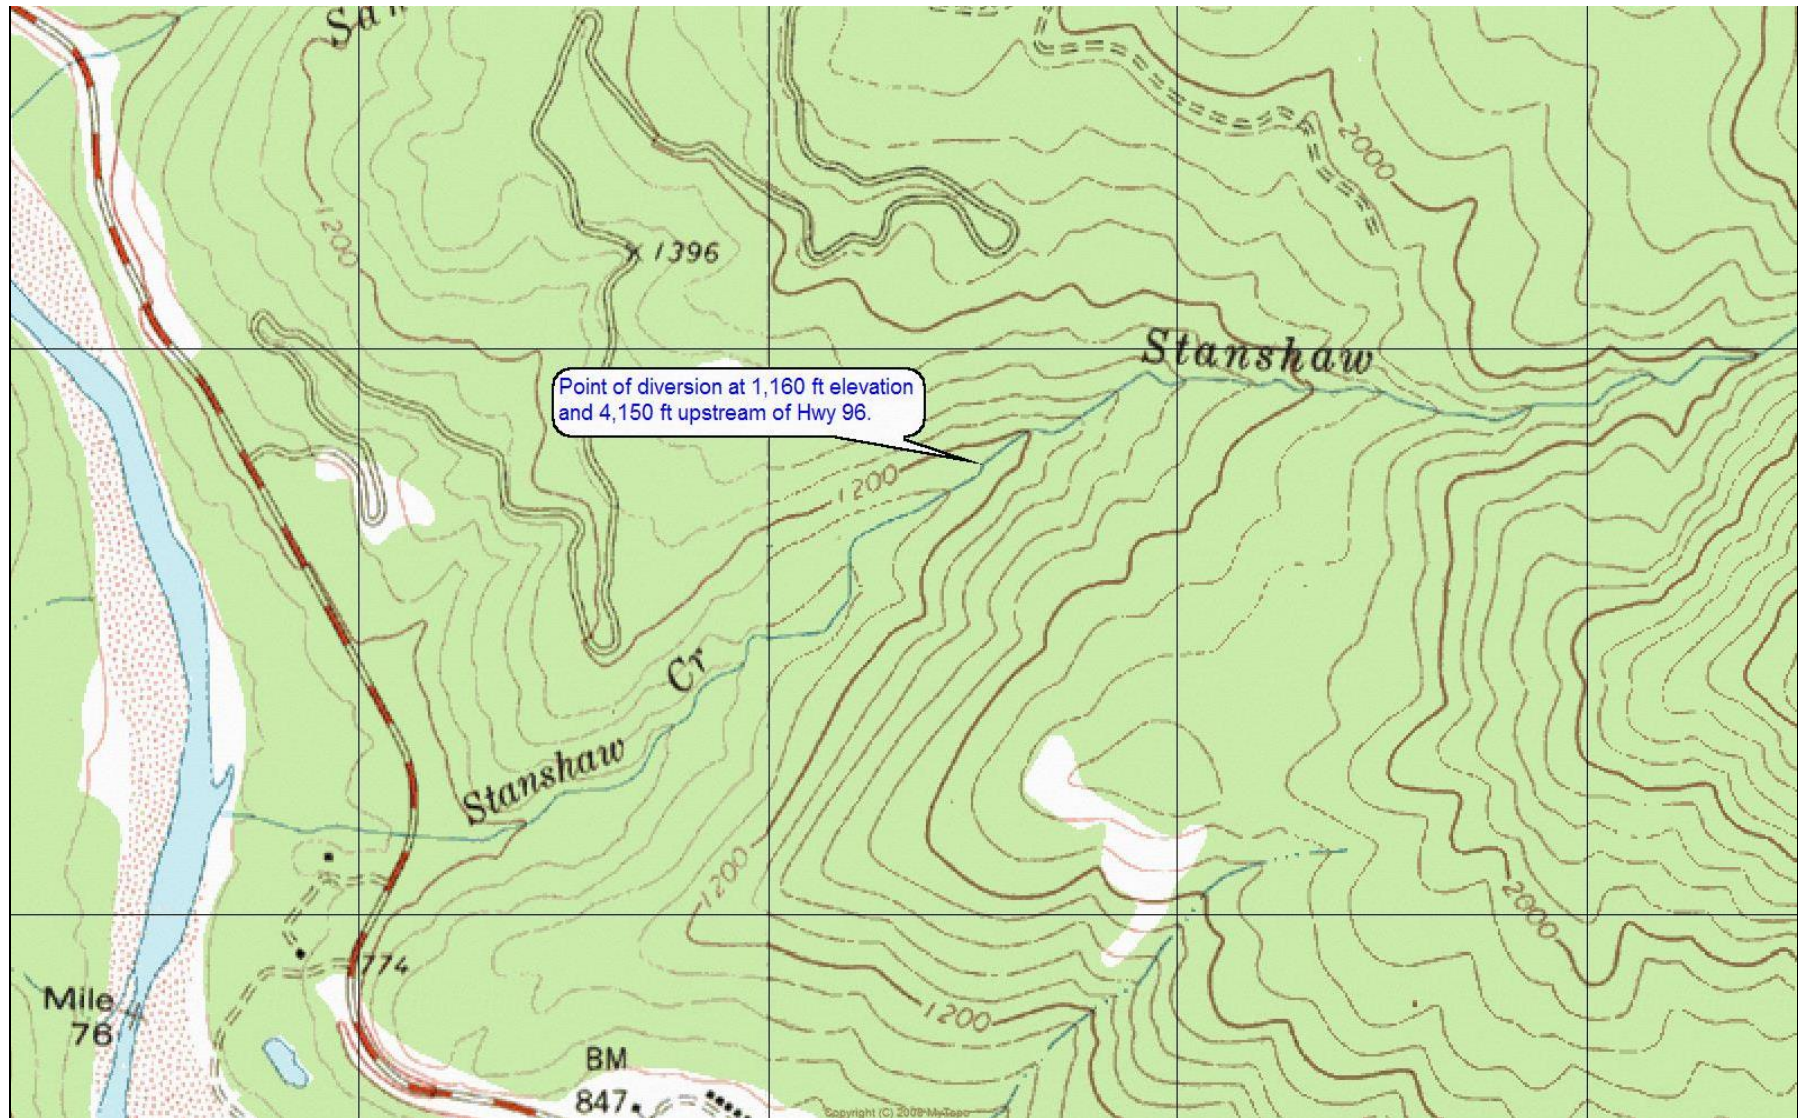
Figure 1. Stanshaw Creek and location of the Marble Mountain Ranch’s point of diversion.

Stanshaw Creek is a small tributary of the Klamath River with a drainage area of approximately four square miles (Figure 1). The creek's confluence with the Klamath River is located at N41.4764518; W123.5111116 (Figure 1). Stanshaw Creek has approximately 5,500 feet of potential fish-bearing habitat (up to sustained slope >15% on the USGS topographic map). The first 2,500 feet has a channel slope of approximately 9% and the next 3,000 feet has an overall slope of nearly 11%. The mouth of Stanshaw Creek enters the Klamath River approximately 1,400 feet downstream of Highway 96 (at CalTrans post-mile 8.20).

RTA also inspected the Stanshaw Creek surface water diversion located approximately 4,200 feet upstream of Highway 96. This diversion is maintained and utilized by the Marble Mountain Ranch (MMR) for power generation and other domestic uses. None of the water diverted from Stanshaw Creek by the MMR is returned to Stanshaw Creek; all non-consumptive flow is bypassed into Irving Creek.

Because the MMR diversion is located on U.S. Forest Service property, RTA was able to inspect the diversion during the 11/17/14 stream habitat assessment. Stanshaw Creek was being diverted by the placement of rocks across the channel which shunted nearly all of the surface flow into an open ditch. At the point-of-diversion (POD), the diversion was not screened and RTA conservatively estimated that 80-90% of the surface flow was being diverted into the ditch. Approximately 300 feet of the diversion ditch was inspected and the following was noted: (1) a bypass existed to possibly return excess flow to Stanshaw Creek; however all the diverted flow was going down the ditch and (2) this reach of the ditch had failed in several spots and was crudely repaired with cinder blocks, plastic sheeting and fill material. Leakage and erosion was noted at these locations.

1. Installation of a control gate at the POD so that MMR diverts only their allocated flow. Control gate should also provide the downstream channel its required minimum flows as a priority over the MMR diversion. Diversion at POD should be properly screened.

2. Implement water conservation measures such as: enclose MMR's diversion in a pipe instead of an open ditch, relocate POD farther upstream to create more drop or head pressure, upgrade MMR's hydropower system to a more efficient system, consider other sources of power generation (such as solar during summer when flows are low).
