Stanshaw Creek Coho Habitat Enhancement Project

FRGP Grant Number: P1110319

Mid Klamath Watershed Council

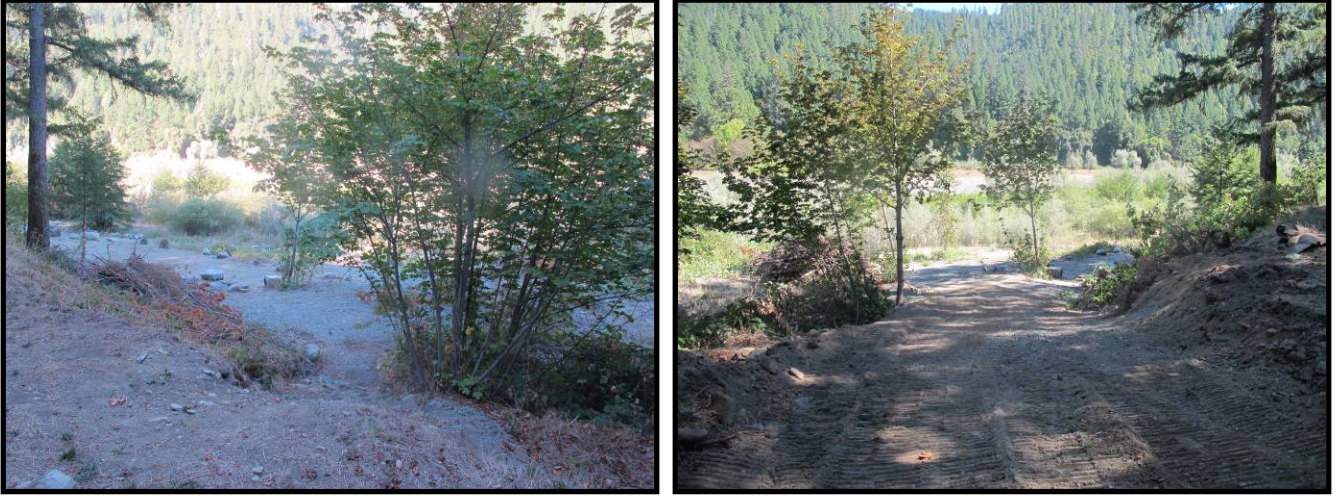
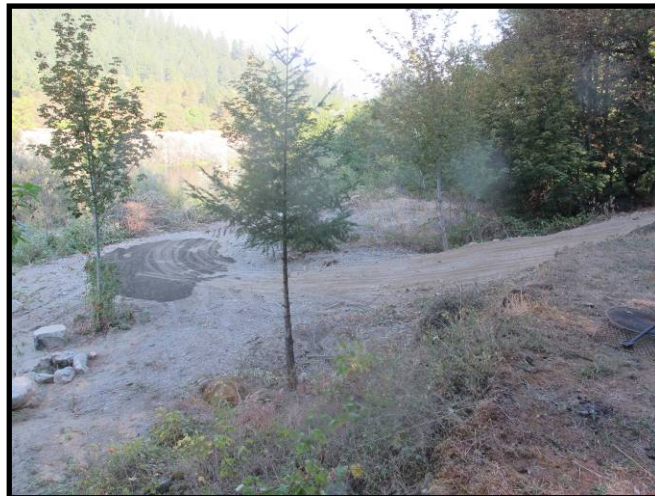
A 200 foot access road was constructed between an existing roadway and the project site, across the Klamath River floodplain. This access road was seeded and mulched after project construction was completed. Images above left and right show the access road from the top, before and after construction. Below, the perspective show's a more complete view of the access road from the top and across the river floodplain.

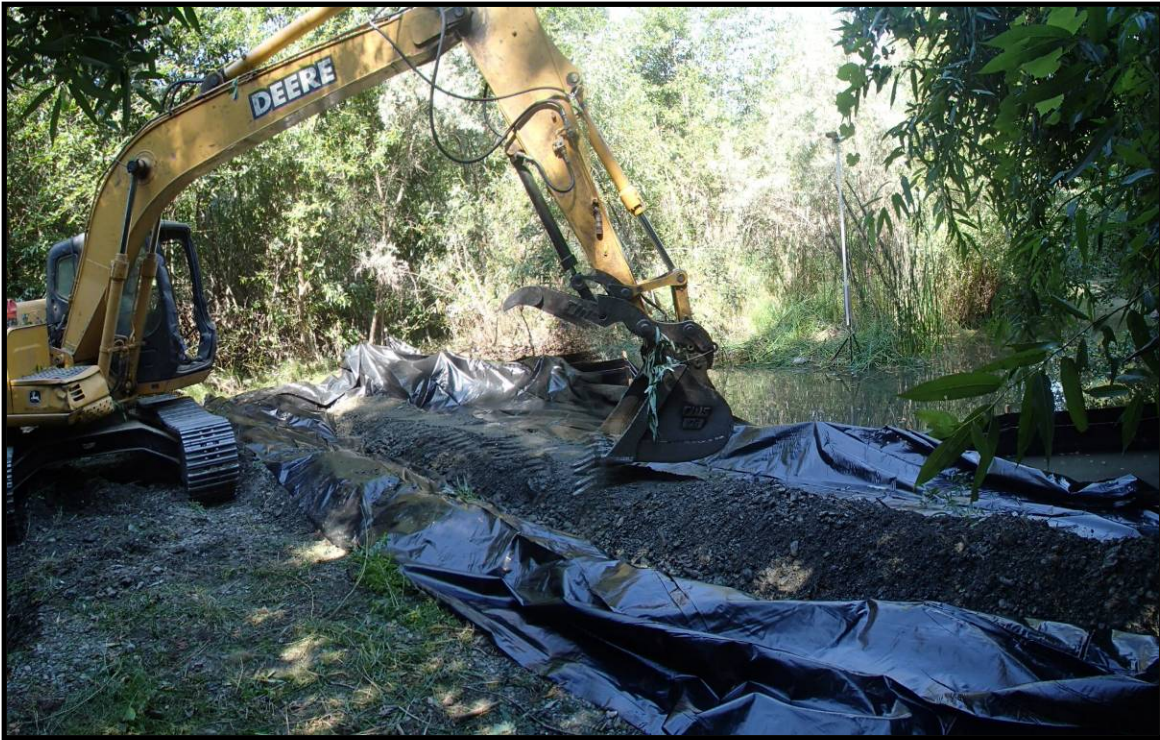
Before excavation began, a thirty foot coffer dam was constructed using 10mm plastic wrapped around washed gravel. This coffer dam excluded all mechanical construction activities from the existing pool habitat. Once construction activities were complete the dam was manually dismantled.

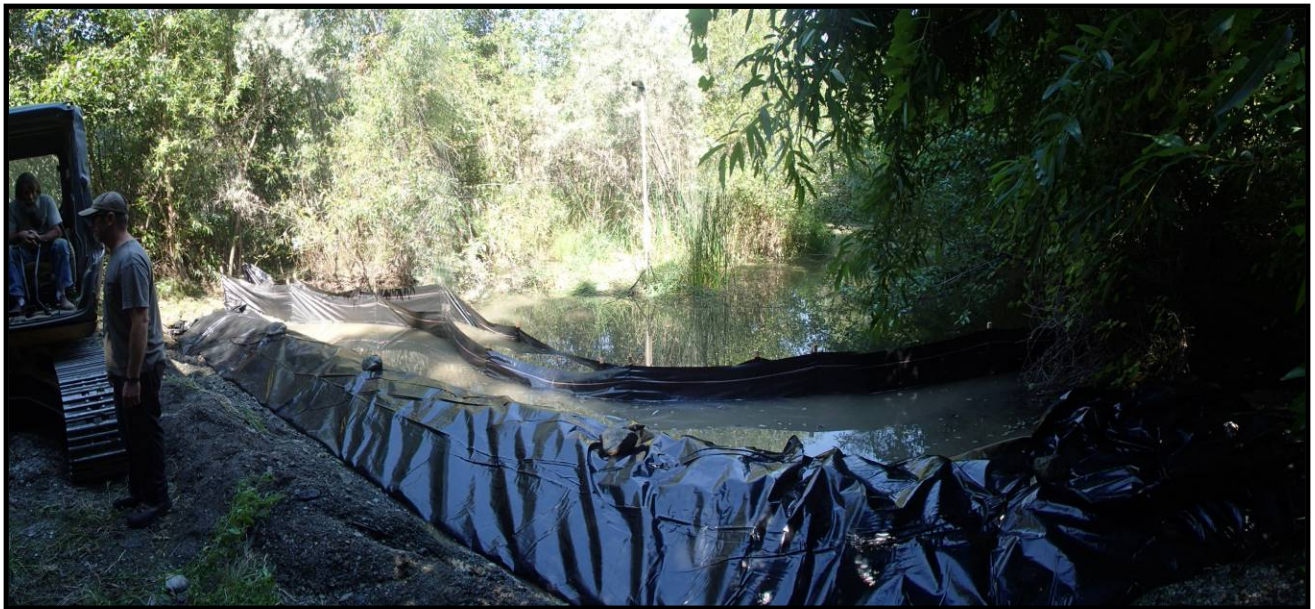
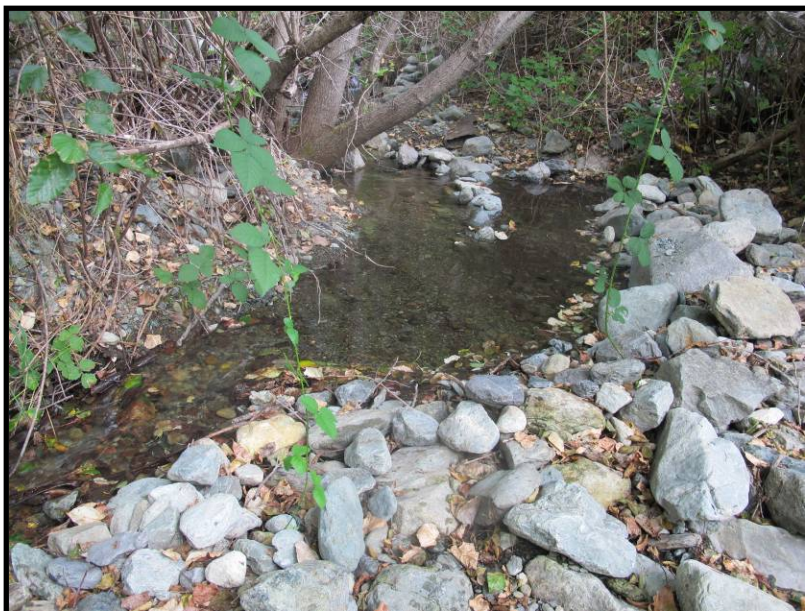
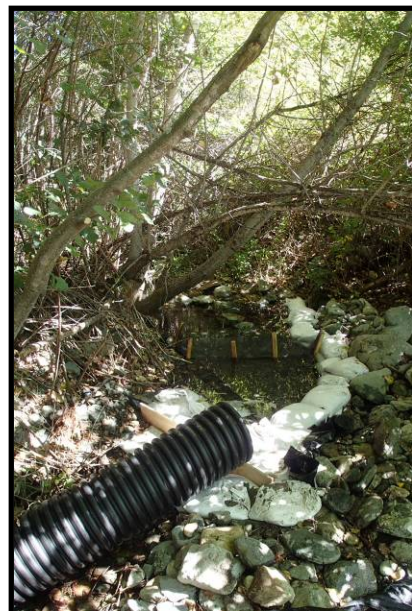
Prior to construction activities, it was necessary to divert a small amount of Stanshaw Creek's flow around the project area. The point of diversion was located at the top of Stanshaw Creek's active delta (above left and right), and 120' of 16" flexible tile was used to reroute approximately .24 cfs of water around the site and into the existing pool habitat, assuring a cold water connection to this habitat (below). The "head gate" was constructed using a plywood splash board, sand bags, and 1/8' screening both on the end of the tile and across the stream bed, approximately 6' above the diversion.

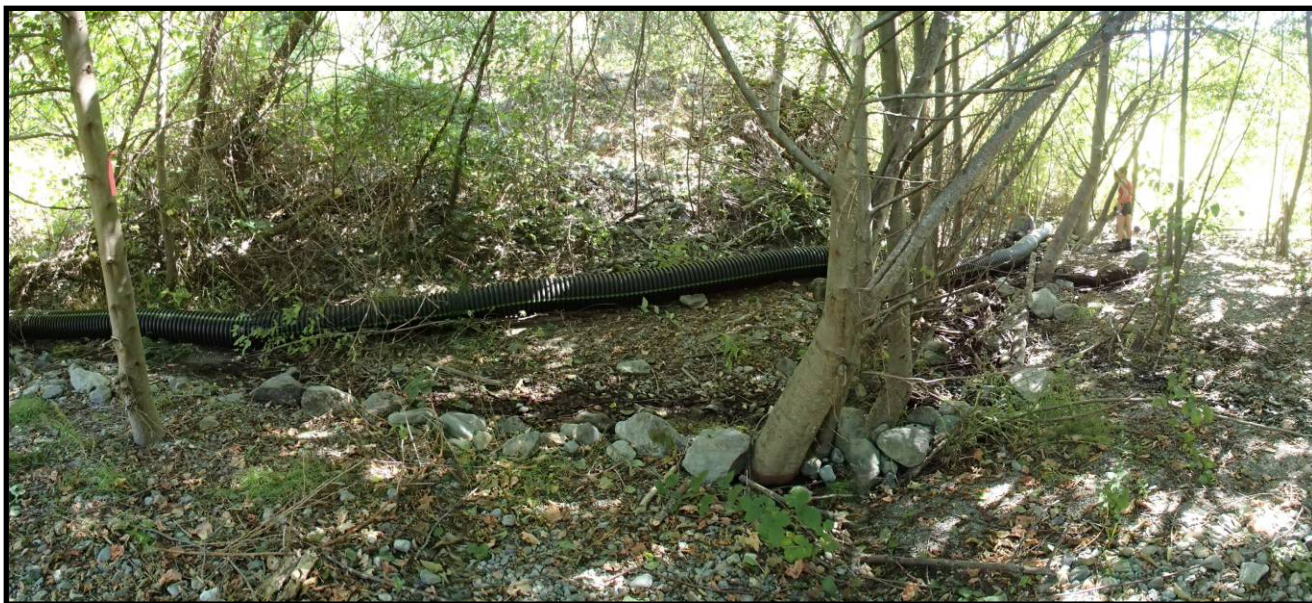
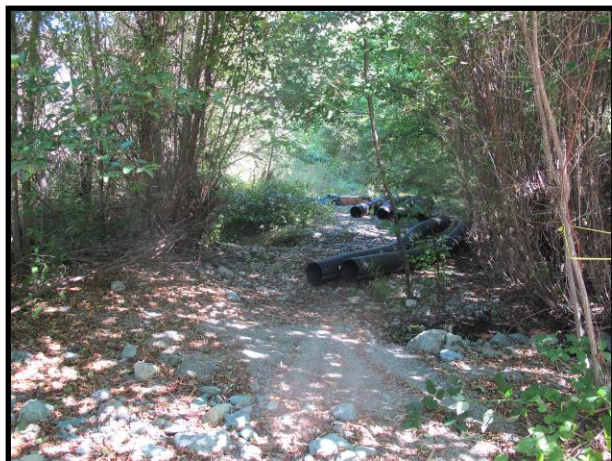
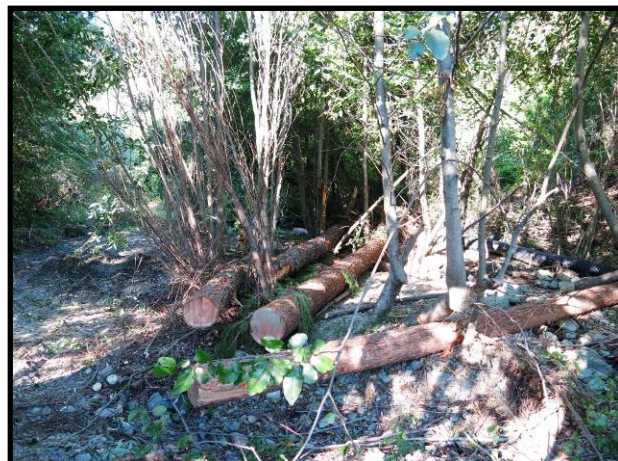
Five 30' logs with rootwads attached were locked into existing vegetation at the head of the off-channel pool, designed to redirect sediment around the project area in high flow events. The upper left and right photos show a close up, before and after, of the log placement, while the photo below shows the structure in relation to Stanshaw Creek and the off-channel habitat during winter flows.

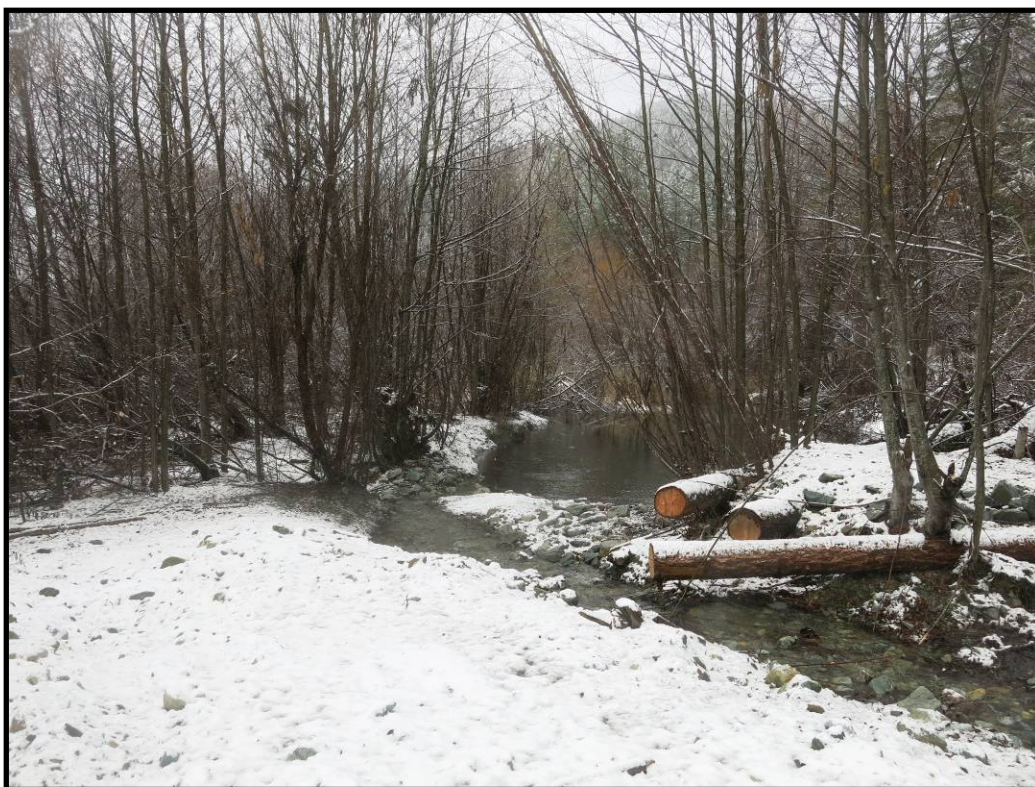
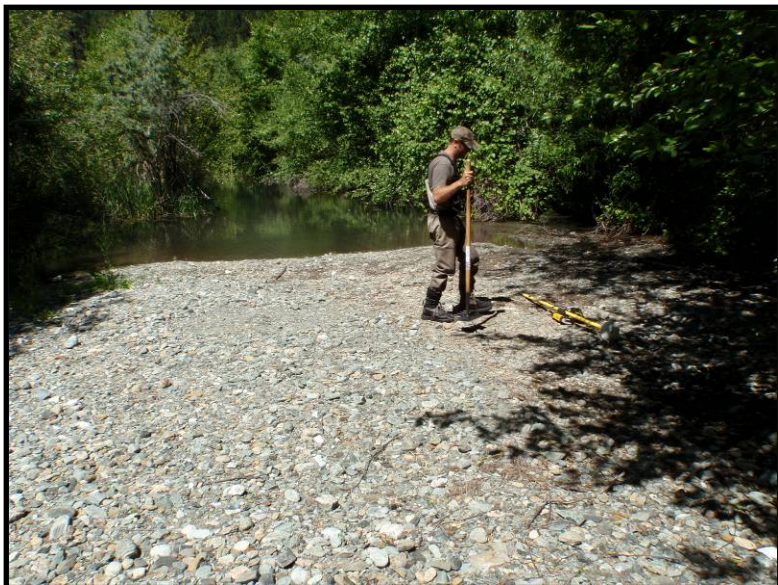
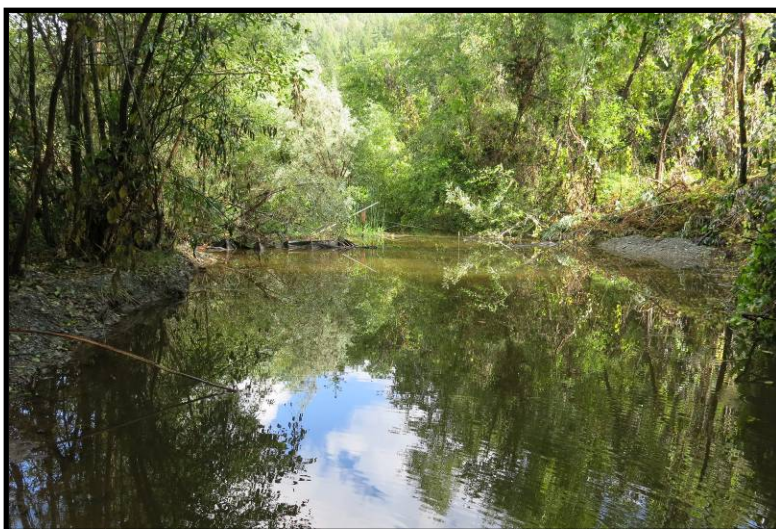
Approximately 560 cubic yards of gravel, rock and sand was removed from the site, more than doubling the volume of off-channel habitat. Photos taken before and after (above and below) illustrate the quality and quantity of habitat restored through this project.
