**Leviathan Mine
October 2011
TAC Meeting
Lahontan Water Board**

Maintenance Activities in 2011

Project:
**ACCESS ROAD PAVING &
 DRAINAGE IMPROVEMENTS**

LEVIATHAN MINE
 ALPINE COUNTY
 LAHONTAN REGIONAL WATER
 QUALITY CONTROL BOARD

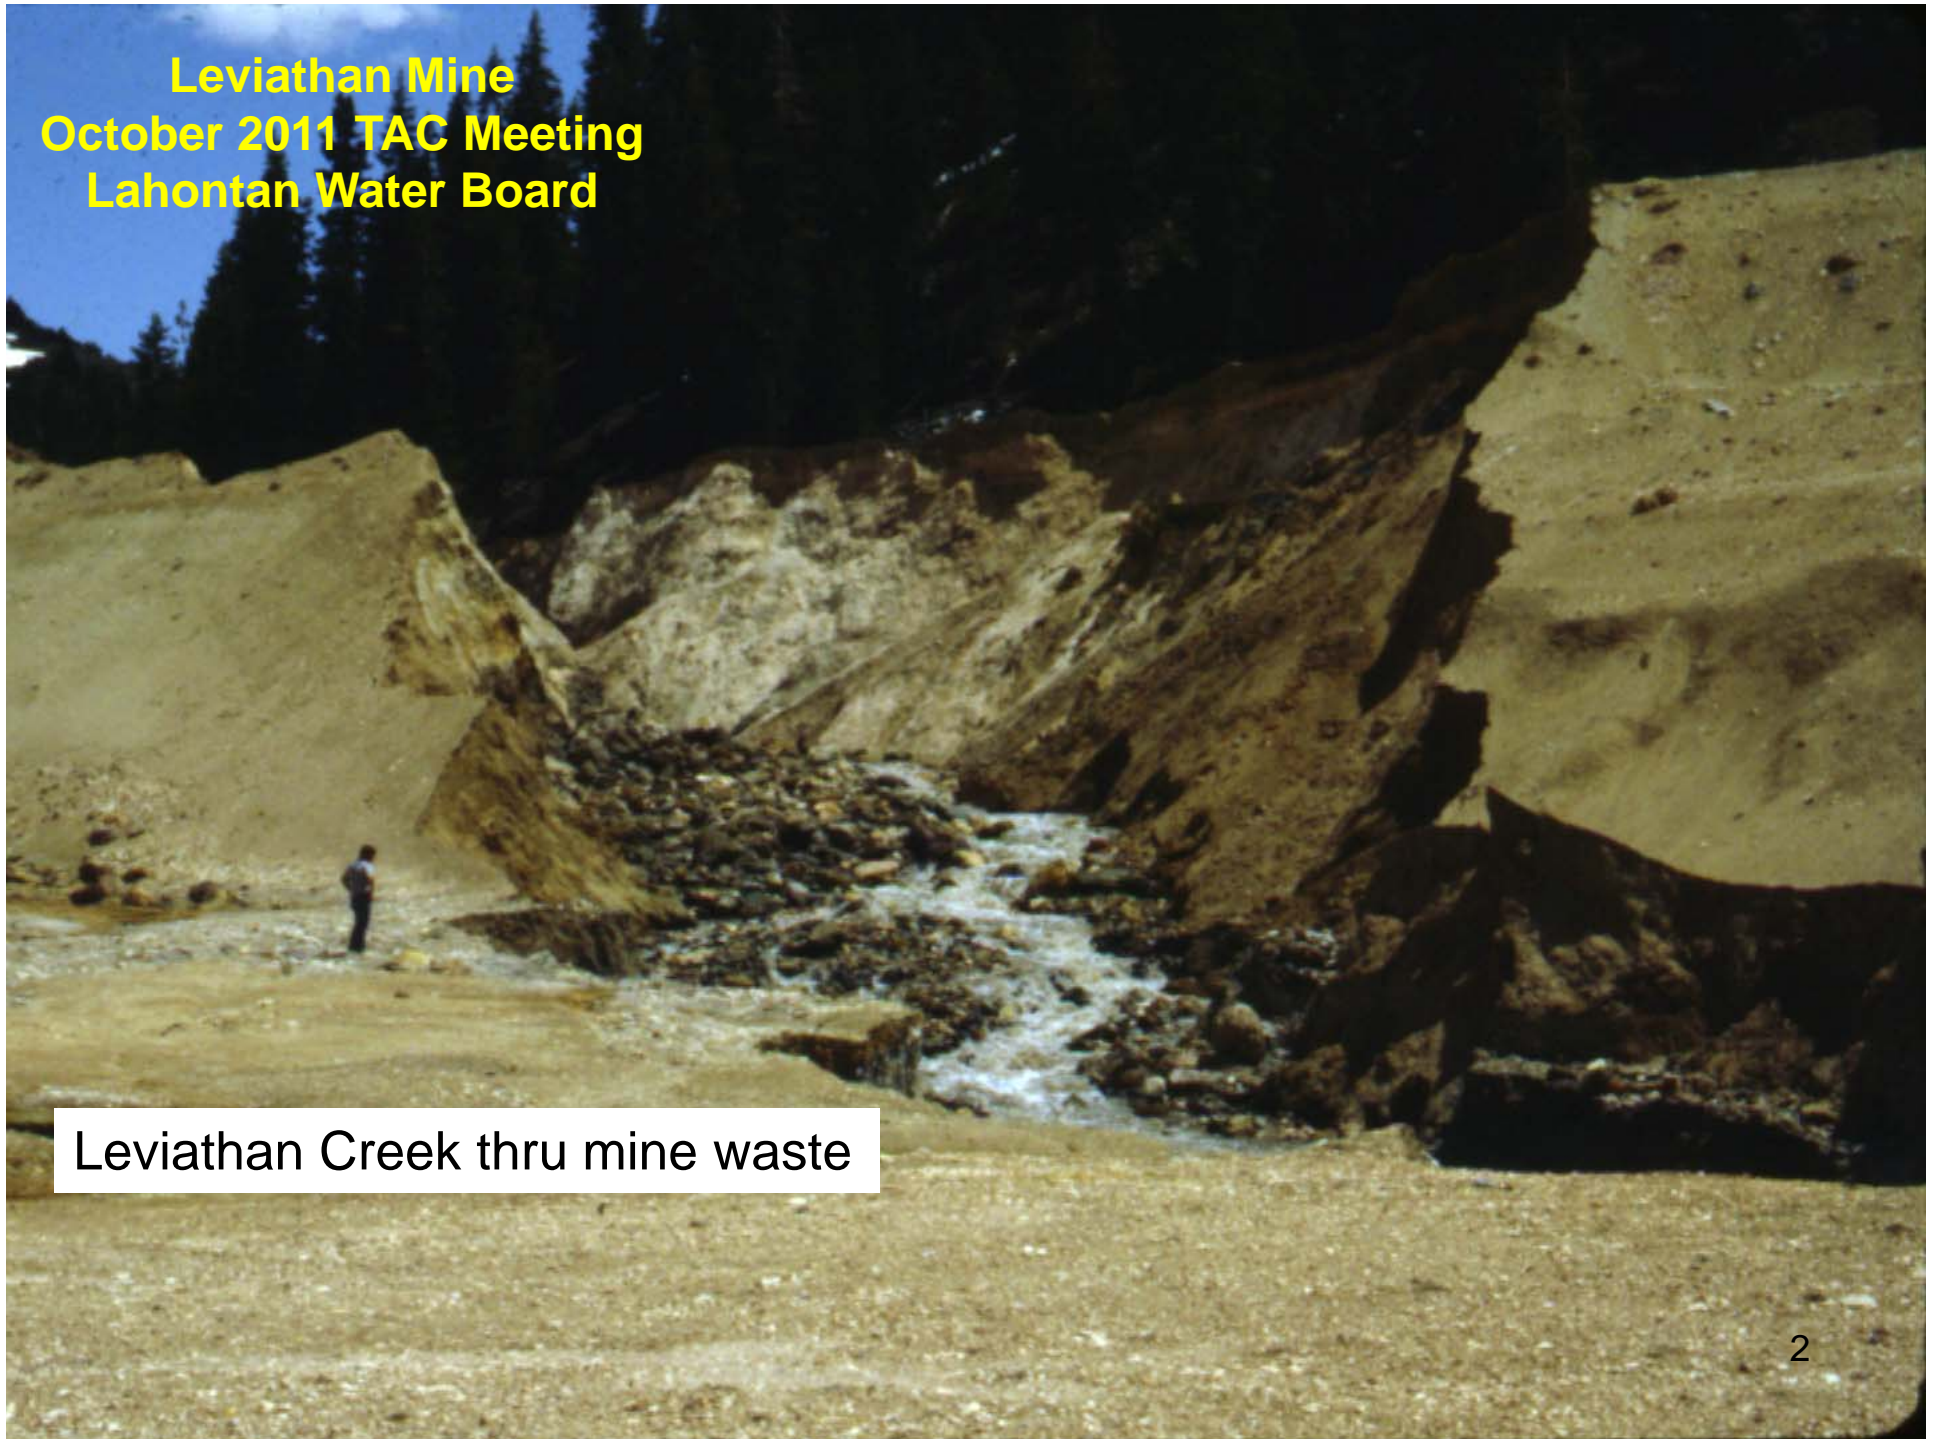
Leviathan Creek thru mine waste

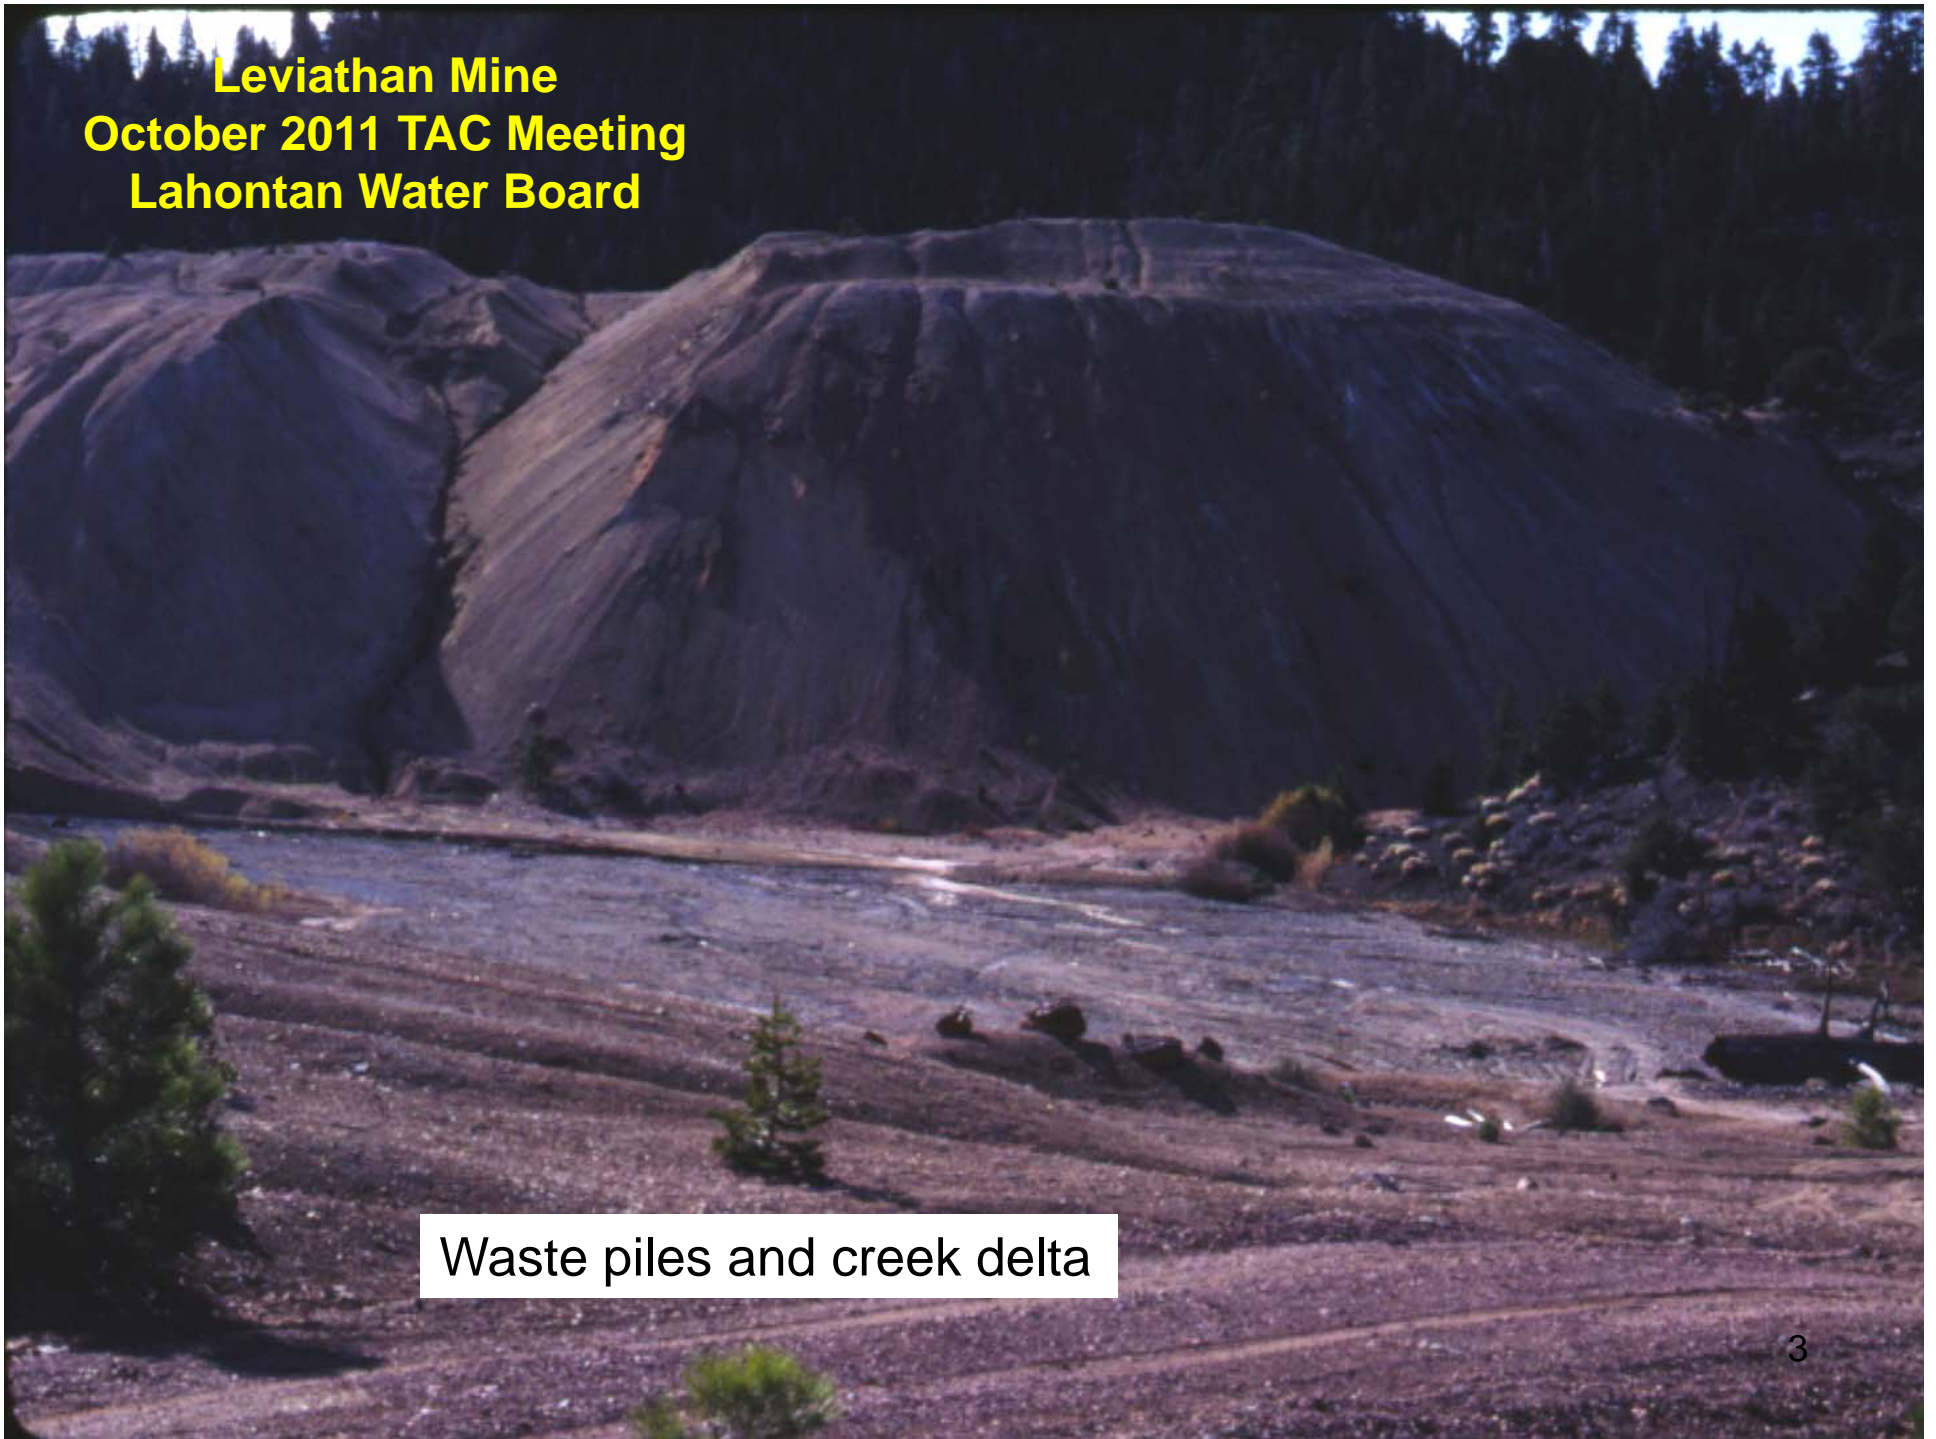
Waste piles and creek delta

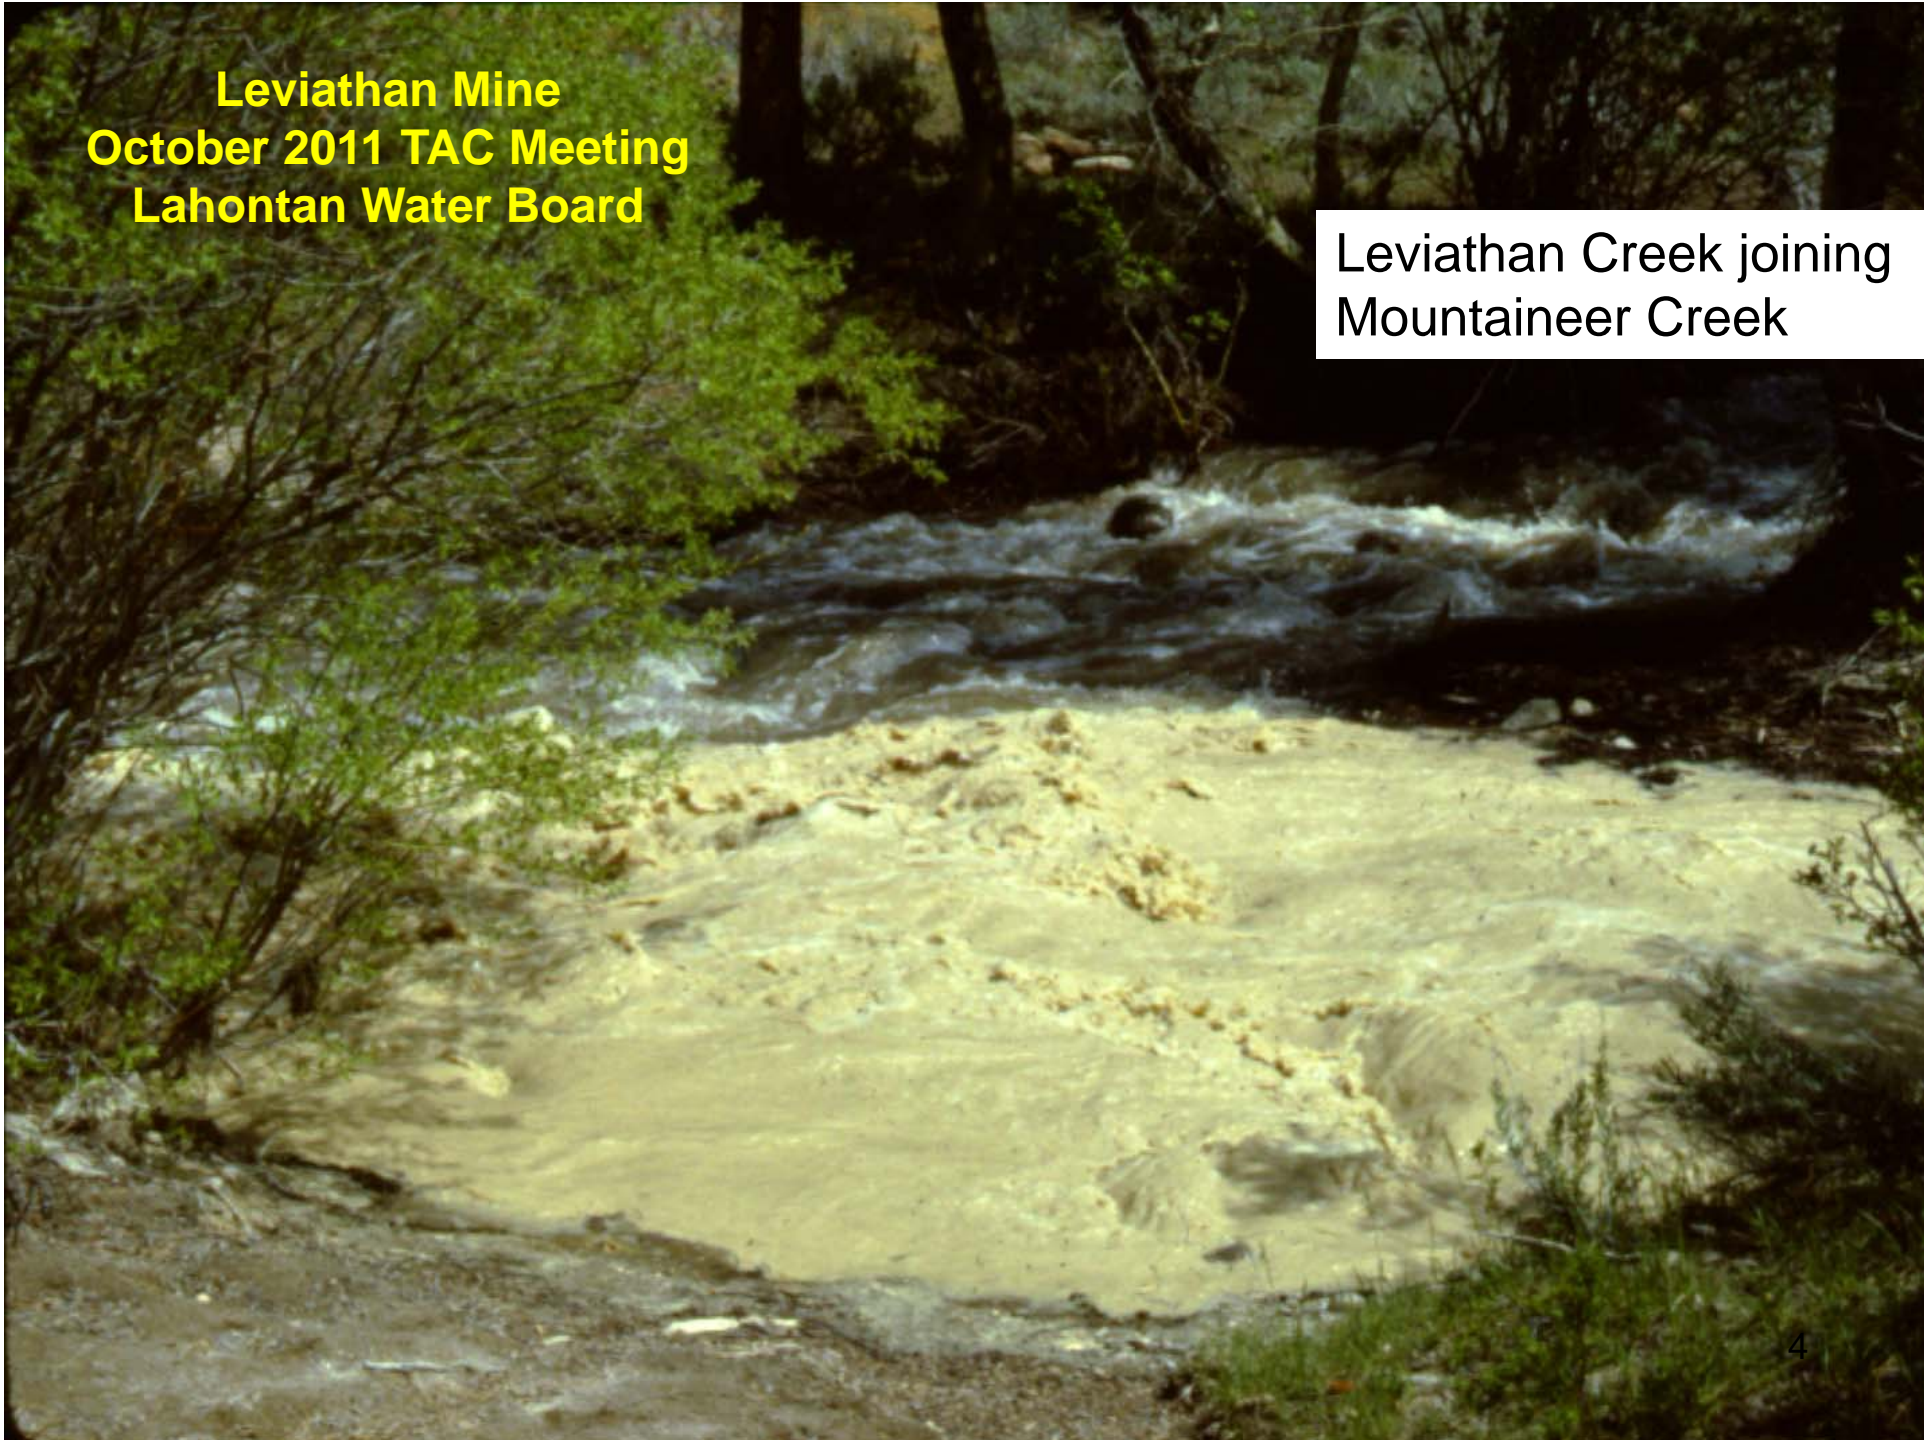
Leviathan Creek joining
Mountaineer Creek

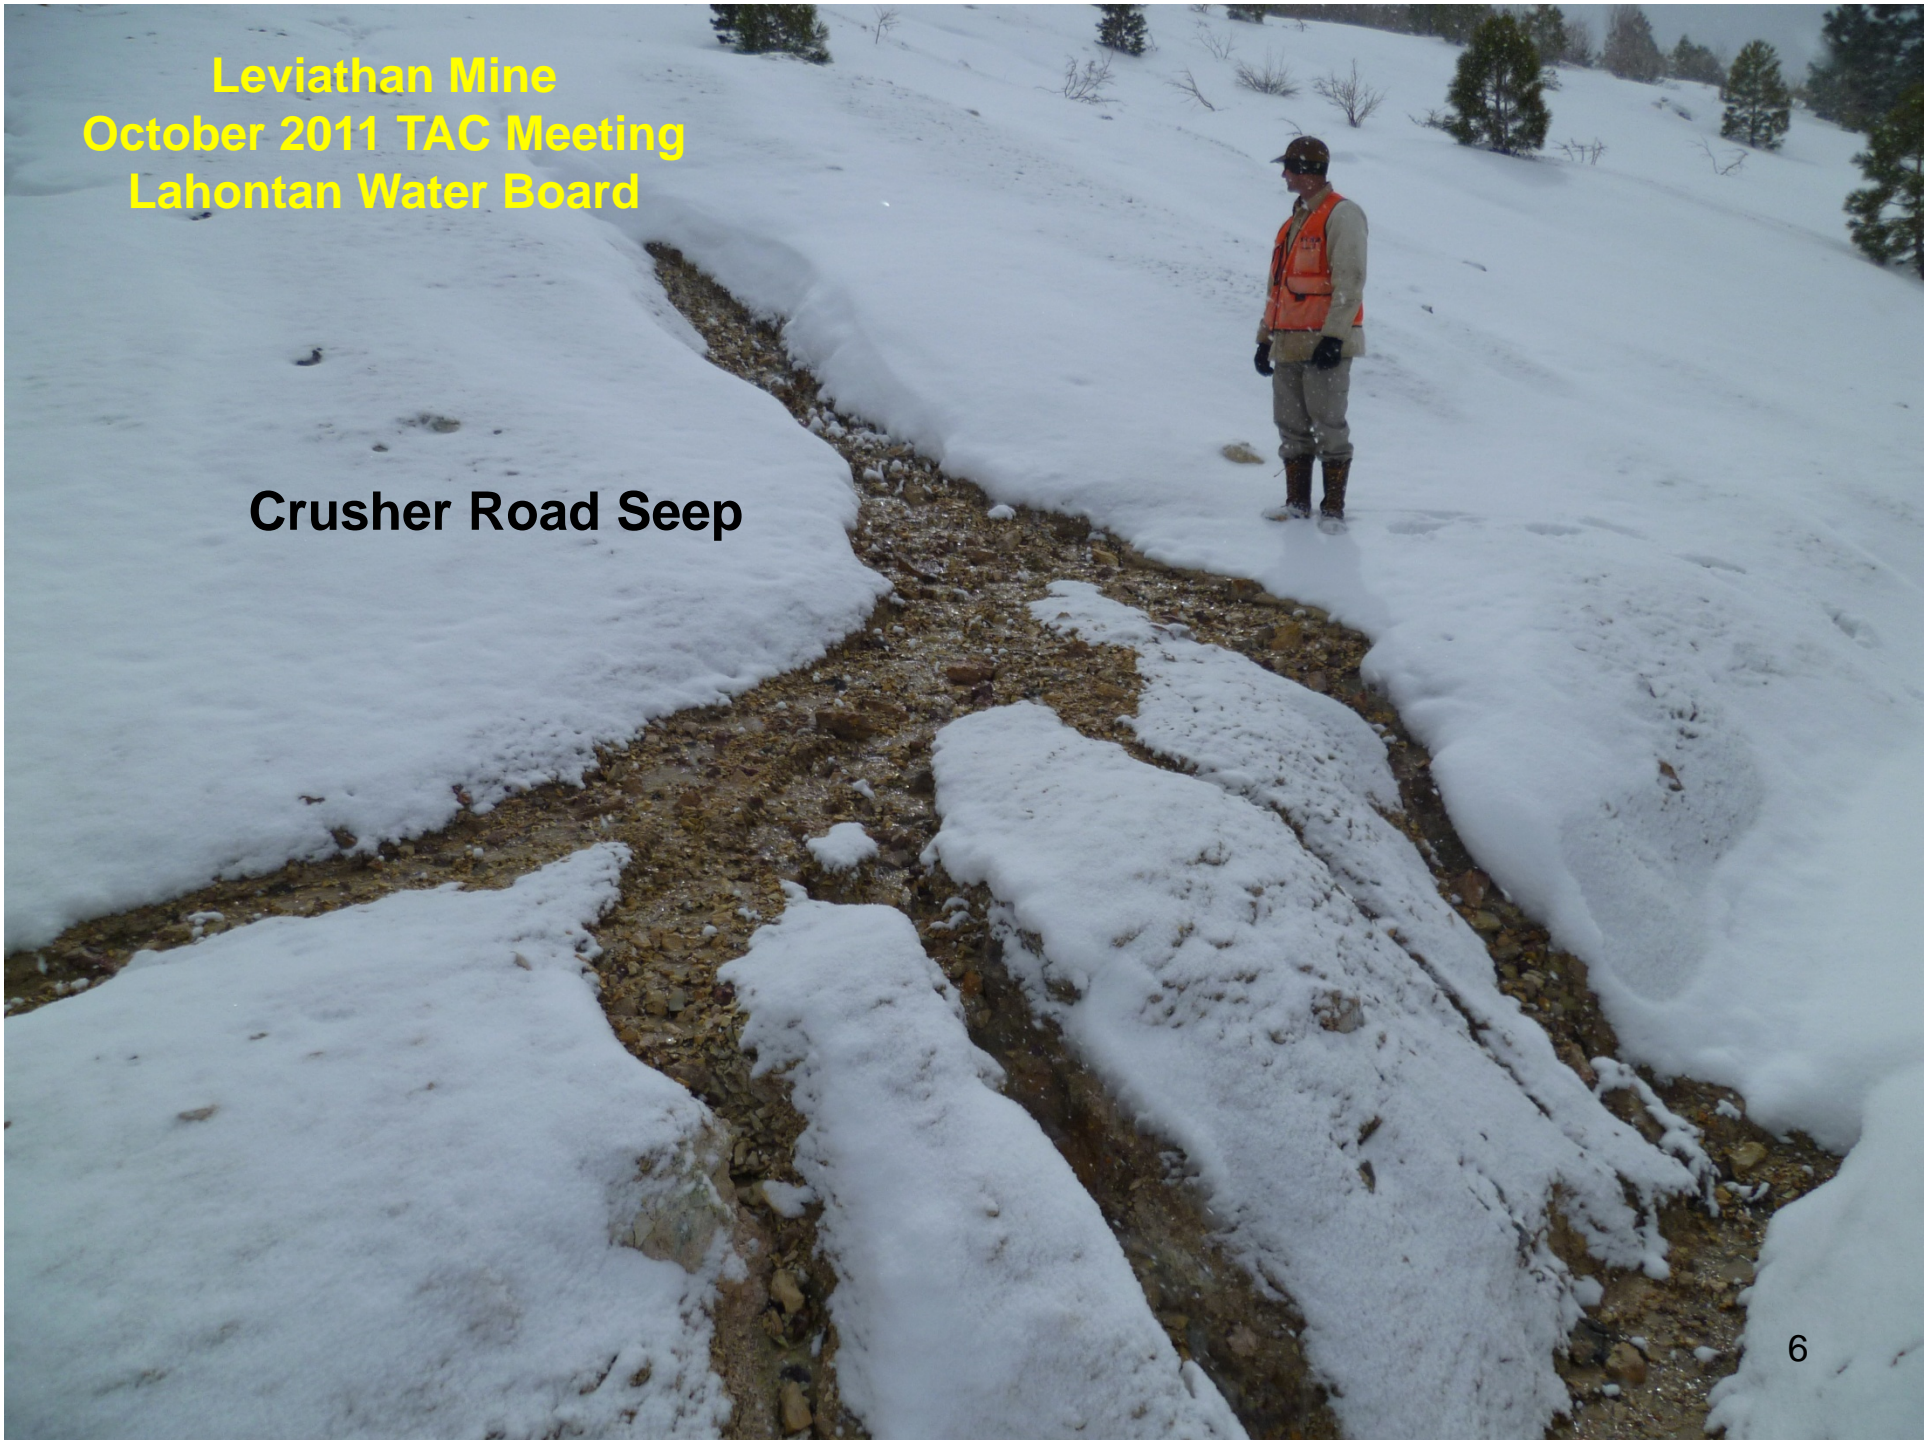
Crusher Road Seep

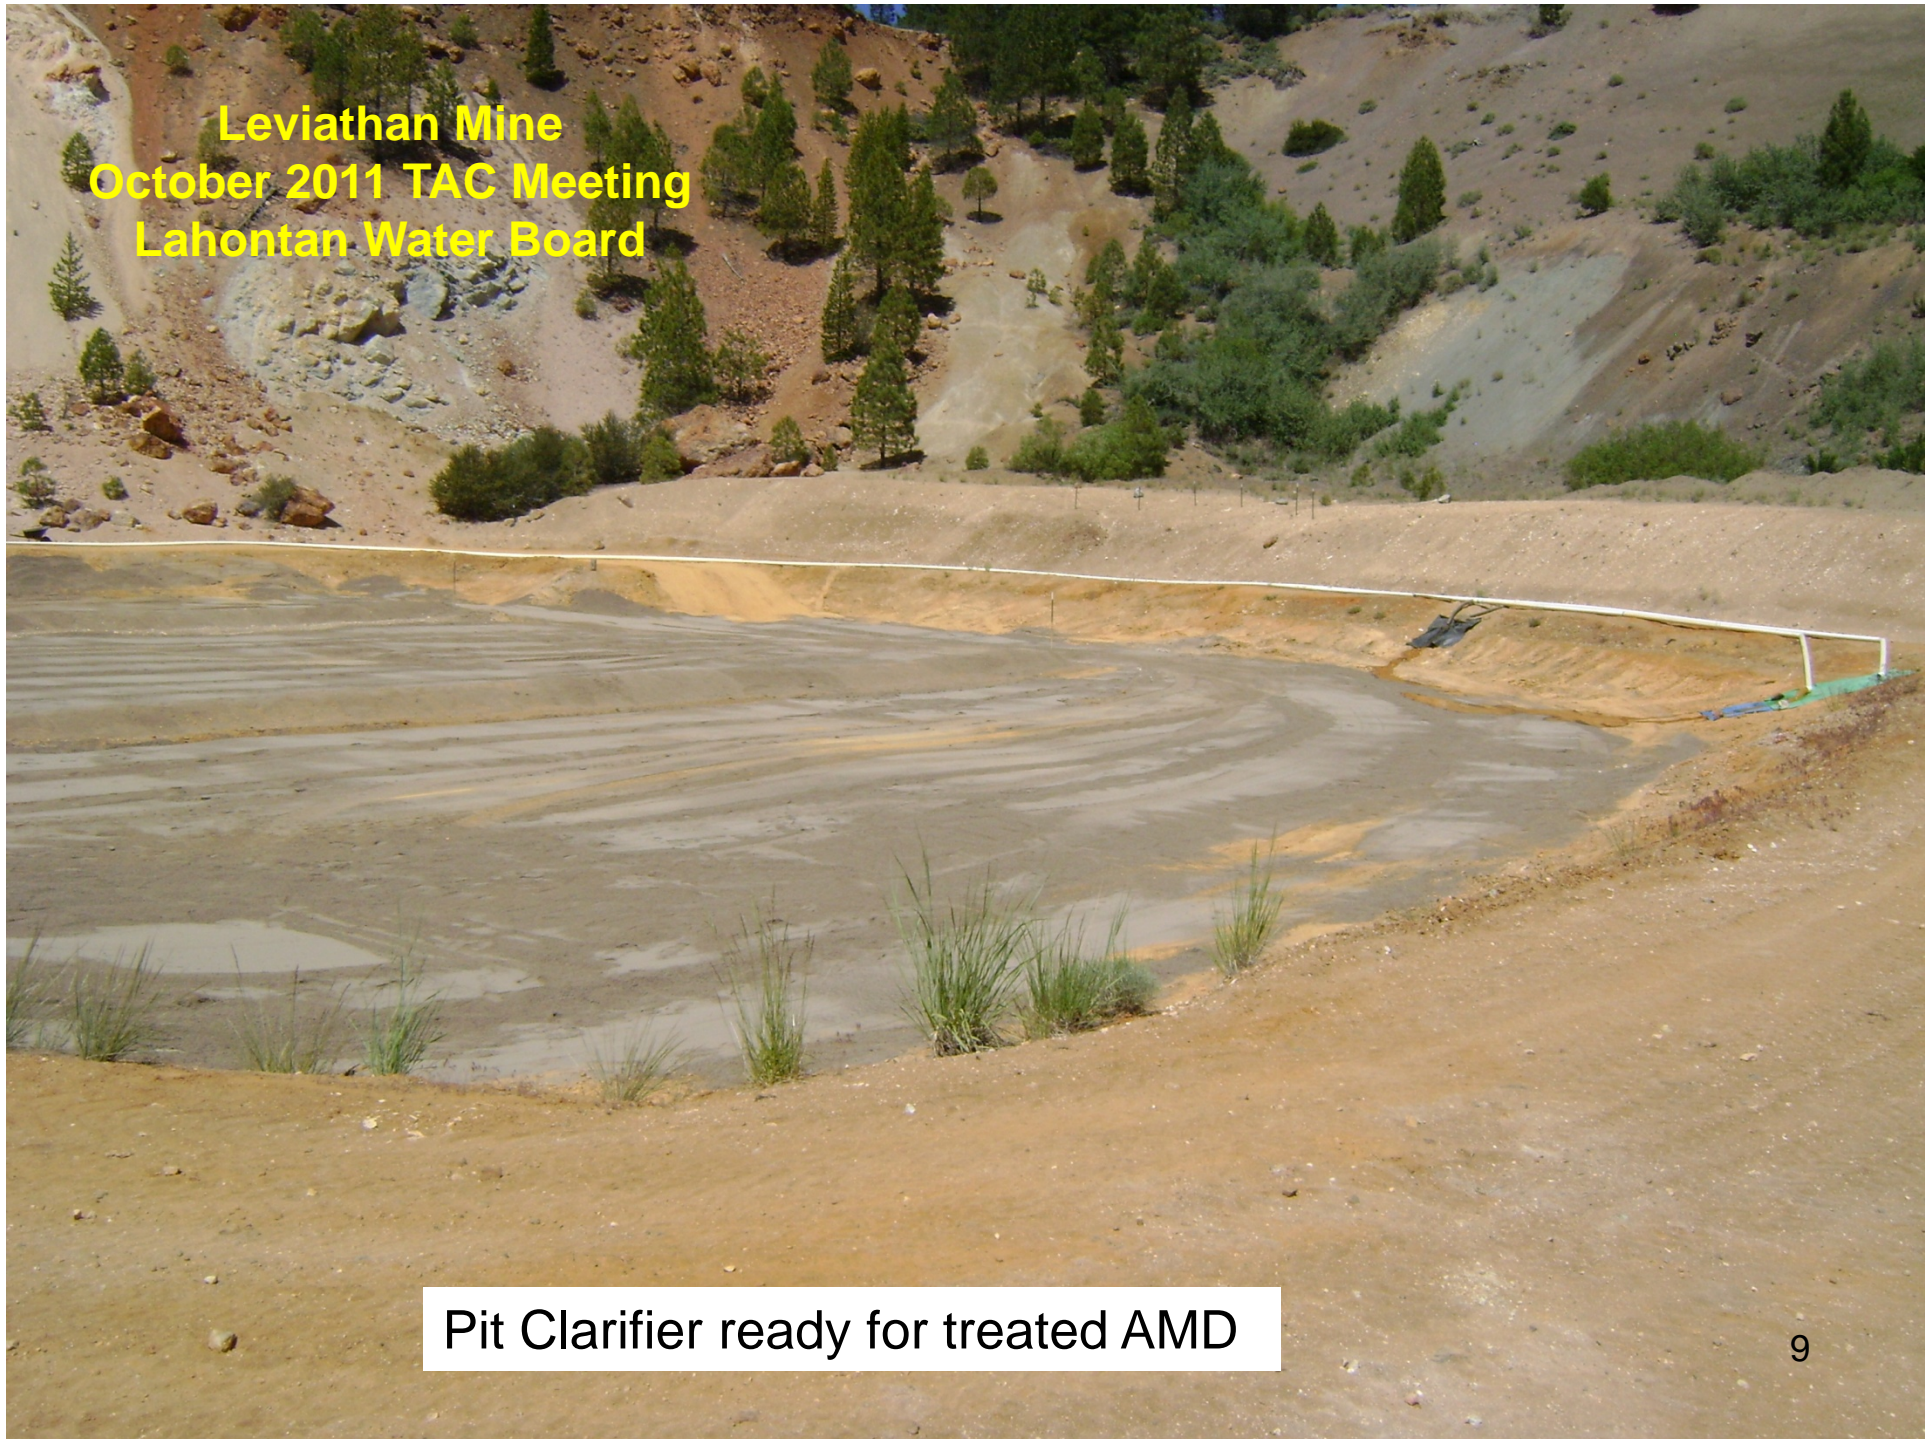
Pit Clarifier ready for treated AMD

A photograph of a water treatment facility at the Leviathan Mine. In the foreground, a large, shallow pond contains murky, reddish-brown water. In the middle ground, several large, white cylindrical storage tanks are arranged in a row, with yellow ladders and pipes connecting them. To the left, there are several white utility buildings and a white pickup truck. The background features a steep, sandy hillside with sparse green trees under a clear blue sky.

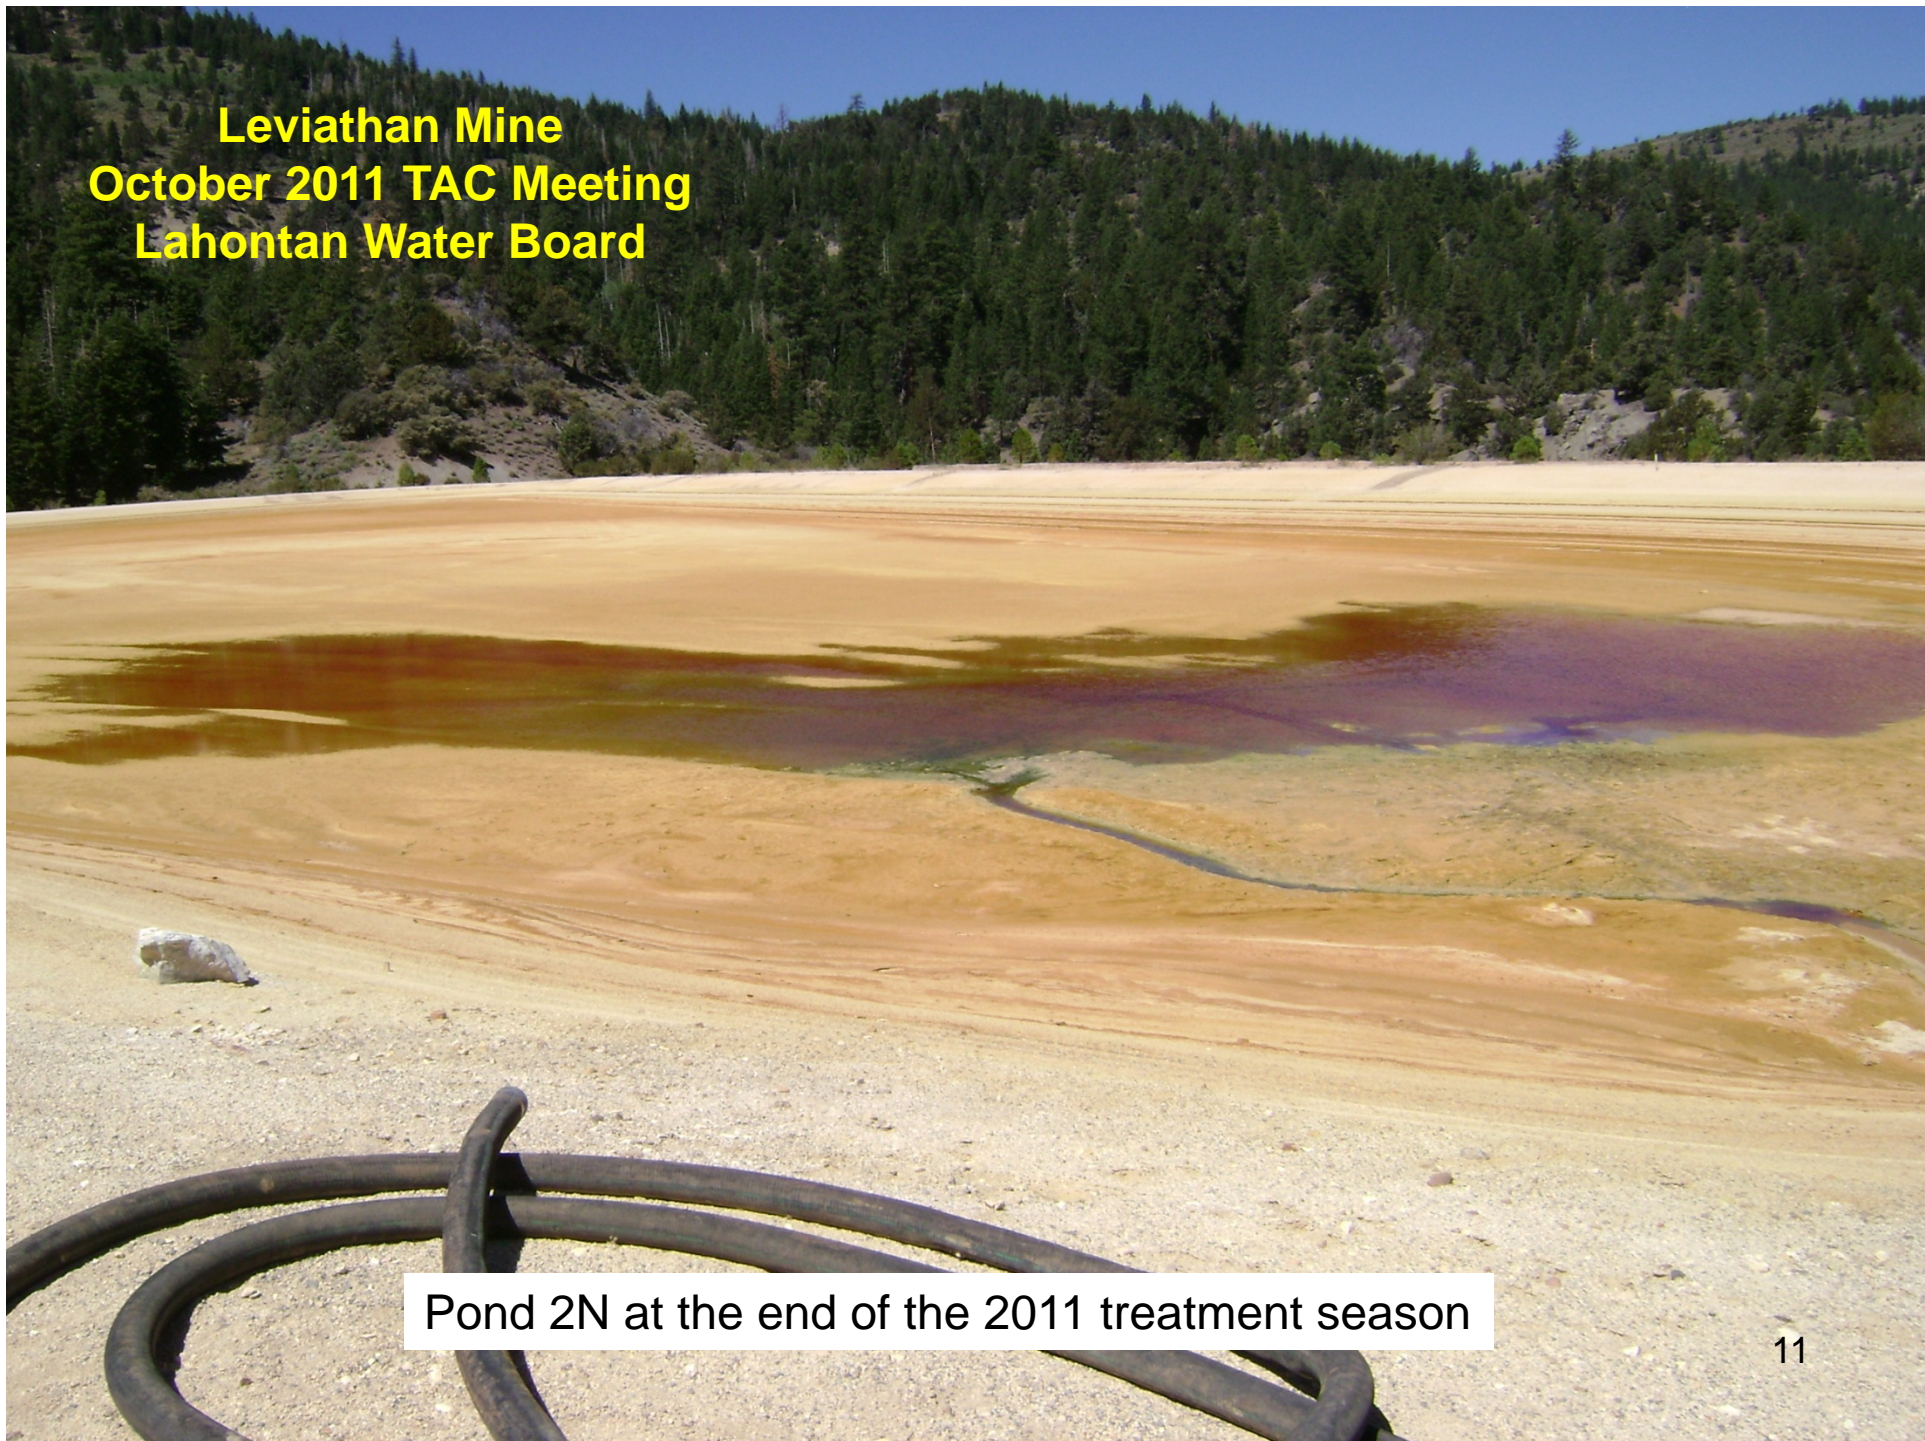
Pond 2N at the end of the 2011 treatment season

- ~800 – 1,000 tons of sludge will be hauled off site for disposal in 2012

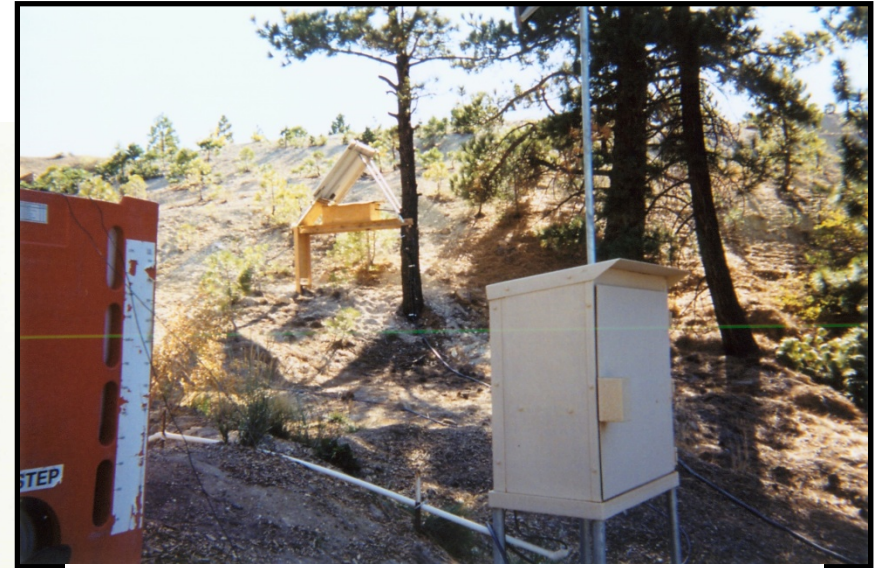
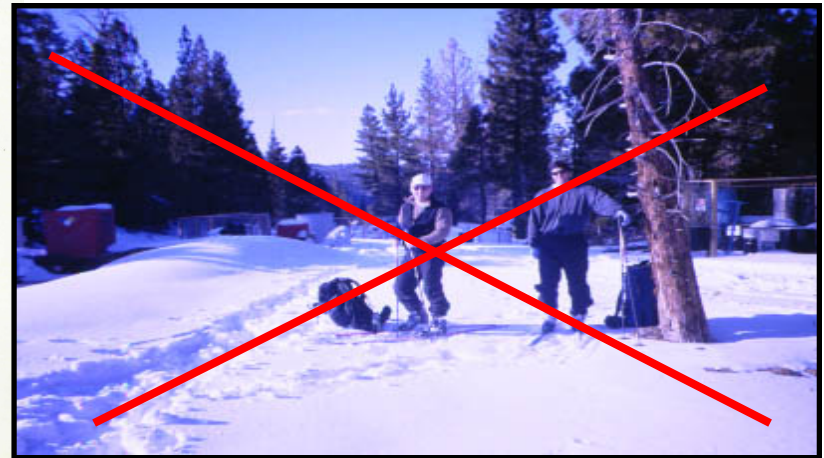
USGS Stage and Flow Monitoring

No SW sampling 2010-11

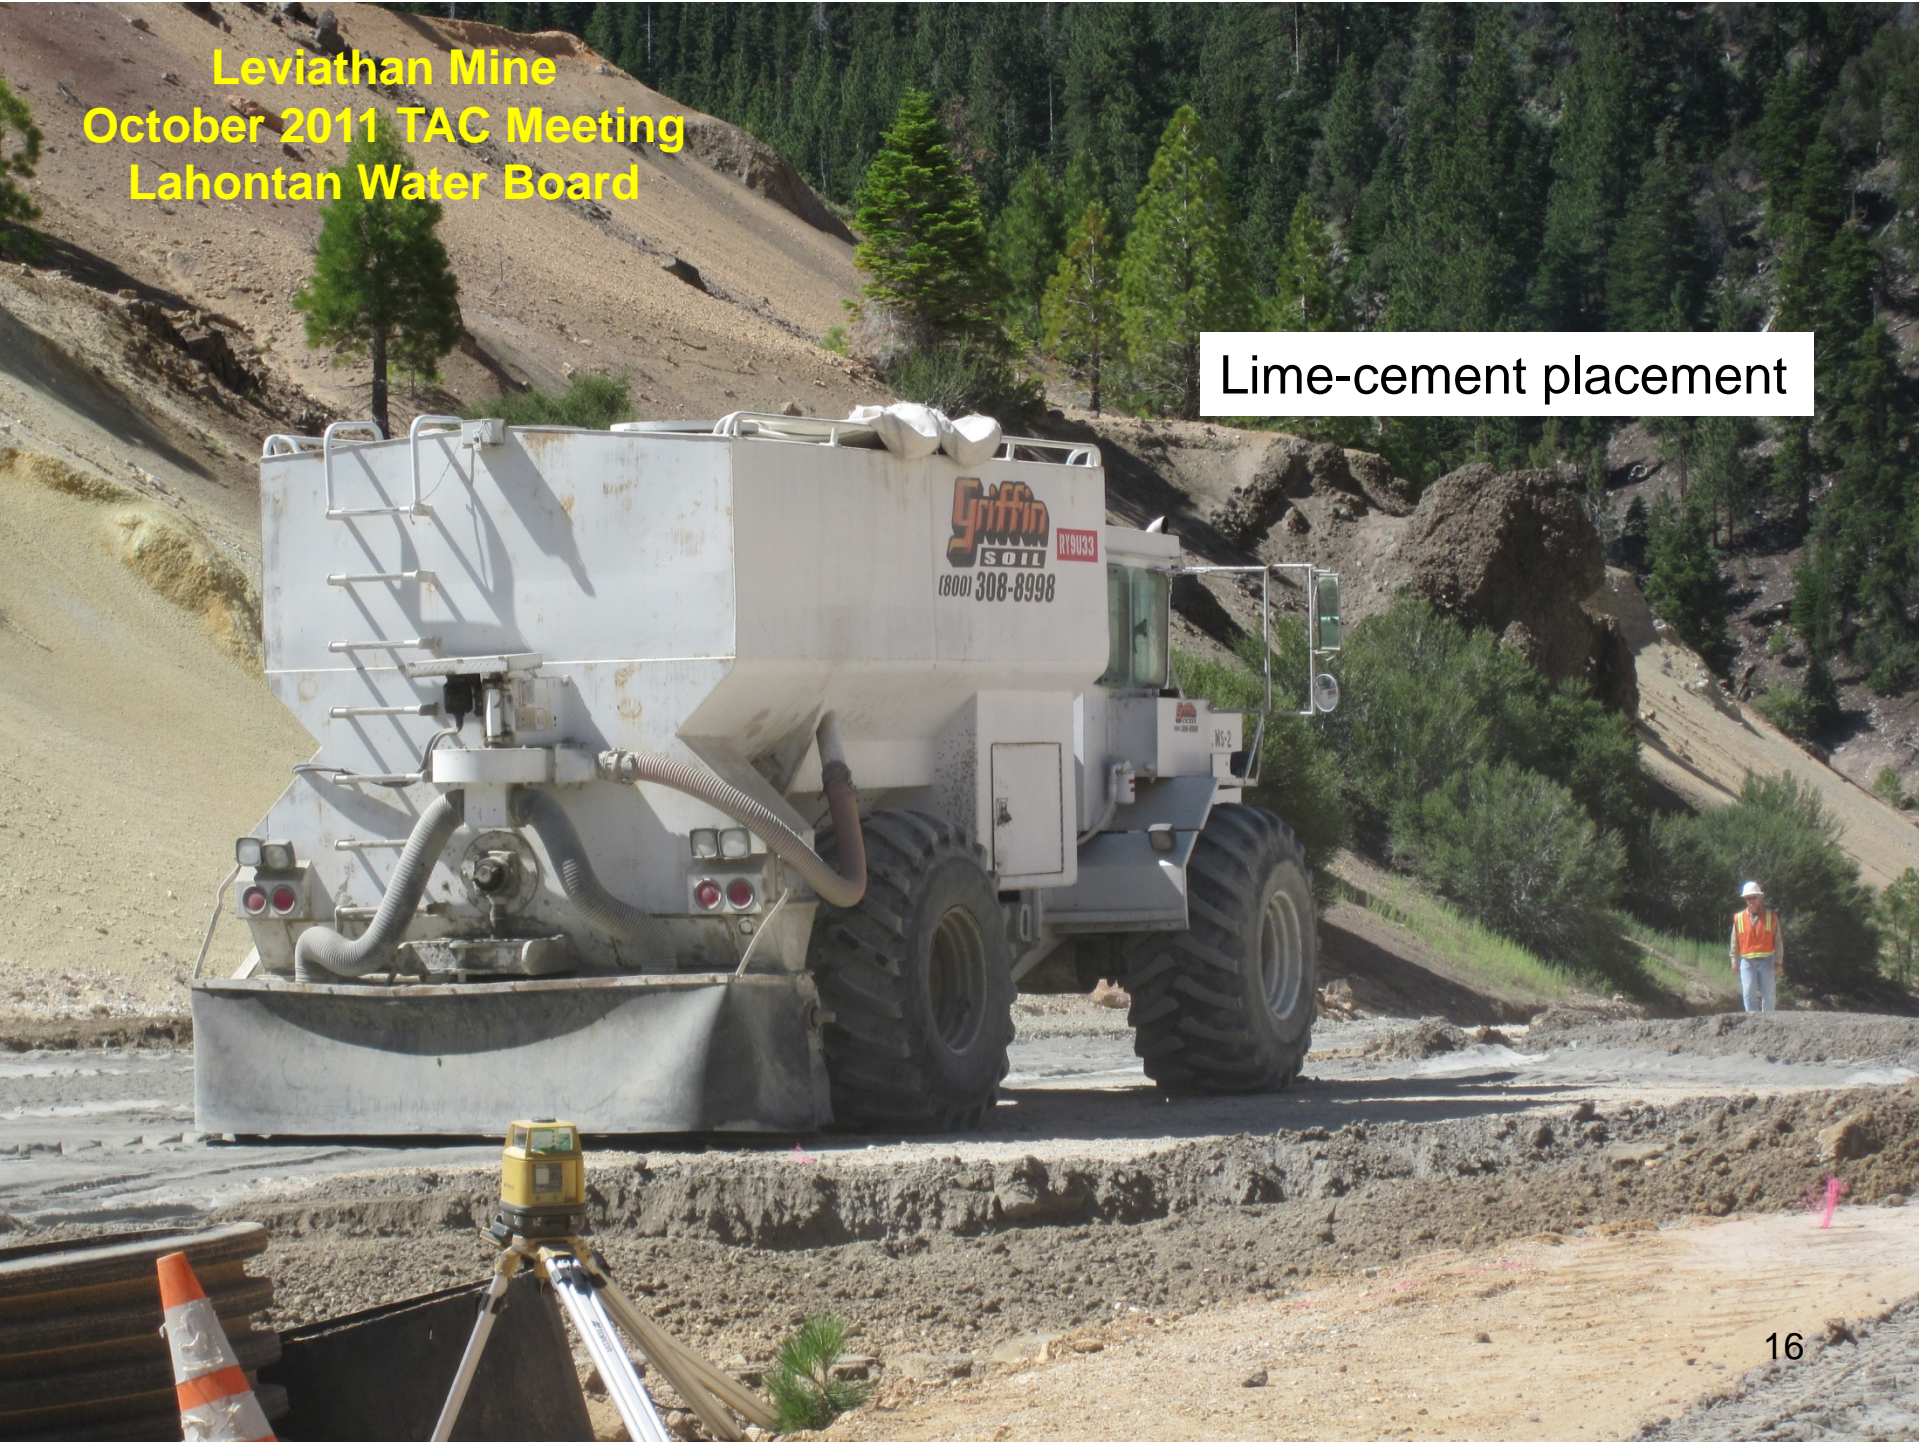
Lime-cement placement

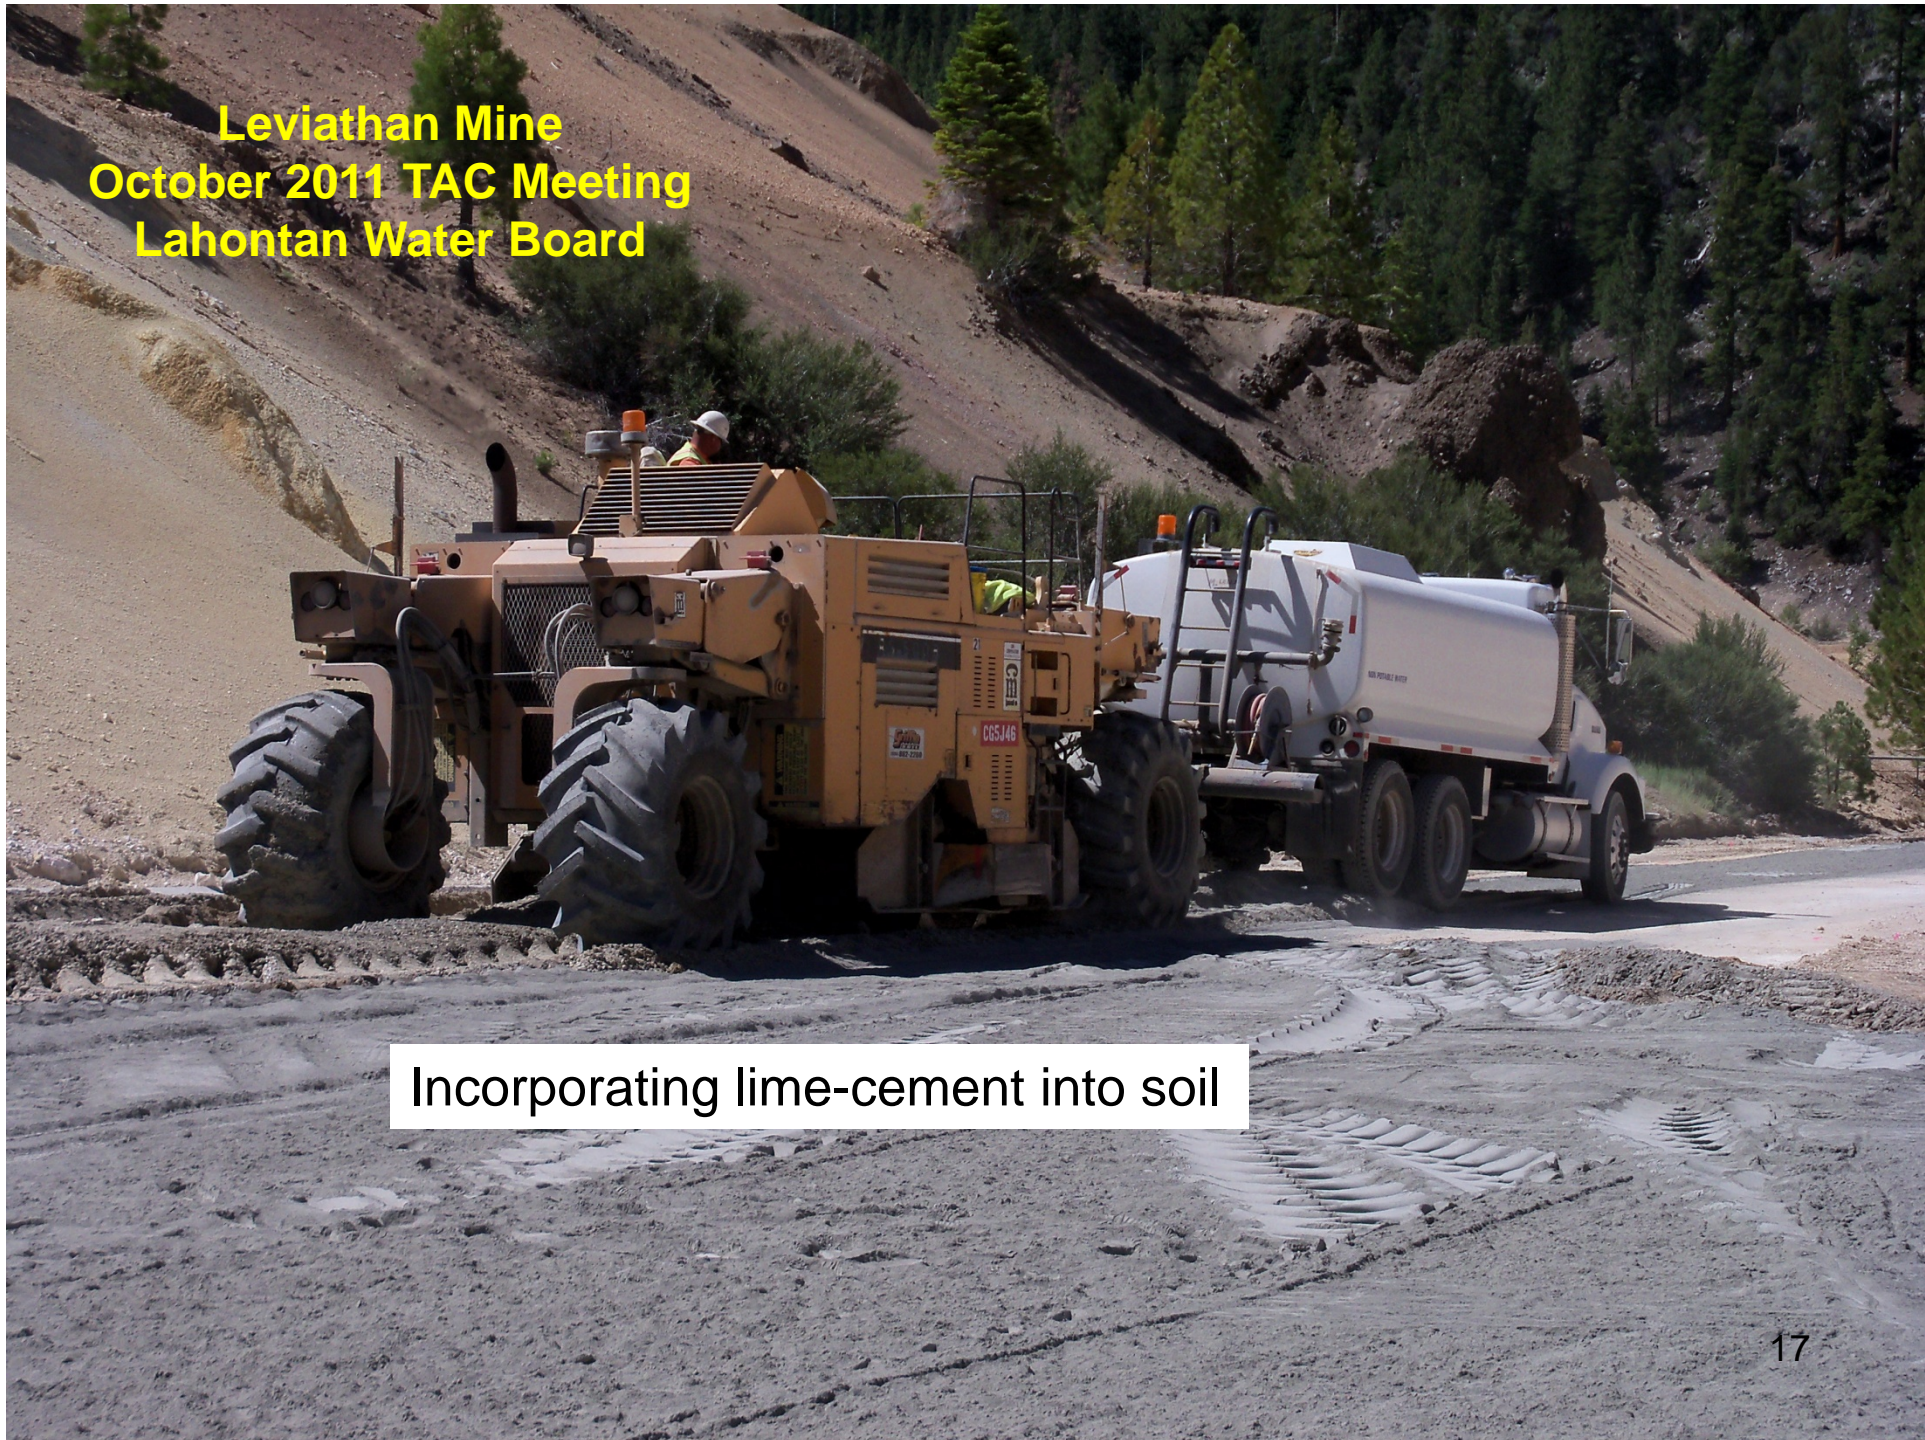
Incorporating lime-cement into soil
