**Leviathan Mine
October 2011
TAC Meeting
Lahontan Water Board**

Maintenance Activities in 2011

Project:
**ACCESS ROAD PAVING &
 DRAINAGE IMPROVEMENTS**

LEVIATHAN MINE
 ALPINE COUNTY
 LAHONTAN REGIONAL WATER
 QUALITY CONTROL BOARD

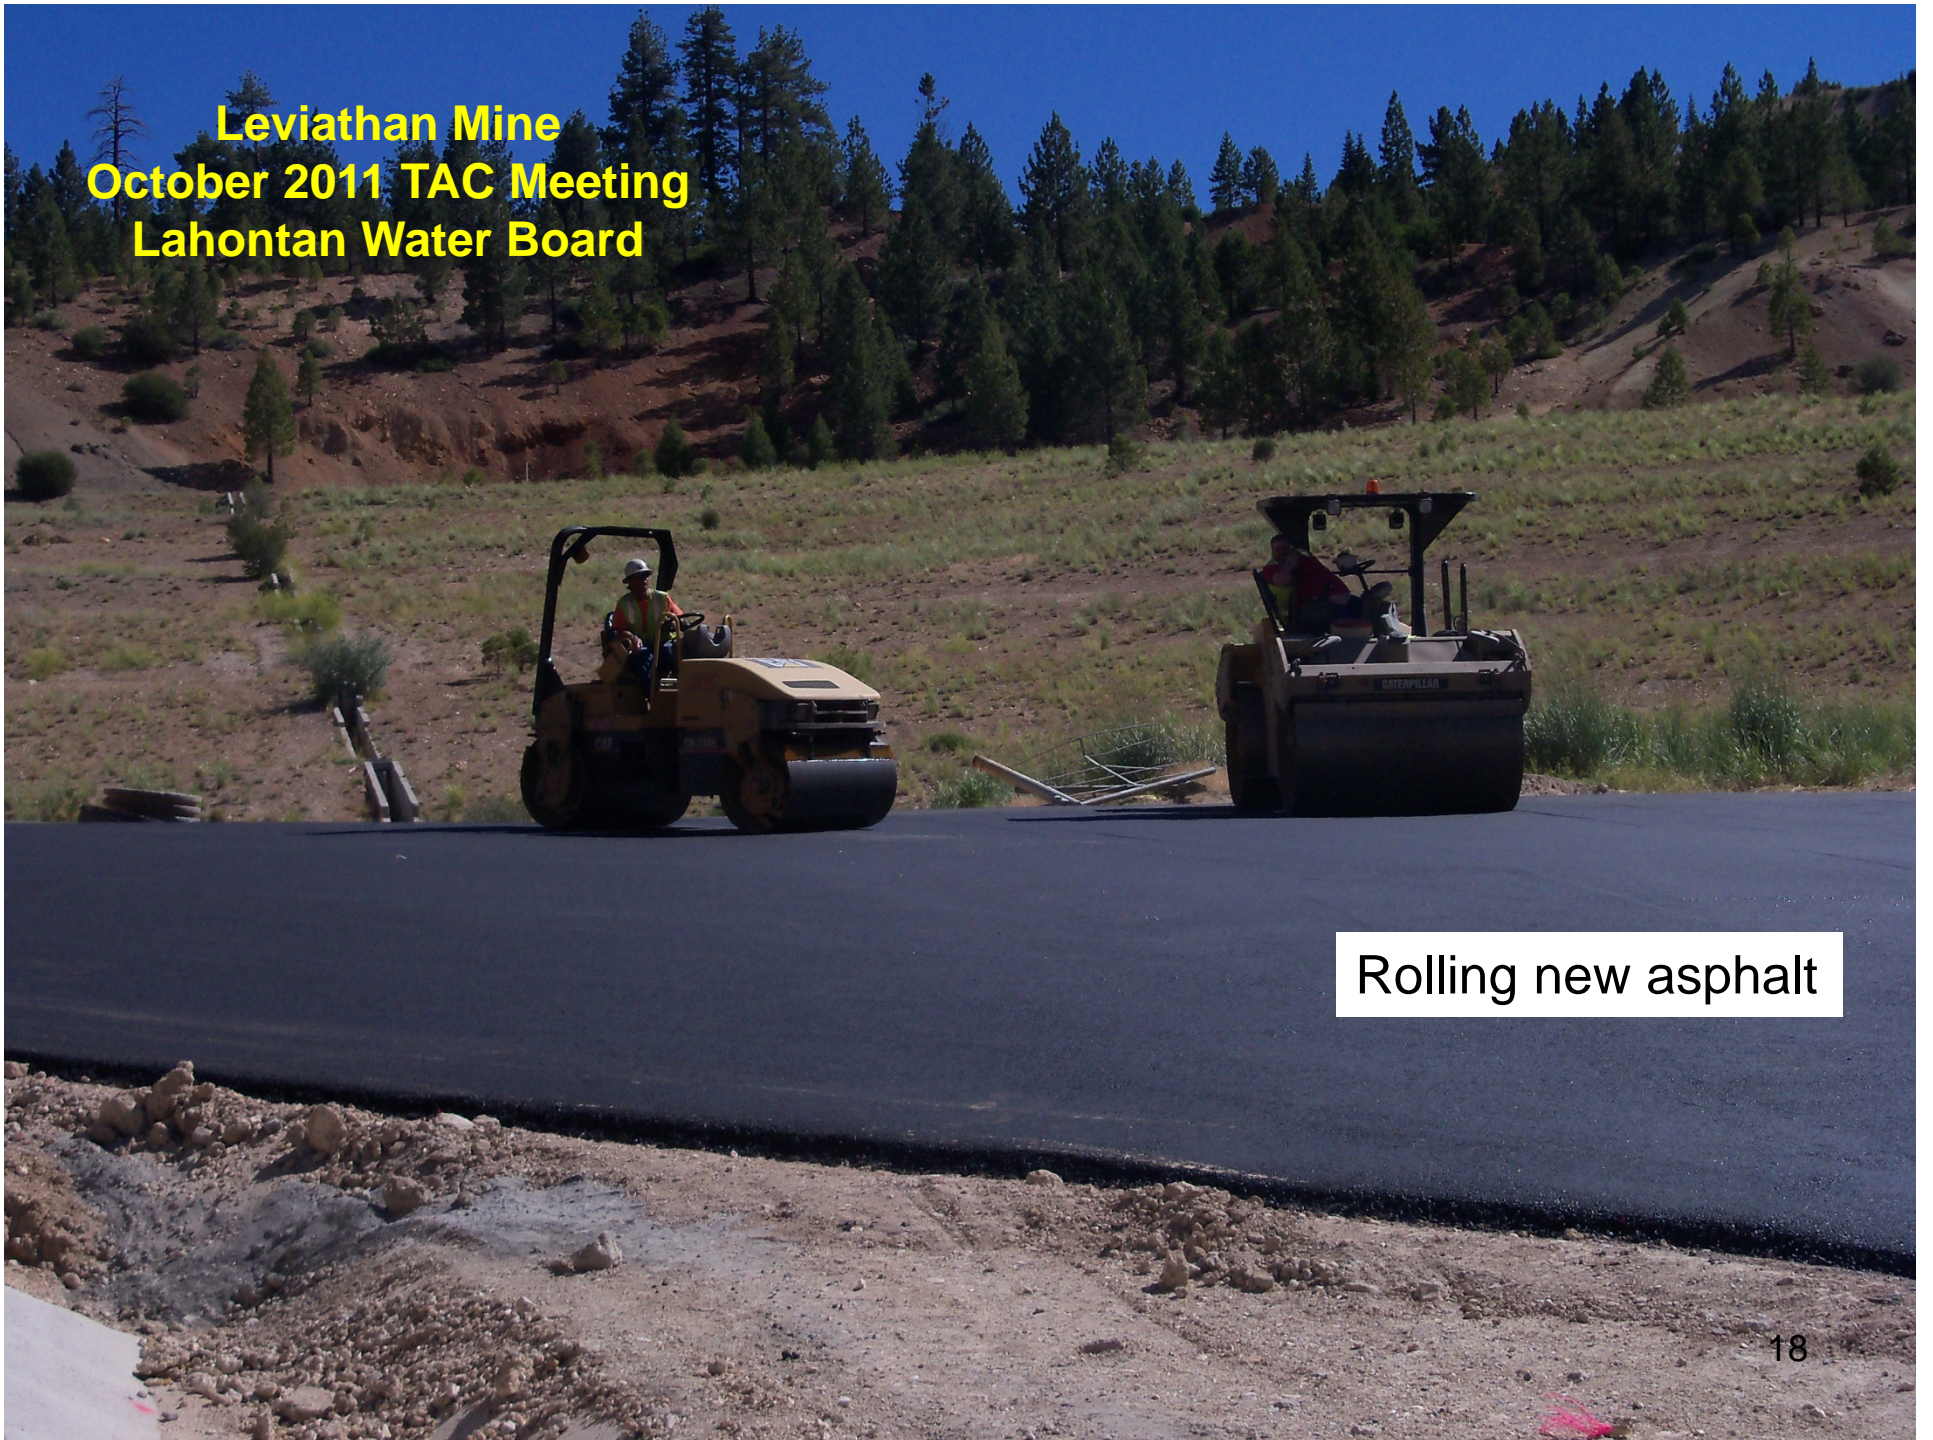
Rolling new asphalt

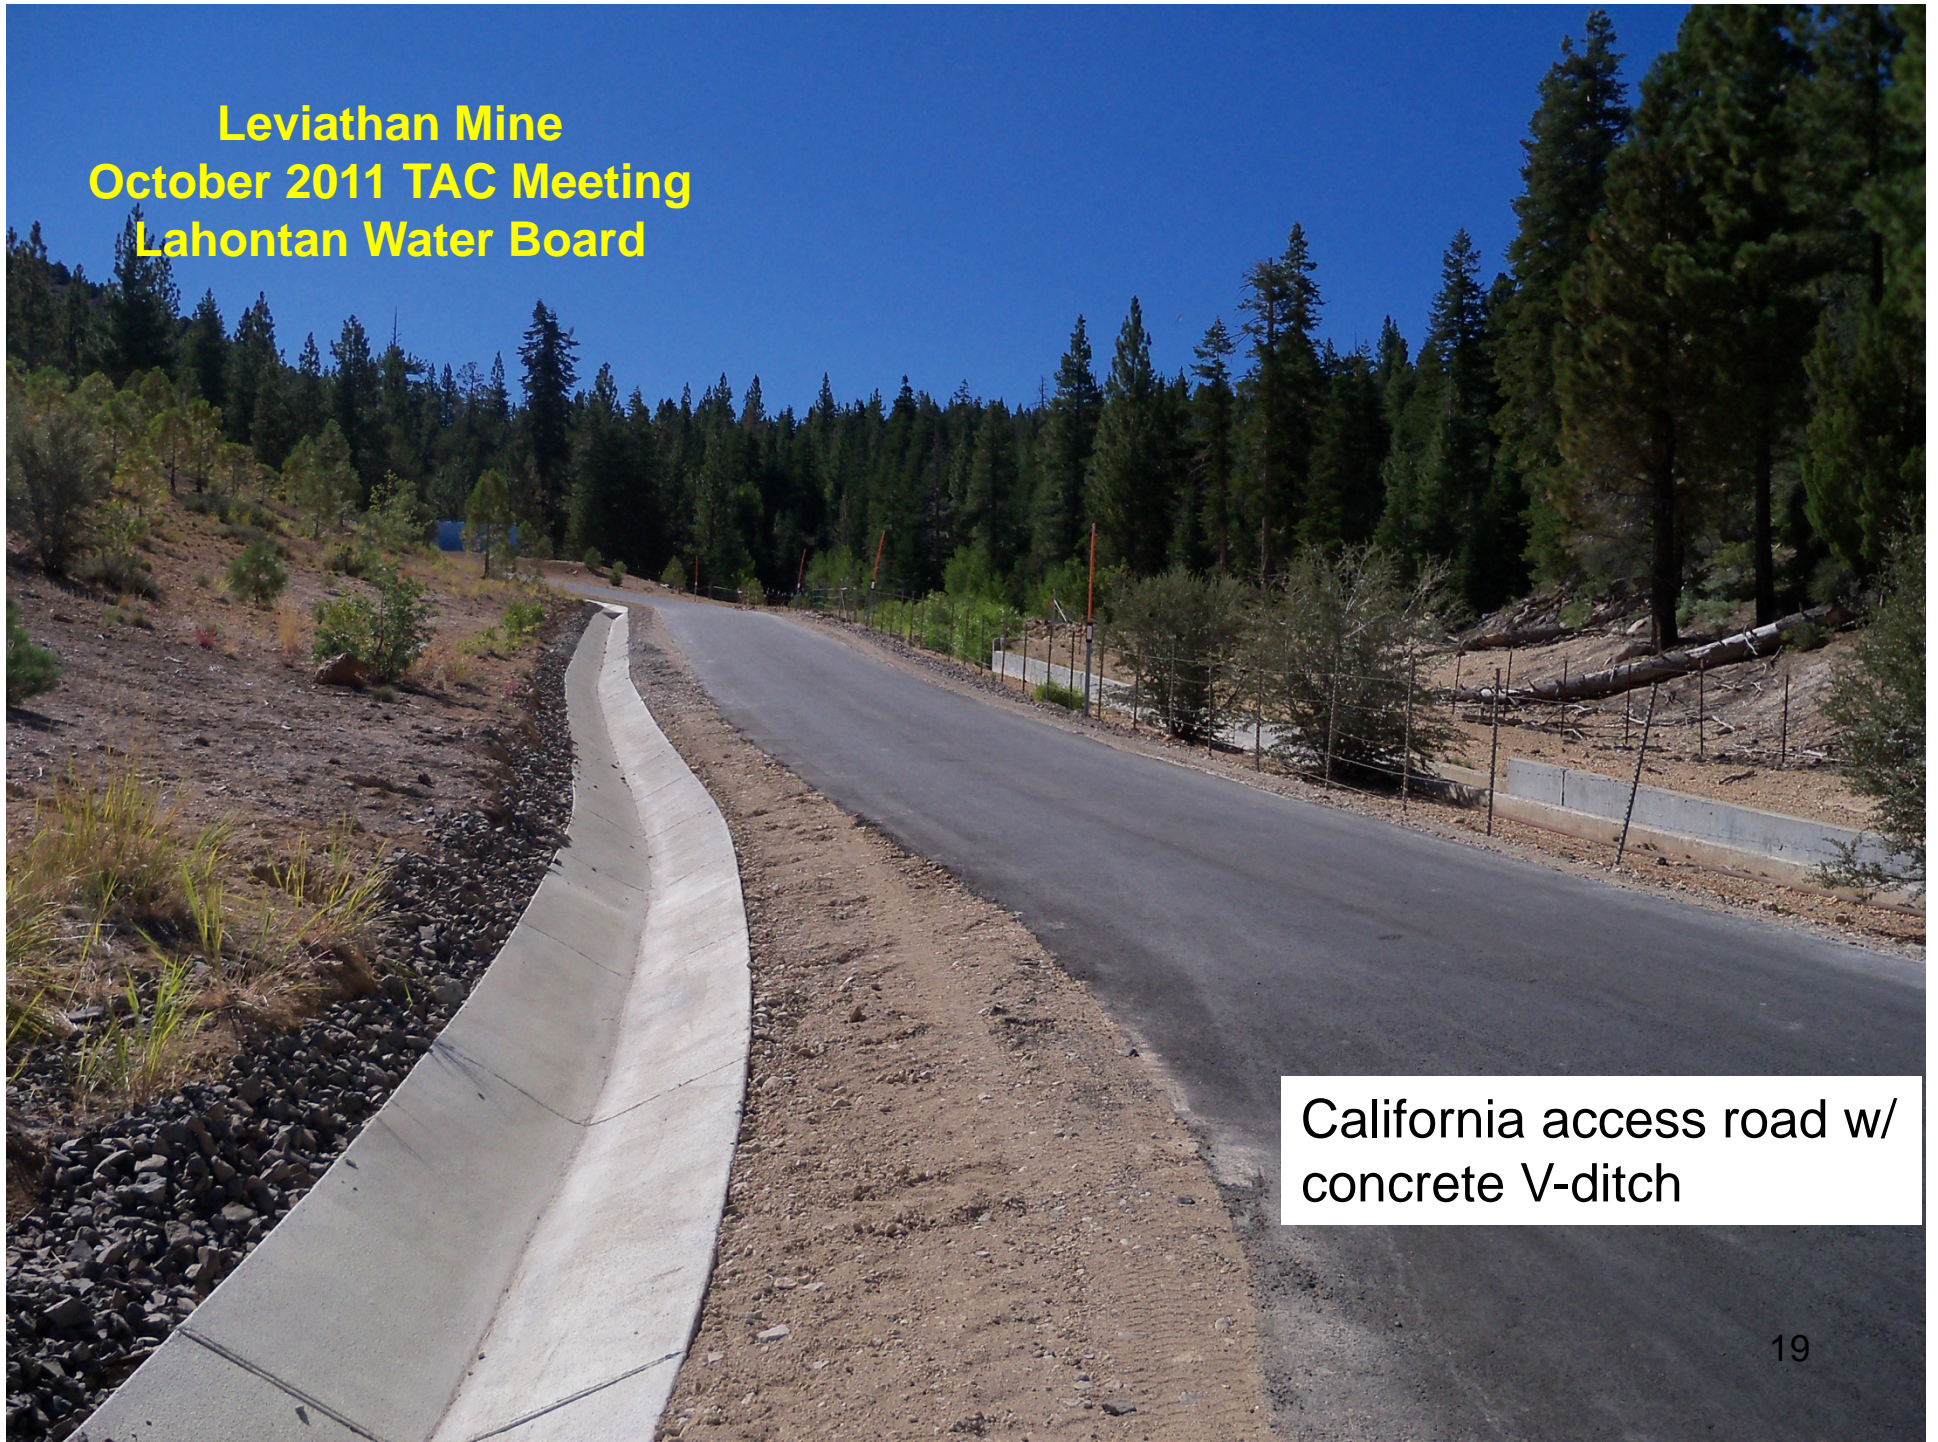
California access road w/
concrete V-ditch

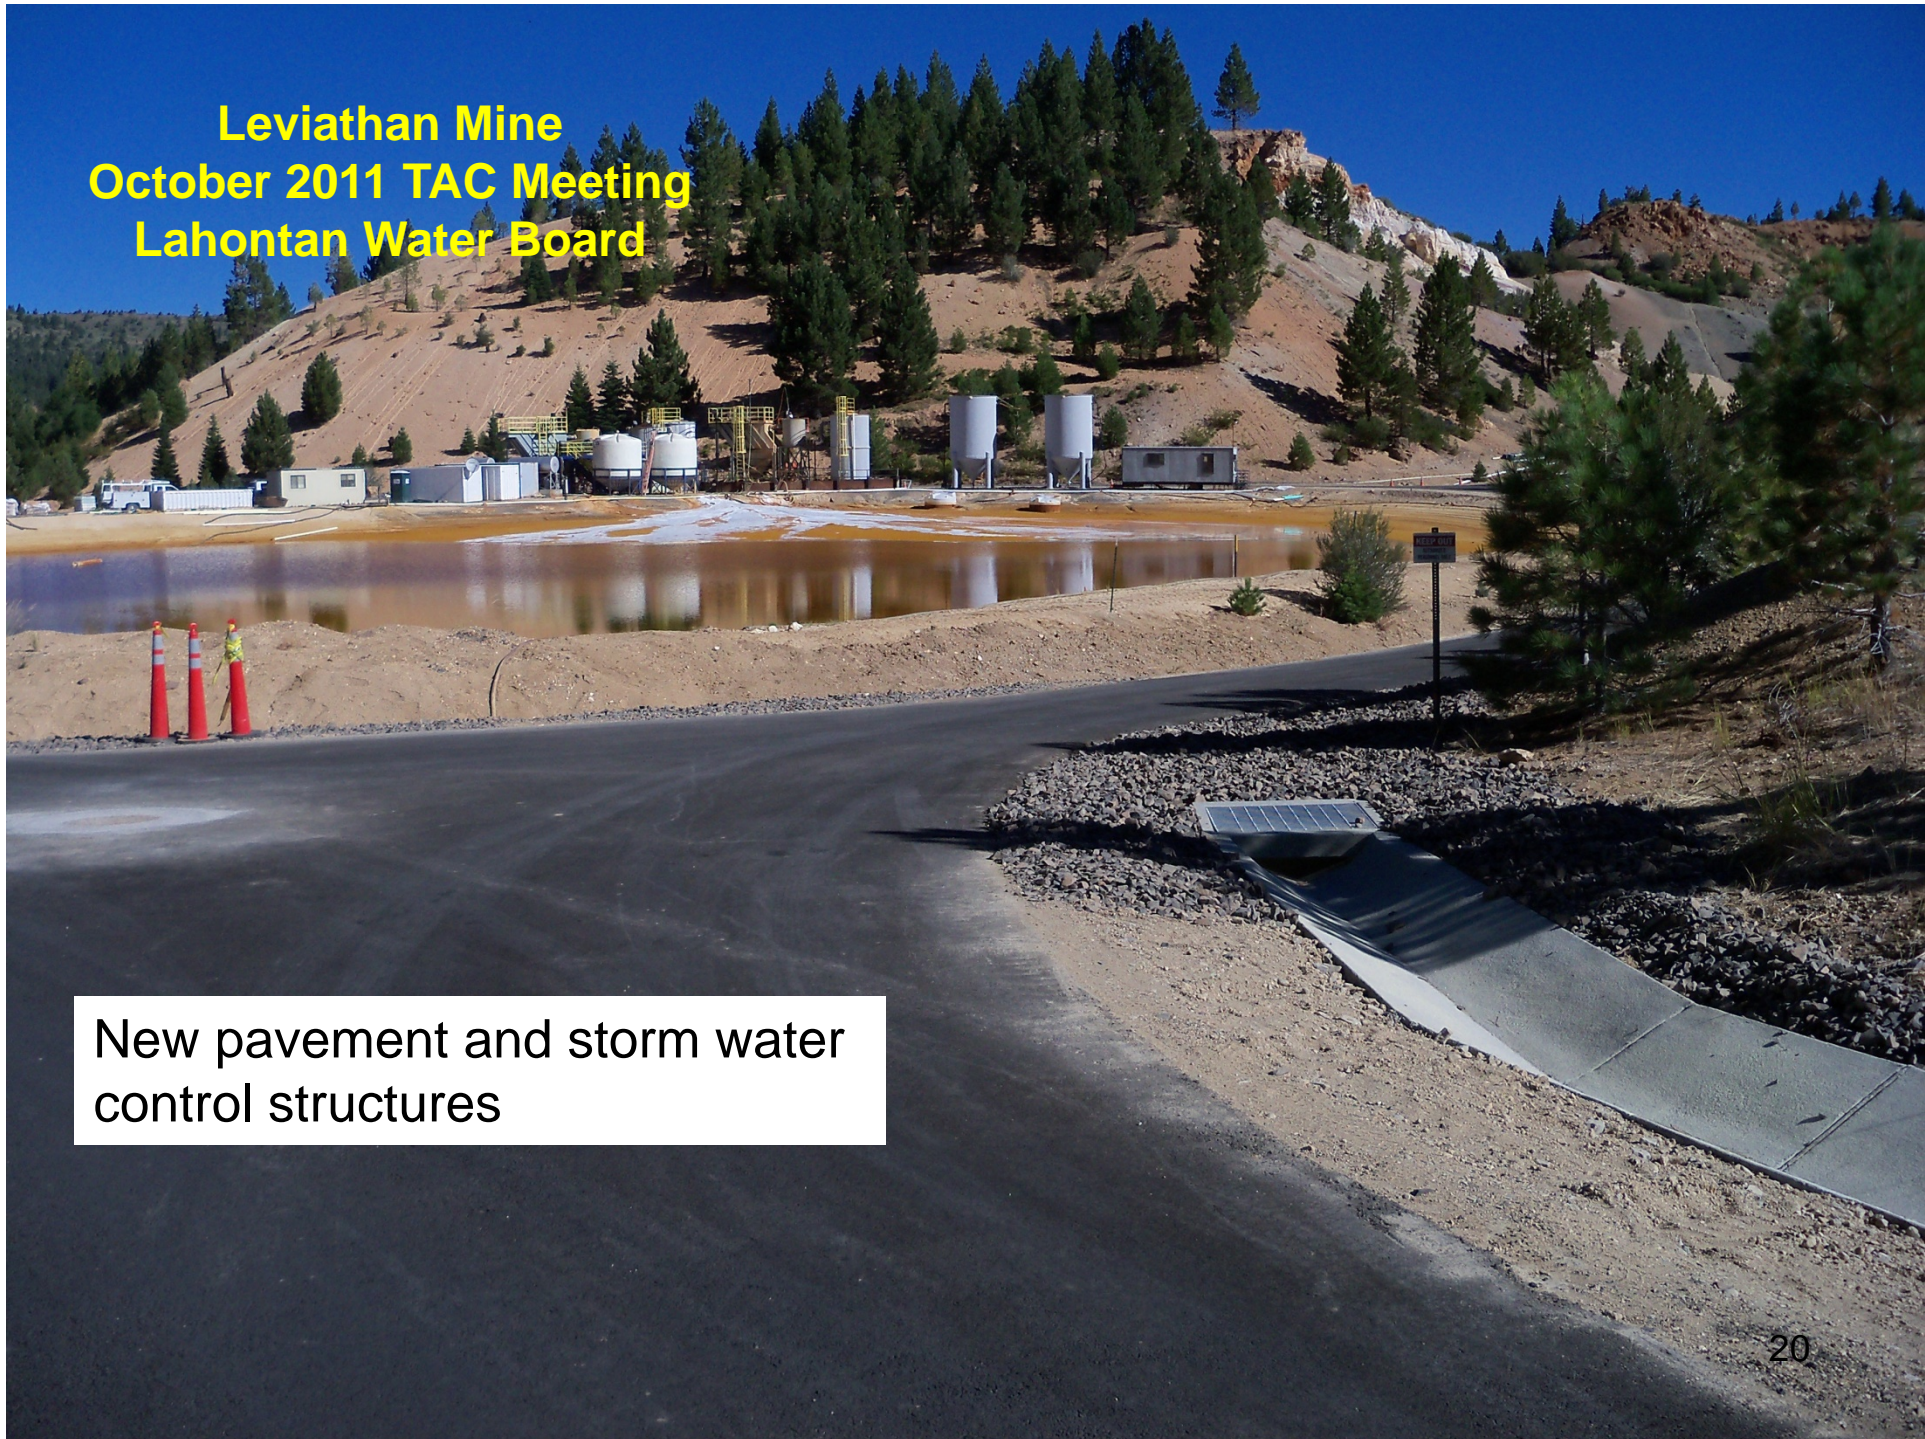
New pavement and storm water
control structures
