RECREATIONAL USE REASSESSMENT (RECUR) OF THE ENGINEERED CHANNELS OF THE LOS ANGELES RIVER WATERSHED

[Part I: Background, Methodology and Results](#)

[DRAFT - December, 2013](#) [FINAL REPORT October, 2014](#)

Los Angeles Regional Water Quality Control Board

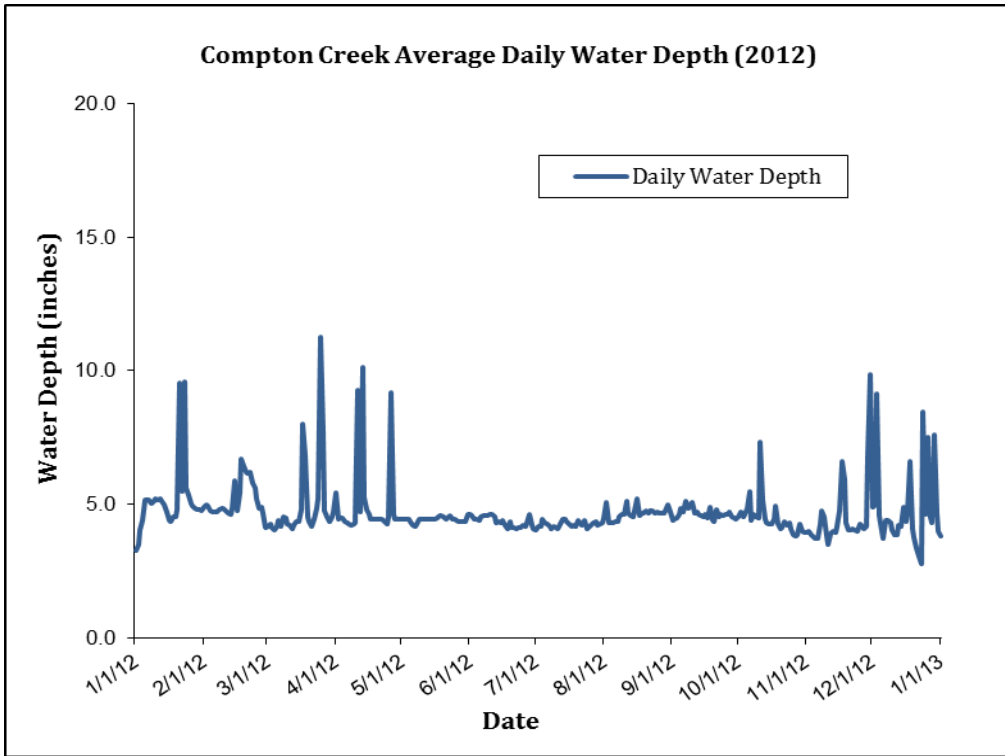
FIGURE 5-2.2a DAILY AVERAGE FLOW IN COMPTON CREEK FOR THE YEAR 2012

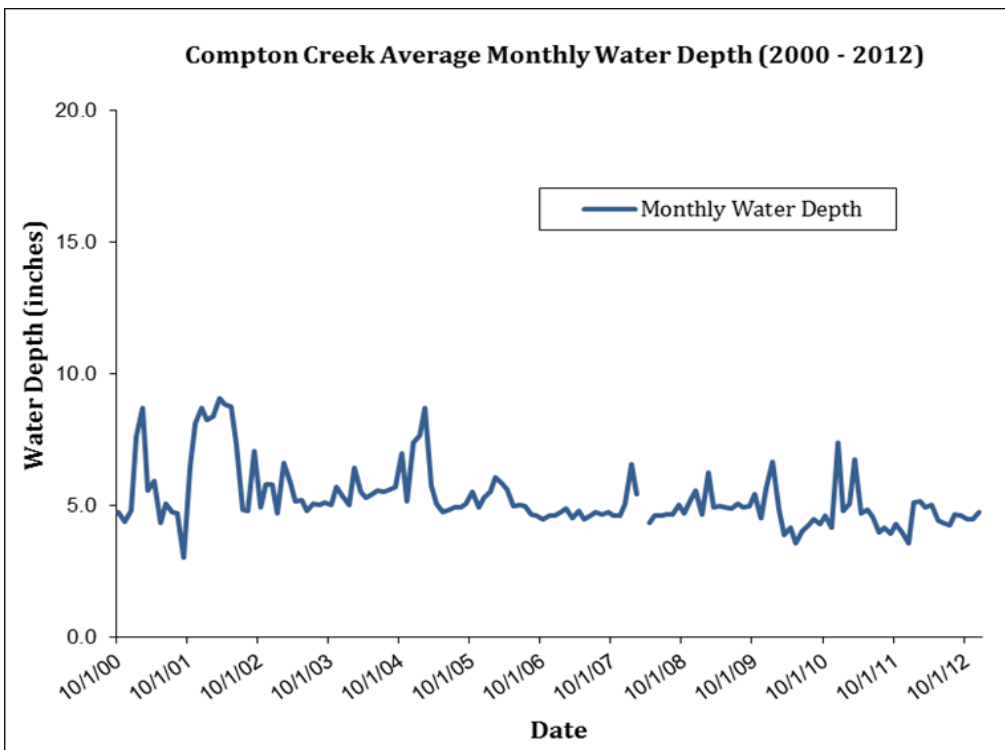
FIGURE 5-2.2b MONTHLY AVERAGE FLOW IN COMPTON CREEK FROM 2001 TO 2012

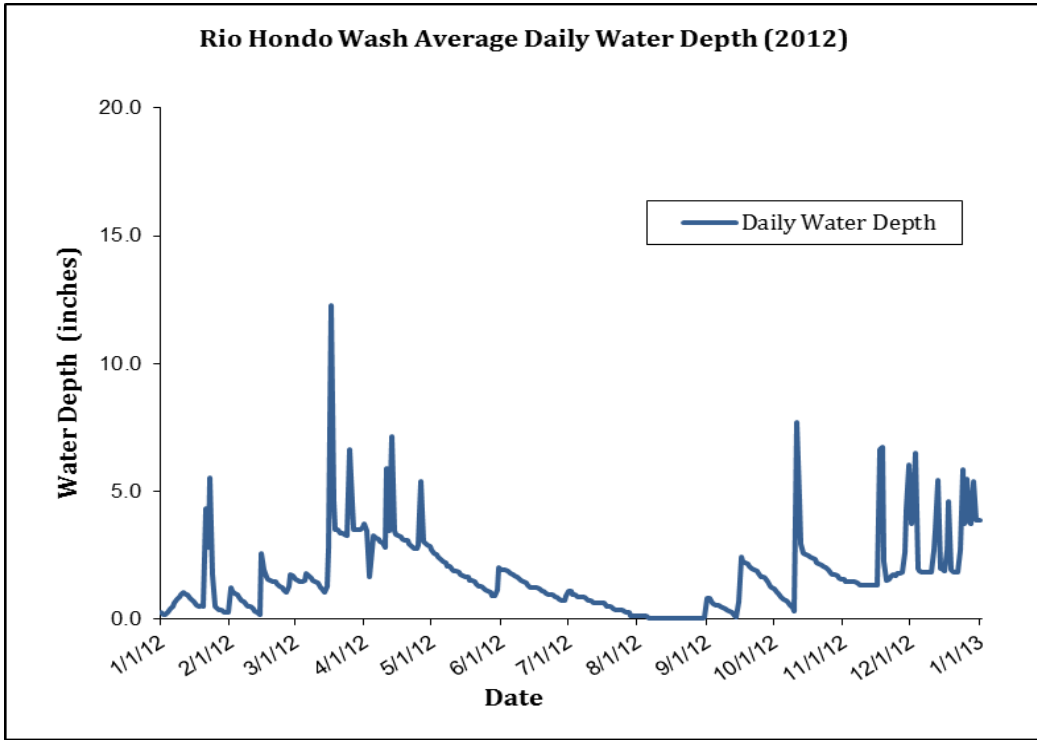
FIGURE 5-2.5a DAILY AVERAGE FLOW IN RIO HONDO FOR THE YEAR 2012

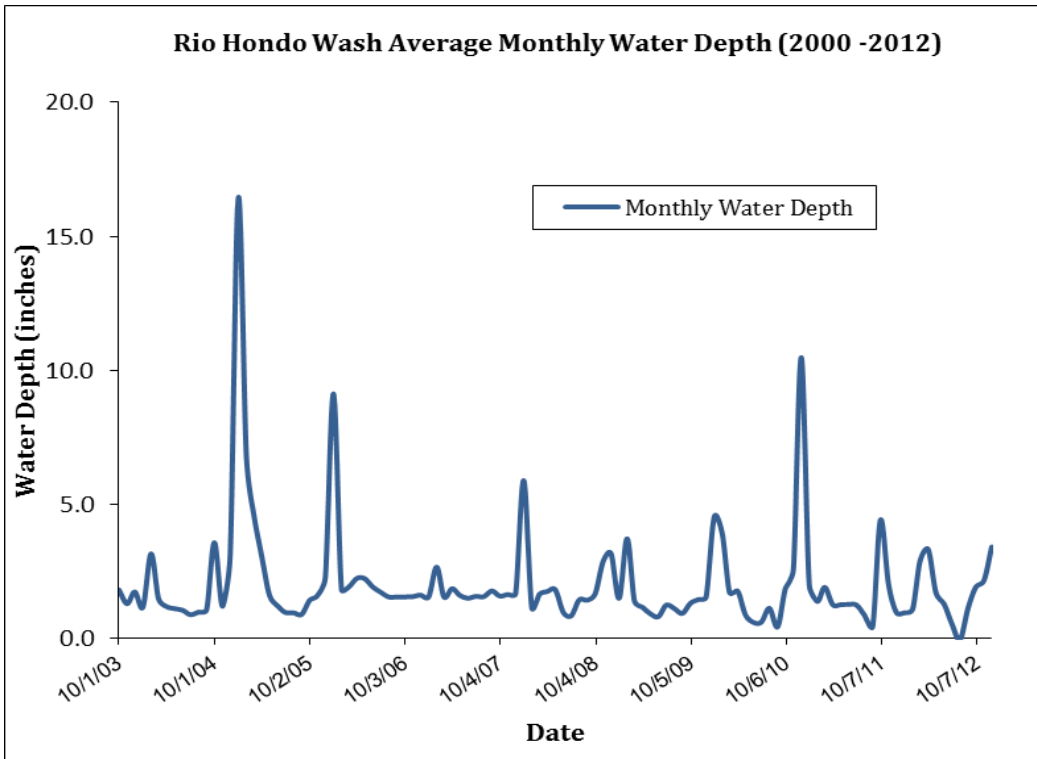
FIGURE 5-2.5b MONTHLY AVERAGE FLOW IN RIO HONDO FROM 2003 TO 2012

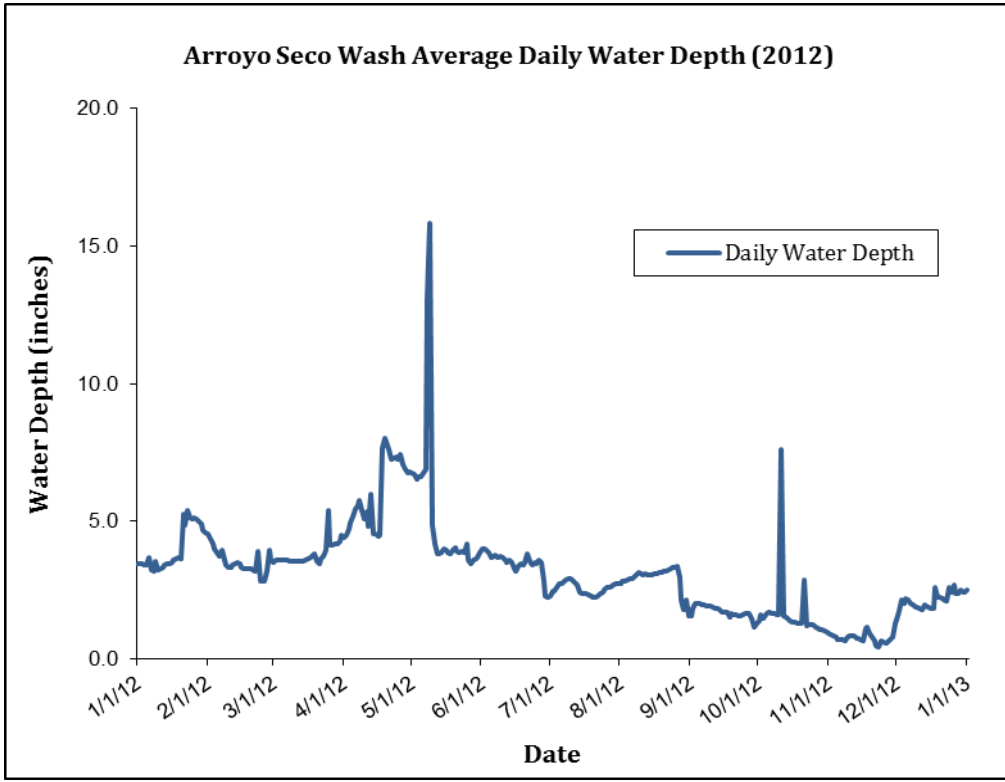
FIGURE 5-2.8a DAILY AVERAGE FLOW IN ARROYO SECO FOR THE YEAR 2012

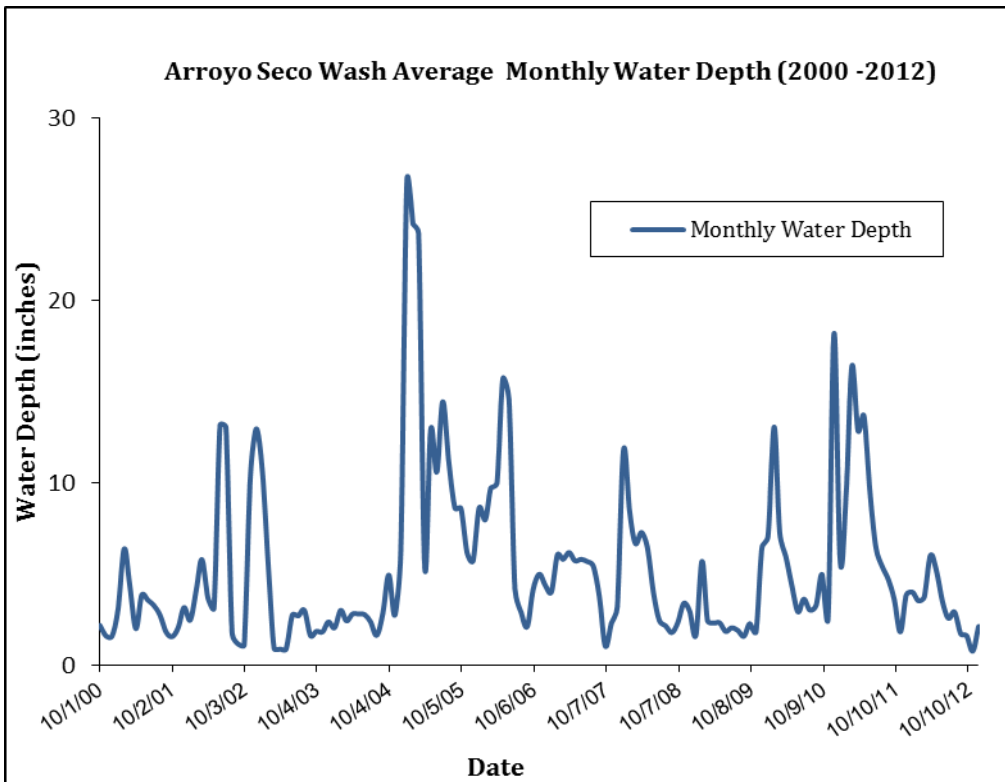
FIGURE 5-2.8b MONTHLY AVERAGE FLOW IN ARROYO SECO FROM 2000 TO 2012

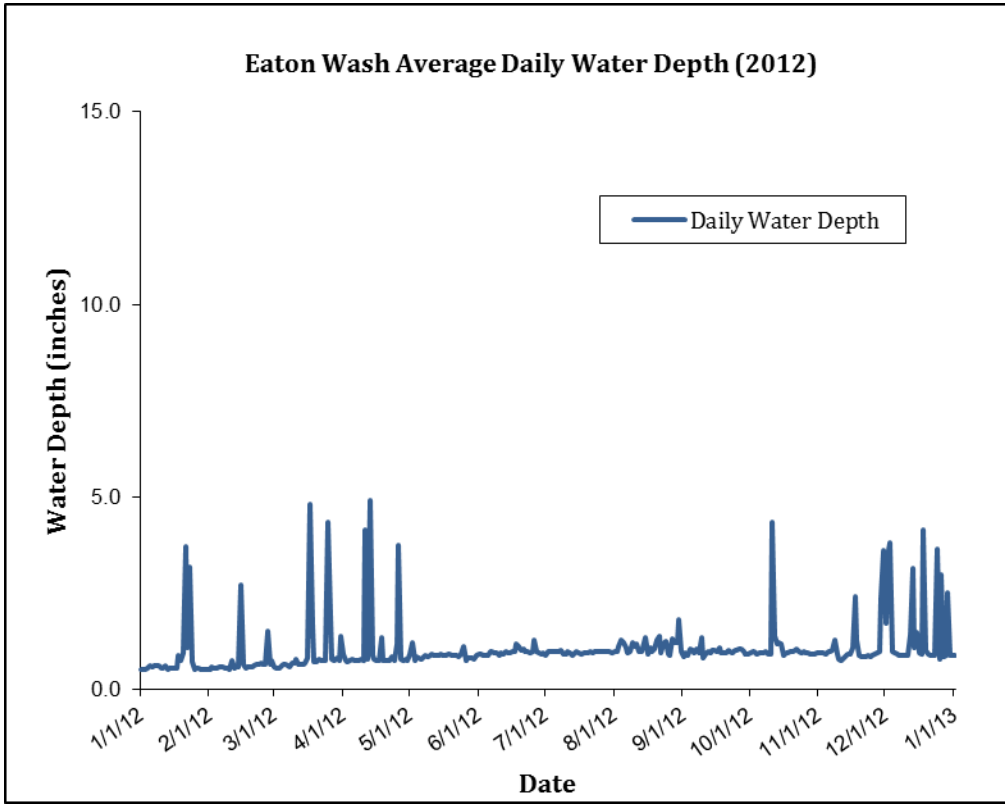
FIGURE 5-3.4a DAILY AVERAGE FLOW IN EATON WASH FOR THE YEAR 2012

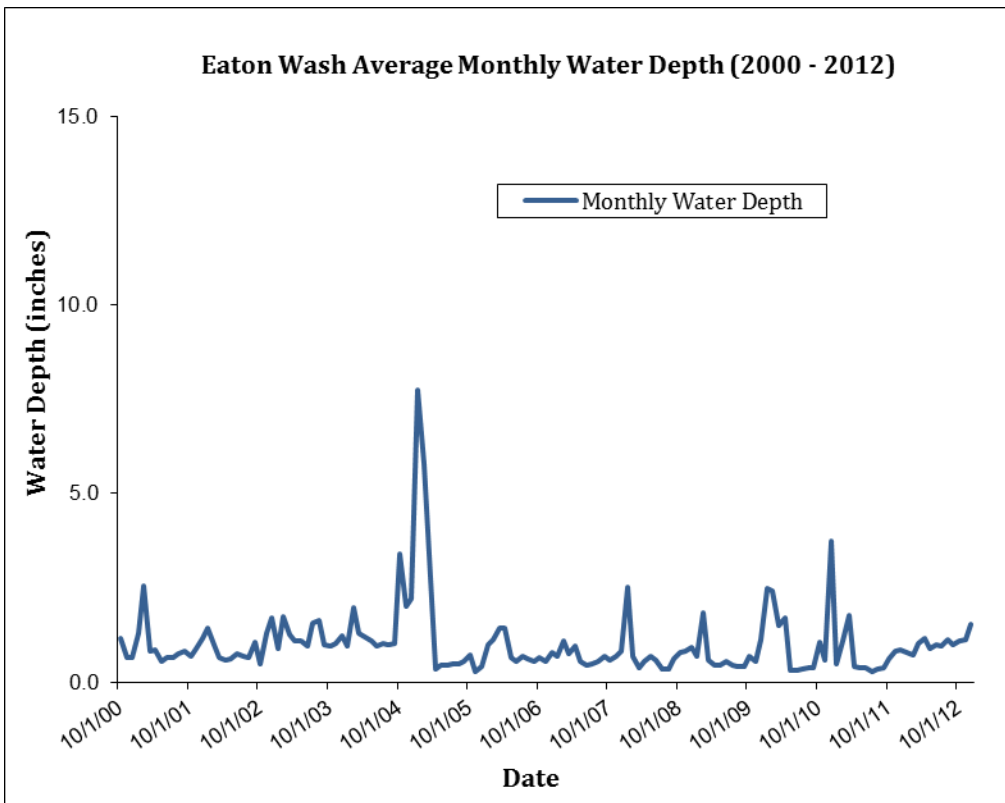
FIGURE 5-3.4b MONTHLY AVERAGE FLOW IN EATON WASH FROM 2000 TO 2012

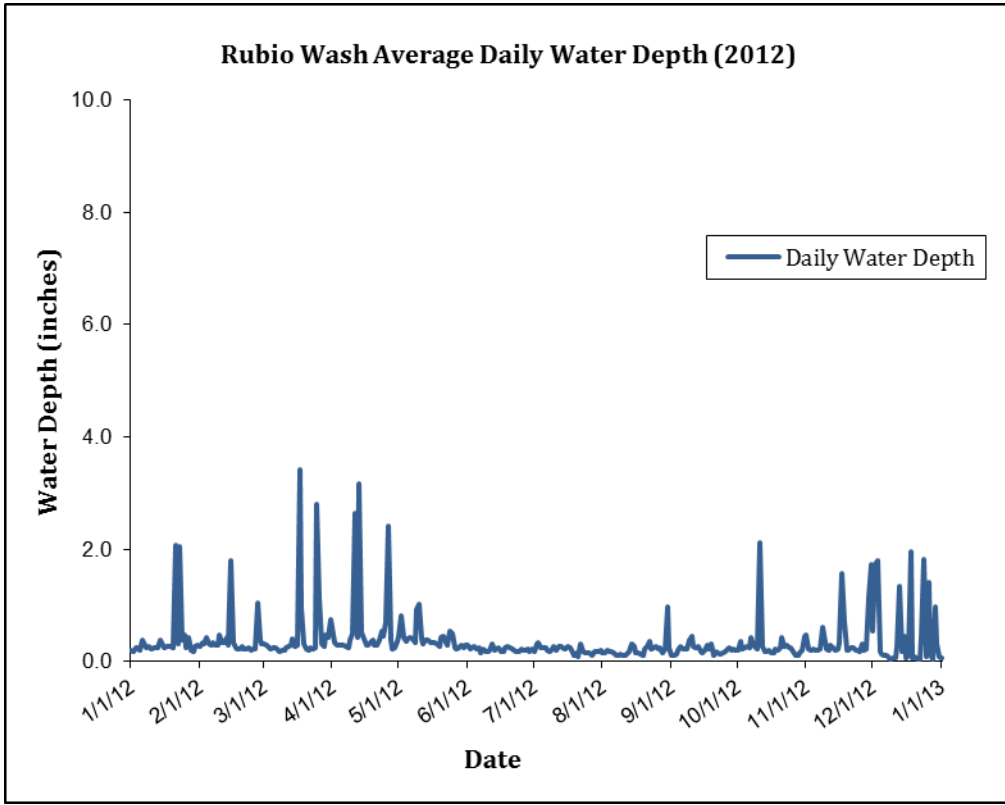
FIGURE 5-3.6a: DAILY AVERAGE FLOW IN RUBIO WASH FOR THE YEAR 2012

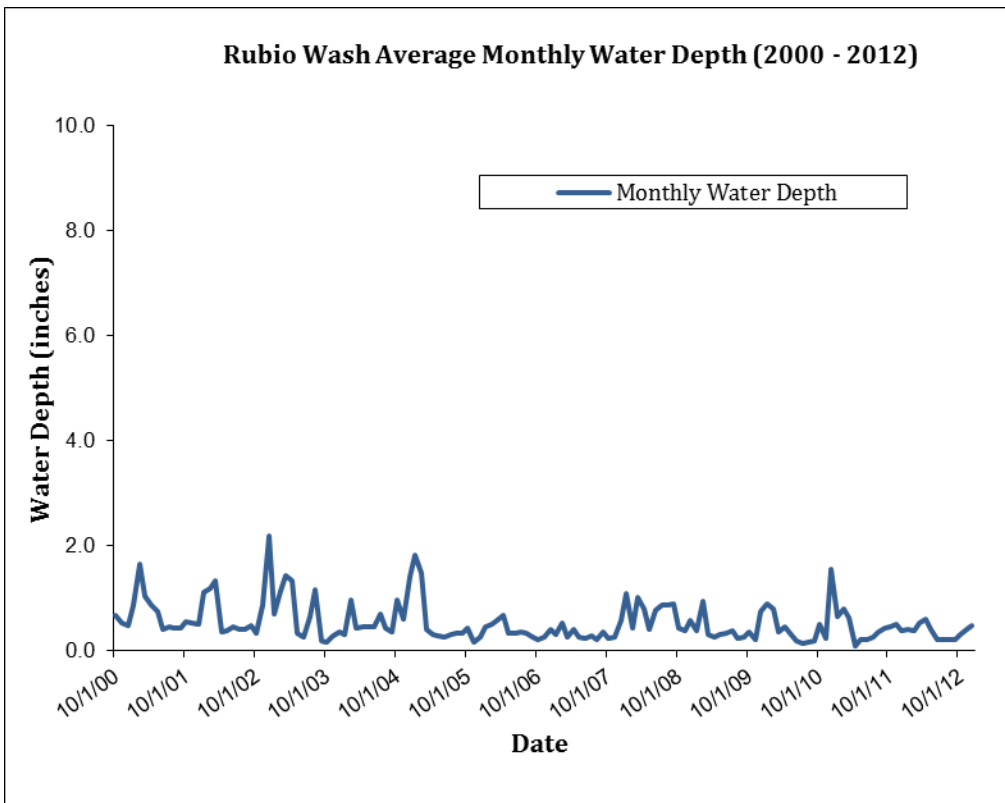
FIGURE 5-3.6: MONTHLY AVERAGE FLOW IN RUBIO WASH FROM 2000 TO 2012

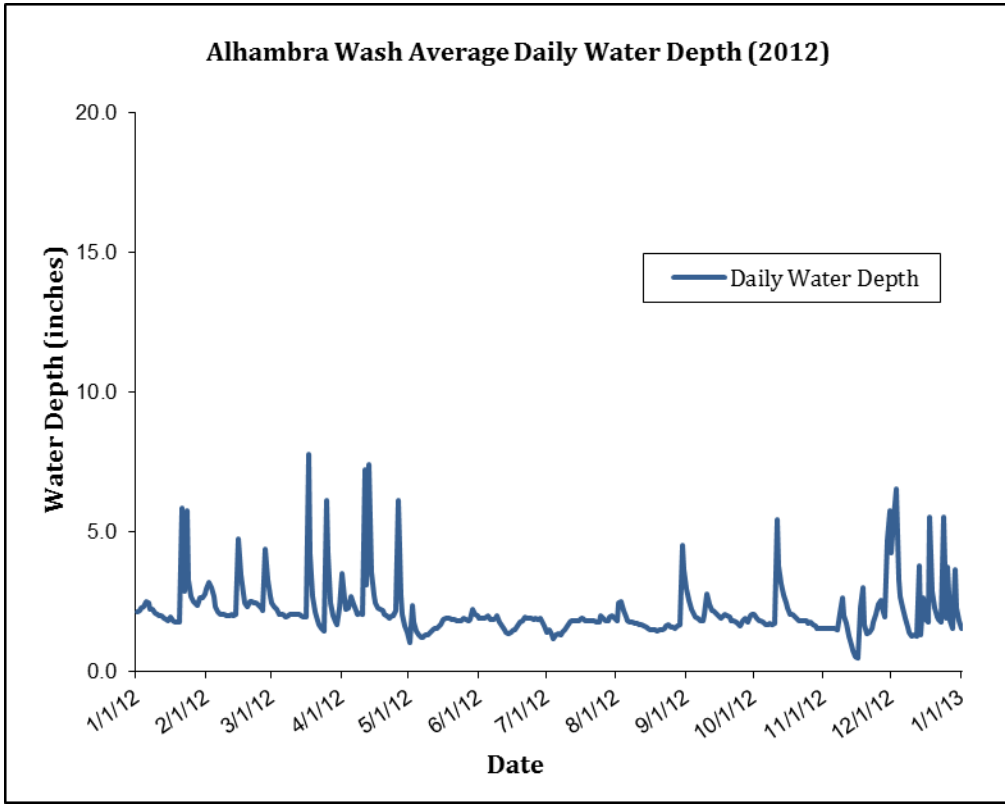
FIGURE 5-3.9a DAILY AVERAGE FLOW IN ALHAMBRA WASH FOR THE YEAR 2012

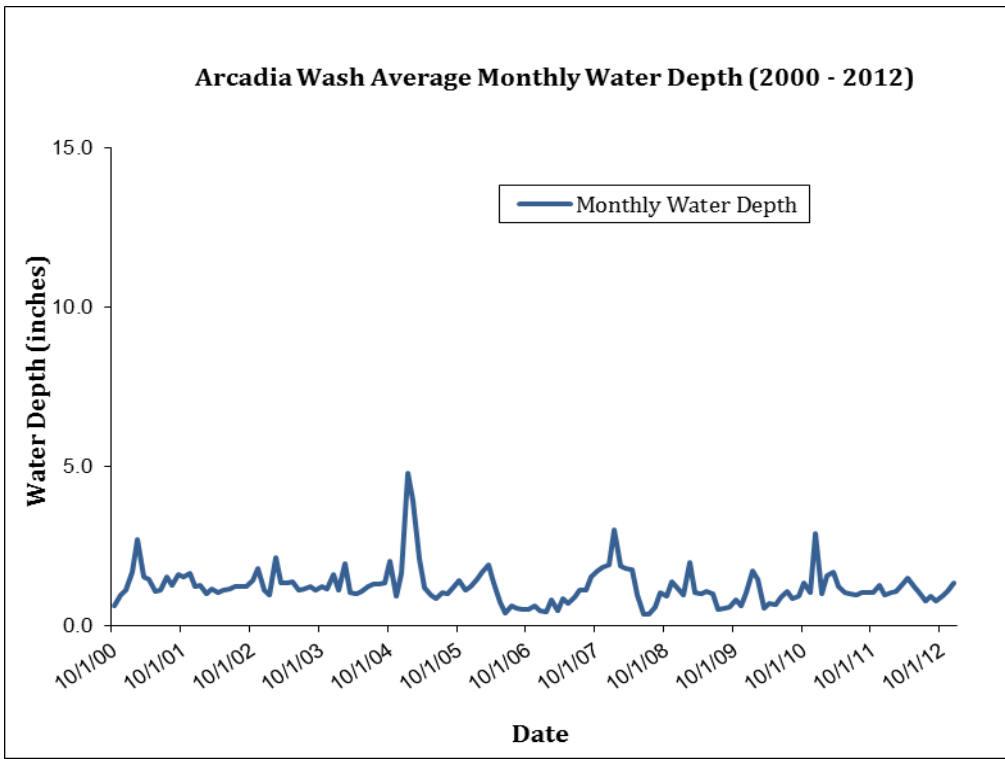
FIGURE 5-3.11b MONTHLY AVERAGE FLOW IN ARCADIA WASH FROM 2000 TO 2012

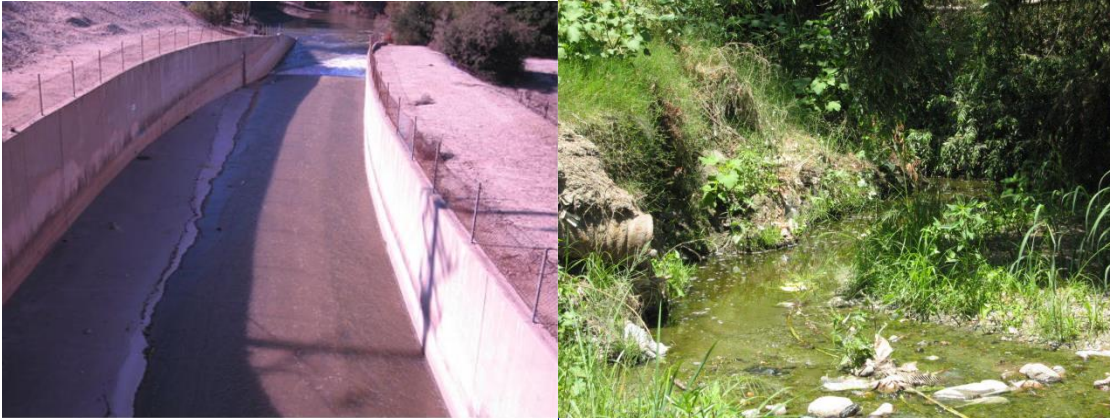
FIGURE 5-3.12: SAWPIT WASH FLOWS INTO PECK ROAD PARK LAKE

[Concrete channel transitions to short natural segment just upstream of confluence with lake](#)

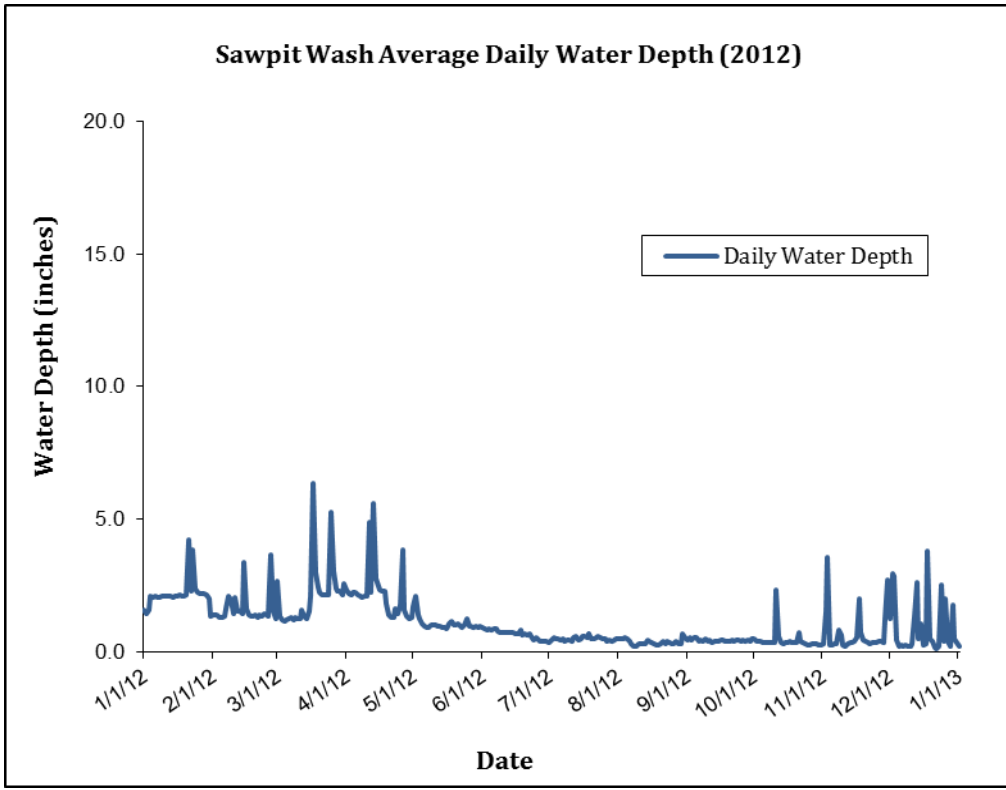
FIGURE 5-3.14a DAILY AVERAGE FLOW IN SAWPIT WASH FOR THE YEAR 2012

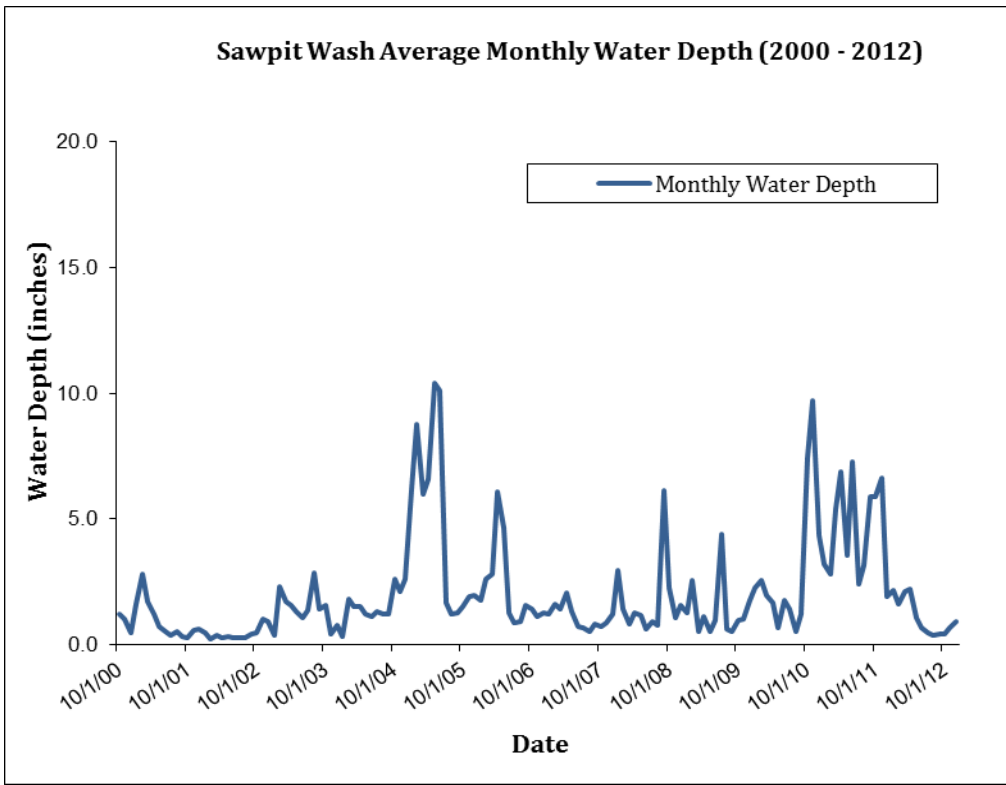
FIGURE 5-3.14b MONTHLY AVERAGE FLOW IN SAWPIT WASH FROM 2000 TO 2012

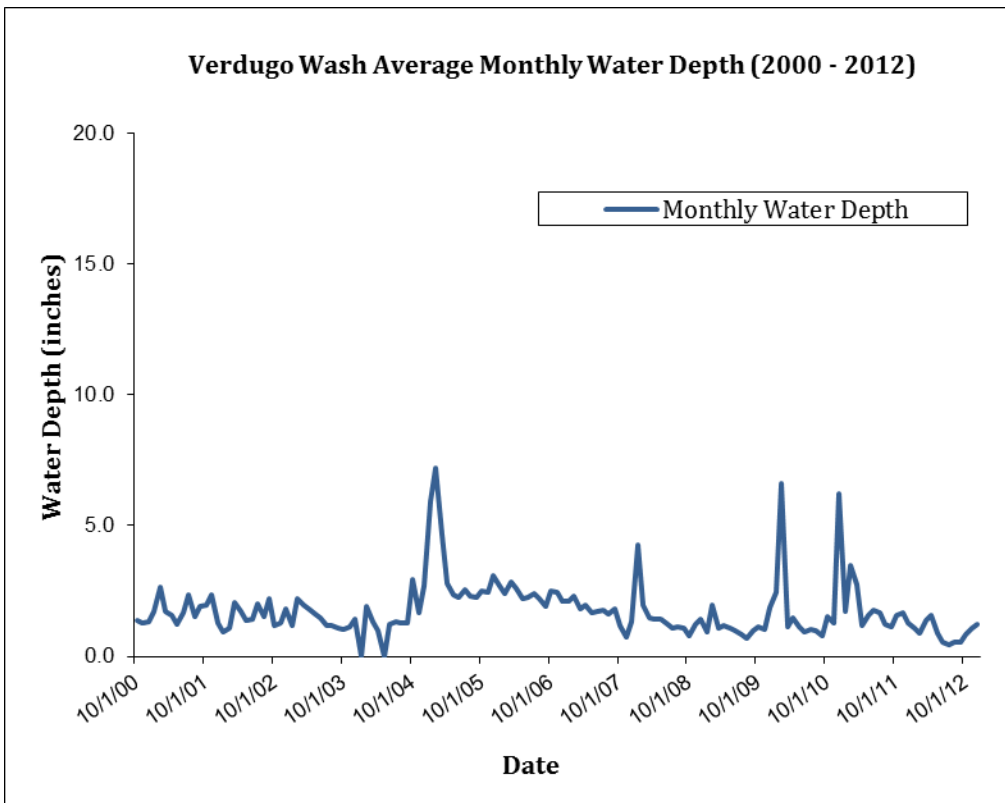
FIGURE 5-4.2b MONTHLY AVERAGE FLOW IN VERDUGO WASH FROM 2000 TO 2012

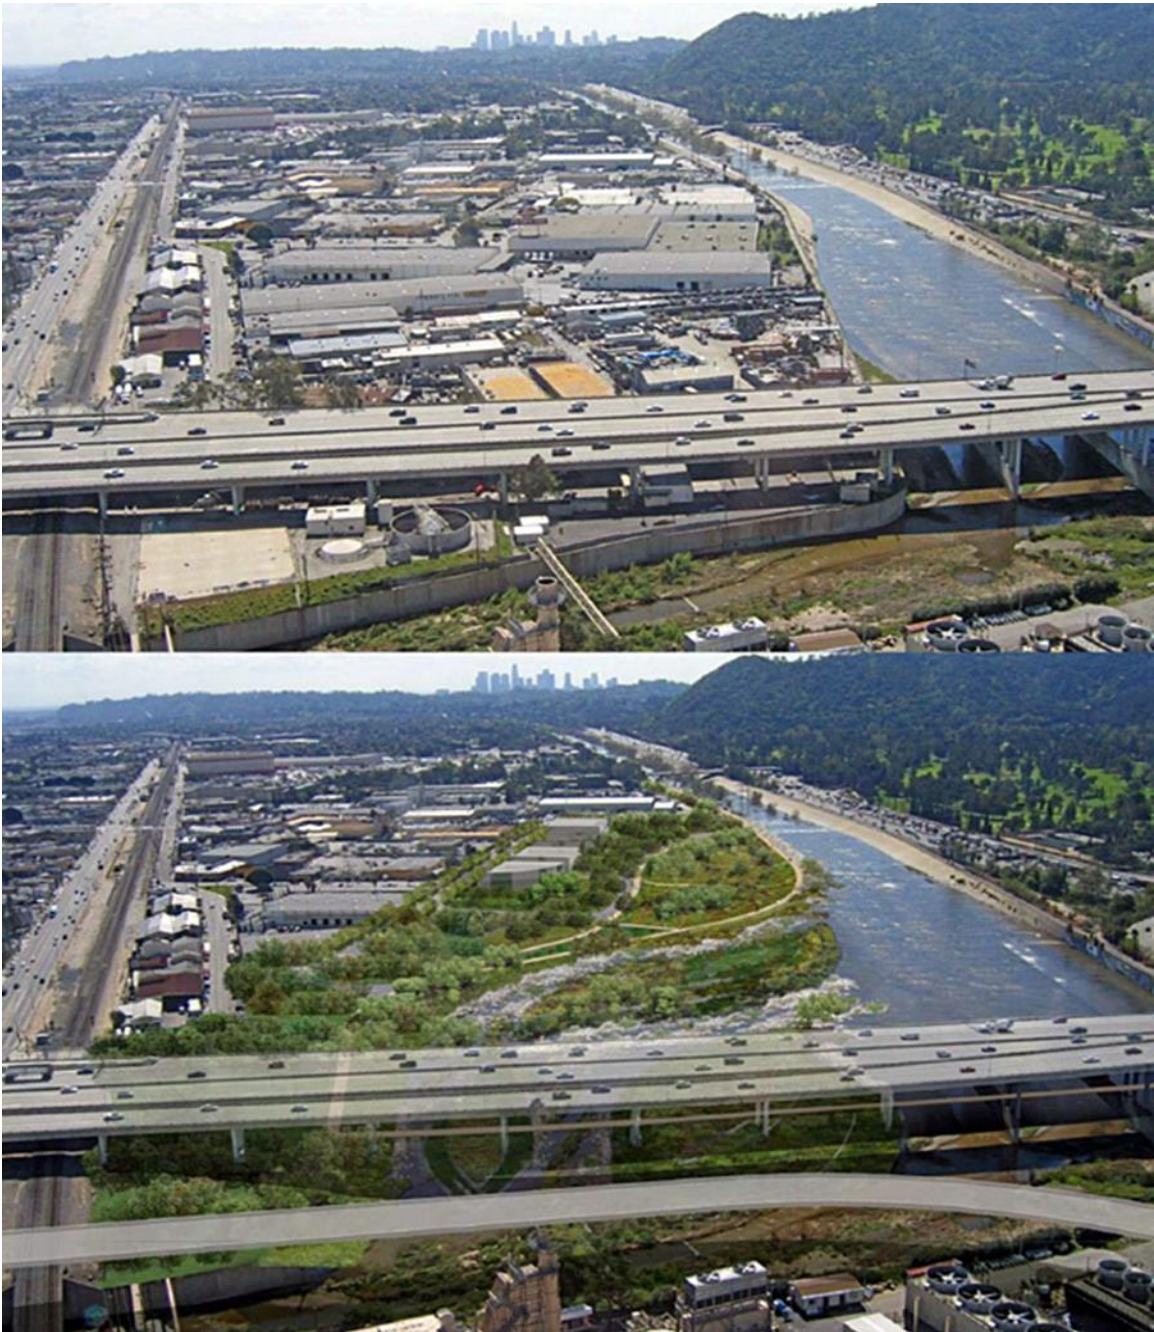
FIGURE 5-4.3B: ILLUSTRATIONS OF THE VERDUGO WASH LOS ANGELES RIVER CONFLUENCE BEFORE AND AFTER RESTORATION (SOURCE Los Angeles River Ecosystem Restoration Integrated Feasibility Report (ACOE, 2013))

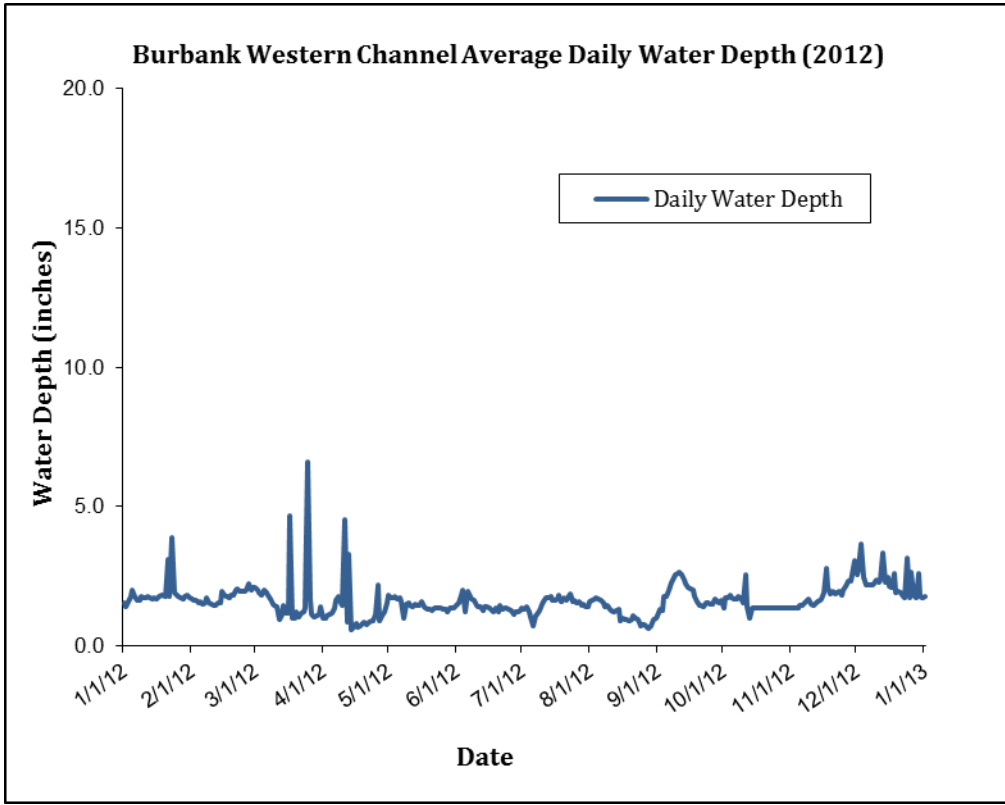
FIGURE 5-4.5a DAILY AVERAGE FLOW IN BURBANK WESTERN CHANNEL FOR THE YEAR 2012

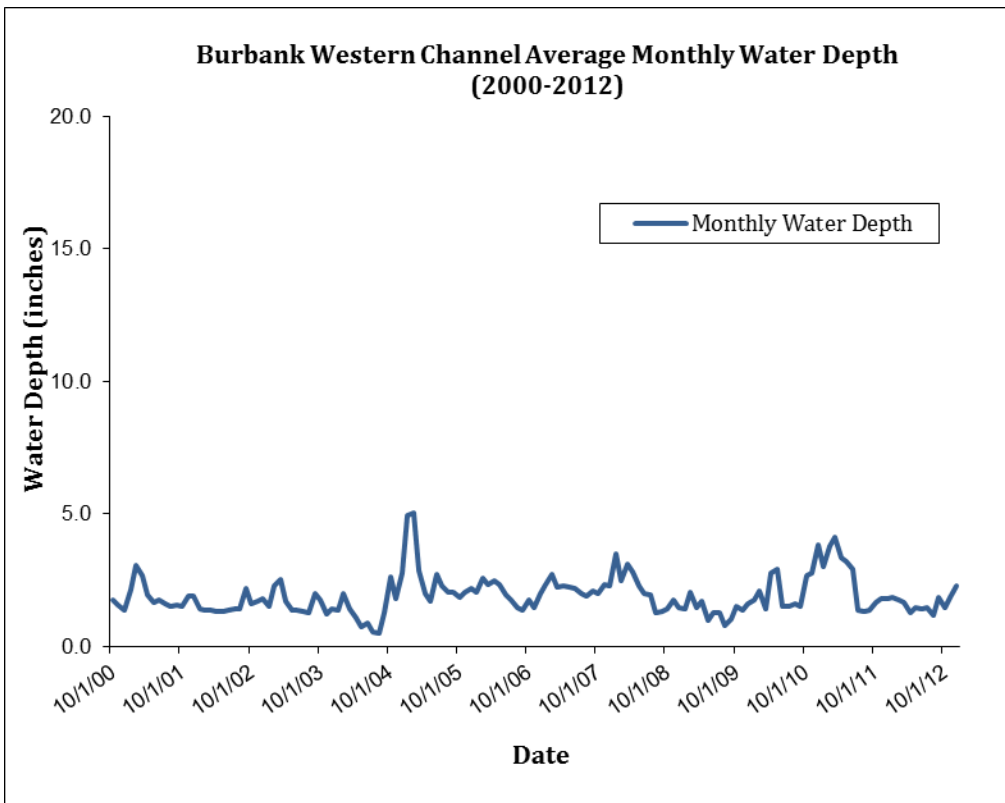
FIGURE 5-4.5b MONTHLY AVERAGE FLOW IN BURBANK WESTERN CHANNEL FROM 2000 TO 2012

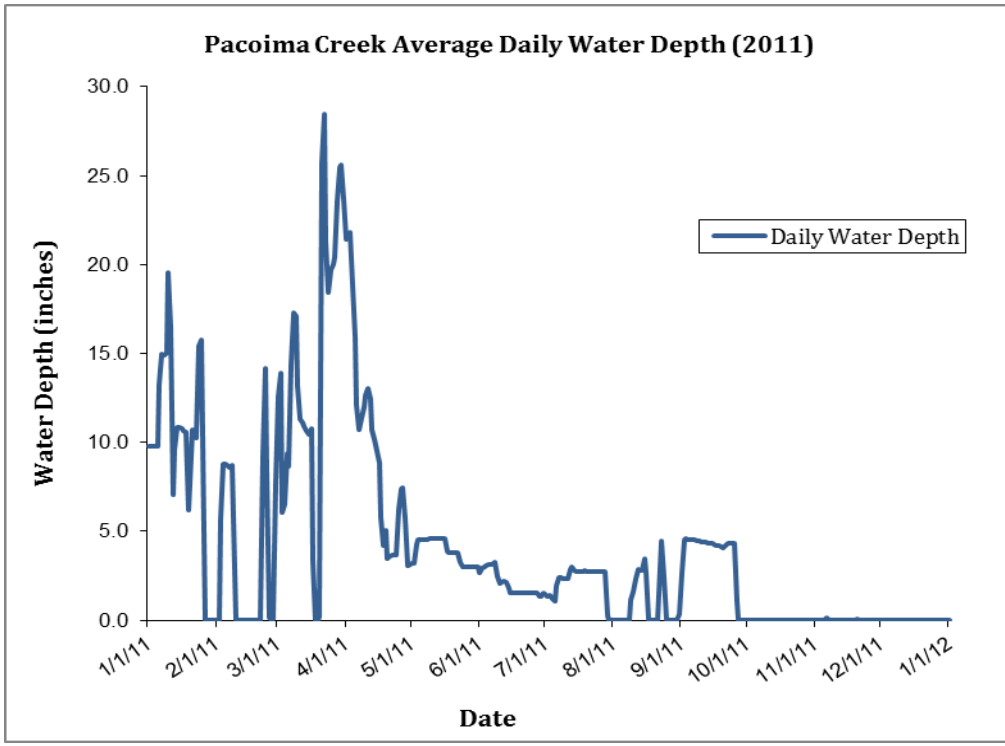
FIGURE 5-4.4a DAILY AVERAGE FLOW IN PACOIMA WASH FOR THE YEAR 2012

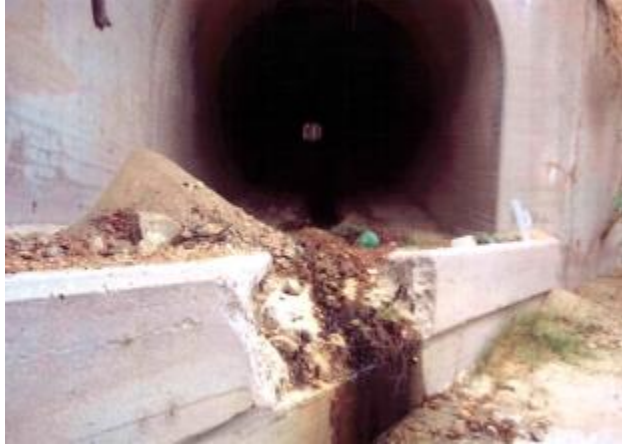
FIGURE 5-5.3: WATER DEPTH AND FLOW CONDITIONS IN SNOVER CANYON WASH SEPTEMBER 2011 THROUGH MAY 2012
 (Photos and data provided by County of Los Angeles Department of Public Works)

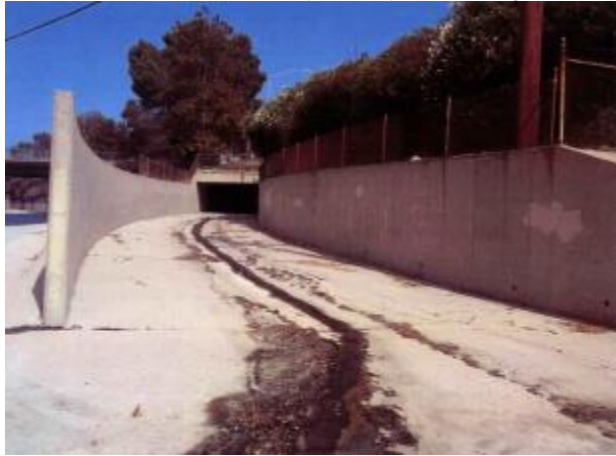
FIGURE 5-5.4: WATER DEPTH AND FLOW CONDITIONS IN PICKENS CANYON WASH- SEPTEMBER 2011 THROUGH AUGUST 2012
 (Photos and data provided by County of Los Angeles Department of Public Works)

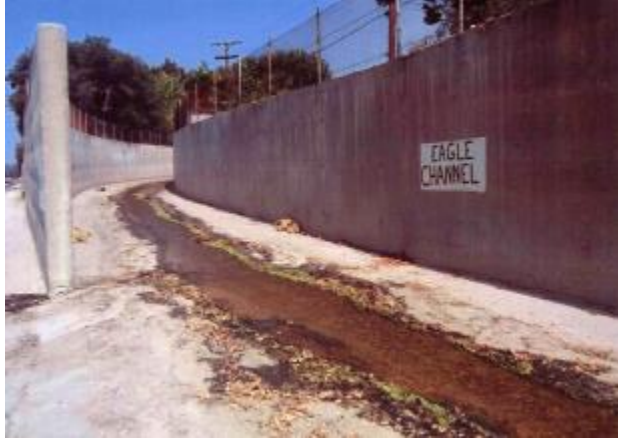
FIGURE 5-5.6: WATER DEPTH AND FLOW CONDITIONS IN EAGLE (SHIELDS) CANYON WASH SEPTEMBER 2011 THROUGH AUGUST 2012
 (Photos and data provided by County of Los Angeles Department of Public Works)

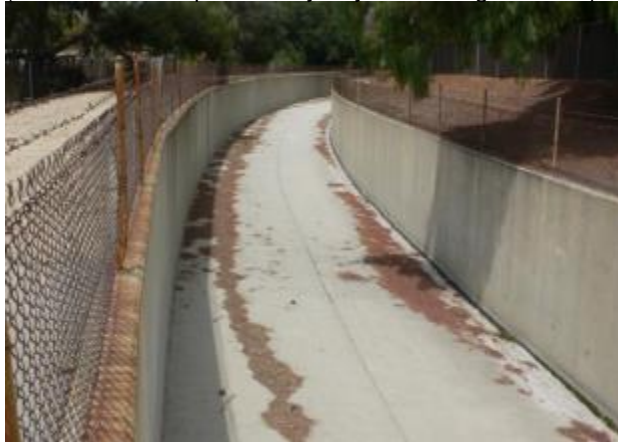
FIGURE 5-5.7: WATER DEPTH AND FLOW CONDITIONS IN LA TUNA CHANNEL AUGUST 2011 THROUGH MAY 2012
 (Photos and data provided by City of Los Angeles BOS)

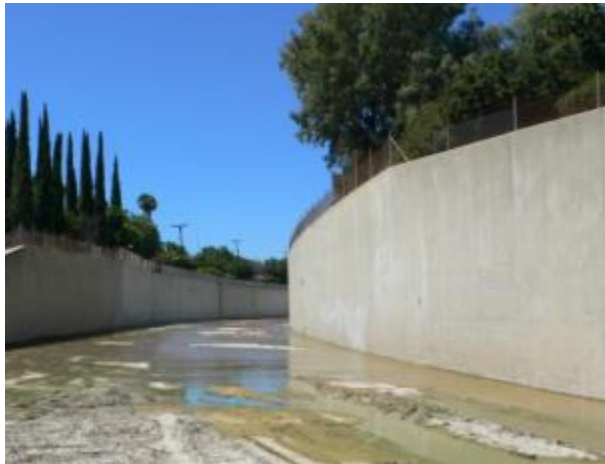
FIGURE 5-6.1: WATER DEPTH AND FLOW CONDITIONS IN BROWN CANYON CREEK AUGUST 2011 THROUGH MAY 2012
 (Photos and data provided by City of Los Angeles BOS)

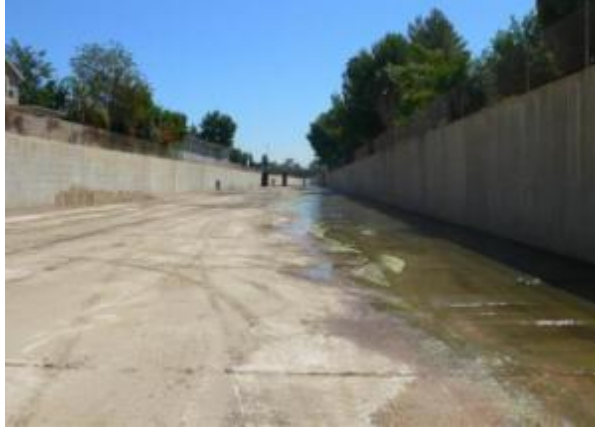
FIGURE 5-6.8: WATER DEPTH AND FLOW CONDITIONS IN BELL CREEK AUGUST 2011 THROUGH MAY 2012
 (Photos and data provided by City of Los Angeles BOS)

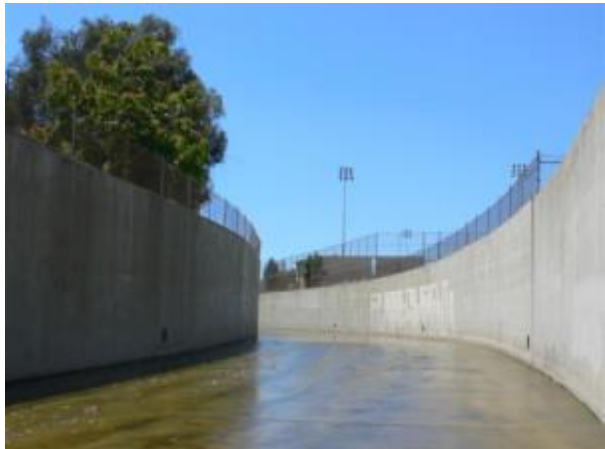
FIGURE 5-6.9: WATER DEPTH AND FLOW CONDITIONS IN ARROYO CALABASAS AUGUST 2011 THROUGH MAY 2012
 (Photos and data provided by City of Los Angeles BOS)

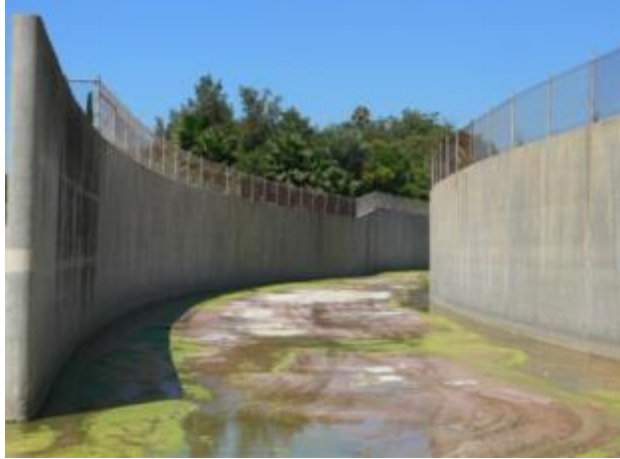
Figure 5-7.1: Water Depth and Flow Conditions in Dayton Canyon Creek August 2011 through May 2012
 (Photos and data provided by City of Los Angeles BOS)

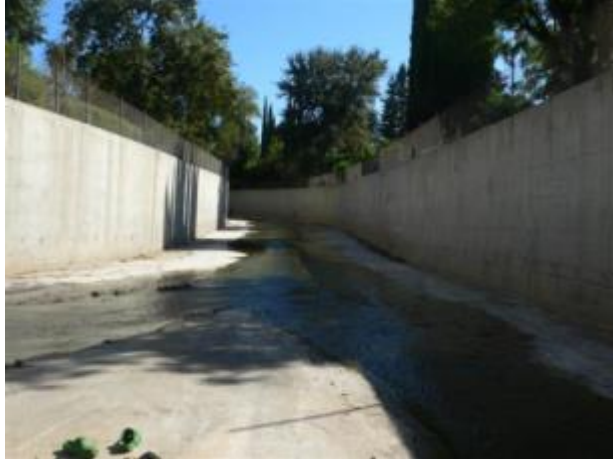
FIGURE 5-7.2: WATER DEPTH AND FLOW CONDITIONS IN DRY CANYON CREEK AUGUST 2011 THROUGH MAY 2012
 (Photos and data provided by City of Los Angeles BOS)
