For Stay of Revised Order To Submit
Investigative Reports Pursuant To Water
Code Section 13267, Mount Diablo
Mine, Contra Costa County, dated
December 30, 2009

**SUNOCO, INC.'S PETITION FOR
STAY OF REVISED TECHNICAL
REPORTING ORDER NO. R5-
2009-0869**

The Source Group, Inc. (SGI) has conducted a characterization of conditions at the former Mount Diablo Mercury Mine in Contra Costa County, California (the Site, Figure 1-1) on behalf of Sunoco Inc. (Sunoco). This characterization was conducted in order to satisfy, in part, the requirements of the California Regional Water Quality Control Board (CRWQCB) in their Revised Technical Reporting Order R5-2009-0869 (Rev. Order) of December 30, 2009.

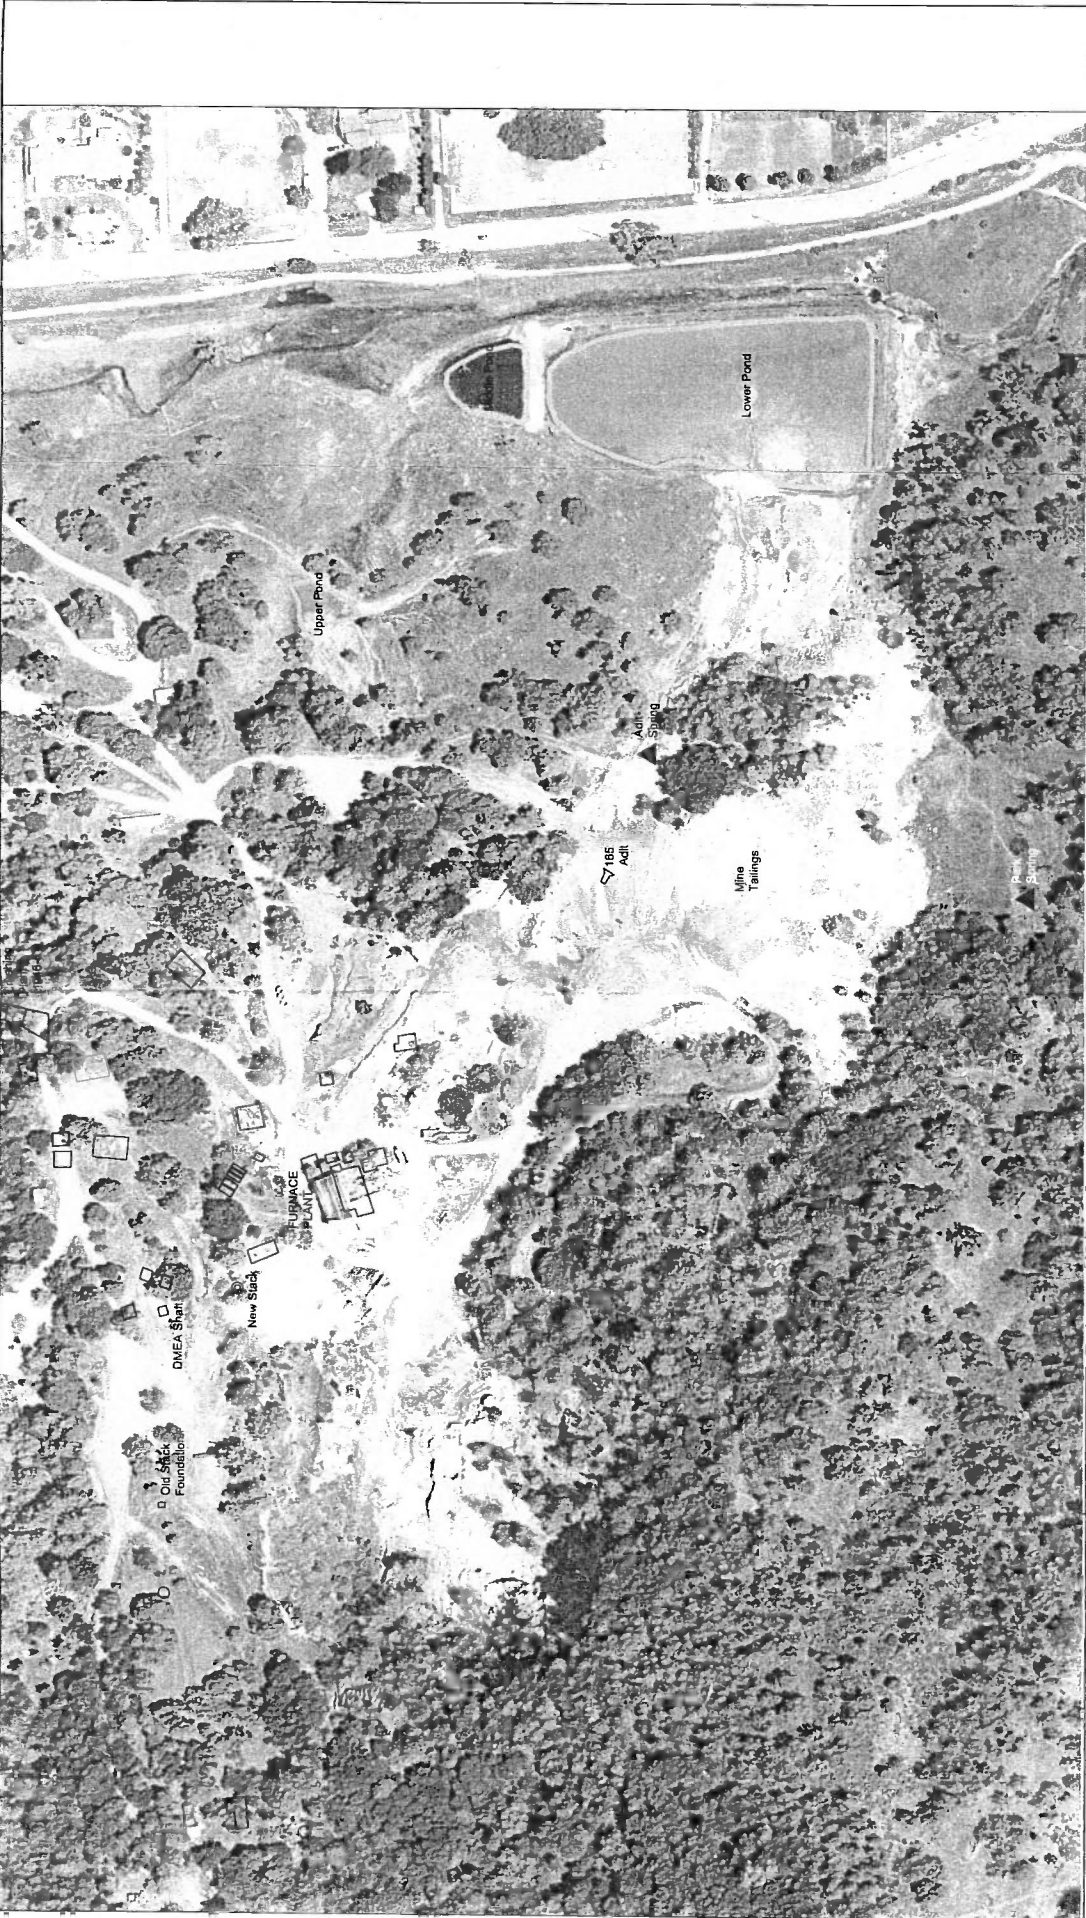
FIGURE:
2-2

and Geology (Pampeyan, 1963). As a result of the mining and milling conducted by the Bradley Mining Company, records indicate that all or nearly all of the currently existing waste and tailings piles at the Mine can be attributed to generation by the Bradley Mining company as their configuration matches the mapped site conditions as documented by Site mapping conducted in 1953 by the California Division of Mines and Geology (Pampeyan, 1963). Figure 2-2 provides a map depicting the locations of the tailings and waste rock piles on the site as generated by the Bradley Mining Company. Field confirmed locations of Mercury mine tailings and waste rock are depicted in blue hatched outline and can be readily discerned as bare looking areas on the aerial photographs. The waste dump that received Quarry waste rock is north (northern waste dump) and is circled in a dashed green outline. The northern waste dump area is physically different from the other Bradley waste areas as it has an extensive tree cover as can be seen on Figure 2-2.

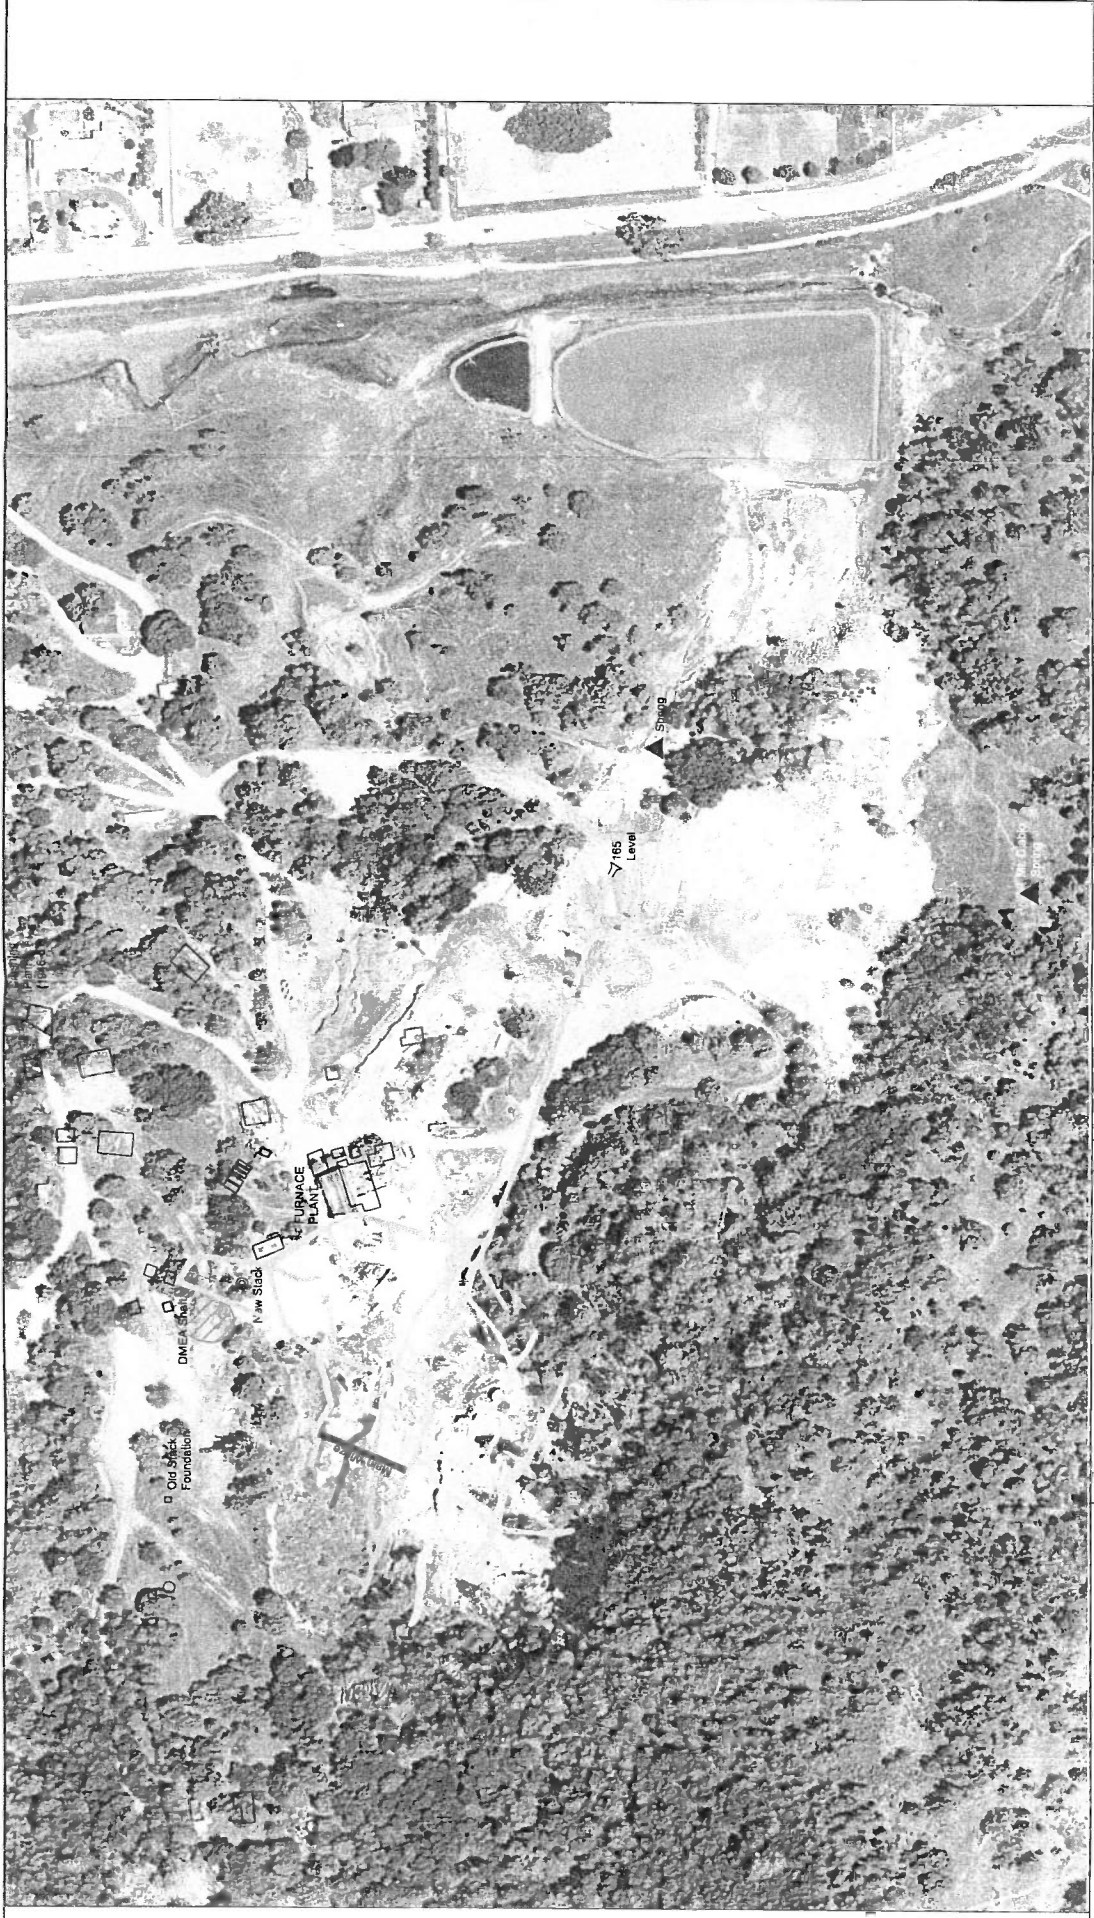
FIGURE NO. 2-7

LEGEND Mine Structure (1953) Spring Pond (2004 Outline) ordero Wasita Rock Main Winze, Sub-Vertical Connector	THE SOURCE GROUP, Inc. <small>environmental</small> 3451C VINCENT ROAD PLEASANT HILL, CA 94523	SCALE 	MT. DIABLO MERCURY MINE CONTRA COSTA COUNTY, CALIFORNIA (2004 AERIAL)	2004 AERIAL PHOTO WITH PRE- AND POST-DMEK/CORDERO MINE FEATURES
	FILE NAME Mine Features Map.dwg	DATE 5/4/09	DR. BY JP	APP. BY PH

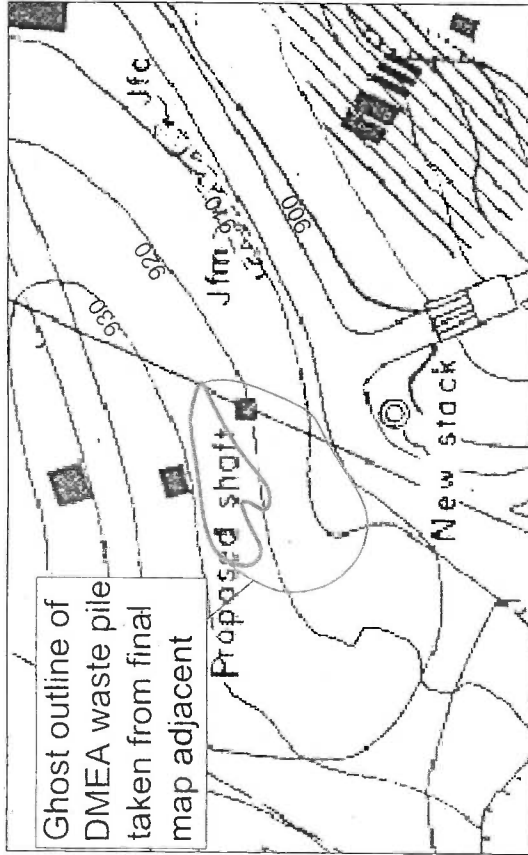
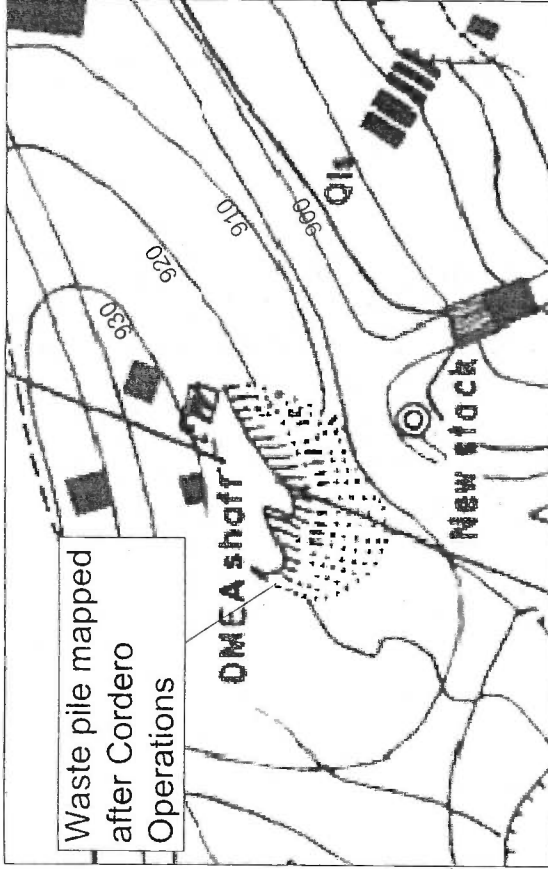
Ghost outline of DMEA waste pile taken from final map adjacent

Waste pile mapped after Cordero Operations

DMEA WASTE PILE COMPARISON
 CLOSE UP VIEW

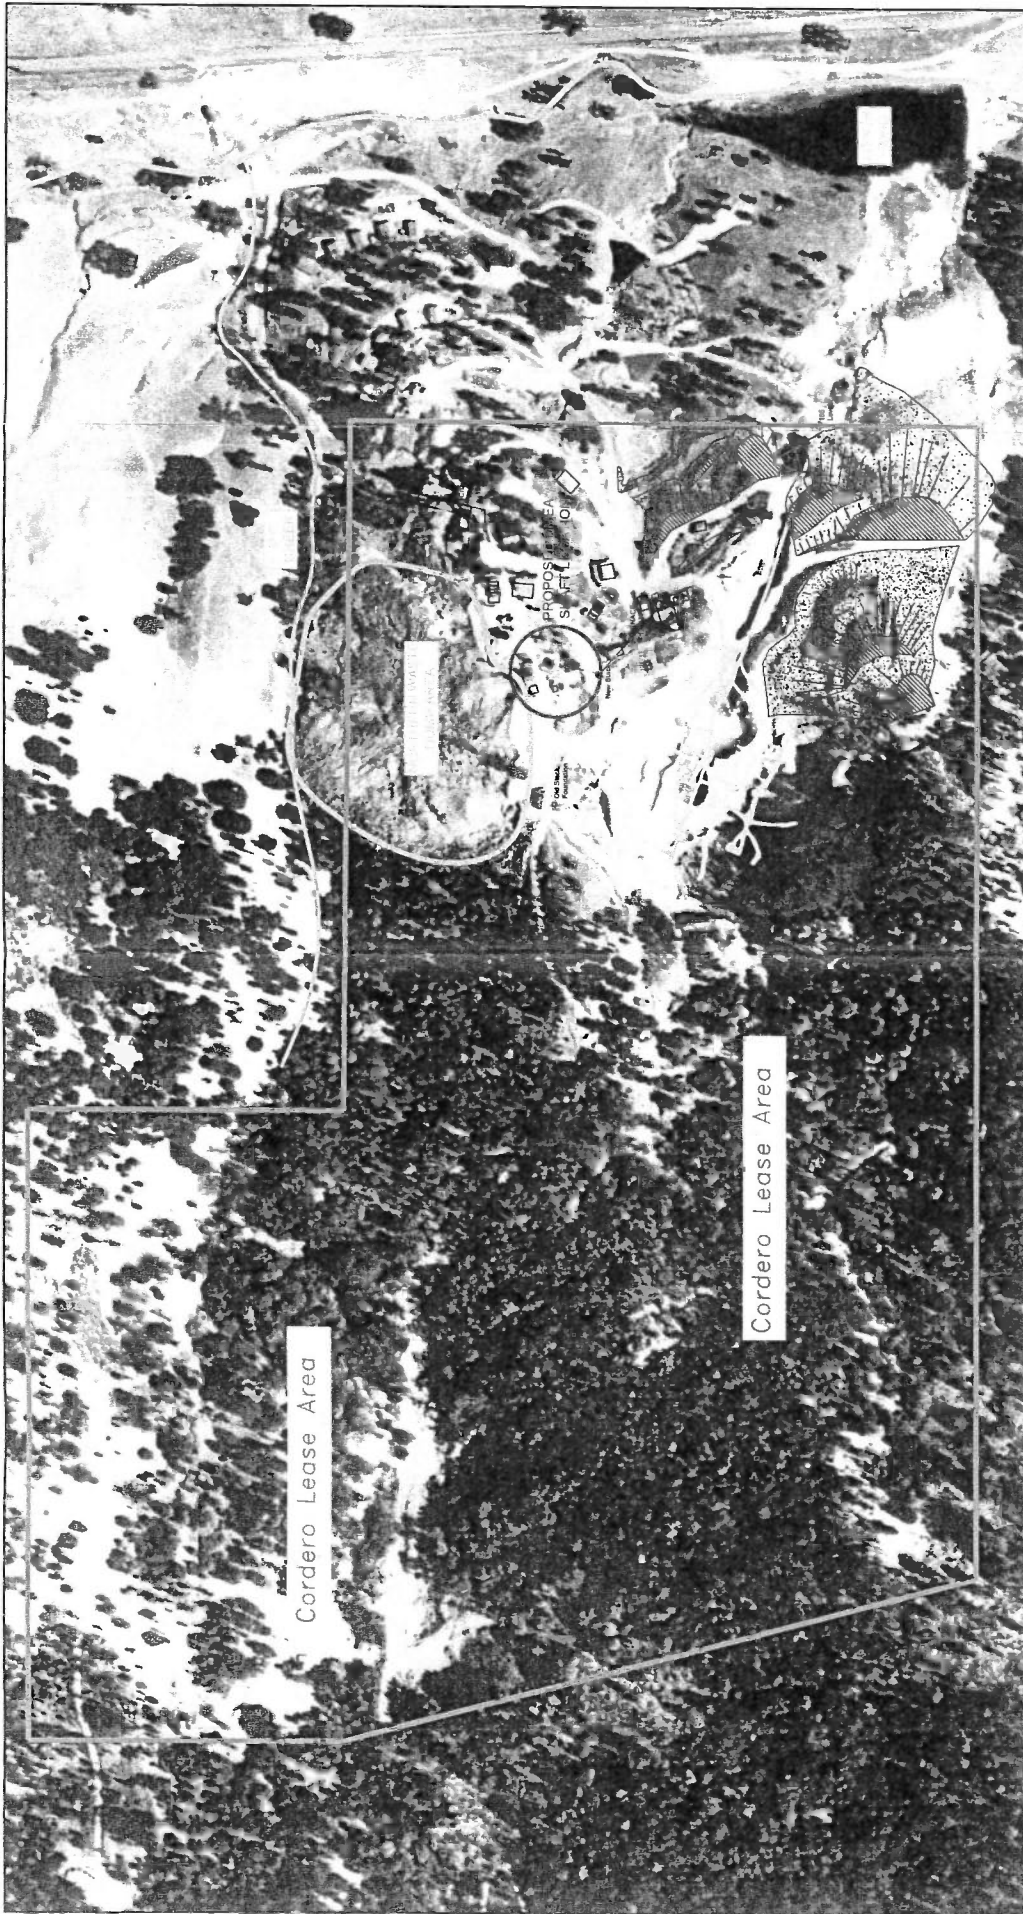
<p>LEGEND</p> <p>   Mine Structure   Pre-Cordero Tailings and Waste Rock   Adit Level   80-ft Level   165-ft Level   270-ft Level </p>		<p>PRE-CORDERO CONDITION 1952 AERIAL PHOTOGRAPH</p>	
PROJECT NO. 01-SUN-050	DATE 07/16/09	DRAWN BY JP	APP BY PH
<p>   HORIZONTAL SCALE IN FEET 0 250 500 </p>		<p>   </p>	
<p>   THE SOURCE GROUP, INC. environmental 3451-C VINCENT ROAD PLEASANT HILL, CA 94523 </p>		<p>FIGURE: 2-10</p>

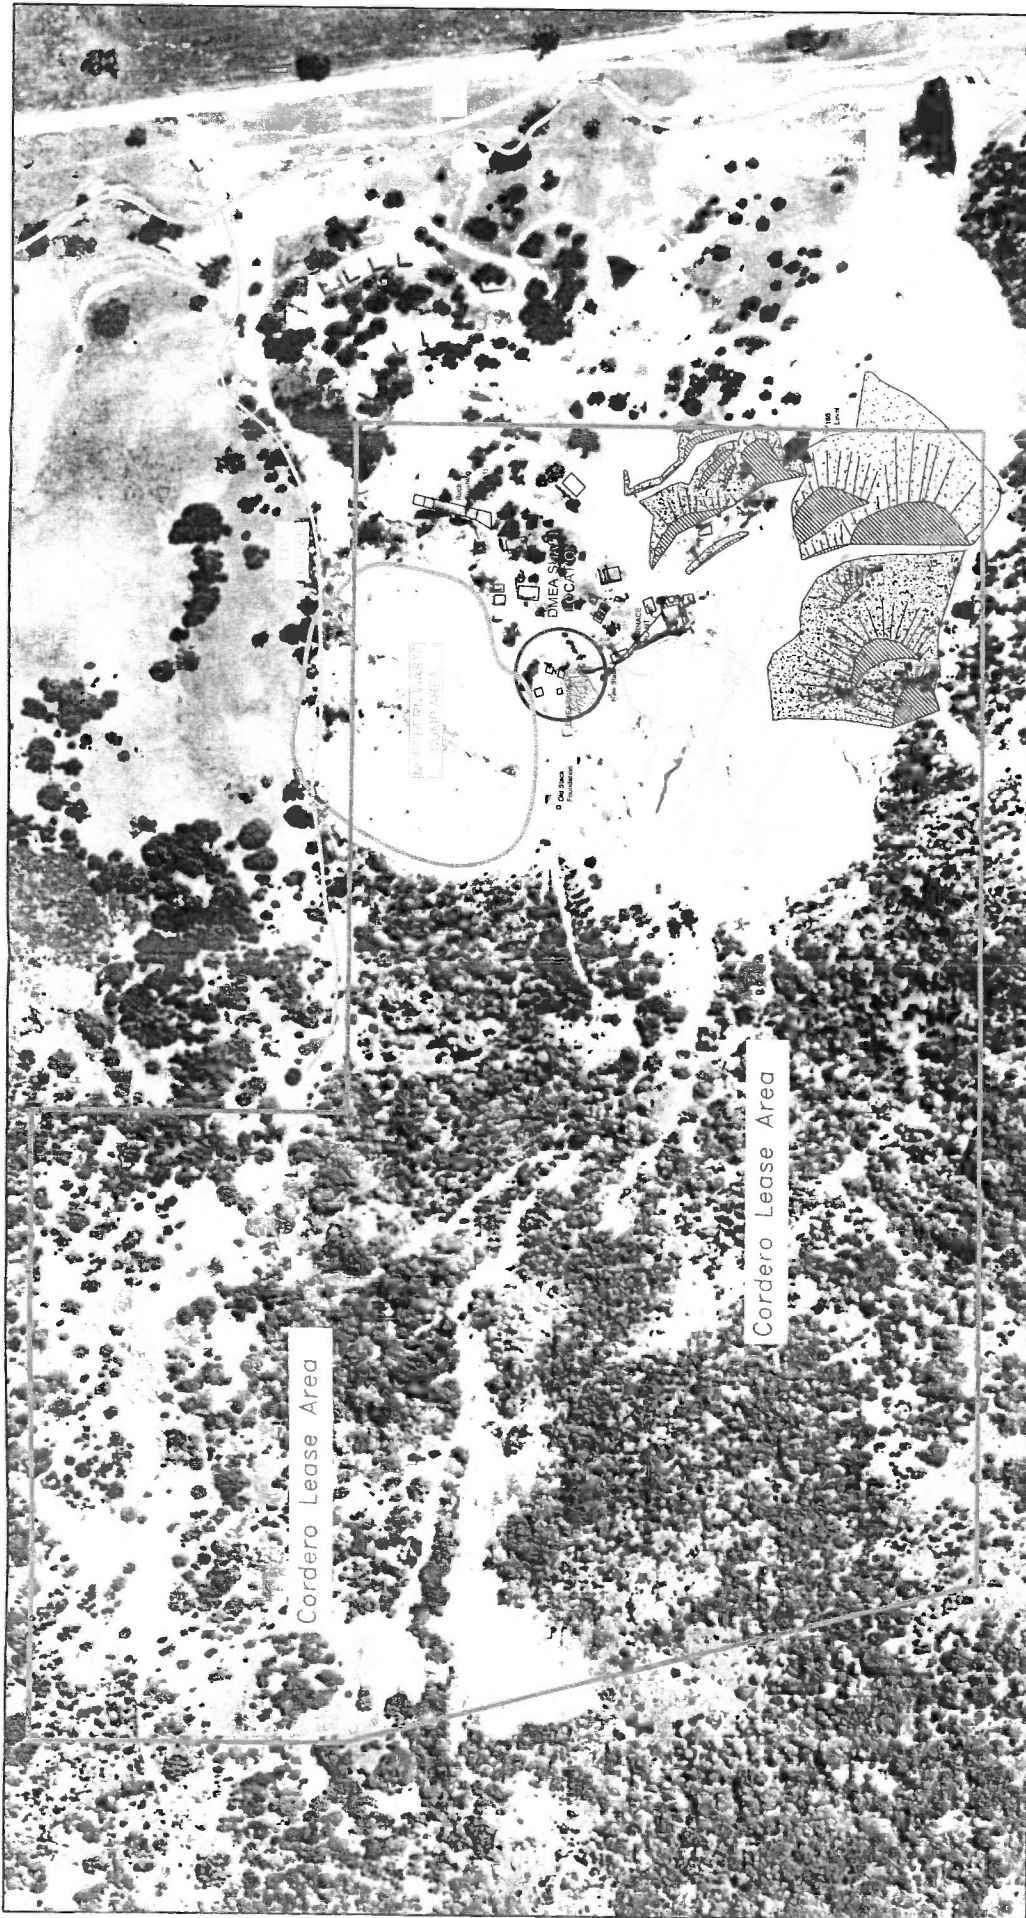
<p>LEGEND</p> <ul style="list-style-type: none"> Mine Structure (1953) Tailings/Waste Rock (Fire Concans) Waste Rock (DIMEA/Cordero) 		<p>Underground Workings</p> <ul style="list-style-type: none"> Adit Level 80-ft Level 165-ft Level 270-ft Level 360-ft Level (Cordero) 	
PROJECT NO.	DATE:	DRAWN BY:	APP. BY:
01-SUN-050	07/16/09	JP	PH
<p>0 250 500 HORIZONTAL SCALE IN FEET</p>			
<p>SGI THE SOURCE GROUP, INC. 3451-C VINCENT ROAD PLEASANT HILL, CA 94523</p>			
<p>POST CORDERO CONDITION 1957 AERIAL PHOTOGRAPH</p>			
<p> N</p>			
<p>FIGURE: 2-11</p>
