Jamestown Mine

Referred to
Attorney General's Office for
Monetary Penalties

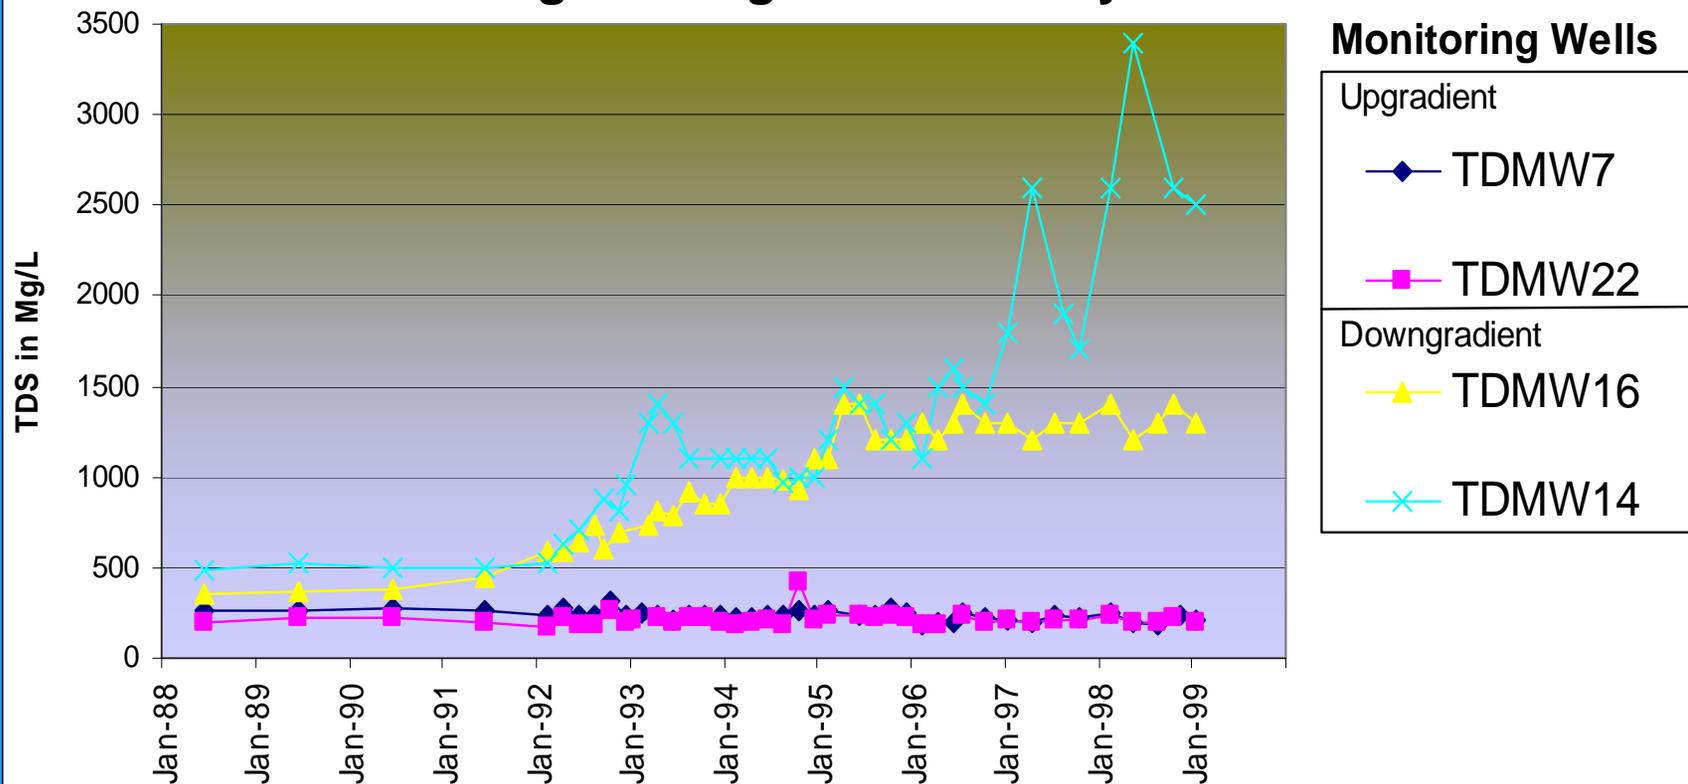
Total Dissolved Solids (TDS) Tailings Management Facility

Groundwater Degradation

Data before 1992 is represented by mean values for that year and is plotted at June. Data for 1992 and after is plotted to the nearest month.

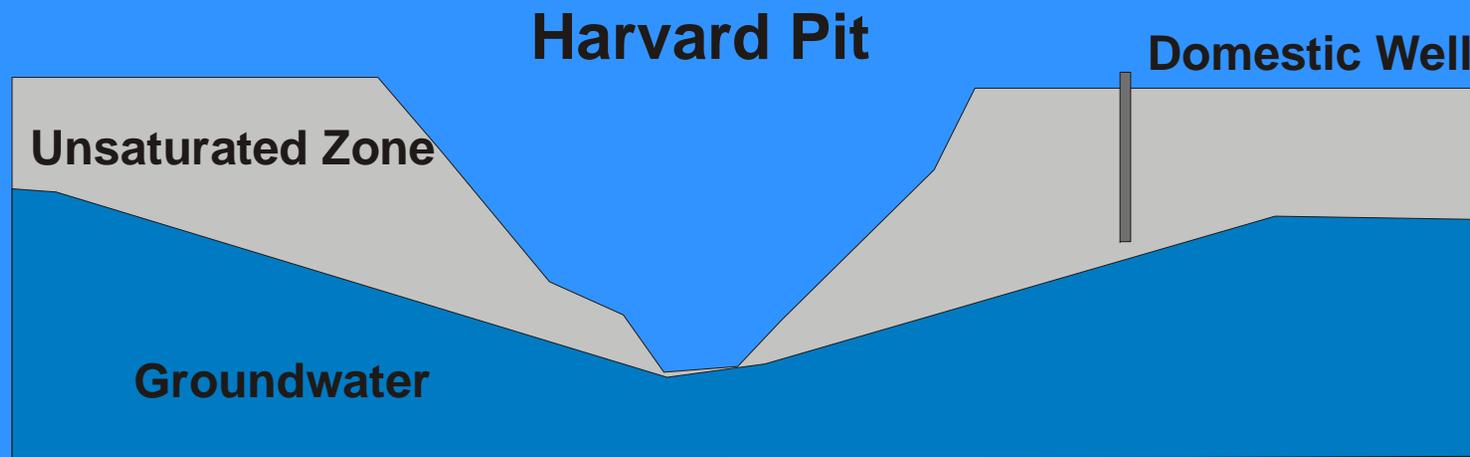
Harvard Pit – Dewatered

Schematic

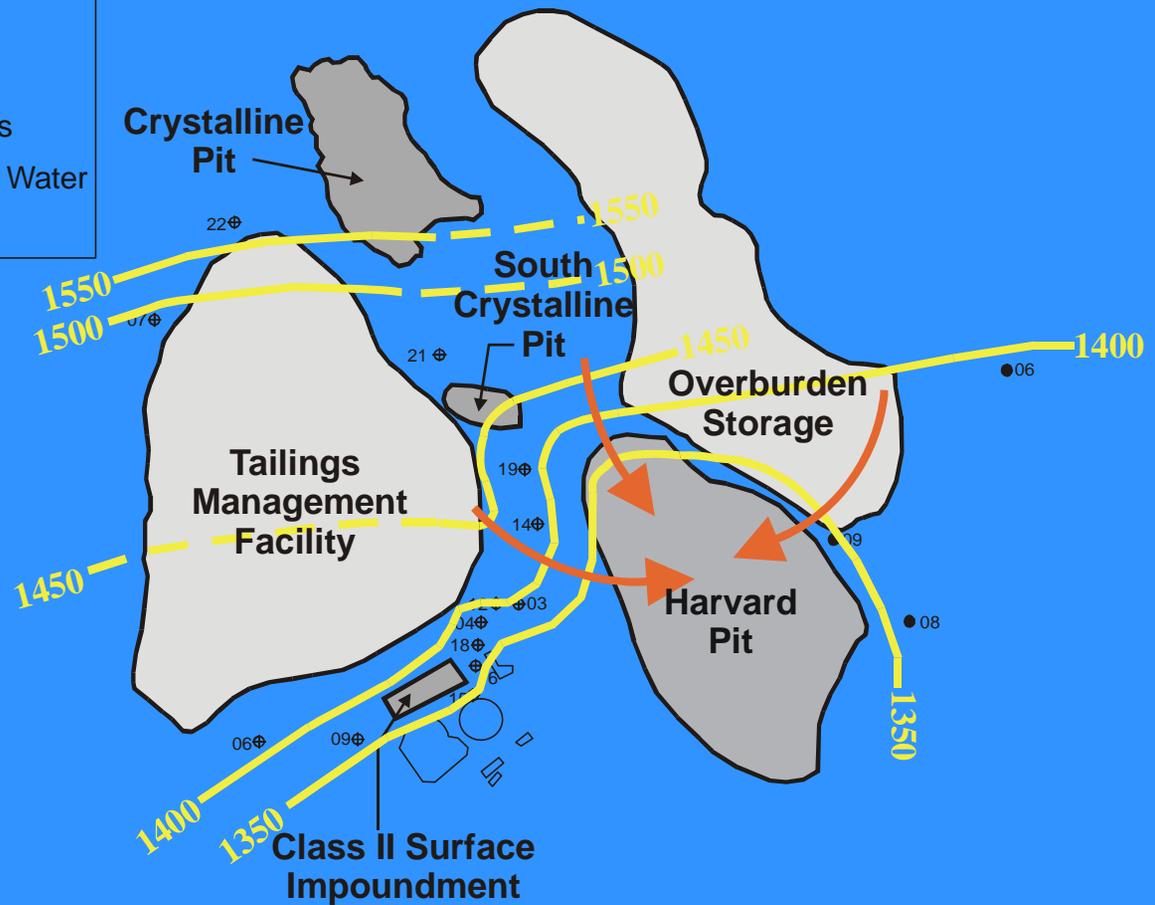
Groundwater Gradient 1999

- ⊕ Tailing Dam Monitoring Wells
- Rock Storage Monitoring Wells

Estimated Ground Water Flow Direction
