CALIFORNIA REGIONAL WATER QUALITY CONTROL BOARD
CENTRAL VALLEY REGION

CLEANUP AND ABATEMENT ORDER NO. R5-2015-0702
FOR

BRENT ALAN VANDERKAM
ASSESSOR PARCEL 099-120-035-000
SHASTA COUNTY

Appendix B - Buggy Road Inspection

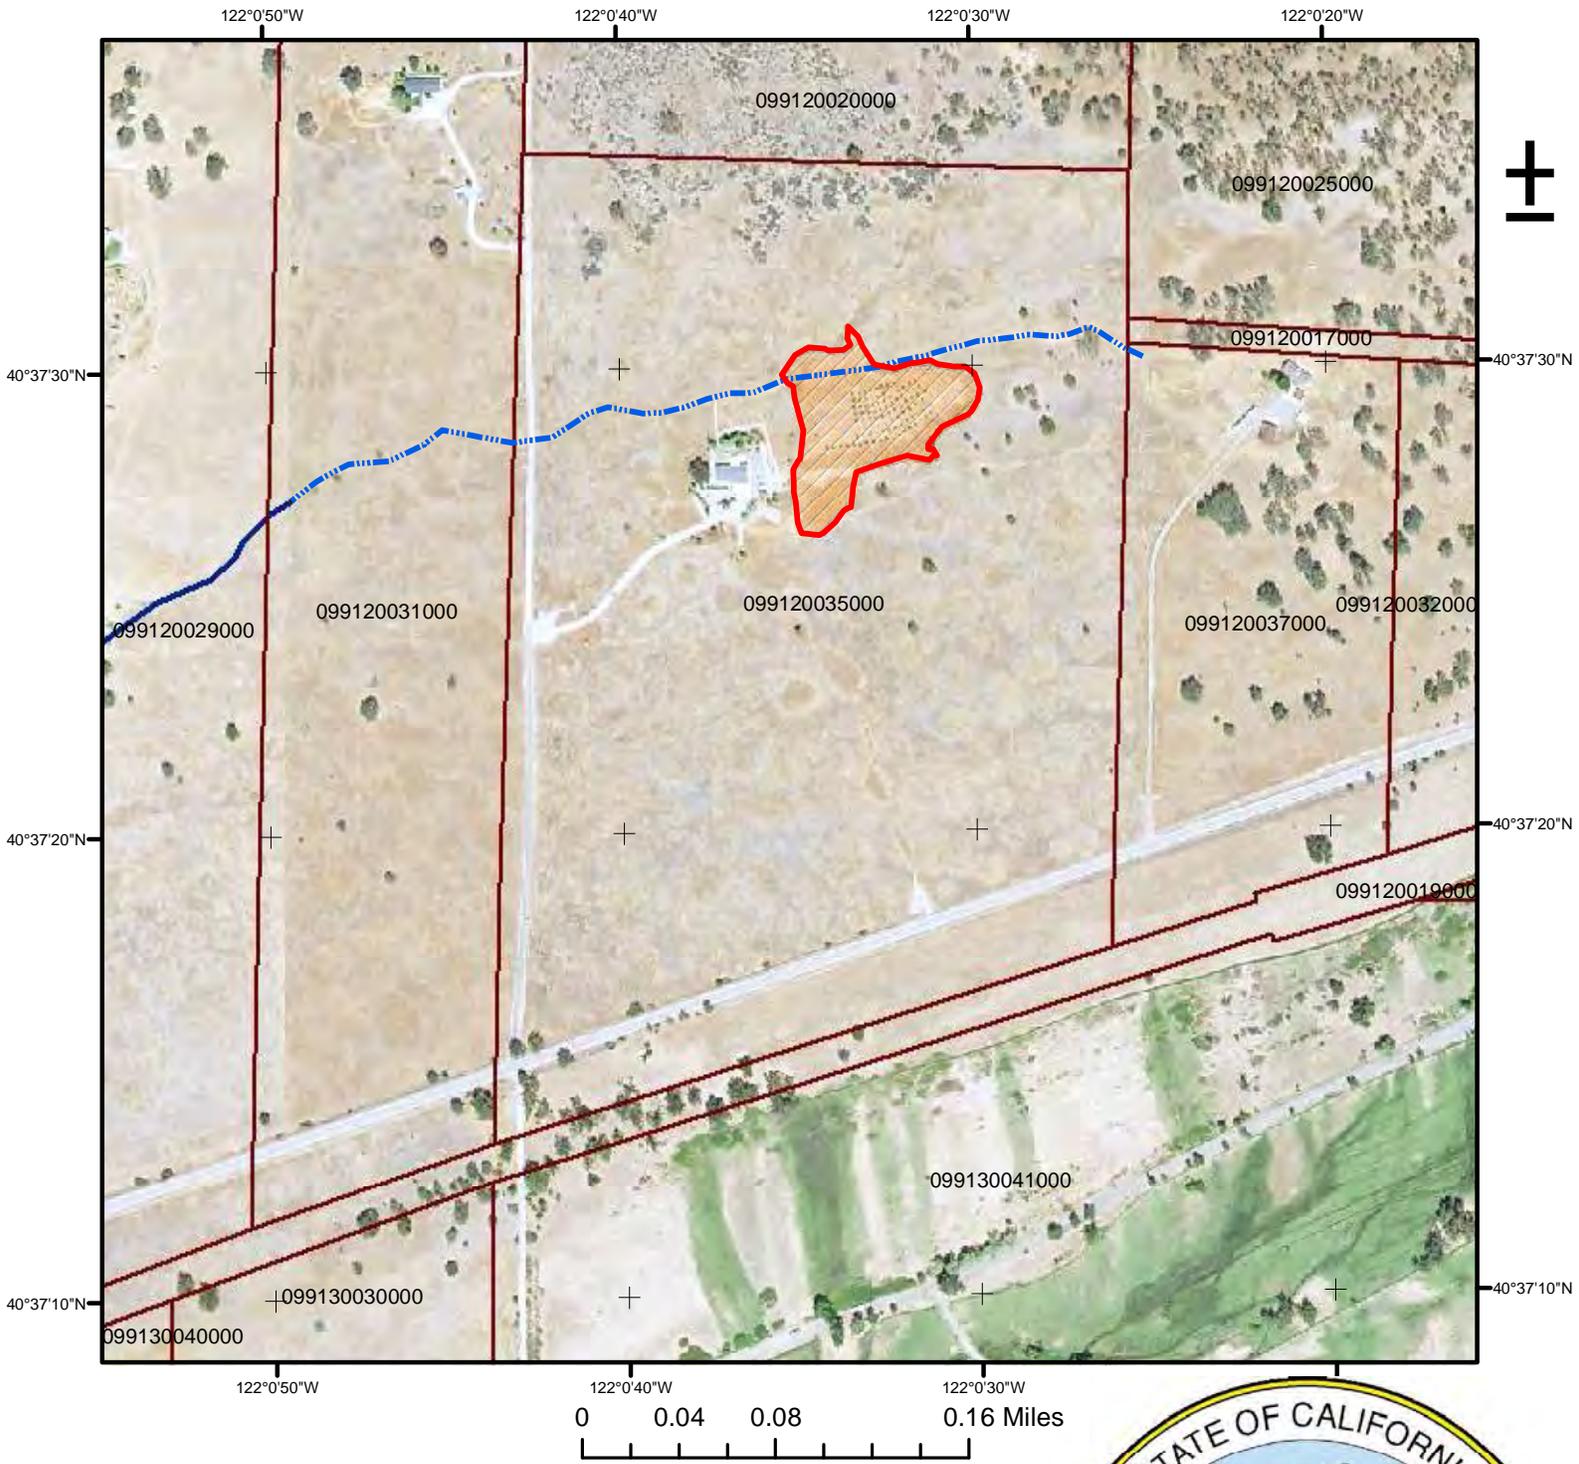
Figure 1: 21 November 2014; Buggy Road Inspection on NAIP 2014 General Location Imagery/Inspection Area

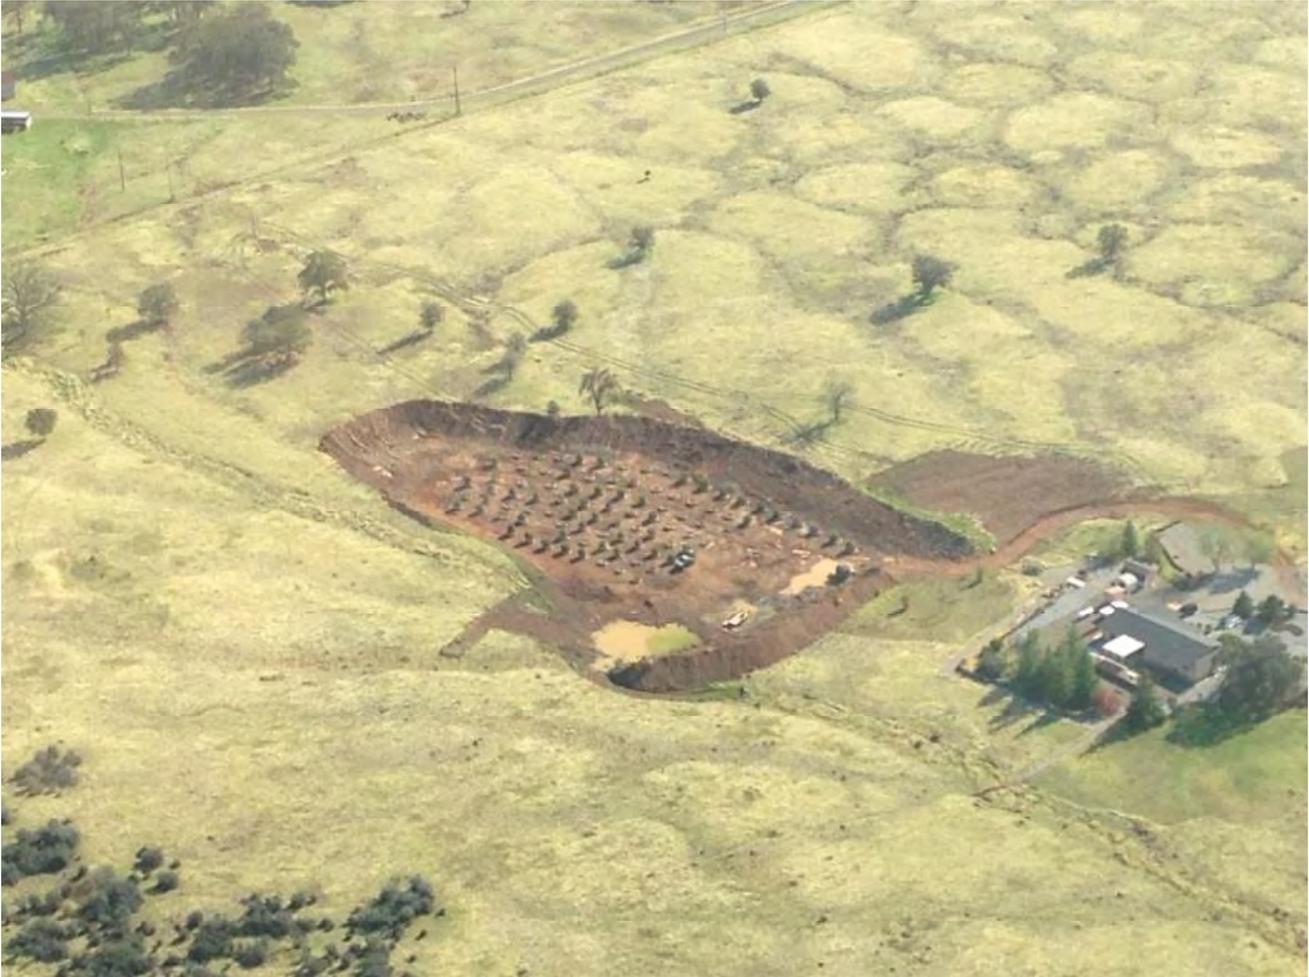
Photograph 1: Aerial photograph from the 5 November 2014 overflight showing potential for water diversion, lack of erosion control, and possible vernal pool topography suggested by the circular patterns in the landscape.

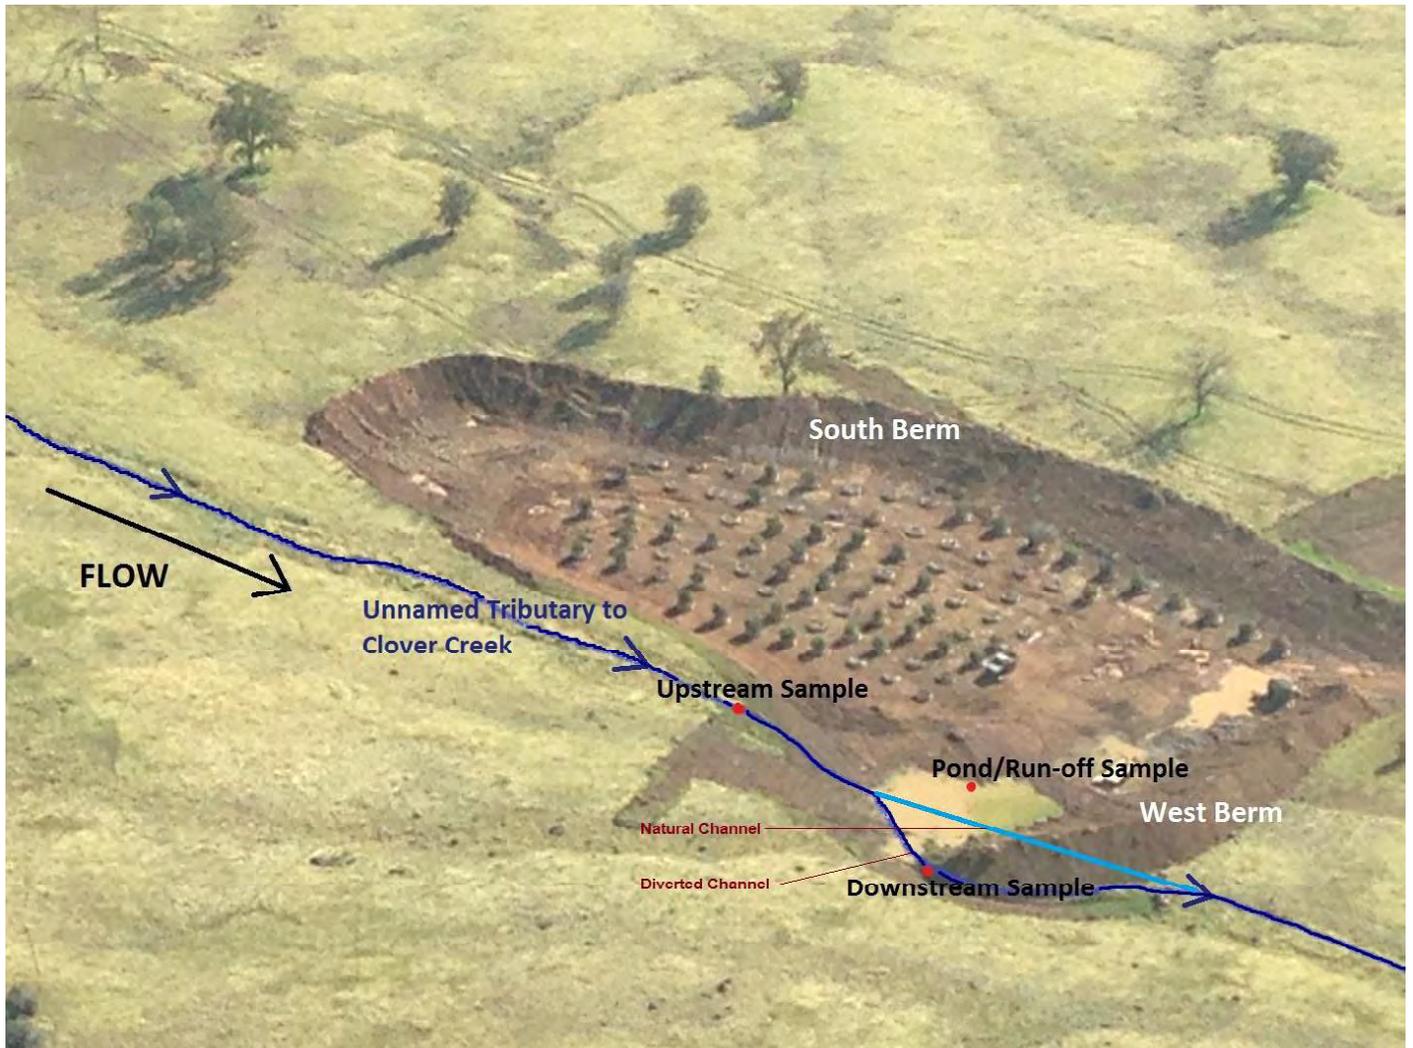
Photograph 2: Second and closer aerial view from the overflight showing ponding water along the western end of the site and potential algal blooms. Labeling shows the direction of flow observed in the stream (identifying both its natural and diverted channels) and identifies berms and sample locations.

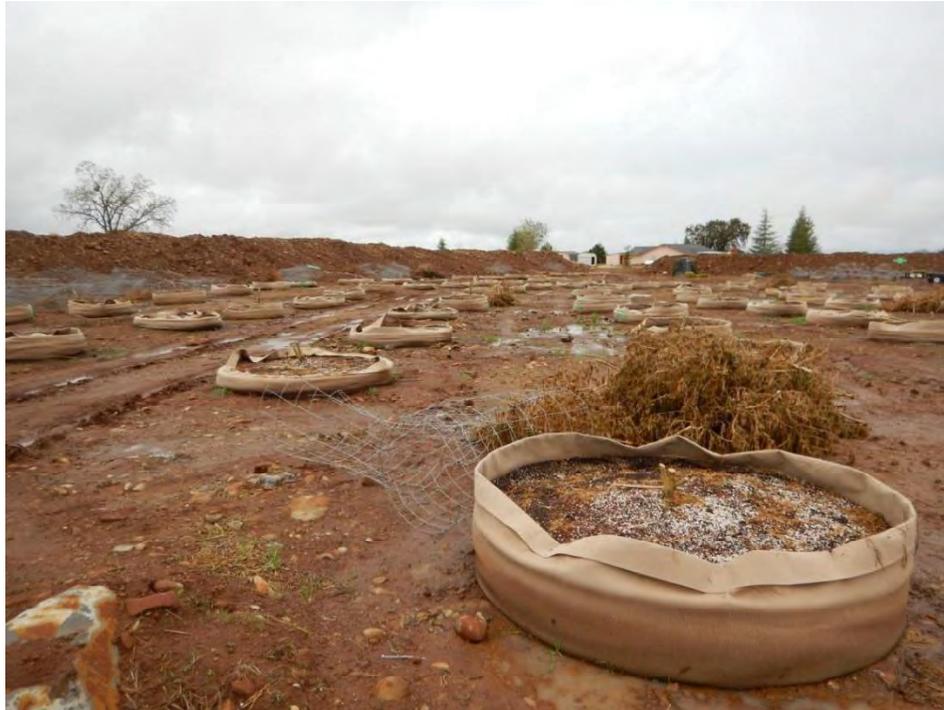
Upon entrance to the grow area, the Watershed Enforcement Team immediately observed an extensive graded area flanked on the west and south by two large berms created from the excavated spoils with no erosion control measures in place (Photographs #1-2). Within the graded area, staff observed 93 cloth grow-bags used to support marijuana plants with trimmings left scattered over the Site (Photograph #3). Water was found ponding on the western interior of the site adjacent to what appeared to be a large mixing/holding tank and along the west berm of the grow site (Photograph #4). A well was located at the top of the hill to the west of the Site between the residence and the western berm. Based on the location of the well, and hosing emanating from the pump house, it is possible that this water may have been used to fill the mixing tank and supply irrigation to the Site. A spray applicator was also observed lying next to the mixing tank (Photograph #5).

Photograph 3: View of grow site towards west and south berms showing the expanse of the grading/excavation and many of the 93 plant bags.

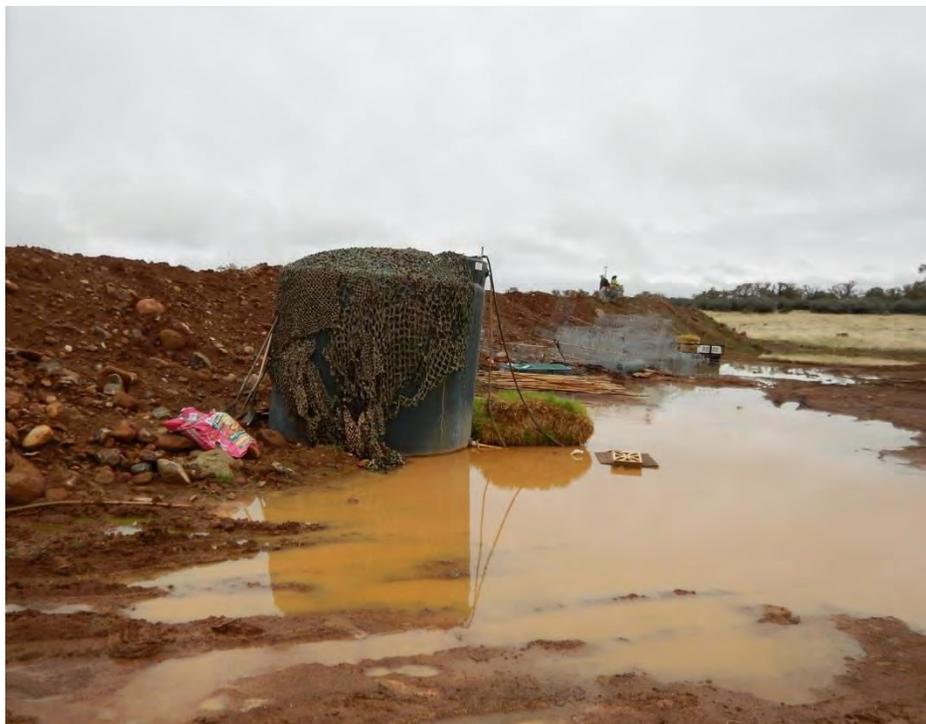
Photograph 4: View of the southwest corner/entrance showing ponding waters adjacent to large mixing tank with hoses stretching to the northwest end of the site.

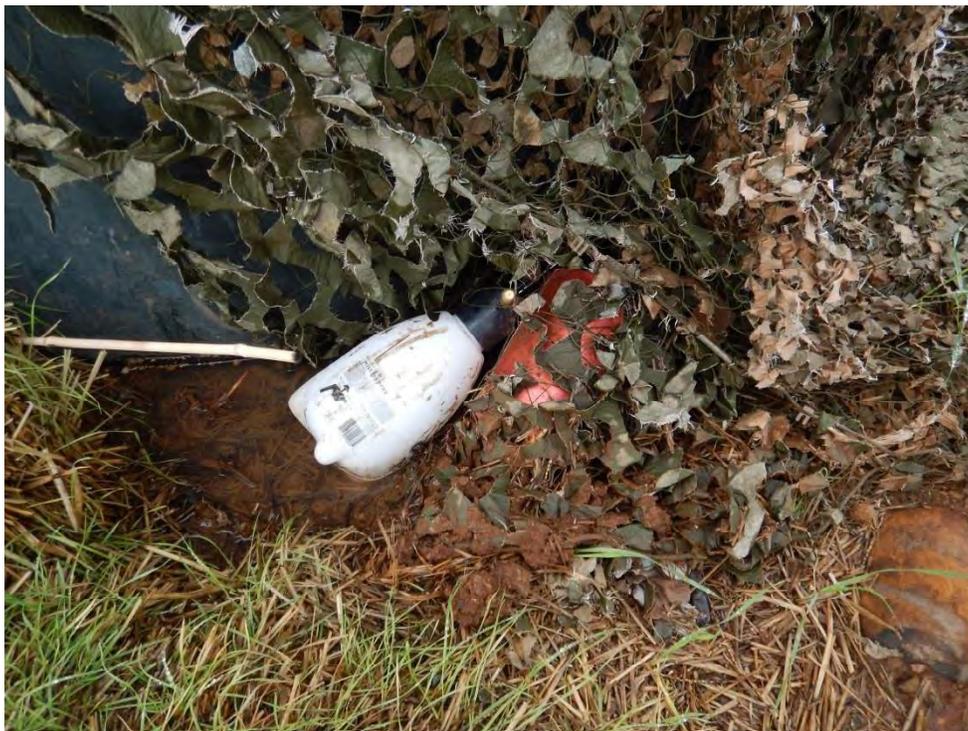
Photograph 5: Spray applicator adjacent to mixing tank.

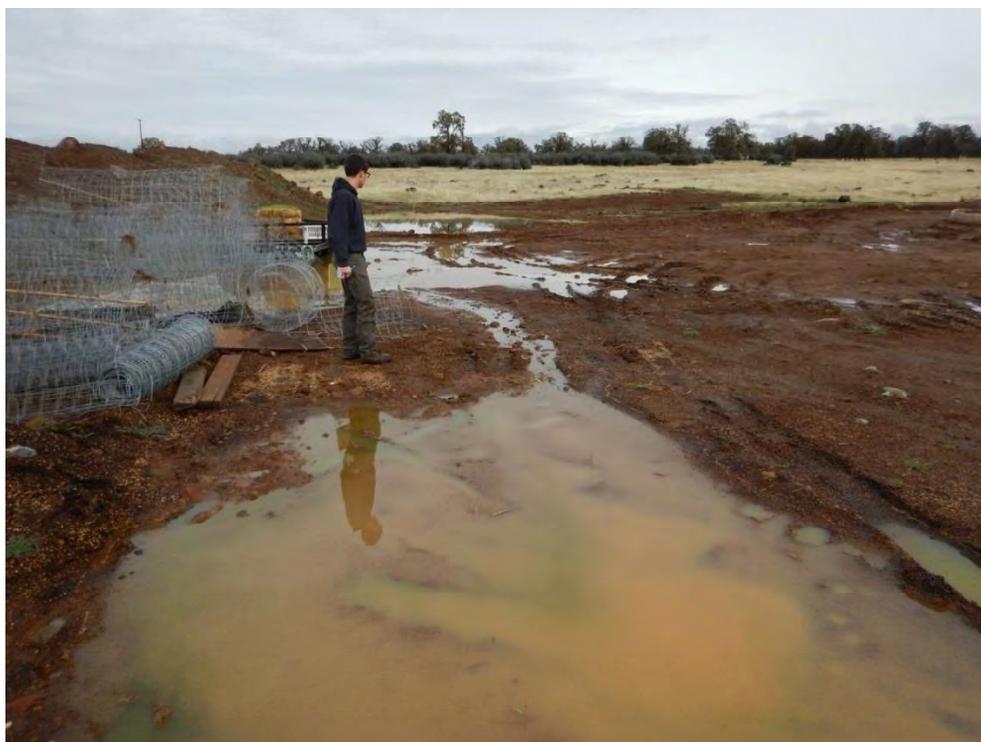
Photograph 6: Water in the southwest corner of the graded site showing evidence of turbidity and algal growth flowing to the northwest corner and intersecting the stream.

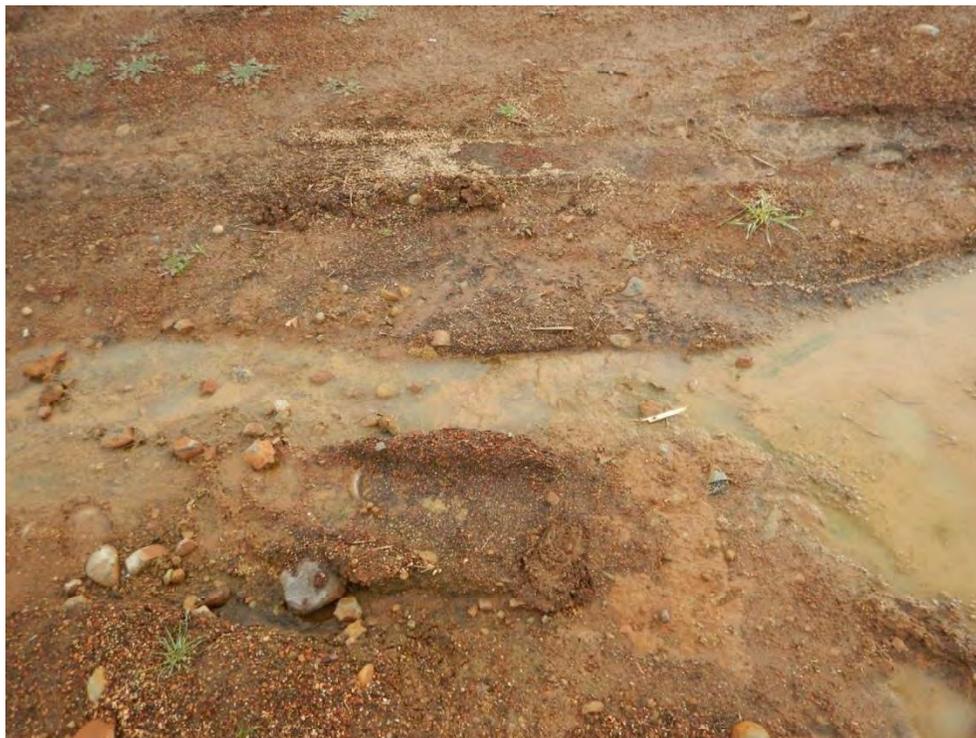
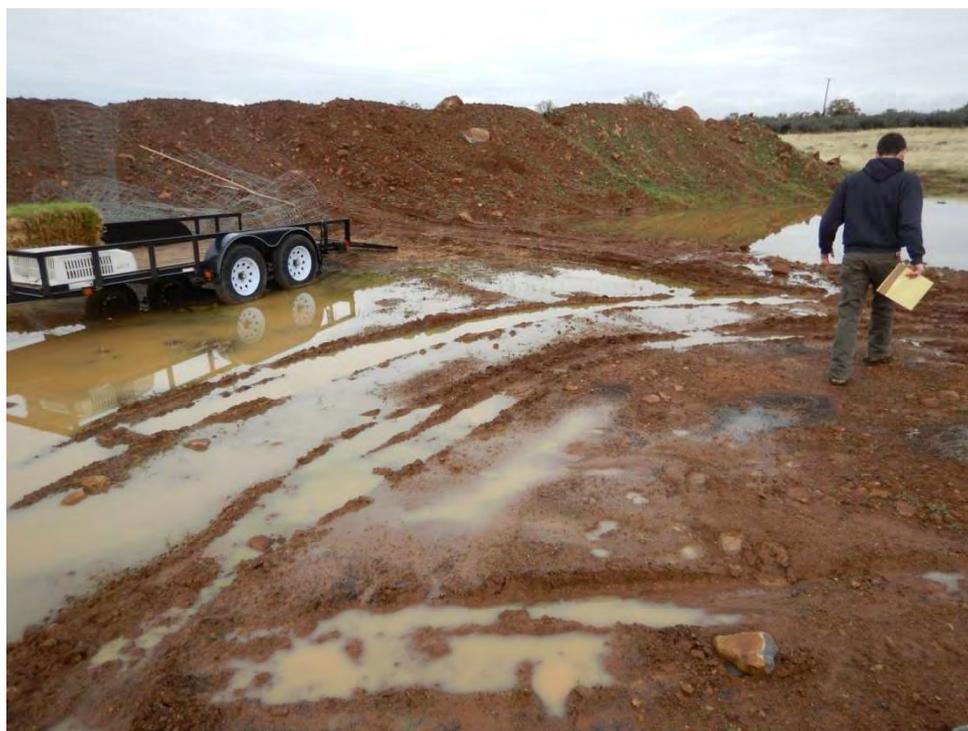
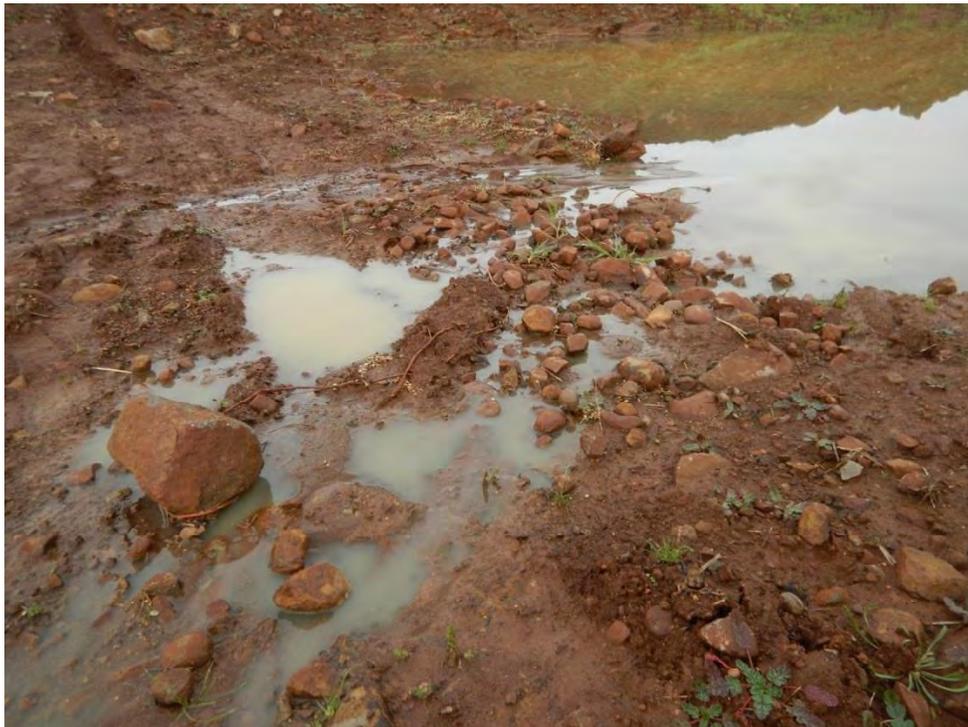
Photograph 7: Water flowing between ponding areas.

Photograph 8: Water flowing between ponding areas.

Photograph 9: Water flowing between ponding areas.

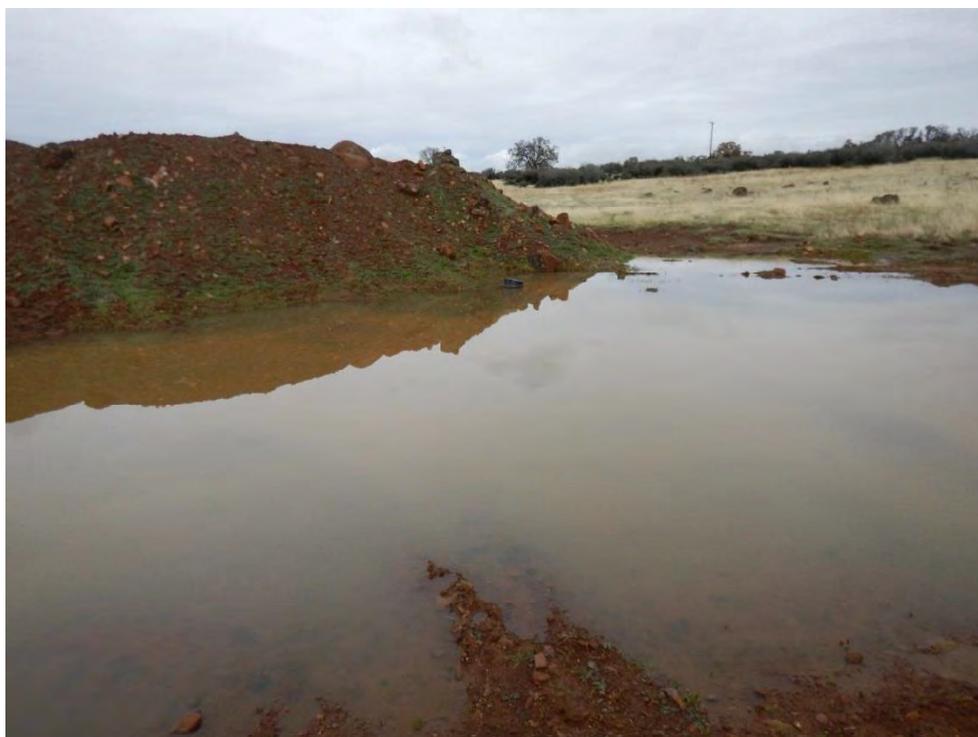
Photograph 10: Turbid water in the last ponding area intersecting with the stream at the northwestern edge of the unprotected berm.

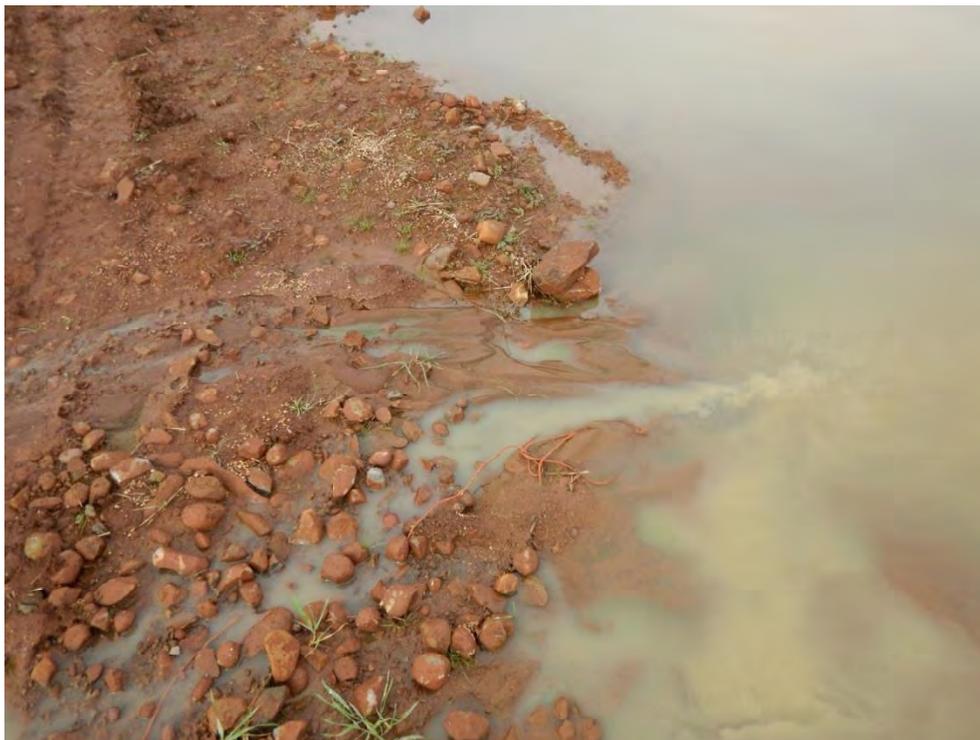
Photograph 11: Sediment plume flowing into last ponding area before discharge to the stream.

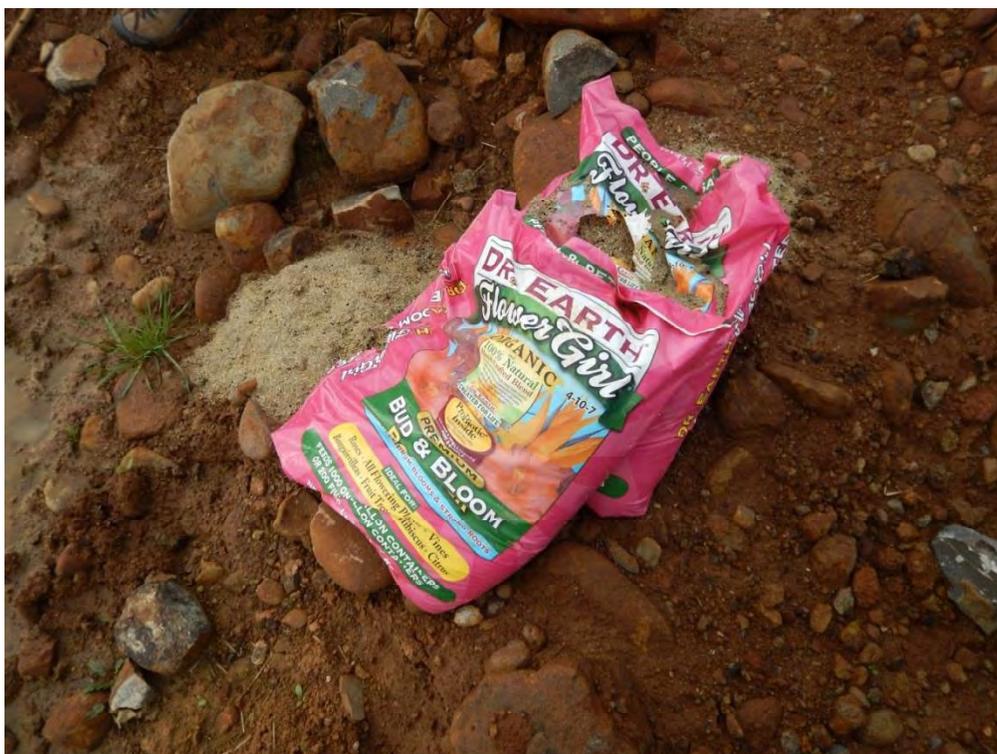
- a. Staff sampled and confirmed the presence of elevated nutrients (nitrate and total phosphorus) originating near a large mixing tank from leaking bags of fertilizer and uncontained potting soil discharging to the Unnamed Tributary.

Photograph 12: Leaking bags of Dr. Earth's Flower Girl organic fertilizer.

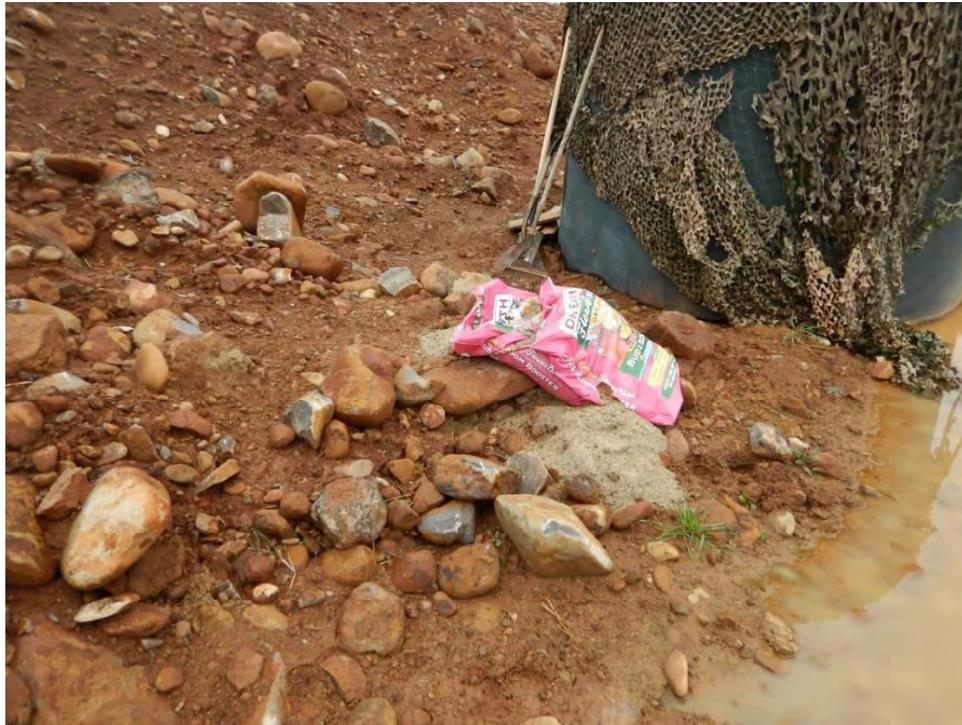
Photograph 13: Leaking bags of Dr. Earth's Flower Girl organic fertilizer adjacent to ponding water – a potential source of nutrients responsible for algal growth.

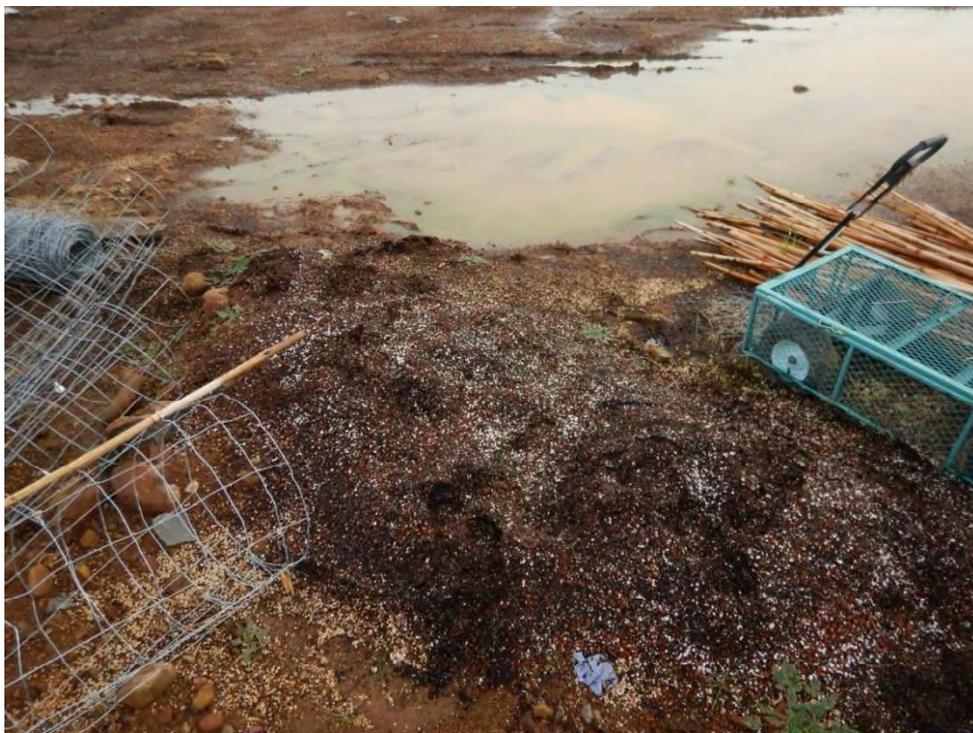
Photograph 14: Loose potting soil and perlite adjacent to ponding water.

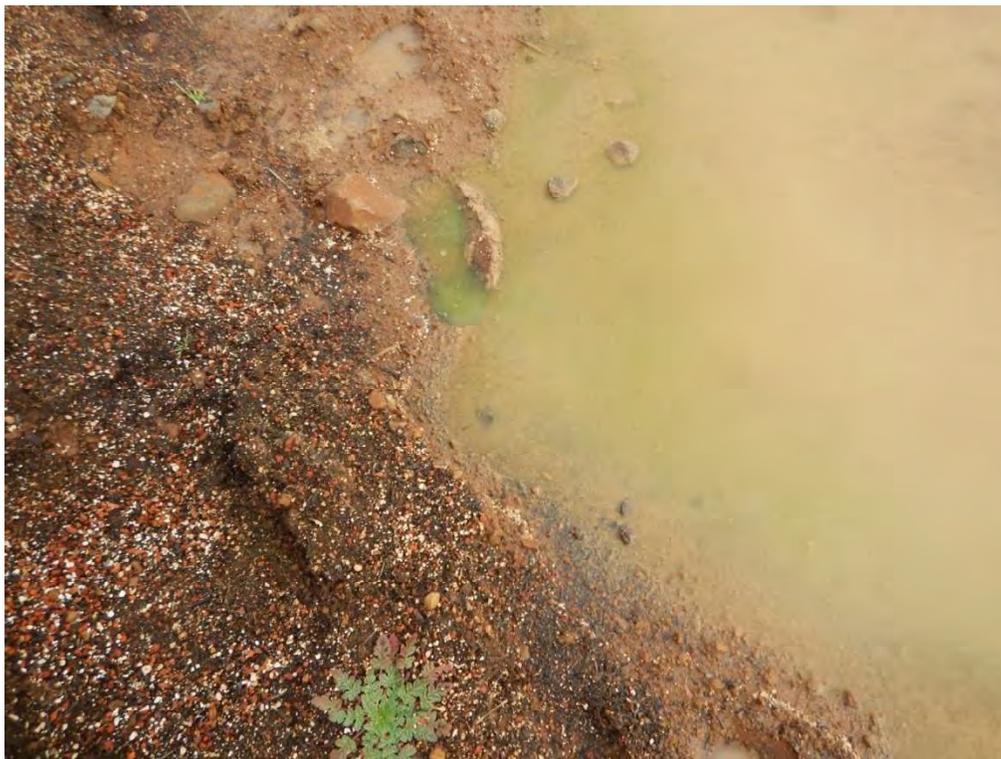
Photograph 15: Loose potting soil with perlite and evidence of algal growth in ponding water.

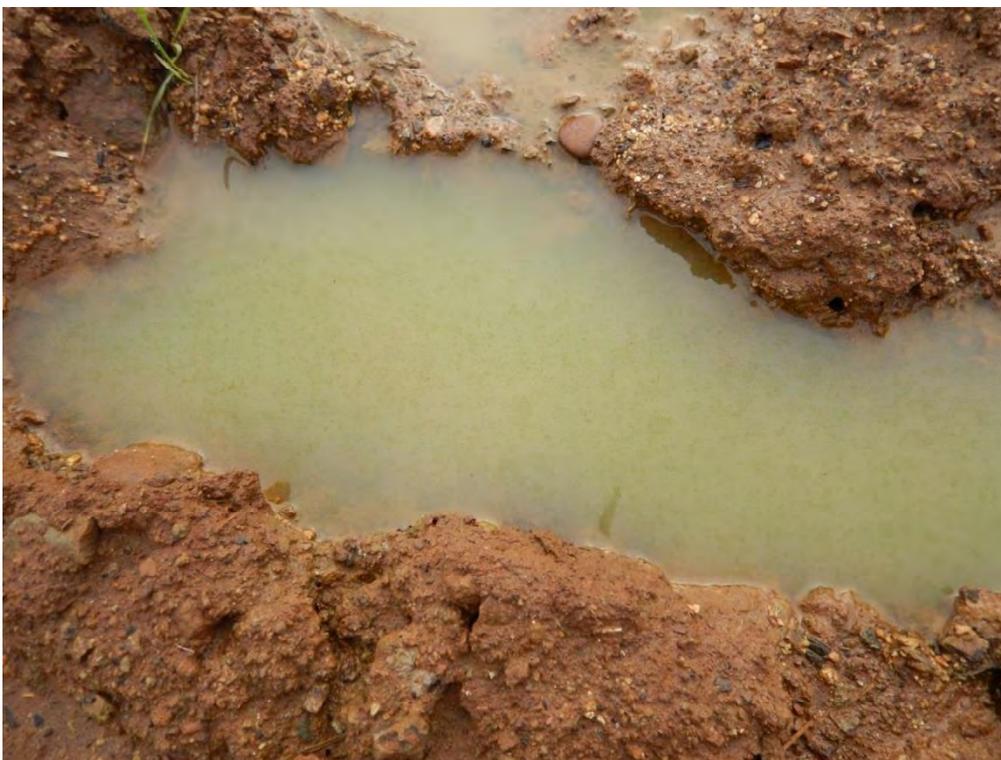
Photograph 16: Algal bloom.

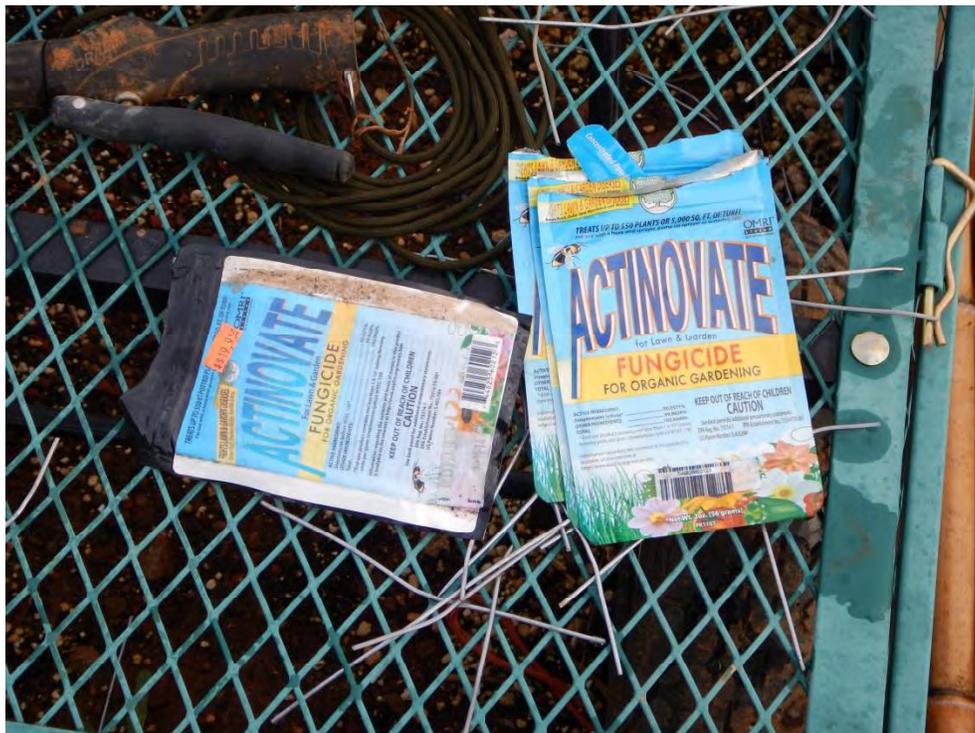
Photograph 17: Uncontained, open packets of Actinovate Fungicide – a bacterial fungicide.

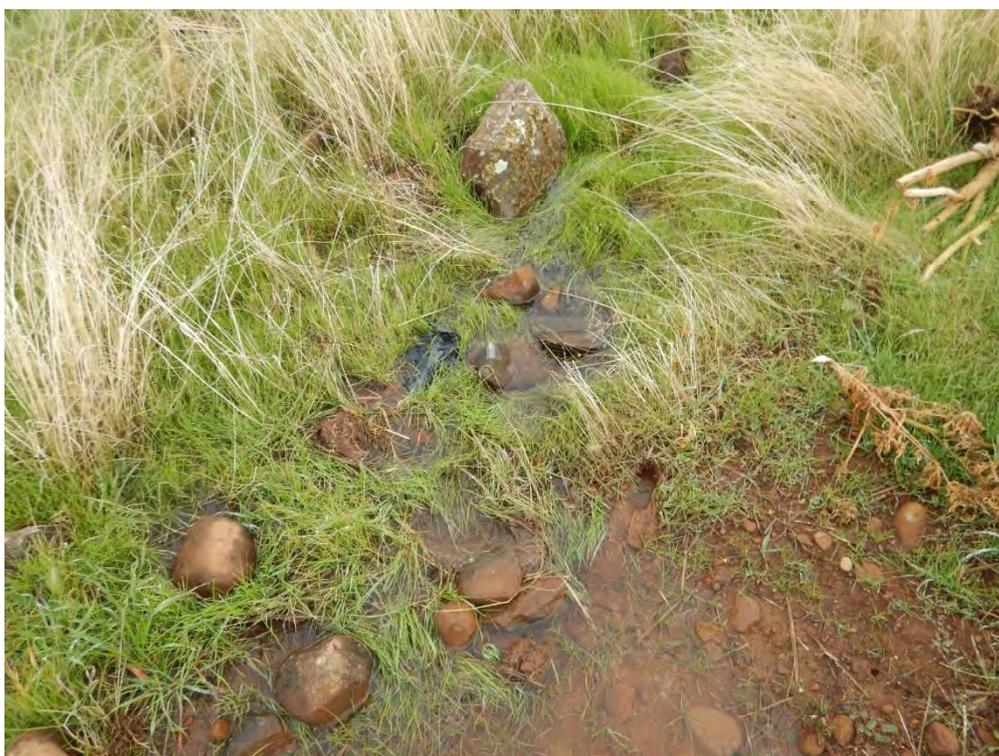
Photograph 17: Ephemeral stream entering the site with low turbidity.

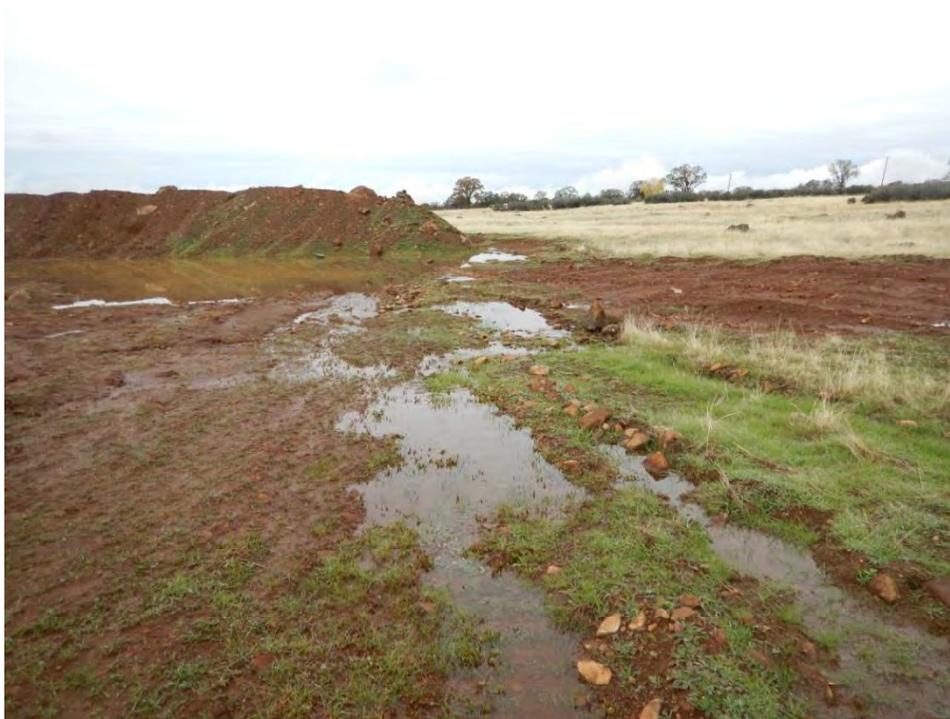
Photograph 18: Stream flowing through the site.

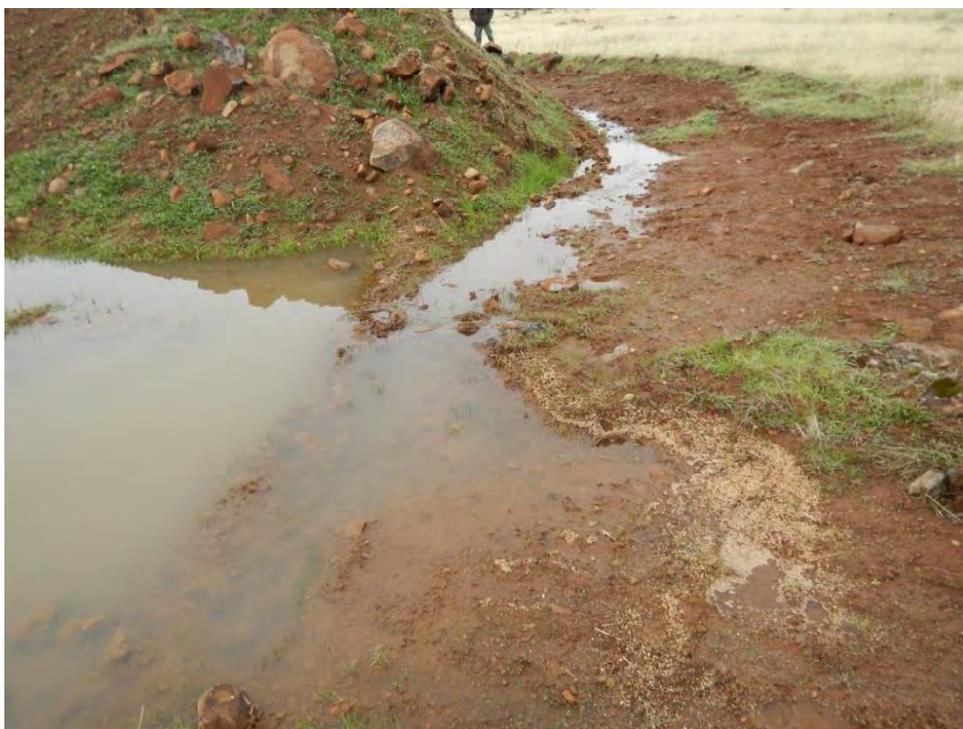
- b. Staff documented turbid plumes and discharge of sediment-laden storm water from disturbed surfaces discharging from the Site to the Unnamed Tributary. Turbidity measurements collected downstream from the Site exceed Basin Plan objectives for turbidity increases where natural turbidity upstream measured between 1 and 5 NTUs². Field turbidity measurements downstream from the Site discharge exceeded background upstream measurements by nearly 30 NTUs.

Photograph 19: Turbid stream after converging with waters from the site and picking up sediment from the excavated soils, traveling around the berm lying in its natural path.

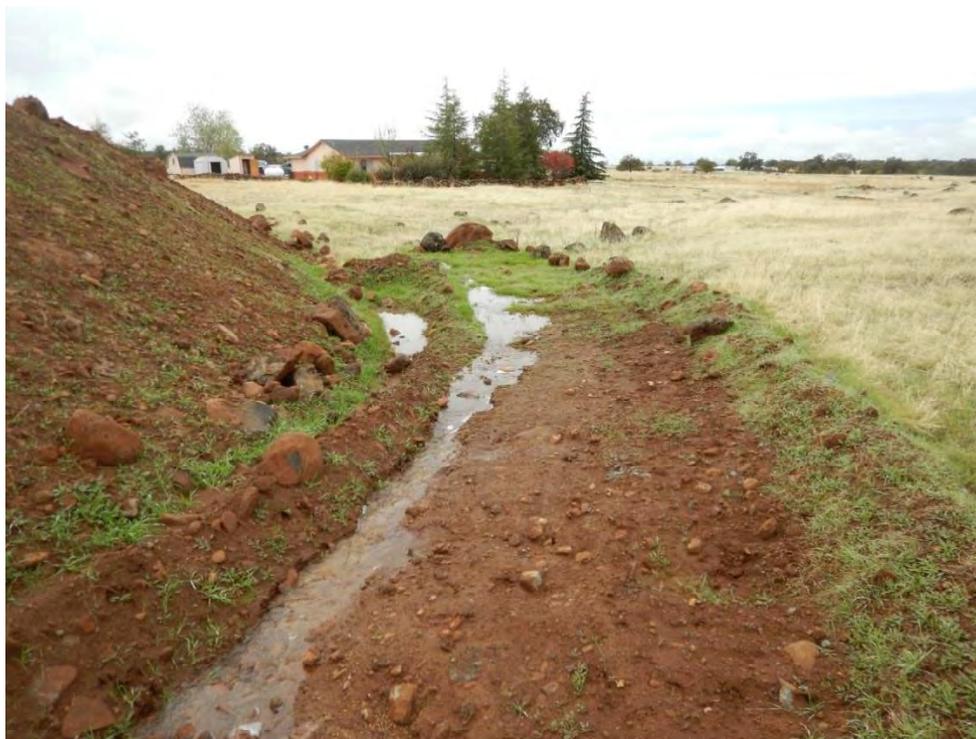
Photograph 20: Stream carving out a new path around the western berm, leaving the disturbed area heading back towards its natural channel.

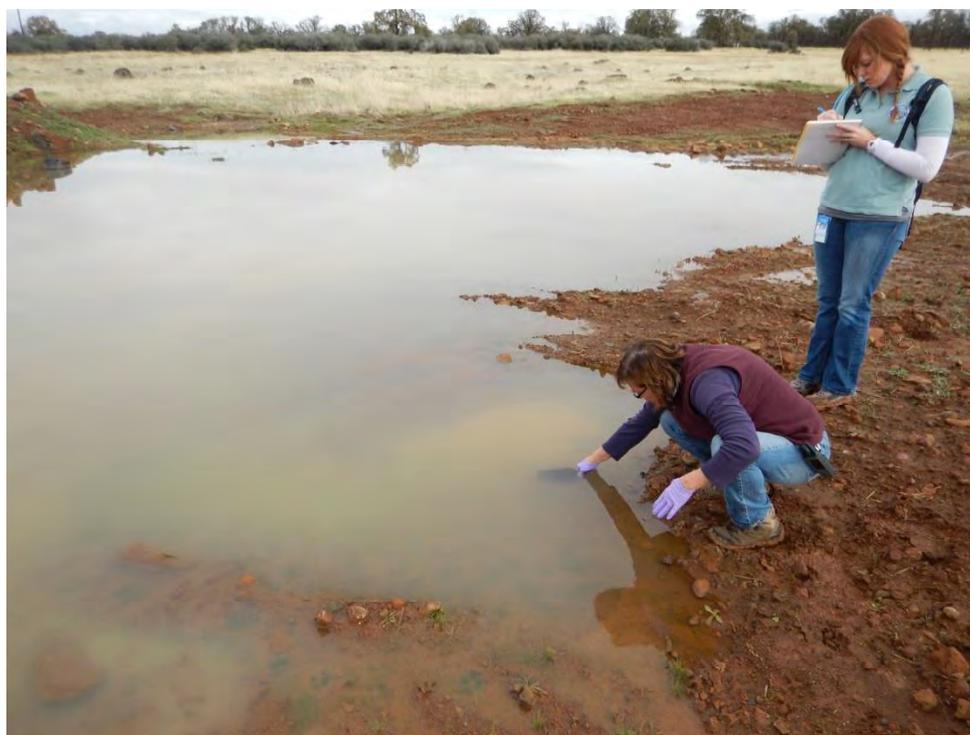
Photograph 21: Sample site #1, Pond\Run-Off Sample - collected from final ponding area before it discharges into stream.

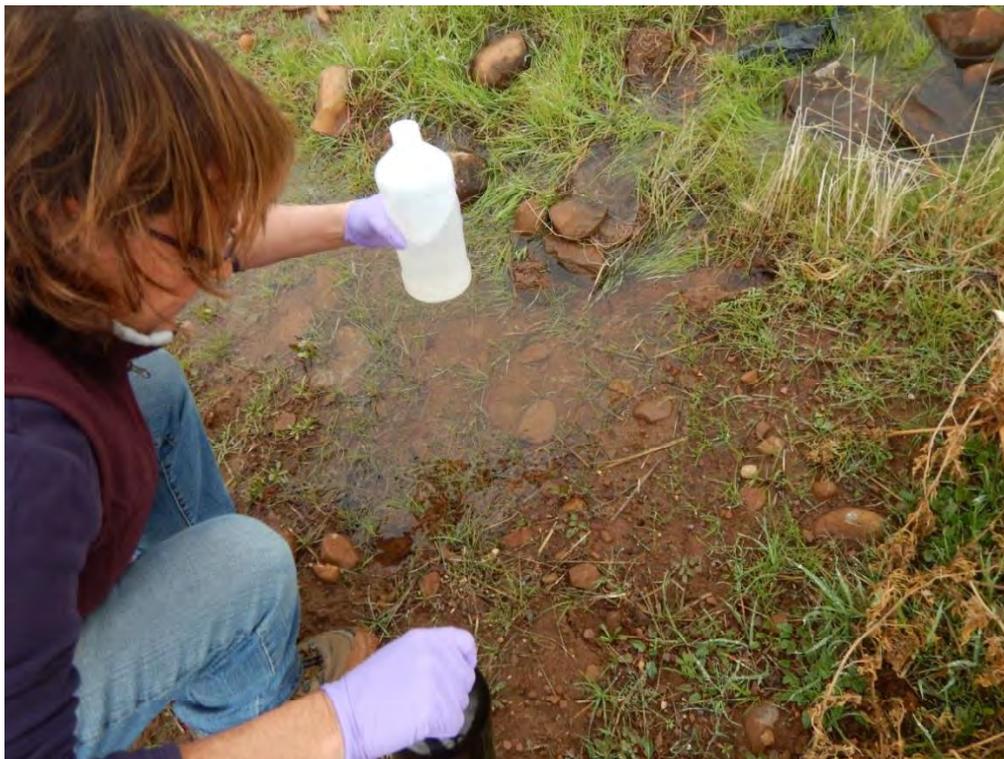
Photograph 22: Sample site #2, Upstream Sample - collected upstream from grow site.

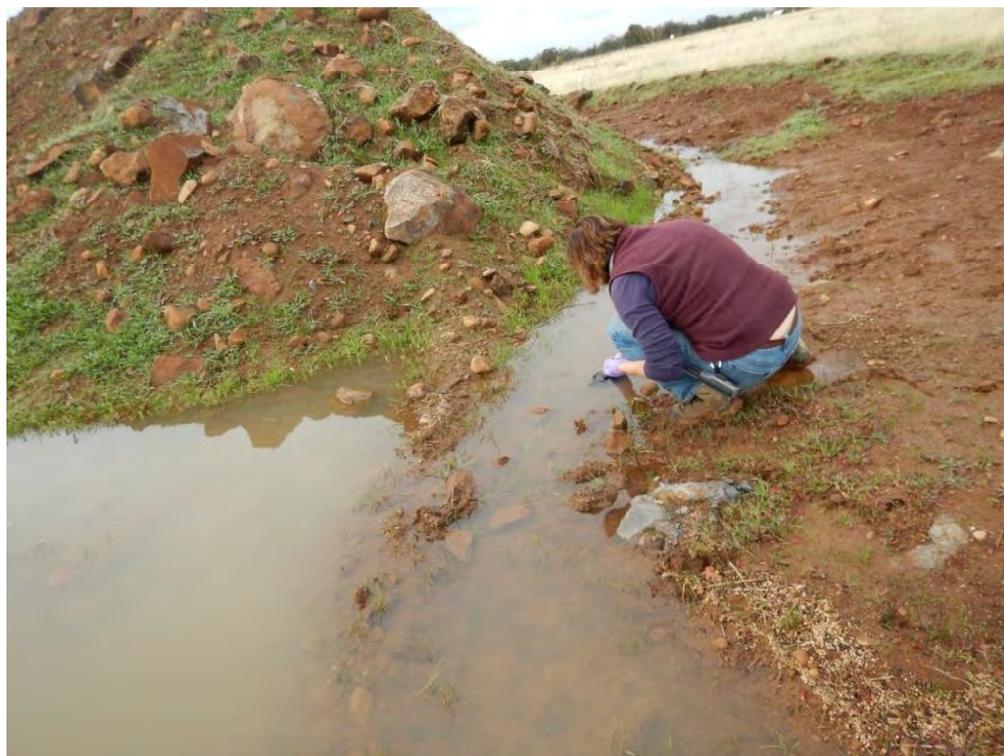
| Photograph 23: Sample site #3, Downstream Sample – collected after convergence of stream with site run-off.

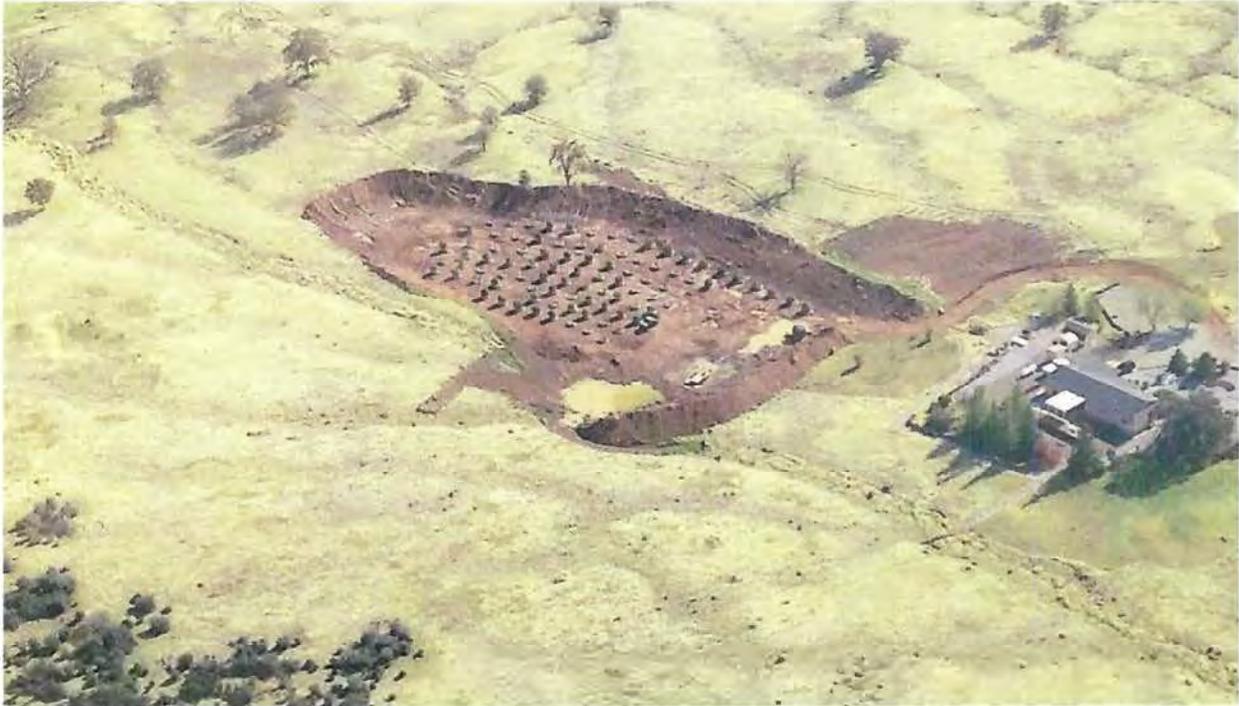
Photo 1: Photo shows graded and excavated site next to dwelling with spoils piled on the western side of the graded area. The photograph also shows excavation occurred within and along the dry tributary. No obvious erosion control measures are in place.
