CALIFORNIA REGIONAL WATER QUALITY CONTROL BOARD
CENTRAL VALLEY REGION

CLEANUP AND ABATEMENT ORDER NO. R5-2015-0702
FOR

BRENT ALAN VANDERKAM
ASSESSOR PARCEL 099-120-035-000
SHASTA COUNTY

Appendix B - Buggy Road Inspection

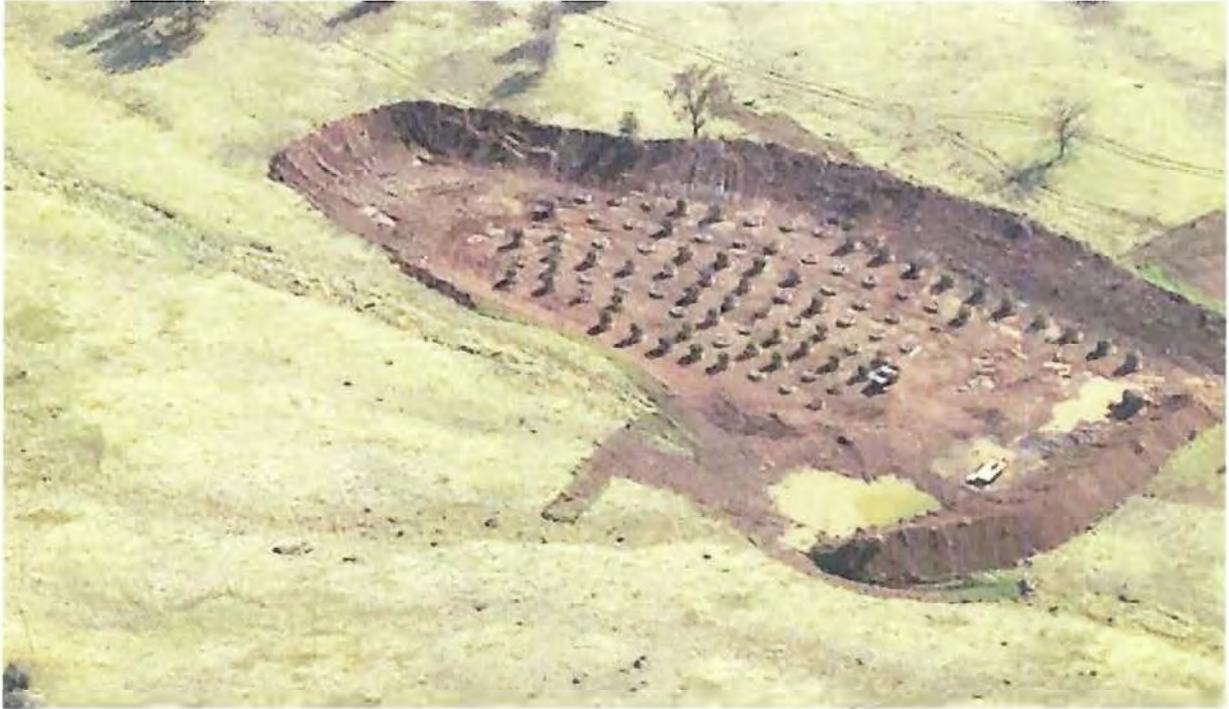
Photo 1: Closer photograph showing the accumulation of muddy water towards the north western portion of the graded area and more evidence for lack of erosion control.

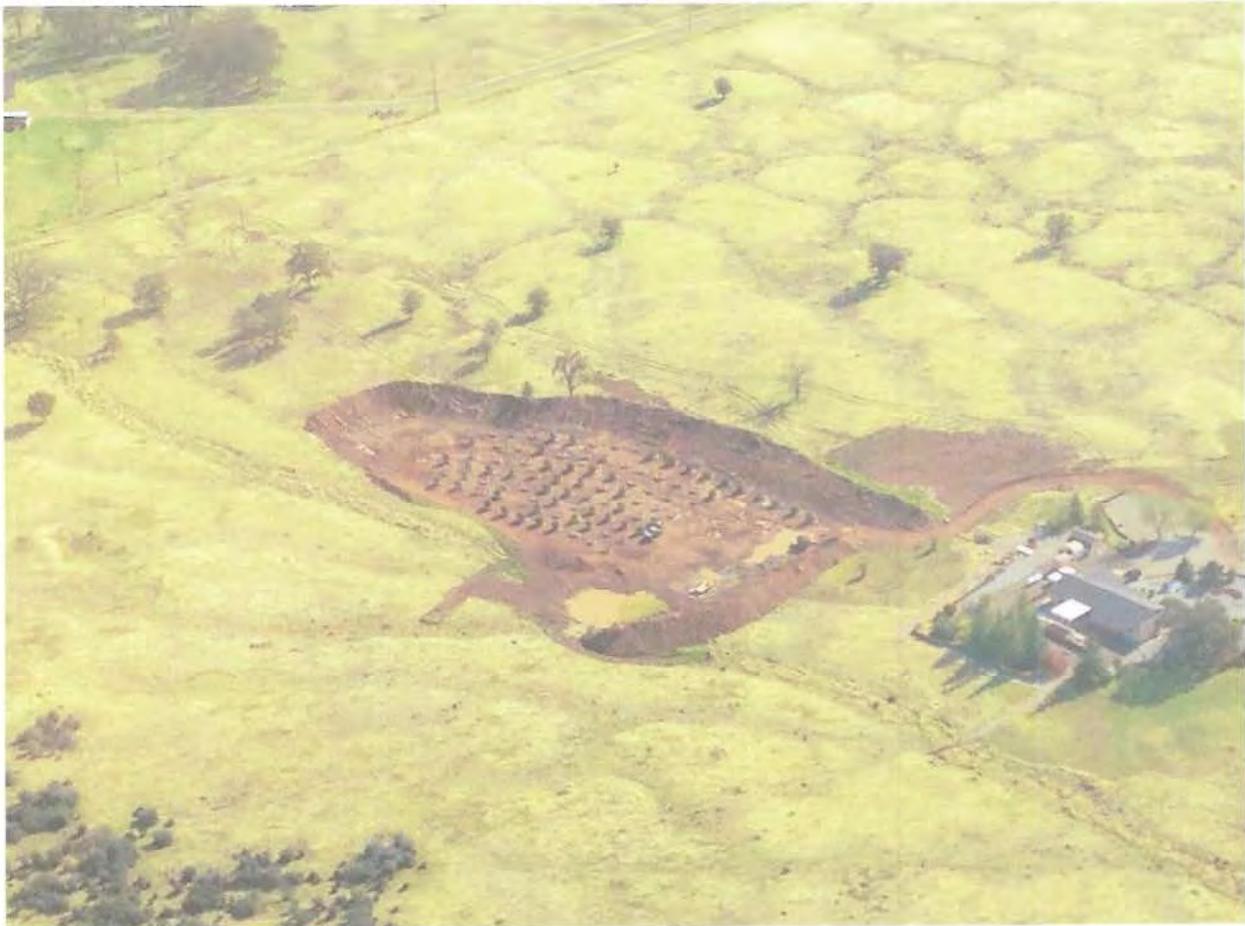
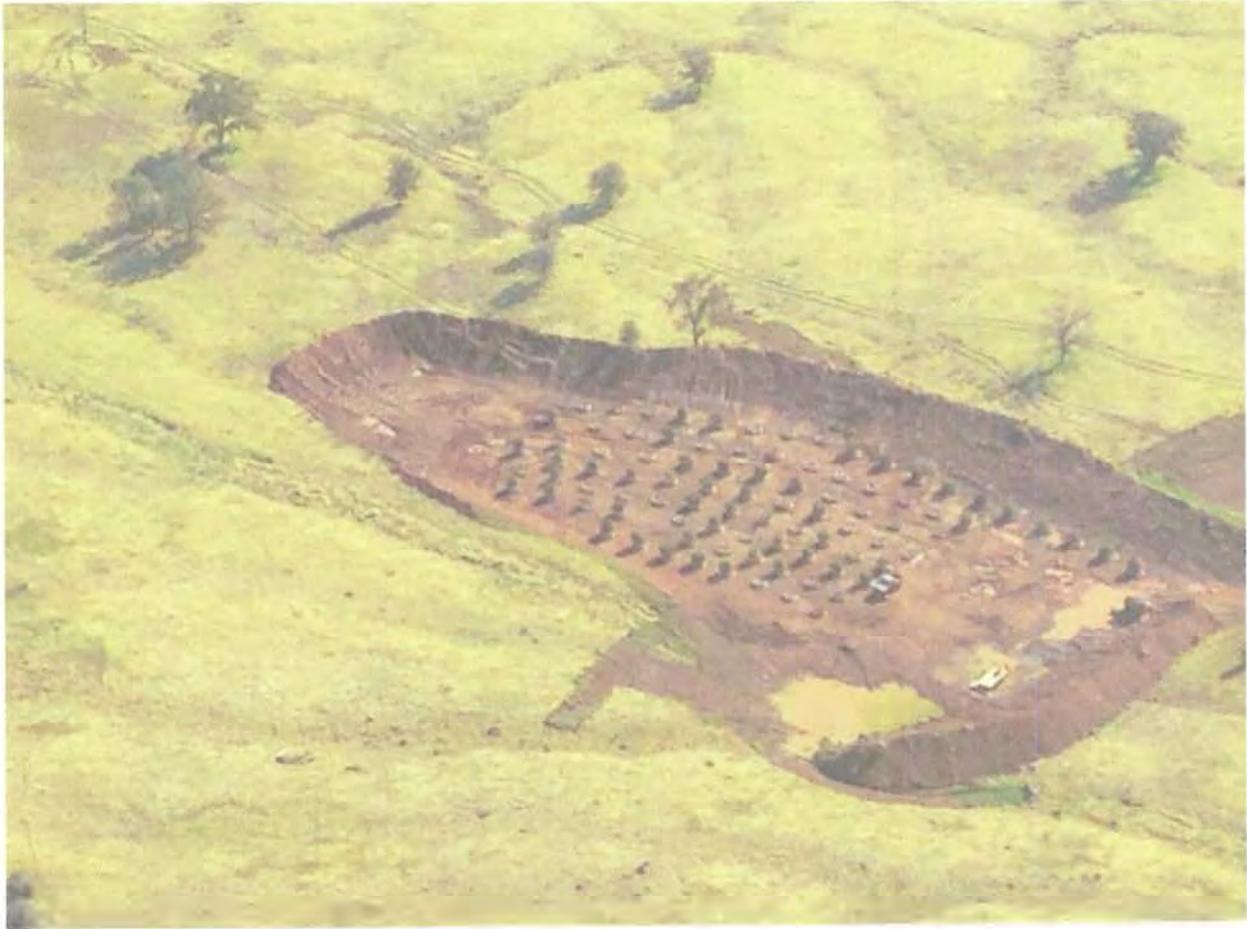
On 11-05-2014, I conducted an overflight of Shasta County with the Shasta County Sheriff's Department Marijuana Investigation Team (MIT). During the flight, I observed a large scale grading operation on Buggy Rd. with the corresponding GPS coordinates of 40° 37.496'N 122° 0.592'W. Incorporated within the graded area, I saw what based on my training and experience; I recognized as marijuana being cultivated. It appeared that the site was excavated and the dirt spoils were pushed up forming a continuous mound around the perimeter of the grow, and appeared to be 10 feet in height. I also noted the grading was done in a dry tributary, with water beginning to accumulate near the southwest corner. The graded area appeared to be in excess of one acre, and substantially altered the tributary. Based my training and experience, I believe the large scale alteration of the tributary, placement of excavation spoils, and the potential for fertilizers and or chemicals commonly used for marijuana cultivation at the site, could be deleterious to fish and aquatic life. I contacted Shasta County Building Division, and found that no grading permits were issued for the site. There appeared to be no erosion control measures taken at the site. See attached images below taken by me on November 5th 2014.

Based on my training and experience, I believe that the work done in the tributary may be deleterious to fish and aquatic life pursuant to Fish and Game code sections 5650 and 1602.
