EXHIBIT K

CONDITIONS OF APPROVAL FOR "PLAN OF OPERATIONS"

Claim Name(s): Big Seam
Red Ink Maid

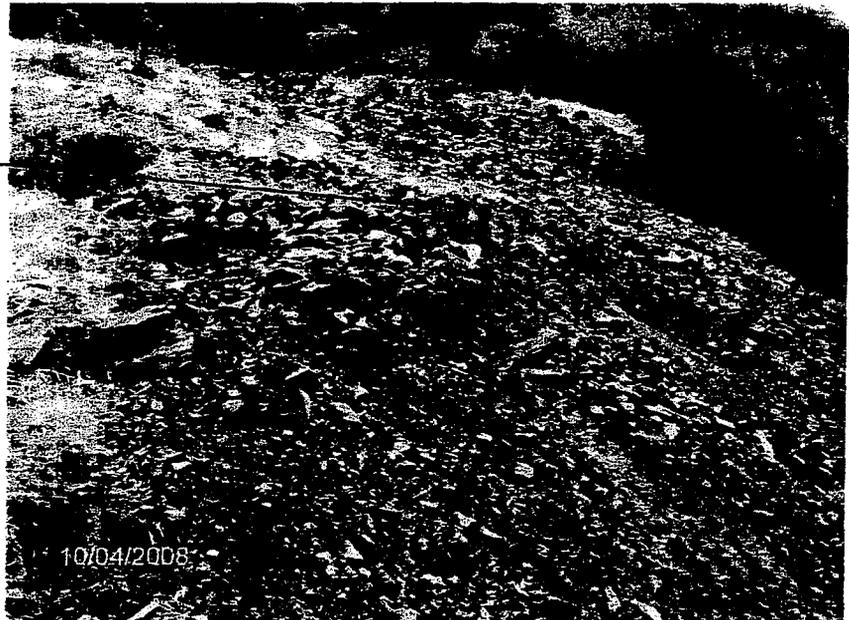
Sampling
Location S2

We also attempted to collect storm water samples from location S2. Sampling location S2 is located near the headscarp formed by the past slope failure near the base of stockpile 2 (see Figure 1 and photo below). At approximately 10:30AM, we were not able to collect storm water samples because there was no surface water flowing at sampling location S2.

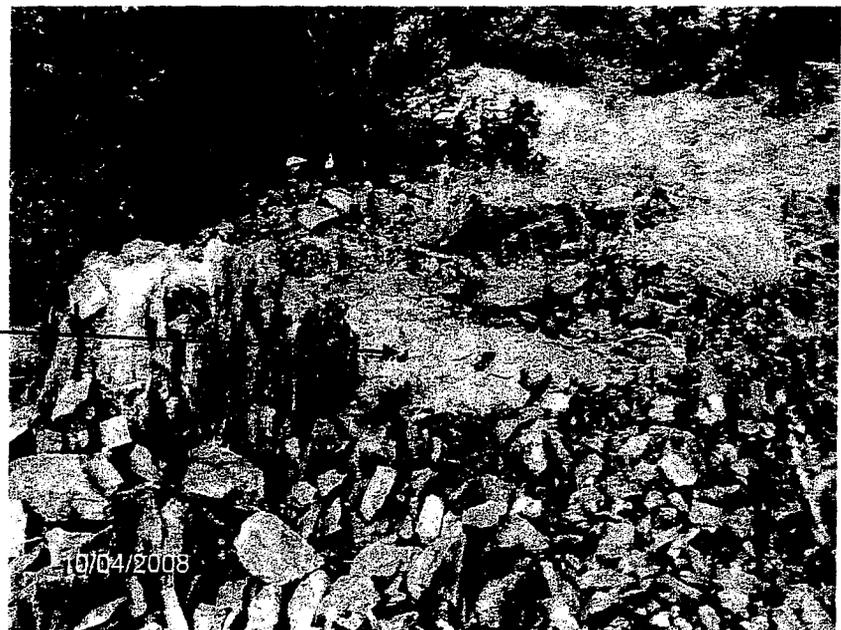
Sampling
Location S3

At approximately 11:15AM we attempted to collect storm water samples at sampling location S3, located at the base of stockpile 4 (see photo below). As with the other sampling locations, we were not able to collect samples because there was no surface water flowing at this sampling location.

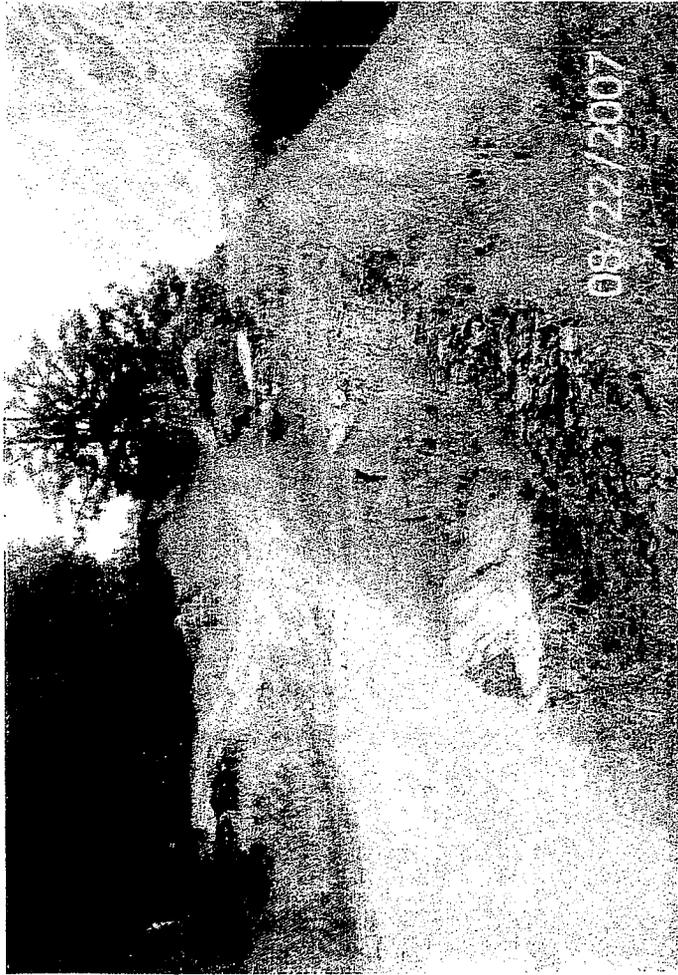
BEFORE - #1

STOCKPILE A

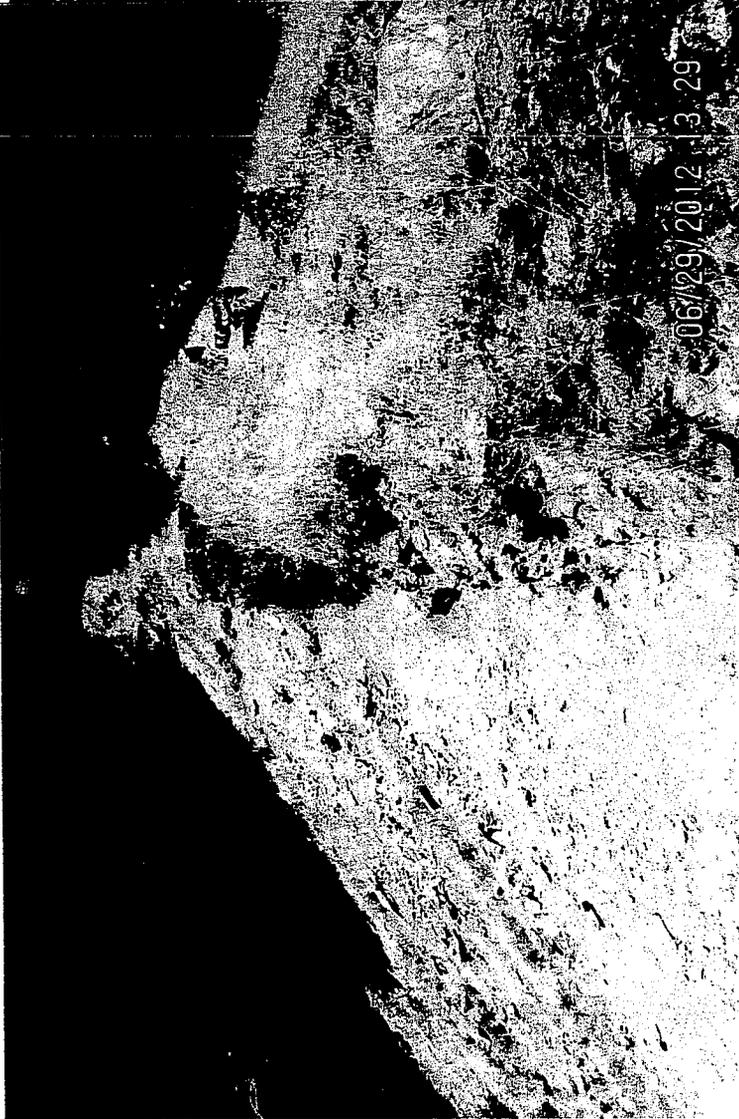
NOW - #1

Now - #1
↑
↘
↓

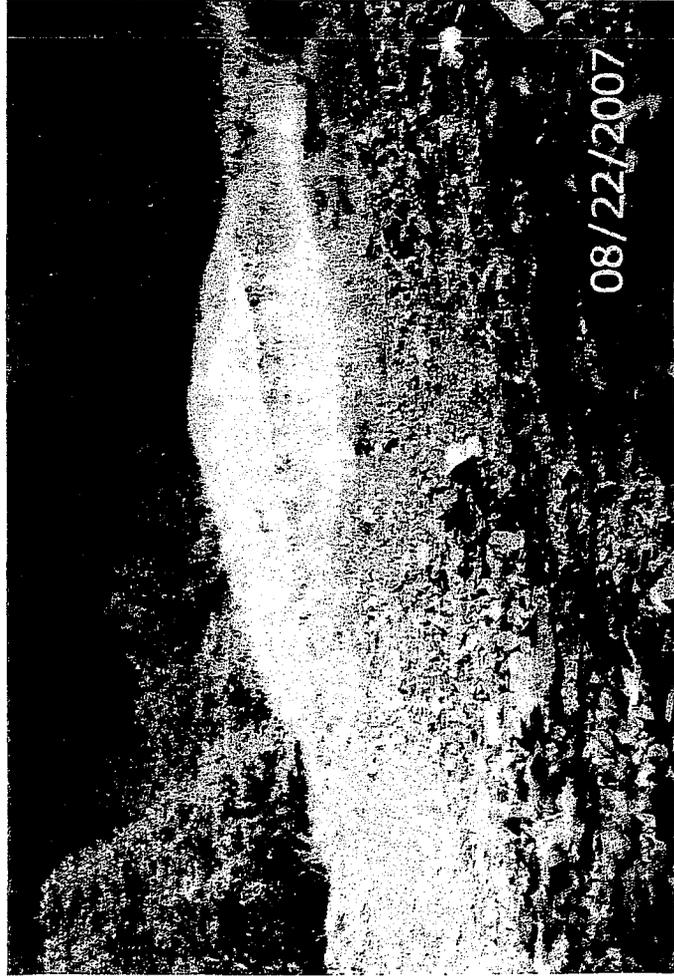
↓ Before - # 4

STOCKPILE 4
