CENTRAL VALLEY REGIONAL WATER QUALITY CONTROL BOARD

CLOSURE INSPECTION

LOCATION & COUNTY: Reeve Road Heifer Ranch
21070 Reeve Road, Tracy
San Joaquin County

INSPECTION DATE: 1 May 2012

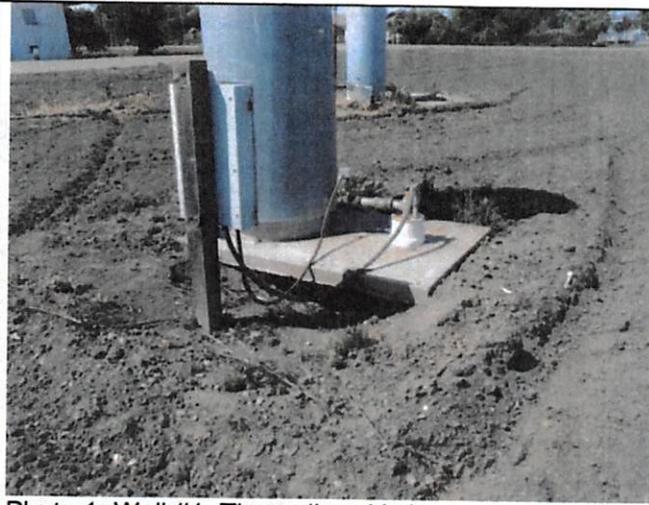
Three wells were inspected. Holes were observed underneath the well-pad at Well #1 (Photo 1). A cracked well-pad was observed at Well #2 (Photo 3). Excessive vegetation and dirt were observed on and adjacent to the well-pad at Well #3 (Photo 2).

Photo 1: Well #1. The well-pad is in good condition. Holes were observed underneath well-pad.

- 3) Repair the well-pads, patch the holes underneath the well-pads, and clear all dirt and vegetation from the well-pads and adjacent to the well-pads at Wells #1-3.

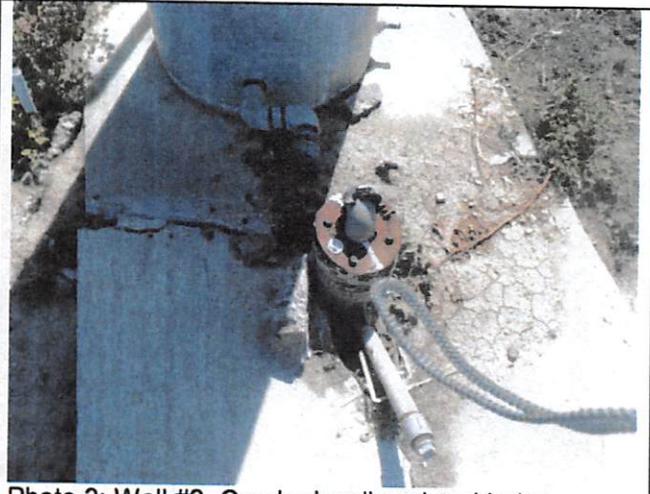
Photo 3: Well #2. Cracked well-pad and holes underneath well-pad.

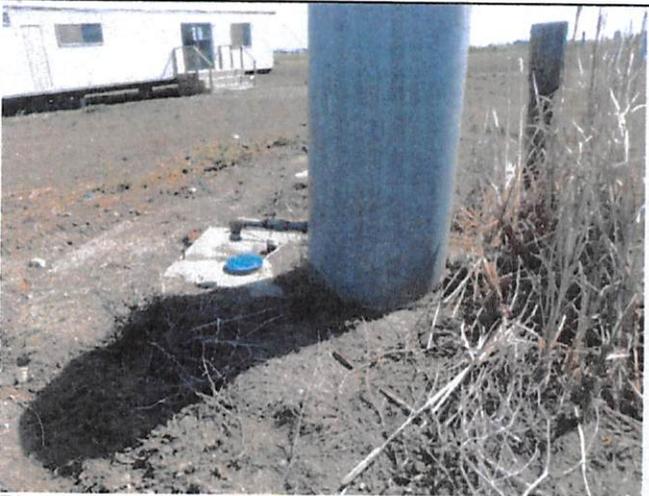
Photo 2: Well #3. Excessive vegetation and dirt on the well-pad.

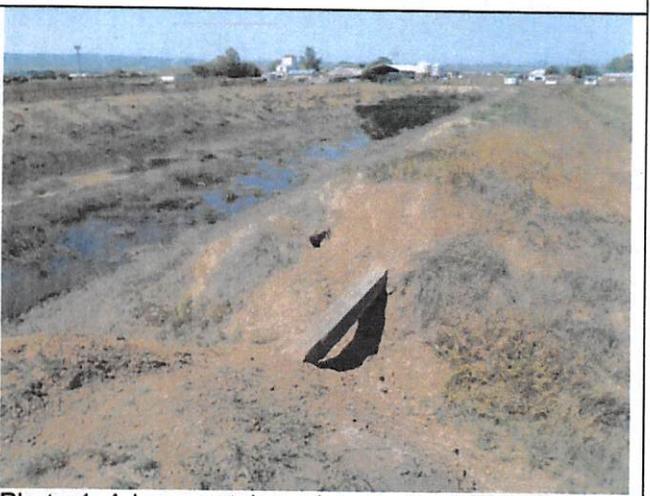
The wastewater storage lagoon is non-operational; there is a large notch cut into the north bank that would allow water to escape (Photo 4).

Photo 4: A large notch cut into the north embankment of the wastewater storage lagoon.

- 4) Remove all manure from the wastewater storage lagoon and export off property. Provide documentation regarding the amount of manure removed and the destination of the manure.

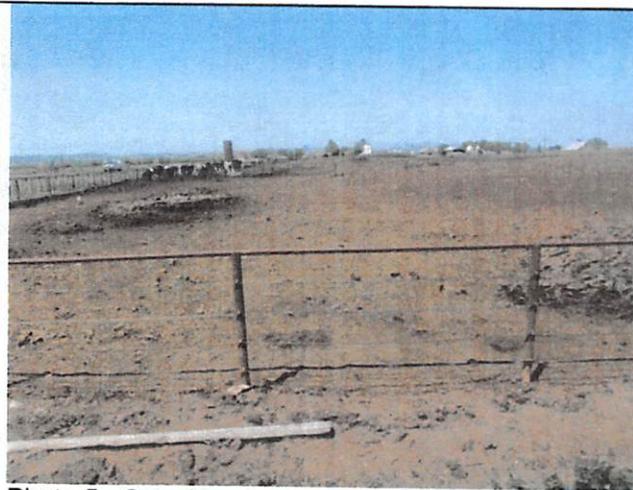
The corrals are contained, clean, and well-graded (Photo 5).

Photo 5: Corrals are clean and well-graded.

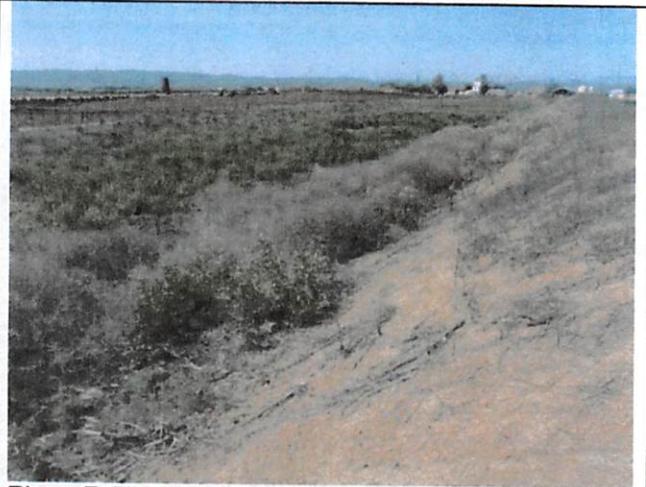
No liquid wastewater or solid manure is applied to the facility's cropland. While inspecting the cropland associated with the Henry Tosta Dairy, Mr. Tosta stated that while dairying at the Reeve Road Heifer Ranch he buried his dead cows immediately south of the wastewater storage lagoon. Staff walked this area and observed a significant amount of bones and solid manure (Photos 6-7). Additional inspection of the cropland revealed an area of disturbed soil.

Photo 7: The area of weeds is located immediately south of the wastewater storage lagoon. Staff observed a significant amount of bones and manure in this area. Later in the inspection, Mr. Tosta stated while he was dairying at this facility he would bury his dead cows in this area (south of lagoon).

- 1) Remove all carcasses, bones, and solid manure from the area south of the lagoon at the Reeve Road Heifer Ranch. All bones and manure must be exported off-site to a landfill. Provide receipts that the bones and manure were exported to a proper facility.

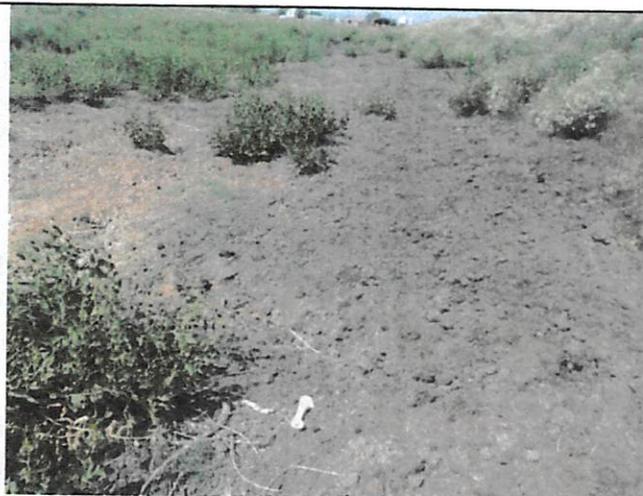
Photo 6: This area is located south of the wastewater storage lagoon. Staff observed a significant amount of solid manure and bones.

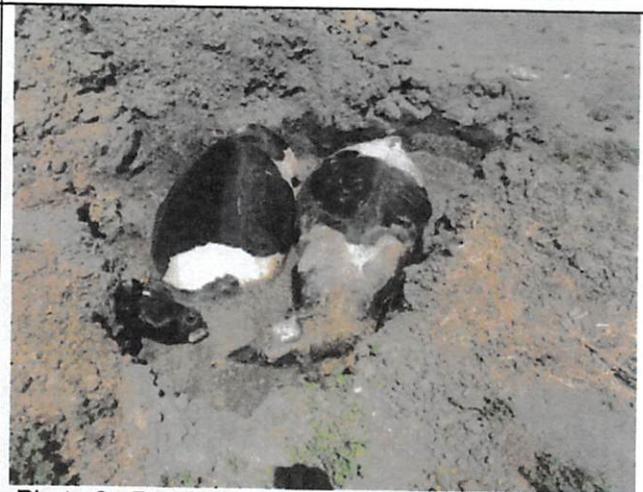
Further investigation revealed an excavation in which two mature cows were being buried; a very strong odor of decaying flesh was also noted in the area (Photos 8-12). The area in the cropland where the dead cows are being buried is immediately adjacent to the Main Drain Canal of Naglee-Burk Irrigation District. Mr. Tosta addressed the issue of burying the dead cows as follows:

Photo 8: Dead cows in an open pit. Note the pit is full of water, but the adjacent fields are dry.

- 2) Excavate all the cows and bones that have been buried in the cropland. All cows and bones must be delivered to a landfill. Provide documentation regarding the number of carcasses removed and the destination of the carcasses and bones. Groundwater samples should be obtained after the animals are removed from the above mentioned area.

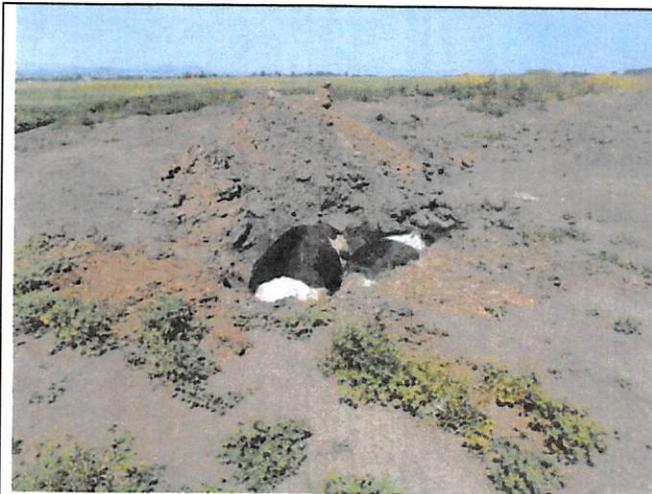
Photo 9: Burying dead cows in the corner of the cropland.

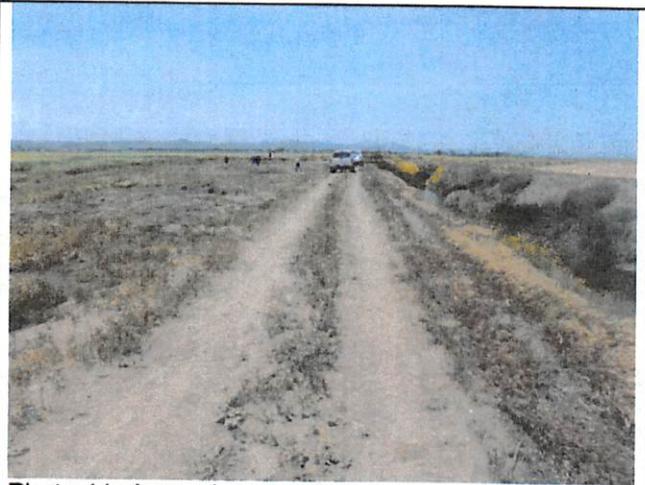
Photo 11: Area where the dead cows are being buried; note the canal on the right is the Main Drain Canal Of Naglee-Burk Irrigation District – this drain discharges directly (via pump) to the Old River which is a major tributary of the San Joaquin River.

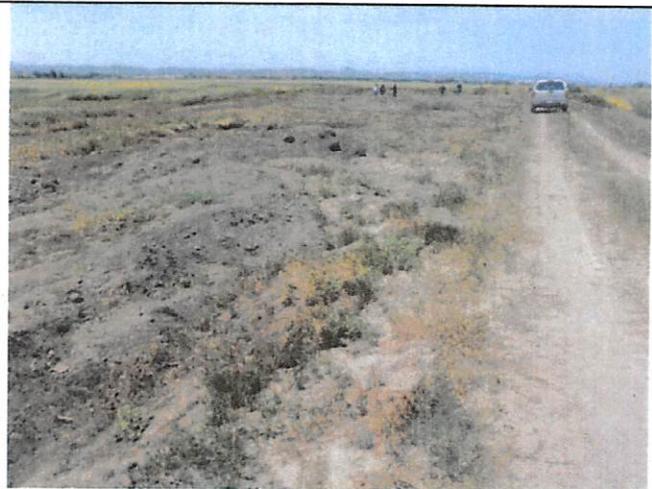
Photo 10: This entire area is being used to bury dead cows.

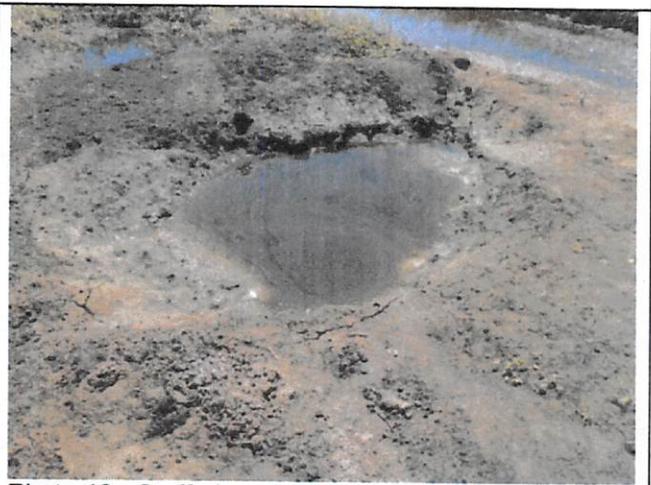
Photo 12: Staff observed several shallow pits like this one at the area of disturbed soil.
