NOTICE OF VIOLATION AND COMPLIANCE EVALUATION INSPECTION, PACIFIC COAST SPROUT FARMS, SACRAMENTO COUNTY

INSPECTION REPORT

DISCHARGER: Pacific Coast Sprout Farms, Inc.

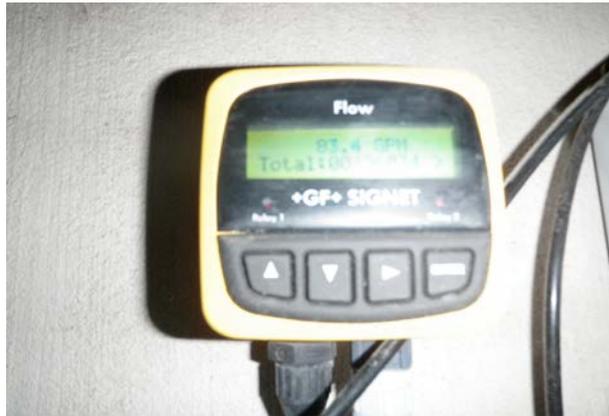
Figure 1: Old influent flow meter totalizer. 8/31/2010. AMH.

2. The Discharger is currently reporting effluent flows using a recently-installed new totalizer flow meter (figure 2). The Discharger maintains a flow meter checklist to maintain daily records of the totalizer readout (figure 3). The new flow meter was calibrated upon installation, approximately June 2010. The old influent flow meter is still in place, but not being used for NPDES compliance purposes (figure 1).

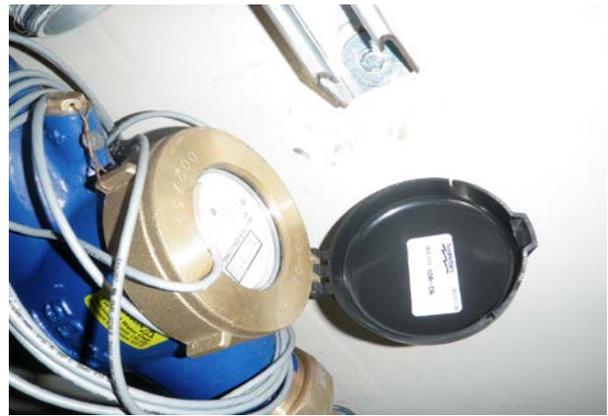
Figure 2: New influent flow meter totalizer. 8/31/2010. AMH.

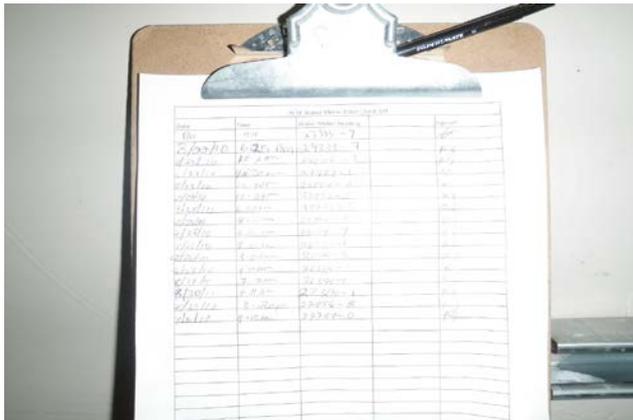
Figure 3: Flow meter checklist. 8/31/2010. AMH.

1. Please provide the test method, identify testing equipment, and the whether the test is done in-house or at a contract laboratory for the weekly total chlorine residual monitoring.
2. Please discuss whether, and if so how, nutrients are used in the grow cycle for the bean sprouts at PCSF.
3. How flow is calculated from the data recorded on the flow meter checklist.

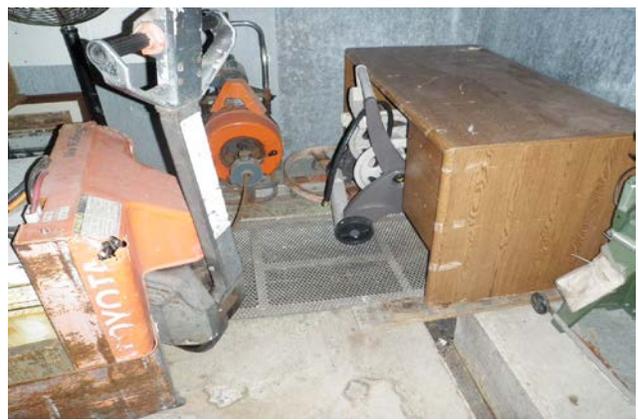
3. Grow Room #1 was being used to store equipment and was not in use for sprout production. Figure 4 shows the floor drain that discharges to Outfall 001. The drain is covered with a screen and had pieces of equipment being stored around and on top of it.

Figure 4: Wastewater drain in Grow Room #1, which is not currently in use. 8/31/2010. AMH.

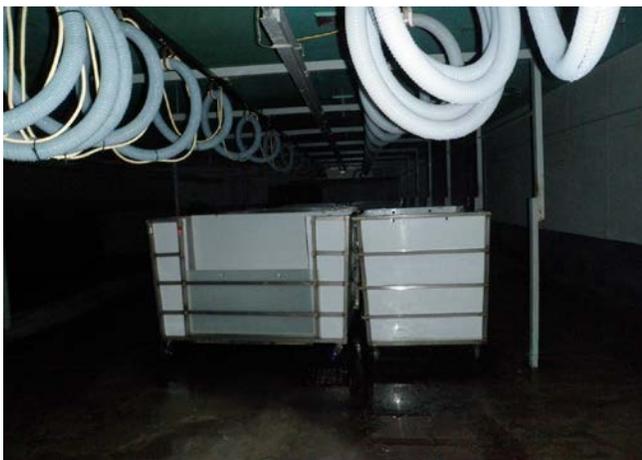
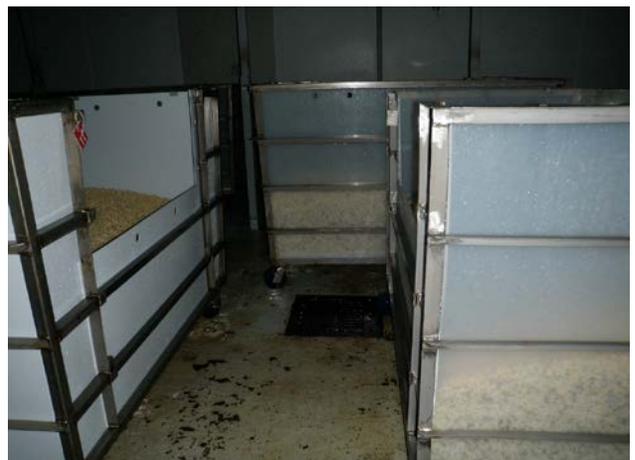
4. Grow Room #2 was in production mode (figures 5 and 6). There were several growing bins of bean sprouts and the ceiling watering system was operational. Production water was flowing into the floor drains as permitted.

Figure 5: Ceiling watering system and sprout growing bins in Grow Room #2. 8/31/2010. AMH.

Figure 6: Three sprout growing bins around the wastewater floor drain. 8/31/2010. AMH.

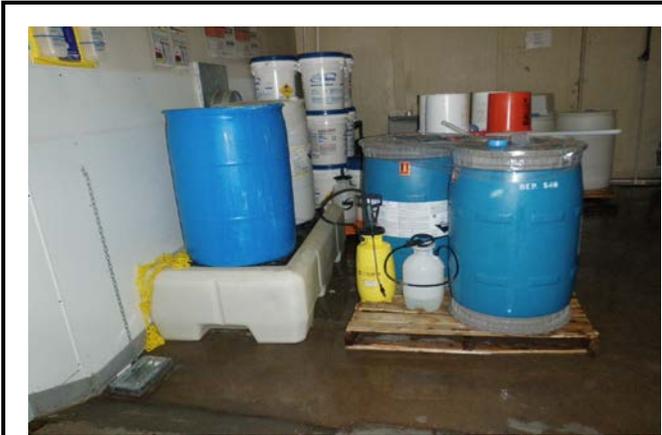
5. The chemical storage contained calcium hypochlorite, potassium hydroxide, and sodium hypochlorite. There was some secondary containment, but not enough for all of the liquid chemicals (figure 7). There was also good chemical safety signage provided in this area.

Figure 7: Chemical storage area with some secondary containment. 8/31/2010. AMH.

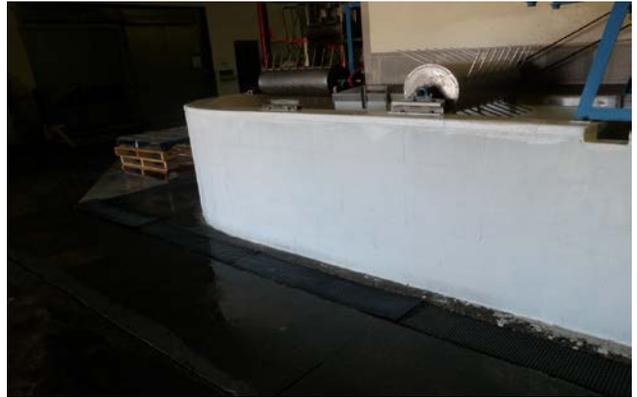
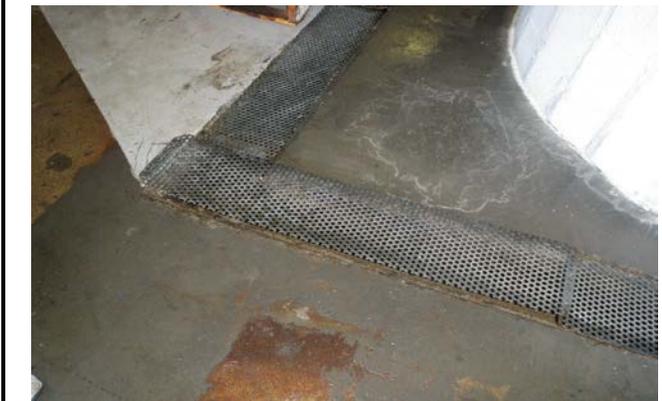
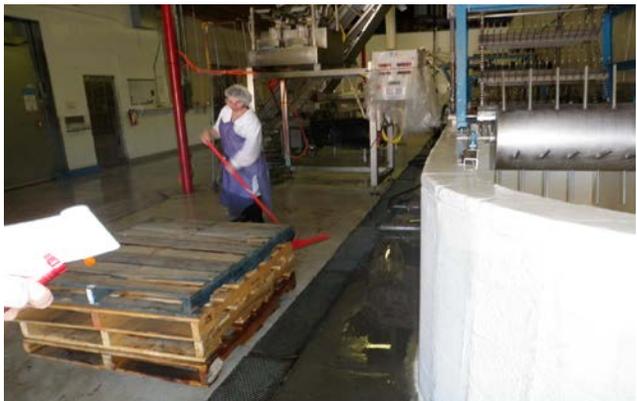
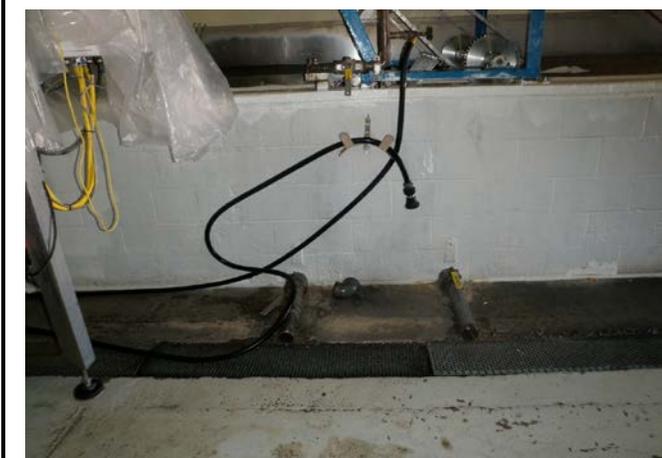
6. The production area contained a large, white basin where bean sprouts are washed and then prepared for distribution. Figures 8 through 11 show the washing basin and the long, screened channel that collects all the wastewater and conveys it to the drain located at the end of the room shown in figures 12 and 13. Mr. Scholl stated that when they use cleaning agents to sanitize the production room, they block-off the drain channel and pump the cleaning wastewater directly to the sewer system. The pump is located next to the drain, as shown in figures 13 and 14.

Figure 8: Production area basin where sprouts are rinsed. Floor drain running along length of basin. 8/31/2010. AMH.

Figure 9: Close-up of floor drain that runs along length of basin. 8/31/2010. AMH.

Figure 10: Farm employee cleaning Production area. 8/31/2010. AMH.

Figure 11: Wastewater from sprout wash basin drains into the floor drain from 2-pipes at the bottom of the basin. 8/31/2010. AMH.

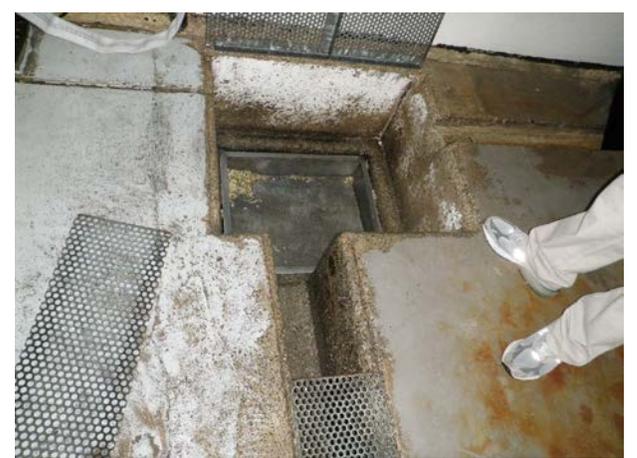
Figure 12: Final drain in production area, discharges to Outfall 001 8/31/2010. AMH.

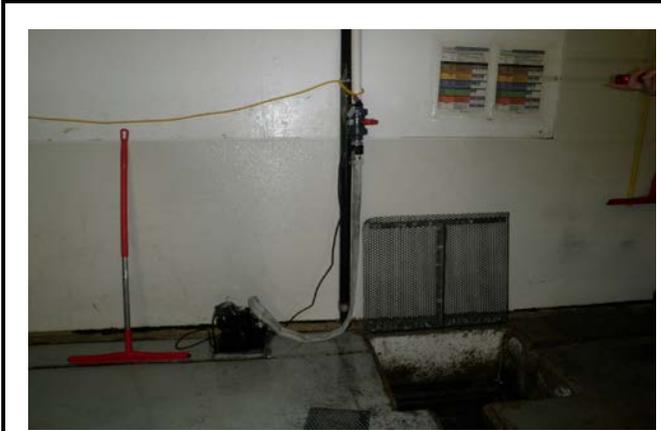
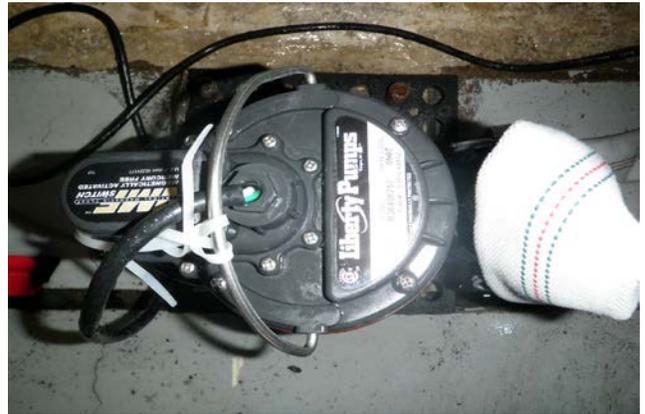
Figure 13: Pump located at the final drain in production area. 8/31/2010. AMH.

Figure 14: Pump from Figure 13. 8/31/2010. AMH.

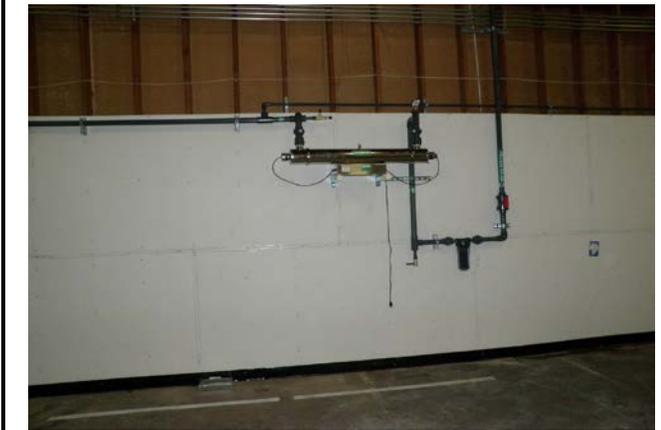
8. The Discharger is planning to begin growing wheat grass as well, and has begun installation of a wheat grass growing system (figure 15).
9. Figure 16 shows the drain that connects into the sewer system and the white facility piping that discharges to it.

Figure 15: Future system for wheat grass. 8/31/2010. AMH.

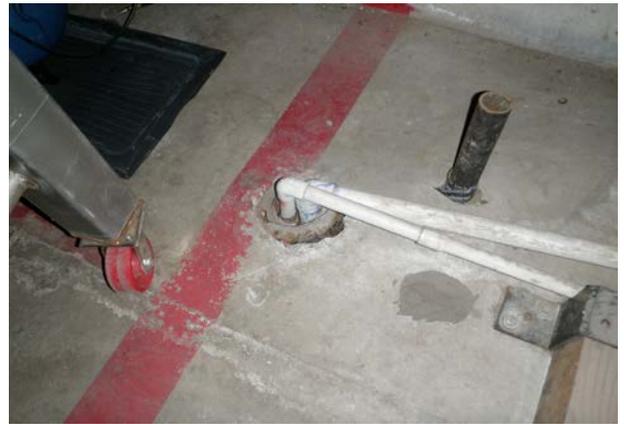
Figure 16: Drain that connects to the city sewer line. 8/31/2010. AMH.
