COMPLIANCE EVALUATION INSPECTION, SCONZA CANDY COMPANY, OAKDALE FACILITY, STANISLAUS COUNTY

INSPECTION REPORT

FACILITY: Sconza Candy Company
1400 S Yosemite Avenue
Oakdale, CA 95361
Stanislaus County

INSPECTION DATE: 29 April 2010, 1015 hours to 1310 hours, announced

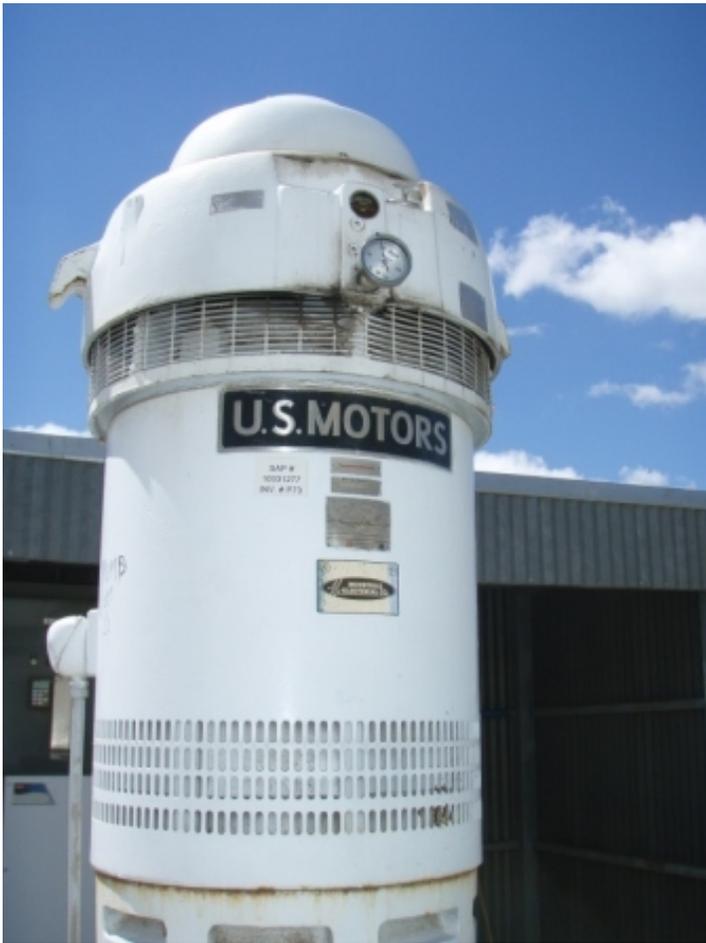
Figure 1. One of the two groundwater wells currently in-use at the facility. MAF.

The sources of this water are from four onsite groundwater wells (Figure 1), two of which are currently operable. After use, non-contact cooling water and reject water from a reverse osmosis unit flows into a 1.4 million gallon lined storage pond (Figure 2). The pond is used as a fire sprinkler reservoir and for irrigation water storage. Wastewater discharge to the OID canal (Figure 3) overflows from the pond through a flat weir (Figure 4) and flows through a Parshall flume (Figure 5) prior to entering the OID canal. During a 2008 inspection, it was noted that during certain times of the year, the OID canal water level is higher than the bottom of the Parshall flume that was previously used to measure effluent flow. Because of the location of the Parshall flume, under low effluent flow rate conditions and high OID canal water level conditions, flow measurements using the flume are inaccurate due to water back-flowing from the canal into the flume (Figure 6). An alternate flow measurement technique is currently used. With verbal approval from Central Valley Water Board staff, effluent flow is calculated based on the sum of water supply well flow rates minus the volume of water used for irrigation and the volume of water discharged to the sanitary sewer. The total influent water supply well flow is continuously monitored with a calibrated flow measurement device. According to the discharger, irrigation flow rate is based on the irrigation pump runtime and previous measurements of irrigation flowrate. The sanitary sewer discharge is measured by the city and available on either the monthly sewer bill from the city or by contacting the city's wastewater utilities department.

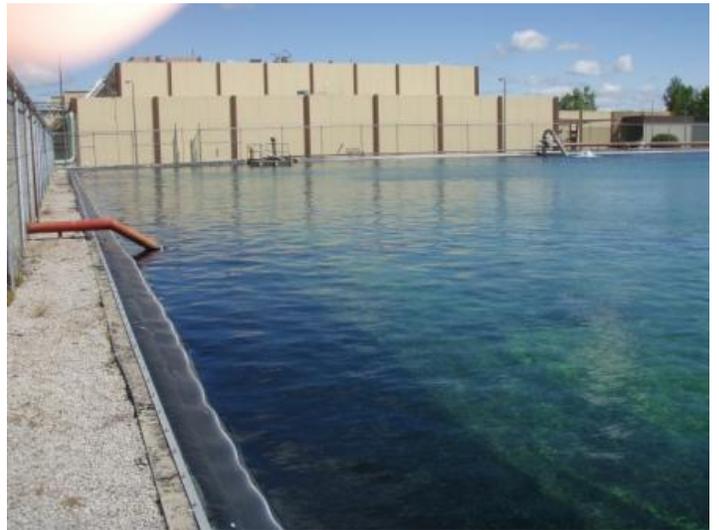
Figure 2. 1.4 million gallon lined storage pond. MAF.

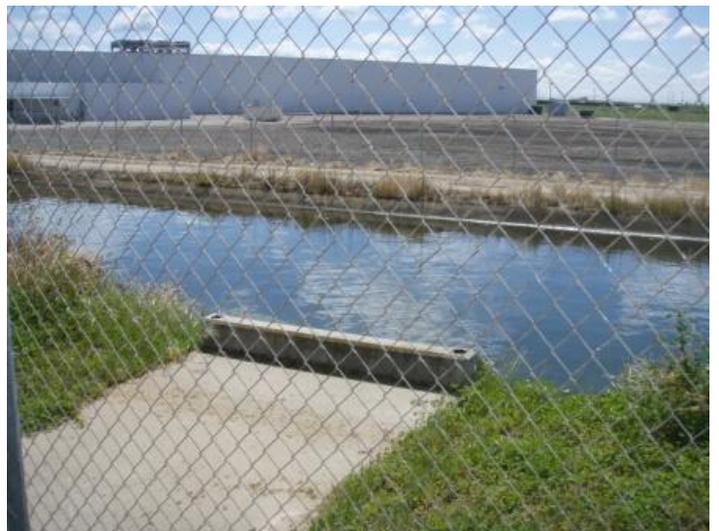
Figure 3. Effluent is discharged to the OID canal. MAF.

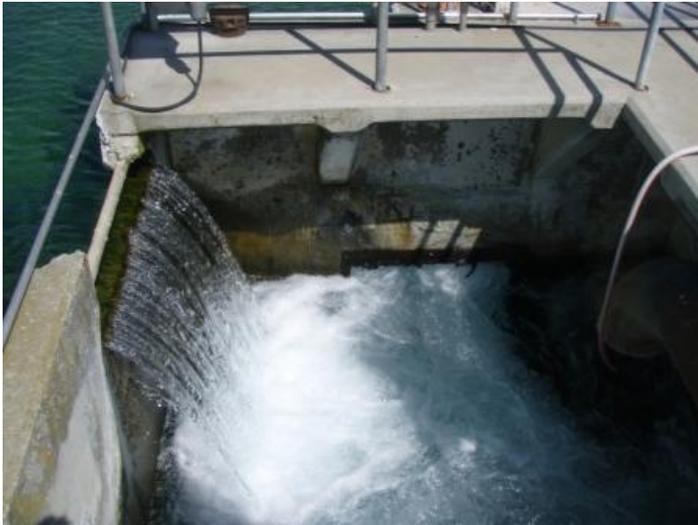
Figure 4. Wastewater storage pond overflow weir. MAF.

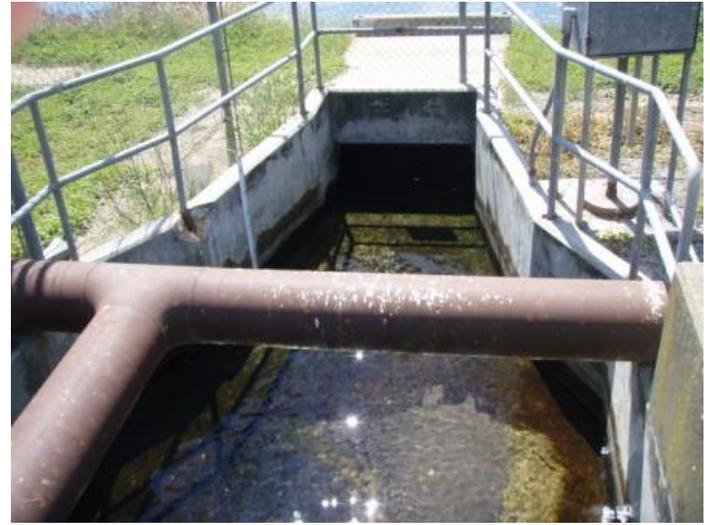
During normal effluent flow conditions, the effluent sample location (Figure 7) currently used is representative of the effluent discharged from the facility. However, during the inspection, it was noted that the water level in the canal can not only interfere with effluent flow rate measurement, but can also compromise the integrity of the effluent water sample under certain conditions. To illustrate this, the Discharger opened an underflow gate to reduce water storage reservoir levels below the level of the effluent weir. After closing the gate, essentially all effluent flow from the storage reservoir had stopped. As shown in Figure 6, standing water that is mixed with OID canal water backs up to the Parshall Flume. The water

Figure 6. Parshall flume standing water from OLD canal under very low effluent flow conditions. MAF.

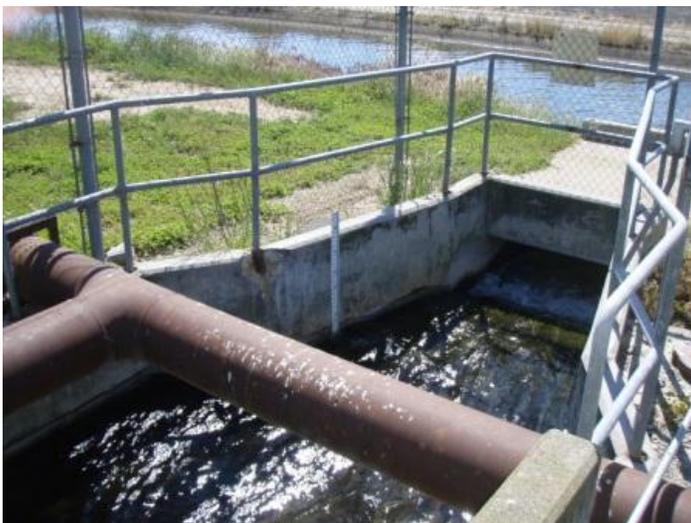
Figure 5. Parshall flume previously used for flow measurement under normal flow conditions. MAF.

The Order requires effluent flow rate to be monitored continuously using a flow meter and this is not being done. Since the Order is being updated and will be revised in the near future, Central Valley Water Board Compliance and Enforcement staff will not enforce the effluent continuous flow meter monitoring requirement if the Discharger submits calculations to support the reported flow rates in future monitoring reports.

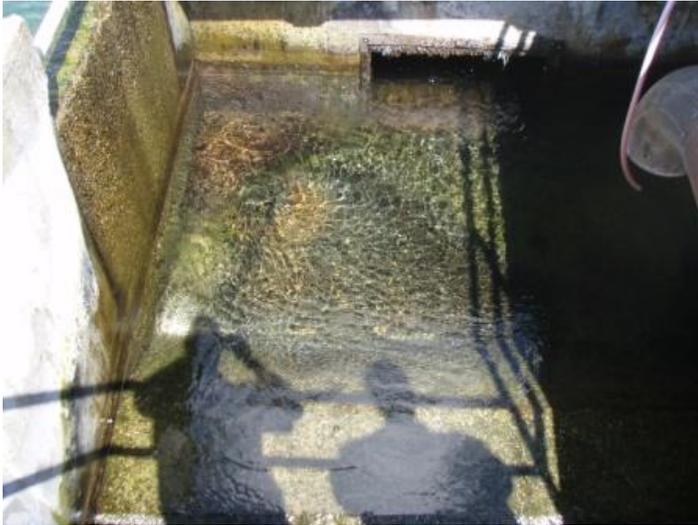
level where effluent water samples are currently collected (below the effluent weir, upstream of the Parshall Flume, Figure 8), was equal to the water level in the OID canal. Water at the current effluent sample collection point can potentially mix with OID canal water when extreme low effluent pond discharge flowrate and high OID canal water level conditions are present.

Figure 8. Current effluent sampling location under very low effluent flow conditions (note water from OID canal present). MAF.

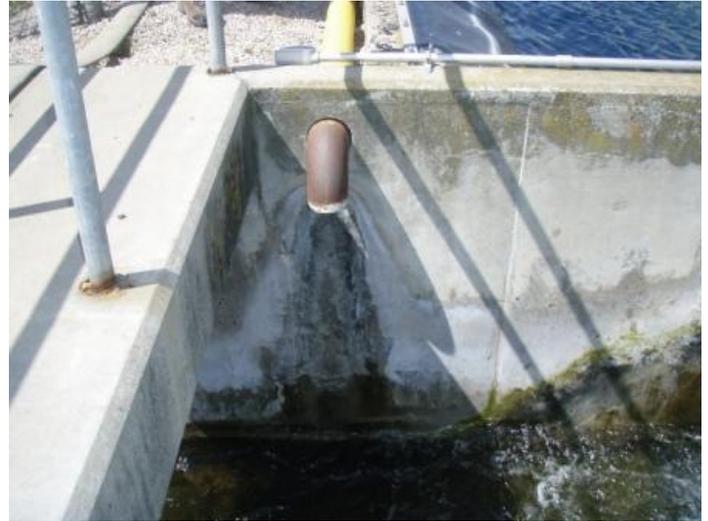
There are several potential inputs to the effluent water flow downstream of the overflow weir. Input #1 is a pressure relief flow from the well piping system that would discharge raw well water into the effluent flow to relieve excess pressure in the water conveyance piping (Figure 10). Input #2 is a pond bypass connected to the pond influent piping that is no longer used (Figure 7). Input # 3 is a hose that was observed hanging over the side of the weir structure, not discharging at the time of the inspection (Figure 7). Since there are several potential inputs to the effluent flow downstream from the overflow weir, the sample can not be collected upstream of the weir unless it is either:

Figure 10. Input #1 – Well pressure relief outlet. MAF.

- documented in the cover letter to the self-monitoring report that no flow is observed from these inputs at the time of effluent sampling; or,
- these inputs are either removed, permanently sealed (not possible for the pressure relief flow), or redirected into the pond.

If these conditions are met, moving the effluent sampling location to directly upstream of the overflow weir is acceptable to Central Valley Water Board staff and no enforcement actions will be taken.

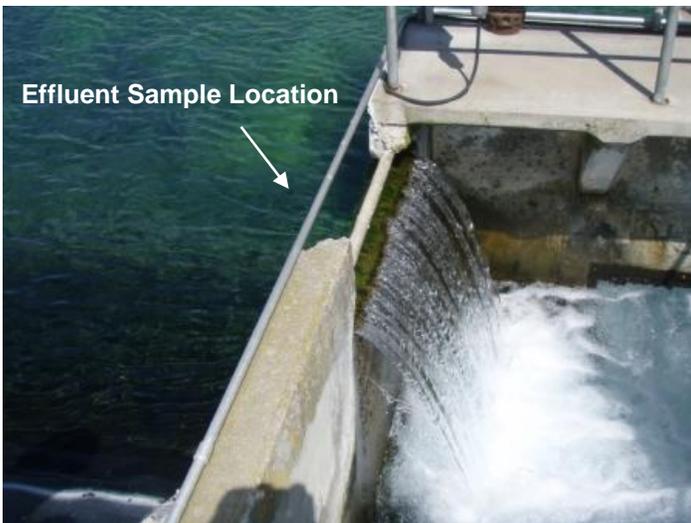
During the inspection, an alternate effluent sample location was discussed. Effluent water samples can be collected from just upstream of the overflow weir (Figure 9) under certain conditions. Order # R5-2002-0111 states:

Figure 9. Suggested effluent sample location. MAF.
