**VALLEY WASTE DISPOSAL COMPANY INSPECTION REPORTS, EDISON FACILITIES,
KERN COUNTY**

FACILITIES INSPECTION REPORT

VALLEY WASTE DISPOSAL COMPANY
RACE TRACK HILL AREA
EDISON OIL FIELD
6 MAY 2010 INSPECTION PHOTOS

VALLEY WASTE DISPOSAL COMPANY
RACE TRACK HILL C-PLANT (SEC 34)
EDISON OIL FIELD
6 MAY 2010 INSPECTION PHOTOS

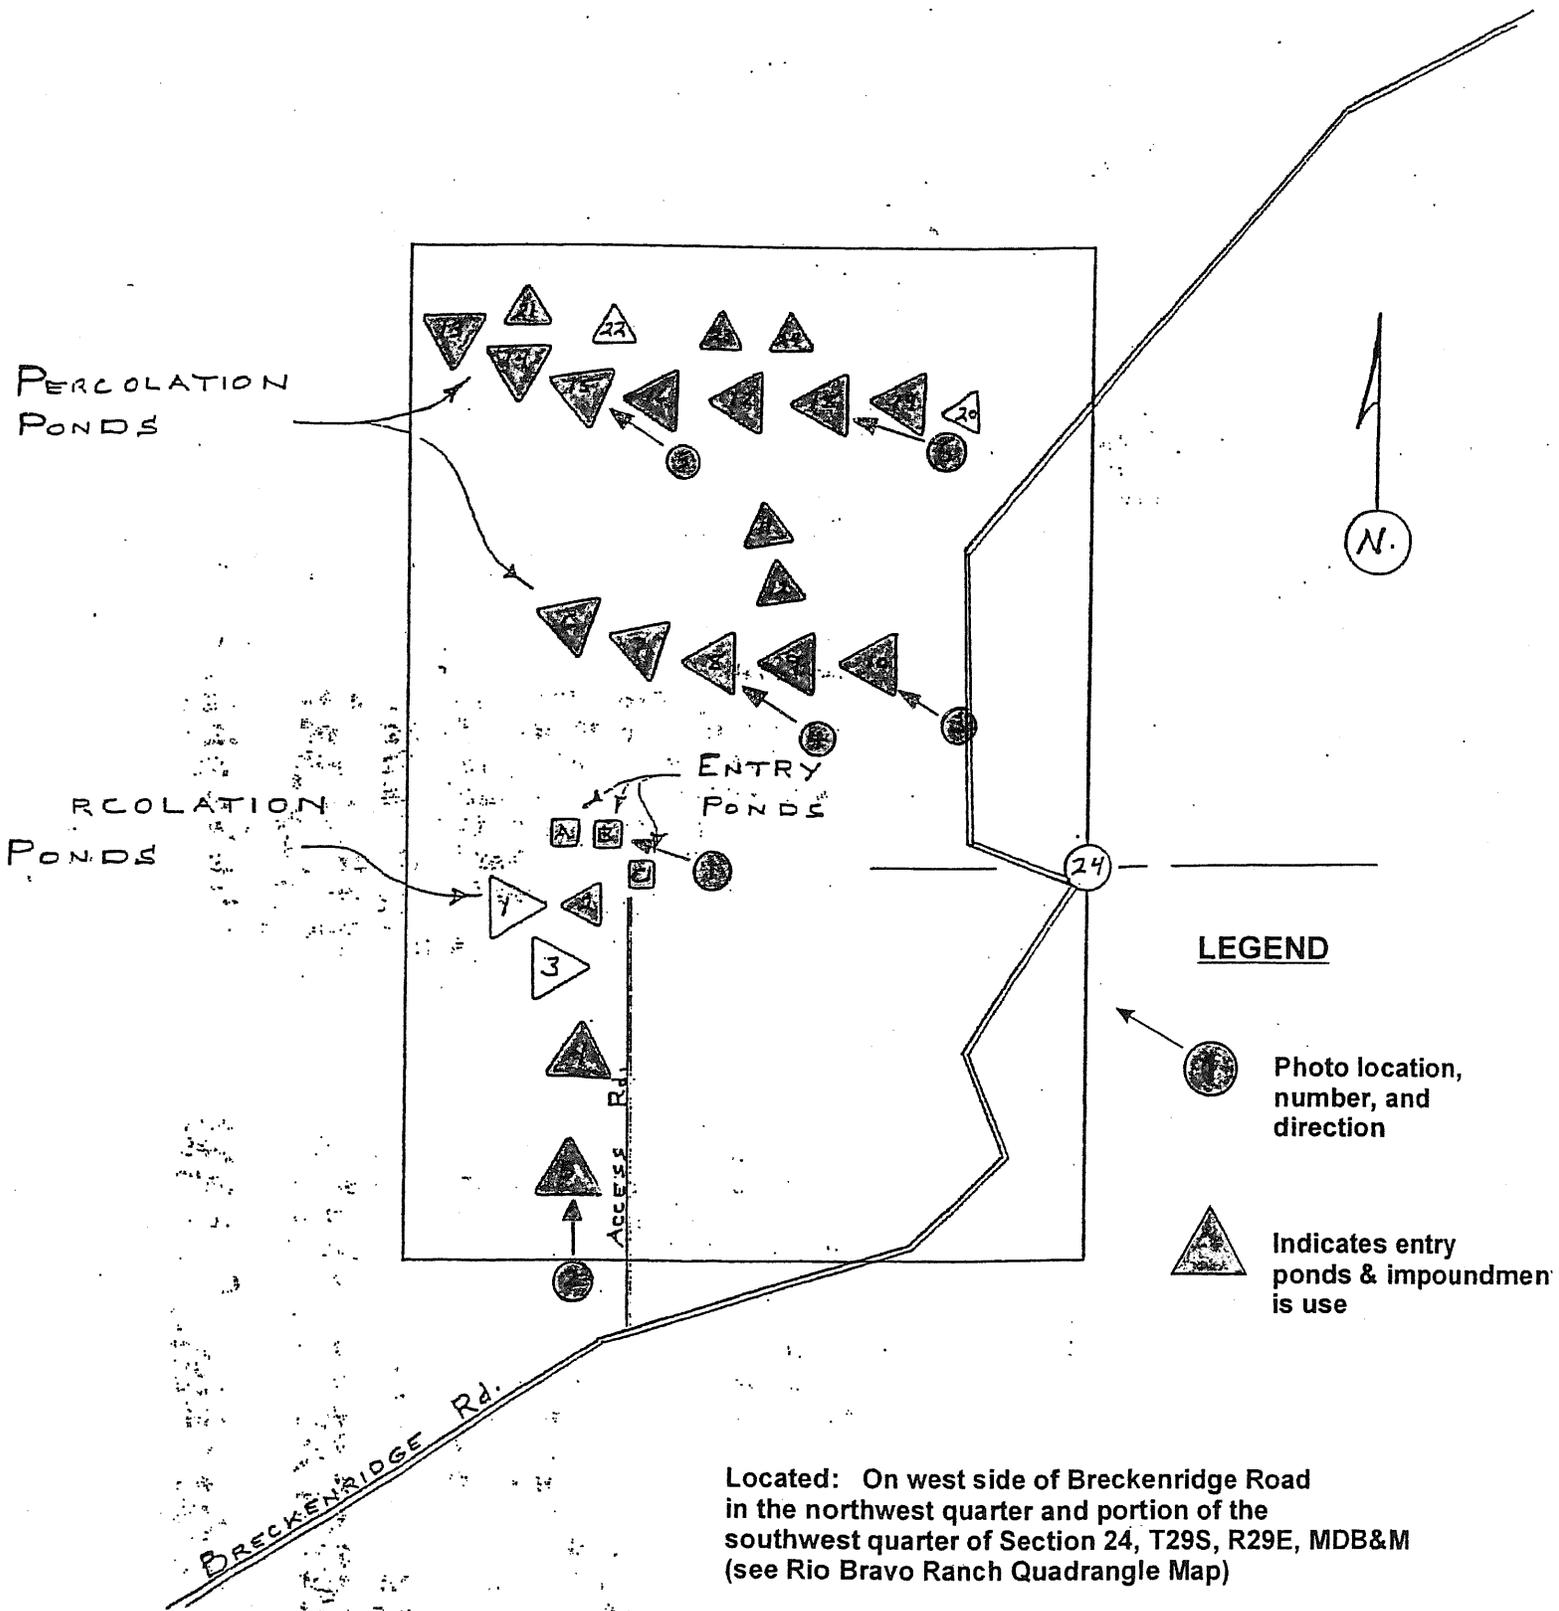
VALLEY WASTE DISPOSAL CO.
EDISON RACETRACK

Photos were taken during the inspection and are included in this report. Also included in the report is a general map of the facility layout showing where the photos were taken.

Located: On west side of Breckenridge Road
in the northwest quarter and portion of the
southwest quarter of Section 24, T29S, R29E, MDB&M
(see Rio Bravo Ranch Quadrangle Map)

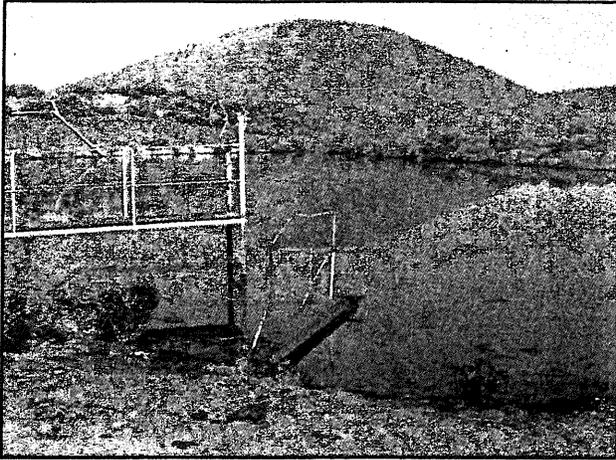
Photo 1 shows the middle Entry Pond B. The entry ponds were free of oil. Other photos show various impoundments that contained wastewater. The impoundments are located in three canyons (South Canyon,

Photo 1: View of Entry Pond B looking westerly.

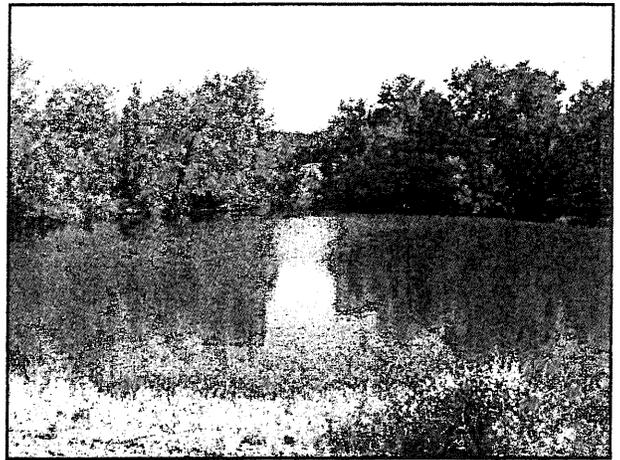
Some of the Middle Canyon impoundments, particularly Impoundment 10, were running near capacity. All the other impoundments with wastewater had adequate freeboard. South Canyon Impoundment 4 contained only a small amount of wastewater. North Canyon Impoundment 19 contained a small amount of wastewater and Impoundment 23 appeared to contain mostly rainwater. No odors were evident during the inspection. A Blue Heron was observed in the southwestern corner of South Canyon Impoundment 5.

Photo 2: View of Impoundment 5 looking north.

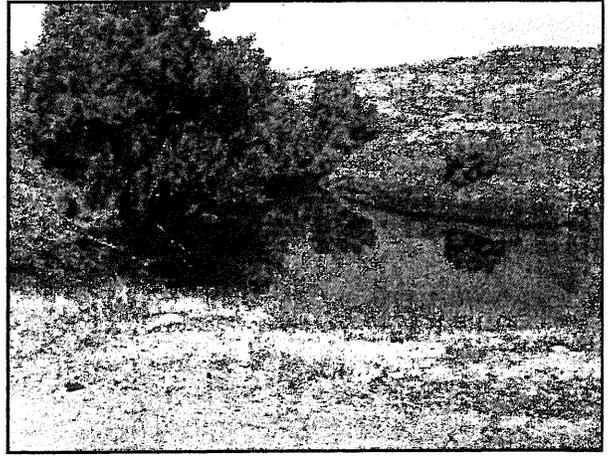
Photo 6: View of Impoundment 18 looking westerly.

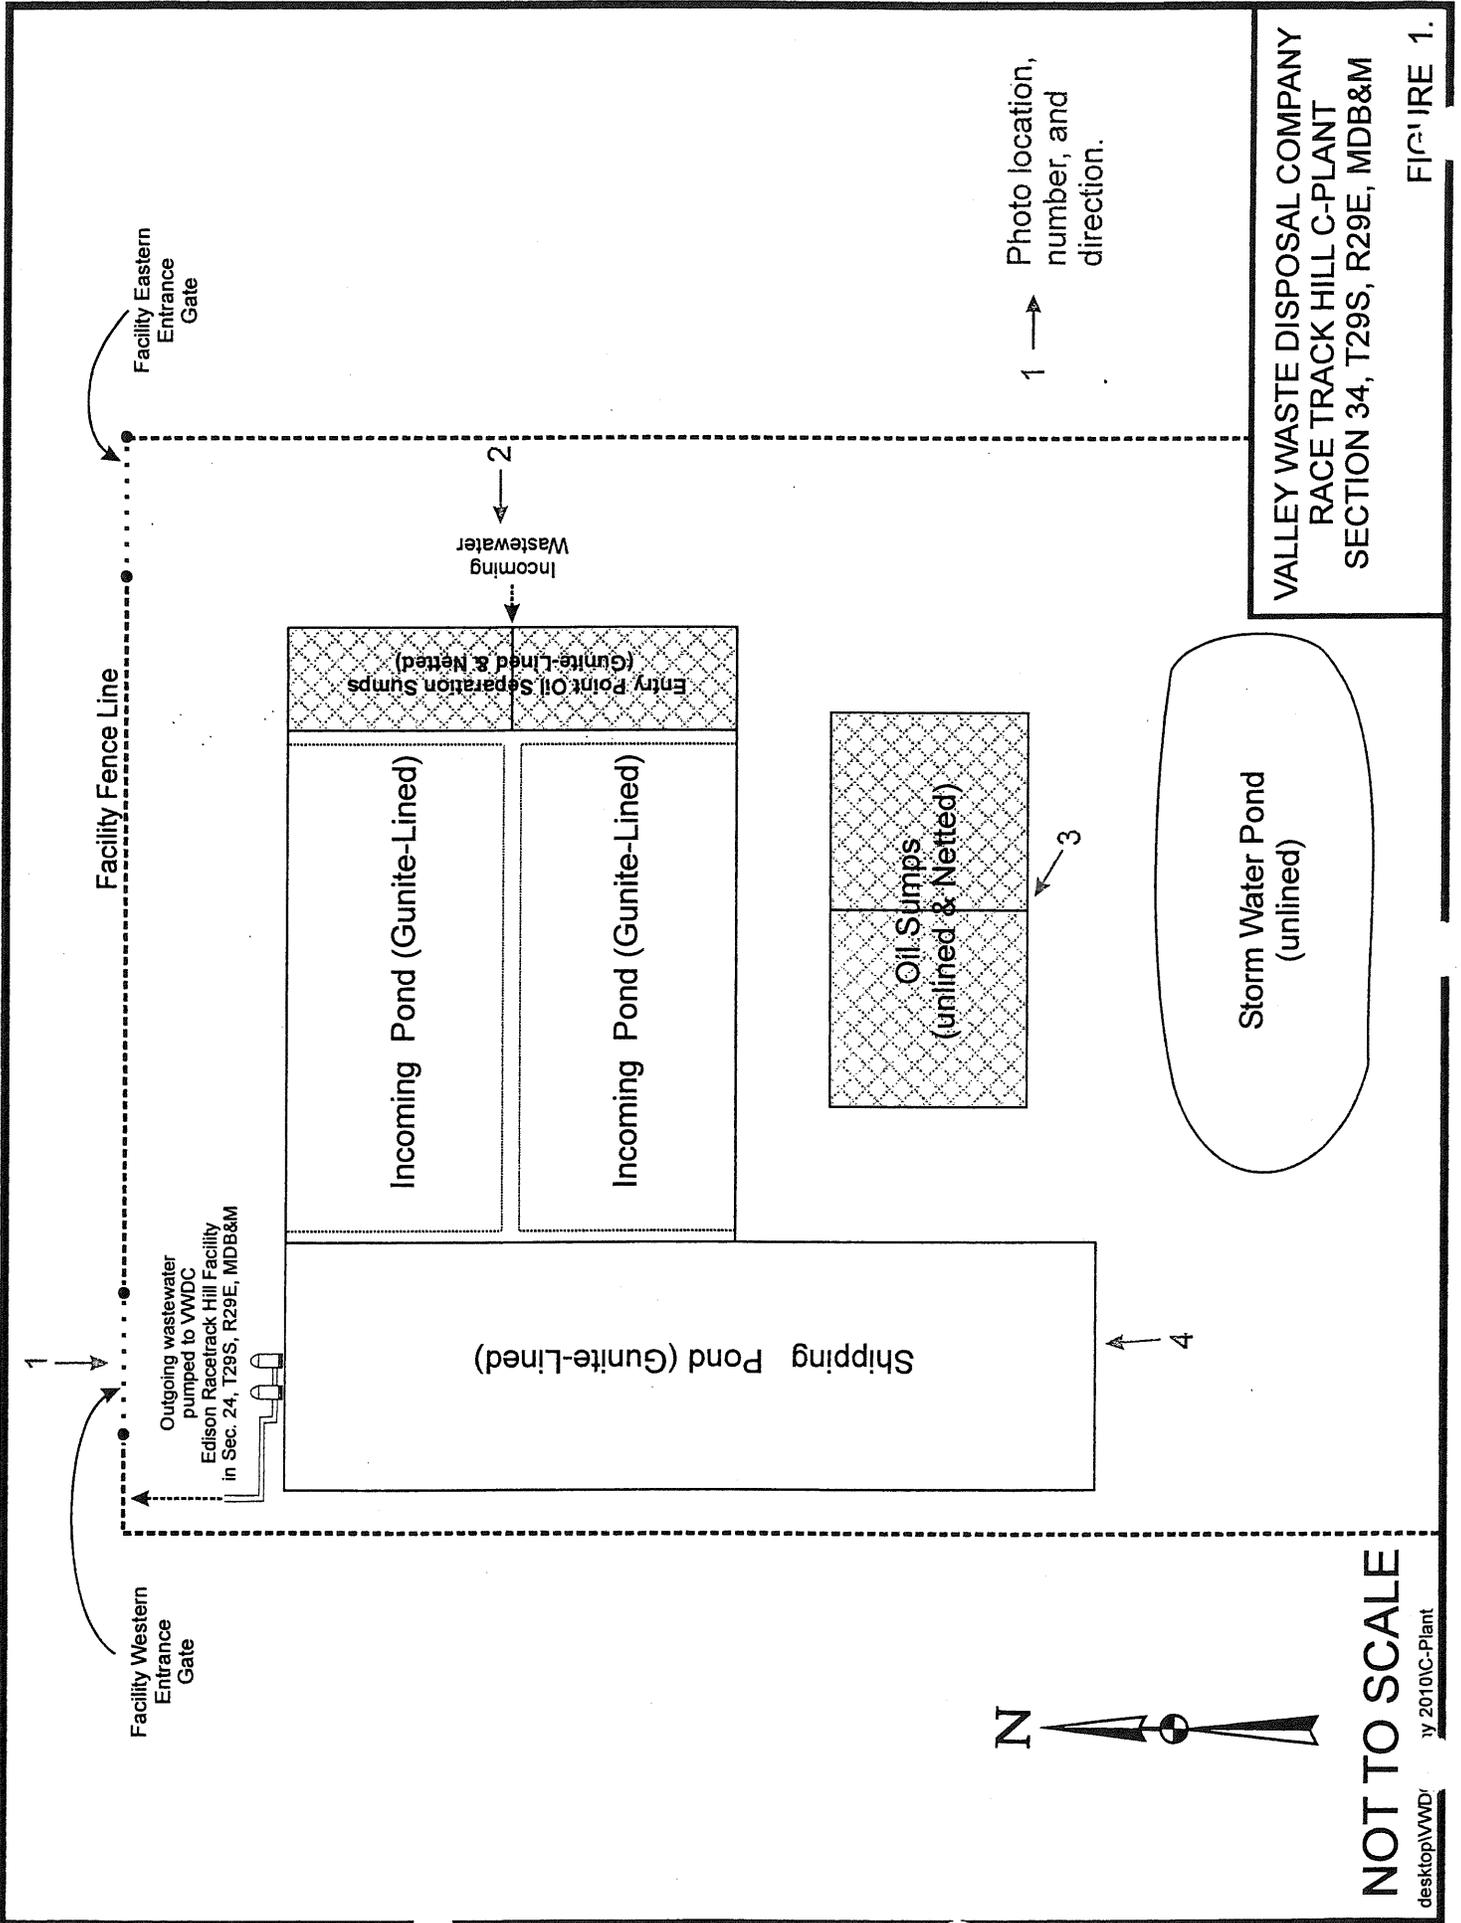
VALLEY WASTE DISPOSAL COMPANY
 RACE TRACK HILL C-PLANT
 SECTION 34, T29S, R29E, MDB&M
 FIGURE 1.

Photos were taken during the inspection and are included in this report. Also included in the report is a general map of the facility layout showing where the photos were taken (see Figure 1).

There was a faint hydrocarbon odor near the incoming wastewater, which was not noticeable outside the fence line of the facility. The storm water pond shown in Figure 1 contained some runoff water from recent storm events. No violations were observed during the inspection. The operation of the facility appeared to be in compliance with the WDRs.

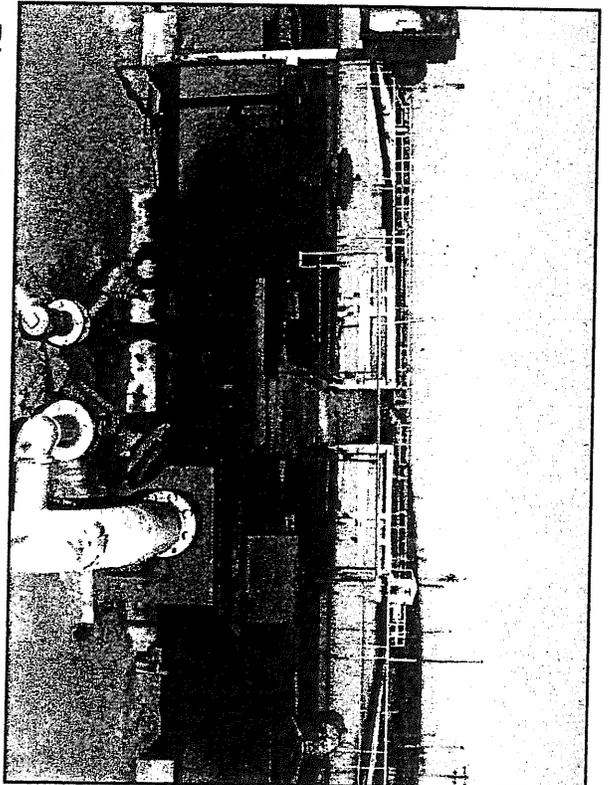
Photo 1 shows the facility western entrance gate that was locked as we arrived for the inspection. Labels on the entrance gate show the facility operator and the current facility phone number. Photo 2 shows the entry joint oil separation sumps (foreground) that are netted. Photo 3 shows one of the sumps where the oil is skimmed from the entry sumps. The netting around the sumps appeared to be in good condition. Photo 4

Photo 2: Looking west at incoming produced oilfield wastewater to the C-Plant Facility.

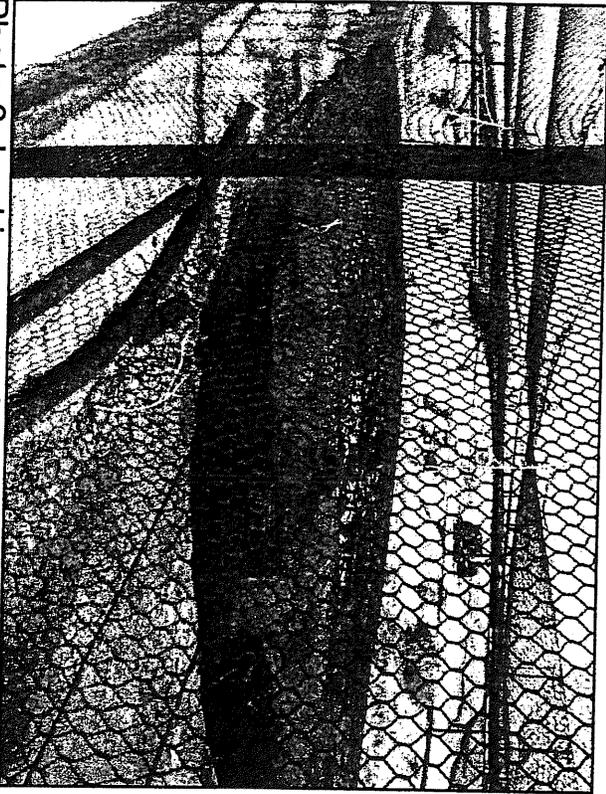
Photo 3: Looking westerly at second sump where oil skin is collected.
