Wetland Mitigation and Monitoring Plan for Impacts to Waters
Panoche Valley Solar Energy Project

Panoche Valley Solar Facility Project

San Benito County, California

June 2015

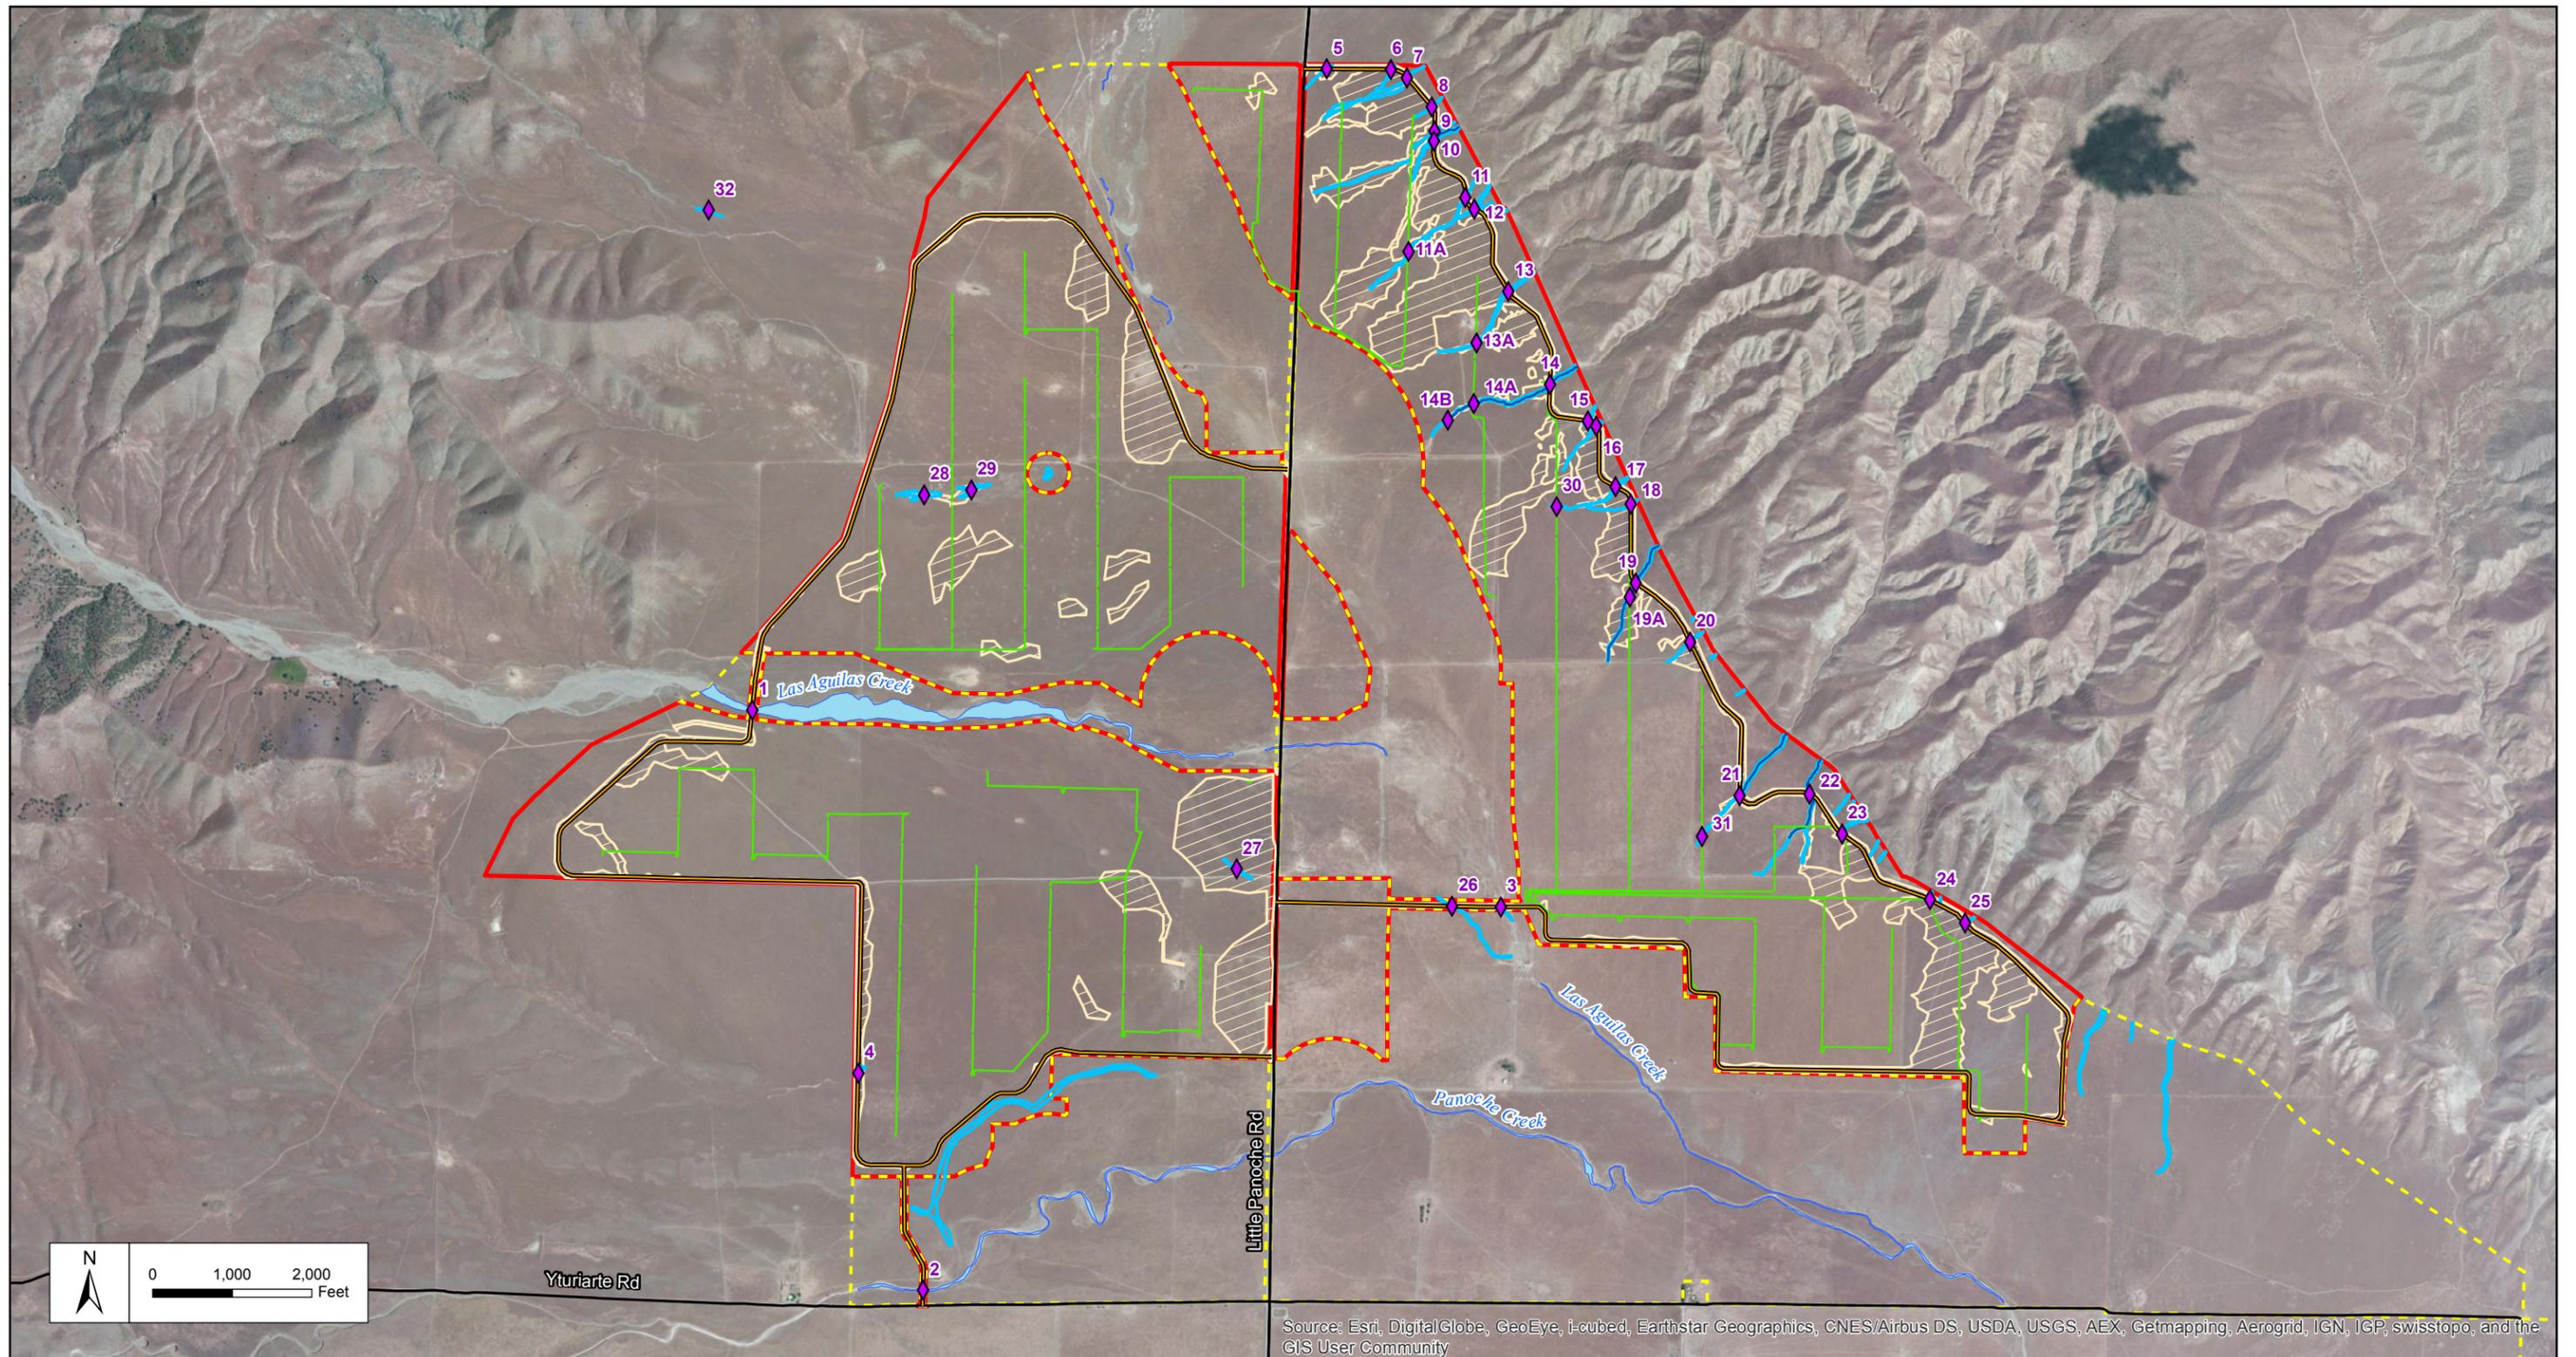
FIGURE
2

Panoche Valley Solar Project
 Drainage Impacts

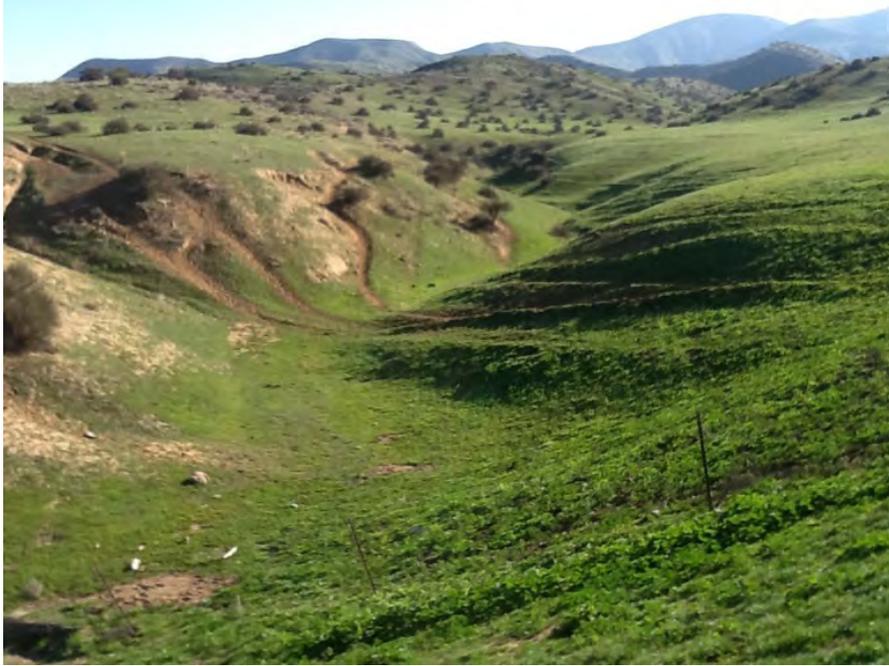
Figure 1: Photo 20 Upstream drainage channel

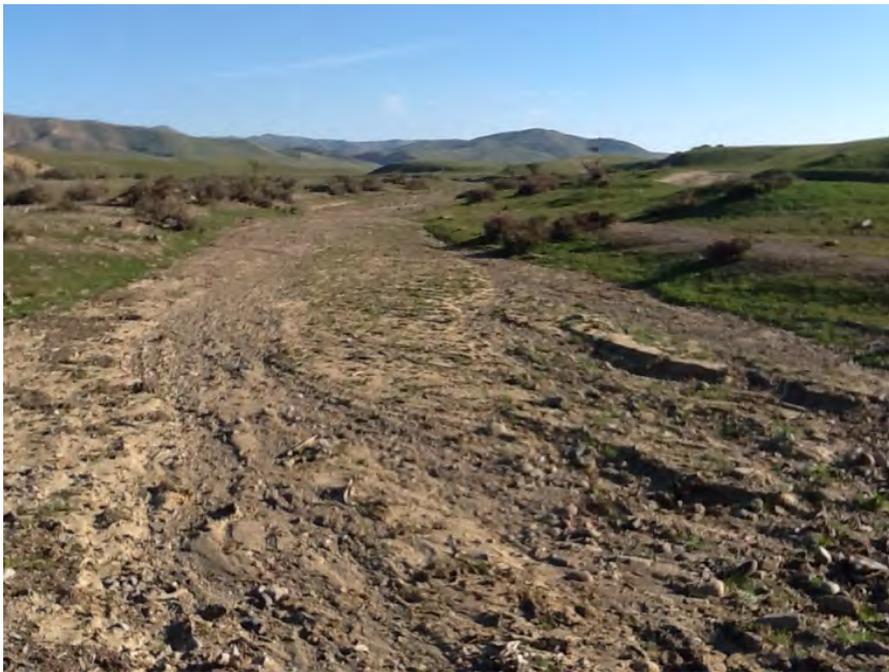
Figure 4: Photo 23a Upstream drainage with grazed ephedra

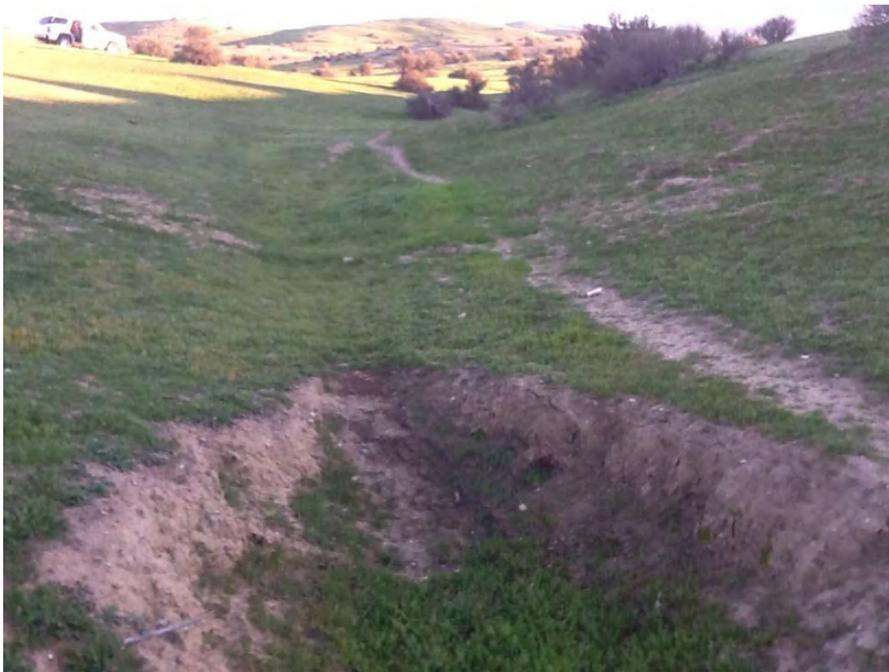
Figure 14: Photo 32 Upstream with head cut

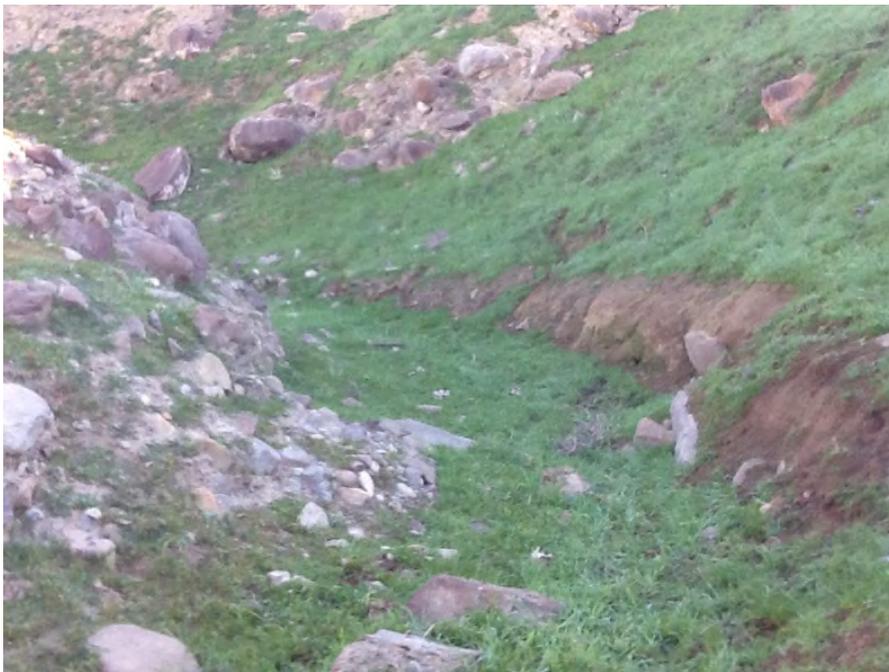
Figure 31: Photo 50 In-line dam structure

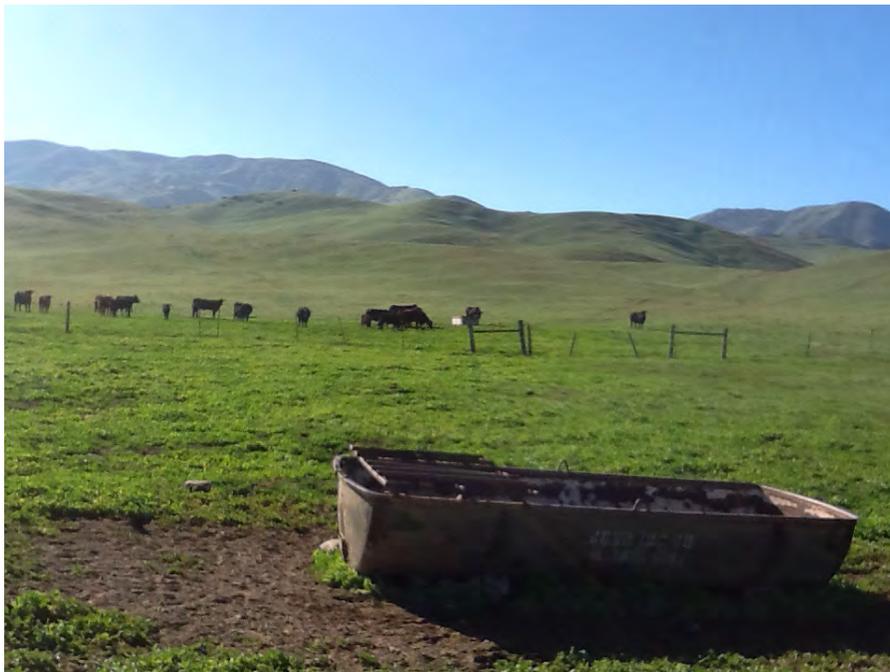
Figure 44: Photo 63 Uphill. No channel evident

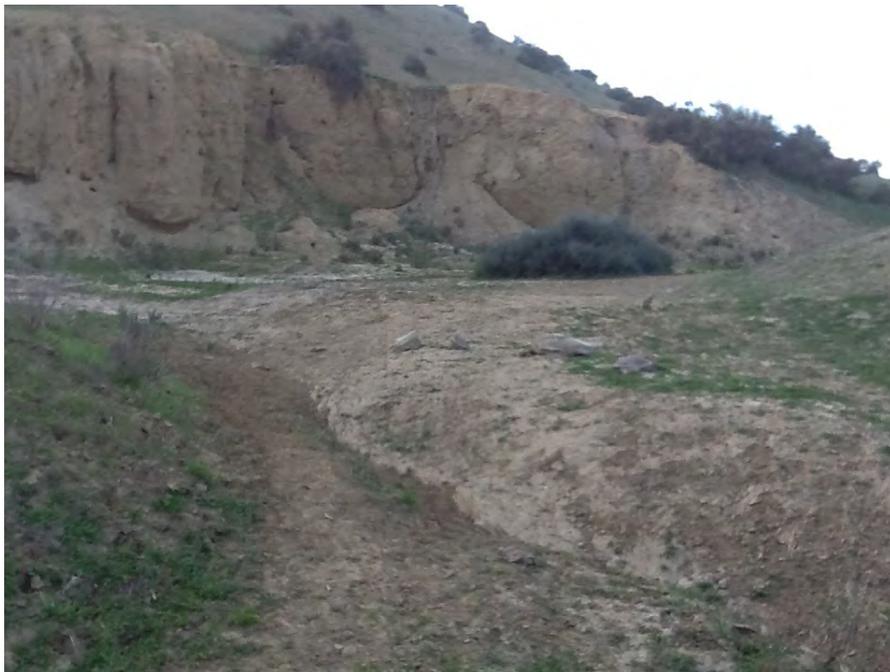
Figure 96: Photo 121 Convergence left historical channel looking upstream

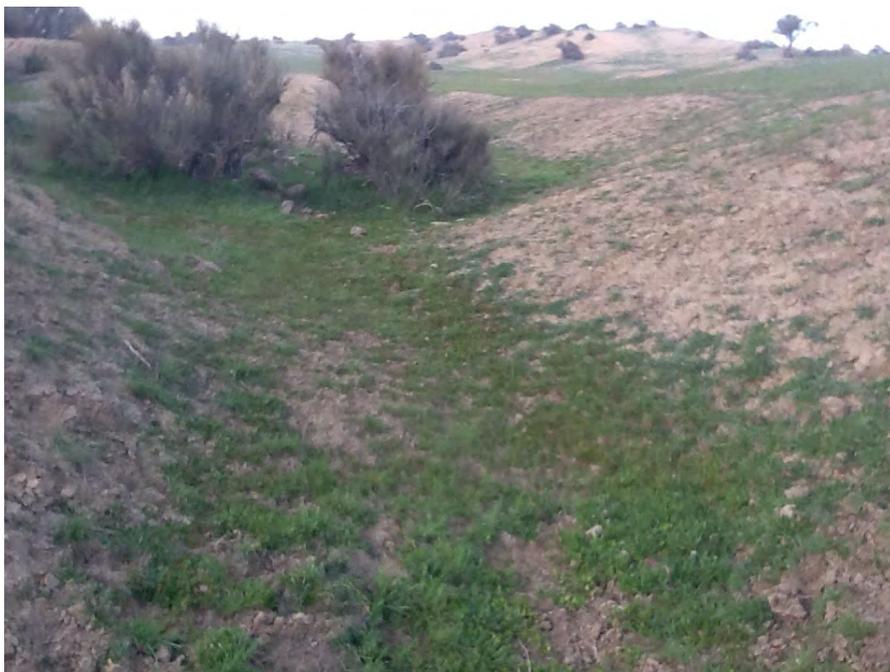
Figure 108: Photo 133 Upstream view of unmapped Drainage. Not indicated on USGS National Hydrography Dataset

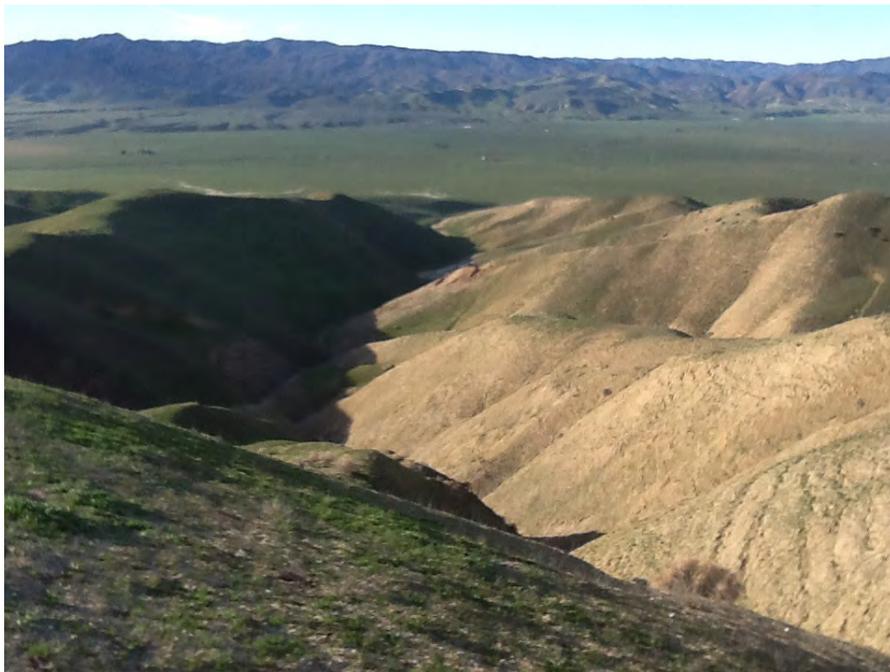
**Figure 114: Photo 139 On hill crest looking into project area at Drainage.
Not indicated on USGS National Hydrography Dataset.**

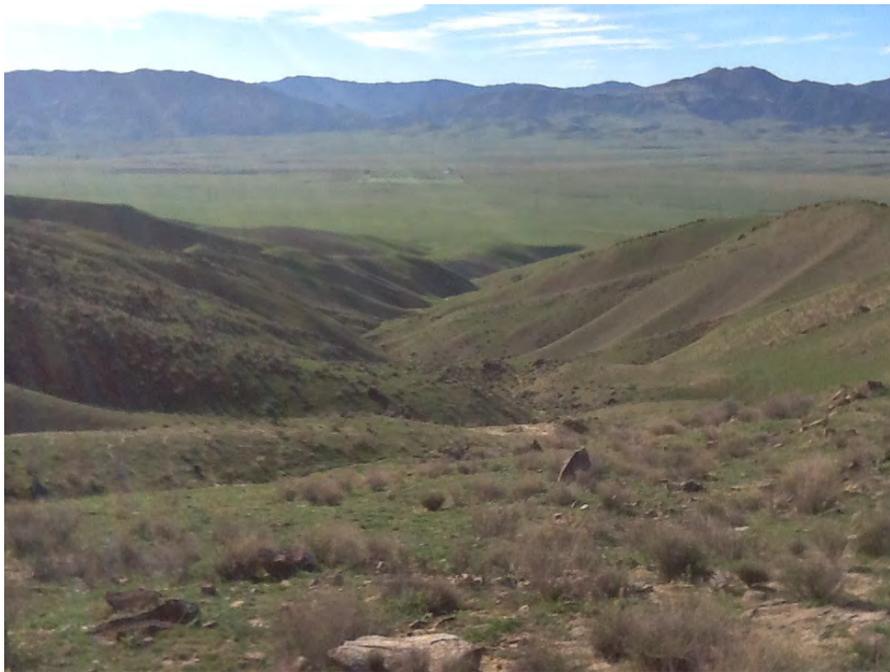
Figure 121: Photo 147 Upstream. Channel w some standing water

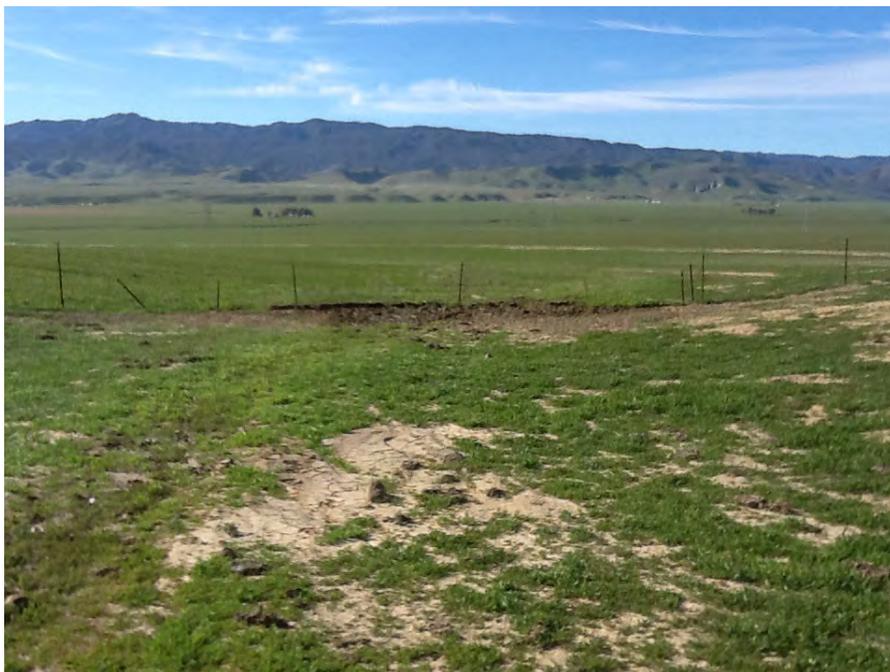
Figure 122: Photo 148 Downstream. Appears to discharge to land, no channel evident.

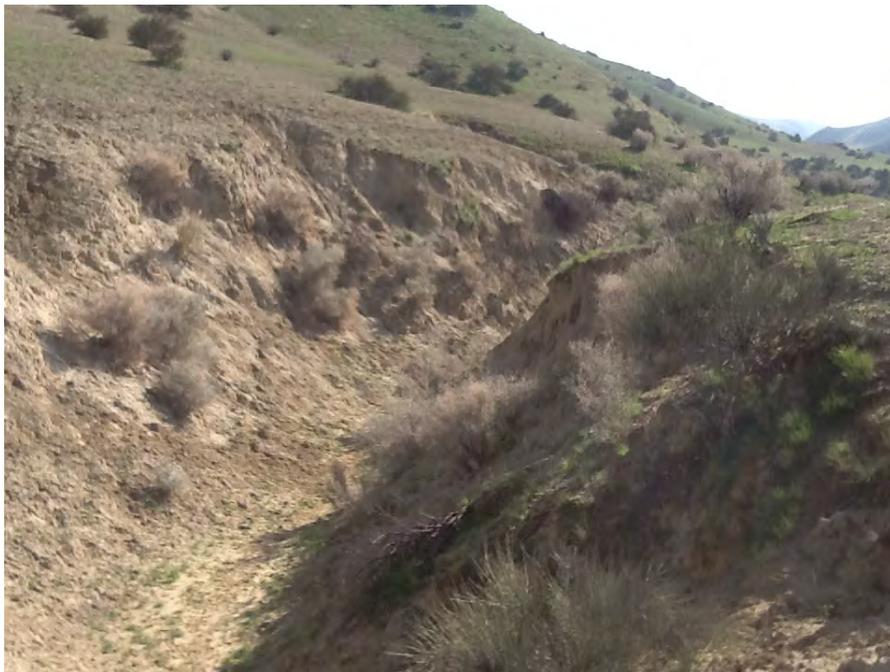
Figure 145: Photo 172 Downstream Drainage. Not indicated on USGS National Hydrography Dataset.

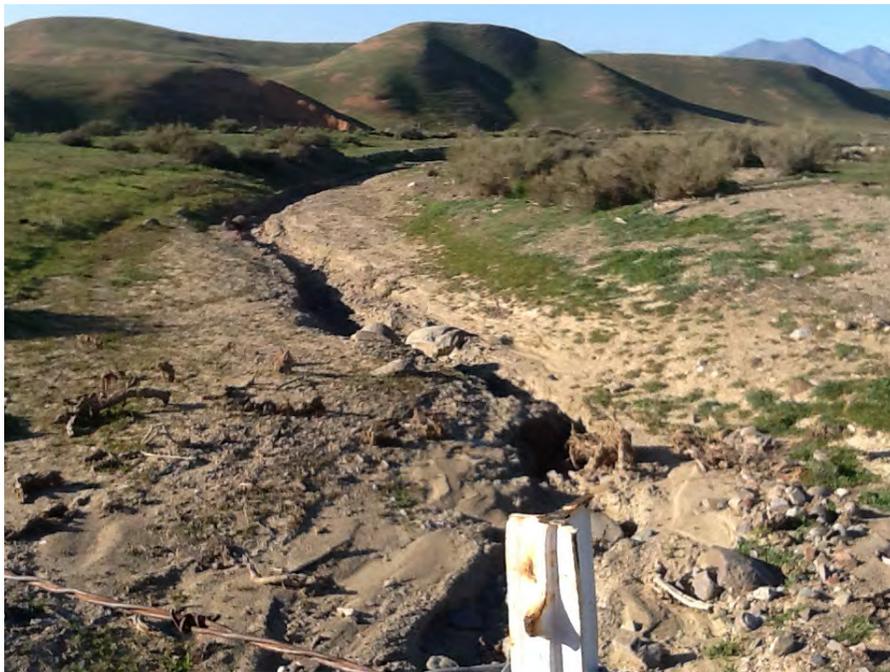
Figure 180: Photo 20c Potential enhancement to remove road (exclude access)

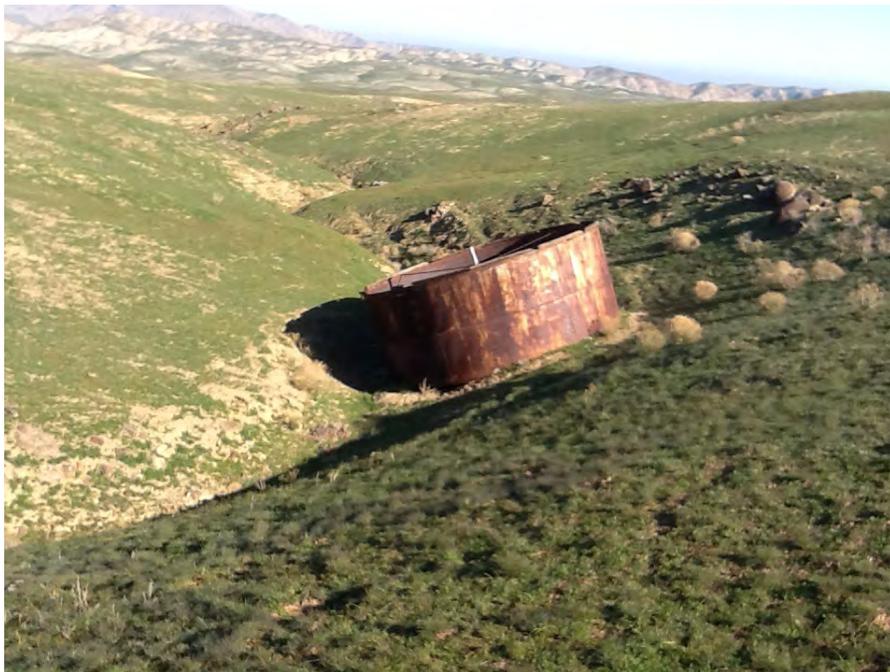
Figure 187: Photo 66 Enhancement trash removal (tank in channel)
