The East San Joaquin Water Quality Coalition (Coalition or ESJWQC) is submitting the 2014 Annual Report for review by the Central Valley Regional Water Quality Control Board (CVRWQCB) as required by the Waste Discharge Requirements General Order for Growers within the Eastern San Joaquin River Watershed that are Members of ESJWQC (R5-2012-0116-R1).

# Annual Report

**January 2013 – September 2013**

**Submitted May 1, 2014**

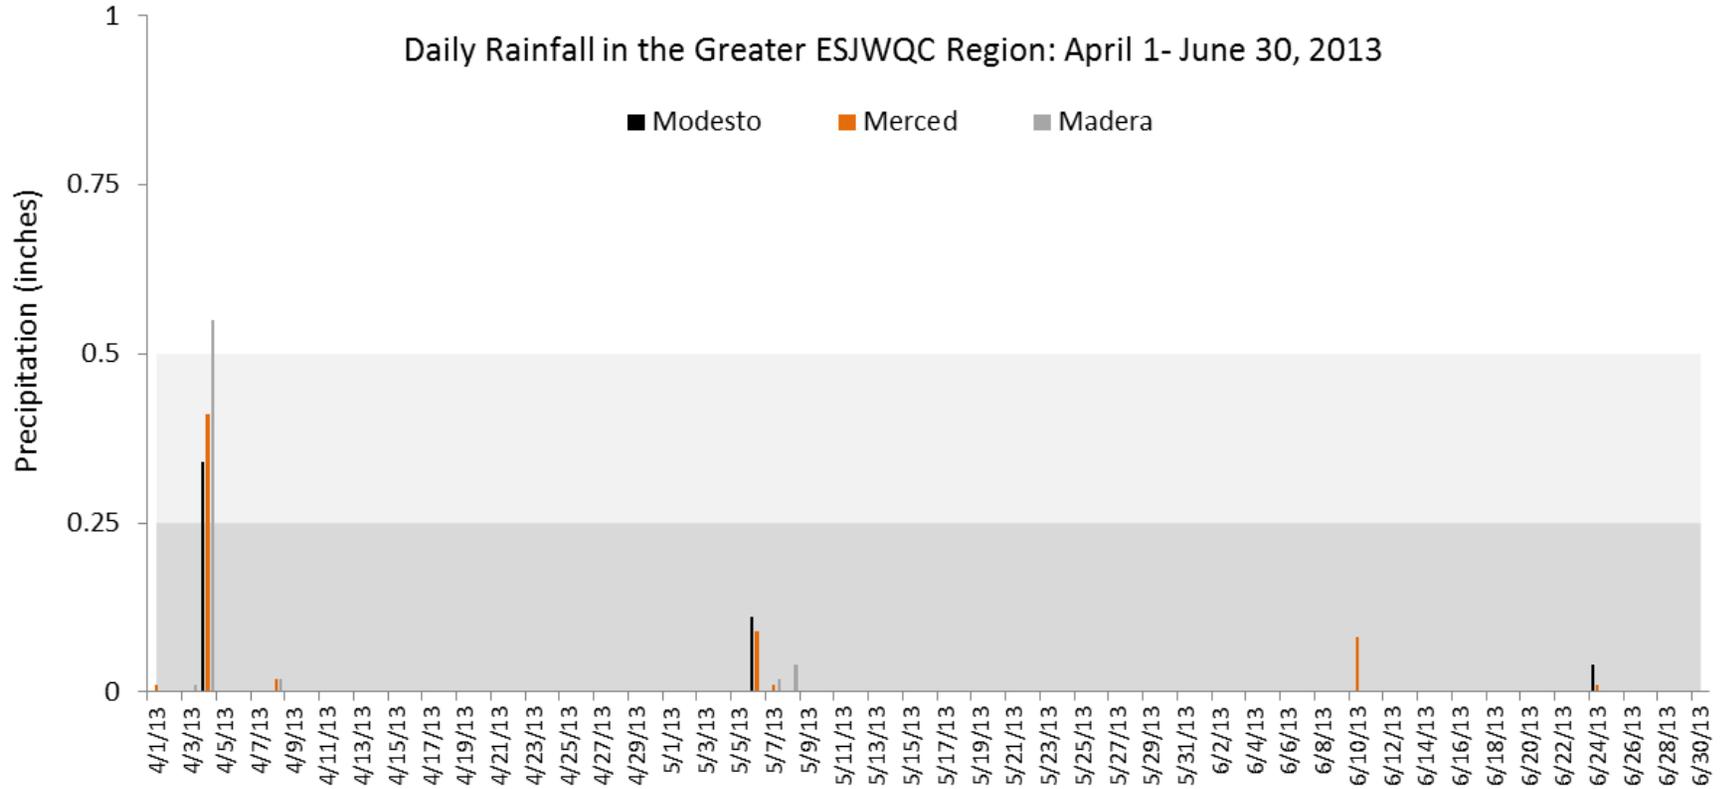
**Figure 11. Precipitation history for Modesto, Merced, and Madera, April through June 2013.**

The shaded gray area represents the trigger to initiate sampling: 0.25" - 0.5" rain in 24 hours. All data reported on <http://www.wunderground.com/>.

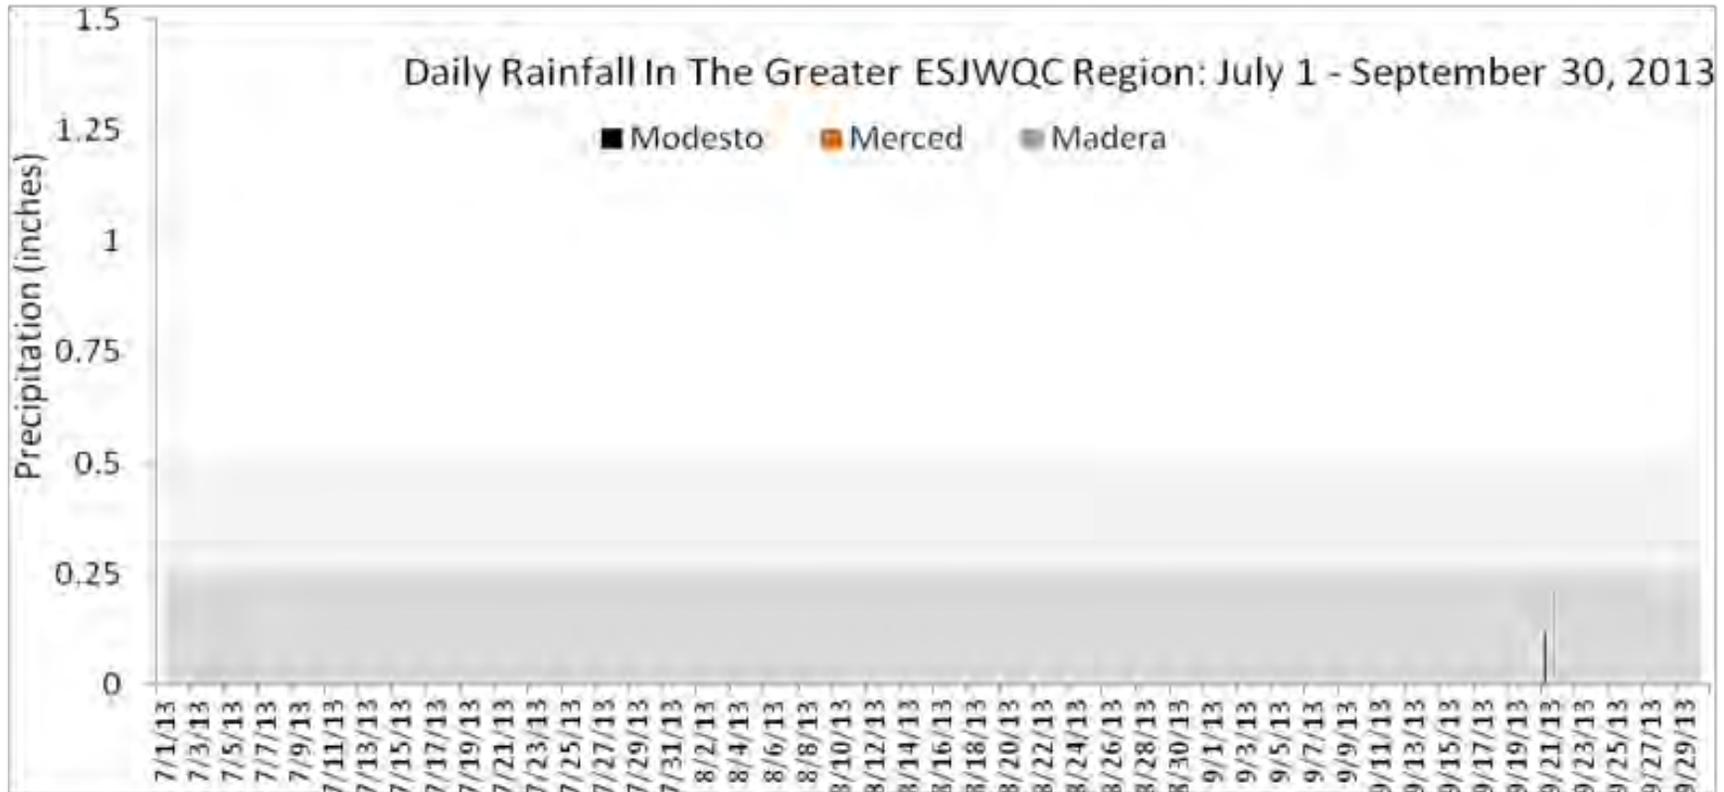
**Figure 12. Precipitation history for Modesto, Merced, and Madera, July through September 2013.**

The shaded gray area represents the trigger to initiate sampling: 0.25" - 0.5" rain in 24 hours. All data reported on <http://www.wunderground.com/>.

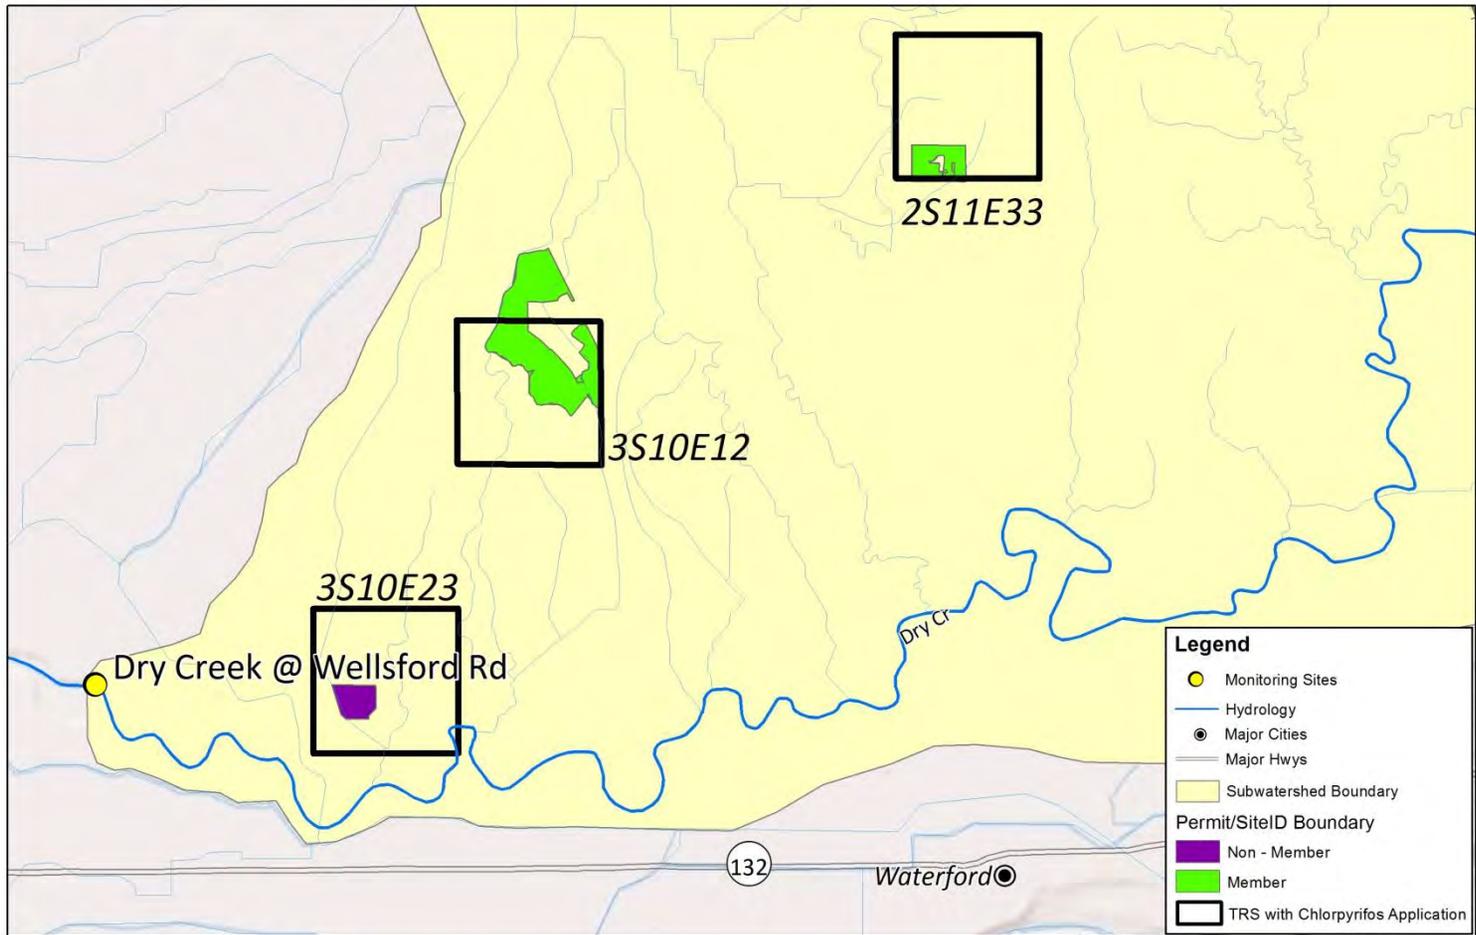
**Figure 13. Dry Creek @ Wellsford Rd chlorpyrifos applications associated with September 10, 2013 exceedance.**

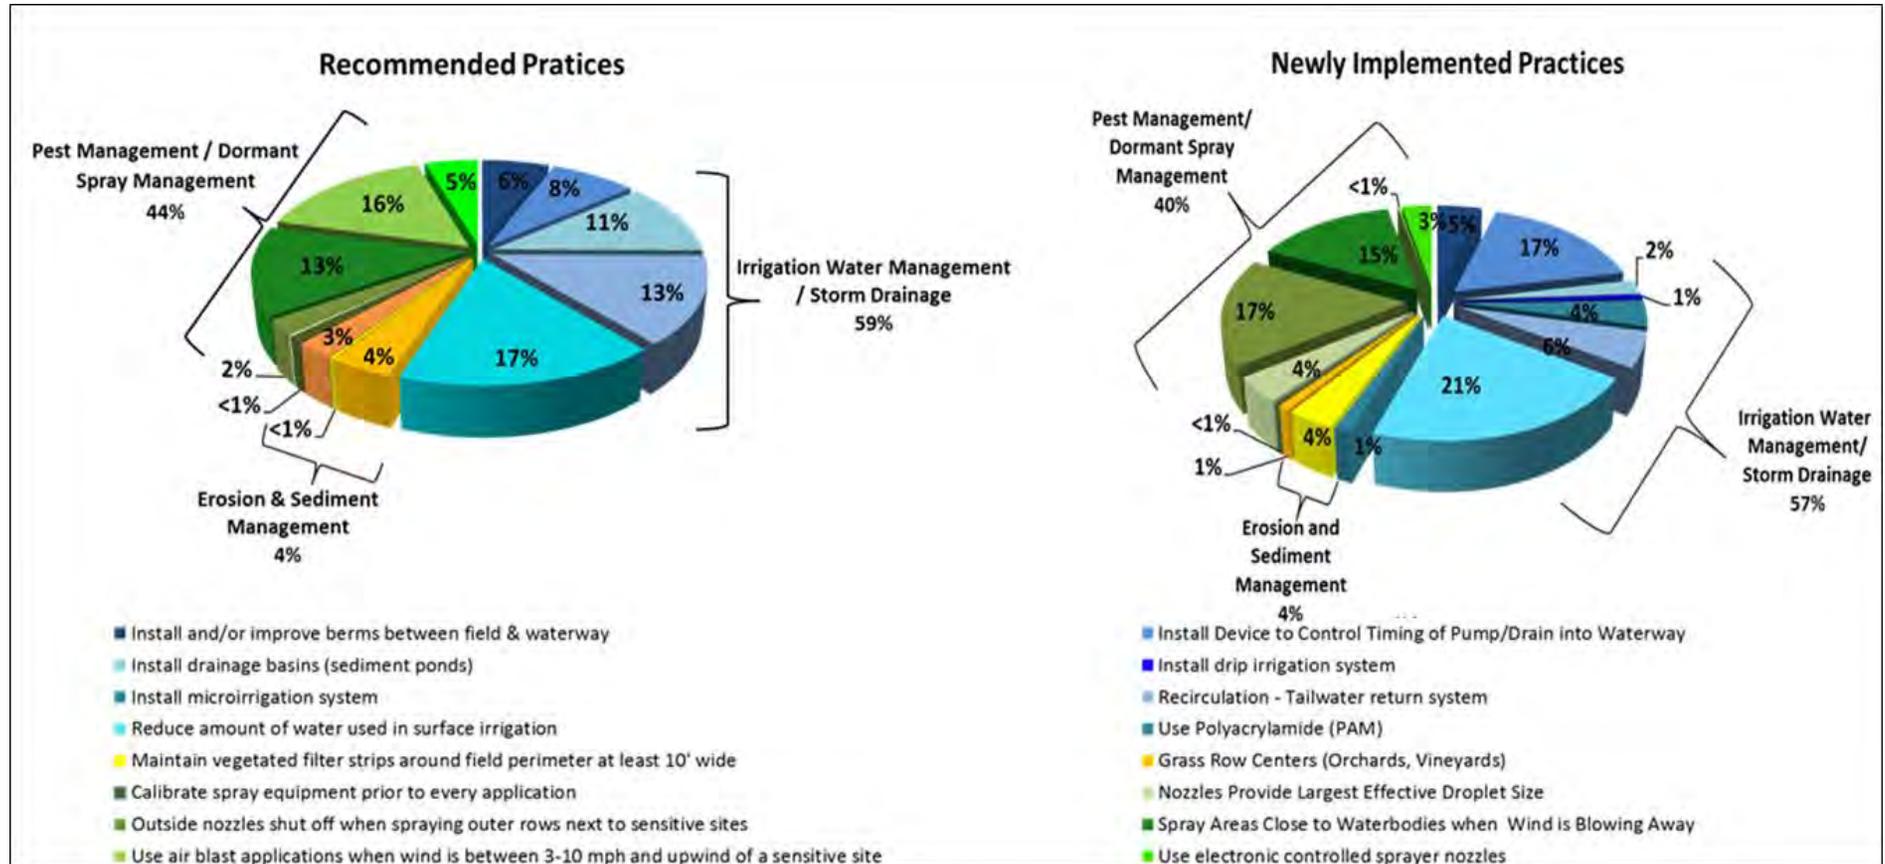
**Figure 14. Percentage of acreage associated with each recommended and newly implemented management practice in the first through fourth priority site subwatersheds.** Irrigation Water Management/Storm Drainage practices (blue shades), Erosion & Sediment Management practices (yellow/orange shades), and Pest Management/Dormant Spray Management practices (green shades) are included.

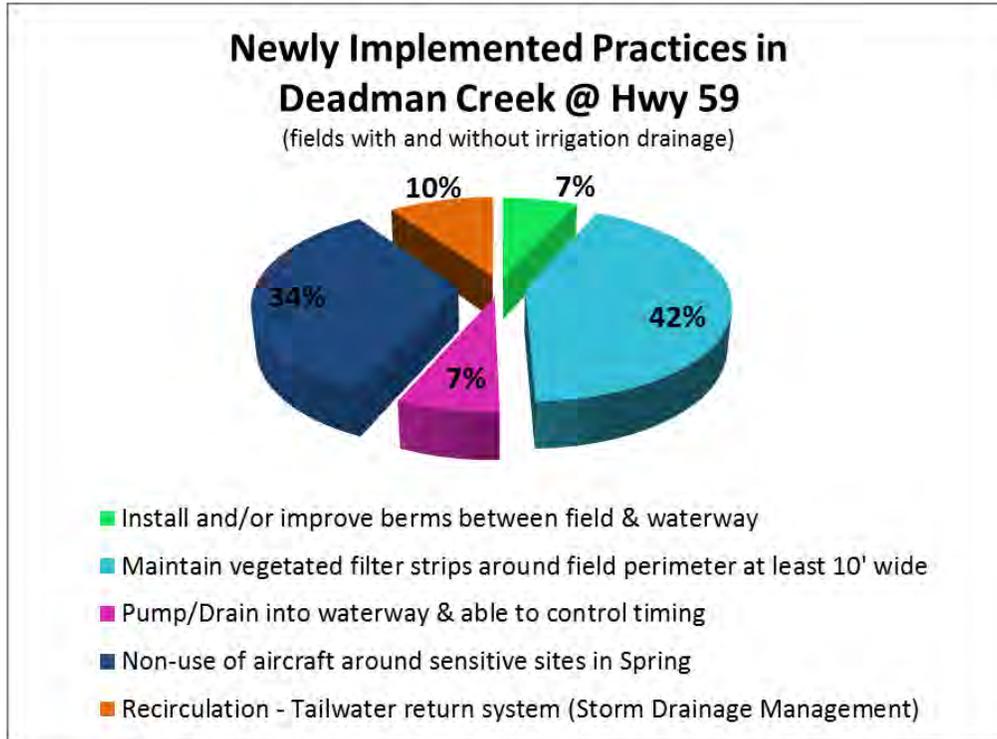
Figure 18. Percentage of acreage represented by newly implemented management practices in the Deadman Creek @ Hwy 59 site subwatershed.

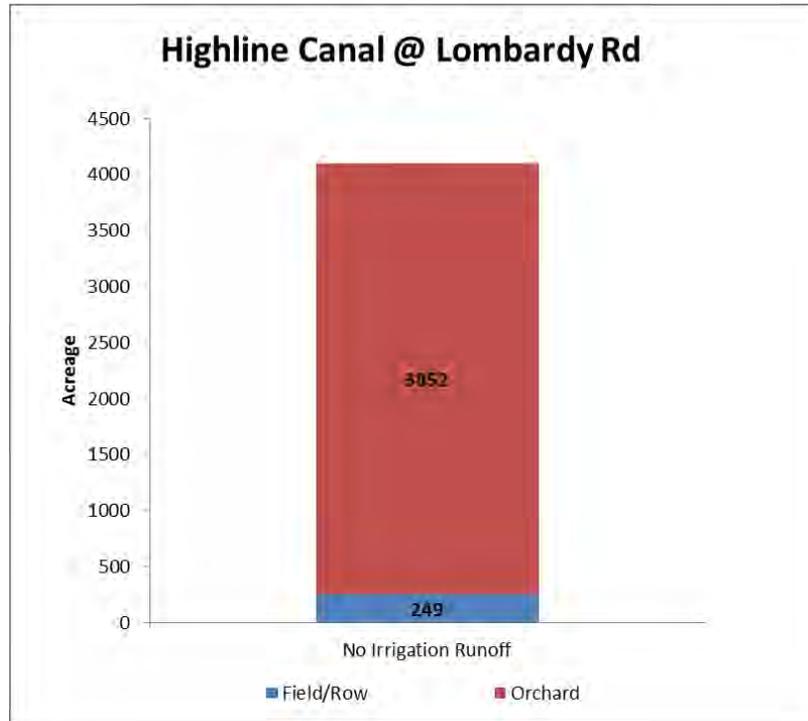
Figure 24. Highline Canal @ Lombardy Rd crop acreage information from member surveys (2013).

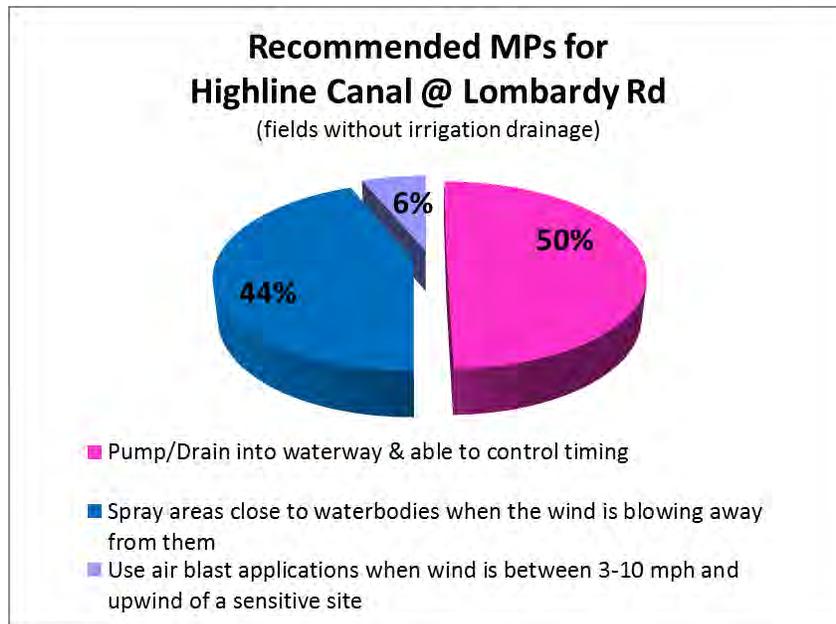
Figure 25. Highline Canal @ Lombardy Rd recommended management practice (2013) acreage percentage for members without irrigation drainage.

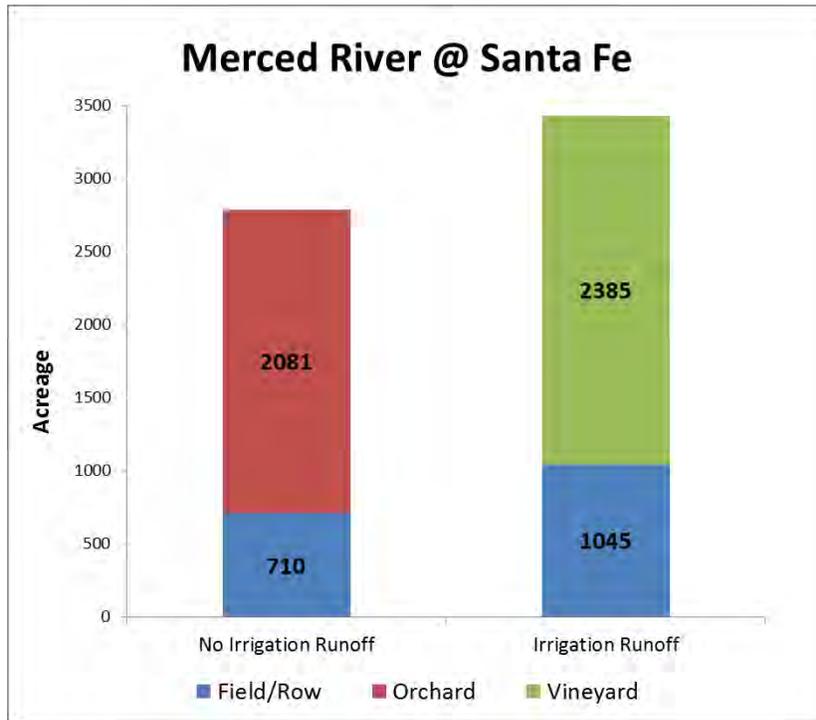
Figure 27. Merced River @ Santa Fe crop acreage information from member surveys (2013).

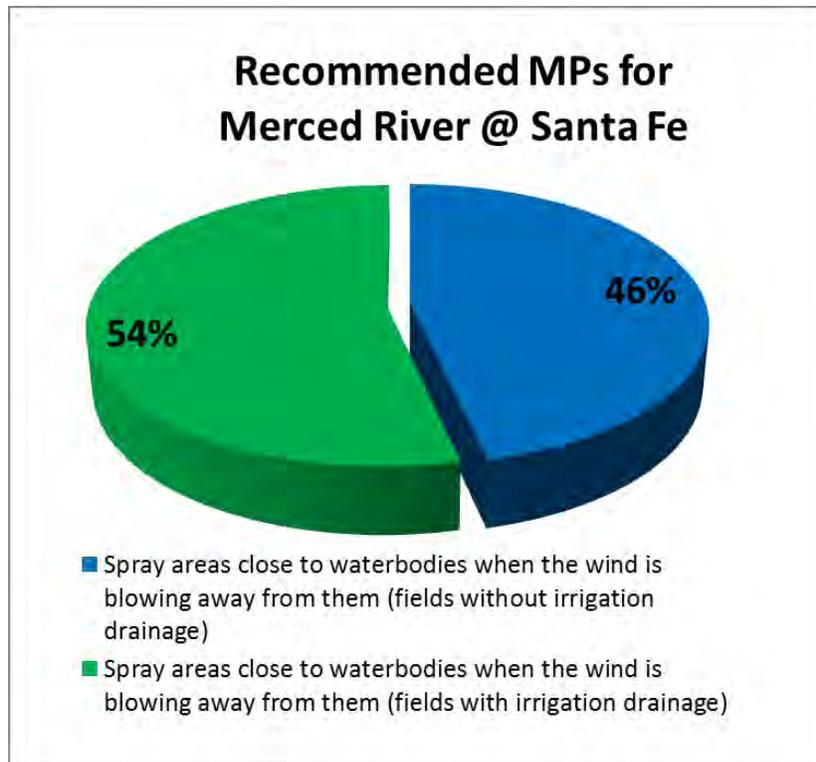
Figure 28. Merced River @ Santa Fe recommended management practice (2013) acreage percentage for members with and without irrigation drainage.

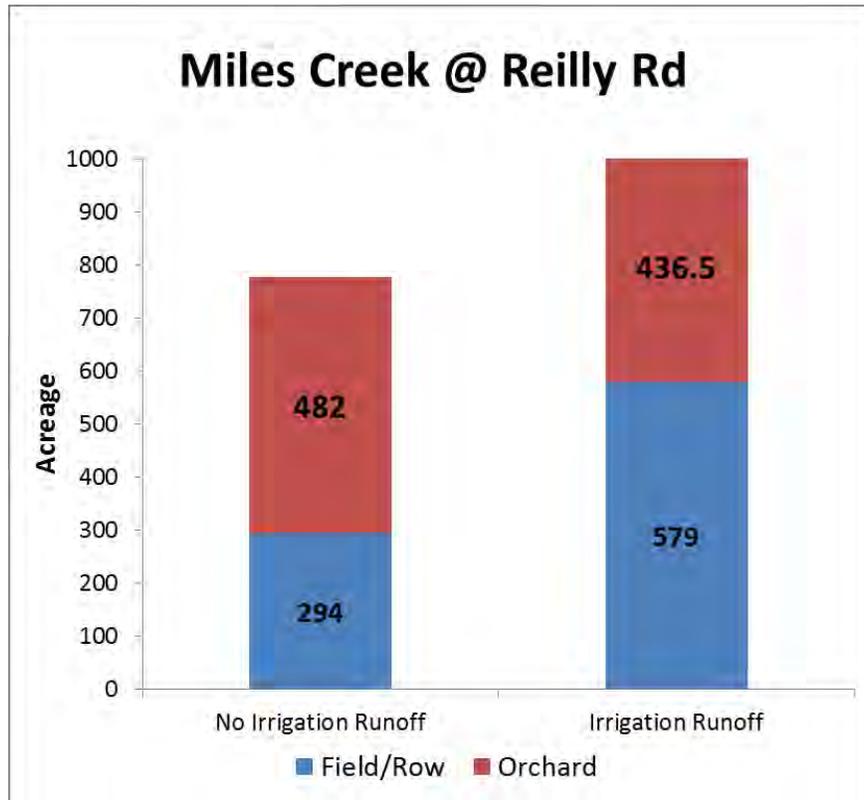
Figure 30. Miles Creek @ Reilly Rd crop acreage information from member surveys (2013).

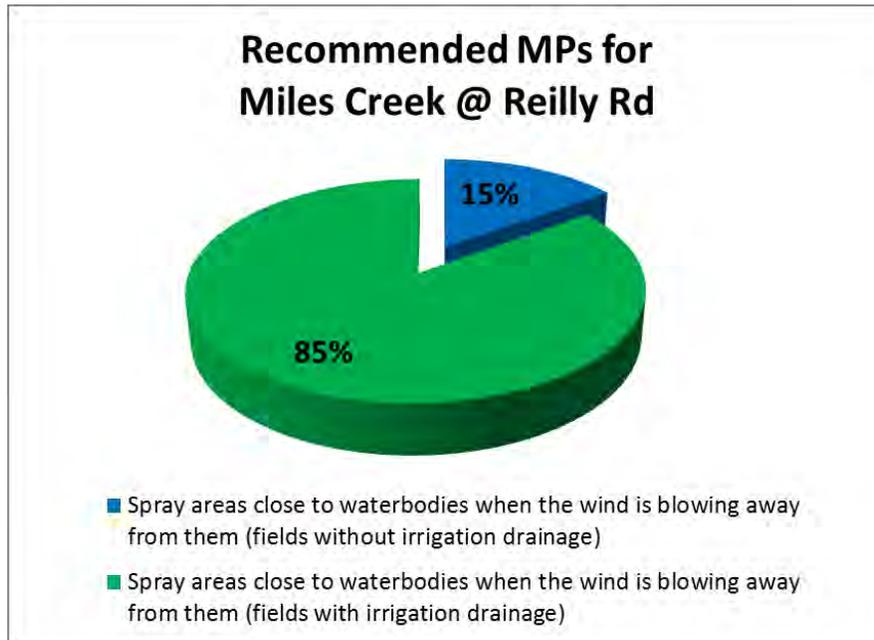
Figure 31. Miles Creek @ Reilly Rd recommended management practice (2013) acreage percentage for members with and without irrigation drainage.

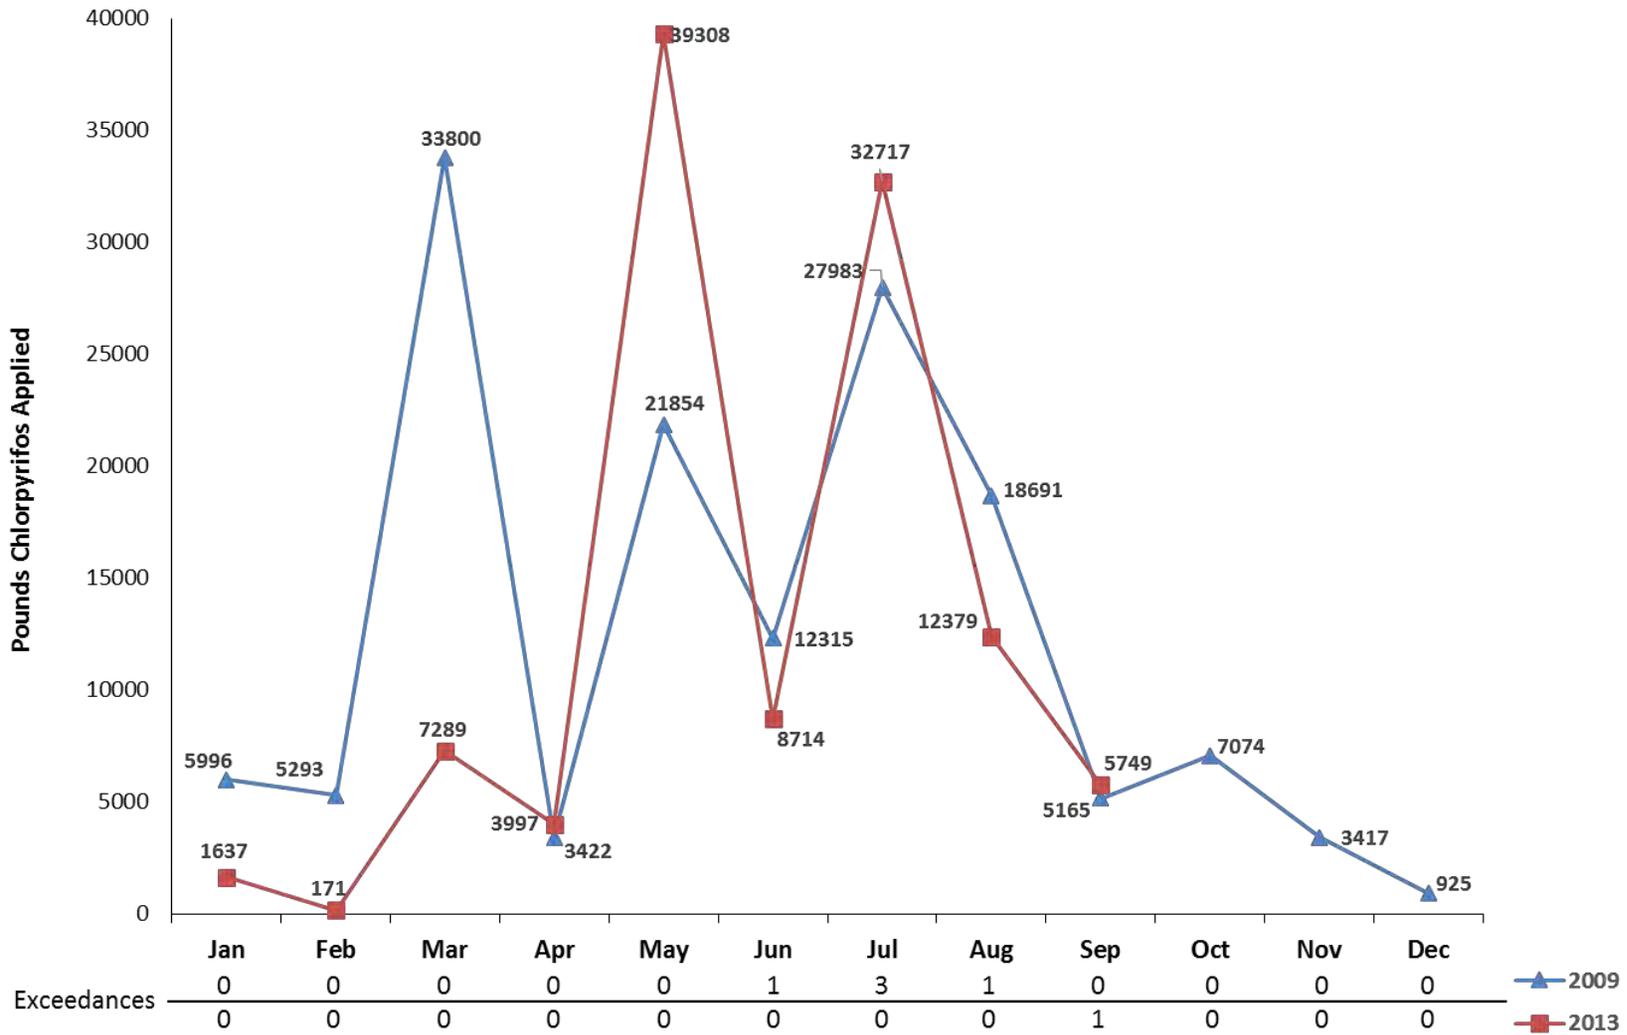
**Figure 37. Magnitude of chlorpyrifos detections and total pounds of chlorpyrifos applied in 2009.**

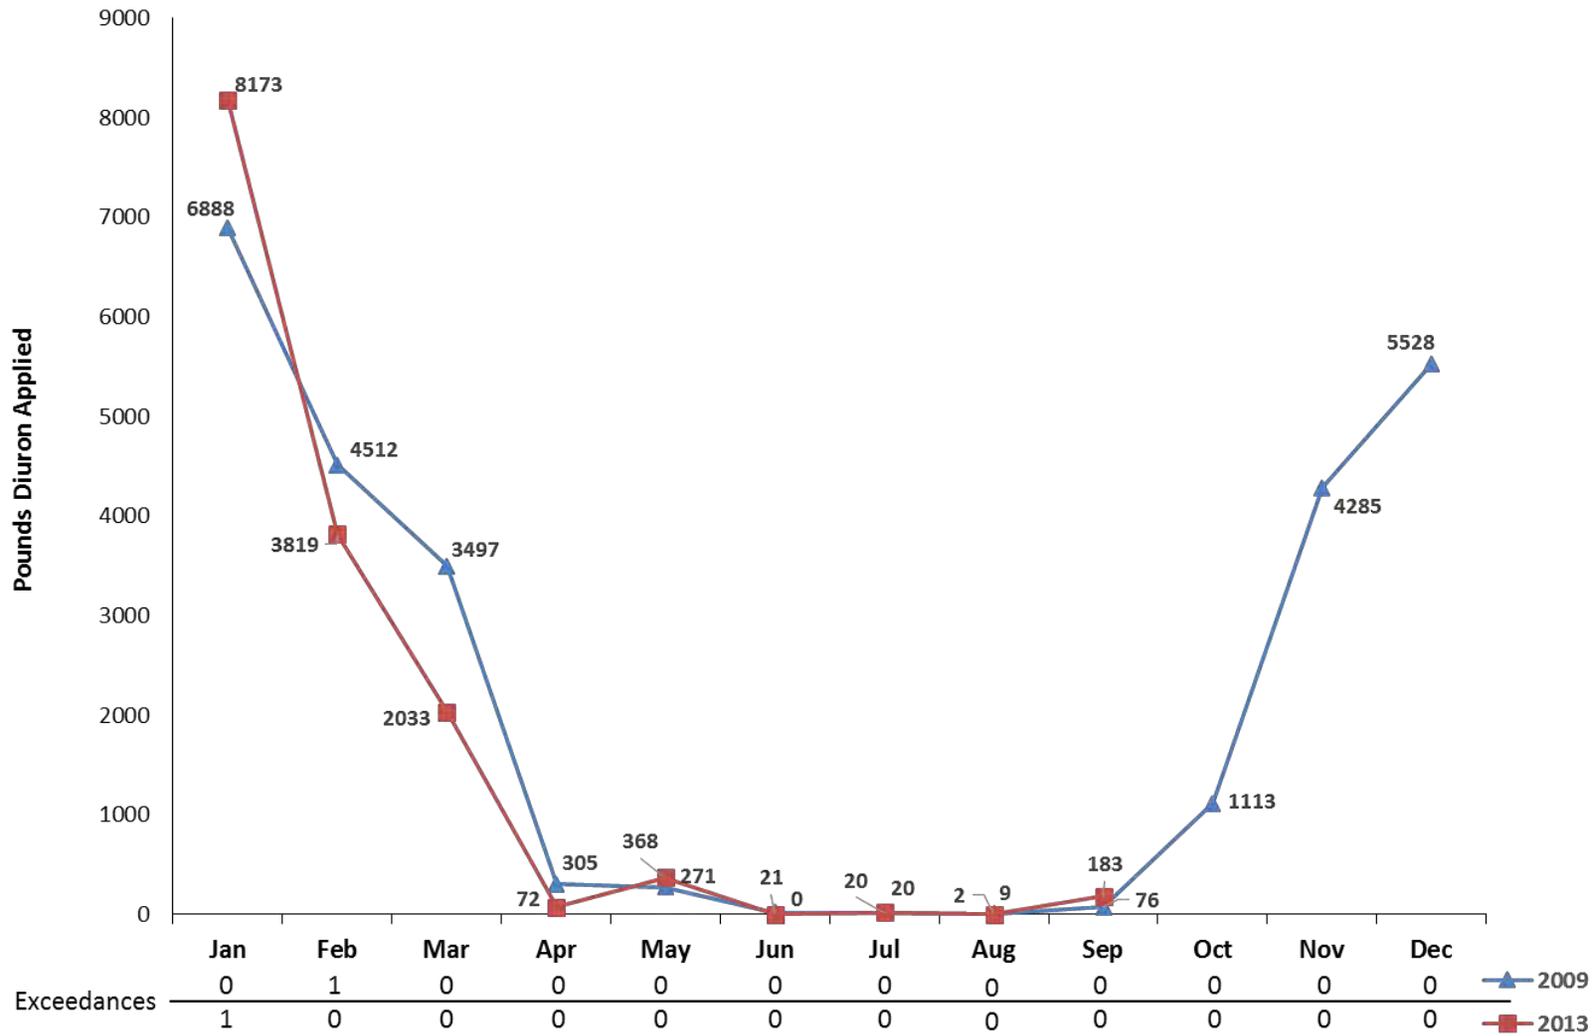
**Figure 42. Magnitude of diuron detections and total pounds of diuron applied in 2009.**

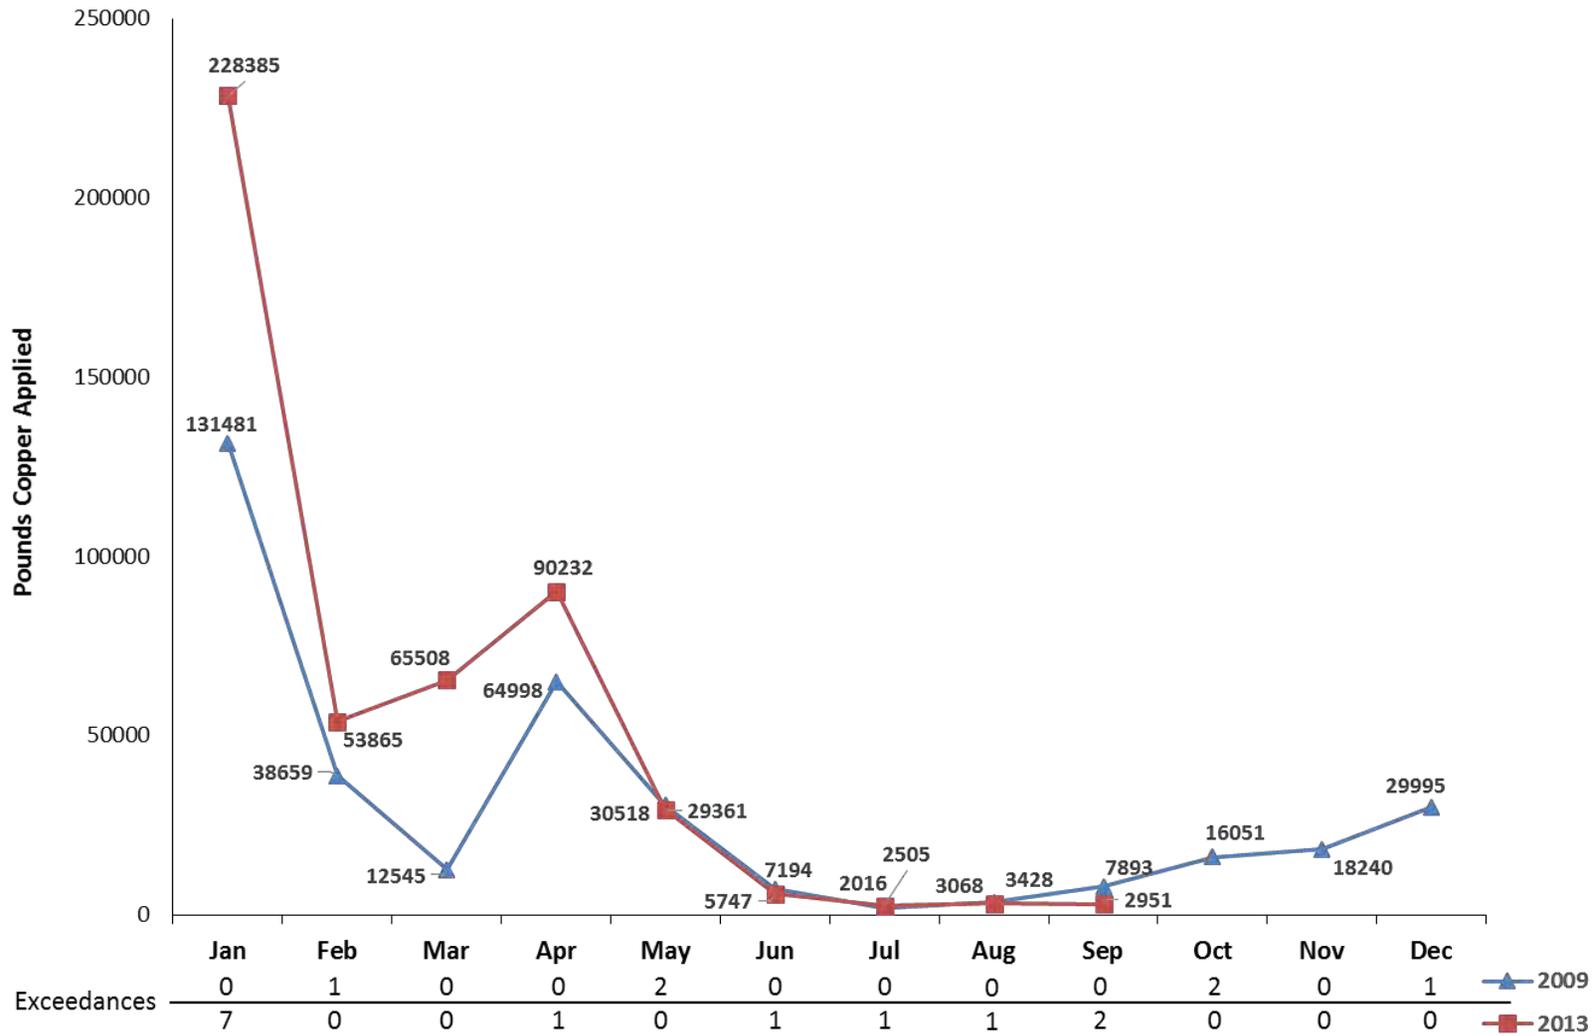
**Figure 47. Magnitude of copper detections and total pounds of copper applied in 2009.**
