Appendix N

15 Minute Resolution Water Quality Monitoring with YSI SONDE 6600 Multi-Parameter Instruments During the 2006 and 2007 Summer Seasons

January 2008

Environmental Engineering Research Program
School of Engineering & Computer Sciences
University of the Pacific
3601 Pacific Avenue, Sears Hall
Stockton, CA 95211

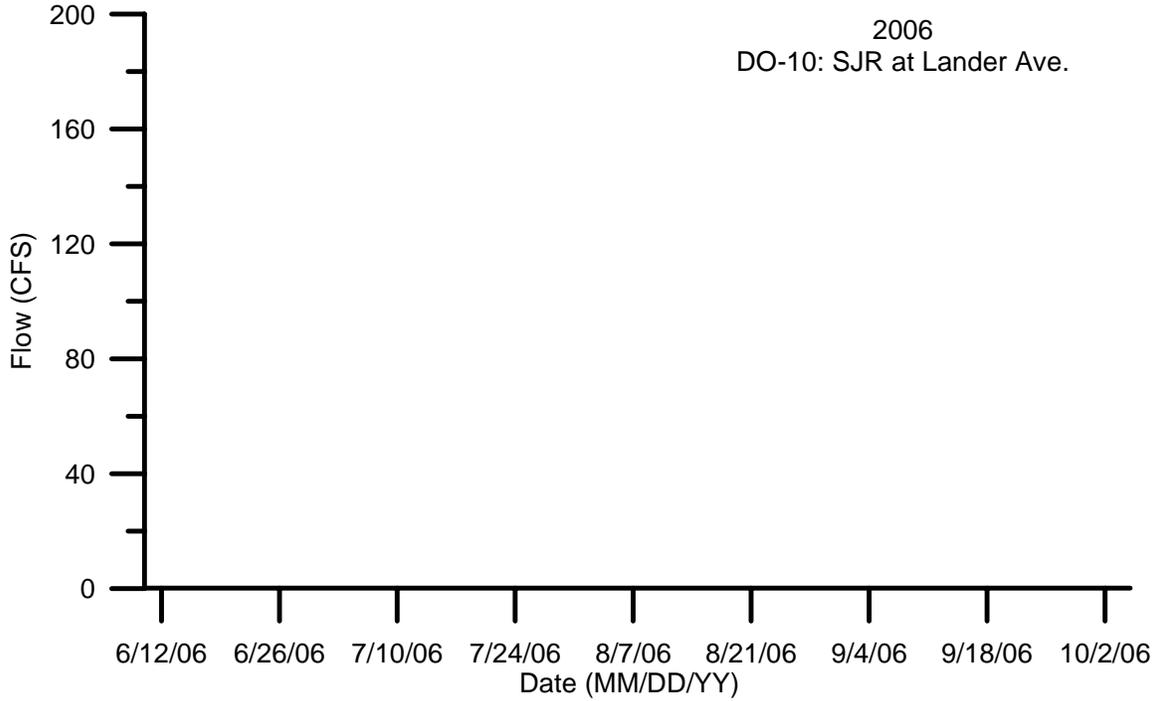
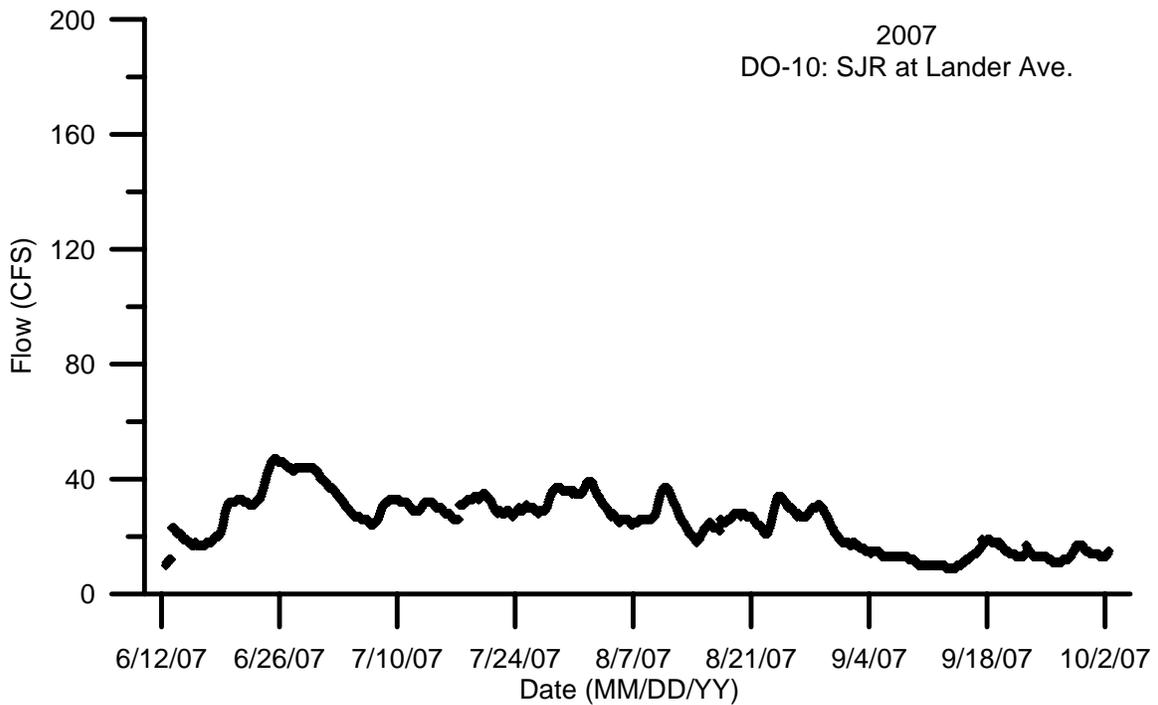
Figure 50: Flow 15 minute data at DO-10 for 2006 and 2007 (site not monitored in 2006).

The initial deployment for 2006 was from June 27 to July 13 during which time the San Joaquin river and it's major tributaries had nearly a 60% decrease in flow. For the rest of the 2006 and 2007 monitoring periods, flows were considerably more consistent (Figures 18, 26, 34, 42, 50, and 58). Electrical conductivity at DO-05 during that same period increased from less than 100 milliSemens (mS) to nearly 450 mS as the flow decreased.
