GROUNDWATER INFORMATION SHEET

Chromium VI

Revised: April 2008

**State Water Resources Control Board
Division of Water Quality
GAMA Program**

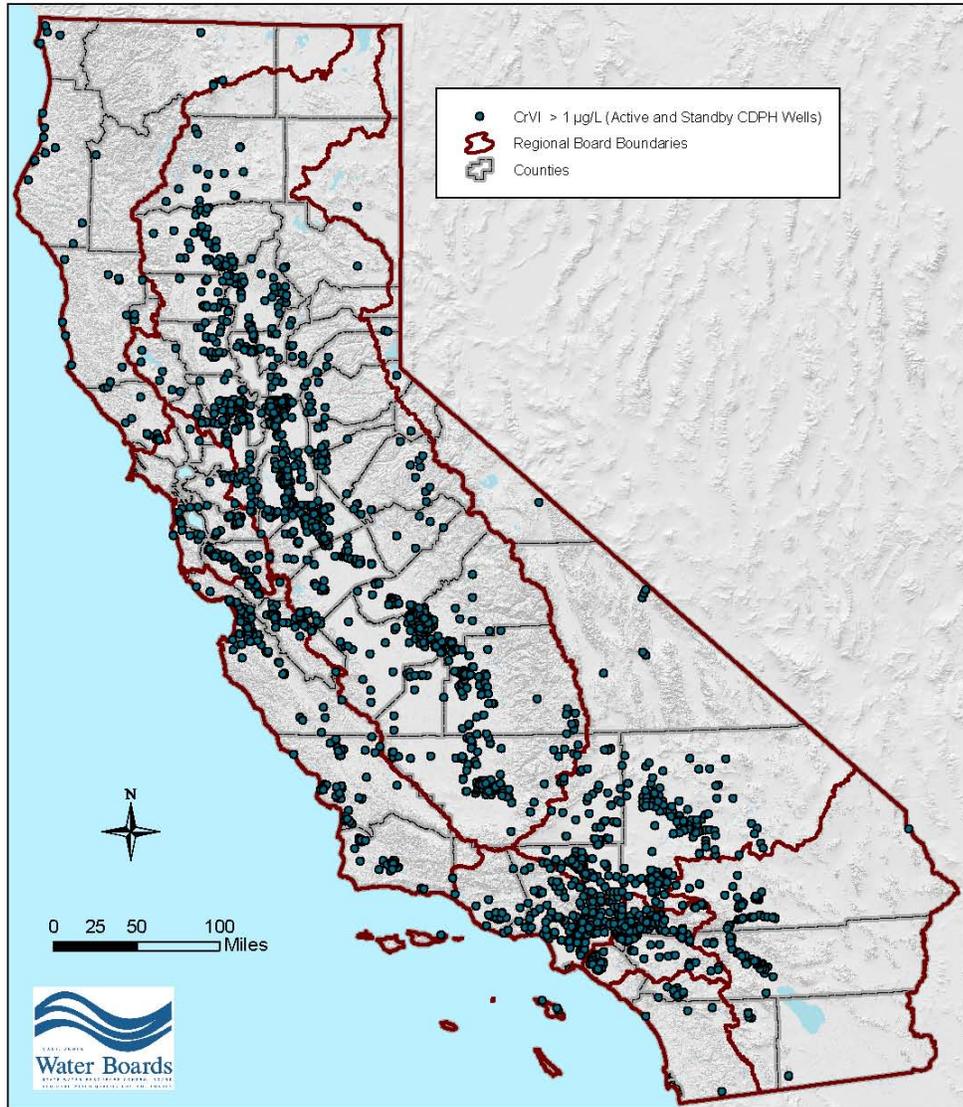
**Active and Standby CDPH Wells with at Least
One Detection of Chromium VI Above the DLR of 1 µg/L (3229 wells)**

Source 1994 - November 2006 CDPH Data
(Map revised October 25, 2007)

SUMMARY OF Cr⁶ DETECTIONS IN PUBLIC DRINKING WATER WELLS²	
Detection Type	Number of Groundwater Sources
Number of active and standby public water wells with Cr ⁶ concentrations > 1 µg/L.	3229 of 6536 public wells tested
Top 3 counties having public water wells with Cr ⁶ concentrations > 1 µg/L.	Los Angeles, San Bernardino, Fresno

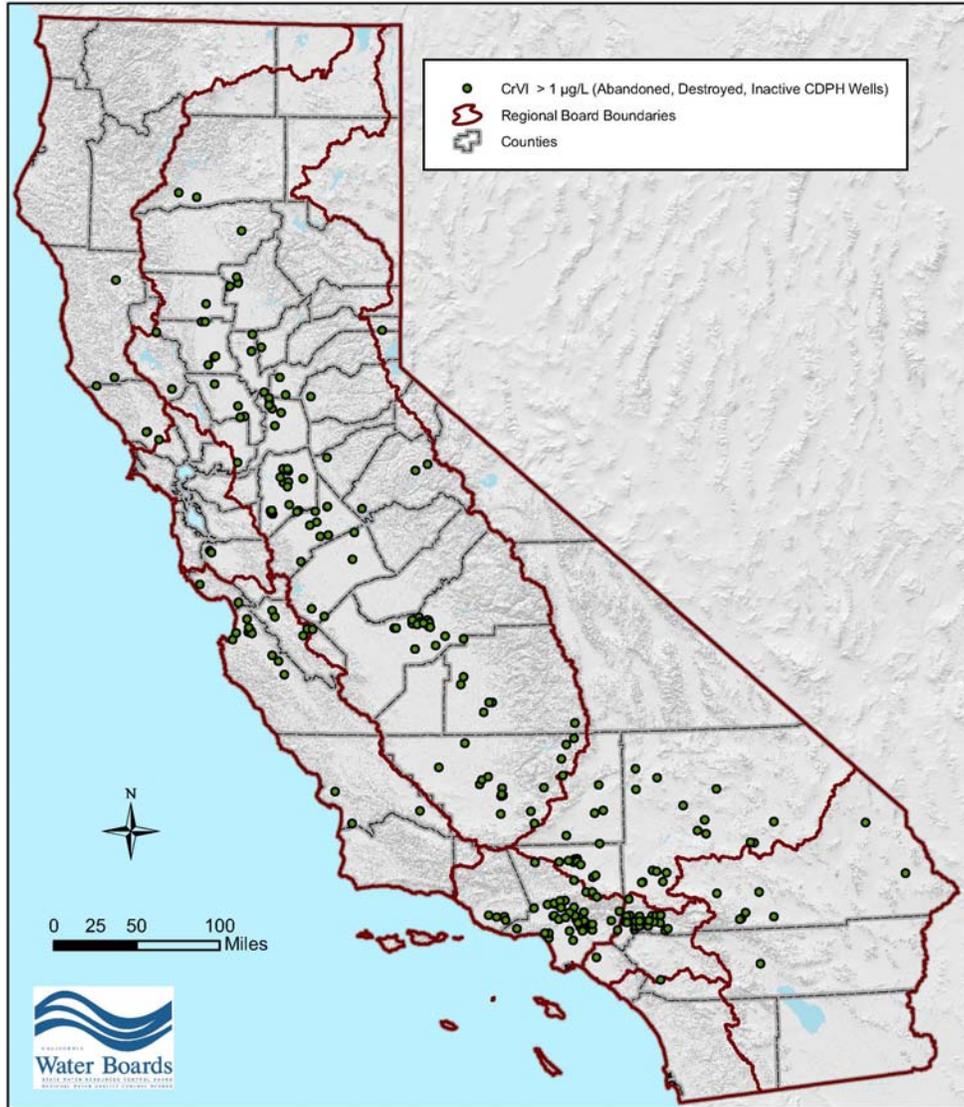
**Abandoned, Destroyed, Inactive CDPH Wells with at Least
One Detection of Chromium VI Above the DLR of 1 µg/L MCL (260 wells)**

Source 1994 - November 2006 CDPH Data
(Map revised October 25, 2007)
