**CALIFORNIA REGIONAL WATER QUALITY CONTROL BOARD  
LAHONTAN REGION  
MEETING OF JULY 12-13, 2017  
BISHOP**

**Status of Proposed Cease and Desist Order and Stipulated Agreement with the United States Forest Service, Lake Tahoe Basin Management Unit; Meeks Bay Marina Resort, El Dorado County**

**STIPULATED AGREEMENT  
WITH THE UNITED STATES FOREST SERVICE, LAKE TAHOE BASIN  
MANAGEMENT UNIT  
TO MAINTAIN TEMPORARY BEST MANAGEMENT PRACTICES (BMPS) TO  
INFILTRATE STORMWATER RUNOFF AT MEEKS BAY RESORT MARINA AND  
DEVELOP AND IMPLEMENT PLANS TO COMPLY WITH THE  
WATER QUALITY CONTROL PLAN FOR THE LAHONTAN REGION;  
MEEKS BAY MARINA,  
WDID NO. 6A090050000  
CEASE AND DESIST ORDER NO. R6T-2017-0013  
El Dorado County**

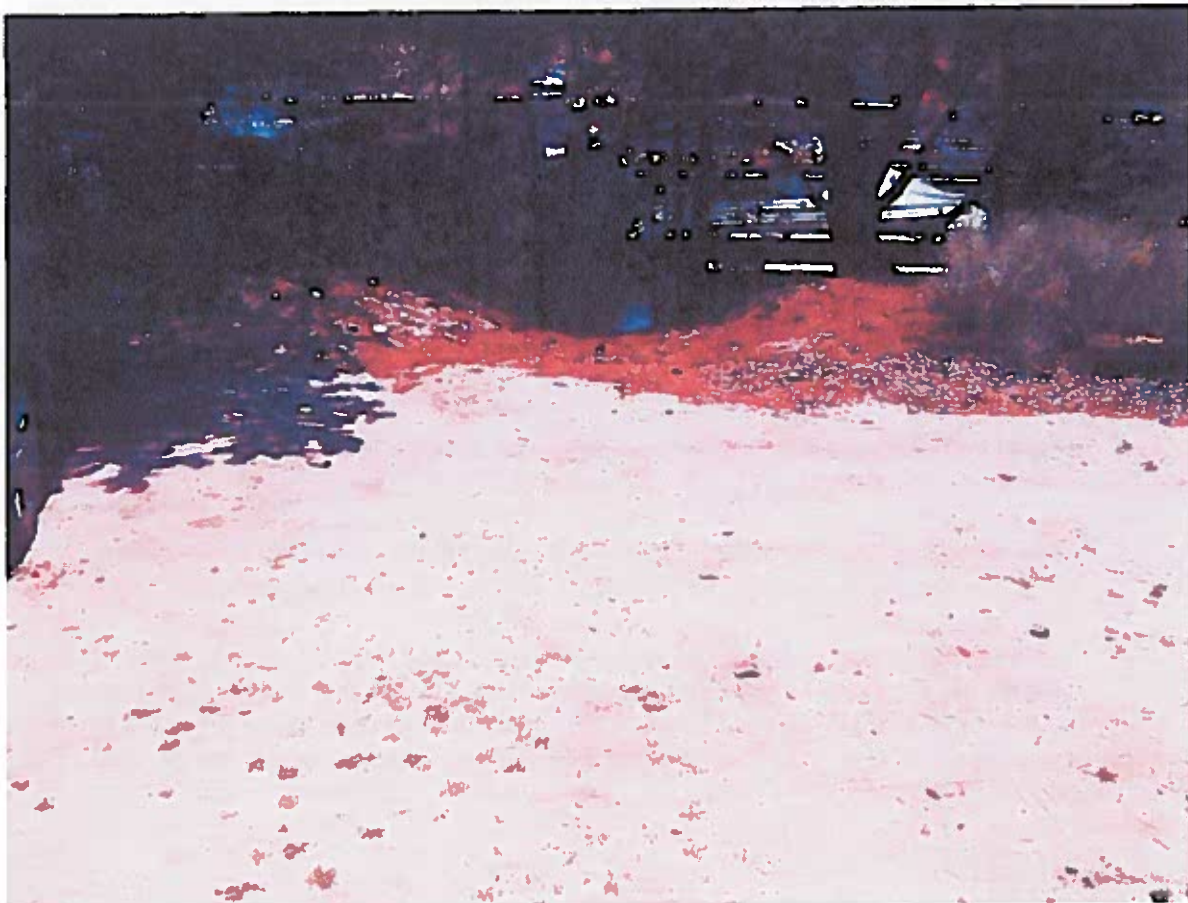
**Picture 1: The parking lot is composed of exposed loose dirt and a small amount of gravel on the edges. The depression in the photo is a gangway to the marina slips below. There is no berm protecting this area from concentrated flow down along the gangway causing erosion.**

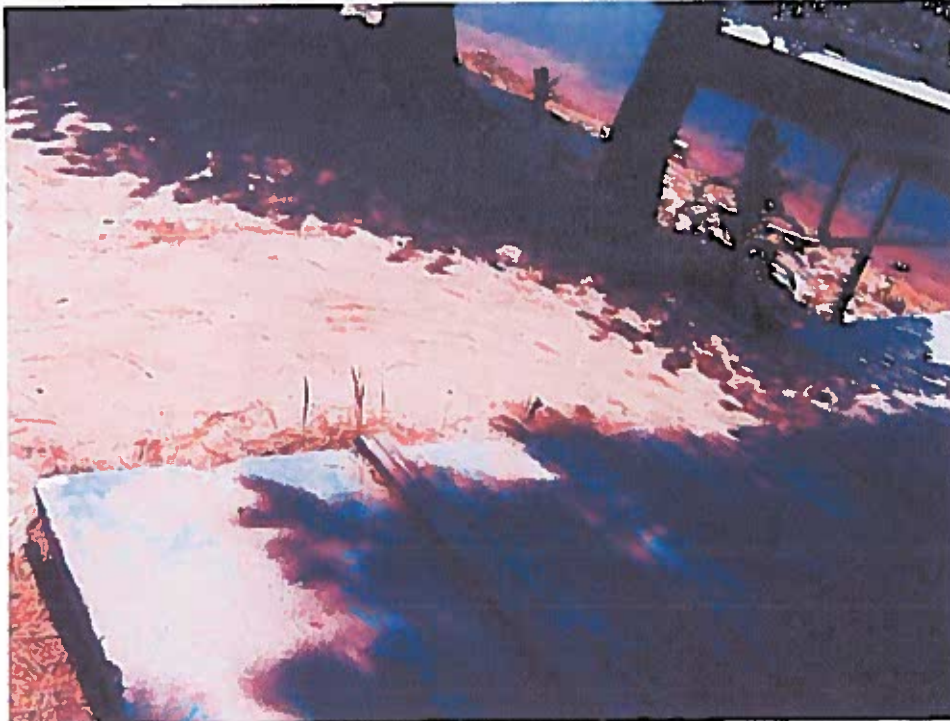
**Picture 4: This is gangway number 1, closest to the lake. Due to the topography of the parking lot, a low spot forms at the top and runs down during significant rain events.**

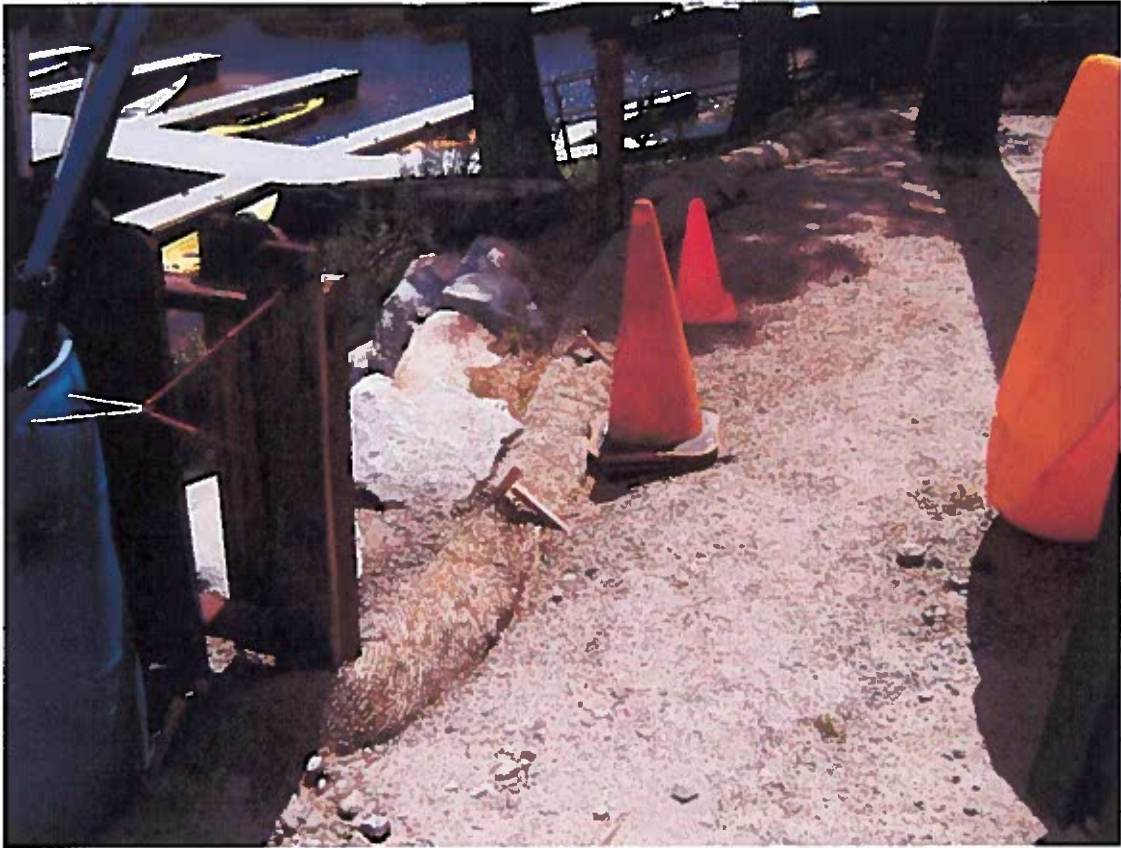
**Photograph 05 - Flattened fiber roll adjacent to marina office, facing southwest. Also, the end of the fiber roll is installed perpendicular to the gradient, which will channelize storm water runoff.**

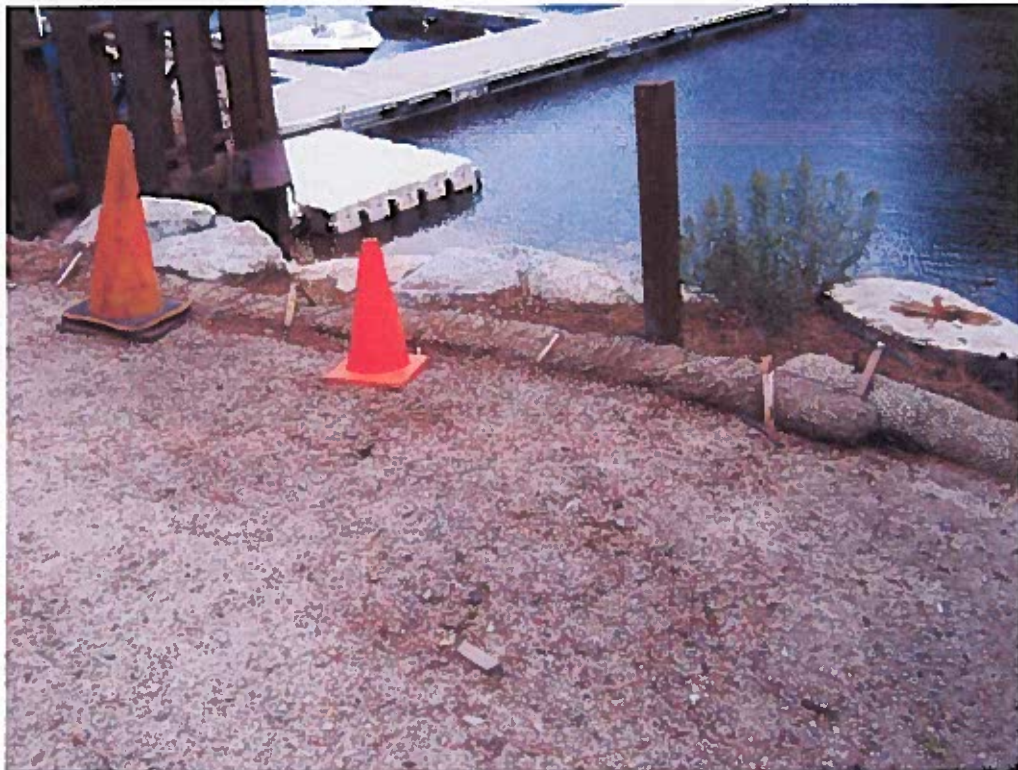
**Photograph 06 - BMP joint is not J-hooked, and the fiber roll section by the pylons has been flattened. This area is by marina office, facing southeast**

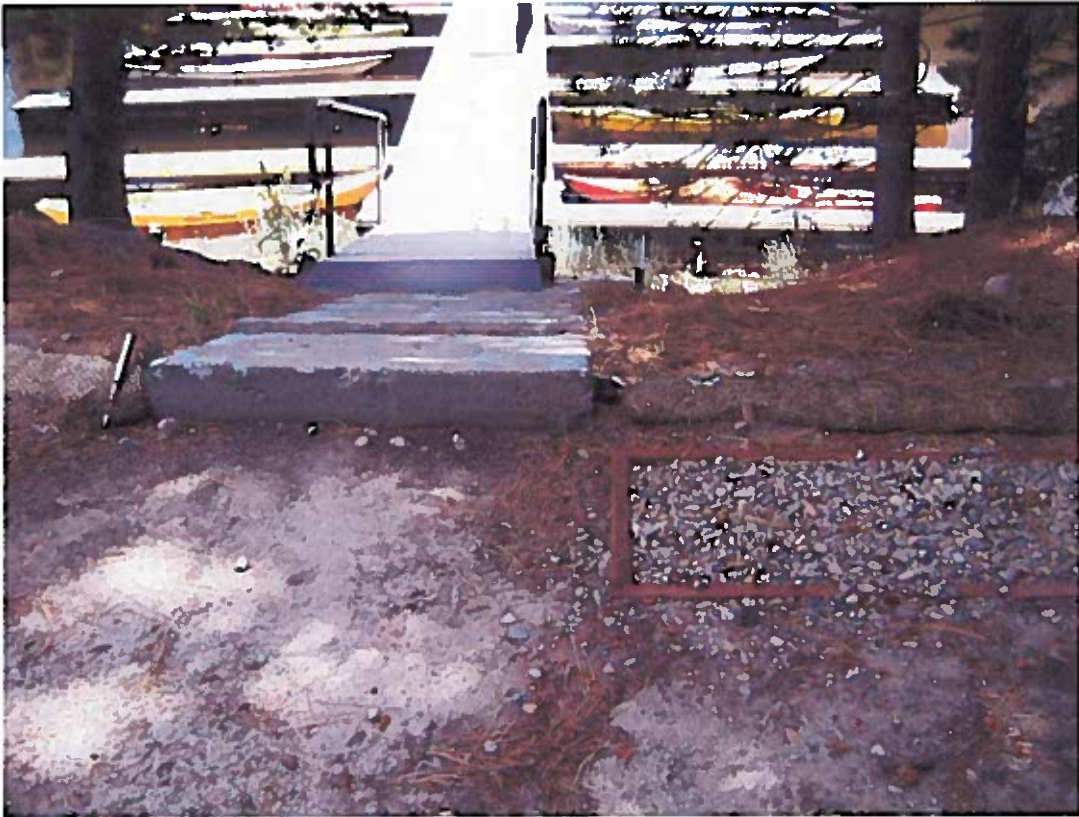
**Photograph 07 - First ramp west of office, facing south. A gap exists between the concrete section of the ramp walkway and the fiber roll to the right (west) of the ramp. Runoff that bypasses the drainage ditch will flow through this area and into the marina.**

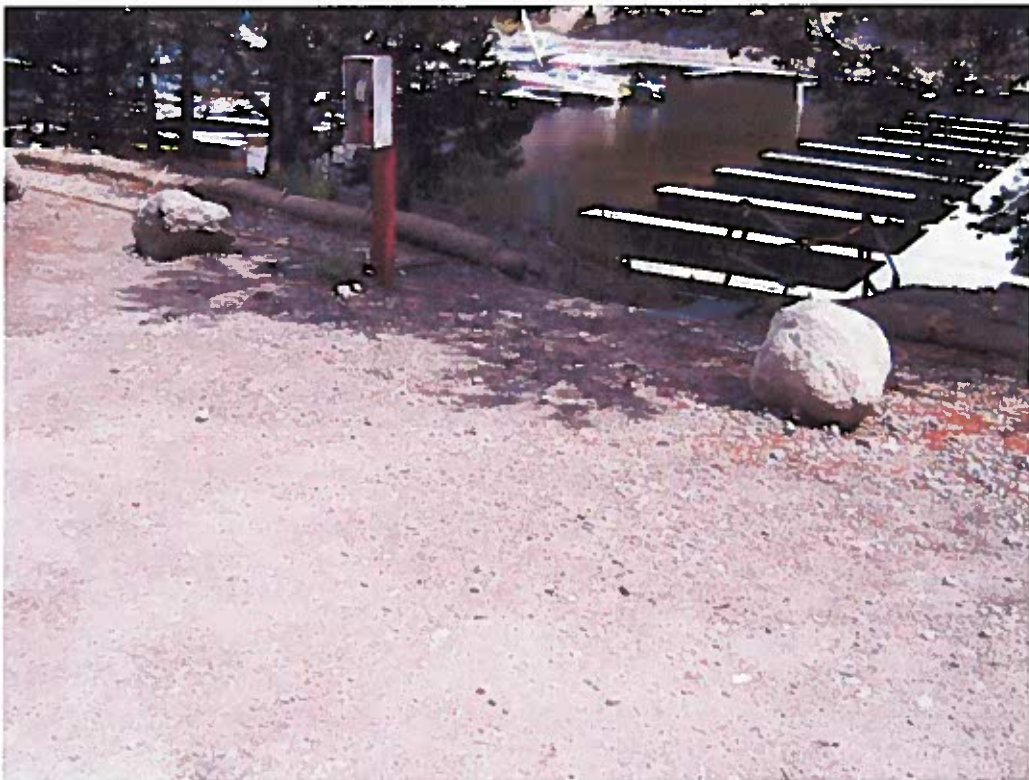
**Photograph 08 - Second ramp west of office, facing southeast. Fiber rolls do not prevent runoff from going down ramp and into marina.**

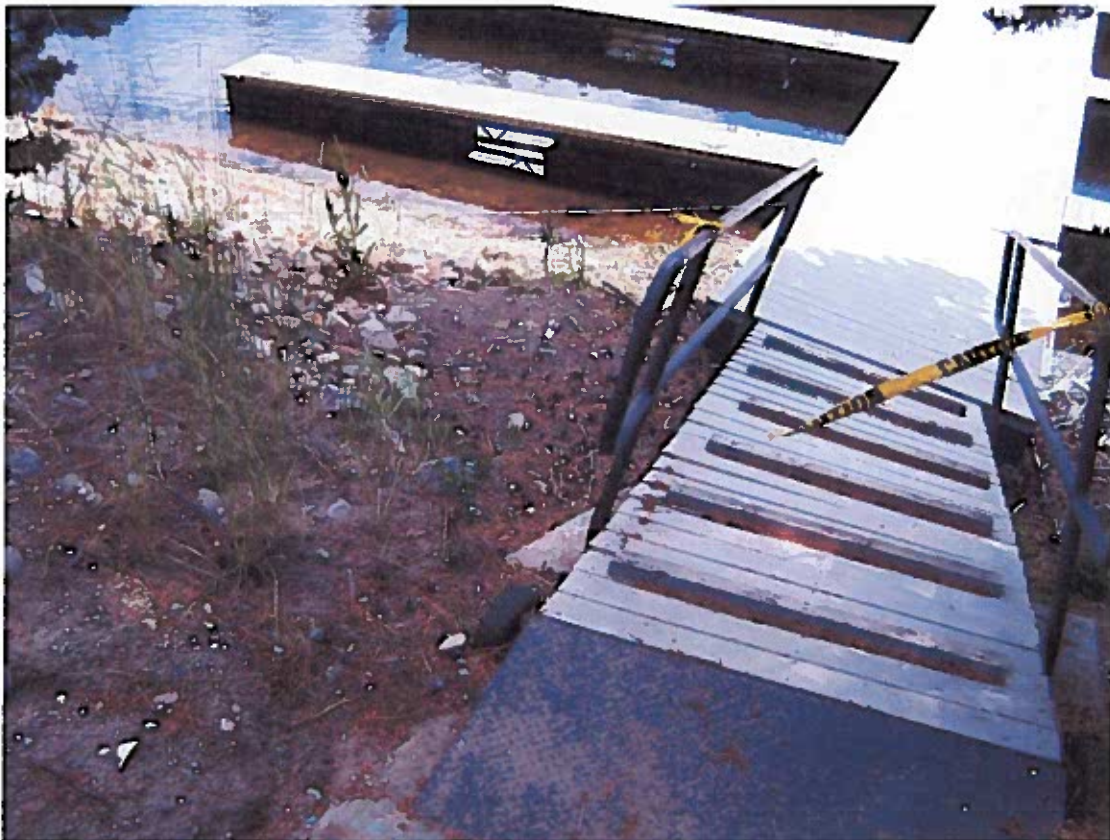
Photo 12 - Moving closer to the second ramp west of office to get a further close up within the marina area. Note that the fiber rolls were unable to prevent runoff from going down ramp and into marina, as evidenced by a sediment deposit in marina located on left (east) side of ramp.

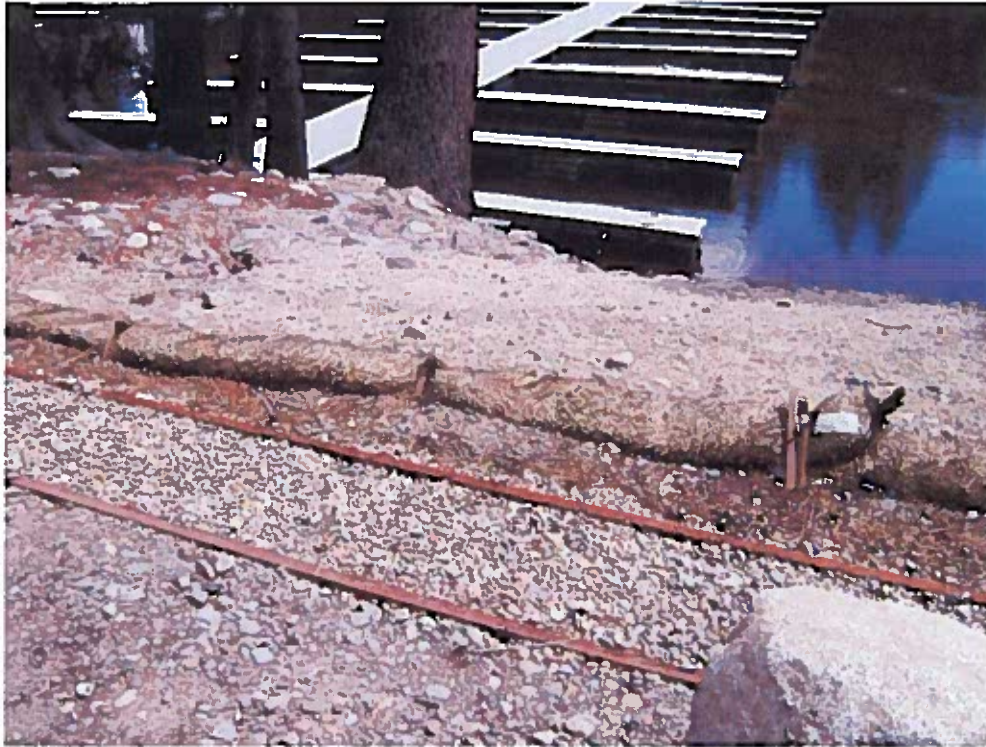
**Photograph 15 - About 20 feet west of 2nd ramp west from office, looking south-southeast. The fiber roll has been degraded degraded and flattened.**

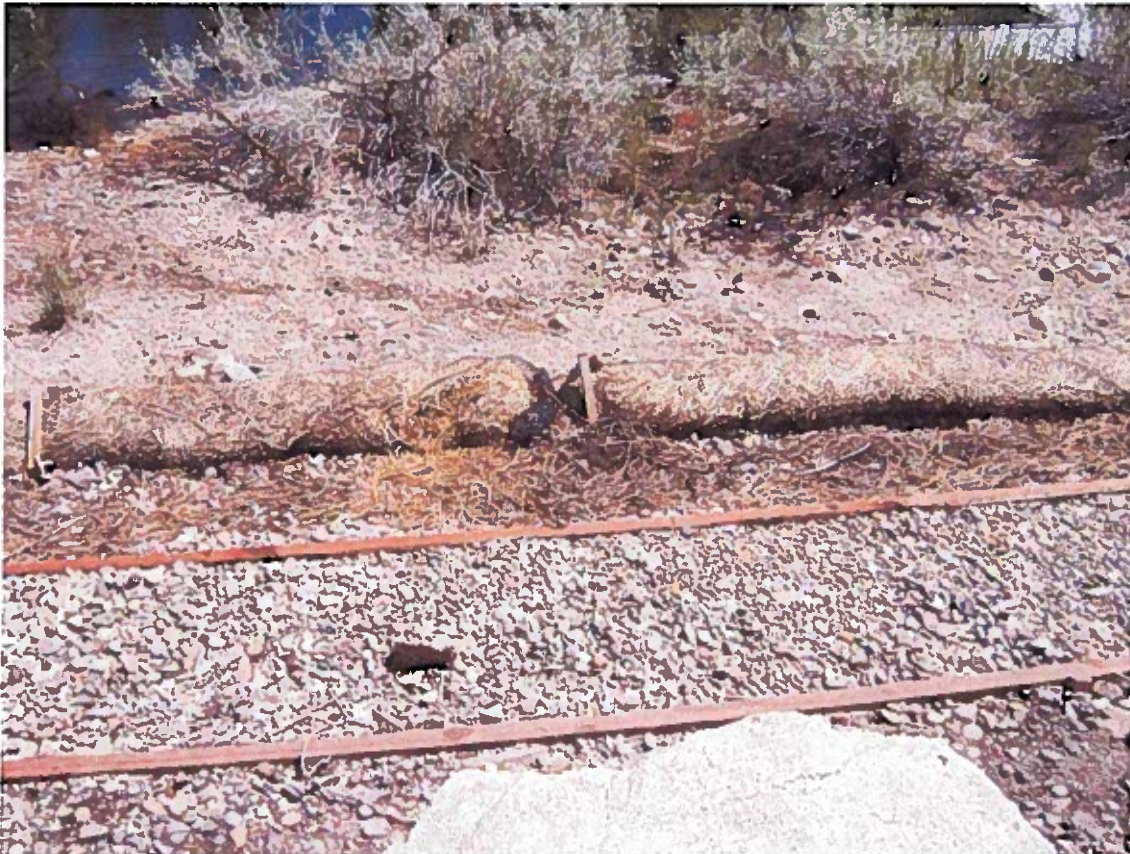
**Photograph 16 - Mid-way between 2nd and 3rd ramps west from the office. The fiber rolls have been slightly flattened, and the ends have not been overlapped leaving a gap between the rolls where stormwater runoff can become concentrated.**

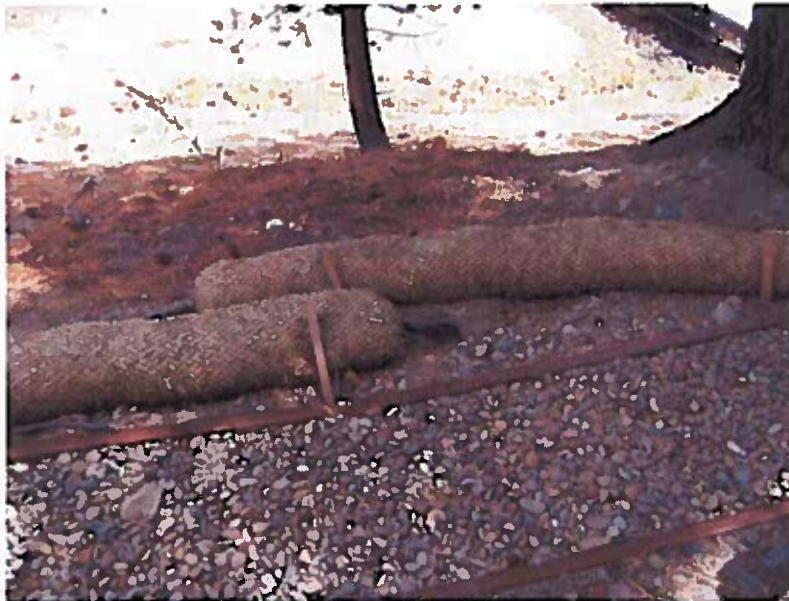
Photograph 19 - West of photo 18, between 3rd and 4th ramps west of office. In this area, the fiber rolls are adequately overlapped.

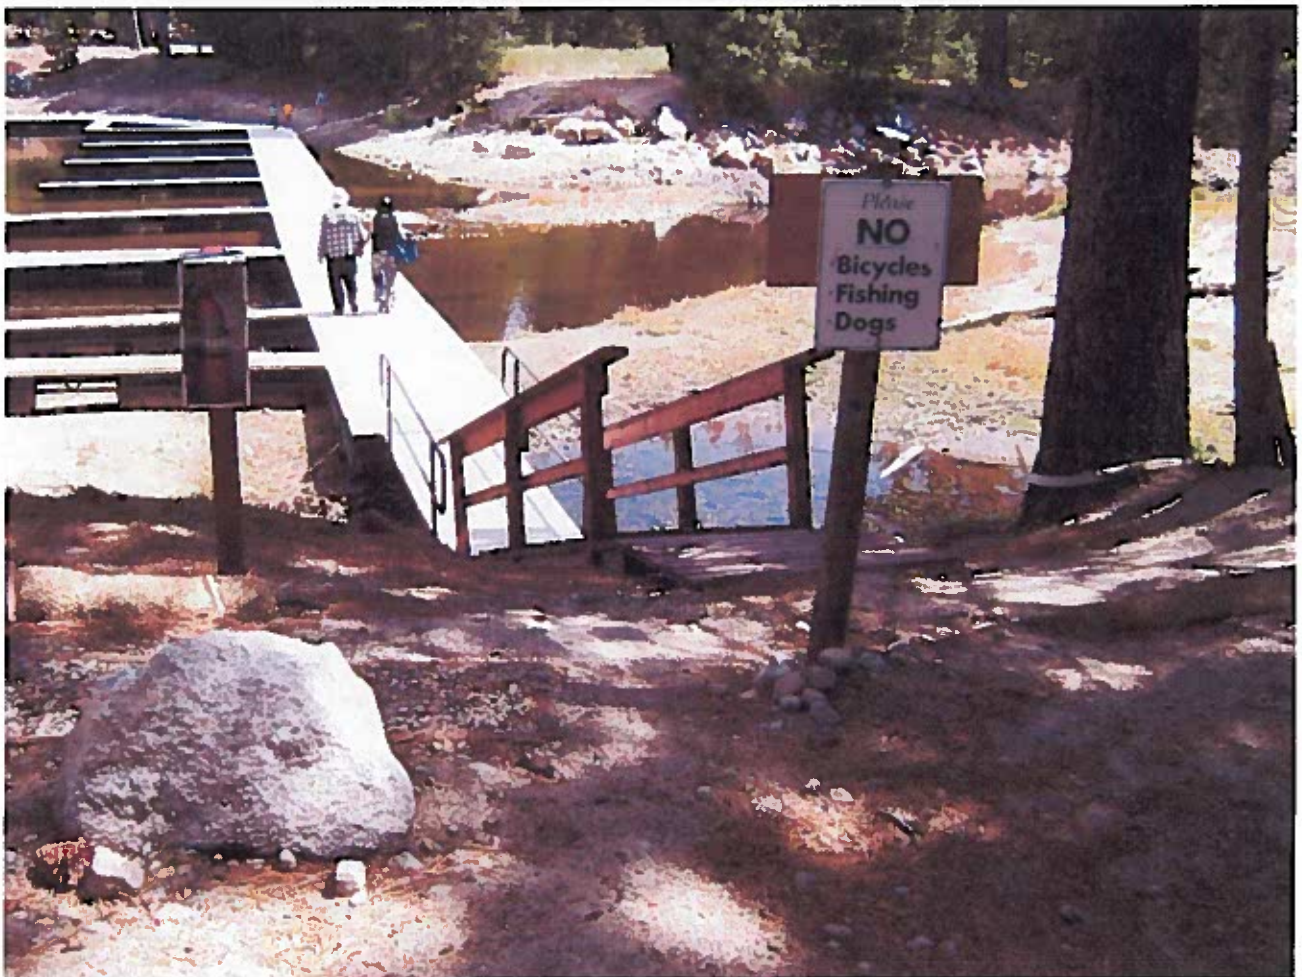
Photograph 20 - At 4th walkway ramp west of office. Fiber rolls to left of walkway and above walkway are not J-hooked at their ends. Fiber roll on right and above walkway is inundated with sediment, and evidence of sediment discharge into the marina is apparent.

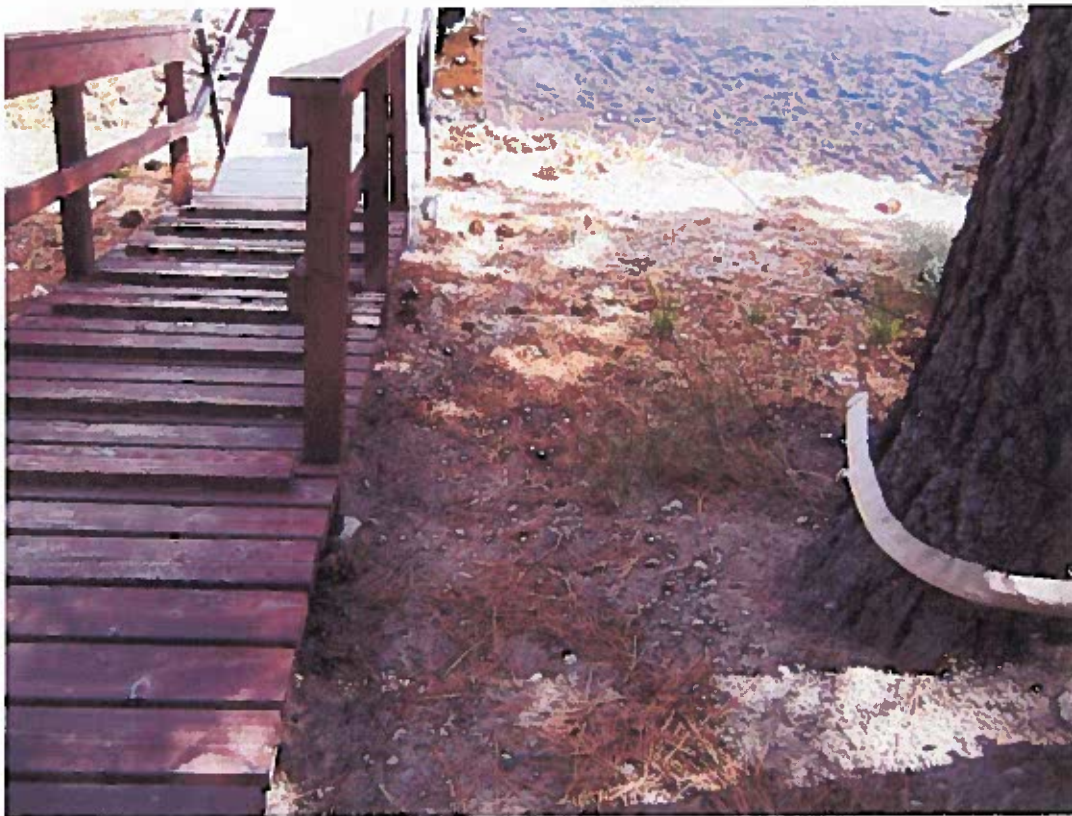
Photograph 24 - Close-up of the west side of the 4<sup>th</sup> walkway shown in Photograph No. 20. Evidence of erosion can be observed.

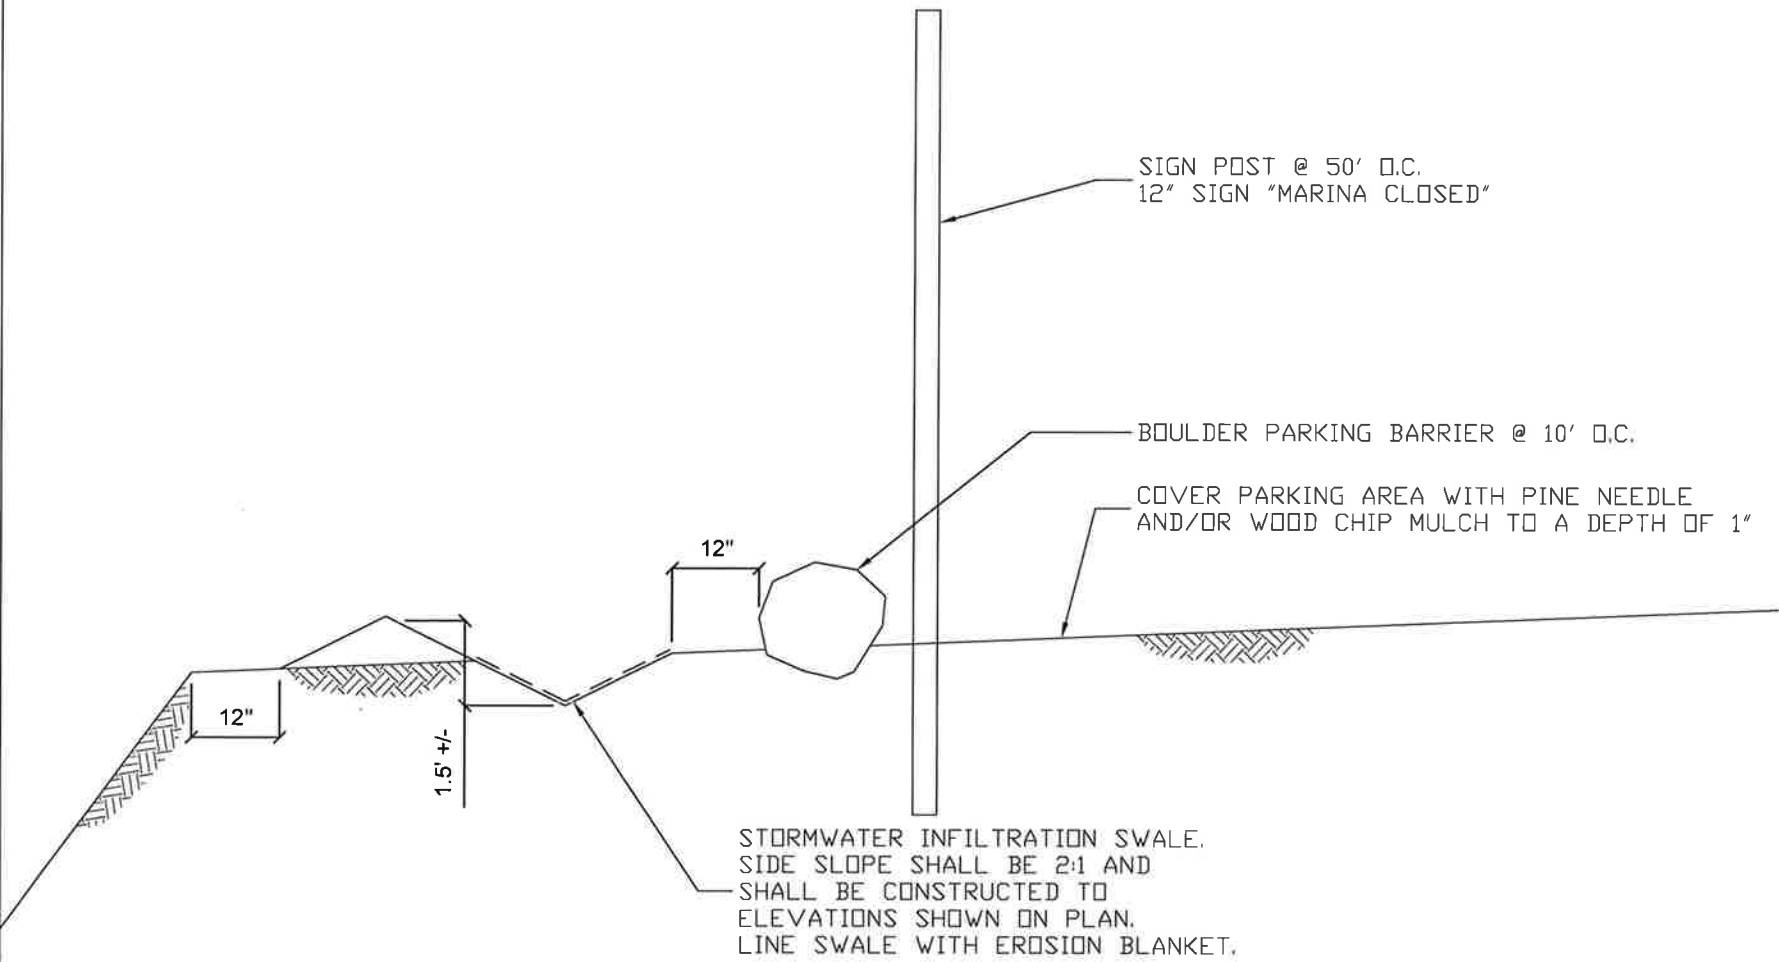
STORMWATER INFILTRATION SWALE.  
SIDE SLOPE SHALL BE 2:1 AND  
SHALL BE CONSTRUCTED TO  
ELEVATIONS SHOWN ON PLAN.  
LINE SWALE WITH EROSION BLANKET.

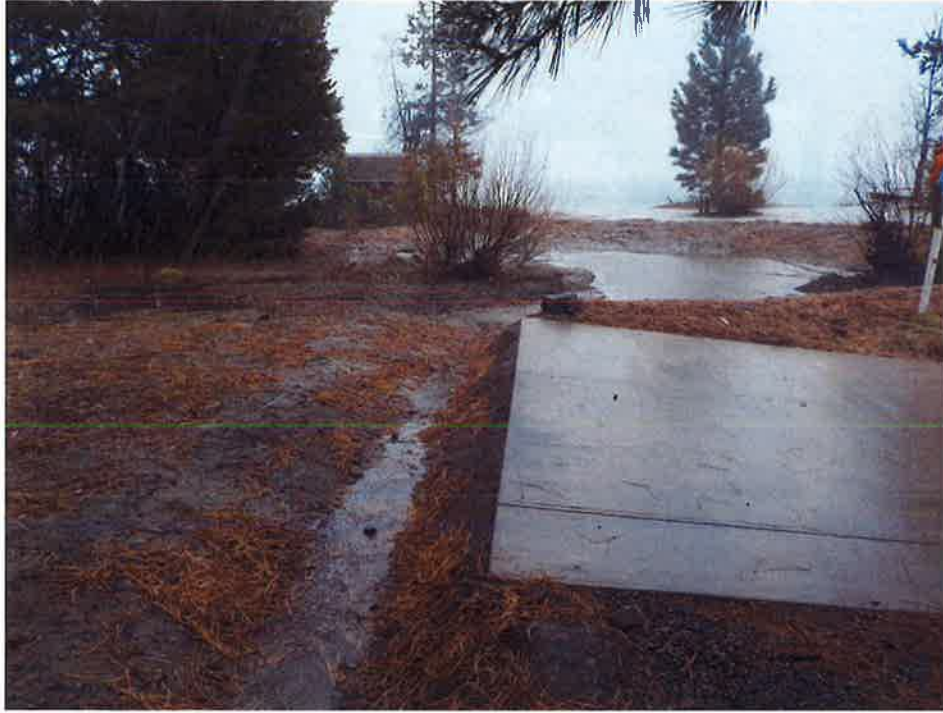
December 10, 2015. Swale and basin looking east at STA EAST 2+00 following precipitation.

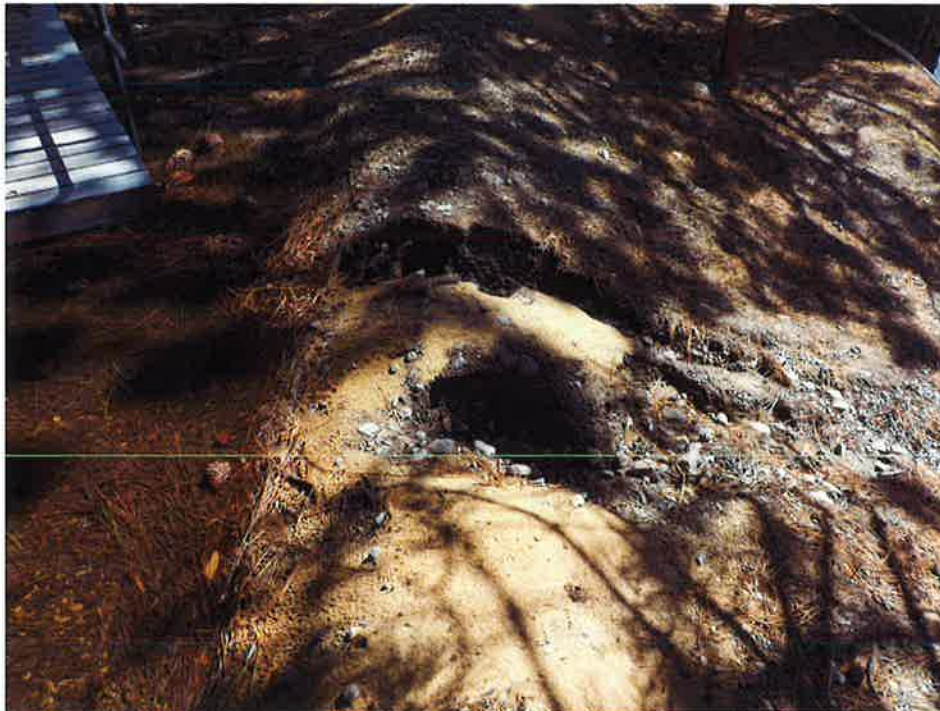
On April 20, 2017 inspections identified a portion of the berm approximately two feet in length at STA 2+40 which was eroded. This segment of berm was repaired at the time of discovery. The remaining swale, berm and basins were found to be substantially functional to retain runoff from future 2 inch design precipitation events. Between November 1, 2016 and April 20, 2017 El Dorado County recorded four rain events in Tahoma which exceeded 2 inches of rain in 24-hours. The largest 24-hour rainstorm was on December 10, 2016 and recorded 3.87 inches of rainfall which possibly resulted in the breach of the berm at STA 2+40. Regardless of the breach and in spite of the extreme rainfall, since runoff is directed towards the east the majority of the swales, berms and basins performed in accordance with the design. Based on these observations twice annual inspections are appropriate but should be supplemented by inspections following extreme rainfall events which exceed the design criteria used to size the BMPs.

April 20, 2017. Eroded berm at STA WEST 2+40 looking east showing signs where water surface elevation in swale exceeded the design water surface elevation causing erosion.

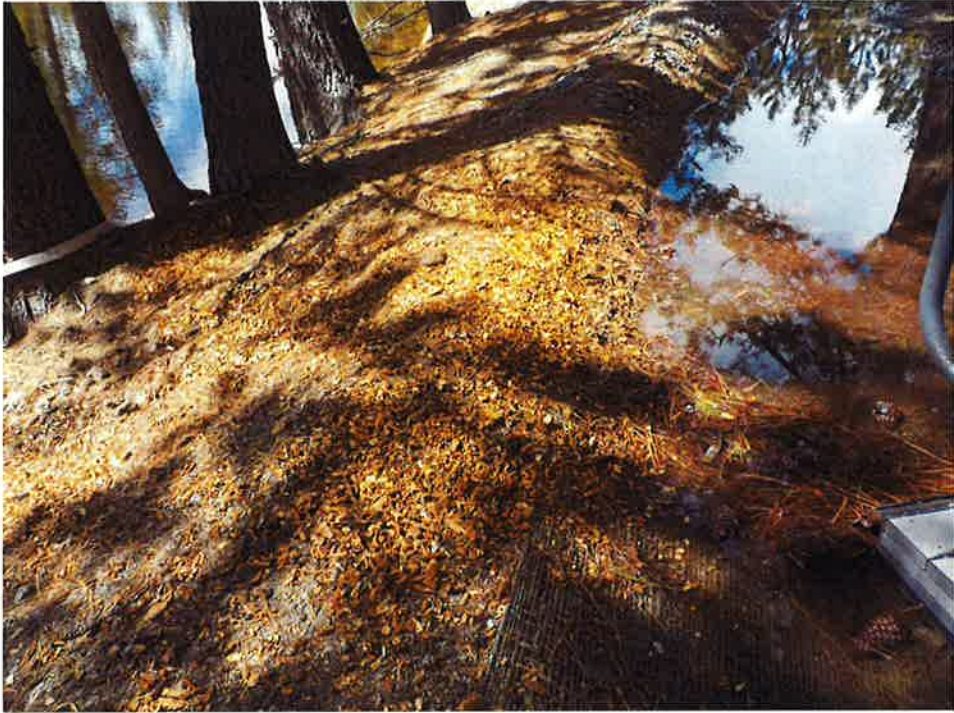
April 20, 2017. Repair of eroded berm at STA WEST 2+40 looking west.
