# **TOTAL MAXIMUM DAILY LOAD FOR BEDDED SEDIMENT**

## **BLACKWOOD CREEK, PLACER COUNTY**

*Draft Staff Report*

**August 2007**

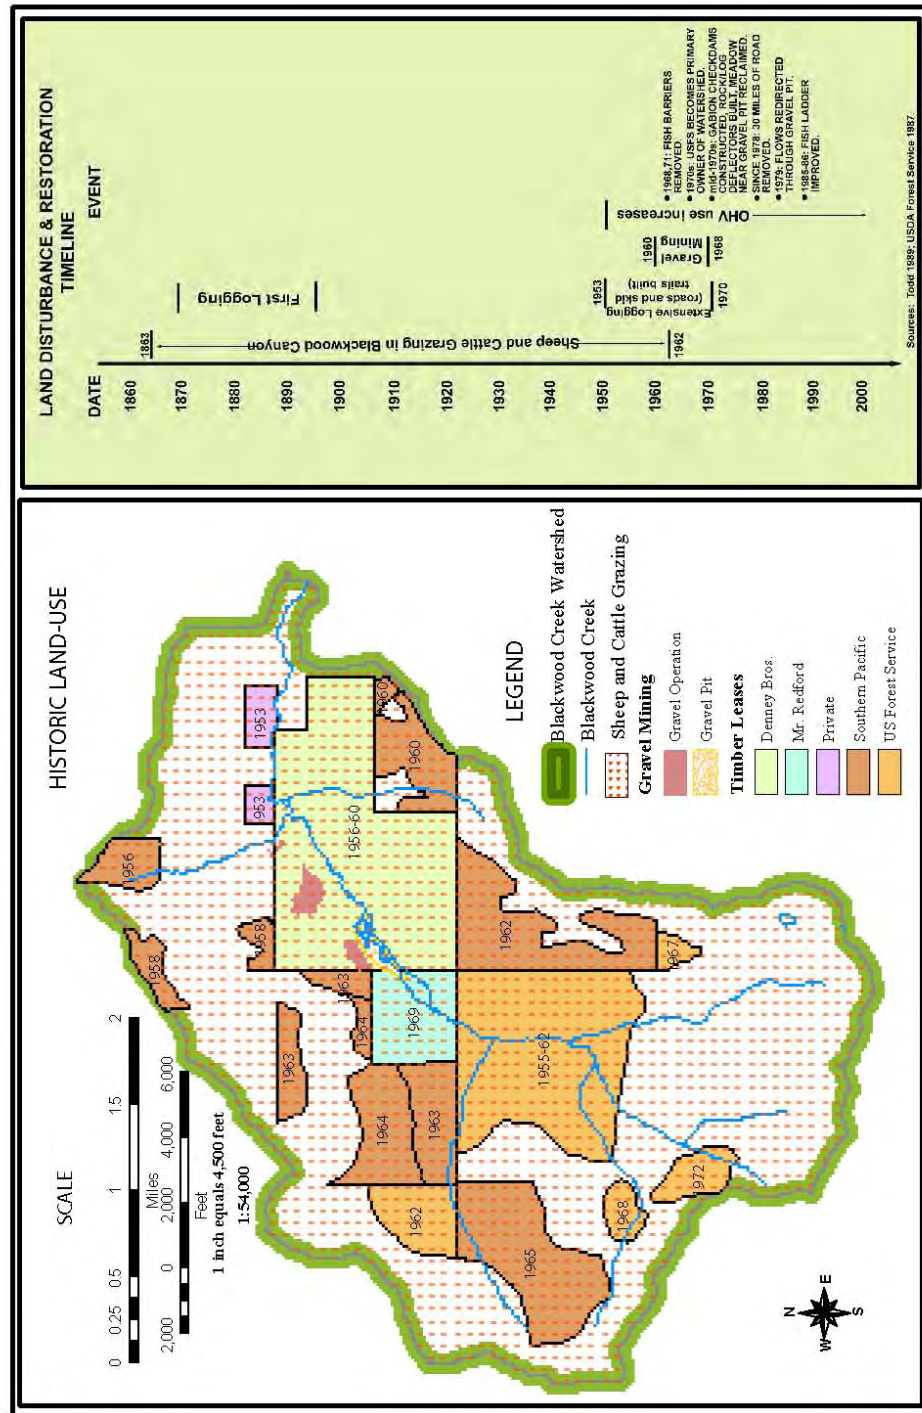
**Figure 2**  
Historic Land Use in Blackwood Creek Watershed  
[Figure modified from Swanson (2003)]

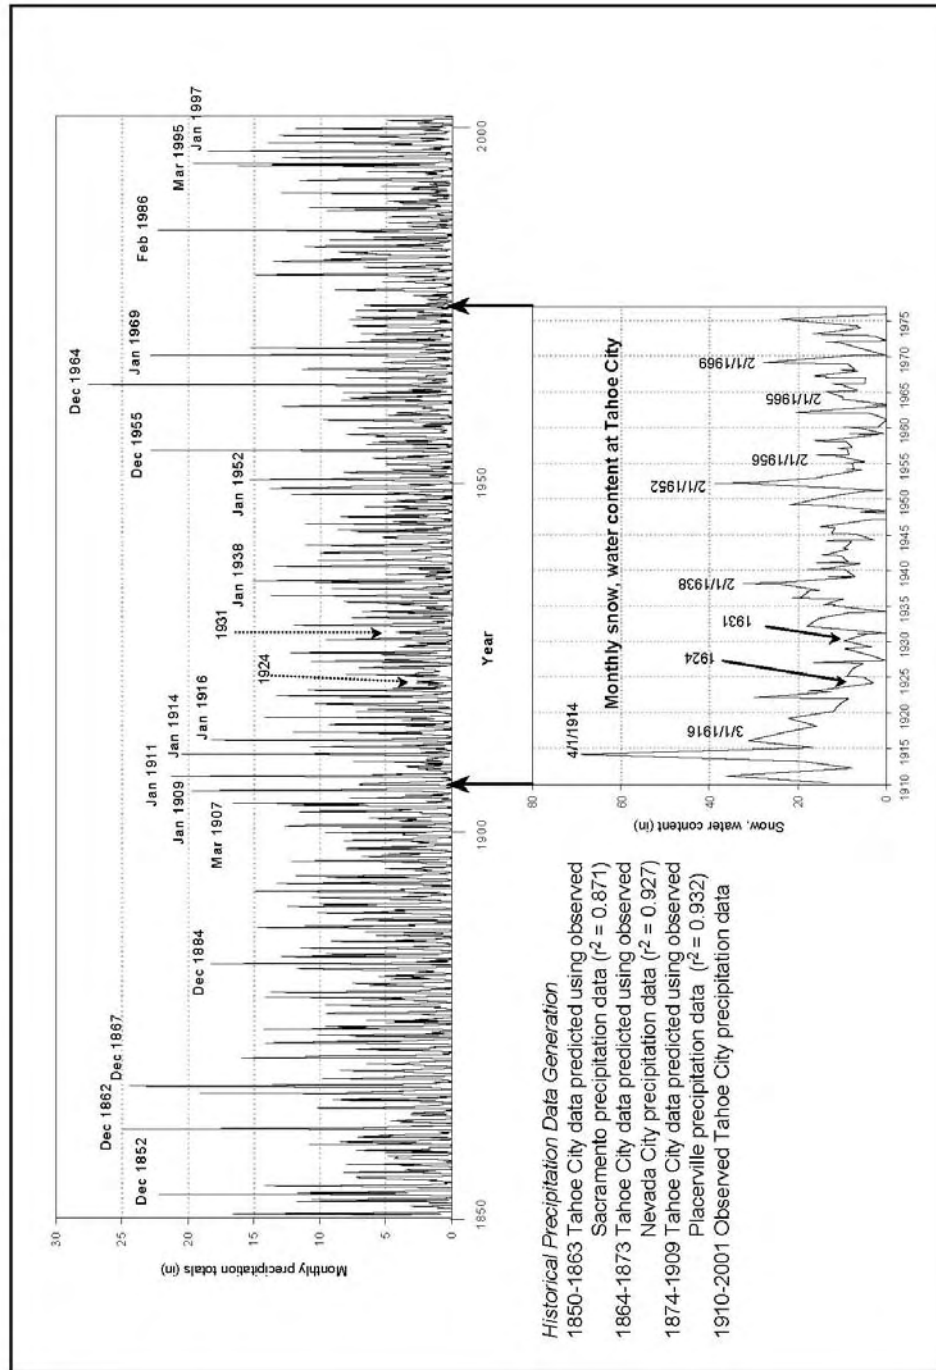
**Figure 3**  
Summary of Monthly Tahoe City Precipitation Values, 1850 - 2001  
[Figure from Swanson (2003)]

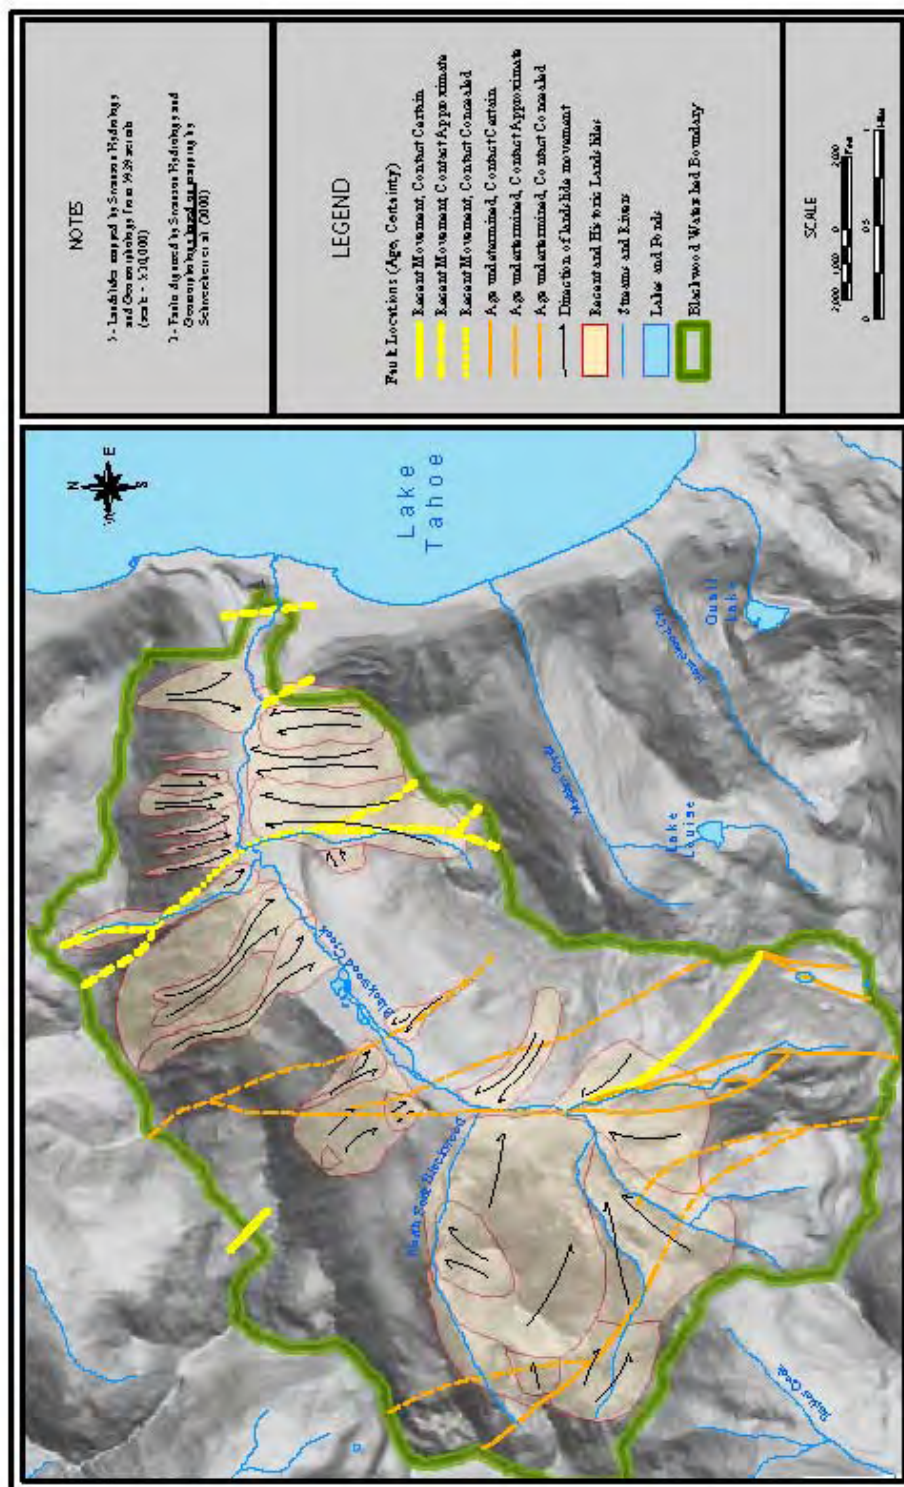
**Figure 4**  
Landslides and Faulting in Blackwood Watershed  
[Figure modified from Swanson (2003)]

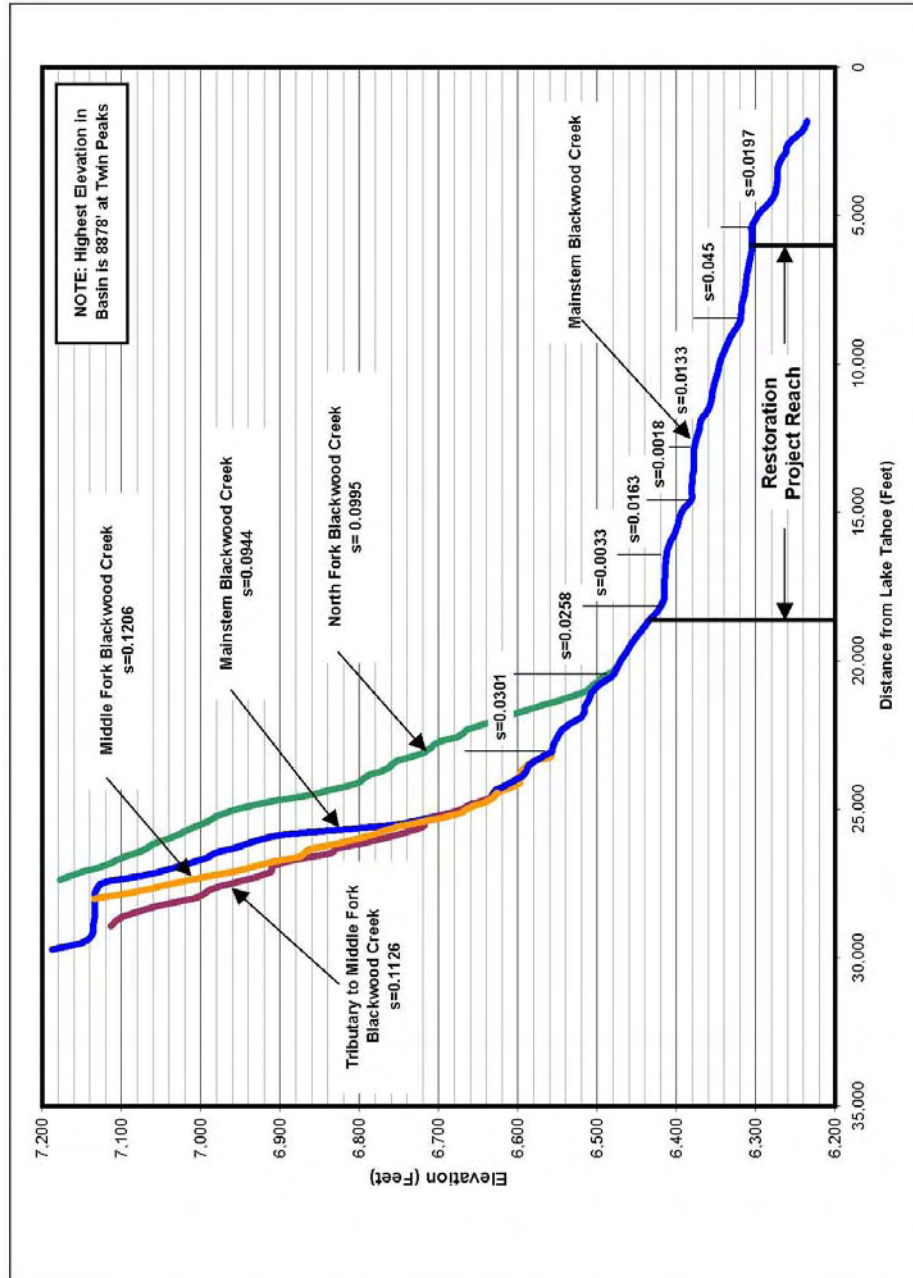
**Figure 5**  
Profile of Blackwood Creek and Tributaries  
[Figure modified from Swanson (2003)]

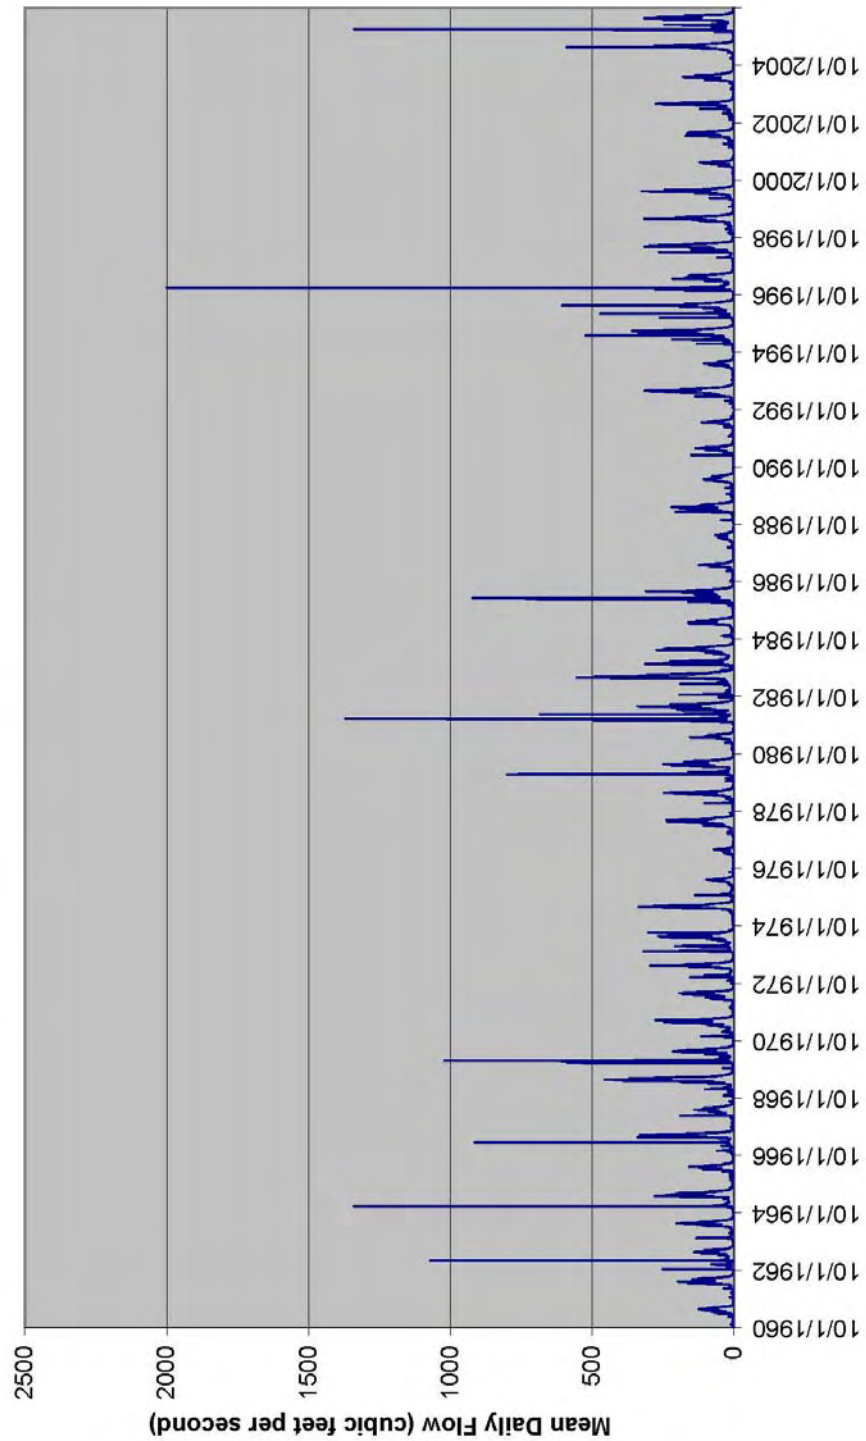
**Figure 6**  
Mean Daily Flows in Blackwood Creek, Water Years 1961 - 2006  
[Data from USGS: Site 10336660]

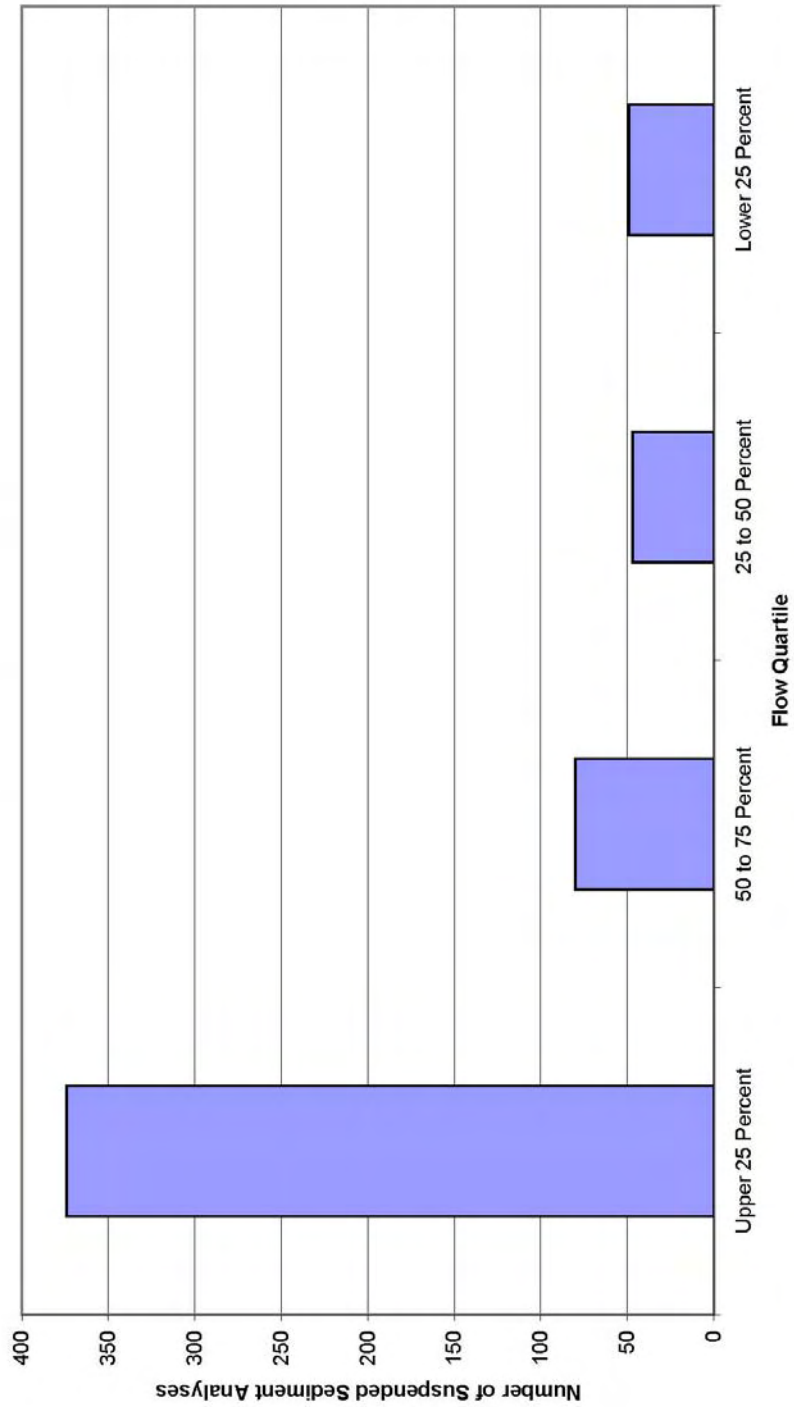
**Figure 7**  
Frequency of Suspended Sediment Analyses Versus Flow Quartile  
[Data from USGS: Site 10336660]  
[Suspended Sediment Data Collected from 1974 to 2004]

Because of the sample bias toward high flow events, the 90<sup>th</sup> percentile of SSC data would also be biased high. For that reason, Staff does not believe that the existing SSC dataset is appropriate for comparison to the suspended sediment numeric WQO. To characterize the 90<sup>th</sup> percentile value, the dataset should be representative of conditions throughout the year. Therefore, to interpret compliance with the suspended sediment WQO, Staff used sediment rating relationships developed by Simon et al. (2003) to predict the 90<sup>th</sup> percentile SSC for Blackwood Creek.

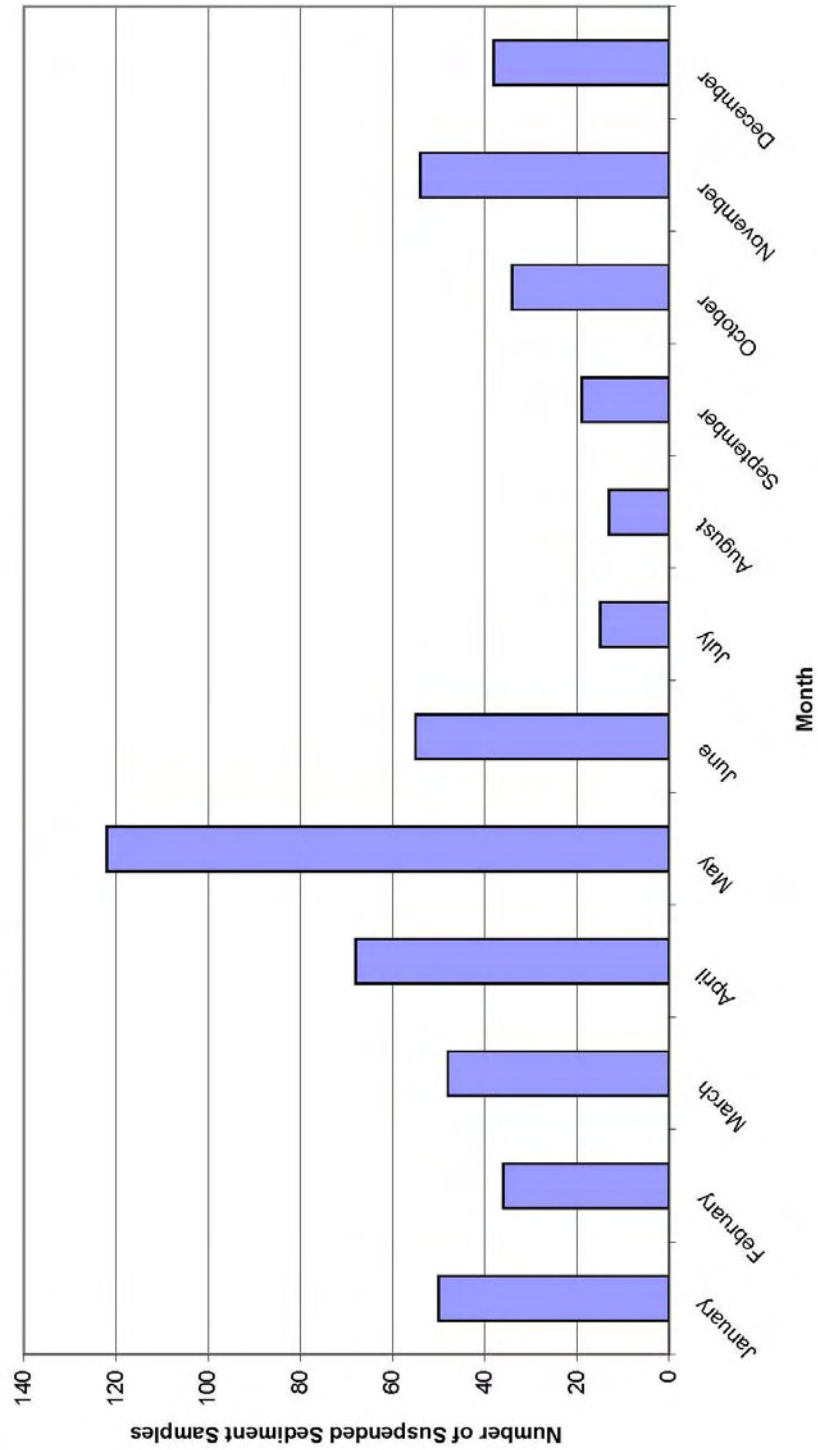
**Figure 8**  
Frequency of Suspended Sediment Analyses Versus Month  
[Data from USGS: Site 10336660]  
[Suspended Sediment Data Collected from 1974 to 2004]

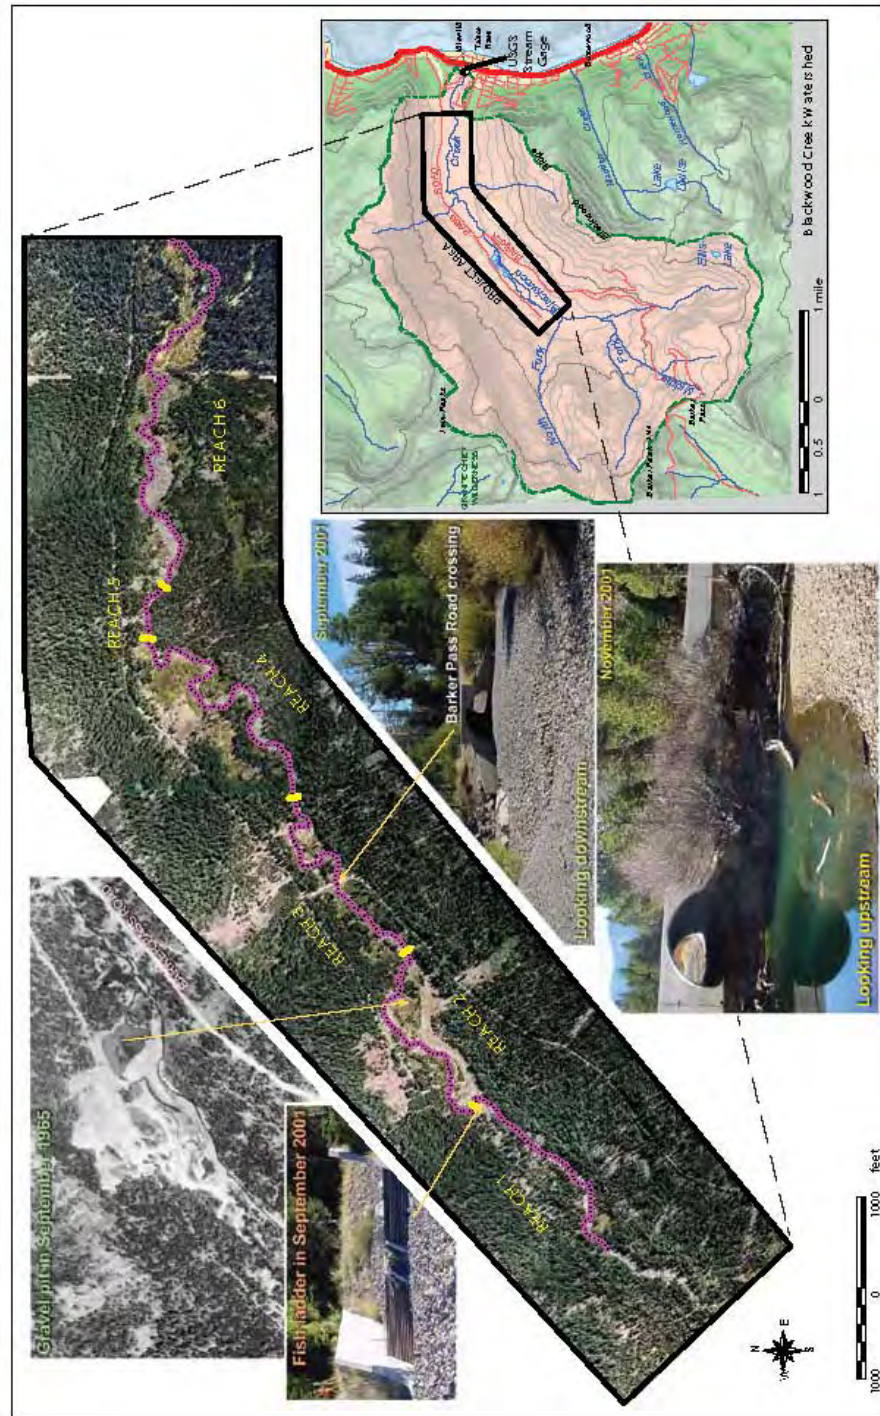
**Figure 9**  
Former Gravel Pit, Former Fish Ladder,  
Former Low Water Crossing, and Designated Reach Breaks  
[Figure modified from Swanson (2003)]

In light of the complex history of the fishery in Blackwood Creek and Lake Tahoe, the fishery seemed to be in good condition from the 1930s through the 1950s; however, it was also stocked for most of that period. Even in 1971, after almost 10 years of in-stream gravel mining, DFG found the creek to be in fair to good condition. Until recently, two manmade structures likely impaired the MIGR beneficial use: (1) culverts installed at the Barker Pass Road crossing, and (2) the fish ladder at the diversion structure (Figure 9).

porous material during low flows (Tetra Tech, 1999). The USFS removed and replaced the fish ladder in 2001 with a boulder step-pool channel.

- In the fall of 2006, the USFS installed a clear-span bridge to replace the Barker Pass Road crossing, which had consisted of a 7-foot-diameter culvert set in a concrete roadway. Outfall height and water depth were barriers to fish migration. Additionally, high velocity flows that exited the former culvert caused scour and bank erosion downstream of the crossing. The bridge installation included the reconstruction of about 250 lineal feet of channel.

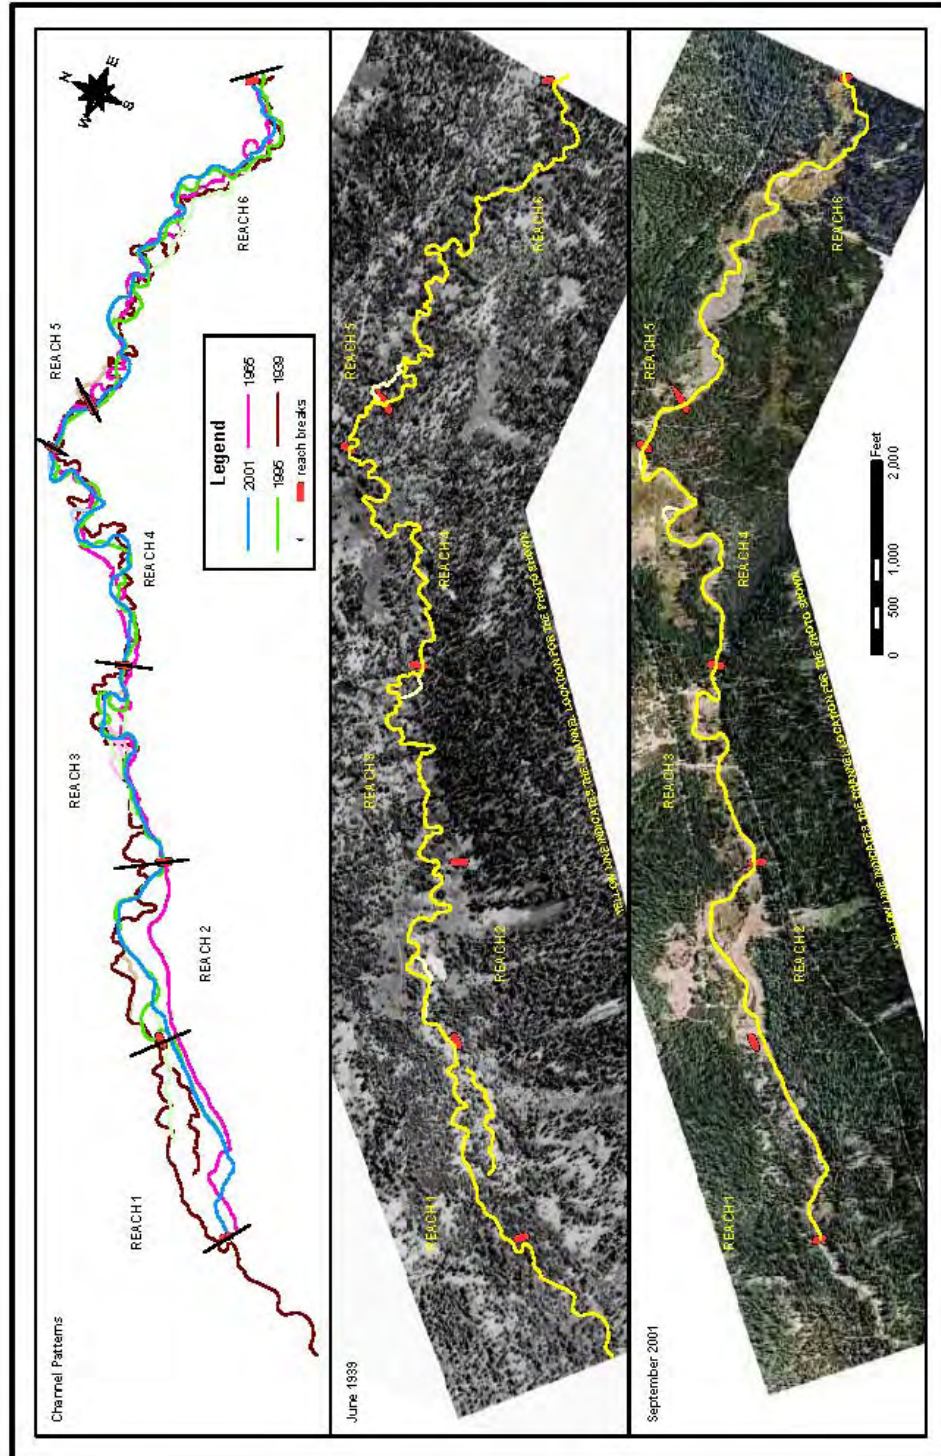
**Figure 10**  
 Historic and Current Channel Patterns of Blackwood Creek  
 [Figure modified from Swanson (2003)]

Aerial photographs from 1939 show Blackwood Creek to be contained in a narrow and meandering channel with a wide, vegetated floodplain in the area below where the gravel pit would be constructed. DFG records in 1934 and 1938 described Blackwood Creek as “a wonderful stream for spawning in normal winters,” having “good natural propagation,” and containing “beautiful pools, continuous shade, and shelter.” Swanson considers the 1939 aerial photograph (Figure 10) to show a relatively undisturbed channel condition and indicates that the channel was resilient, stating:

Prior to human disturbance, Blackwood Creek channel was narrow and sinuous. In 1939, the average channel sinuosity in the project area was 1.6, with a maximum sinuosity of 1.77 recorded in Reach 3. Therefore, throughout the project area, the long-term average channel sinuosity should be greater than or equal to 1.6 by year 20 following restoration. It should be noted that flow conditions could significantly affect this long term target. It is possible that a large rain on snow event could damage engineered controls or drought conditions may not provide sufficient flows to develop increased sinuosity.

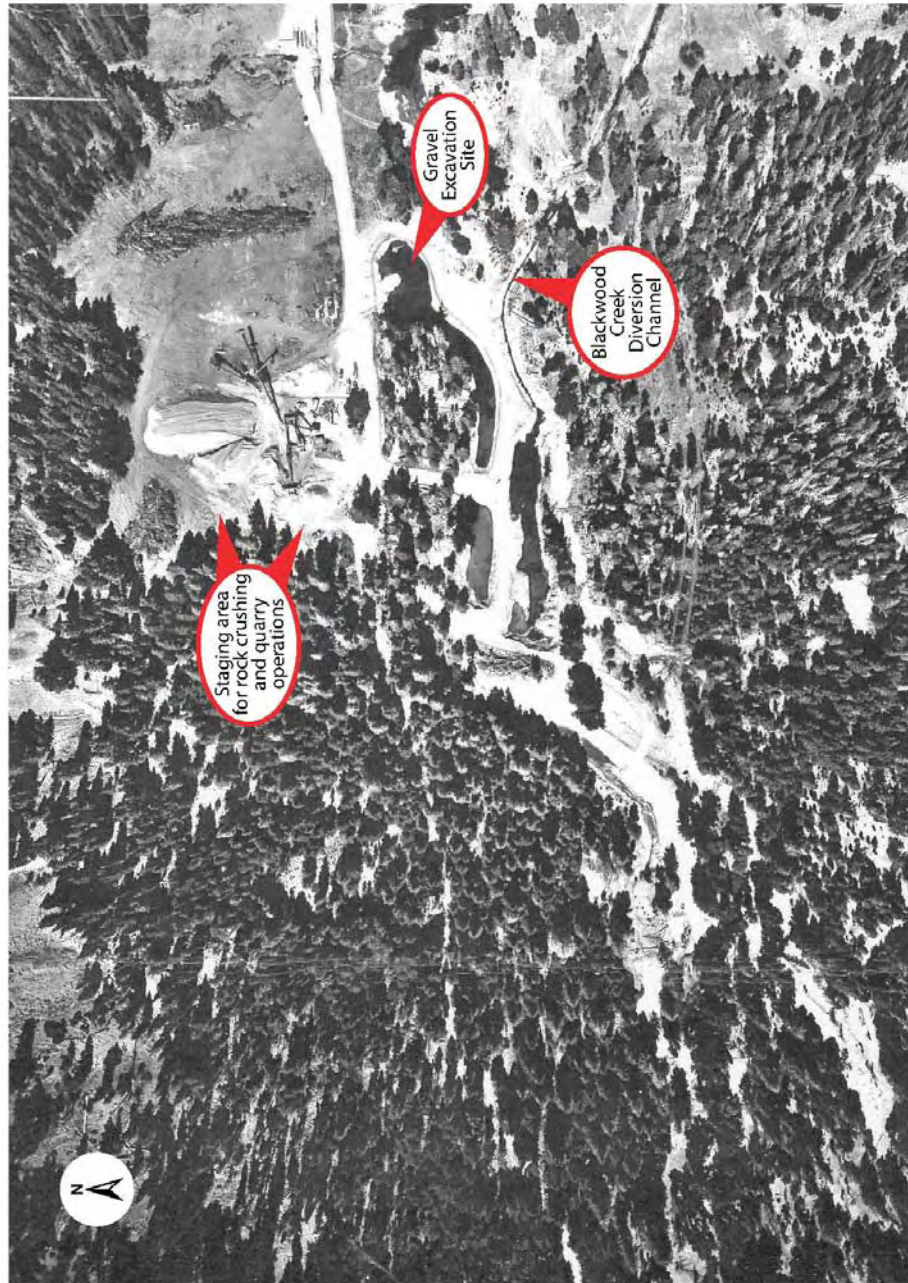
**Figure 11**  
Gravel Pit Operations and Diversion Channel  
[Source: Department of Fish and Game Files]  
Photo Dated August 4, 1960

As explained by Todd (1989), Blackwood Creek was placed in a 2000-foot-long diversion channel south of the gravel pit. Bed and channel scour of the fragile, freshly exposed soils of the diversion channel is believed to have been a very large source of sediment. In addition to unstable soils, the diversion channel had a steeper gradient and was more efficient at moving water and sediment than the historic channel. Swanson (2003) noted:

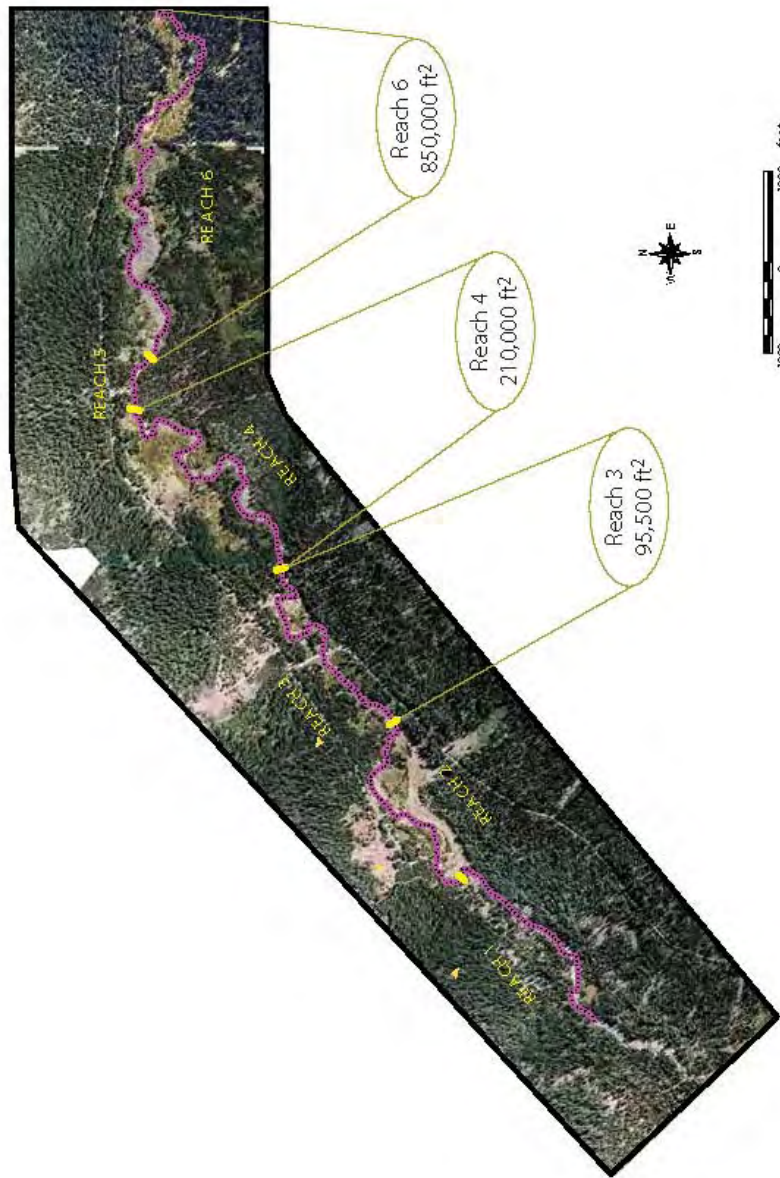
**Figure 12**  
Location and Estimates of Excess Bedded Sediment  
[Figure modified from Swanson (2003)]
