**UNITED STATES DEPARTMENT OF THE INTERIOR
BUREAU OF LAND MANAGEMENT
NEEDLES FIELD OFFICE**

Horse Thief Springs Riparian Area Restoration
and Public Use Management Program -
Supplemental Environmental Project
Molycorp Consent Agreement

Completion Report/Status Report
2008 Scheduled Tasks

Horse Thief Springs Work Plan

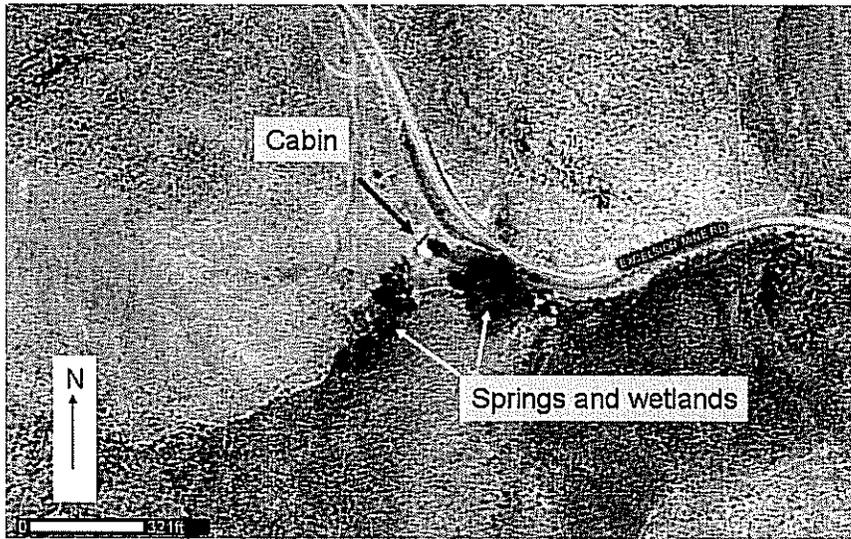
Figure 1. Site Map

The Horse Thief Springs site is located at the northern base of the Kingston Range, San Bernardino County, California in Township 19 North, Range 10 East, Section 3 (Latitude 35.77174 degrees and Longitude -115.88705 degrees. A unique wetland occurs at the site at an elevation of 4,610 feet above mean sea level. This wetland forms a short reach that crosses the study area just east of the abandoned ranch cabin (Figure 1).

The investigation focused on the wetland southeast of the cabin.

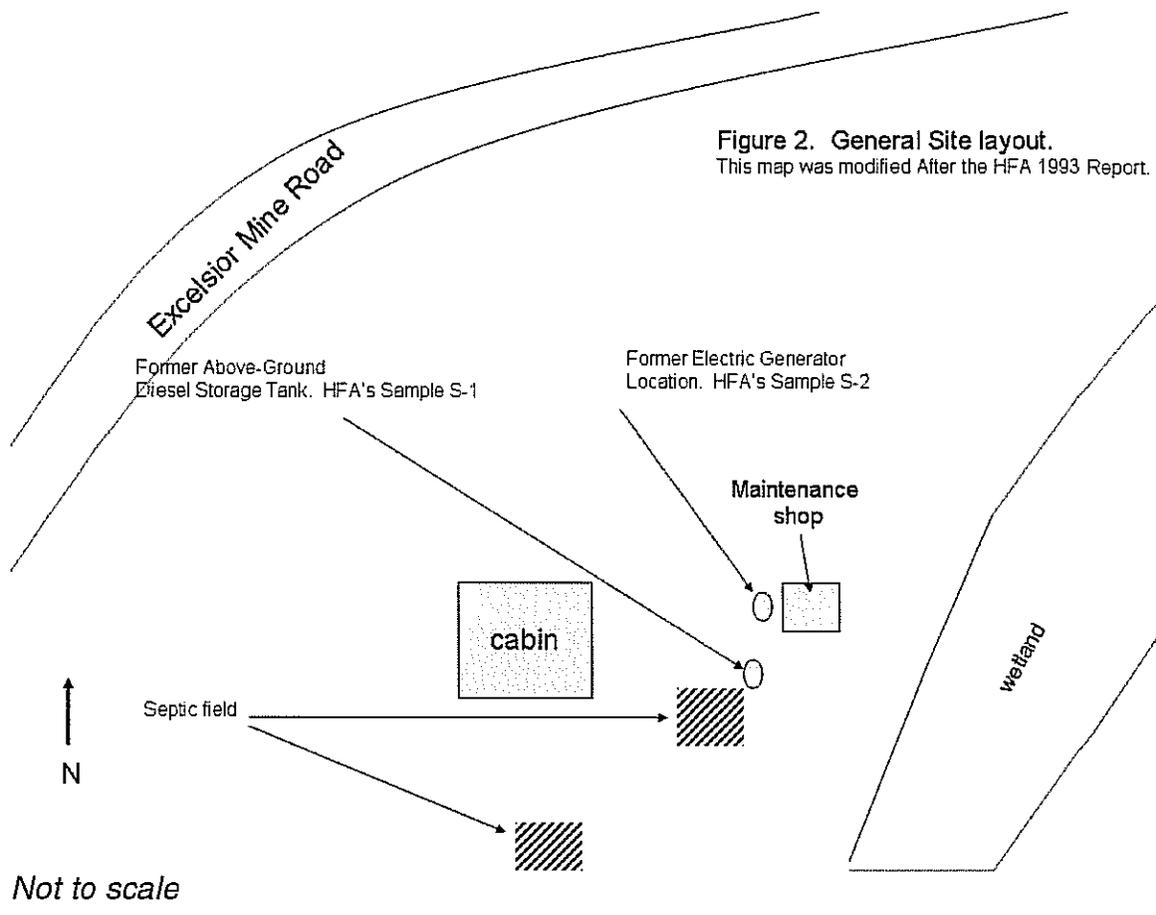
Figure 2. General Site layout.
This map was modified After the HFA 1993 Report.

Figure 2. General Site Layout. The approximate locations of the HFA samples collected in 1993 are shown. Sample S-1 was collected from soils beneath the location of the above ground fuel tanks. Sample S-2 was collected from the "oil pit" associated with the electric generator.

Bernardino County, California to the BLM September 20, 1993 and an updated document of this title September 30, 1993. HFA sampled and analyzed two areas (designated S-1 and S-2), both are located a short distance (approx. 40 feet) southeast and east, respectively, of the cabin. Sample S-1 was collected from the location of the former above ground fuel tanks which were located southwest of the maintenance shop. Sample S-2 was collected from the "oil pit" associated with an electric generator, and was located on the west side of the former maintenance shop. The oil pit was previously subject to an unsupervised attempt to remove hydrocarbon contaminated soils by the ranch lessee. The HFA sample results conclude that petroleum contamination remained in both areas (Table 1). HFA estimated less than 20 cubic yards remain, and this estimate includes unintentional mixing of clean soils which occurs during a removal. HFA also proposed to investigate the former electrical generator shed, the location of a single drum of waste engine oil adjacent to (east) of HFA's sample S-1 (Figure 2) and other equipment storage areas to determine the degree of contamination; however, this investigation was never implemented. Ultimately, the extent of soil contamination was not determined by the time of KRE's grazing and cabin leases were terminated in 1997 and 1999. To date, no further soil sampling or contaminated soil removal has been done.

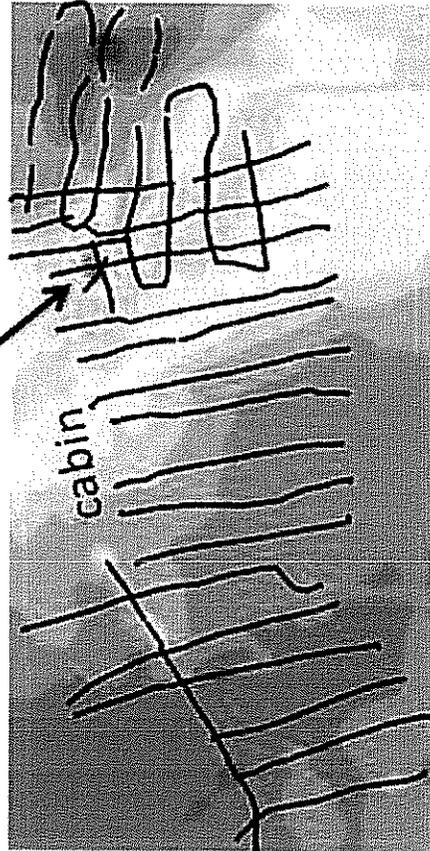
A resistive anomaly is found in the area of the maintenance shop (figure 3 and 4), and is considered to be the area of the previous soil removal. The cause for this anomaly is the backfill material used to fill the removal pit is sandier relative to the surrounding soil thereby producing a good EM contrast. The signature of this anomaly weakens with lower EM frequency (figure 4) suggesting a relative shallow depth.

Figure 3. The EM's 47k Hz located a resistive anomaly at the location of the previous soil removal that occurred near the Maintenance shop

The EM survey was conducted along a grid of parallel transects 3 to 5-meters wide. The preliminary EM results were assessed in the field, and augmented with the historical photographs in order to place additional survey lines in the area of the above ground storage tanks and the maintenance shop (figures 3 and 4). The survey lines (black lines) are shown in figures 3 and 4. Several breaks occur in the eastern end of the survey due to the tree canopy interfering with GPS coverage. Two EM frequencies are chosen to illustrate the changes in EM properties at slightly greater depths. The 47k Hz (figure 3) is relatively shallow, and considered to be (less than 0.5m depth). The 7k Hz frequency is considered to illustrate the apparent conductivity at greater depths (approx. 1m to 1.5m).

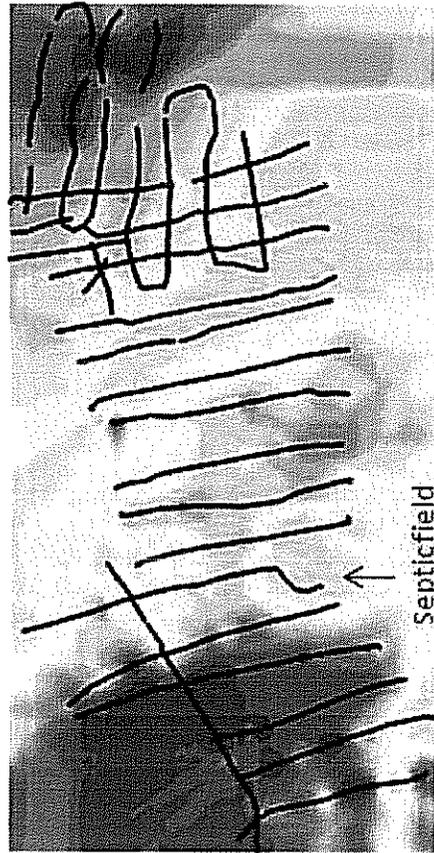
Only one other EM anomaly was found, and occurs in the location of the septic field south of the cabin. A transect line curves around this area to avoid a scrap wood pile containing a metal gate. Nonetheless, a subtle conductive anomaly occurs beneath two adjacent lines in the lower EM frequency (figure 4) suggesting an occurrence at a slightly greater depth.

Figure 4. The EM's 7k Hz map also shows the location of the previous removal and also shows the location of the septic field

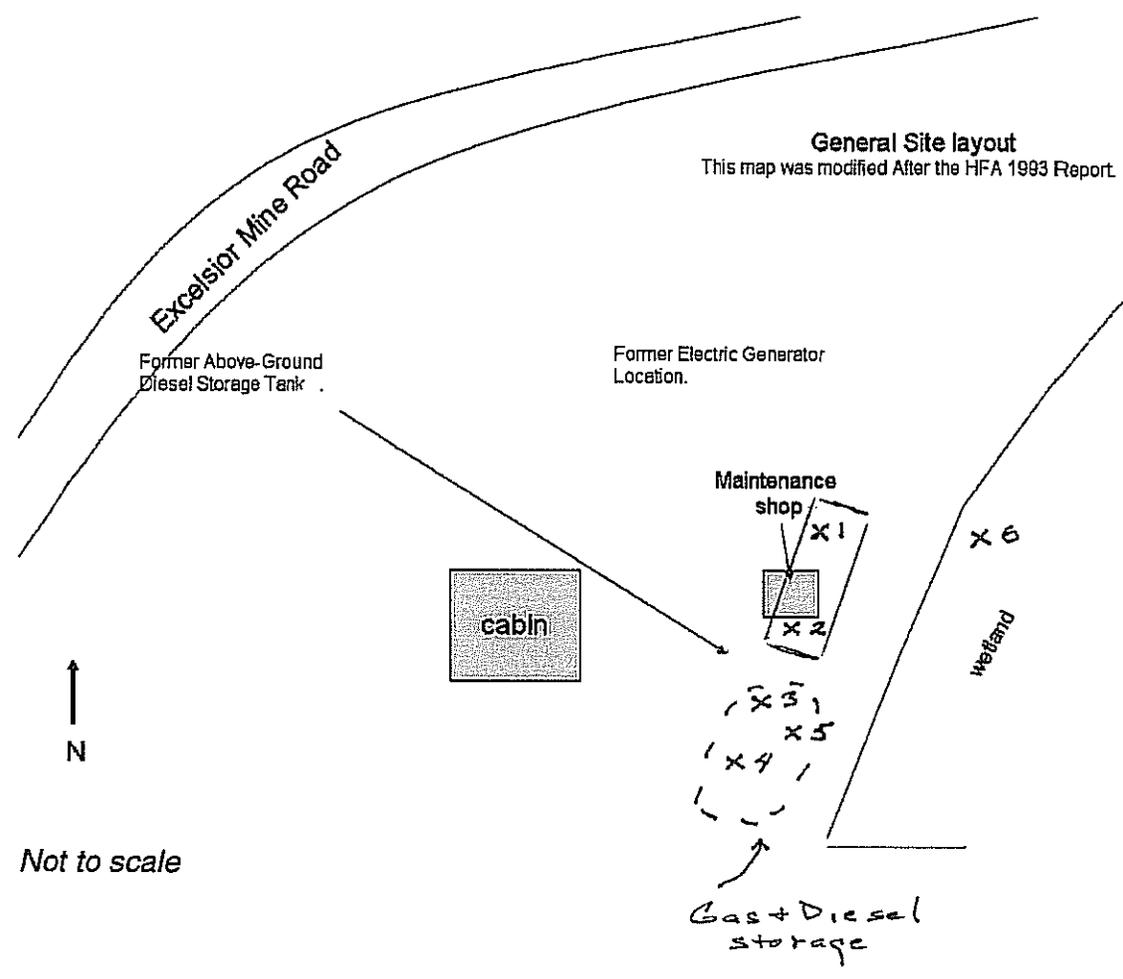
Horse Thief Springs - Solid Matrix Sample Locations

Based upon the findings of Step 1 and 2, the soil sampling focused on the source areas with the greatest potential of producing hydrocarbon contamination impacting the wetland; the maintenance shop/electrical generator and above ground fuel storage tanks (figure 5).

The analytical results of the soil samples indicate the presence of only DRO in the immediate location of the maintenance shop and above ground fuel storage (figure 5). The sample with the greatest DRO concentration (8mg/kg) occurs near the above ground fuel storage tanks. There is no detection of GRO.

Six soil samples were collected from a depth of 1ft and analyzed for Diesel Range Organics (DRO) and Gasoline Range Organics (GRO). The soil type amongst the samples were the same; a sandy silty matrix with some organic plant material.

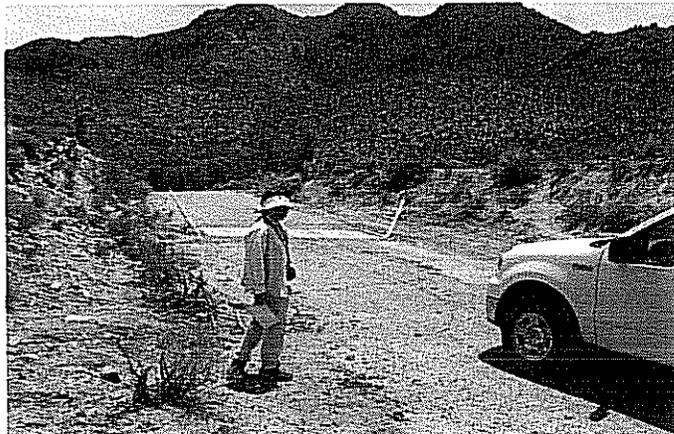
1. Two cattle guards were installed within Excelsior Mine Road in May. The trenches were excavated, and the sections of the cattle guard were installed by a backhoe and the remaining fill dirt was spread along the road by dump truck to fortify the road base.

2. Project associated fence wire, t-posts and cattle guards were purchased in April. Fencing material was transported to the Landing Strip Coral adjacent to the observation site in June.

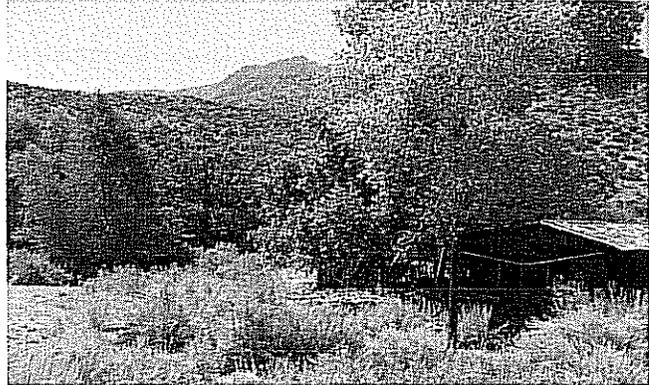
Since the design of the Horse Thief Springs project, the extent of spring seepage has expanded along the western site access road. Consequently, the Bureau of Land Management believes that the planned usage and development of the western access road should not be undertaken in deference to the wetland's natural expansion.

The construction of a visitor parking area at the western site access road entry adjacent Excelsior Mine Road was completed in April.

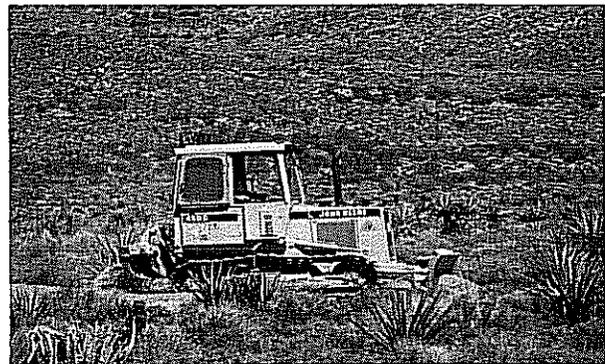
A. Construction of the turnaround on route NN0435 to proper radius was completed during camp site construction in April.

B. Camp site spurs and access roads were completed during camp site construction in April.

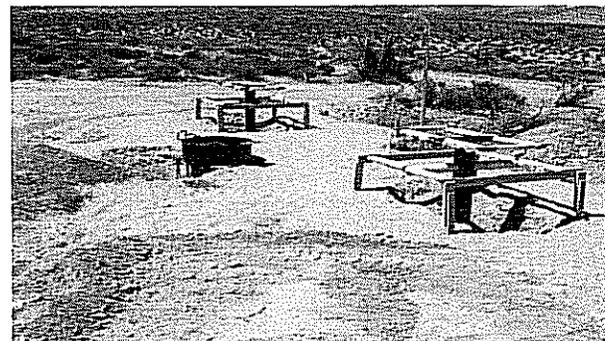
A. Site layout was completed in March.

B. Layout and construction of back-in spurs, tent pads, and community areas were completed in April. All site amenities, (picnic tables, fire rings, and lantern holders) were installed in concrete in April.

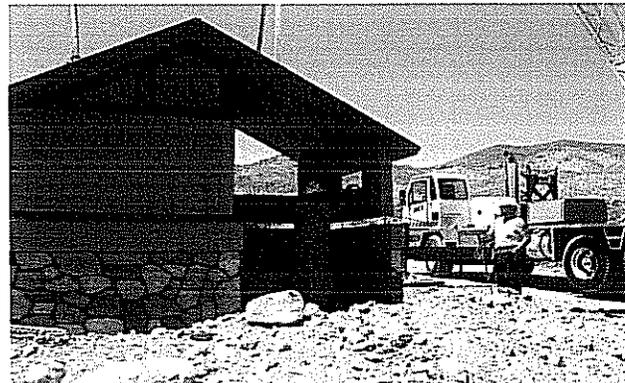
A. Site layout and site clearing was completed in April.

B. The vault toilet was delivered and installed in May. Weekly maintenance of the vault toilet is now being performed by BLM staff.
