Calcium Hydroxide (Activator of Sodium Persulfate)

Evaluation of Calcium Hydroxide for Inclusion in the General WDR Permit

By: Gary Cronk, P.E.
JAG Consulting Group, Inc.

May 15, 2013

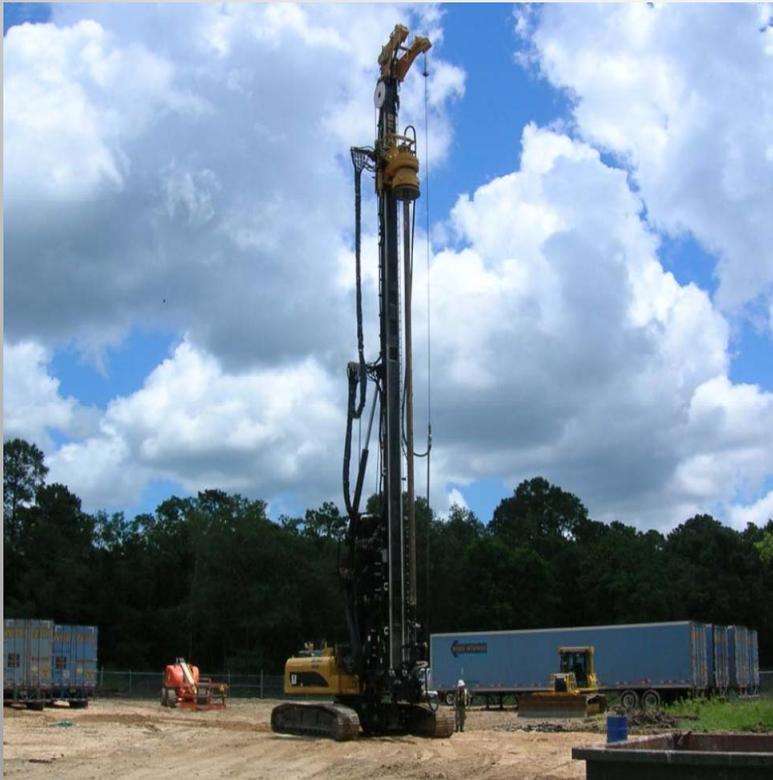
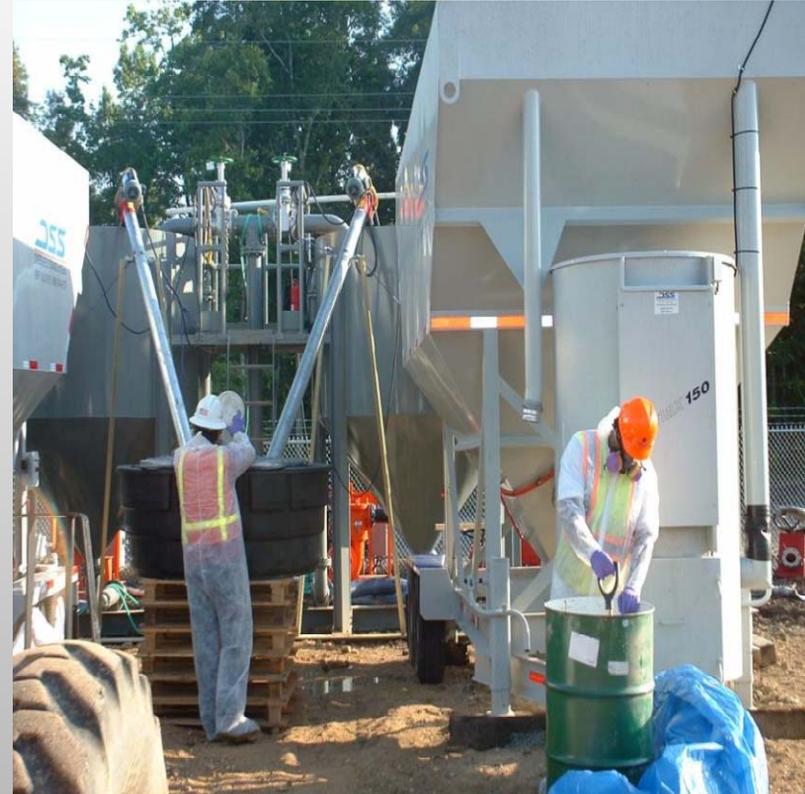
Case Study No. 1 - Turtle Bayou, Texas

- Former waste disposal facility contaminated with over 20 chlorinated VOC compounds and petroleum hydrocarbons
- Mixed 760,000 pounds of persulfate with Hydrated Lime into soil using a large diameter auger excavator
- Confirmation sampling verified a 84% mass reduction of VOCs was attained after 30 days (exceeded goal)

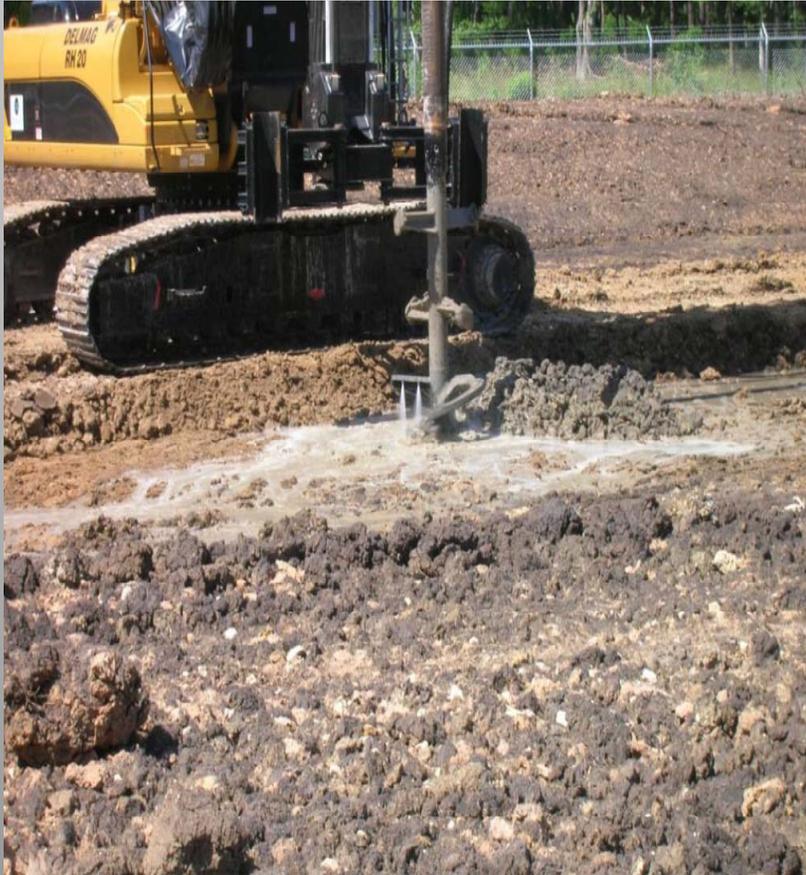
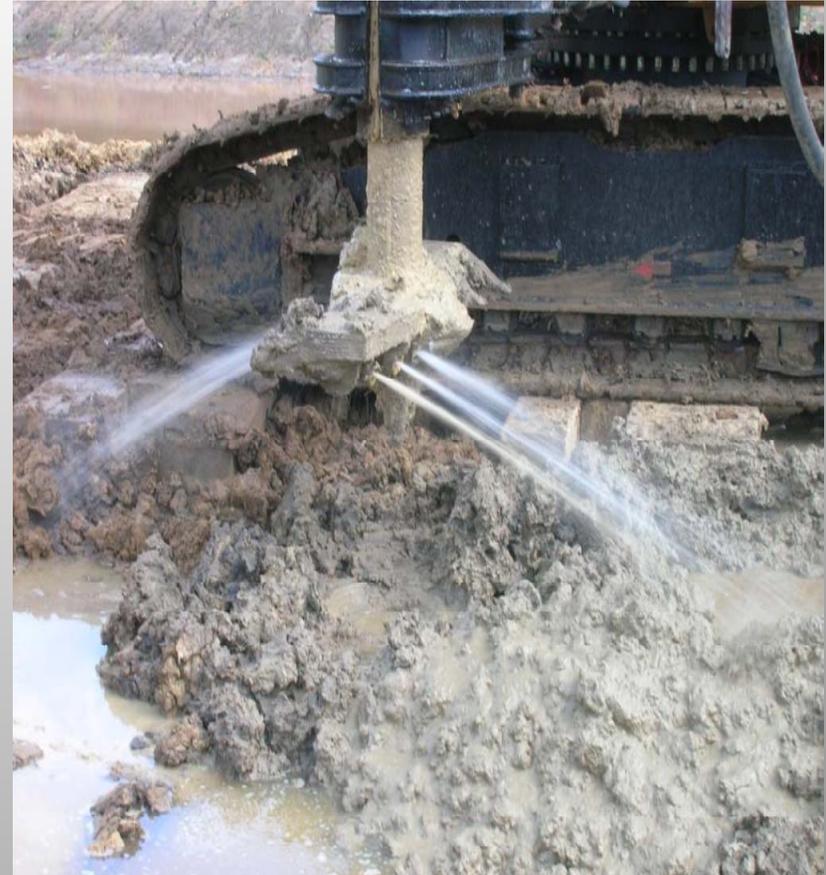
Case Study No. 1 – Mixing Head with Water Nozzle

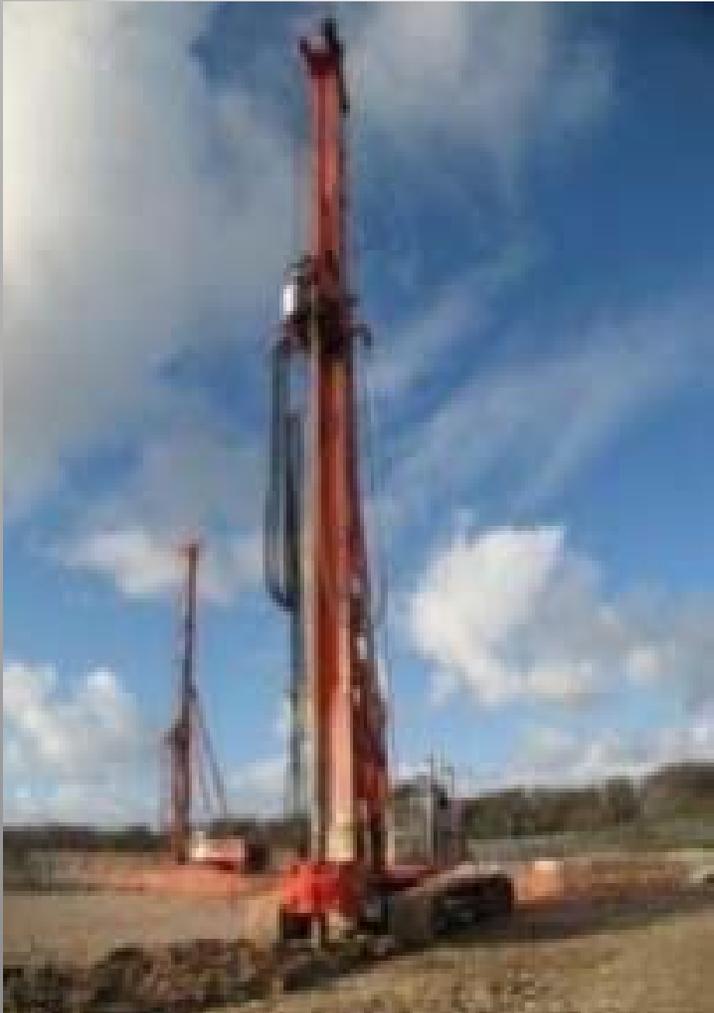
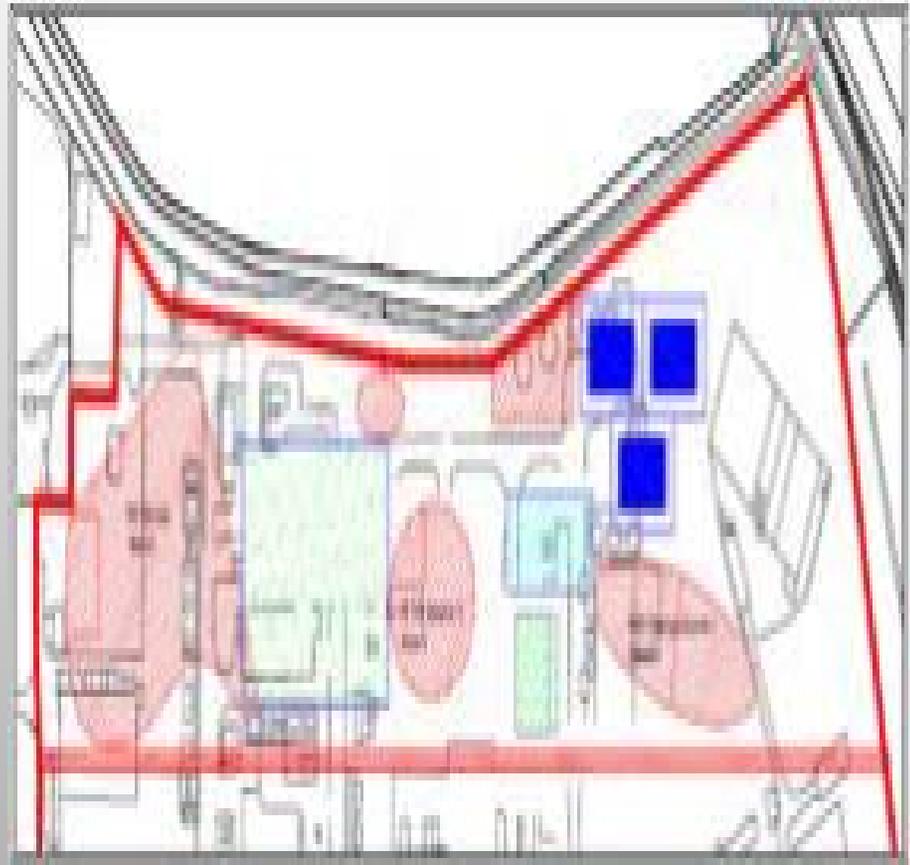
Case Study No. 2. Thornton, England

- Lime activation of persulfate used to treat Chlorobenzenes and Dichlorobenzenes five large areas of soil contamination (7,300 m²)
- Used continuous flight augers
- Heat released from Lime resulted in enhanced mobilization from NAPL and sorbed contaminants.
- Soil concentrations of COCs were reduced by 10-fold using Lime Activation
- Estimated that 11,300 kg of COCs were destroyed
- Cleanup met the Environmental Quality Standards of UK. Site received Closure
- Churngold Remediation Limited won 2008 Brownfield Remediation Innovation Award for "Best Conceptual Design"

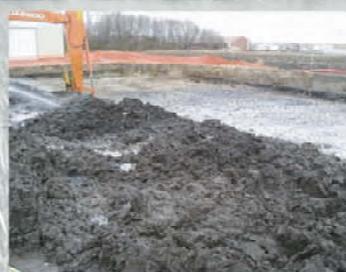
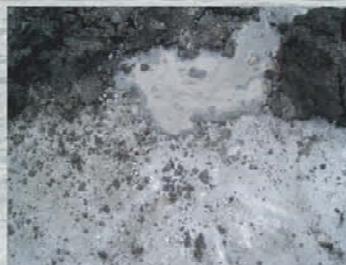
Beginning treatment

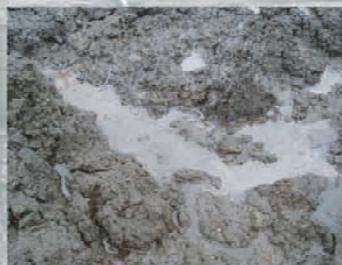
Ending treatment

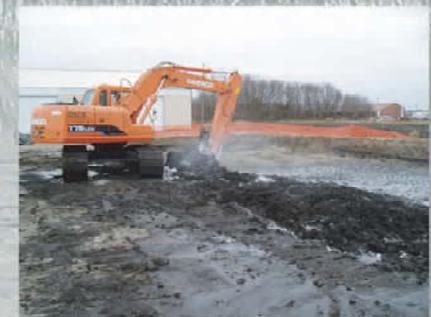
During treatment, 7,000 lb of lime were added to temporarily raise the pH and to reduce the moisture content before landfilling.

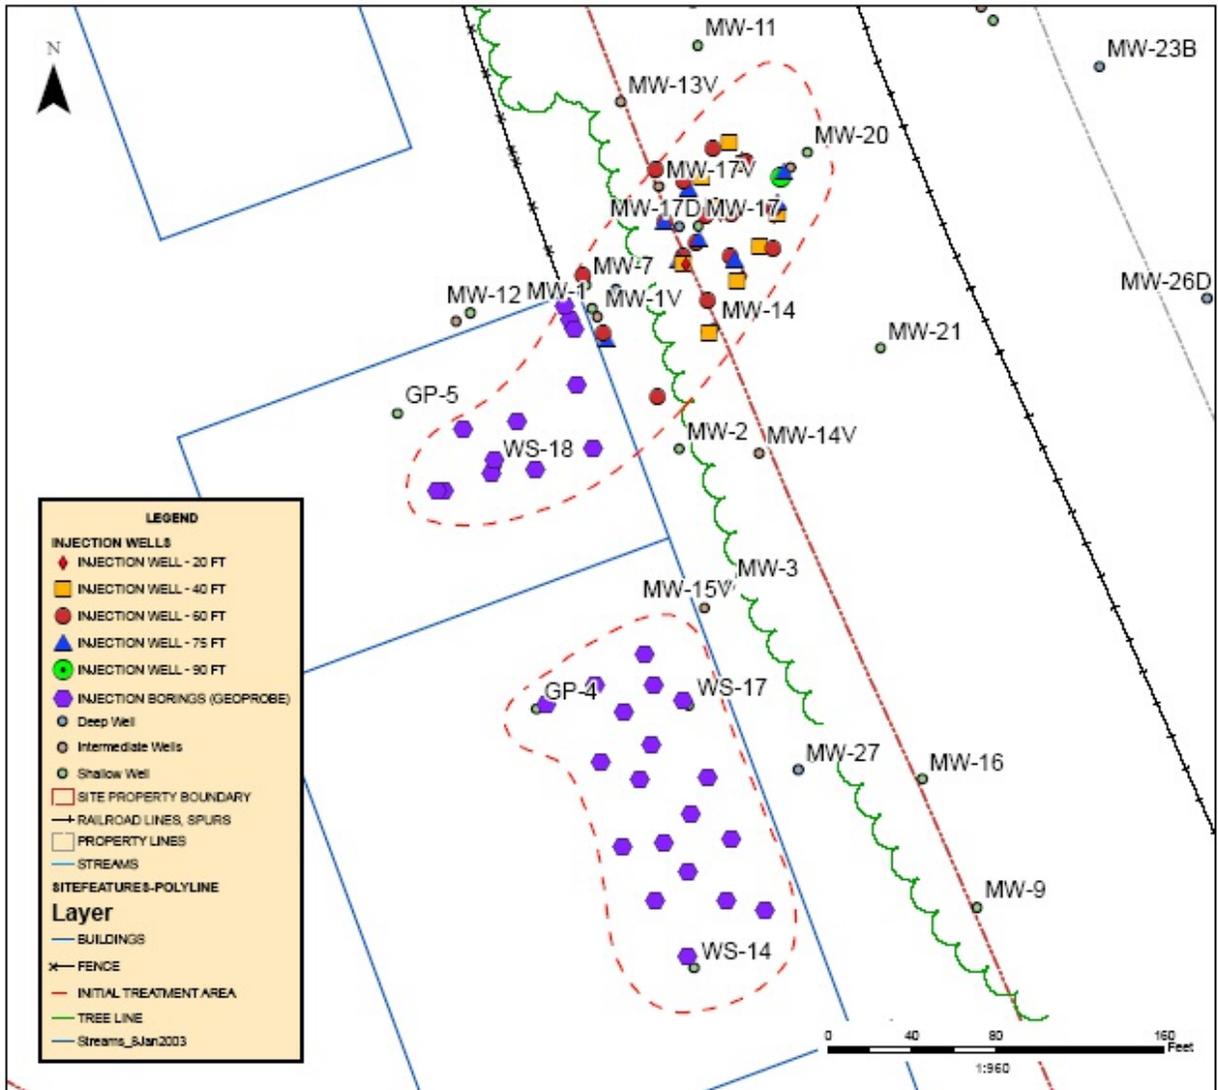
4-c) Number of Injection Points (picture/diagram)

There were a total of 30 injections points installed inside the building, which encompassed one-half the treatment plume. Outside the building, approximately 60 injection points were installed.

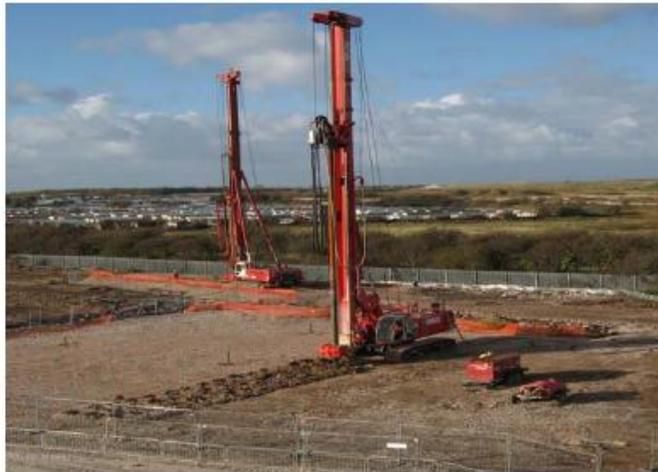
Figure 1: CFA Rigs In full swing
