| <i>Final Technical Report</i> | 2007 |

A Rapid Trash Assessment Method Applied to Waters of the San Francisco Bay Region: Trash Measurement in Streams

April 2007

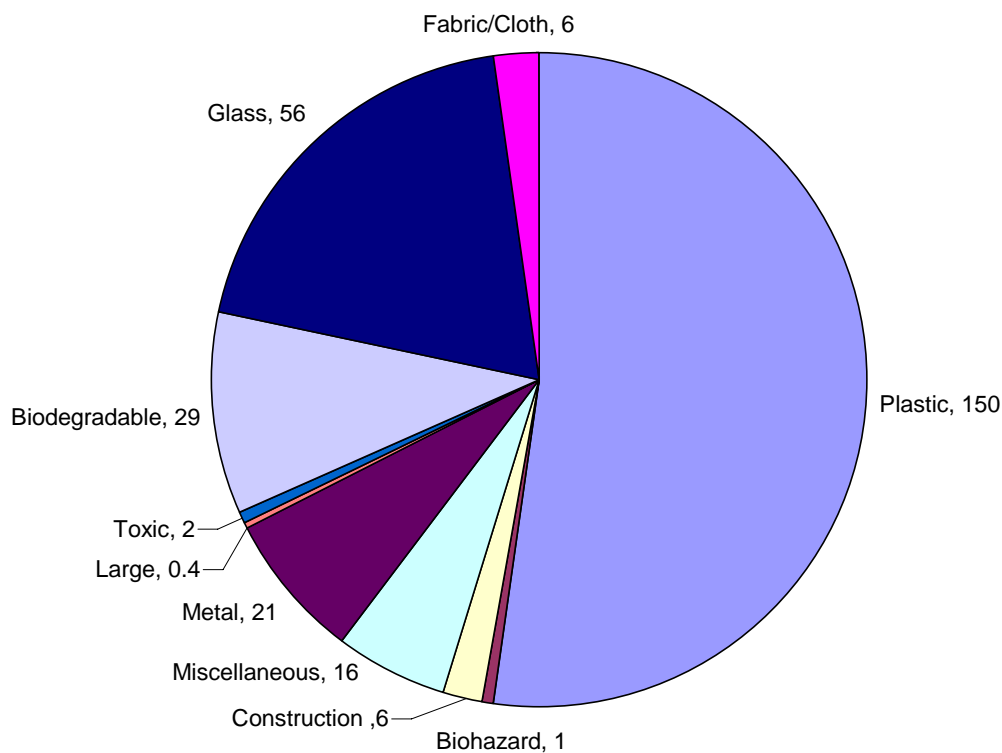
Figure 2: Average number of pieces of trash, by category, per 100 foot reach for all sites and all seasons.

The 93 site visits conducted by Water Board staff and students over three years and multiple seasons confirmed that high levels of trash are present throughout urban streams in the San Francisco Bay Region. On average, across all sites and seasons, 288 pieces of trash were collected per 100 foot reach of stream, equaling 2.88 pieces per linear foot of stream (Figure 2). Over 50% of this total, or 1.56 pieces per linear foot of stream, was composed of plastic items. Glass (19%) and biodegradable items (10%) were also commonly found. Most sites contained less than 500 pieces of trash, while several sites contained many more pieces, up to a maximum of 1133 pieces, or 11.33 pieces per linear foot of stream (Figure 3). Overall, 72% of all trash items were found below the high-water line, while 28% of items were found above the high-water line. Certain types of

items were found almost exclusively below the high-water line, including toxic items (87%), construction debris (87%), and glass (82%). Forty-two percent of biodegradable items were found above the high water line, indicative of the frequency with which paper is transported by wind into stream channels. The average total Rapid Trash Assessment (RTA) score was 47, with a range from 8 to 112 (out of a possible 120) (Figure 4). Lower RTA scores reflect higher levels of trash. A high RTA score, overall or in a specific category, represents more desirable, less trashed conditions. Total RTA scores were strongly related to the number of plastic pieces found at sites (Figure 5).

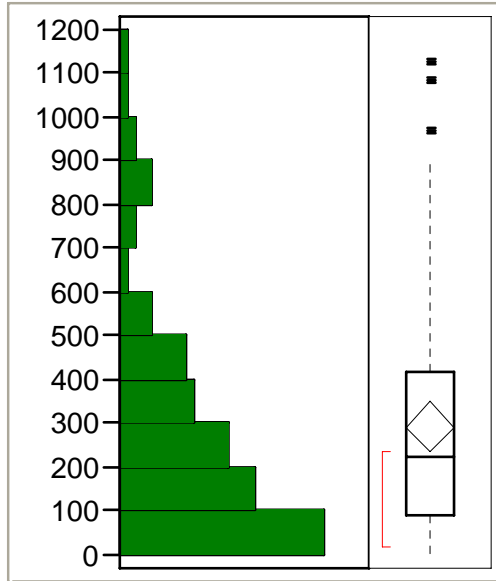
Figure 3: Frequency histogram of the number of pieces of trash found per 100 foot reach (site). A total of 93 site visits were conducted. The diamond indicates the mean and the standard error about the mean. The box indicates the median and the 25th and 75th percentiles, while the whiskers indicate the 5th and 95th percentiles.

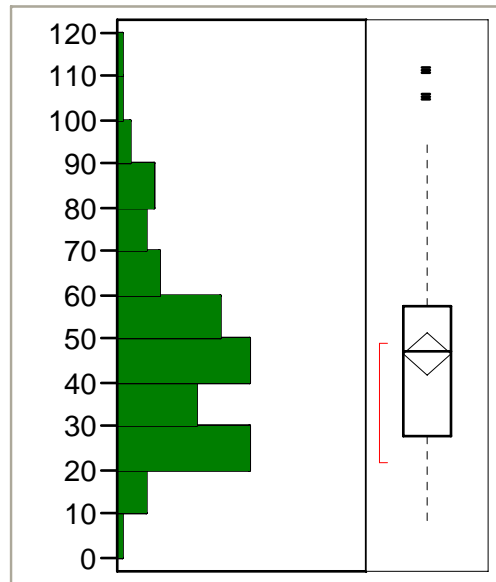
Figure 4: Frequency histogram of total RTA trash scores for each site visit. A total of 93 site visits were conducted. Symbols are the same as in Figure 3.

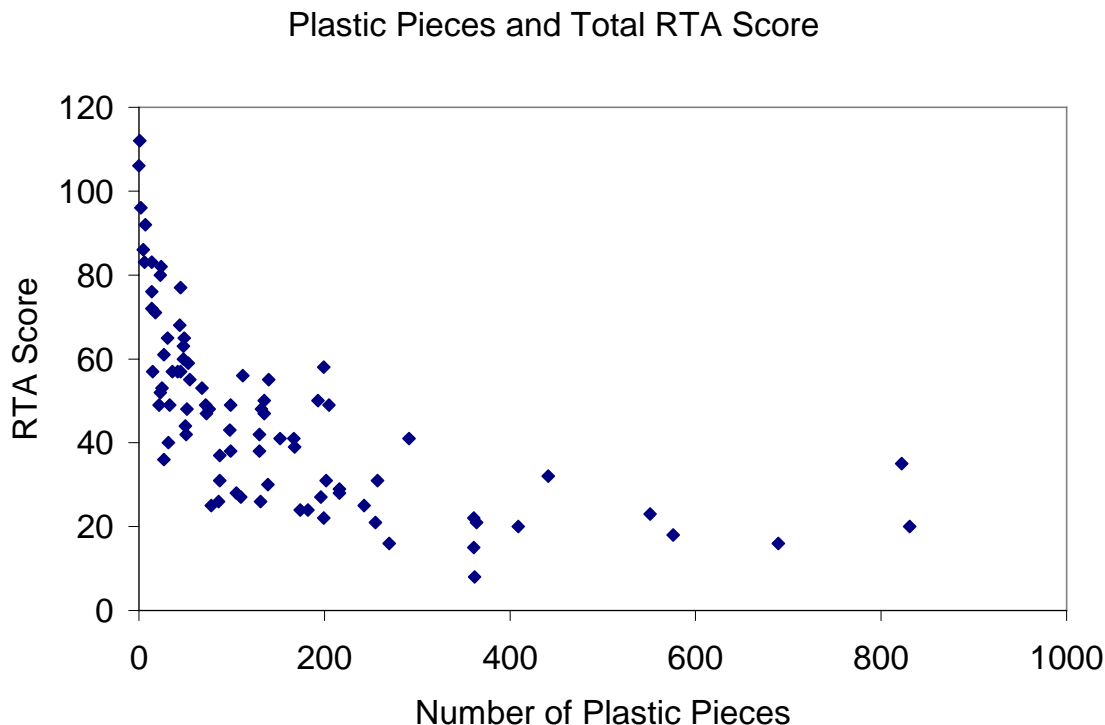
Figure 5: Total RTA score relative to the total number of plastic pieces collected.

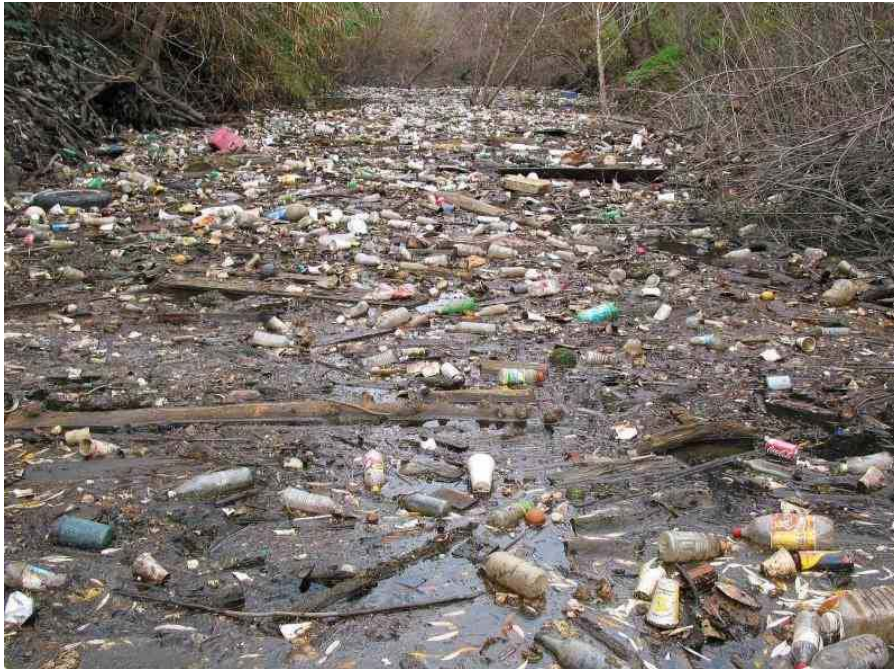
Figure 6: Photo of the trash buildup behind a fallen tree immediately downstream of the Julian Street bridge, Coyote Creek, San Jose, CA, January 27, 2004. Photo by Friends of Coyote Creek.

The 26 sites surveyed did not include the worst-case conditions of trash in the region (e.g. Figure 6), where obstructions can cause buildup of floating trash in wet weather conditions. The most trash pieces per 100 feet of stream documented in this report was 1,133 pieces at Baxter Creek at Booker Park in Richmond. For comparison, trash stored behind obstructions may exceed 10,000 pieces per 100 feet (Figure 6). Other problem sites not surveyed include homeless encampments, although some of the sites were downstream of such major sources of trash.

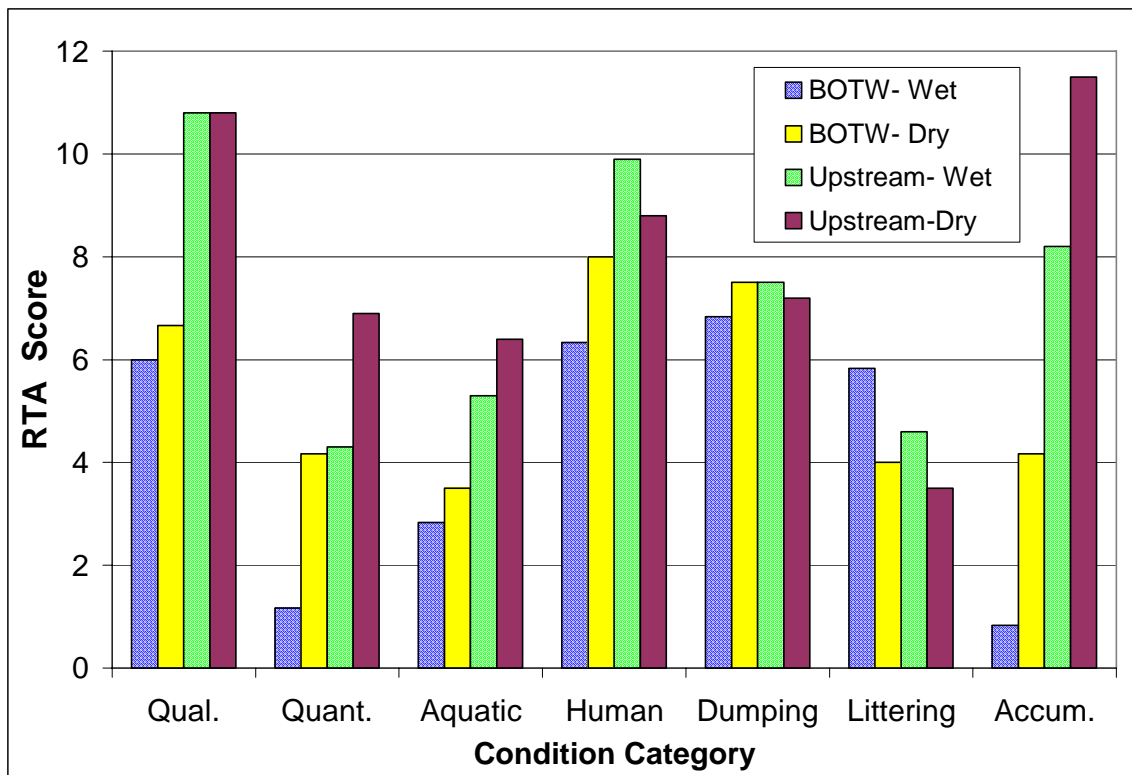
Figure 7: Average condition category scores from a subset of sites that were sampled during revisits that bracketed both wet and dry seasons. Data are presented for both wet and dry season surveys from 6 BOTW sites and 10 upstream sites. Maximum RTA scores for all condition categories is 20, except littering and dumping which is 10.

upstream. Bottom of the watershed (BOTW) sites generally scored lower than sites further upstream in the watershed in nearly all trash condition category scores, with the exception of dumping and littering (Figure 7). Qualitative scores were much lower at BOTW sites than upstream sites, indicating the “first impression” of BOTW sites is consistently more negative with respect to trash.

Accumulation scores were also much lower at BOTW sites than upstream sites, but wet season scores are much lower for both site locations than dry season scores, reflecting the seasonality of trash accumulation. At BOTW sites, the dry season scores for accumulation were markedly lower than the wet season accumulation scores for upstream sites, shown at the far right of Figure 7. As noted above, at BOTW sites the trash is dominated by plastics. Plastics continue to be delivered to the bottom of watersheds and into the San Francisco Bay during the dry season. Trash can be delivered to streams, the topographic low points in watersheds, by wind and dry season urban runoff (e.g., over-irrigation), and these data suggest it is a significant source. Trash control efforts in the Los Angeles region associated with TMDL implementation tend to focus on runoff events to capture the largest volume of trash, but the observations documented in this report show that dry season delivery of trash is likely significant.

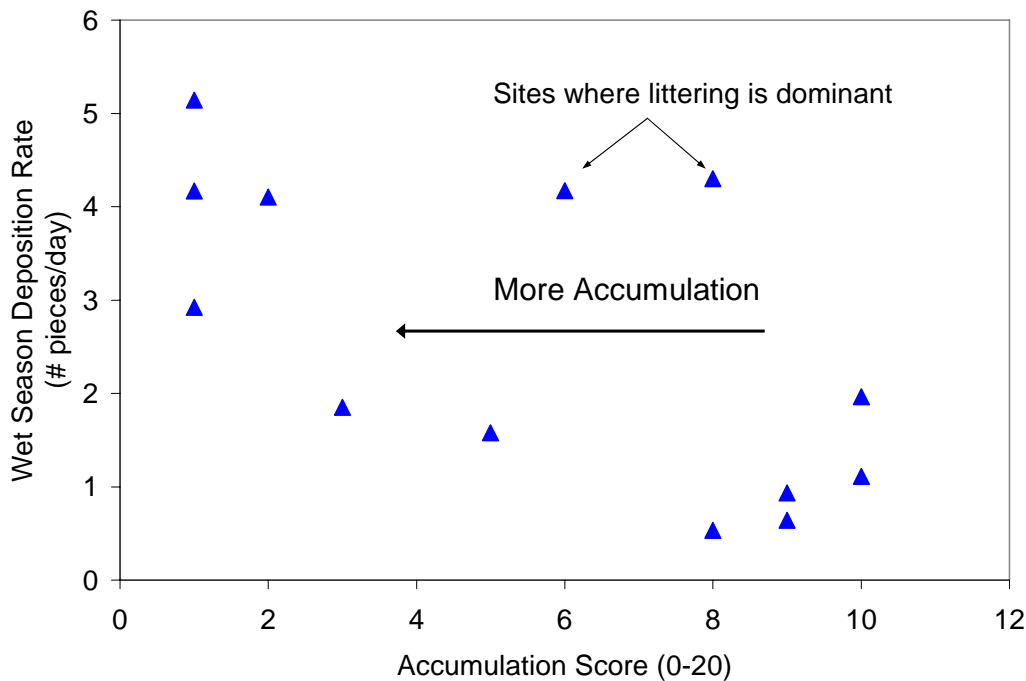
Figure 8: Wet-season trash deposition rates relative to the RTA accumulation score. As the accumulation score decreases (more accumulation) the deposition rates are higher, except at several sites where littering is responsible for high deposition rates during the wet season.

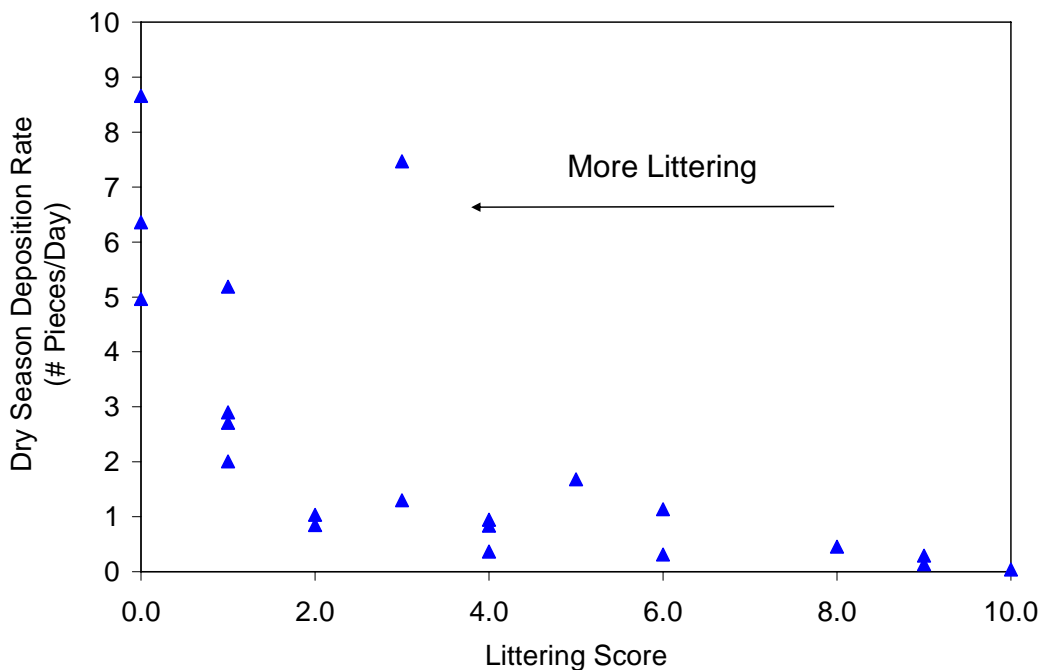
Figure 9: Dry season trash deposition rates relative to the RTA littering score. As the littering score decreases (more littering) the deposition rates are higher.

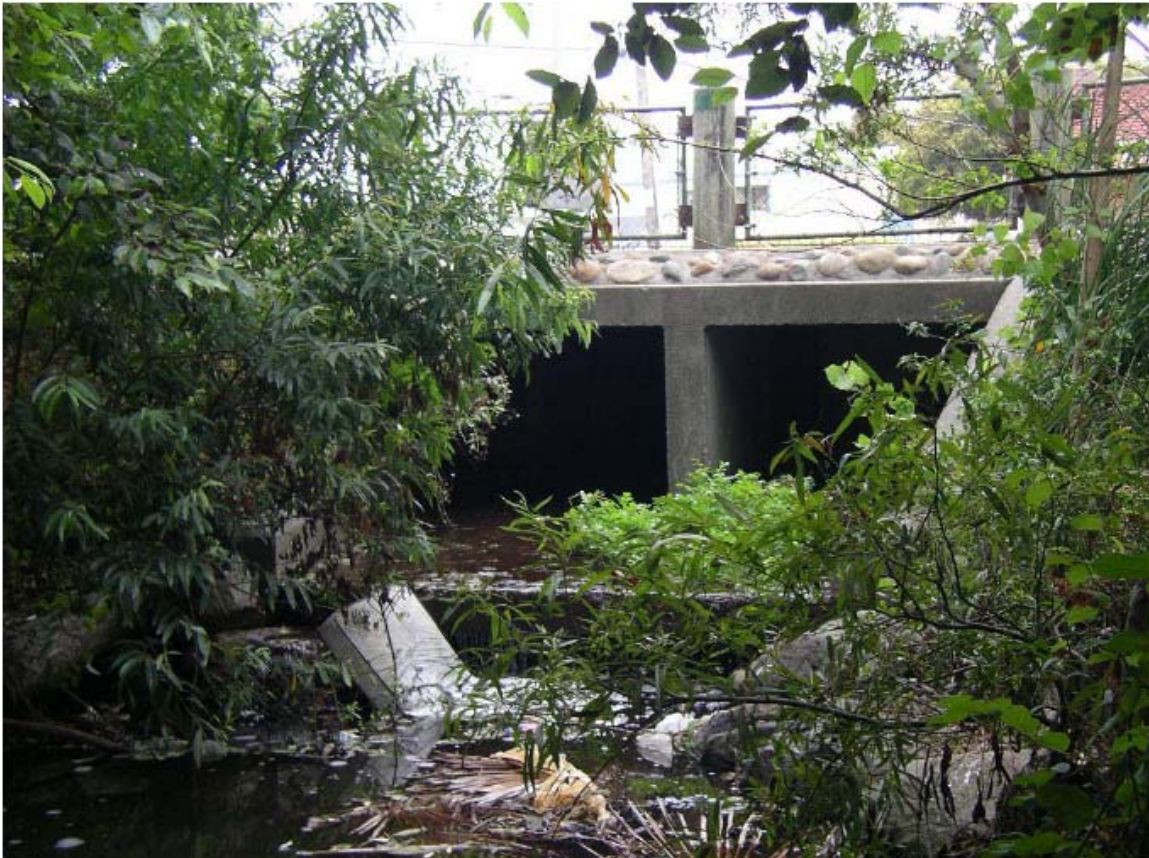
Figure 10: View looking upstream from Booker T. Anderson Park trash survey site (BAX030), showing dumped mattress and low fence above culvert at street crossing, upstream of park. Photo by Steve Moore, August 23, 2005.

The site is surrounded by residential areas. A stream restoration project several years ago removed concrete channel and planted riparian vegetation that is now well established (though at most 20' in width). There was evidence of park use during each survey, particularly on the east bank where there is grass, a playground, and a ball field. At the upstream end of the park is a culvert and a large pool. Many dumped items were observed in this pool, but it is not located within the 100-foot survey reach. The pool is at the edge of the park, along a road, with easy dumping access for vehicular traffic. Some of the dumped items were carried downstream, such as mattresses that were observed in the stream at the lower end of the park. Littering is prevalent here also, though trash cans and a dumpster are present. On the west side of the creek is a recreation center and a large parking lot. A street sweeper was observed cleaning the parking lot. The recreation center has a dumpster at the curb which probably prevents some large items from being dumped into the creek.

The highest trash deposition rate measured in this study occurred at this site during the dry summer months. Following site cleanup on June 8, 2005, 658 pieces of trash were collected on August 23, yielding a trash accumulation rate of 8.66 pieces of trash per day. Much of this trash was believed to have been directly littered (littering score = 0) in the stream at Booker T. Anderson Park. There was also evidence, however, of significant levels of trash coming from upstream sources (accumulation score = 2), even during summer baseflow conditions.

management practices need to address the entire watershed. The next site upstream, where the creek runs under San Pablo Avenue, received a lower RTA score on November 12, 2004 than this site, due to extensive littering of food wrappers from nearby fast-food restaurants. The San Pablo Avenue site also had the fourth highest deposition rate measured in this study; 6.36 pieces per day were deposited during the summer dry season. The Baxter Creek watershed appears to be a significant source of floatable trash to the Bay, and warrants special attention. A progressive program of education, warnings, and penalties may be needed in order to achieve behavioral change. Given the ubiquitous nature of trash in this watershed, structural trash removal alternatives should be evaluated as well.

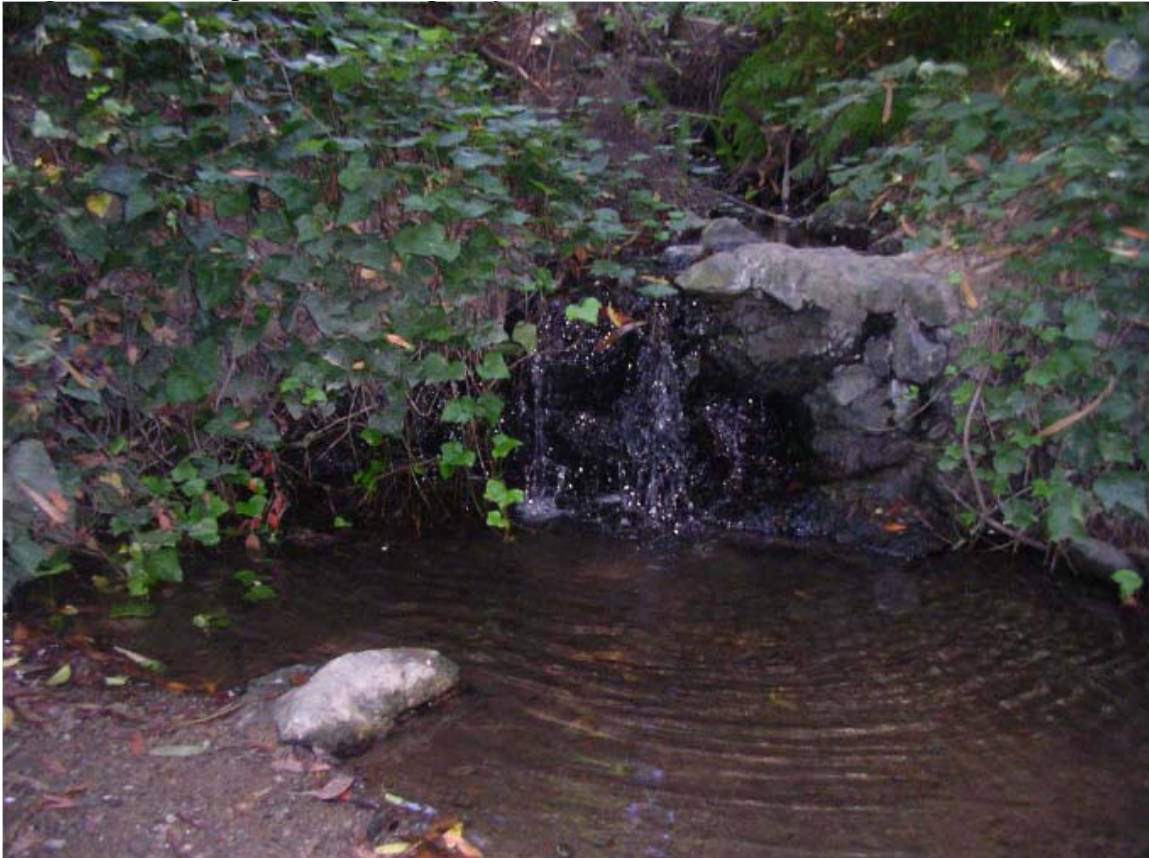
Figure 11: View of trash survey site on Palo Seco Creek in Joaquin Miller Park, Oakland, CA, showing no trash during dry season survey. Some dog waste was in the creek bed, lowering the RTA score from optimal due to the threat to human health. Photo by Steve Moore, August 23, 2005.

Joaquin Miller Park is located near the top of the Sausal Creek watershed, upstream of Highway 13. While there is public access to the park, the trailhead is not well-marked. There are two trash cans and plastic bags available for dog waste at the small three-car parking area at the trailhead. This site may have less public use than many parks, which may explain the remarkably low levels of trash in the stream. Still, there is some evidence of littering, probably related to the use of the site by dog walkers and hikers. On one occasion, pet waste was found near the stream.

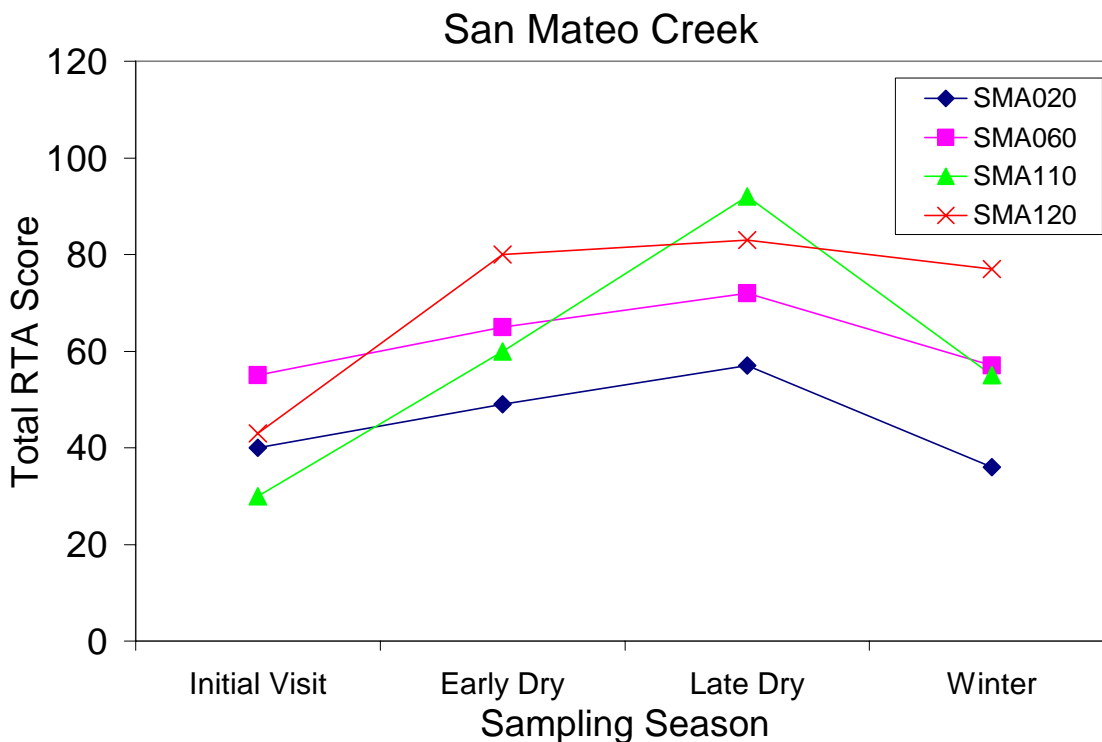
Figure 12: RTA Scores at four sampling sites in the San Mateo Creek watershed along a longitudinal gradient.

The Gateway Park site, though not initially having the highest trash levels, had higher deposition rates of trash in subsequent surveys and hence lower RTA scores (Figure 12). Located 2 miles upstream of the Gateway Park site, the Arroyo Court Park site improved slightly following trash cleanup events, but winter flows delivered high levels of trash that lowered RTA scores. Dry season RTA scores were lower at the Gateway and Arroyo Court Park sites, due to direct littering into the stream at these publicly accessible sites. The Polhemus Creek (SMA110) site had the lowest initial score, but following cleanup it had the highest score in the watershed. Winter flows brought large levels of trash from the upstream residential area, however, significantly lowering the RTA score. The upper San Mateo creek site (SMA120) saw less return of trash with wet weather, due to less upstream sources.

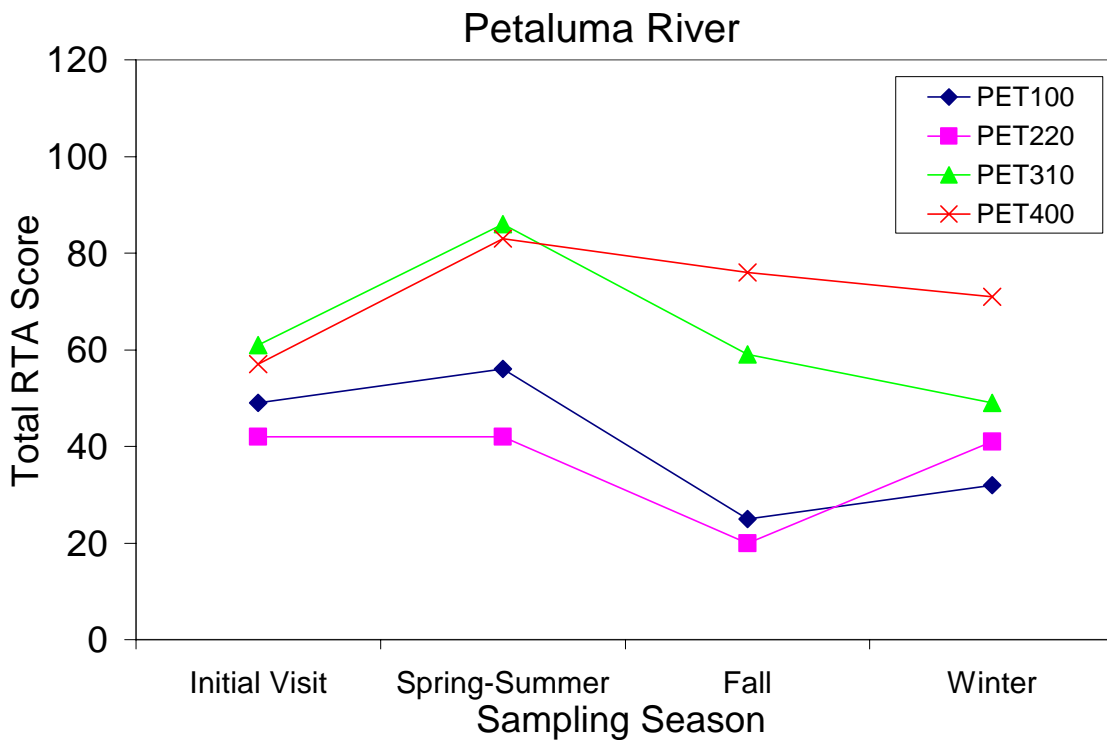
Figure 13: RTA Scores at four sampling sites in the Petaluma River watershed along a longitudinal gradient. PET100 is the lowest site, PET310 is upstream on the main branch, and PET220 and PET400 are the tributary sites. PET220 tributary (Washington Cr.) enters the main branch downstream of PET310. Except for PET400, the final scores are below the initial scores, indicating that trash levels may be getting worse in this watershed.

The Petaluma River watershed sites had lower scores at the end of the survey, following extensive cleanup, than the initial scores (Figure 13), suggesting that trash deposition is pervasive and watershed-wide management efforts are needed.

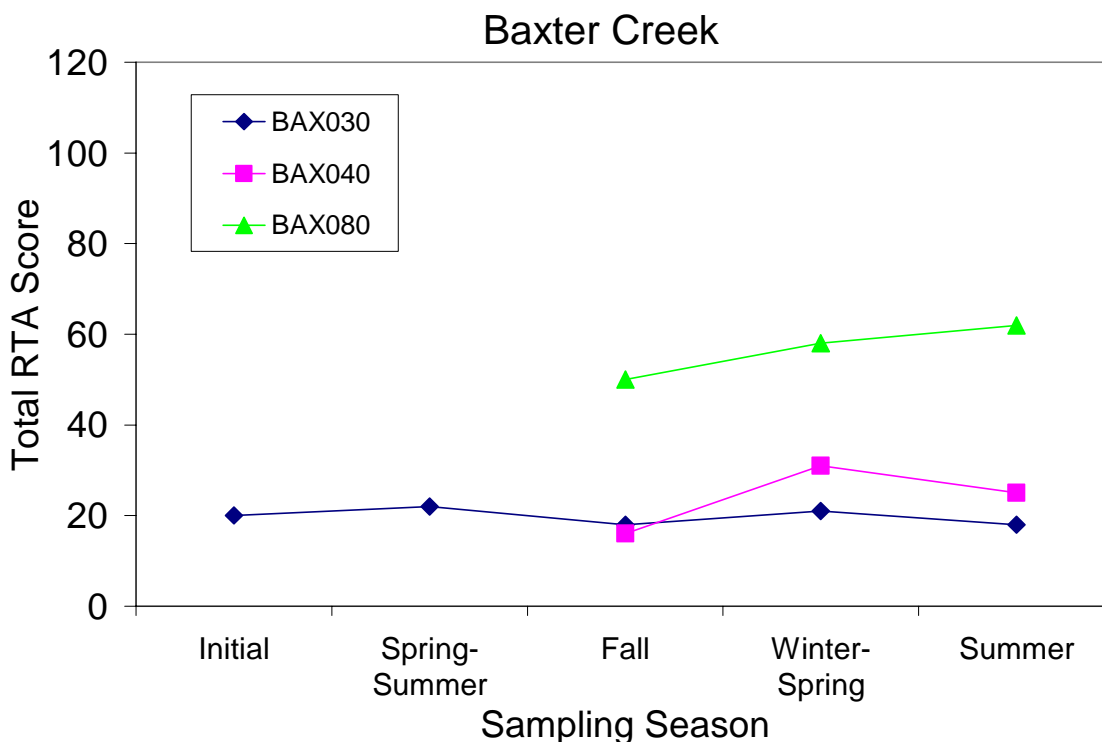
Figure 14: RTA Scores at three sampling sites in the Baxter Creek watershed along a longitudinal gradient. BAX030 is the downstream site, BAX040 is upstream at San Pablo Avenue, and BAX080 is at Canyon Trail Park, in El Cerrito.

The downstream site, at Booker T. Anderson Park (BAX030), exhibits extremely high trash inputs in both the dry and wet seasons. The consistently low RTA scores indicate a constant, high level of trash regardless of trash removal efforts and season (Figure 14). Similar problems were documented at the upstream site (BAX040), but there was less wet season deposition than at Booker T. Anderson Park. The site at Canyon Trail Park in the El Cerrito hills (BAX080) had higher RTA scores in both the dry and wet seasons, but the low to moderate scores (50-62) indicate that this site also experiences significant wet-weather and dry-weather trash deposition.

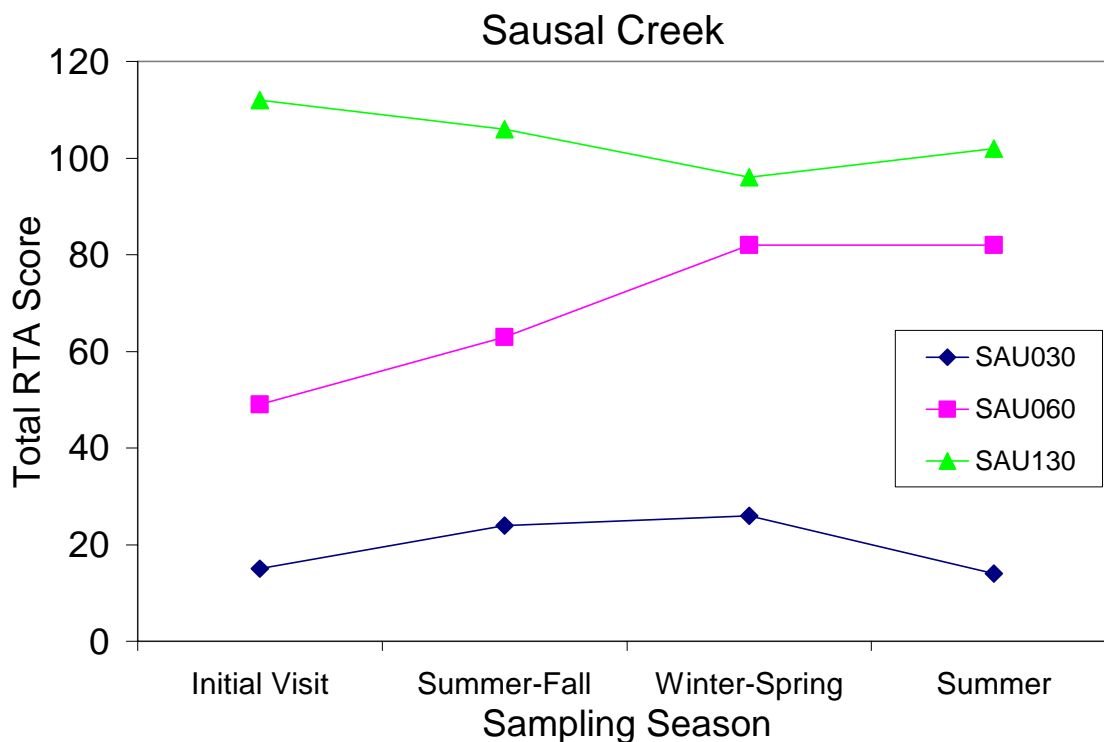
Figure 15: RTA scores at three sampling sites in the Sausal Creek watershed along a longitudinal gradient. SAU030 is the downstream site at E. 22nd Street, SAU060 is at Dimond Park, and SAU130 is on Palo Seco Creek in Joaquin Miller Park, all in Oakland, CA.

The two upper sites in the watershed, Dimond Park (SAU060) and Joaquin Miller Park (SAU130), have the lowest deposition rates in this regional study (discussed above). The City of Oakland's Parks Department and local volunteers from the Friends of Sausal Creek actively manage and remove trash in Dimond Park. Scores at the Dimond Park site improved with successive site surveys; the highest RTA score was recorded at the last site visit during the summer season. The site on Palo Seco Creek in Joaquin Miller Park (SAU130) is publicly accessible, but upstream of most urban areas and not as frequently visited. This site serves as a regional "reference" site in this study because of the very low trash levels.

The downstream Sausal Creek site at East 22nd St. (SAU030) is heavily impacted by trash. The open channel upstream of the site appears to attract illegal dumping and littering, and adjacent landowners were observed dumping their household trash into the stream area. This area could be a focus for progressive education, warning and enforcement of existing littering laws.

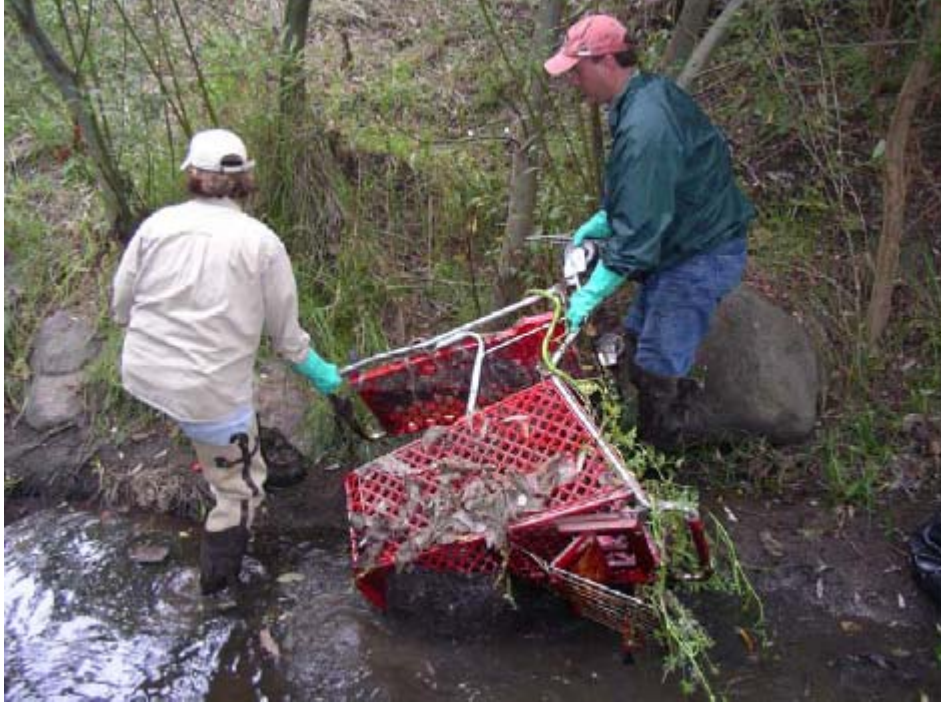
Figure 16: Water Board staff remove a shopping cart from the Booker T. Anderson Park site on Baxter Creek. Photo by Kim Harrison, August 23, 2005.
