March 4, 2014 Inspection Report

Los Angeles Regional Water Quality Control Board

SUBJECT: INSPECTION OF AREAS OF FILL OR PLANNED FILL TO DETERMINE PRESENCE OF WATERS OF THE STATE OR WATERS OF THE UNITED STATES

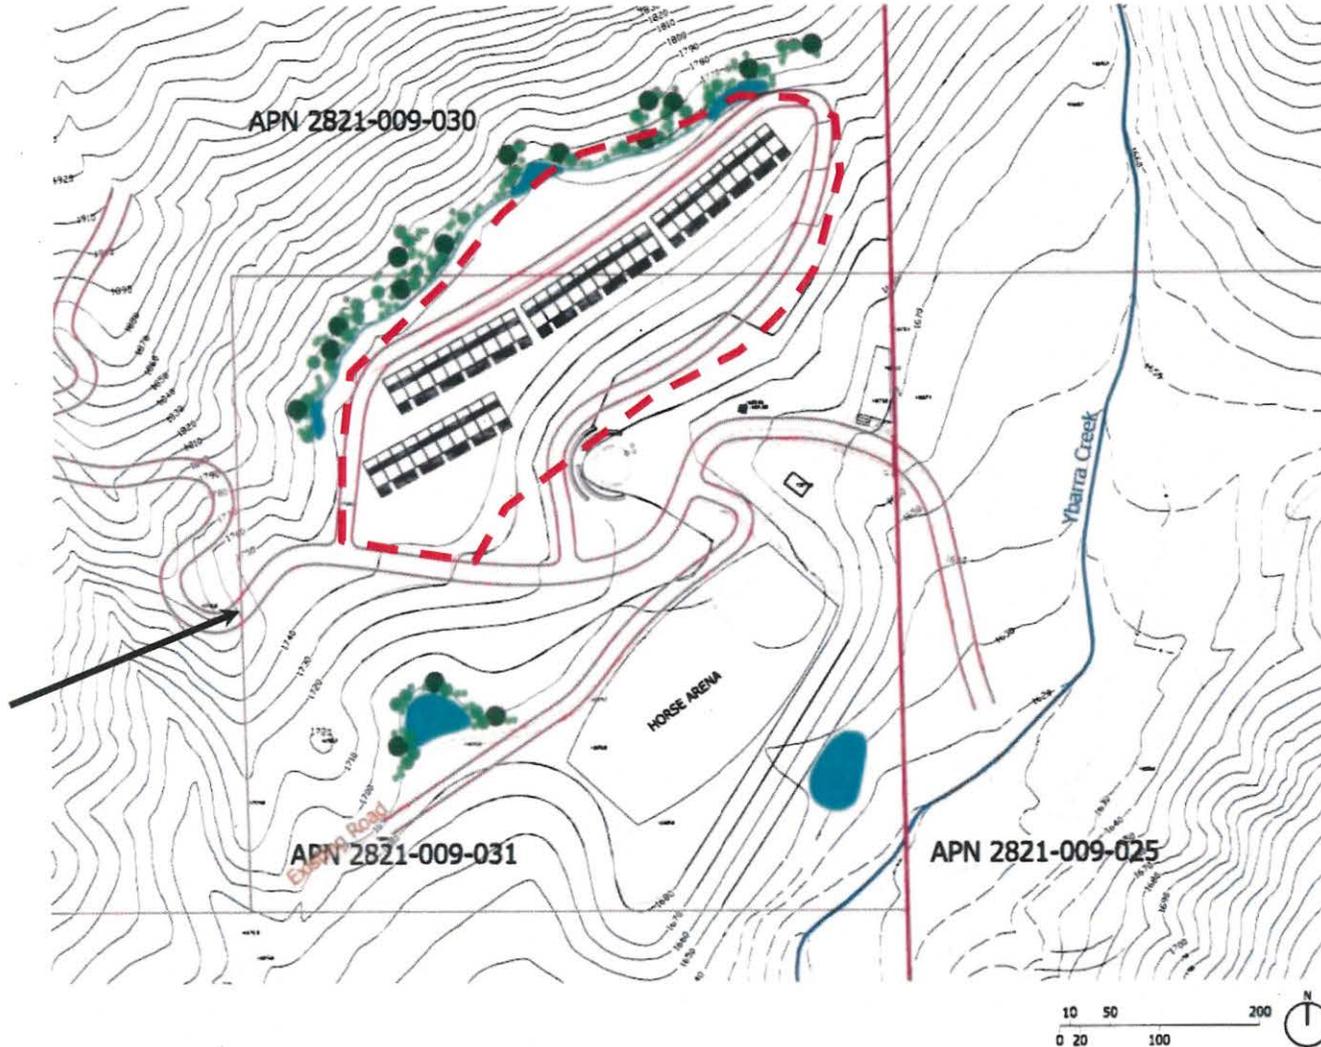
Figure 3:

Revised grading plan for parcels 2821-009-030 and 2821-009-031 presented by Mr. Fishback during the inspection. The plan had not previously been submitted to the Regional Board and is significantly different from the the plan in the October 20, 2014 Regional Board letters of exemption, because 1) grading operations have been expanded significantly to the southeast (area labeled Horse Arena); 2) a road was being graded to the northwest (arrow) to create a new access to the area; 3) as-built contours underlying the main deck area (dashed line) are significantly different and potentially indicate significantly greater inert waste fill volumes.

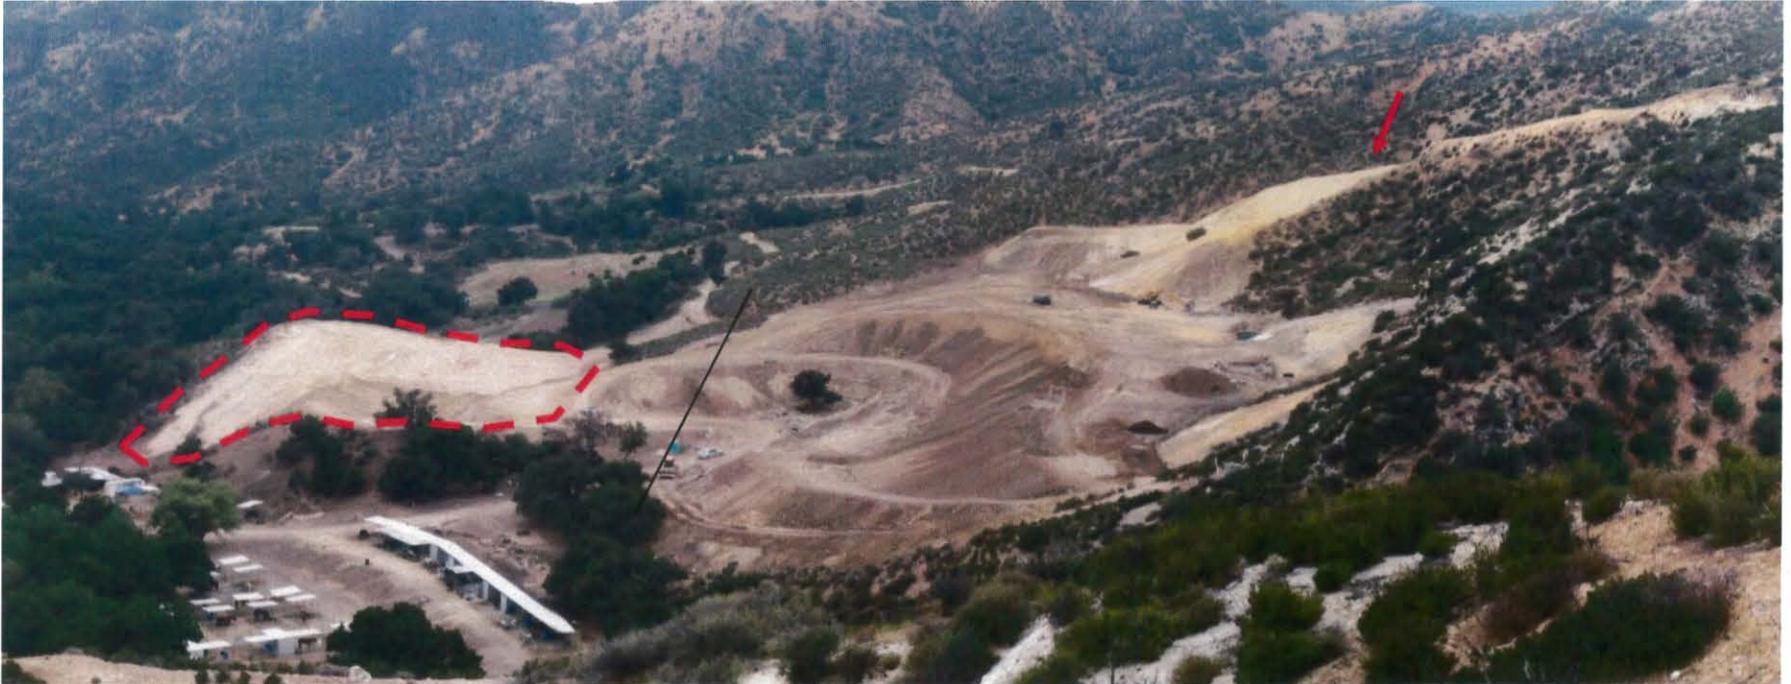
Figure 4:
Panoramic view looking south from the Browns Canyon Road at grading/fill operations in the parcel 2821-009-030, 2821-009-031 area. The dashed line is the approximate boundaries of a large area (proposed horse arena) not included in the initial grading plans and is encroaching towards Ybarra Creek. Grading for new access to the area (arrow) was also not included in the initial grading plans.

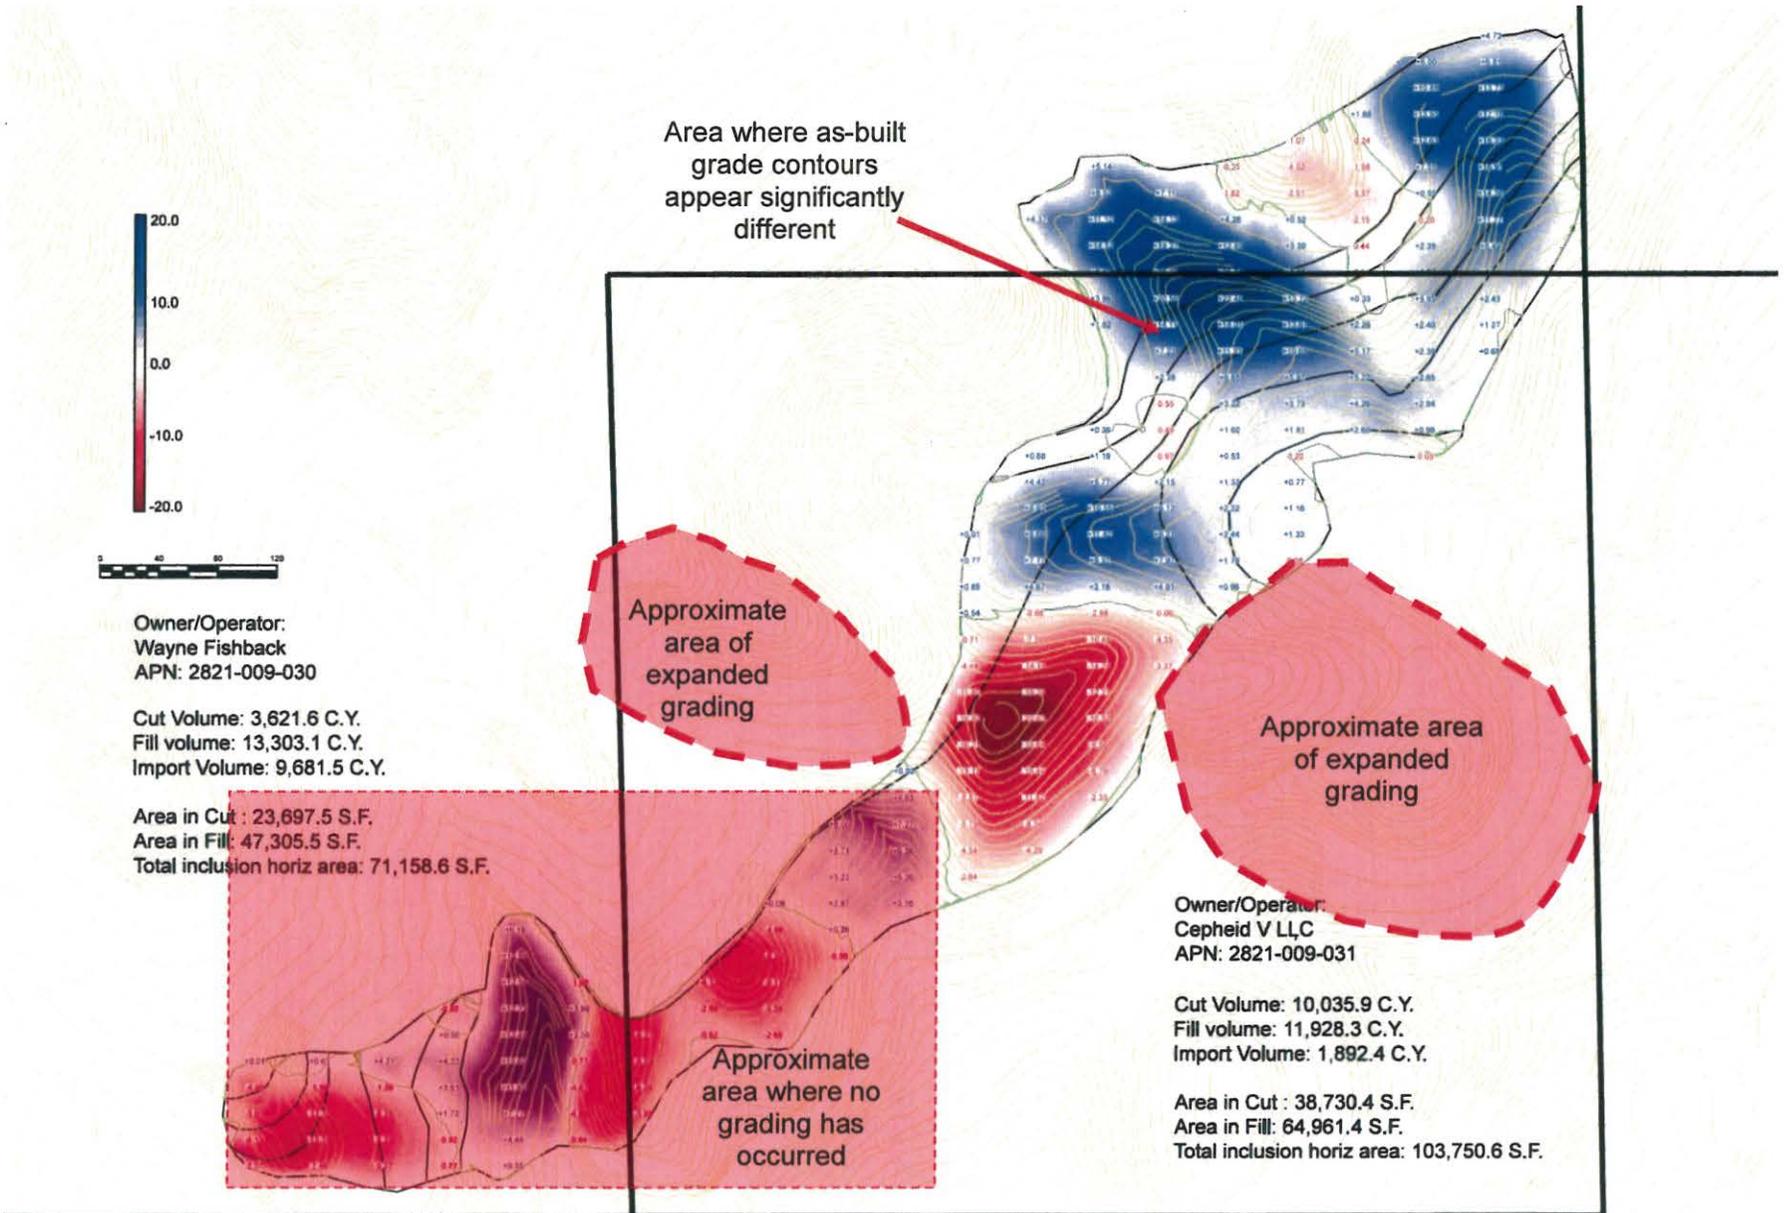
Figure 5:
Grading plan submitted in the ROWD showing areas of potential significant grading deviations relative to as-built conditions.

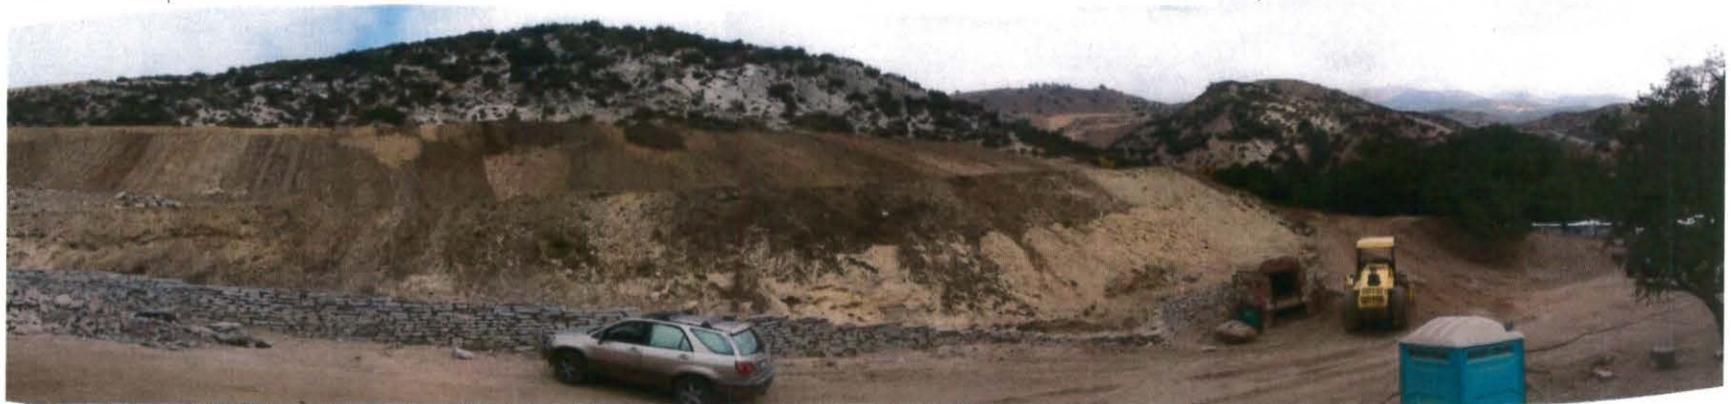
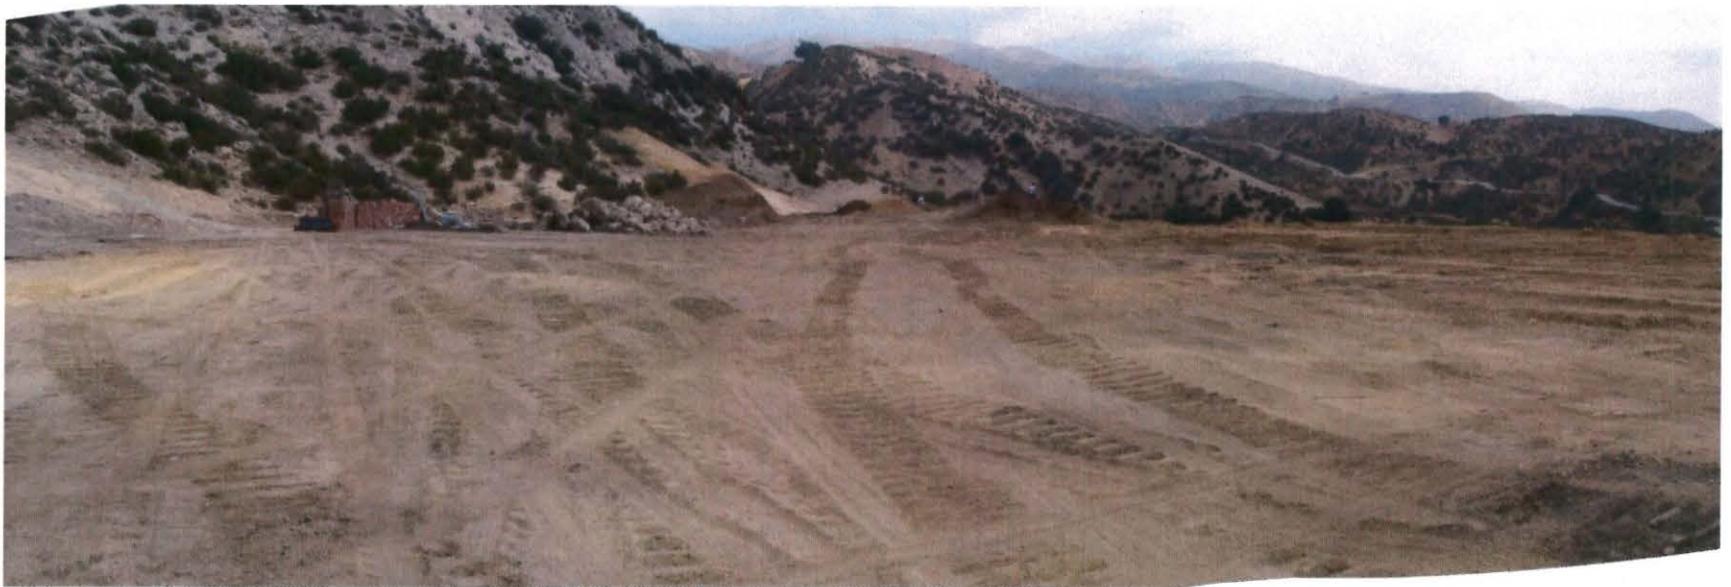
Views of side slope and deck areas created by grading/fill operations in the area of parcel 2821-009-030 and 2821-009-031 that appeared to be generally consistent with initial grading plans in that native ridges have been terraced to augment inert materials to fill the interior ravines but potentially include significantly greater volumes of fill materials.

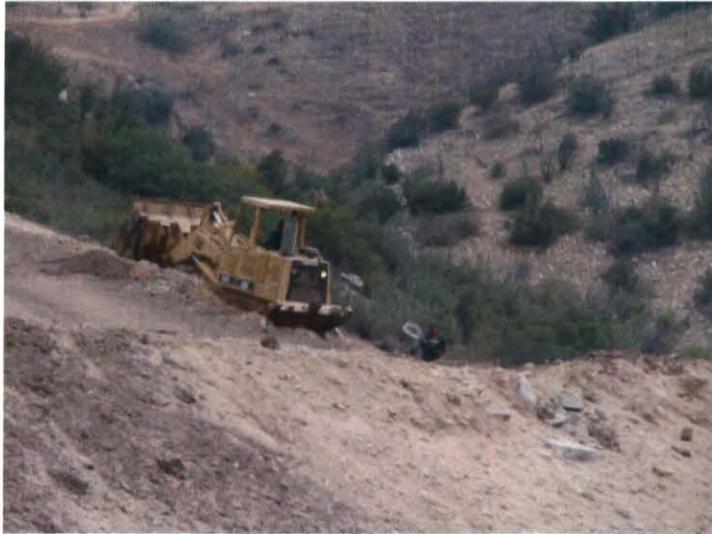
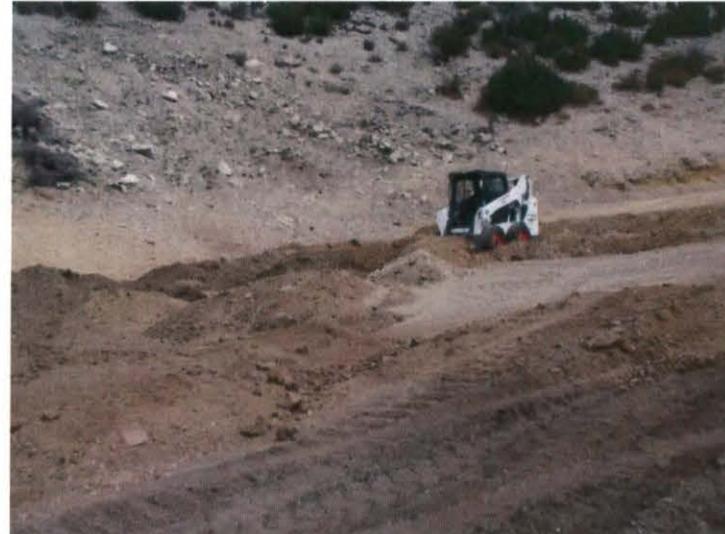
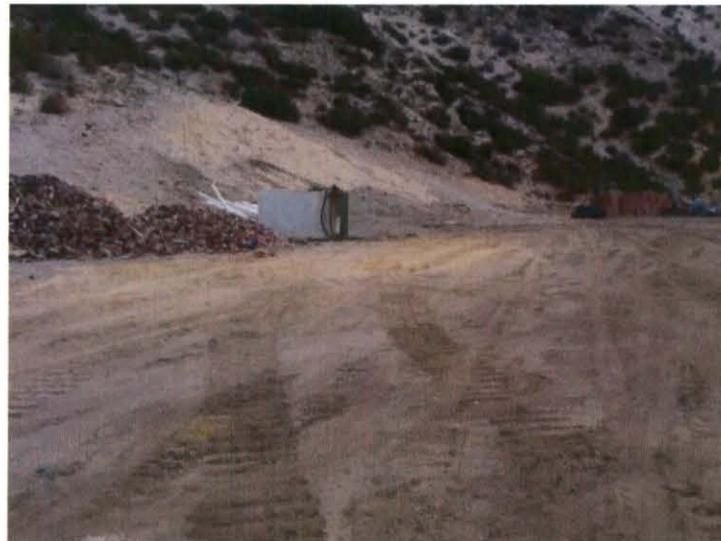
Figure 9:

Observations of grading/contructions activities in parcel 2821-009-030 and 2821-009-031 area. The fuel storage tank had no secondary containment. There were abundant areas of loose bare soil, with no readily evident sediment controls measures.

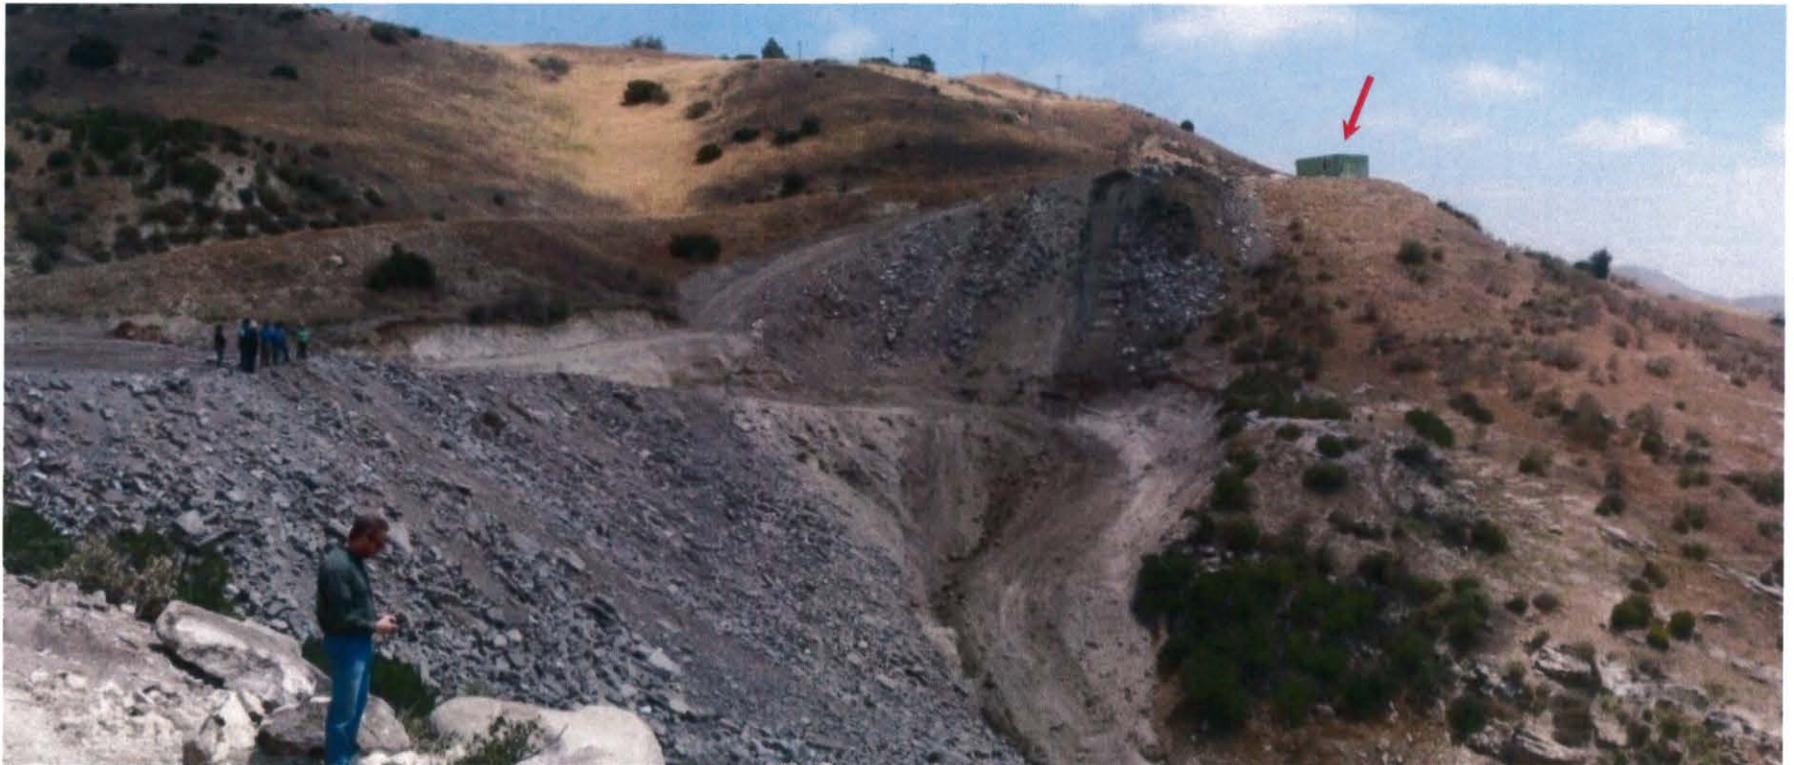
Figure 10:

Panaoramic view of grading/filling operations in the parcel 2821-002-023 area. The field office (arrow) that was recently set up by Mr. Fishback is adjacent to Browns Canyon Road. Mr. Fishback indicated that the grading operations are to construct an access road from Browns Canyon Road across Ybarra Creek via an overhead grade separation to the parcel 2821-002-025 area which is to the right of the field of view. According to Mr. Fishback, the large pile of materials was to stockpile and crush inert materials for the road and grade separation. No application has been submitted to the Regional Board regarding the activities in this area.

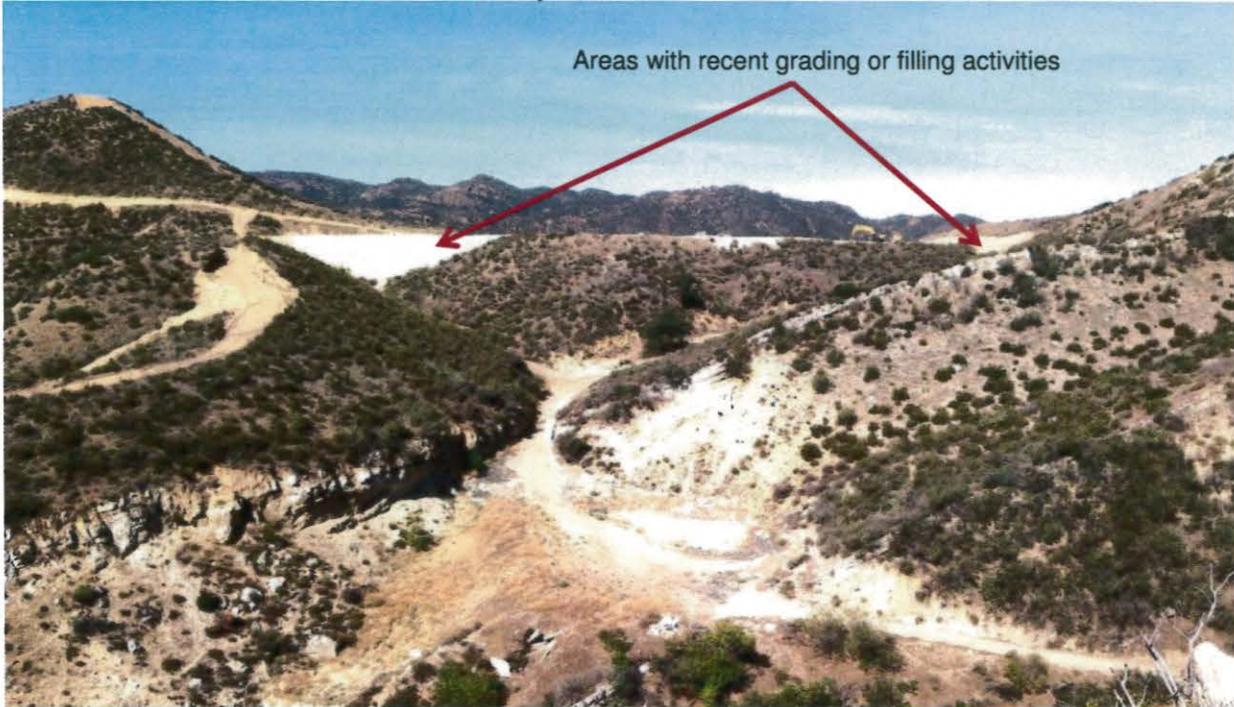
1. APN 2821-002-025 - There had been significant grading/filling activities in the area since the inspection of May 4, 2015. A small valley connected to Browns Canyon appeared to have been filled with debris. The dirt roads in the parcel appeared to have been re-graded or widened recently (Figure 2).
2. APN 2821-002-023 - No significant change was observed in this area since the inspection of May 4, 2015 (Figure 3).
3. APNs 2821-009-030 and 031 - Waste disposal/terracing activities were going on in the area. At least five trucks were observed hauling wastes to that area during the site inspection. Areas of waste disposal/terracing were obviously increased comparing to what was observed during the May 4, 2015, inspection (Figure 4).

Figure 2: APN 2821-002-025, show areas that had been graded or filled since May 4, 2015.

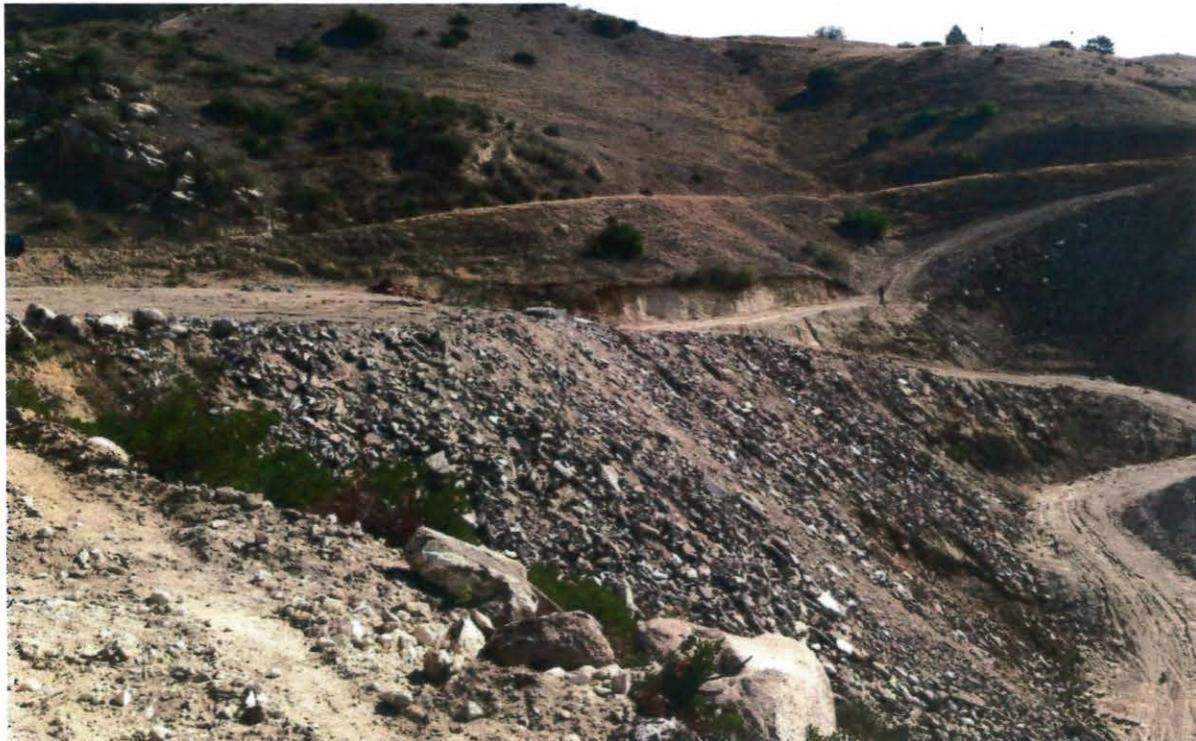
Figure 3: APN 2821-002-023. No significant changes were observed in this area, comparing to what was observed during the inspection on May 4, 2015.

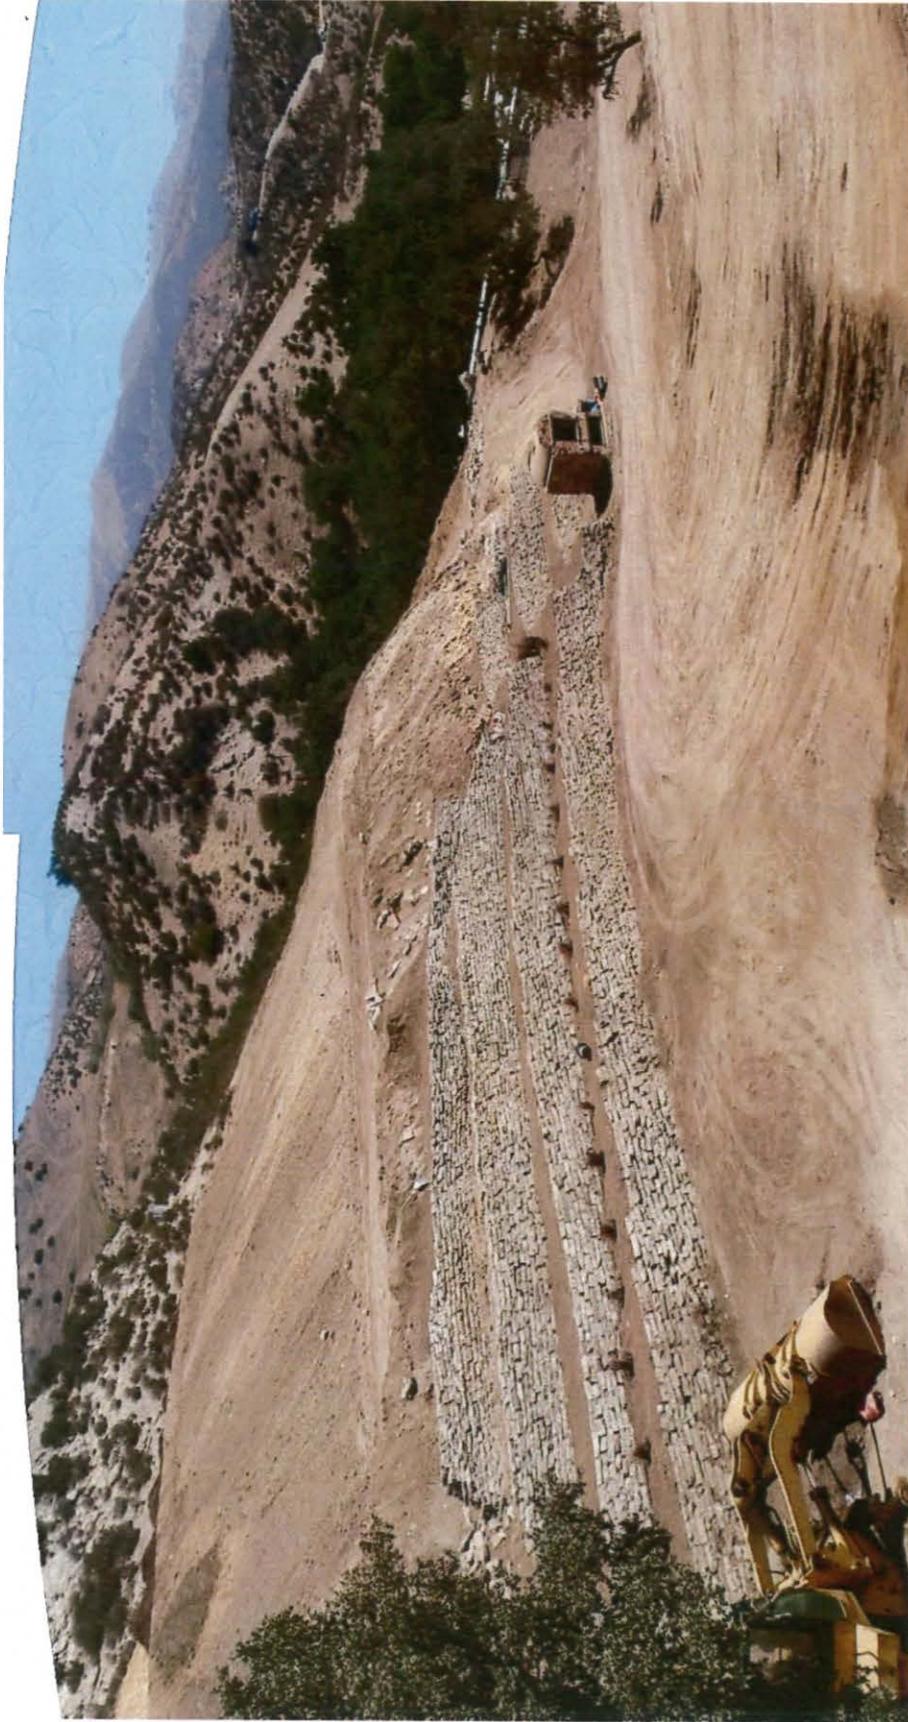
Directly on the other, north, side of Ybarra Creek, approximately 15 feet from Ybarra Creek, is a stockpile of rock and dirt on a steep slope, Figure 5. Mr. Fishback said he was going to build a "detention basin" at the base of the slope but at the time of the inspection there were no BMPS implemented which would control sediment and a rainstorm would cause the rock and soil to enter Ybarra Creek.

Figure 5. Stockpile next to Ybarra Creek. (Enrique Casas)

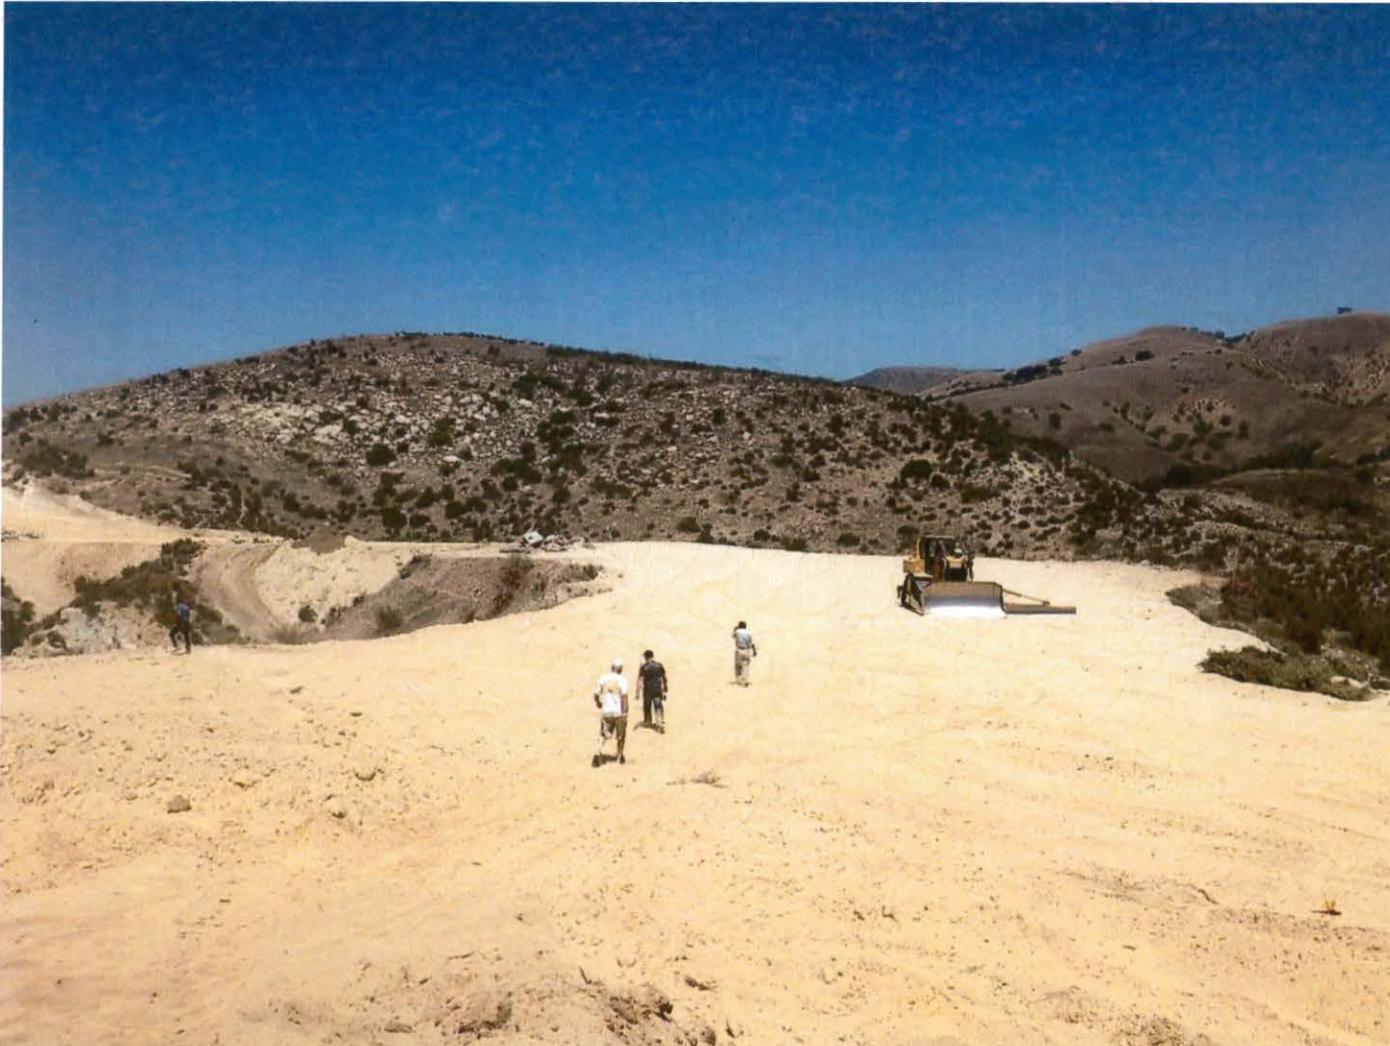
Figure 6. Terracing with concrete. (Enrique Casas)

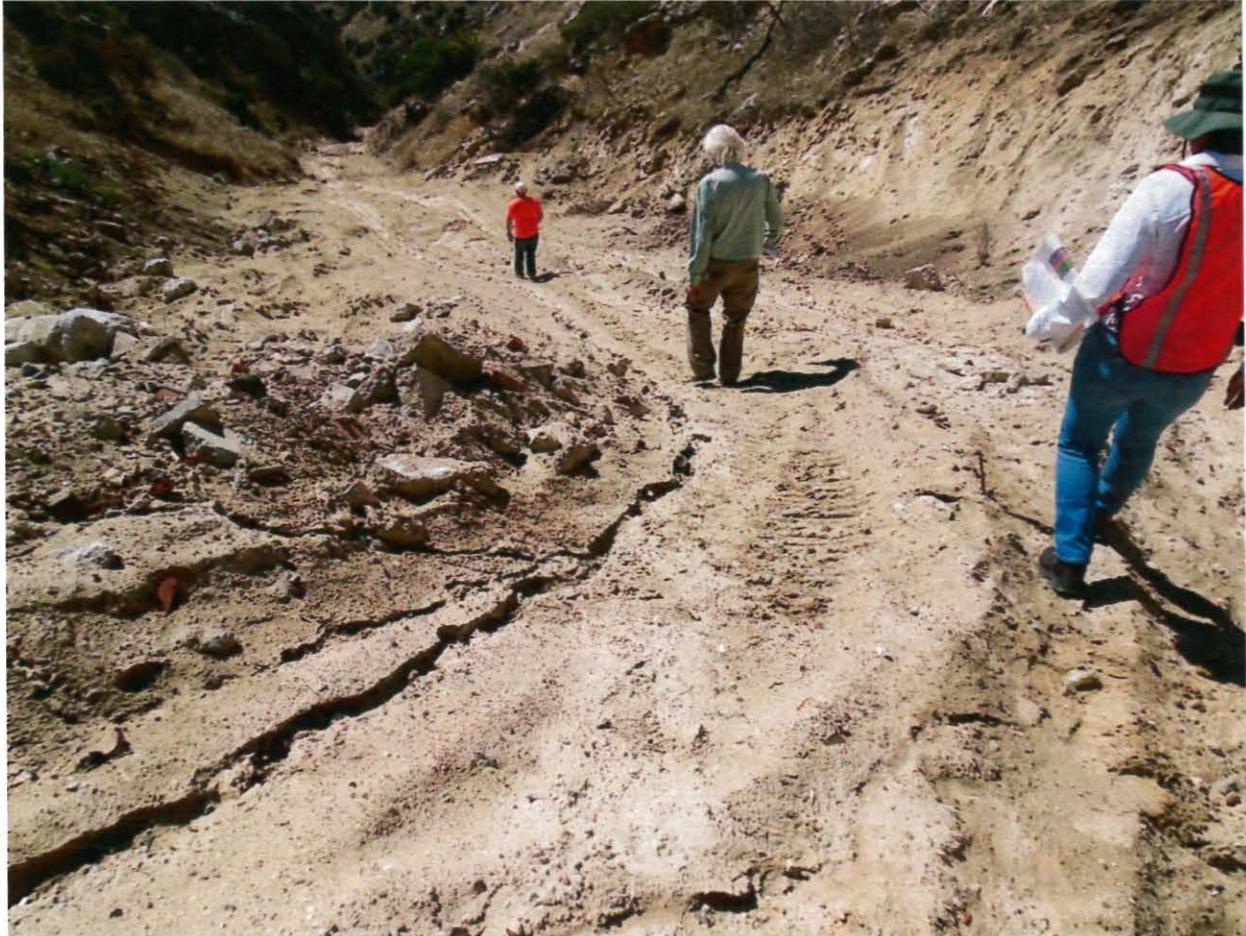
Photo 5. The waste appears piled at the angle of repose immediately above an unnamed tributary that Mr. Fishback admitted having graded that continues down to Ybarra Creek, a water of the state and United States.

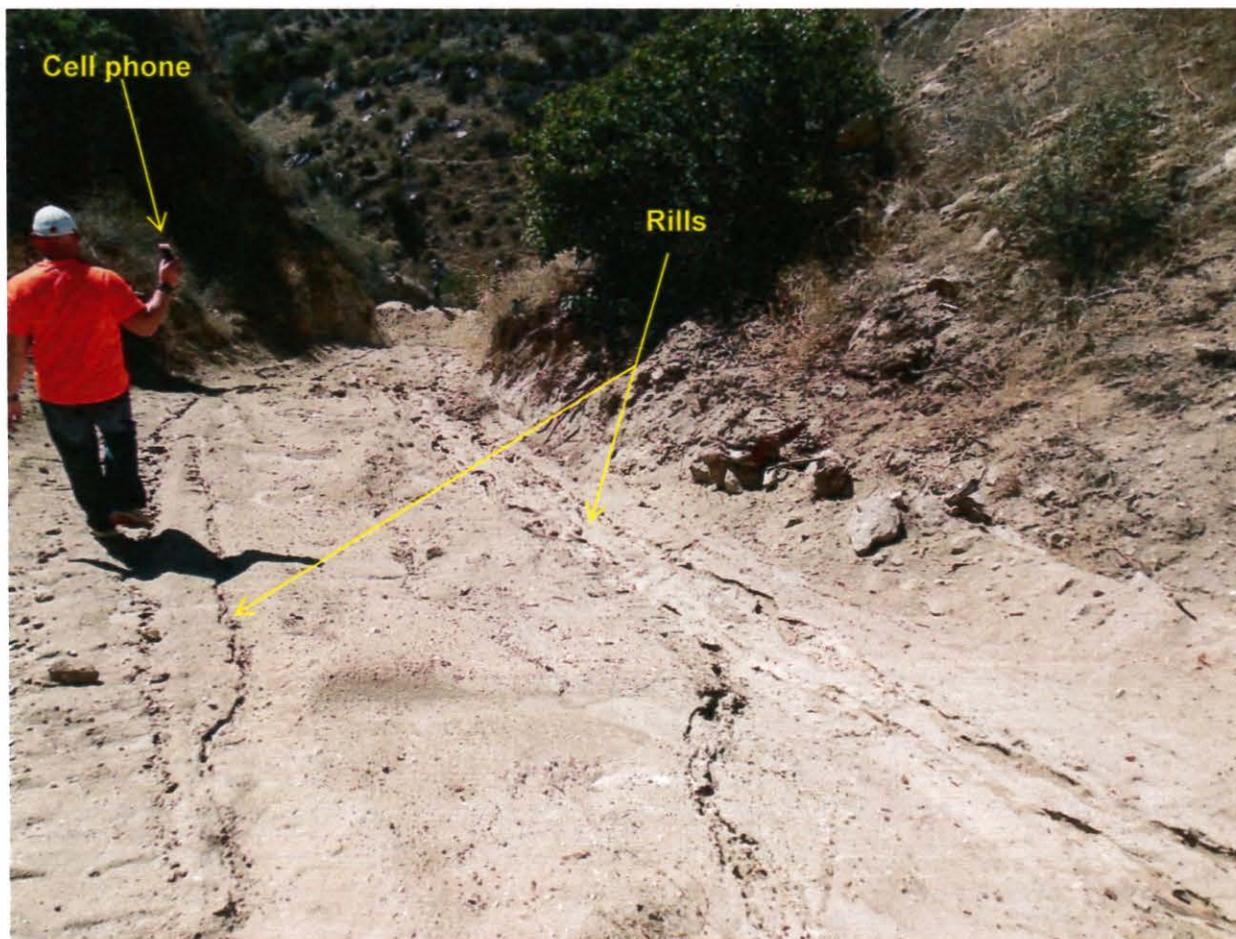
Photo 6. This photo shows the ravine immediately down gradient from the waste stockpile that leads to Ybarra Creek. Note the steep gradient, loose sediment, and rills.

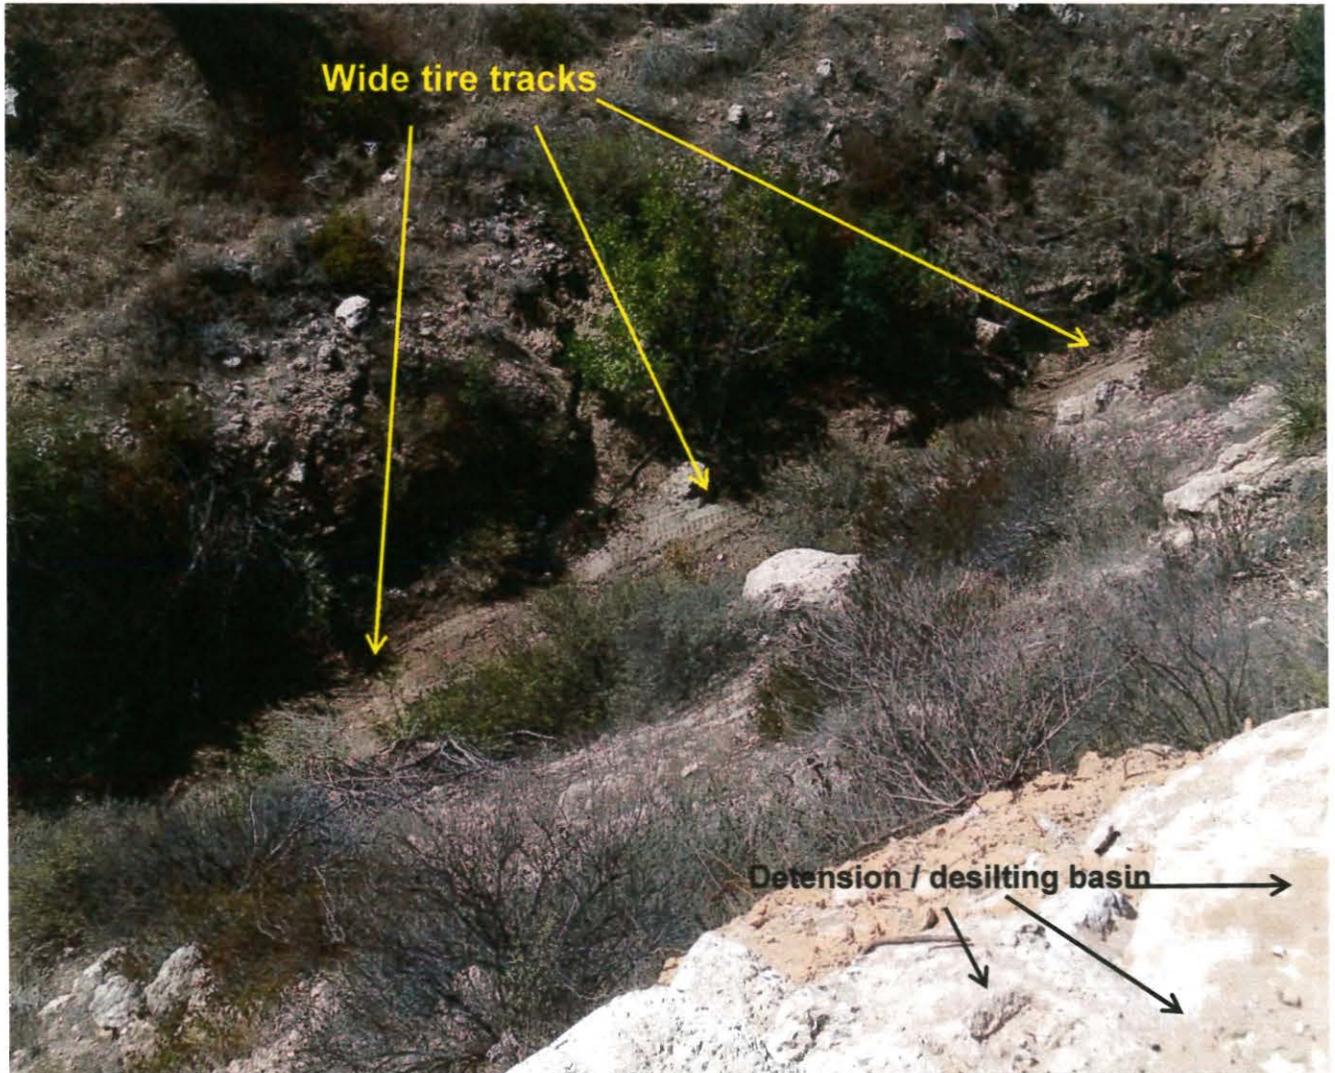
Photo 9. The graded area 2 is so steep that it cannot be freely walked down in places. The steepness and angle of repose entrains some of the material that falls from above, and contained within the steep walls of the ravine.

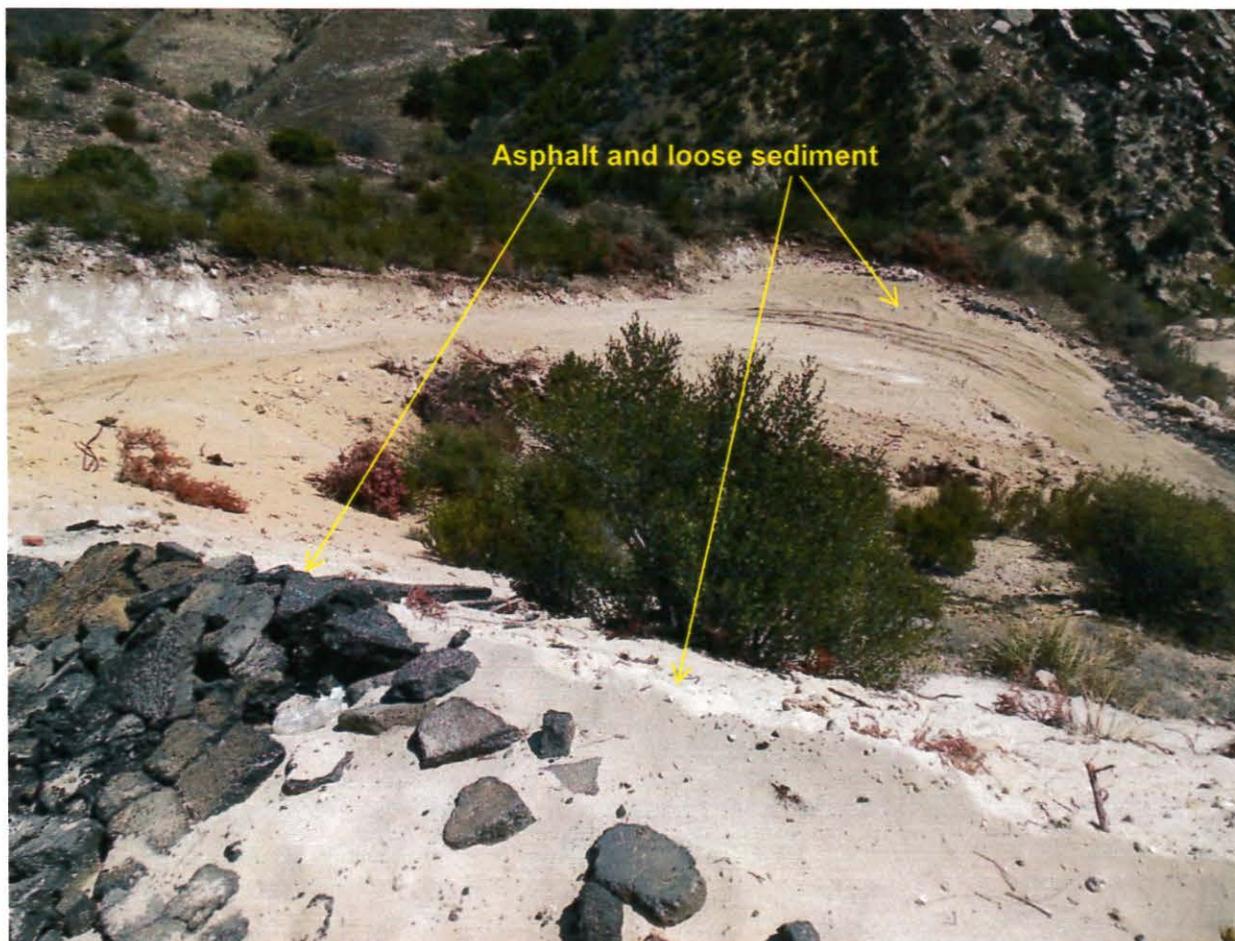
Photo 13. This photo shows graded area 3 with loose sediments, and removed vegetation. Weathered asphalt debris is being used locally to armor/stabilize the roadway.

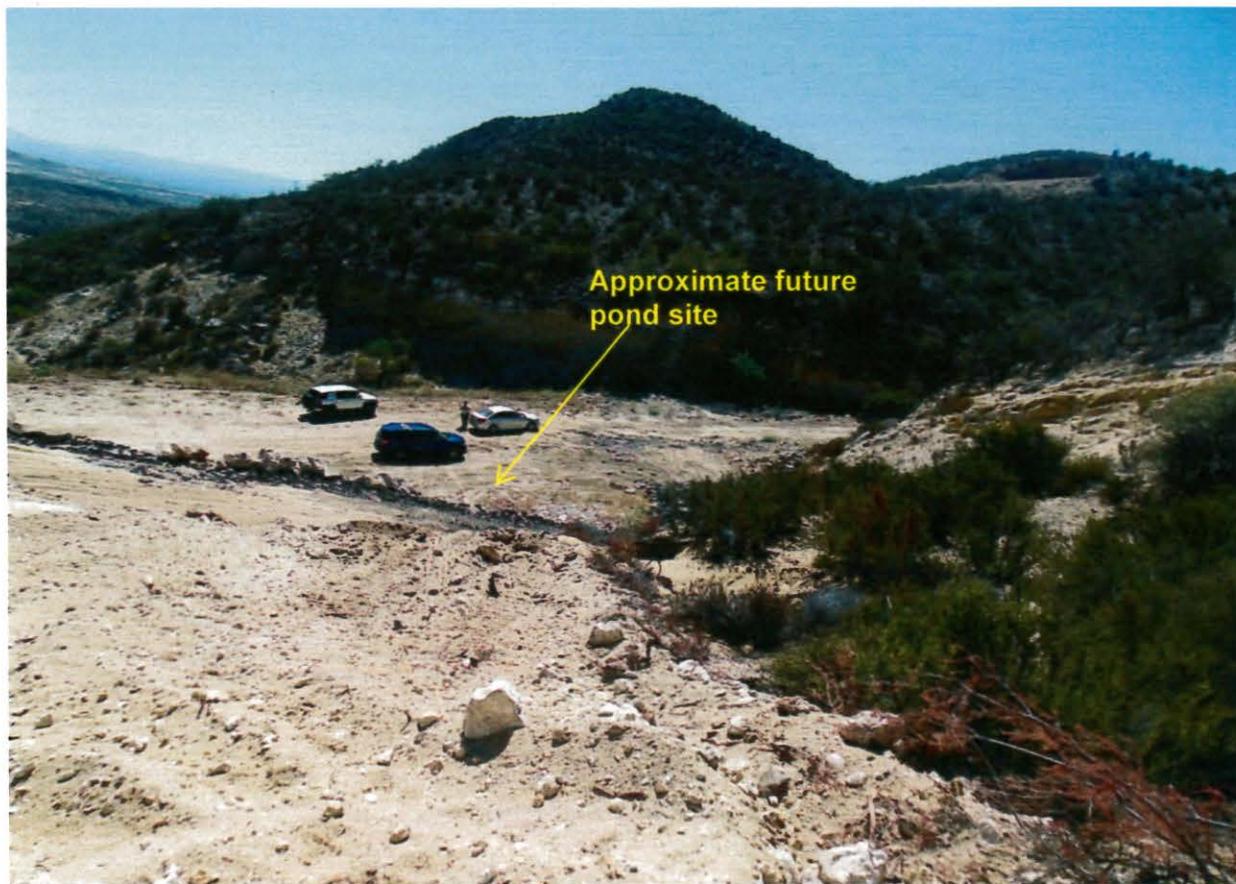
Photo 14. This photo shows pieces of asphalt mixed with soil used to stabilize the roadway, and loose sediments along the road.

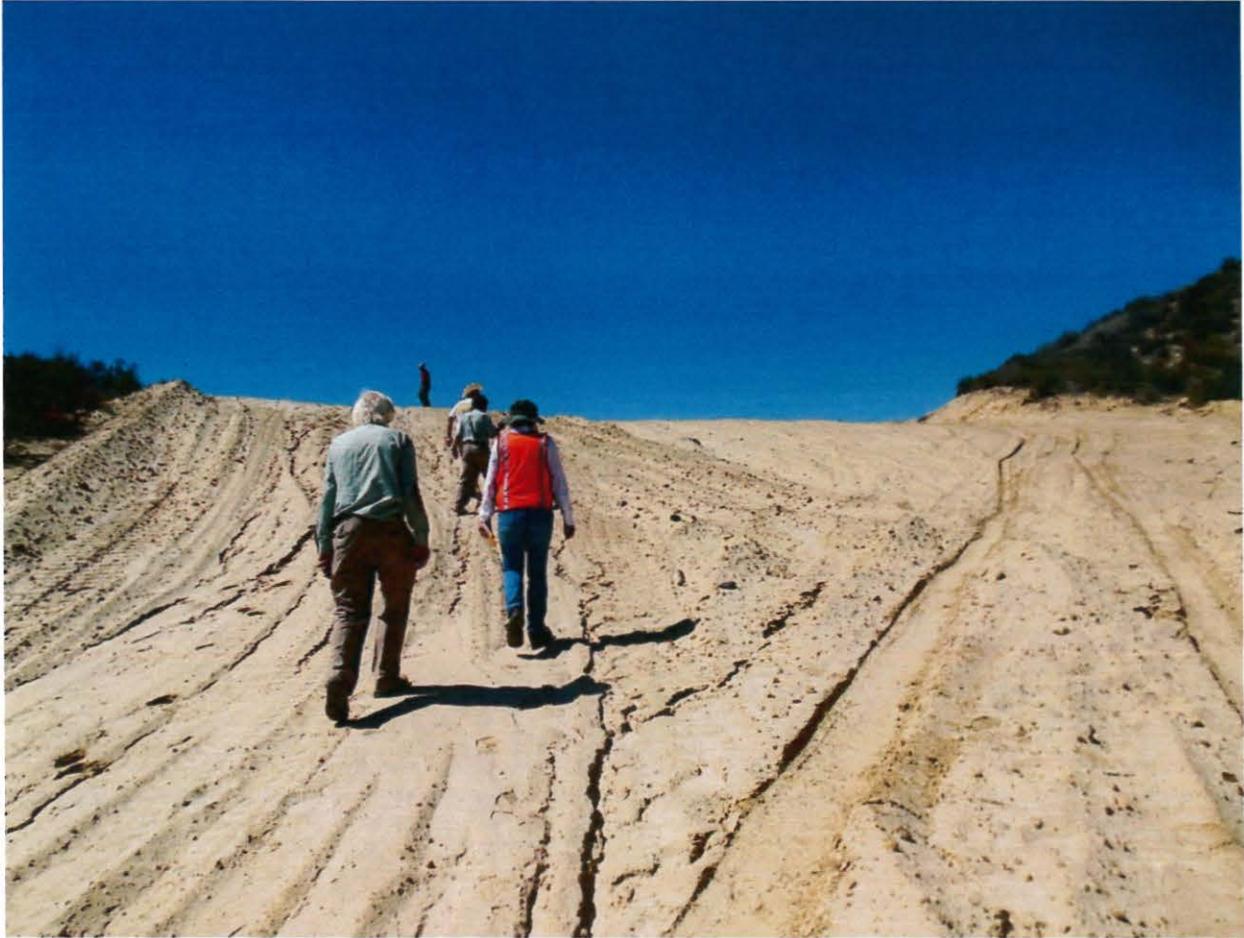
Photo 16. This photo shows the top area of ongoing grading activities shown in photo 10, above.
