March 4, 2014 Inspection Report

Los Angeles Regional Water Quality Control Board

SUBJECT: INSPECTION OF AREAS OF FILL OR PLANNED FILL TO DETERMINE PRESENCE OF WATERS OF THE STATE OR WATERS OF THE UNITED STATES

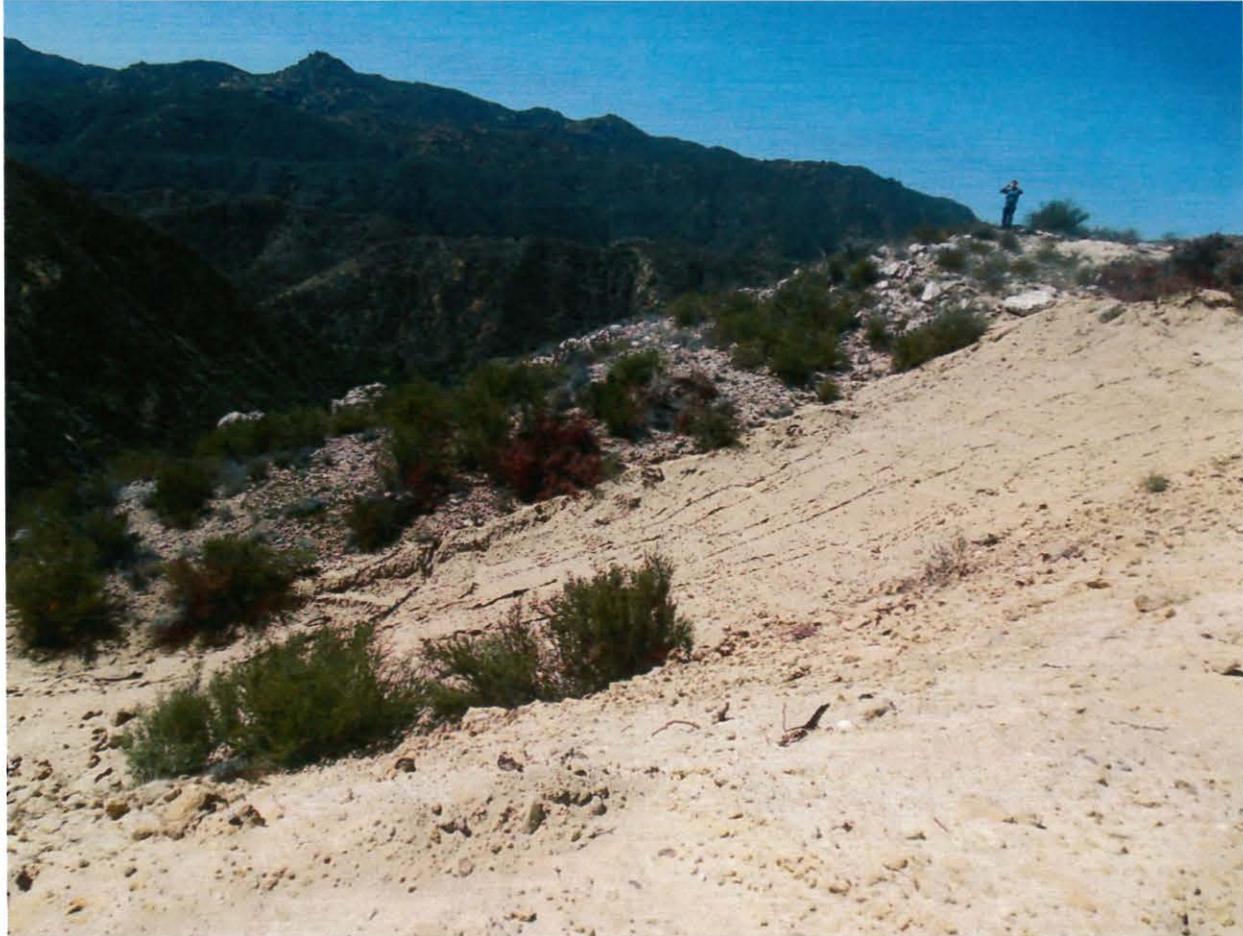
Photo 17. This photo shows another area of graded area 3 with loose sediments and rills.

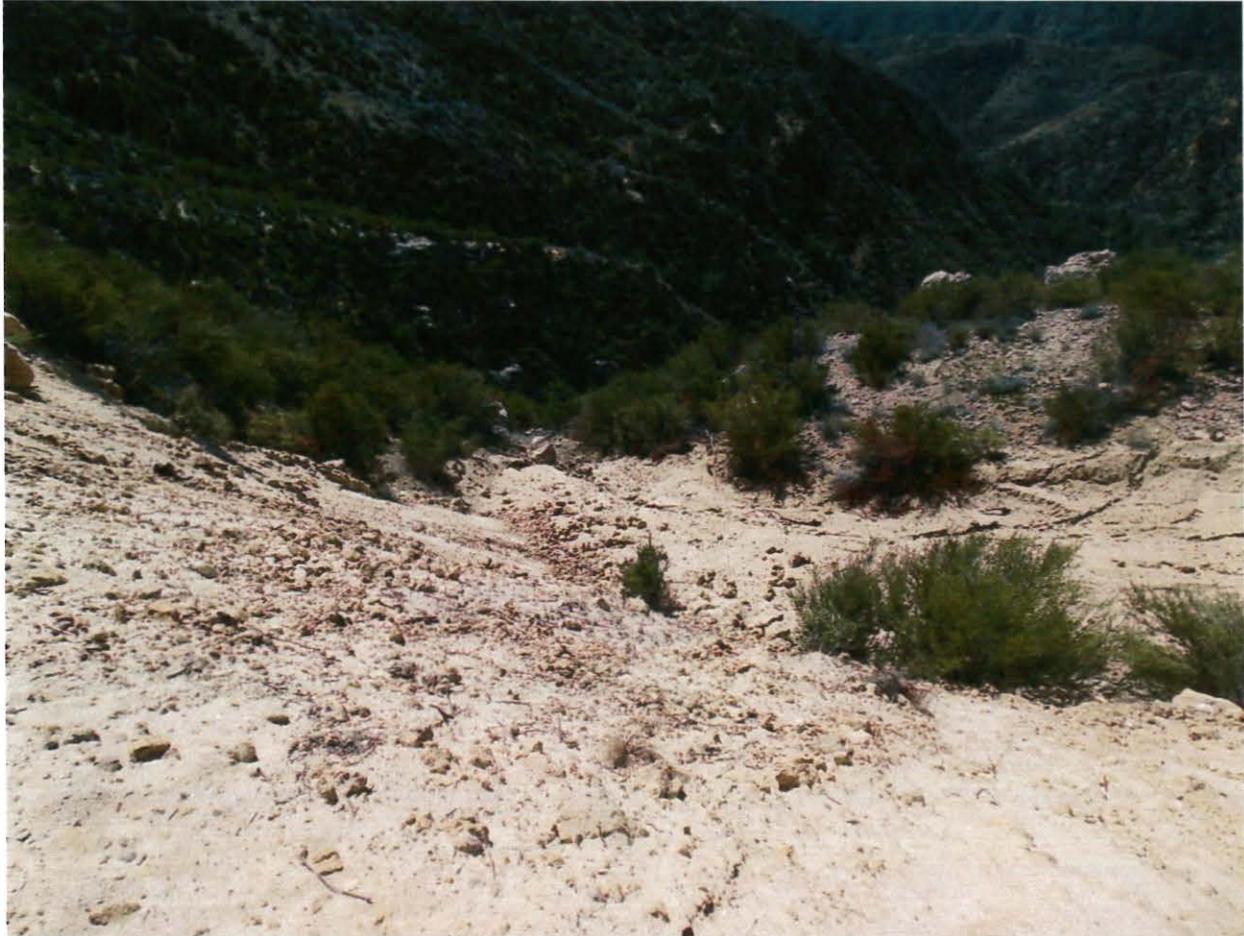
Photo 18. This photograph shows a graded area where vegetation was removed.

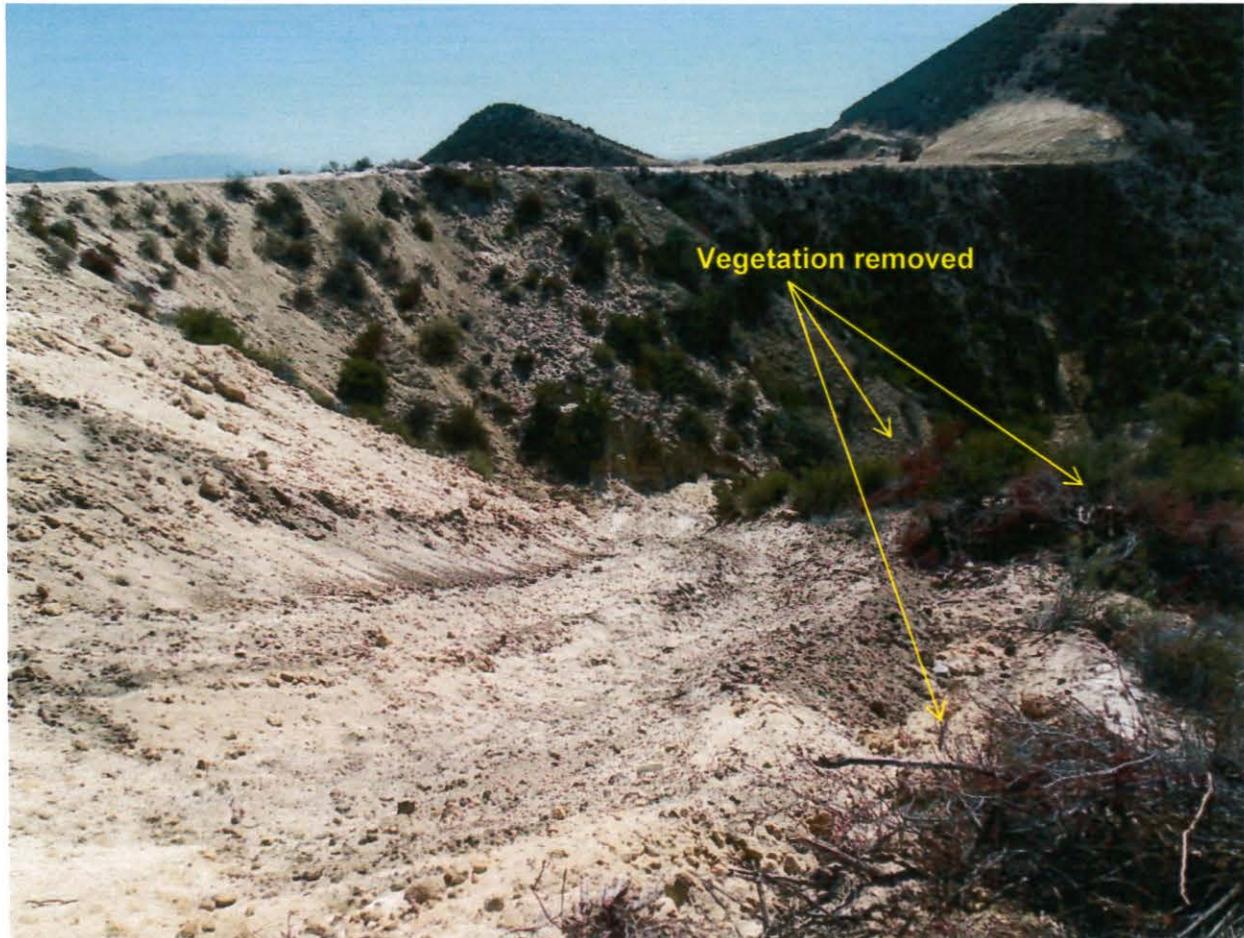
Photo 19. This photograph shows the down gradient of photo 13, above. This area has loose sediment without best management practices (BMPs), and poses a potential for loose sediments to dislodge into the canyon below.

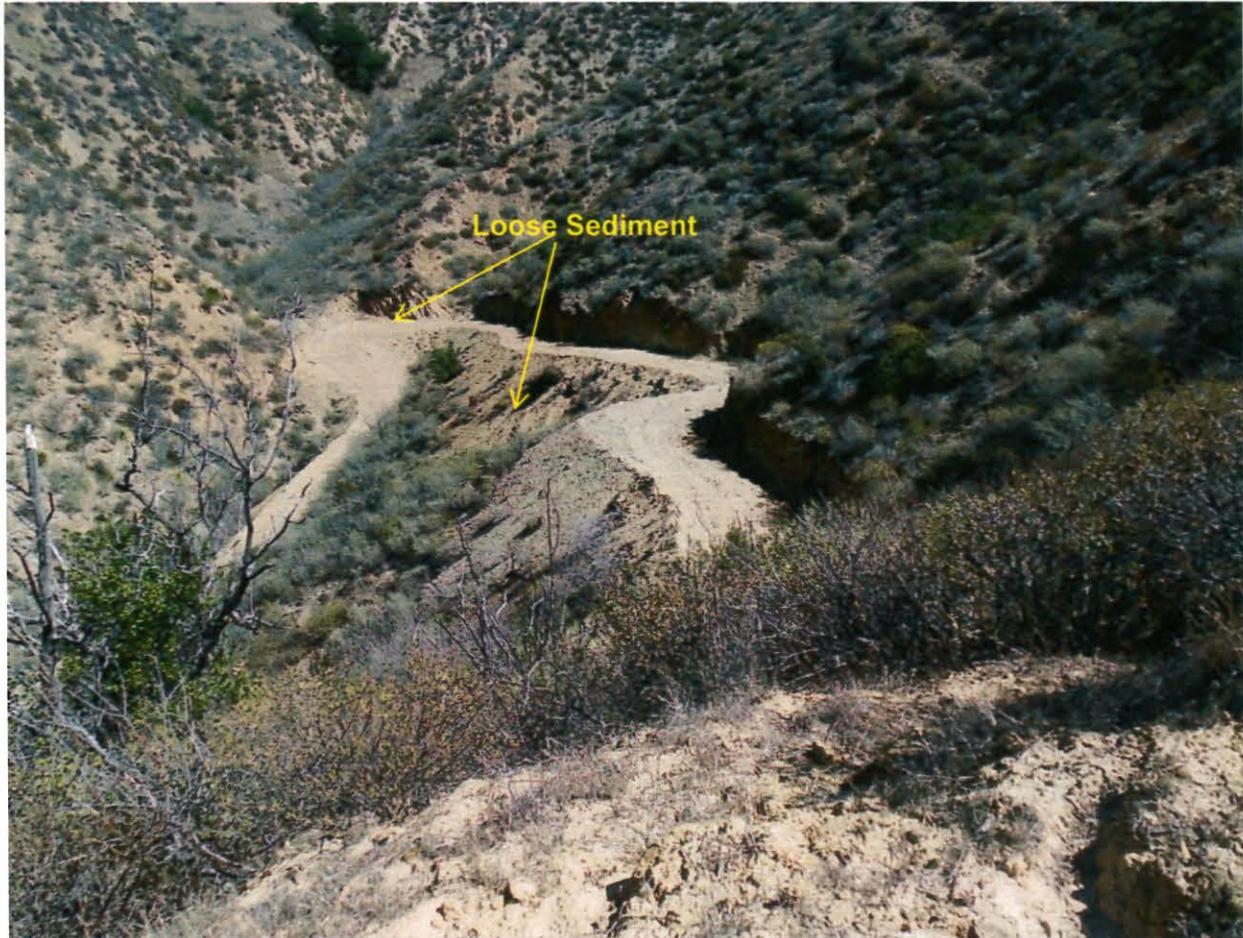
Photo 21. Photo showing a recently graded road of area 3(A) leading towards Devils Canyon and Creek.

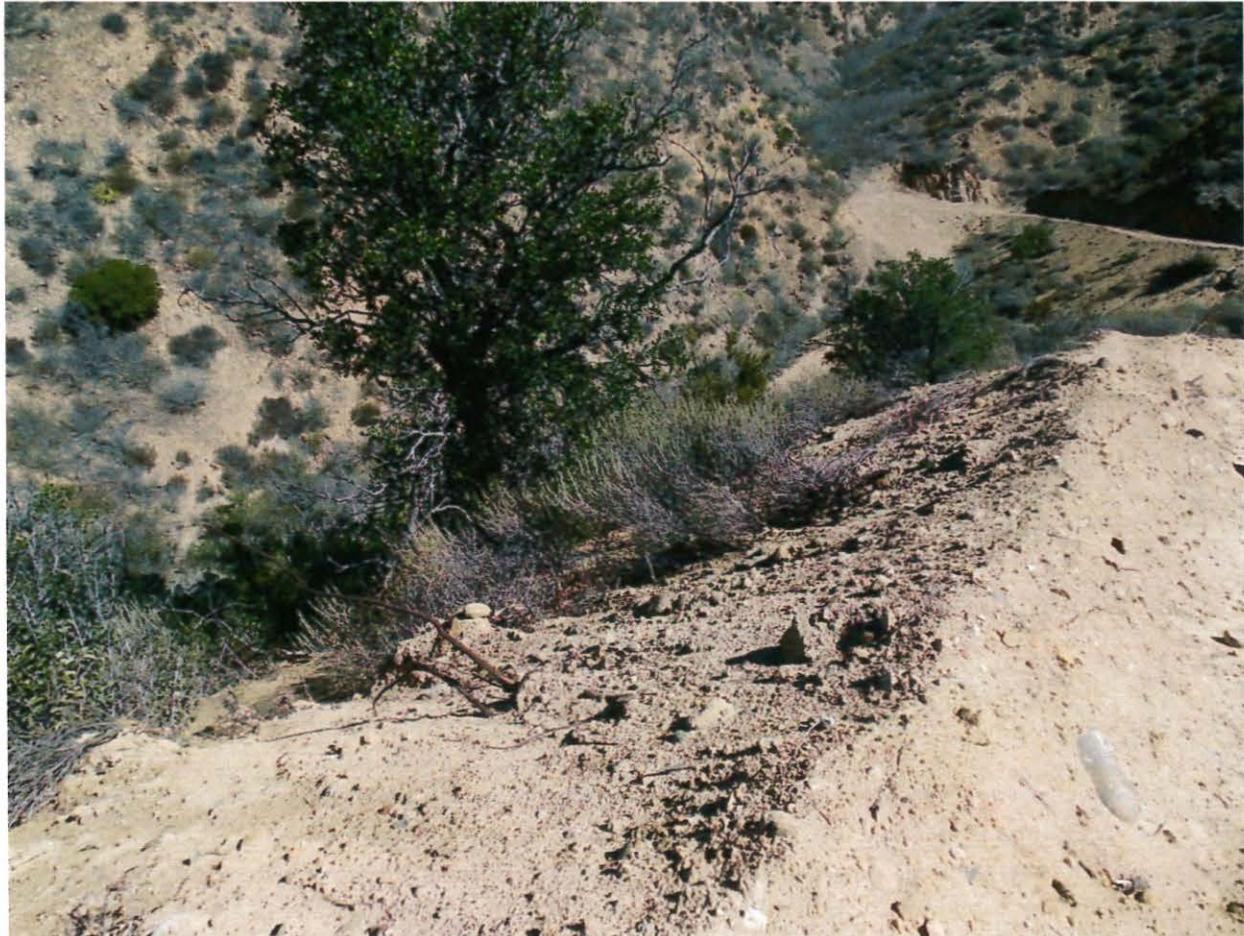
Photo 22. Road leading to Devils Creek with loose sediment and without BMPs.

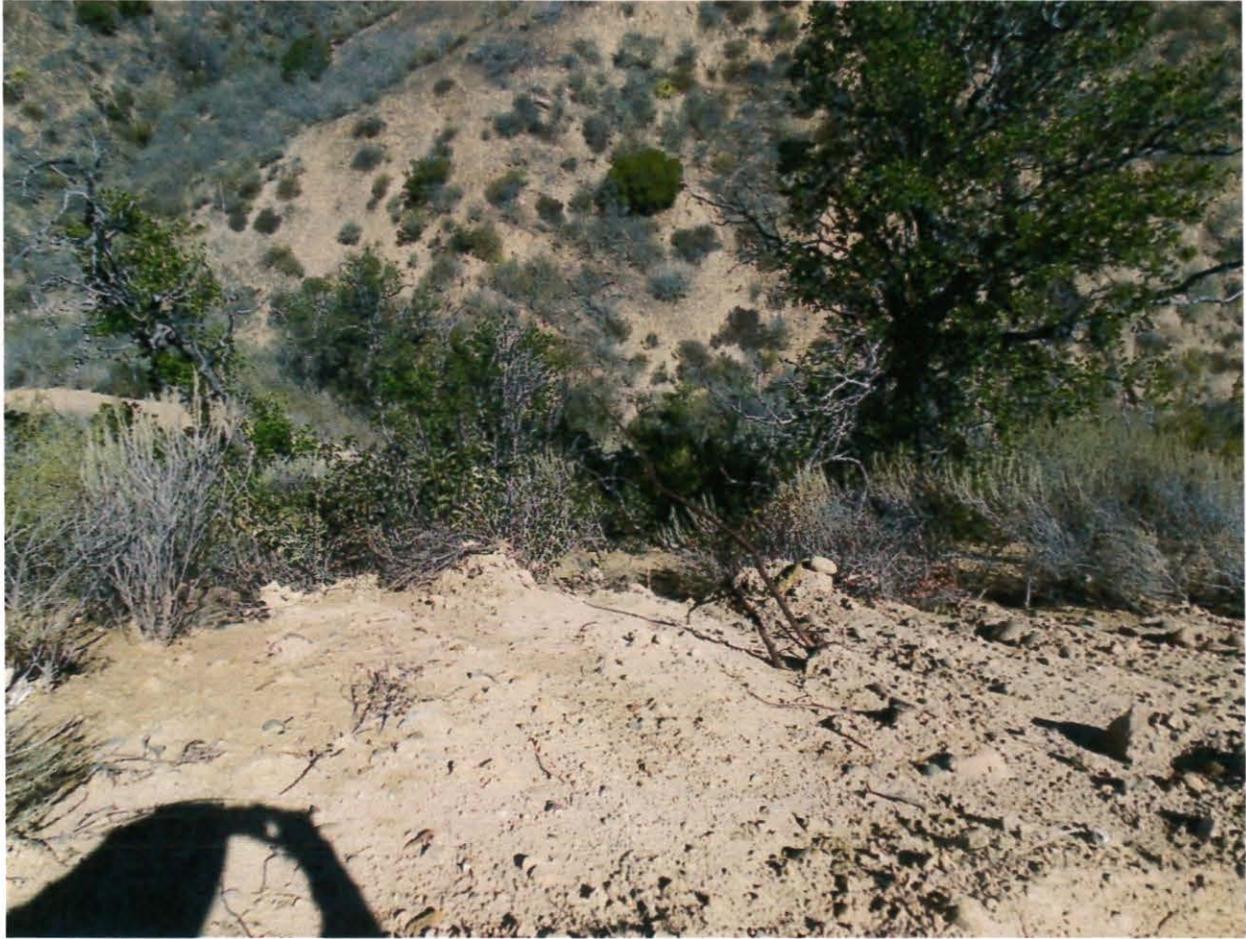
Photo 23. This photo show another view of the loose sediments along the road leading into Devils Creek.

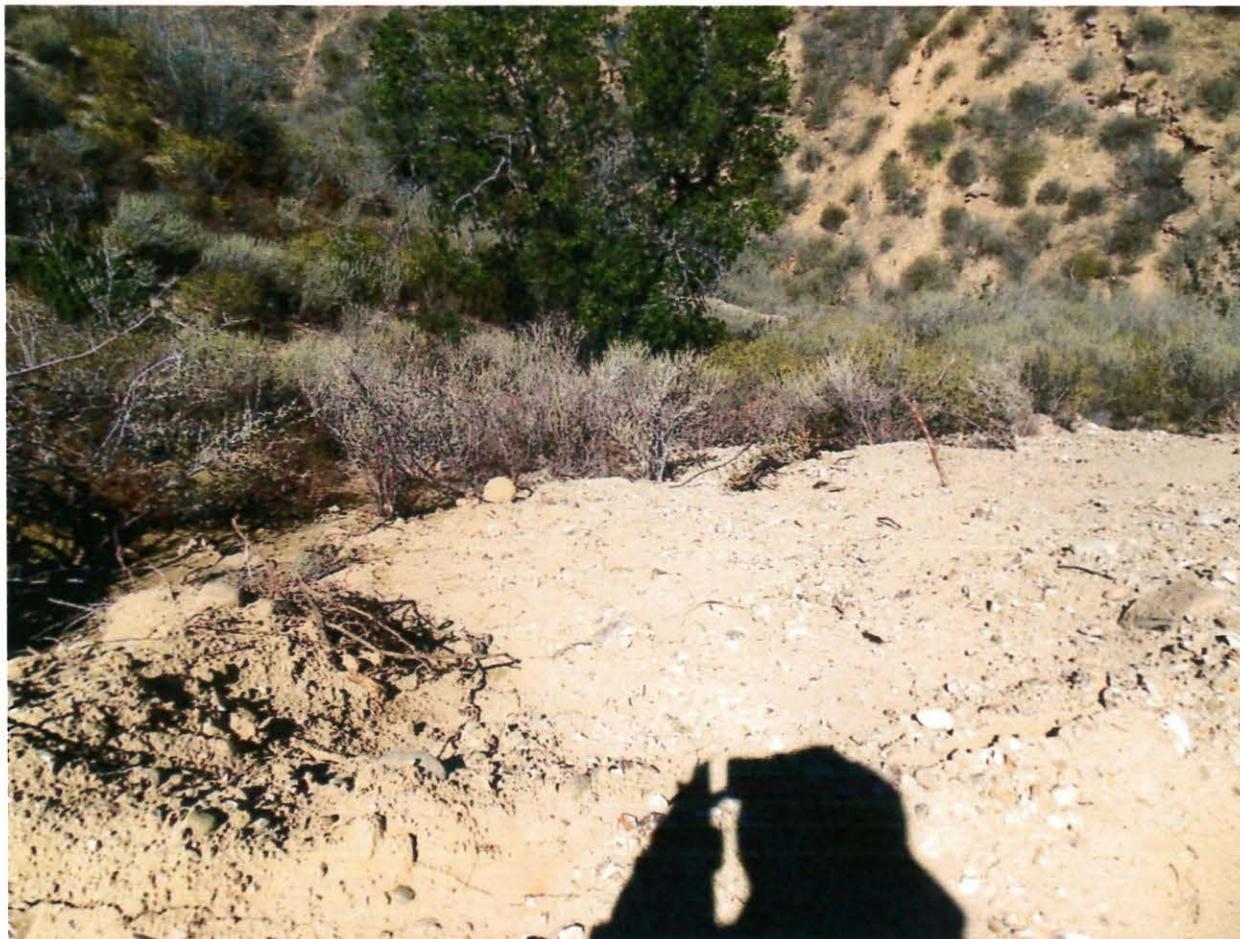
Photo 24. This photo show loose sediments eroding down Devils Canyon and Creek.

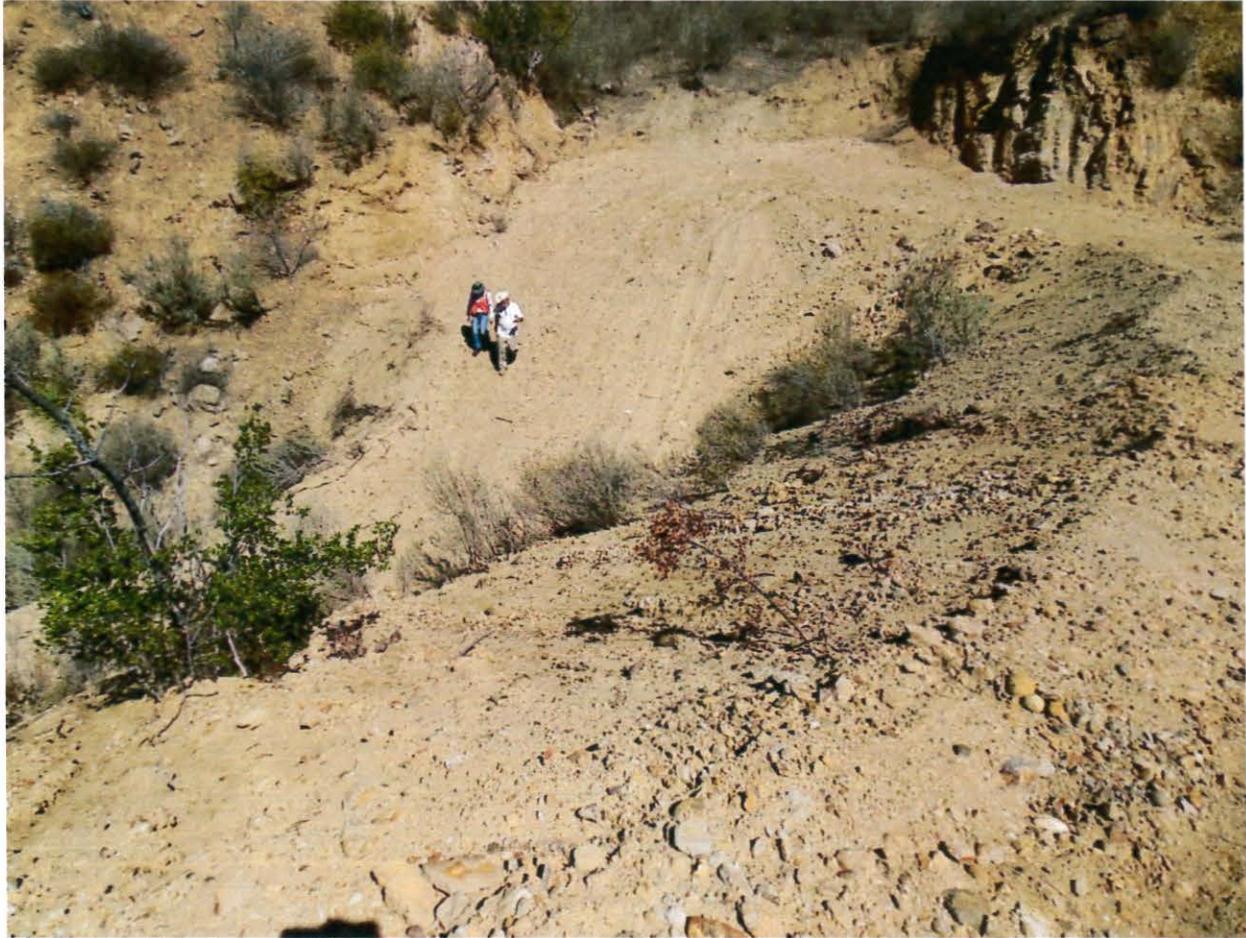
Photo 25. This is another photo of the road leading to Devils Creek with loose sediment and without BMPs.

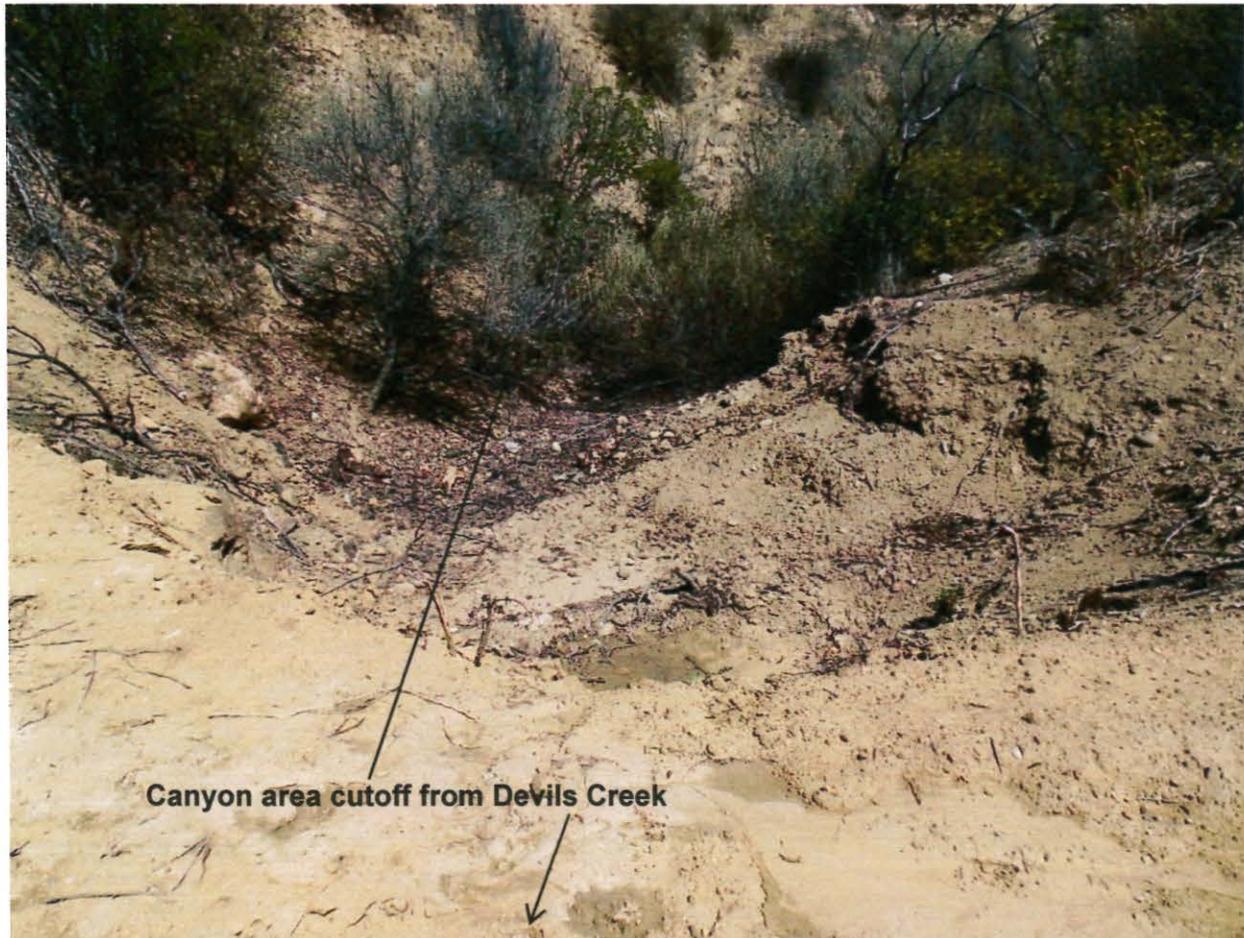
Photo 26. Existing road leading to the Devils Creek and Canyon with loose sediments.

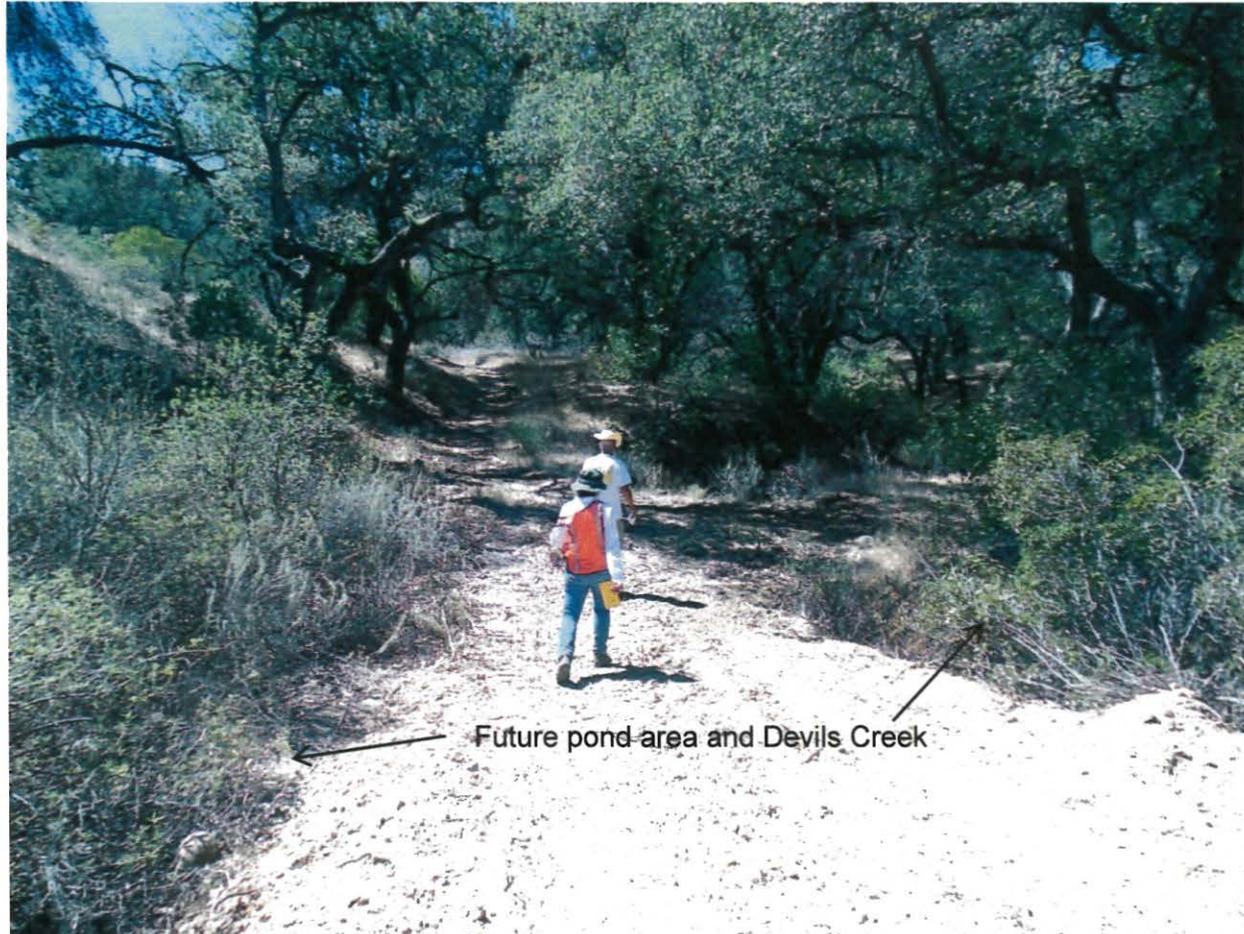
Photo 27. The sediment observed on the road from previous photos (17-21) is collected in a small area above Devils Creek. A road cuts off this area and it is a future site of a pond.

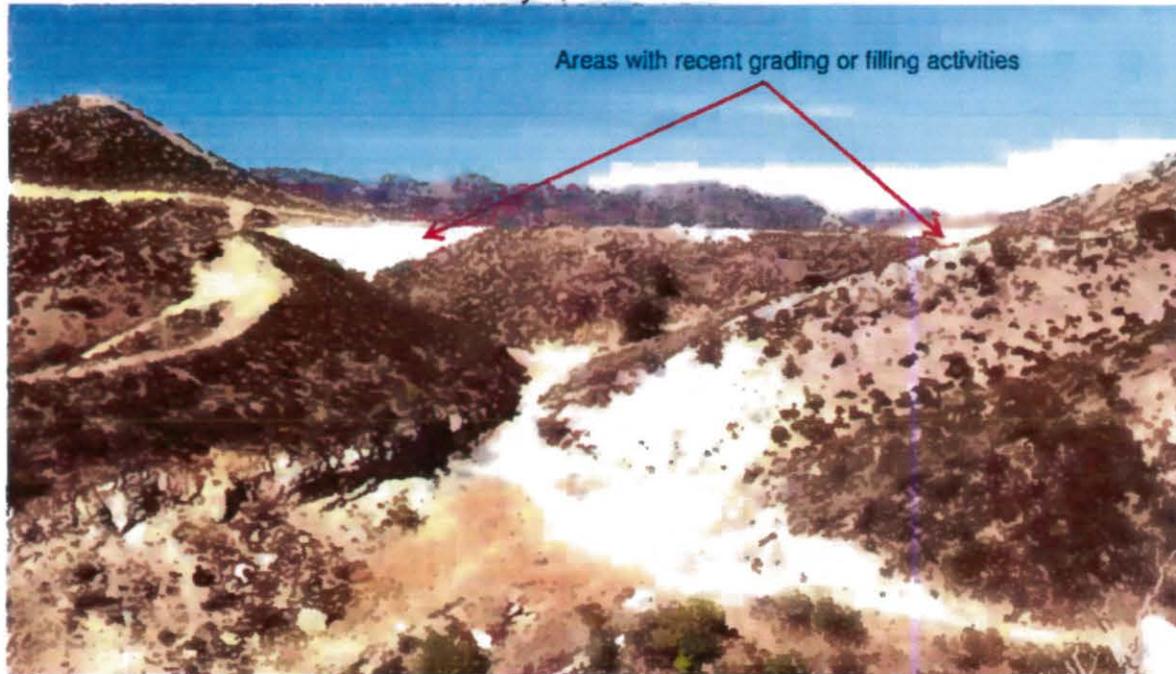
Figure 2: APN 2821-002-025, show areas that had been graded or filled since May 4, 2015.

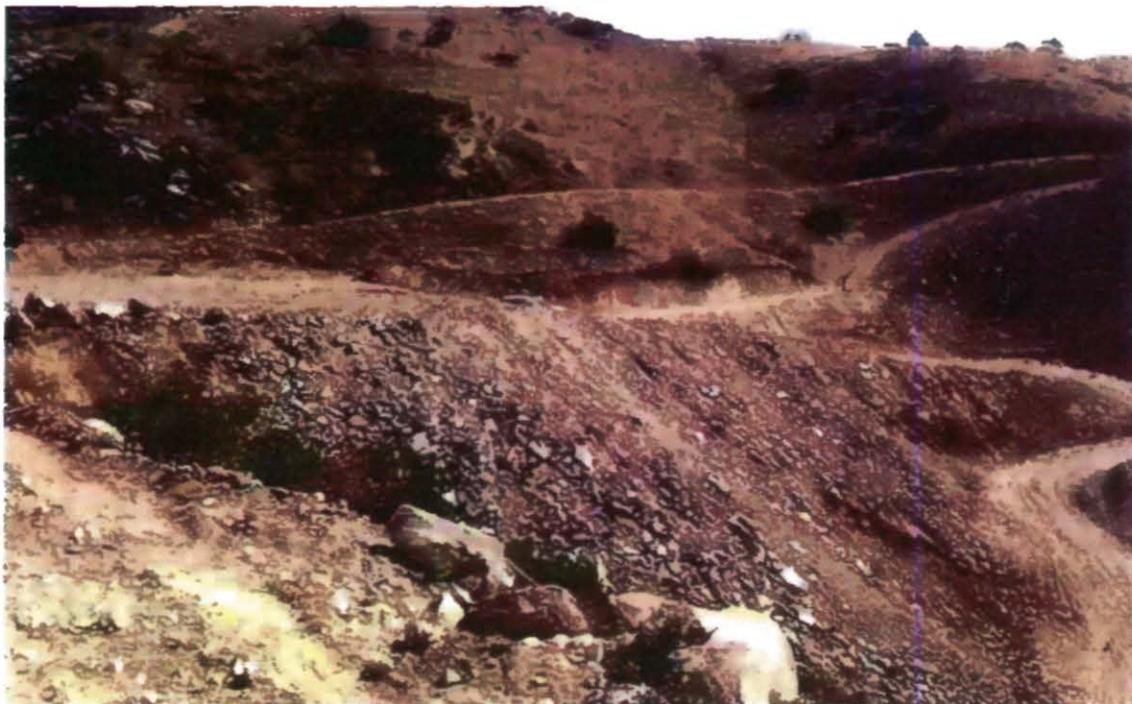
Figure 3: APN 2821-002-023. No significant changes were observed in this area, comparing to what was observed during the inspection on May 4, 2015.
