ENGINEERING SITE OBSERVATION REPORT

SUBJECT: Sam's Club of El Monte, CA (Store No 6614-01) Post-Construction Stormwater BMP Observation Report

FROM: Ken Jewell, M.S., P.E. CPESC

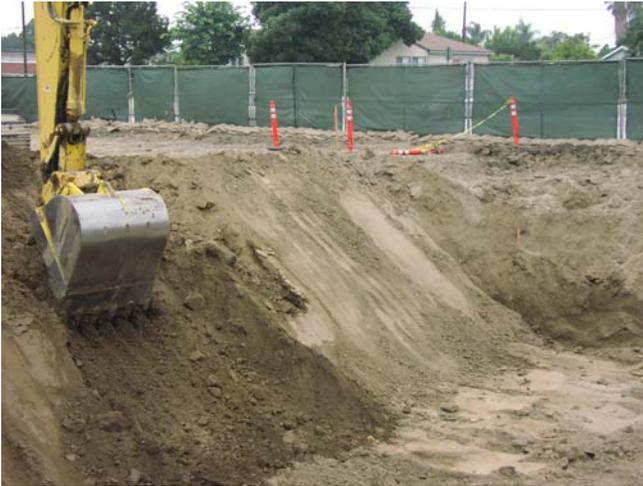
Underground Infiltration Basin – 09/08/08

Excavation of Underground Infiltration Basin No. 2 near the Southern property line adjacent to Lower Azusa Road.

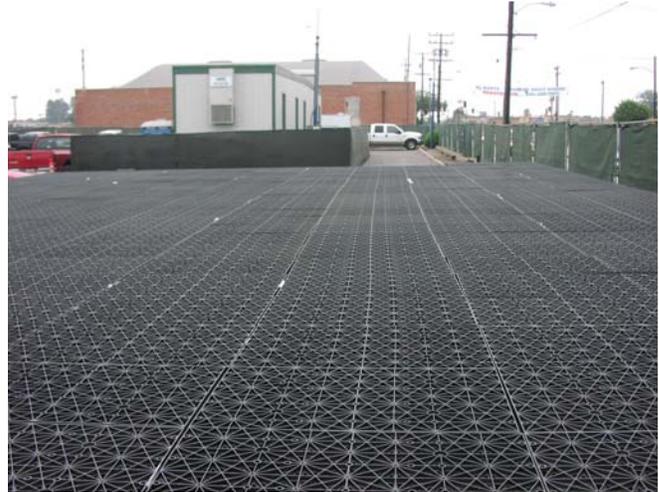
Underground Infiltration Basin – 09/08/08

The underground infiltration tanks modules (Atlantis® Matrix™) were assembled at surface, prior to installation into Basin No. 2.

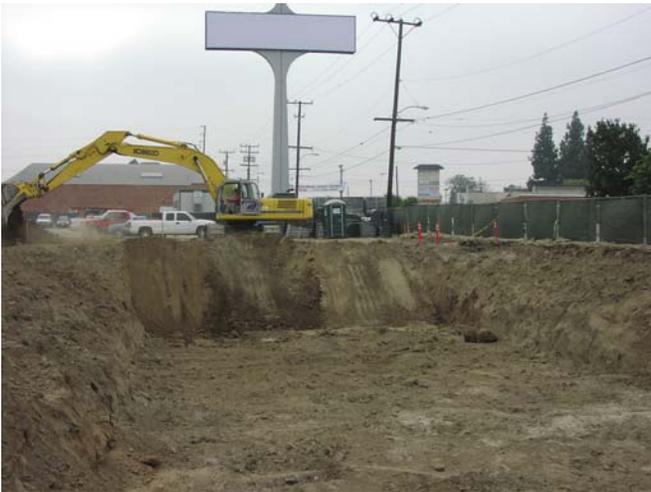
Underground Infiltration Basin – 09/08/08

Excavation of Underground Infiltration Basin No. 2 near the Southern property line adjacent to Lower Azusa Road.

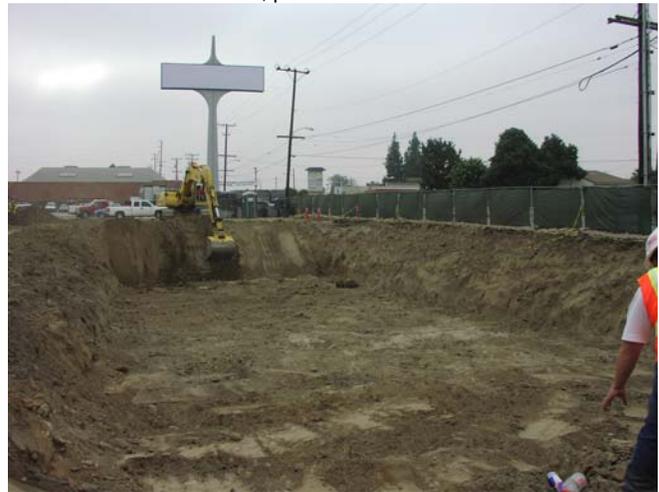
Underground Infiltration Basin – 09/08/08

Excavation of Underground Infiltration Basin No. 2 near the Southern property line adjacent to Lower Azusa Road.

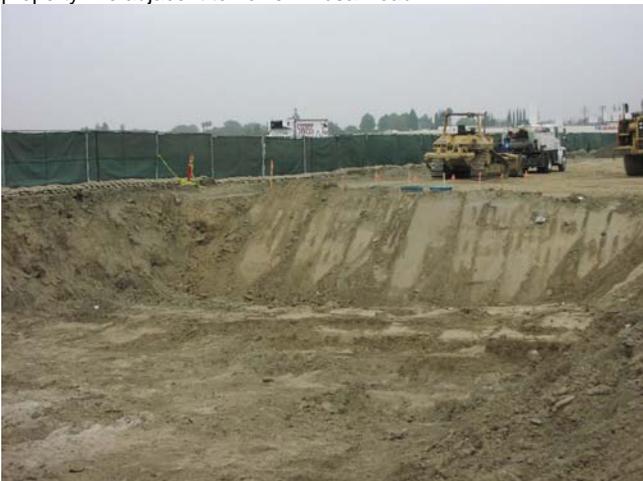
Underground Infiltration Basin – 09/08/08

Excavation of Underground Infiltration Basin No. 2 near the Southern property line adjacent to Lower Azusa Road.

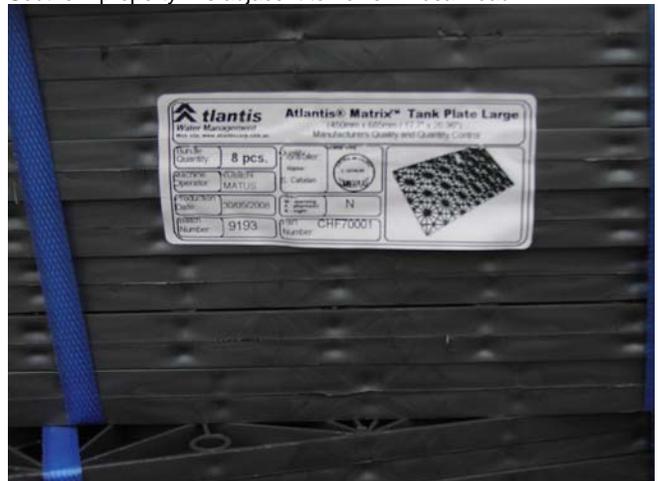
Underground Infiltration Basin – 09/08/08

The underground infiltration tanks modules (Atlantis® Matrix™) were assembled at surface, prior to installation into Basin No. 2.

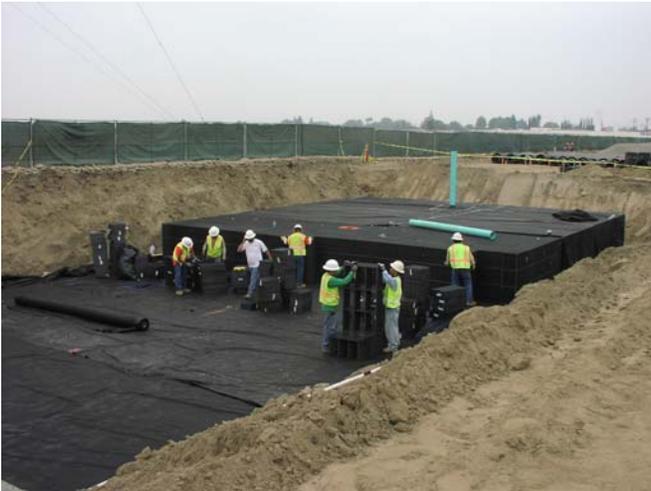
Underground Infiltration Basin – 09/11/08

Installation of Underground Infiltration Basin No. 2, near the Southern property line Note permeable geo-fabric and clean-out portals.

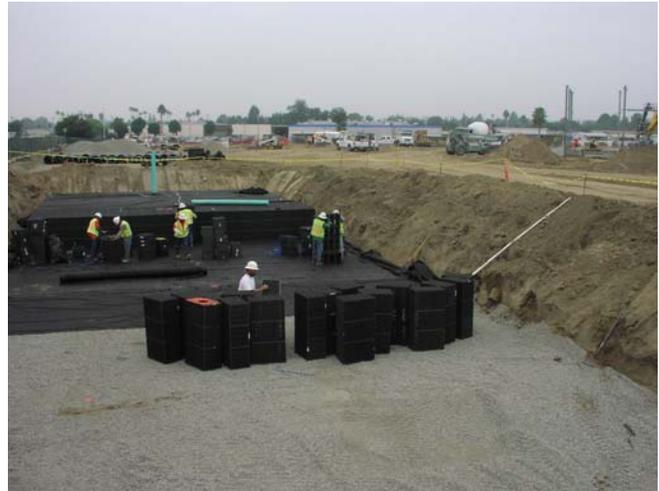
Underground Infiltration Basin – 09/11/08

Installation of Underground Basin No. 2, near the Southern property line Note the gravel base and permeable geo-fabric.

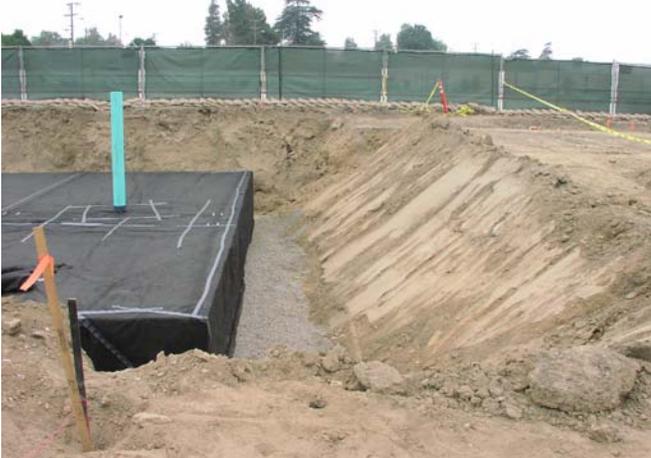
Underground Infiltration Basin – 09/11/08

Installation of Underground Basin No. 2. Please note the gravel base, permeable geo-fabric and cleanout portal.

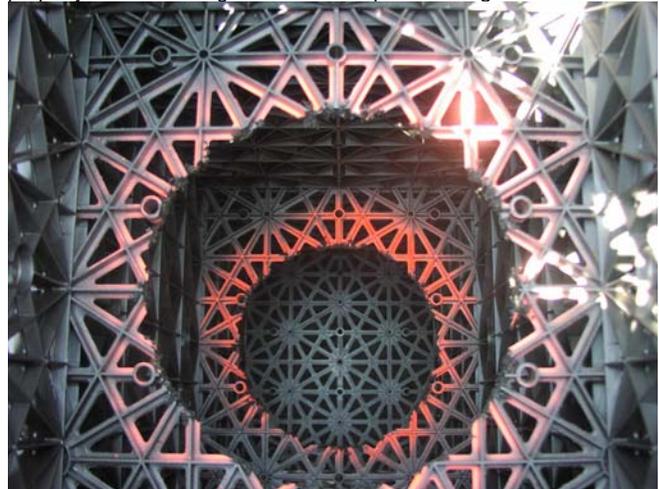
Underground Infiltration Basin – 09/11/08

Installation of Underground Basin 2 -- cleanouts are cut through the modular tank units per the manufacturers' recommendations.

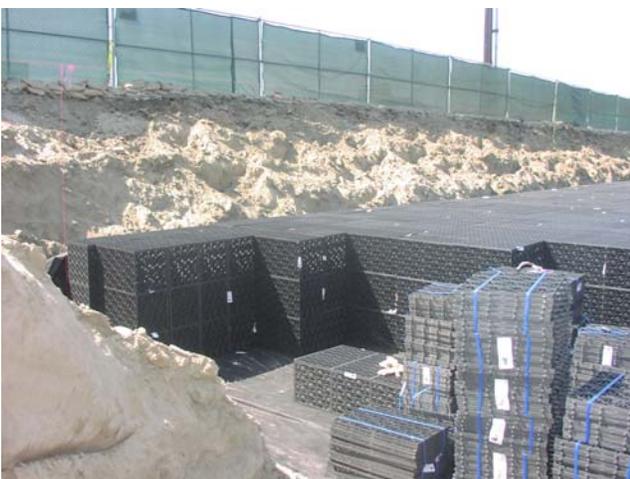
Underground Infiltration Basin – 09/11/08

Installation of Underground Basin No. 2, near the Southern property line Note the gravel base and permeable geo-fabric.

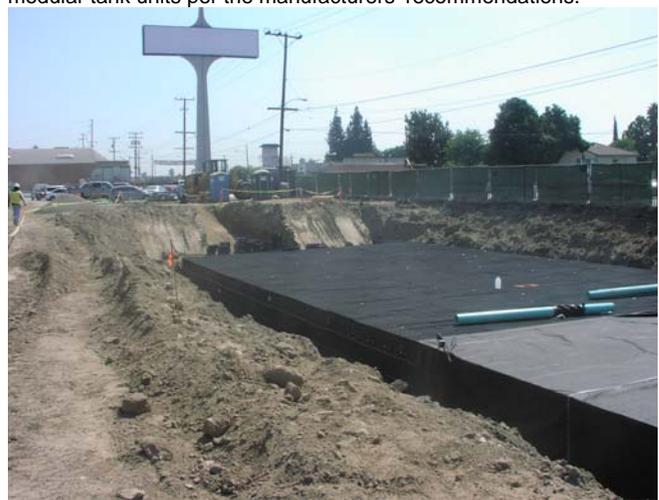
Underground Infiltration Basin – 09/11/08

Installation of Underground Basin 2, near the Southern property line Note permeable geo-fabric and installation nearly complete.

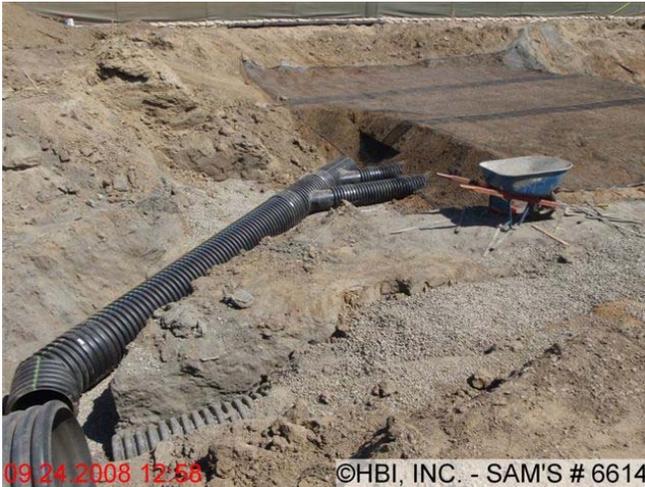
Underground Infiltration Basin – 09/24/08

Installation of the outlet/discharge pipes from Underground Infiltration Basin No. 1. Also note the geo-fabric over 1 foot of sand backfill.

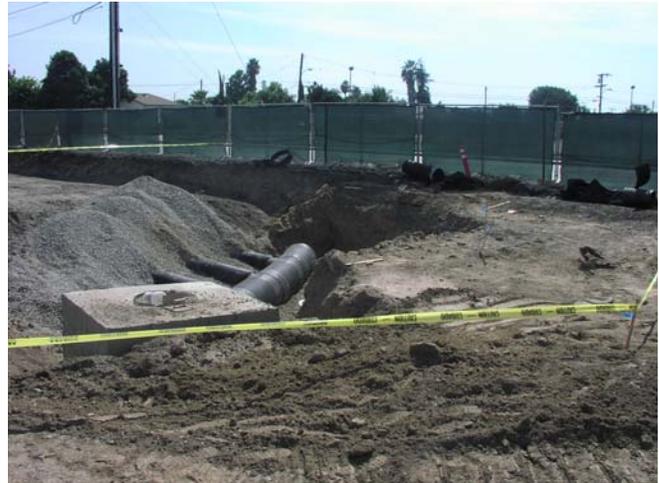
Underground Infiltration Basin – 10/02/08

Installation of the outlet structure and storm drain pipes near the discharge of Underground Infiltration Basin No. 2.

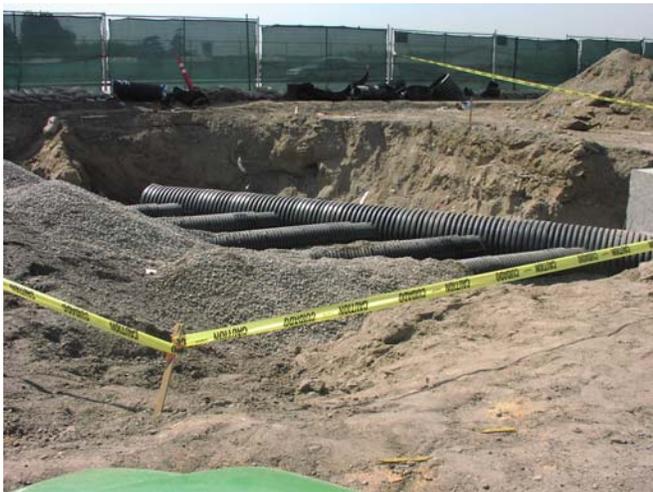
Underground Infiltration Basin – 10/02/08

Installation of the outlet structure and storm drain pipes near the discharge of Underground Infiltration Basin No. 2.

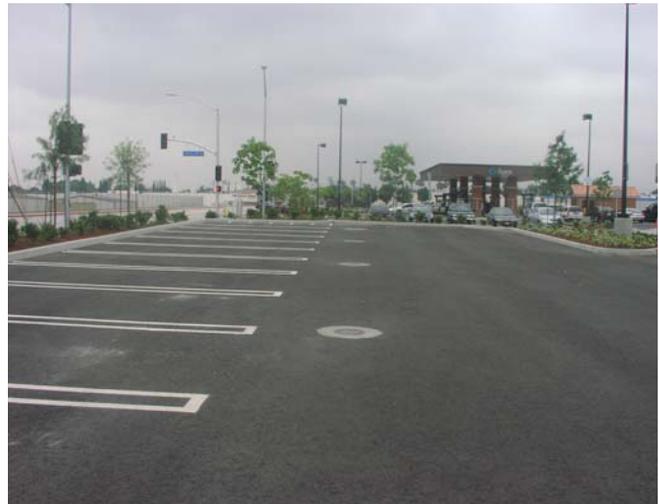
Underground Infiltration Basin – 6/10/09

Cleanouts in the parking area for Underground Infiltration Basin No. 2.

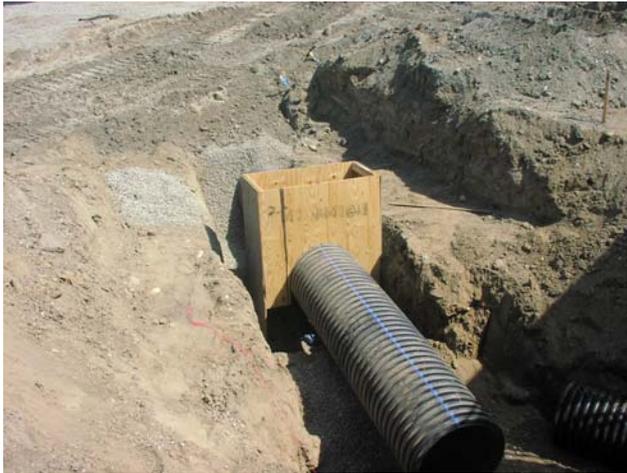
Storm Drain – 10/02/08

Installation of concrete forms for the concrete anchors and storm drain piping at the edge of the bioretention cells to limit water seepage through the storm drain trench.

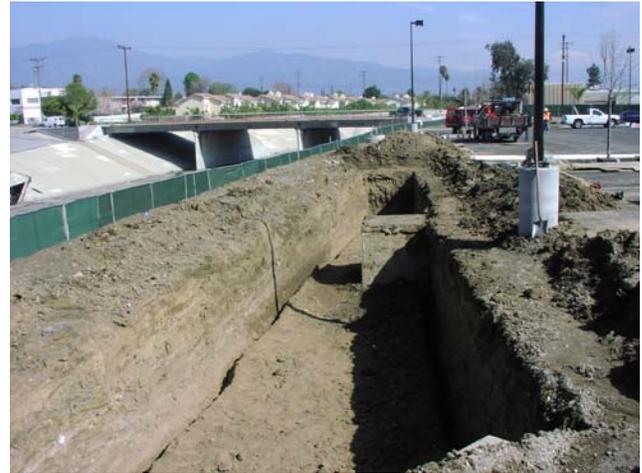
Bioretention Cells -- 02/11/09

Excavation of exiting soil at Bioretention Cell. Note the storm drain inlet and soil preparation for the impermeable vertical liner.

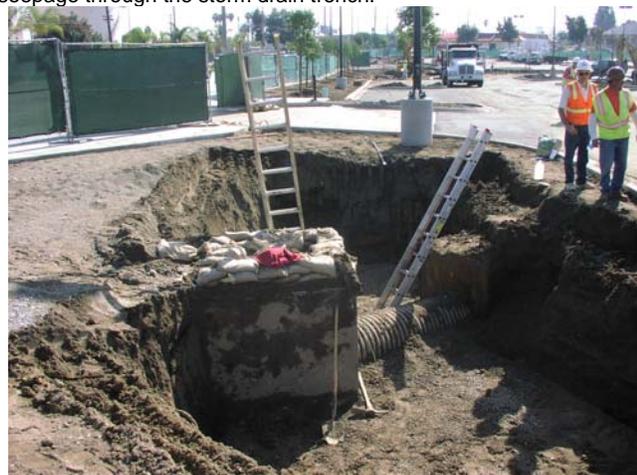
Bioretention Cells -- 02/11/09

Excavation of exiting soil at Bioretention Cell. Note the storm drain inlet and pipe for overflow discharges.

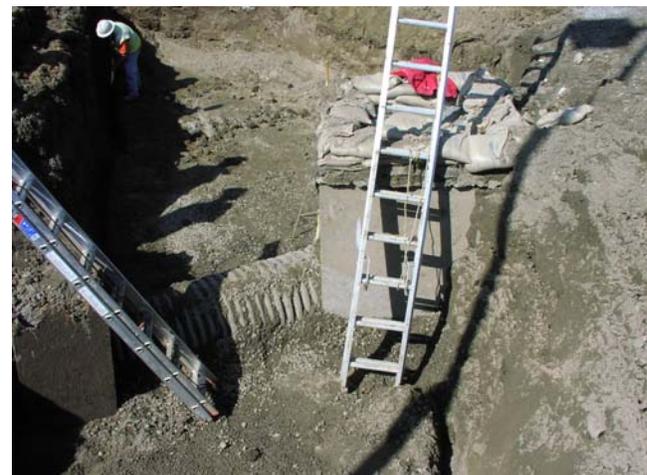
Bioretention Cells -- 02/11/09

Excavation of exiting soil at Bioretention Cell. Note the storm drain inlet and pipe for overflow discharges.

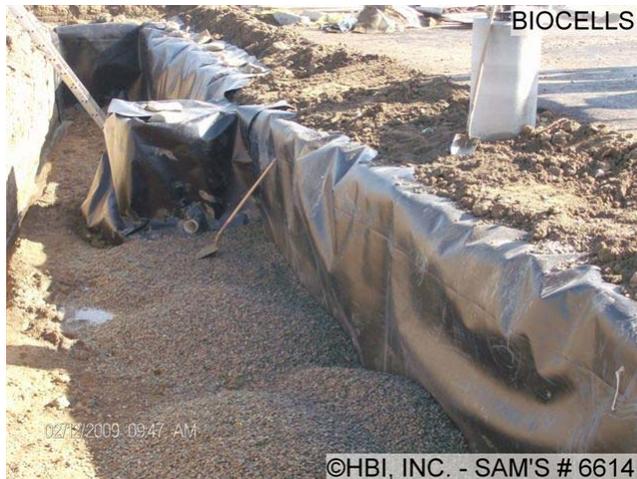
Bioretention Cells -- 02/12/09

Installation of Bioretention Cell. Note the storm drain inlet with under-drain stub-out, and the vertical impermeable liner.

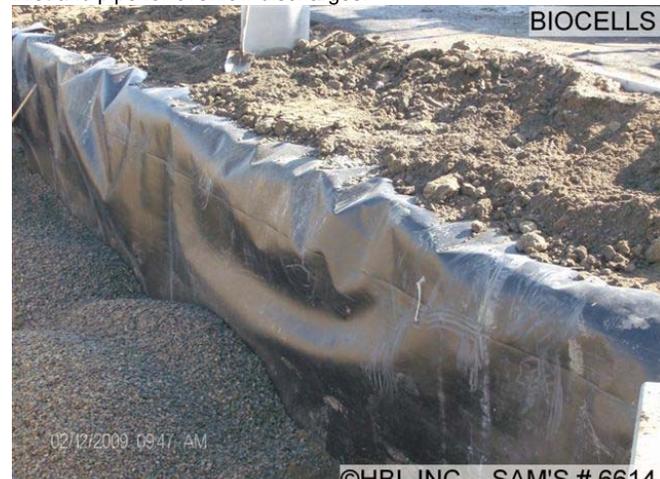
Bioretention Cells -- 02/12/09

Installation of Bioretention Cell. Note the storm drain inlet with under-drain stub-out, and the vertical impermeable liner.

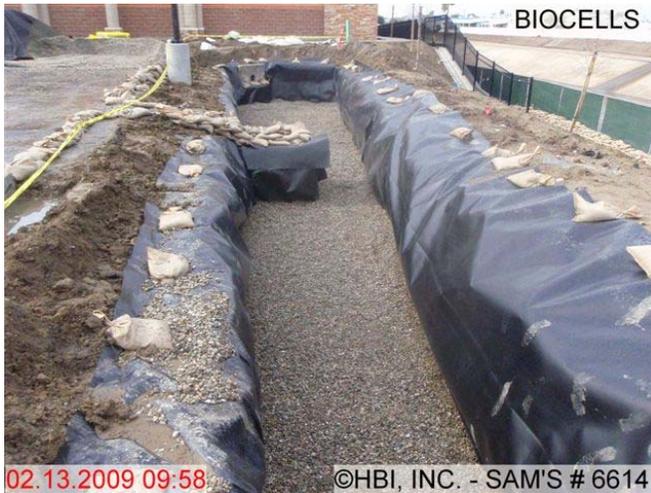
Bioretention Cells -- 02/13/09

Installation of Bioretention Cell. Note the storm drain inlet with under-drain stub-out, the gravel sub-base & the vertical impermeable liner.

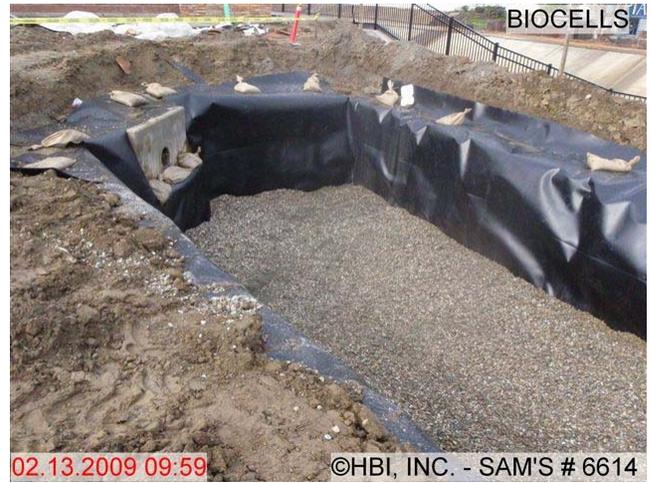
Bioretention Cells -- 02/13/09

Installation of Bioretention Cell. Note the gravel sub-base & the vertical impermeable liner.

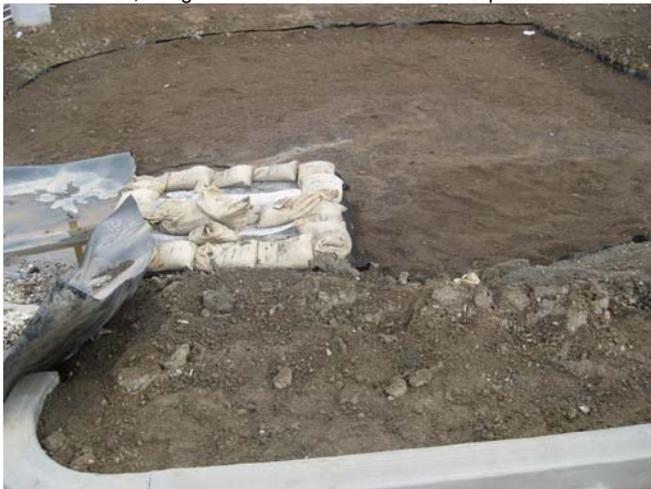
Bioretention Cells -- 03/04/09

Installation of Bioretention Cell. Note the amended soils have been installed and the area is nearly at finished grade.

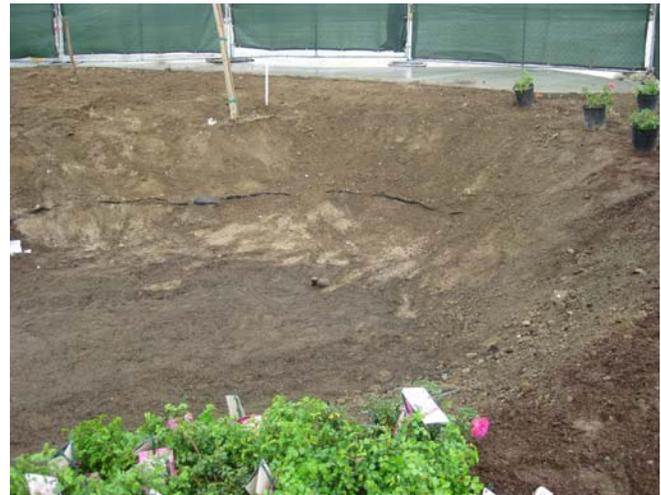
Bioretention Cells -- 03/04/09

Installation of Bioretention Cell. Note the amended soils have been installed and the area is nearly at finished grade.

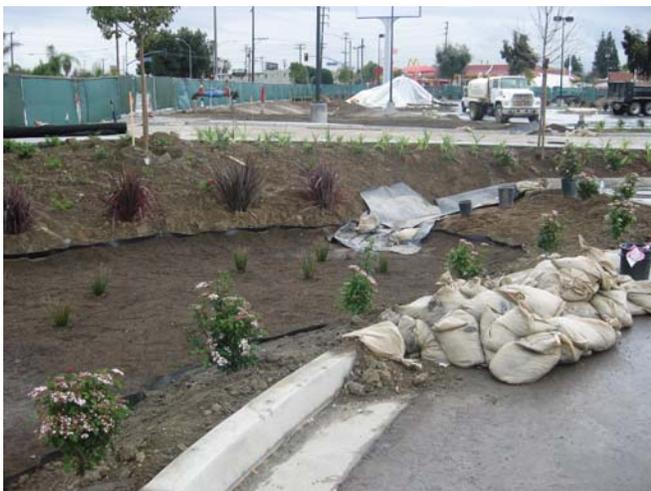
Bioretention Cells -- 03/04/09

Installation of Bioretention Cell. Note the amended soils have been installed and landscaping activities have begun

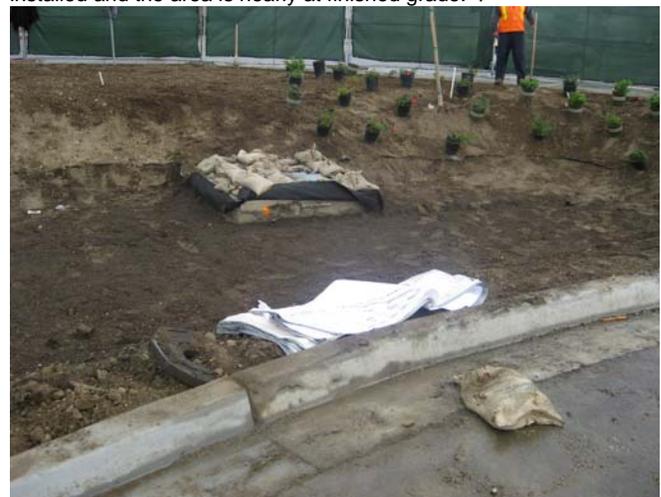
Bioretention Cells -- 03/04/09

Installation of Bioretention Cell. Note the amended soils have been installed and landscaping activities have begun

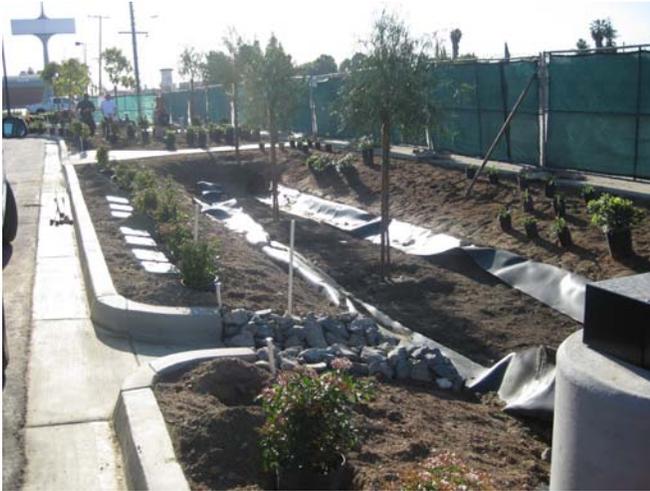
Bioretention Cells -- 03/23/09

Installation of landscaping and irrigation within the Bioretention Cell. Note rip-rap velocity dissipation installed at curb openings.

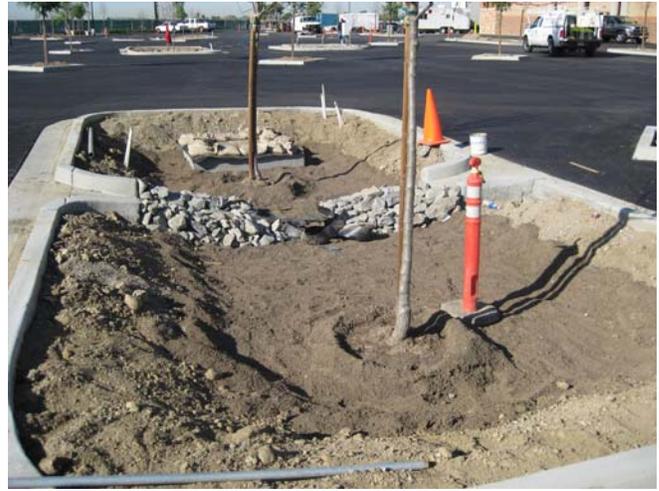
Bioretention Cells -- 03/23/09

Installation of landscaping and irrigation within the Bioretention Cell. Note rip-rap velocity dissipation installed at curb openings.

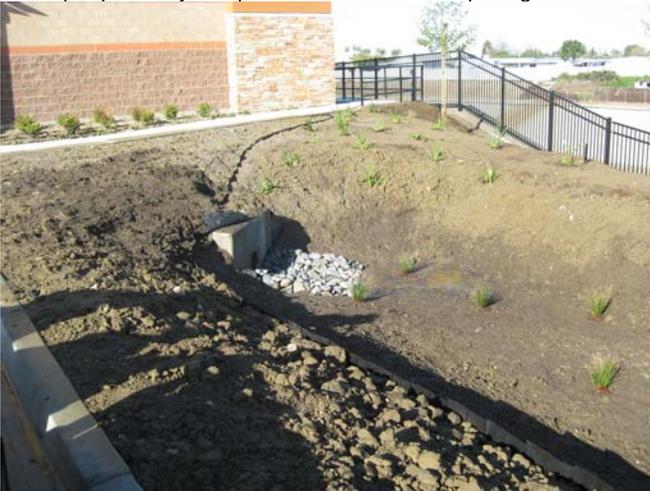
Bioretention Cells -- 03/23/09

Installation of landscaping and irrigation within the Bioretention Cell. Note rip-rap velocity dissipation at inlet to Bioretention Cell.

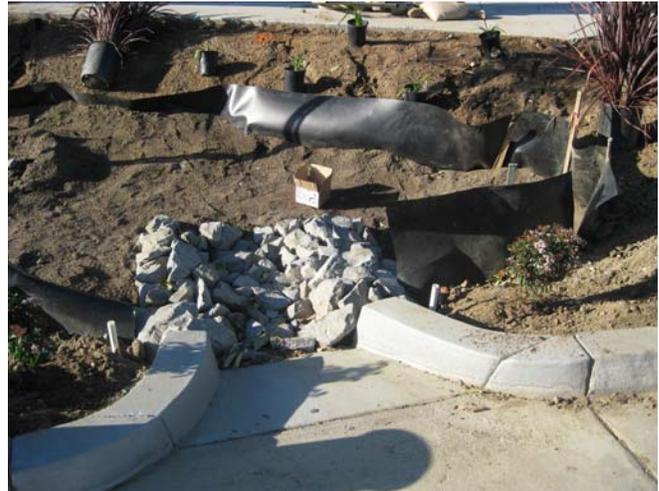
Bioretention Cells -- 03/23/09

Installation of landscaping and irrigation within the Bioretention Cell. Note rip-rap velocity dissipation installed at curb opening.

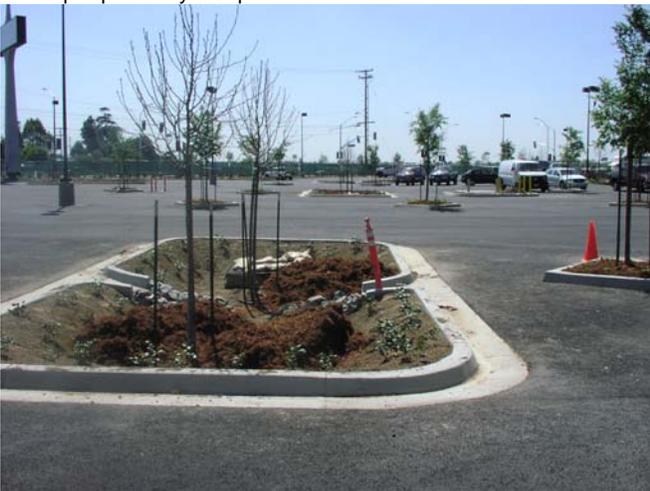
Bioretention Cells -- 04/07/09

Installation of final layer of wood mulch as a part of the filter within the Bioretention Cell. Note rip-rap velocity dissipation at curb openings.

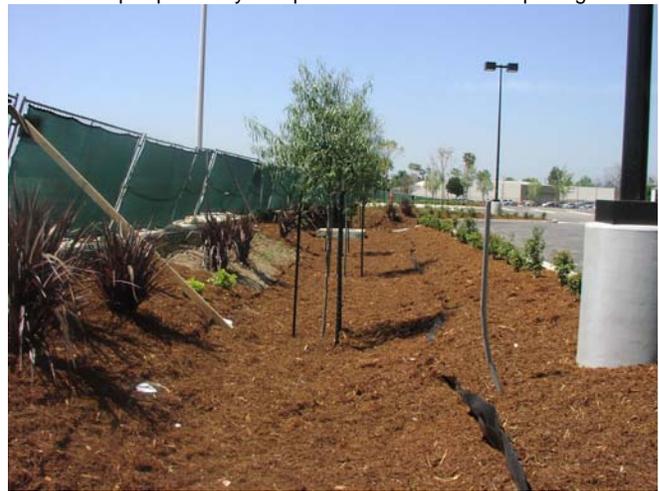
Bioretention Cells -- 04/07/09

Installation of final layer wood mulch as the top filter layer within the Bioretention Cells.

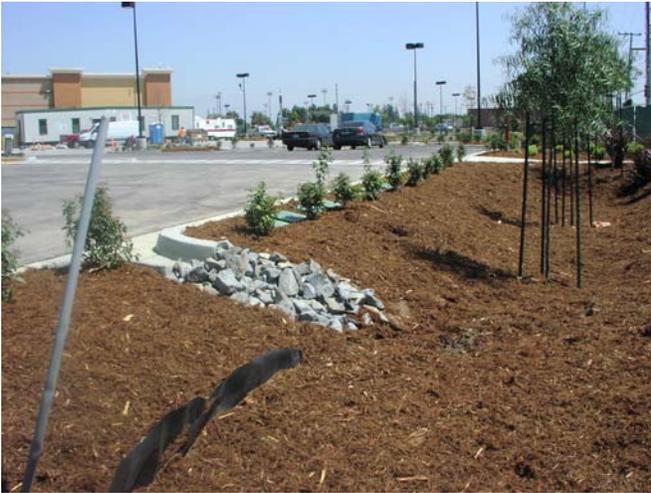
Bioretention Cells – 04/07/09

Installation of final layer of wood mulch as a part of the filter within the Bioretention Cell. Note rip-rap velocity dissipation at curb openings

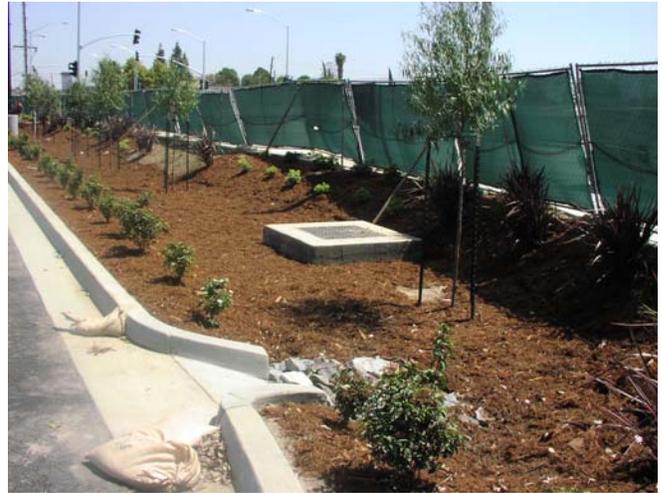
Bioretention Cells – 04/07/09

Installation of wood mulch as the top filter layer within the Bioretention Cell. Note rip-rap velocity dissipation at curb openings.

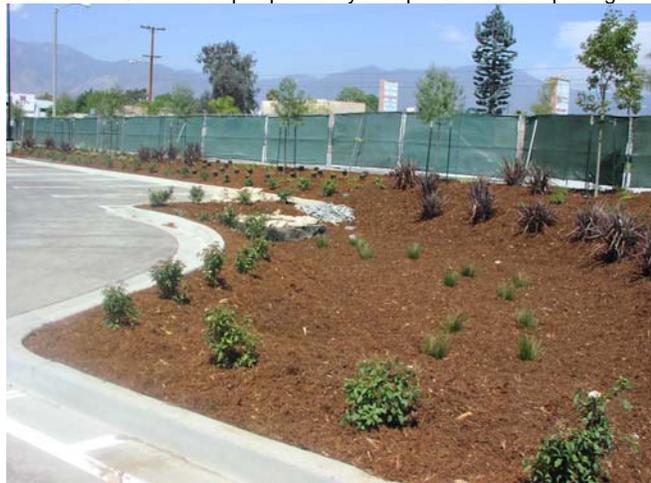
Bioretention Cells – 04/07/09

Installation of final layer of wood mulch as a part of the filter within the Bioretention Cell. Note rip-rap velocity dissipation at curb openings.

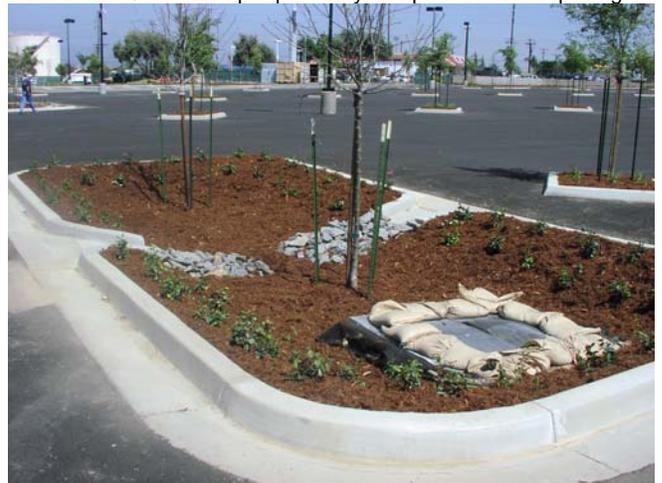
Bioretention Cells – 04/07/09

Installation of wood mulch as the top filter layer within the Bioretention Cell. Note rip-rap velocity dissipation at curb openings.

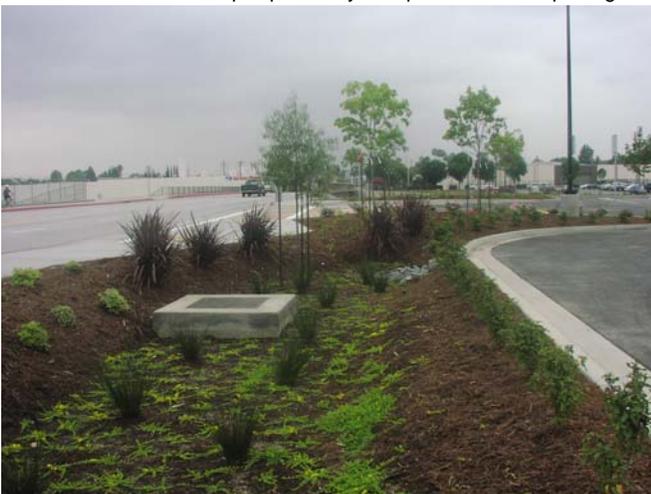
Bioretention Cells – 06/10/09

Completed bioretention cells

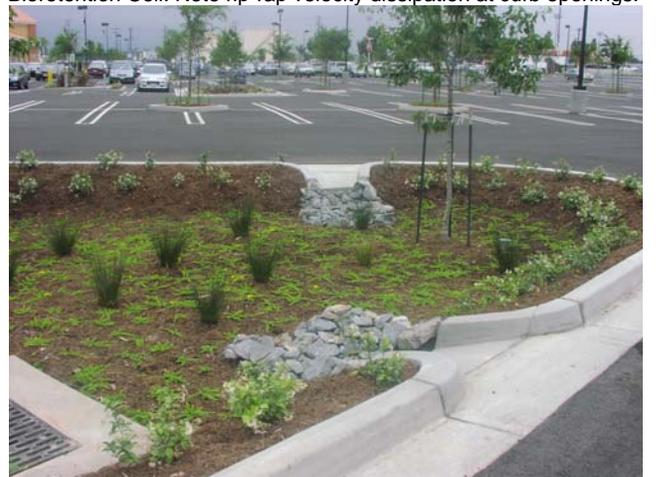
Bioretention Cells – 06/10/09

Completed bioretention cells

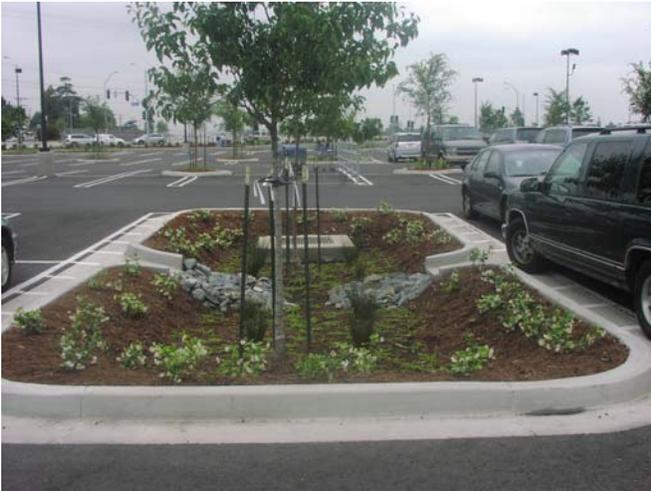
Bioretention Cells – 06/10/09
Completed bioretention cells

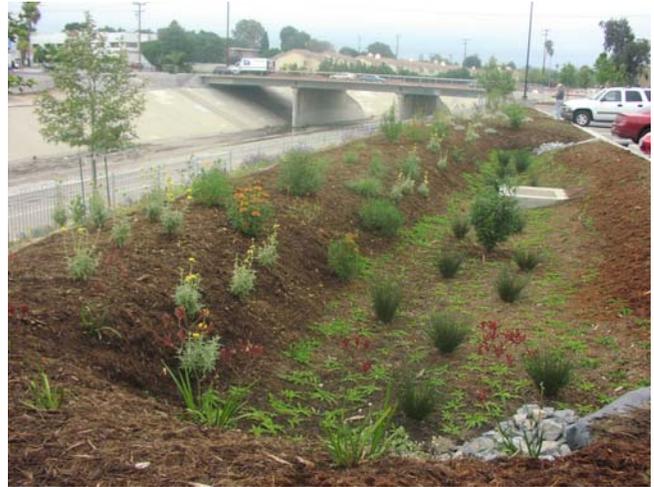
Bioretention Cells – 06/10/09
Completed bioretention cells

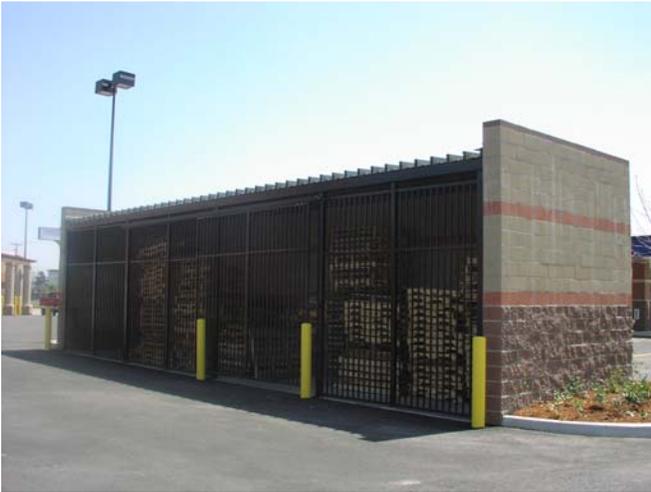
Outdoor Storage Area -- 04/07/09

The outdoor pallet recycling storage area is protected by an impermeable roof, and surface runoff flows drain away from this area.

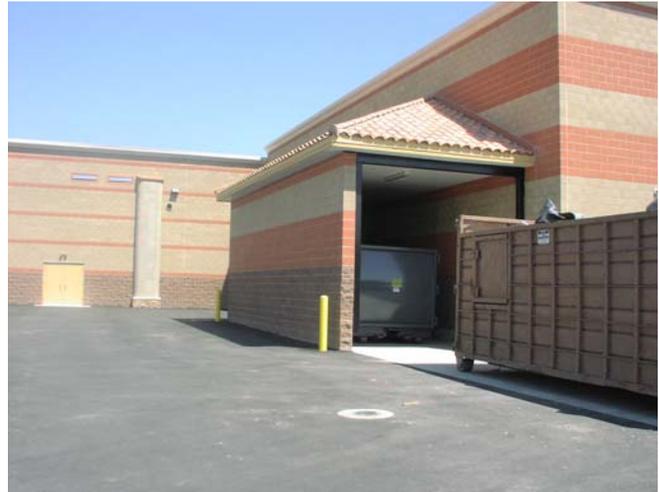
Trash Compactor Area -- 04/07/09

The compactor is covered and the area drain is connected to the sanitary sewer. Surface flows drain away from this area.

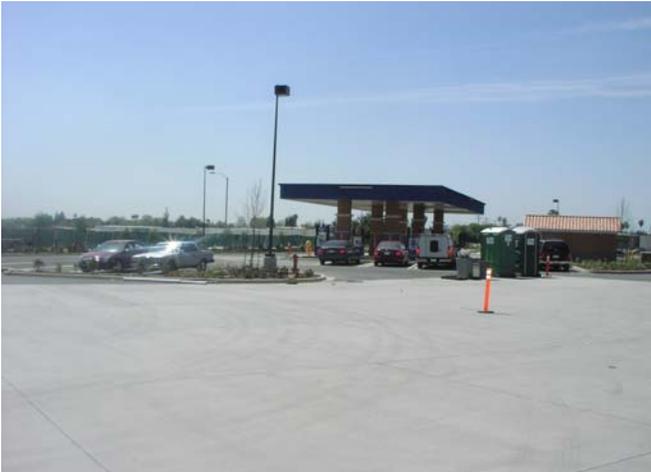
Fueling Station Canopy -- 04/07/09

The fueling area is covered by a canopy and the roof drains are connected to an underground infiltration basin. Stormwater runoff flows drain away from fueling area and the area drain under the canopy is connected to an oil stop valve in case of an accidental spill and nuisance water drainage..

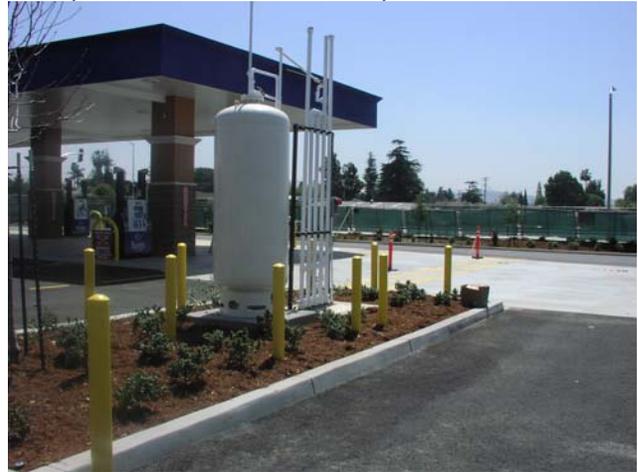
Fueling Station Canopy -- 04/07/09

The fueling area is covered by a canopy and the roof drains are connected to an underground infiltration basin. Stormwater runoff flows drain away from fueling area and the area drain under the canopy is connected to an oil stop valve in case of an accidental spill and nuisance water drainage..

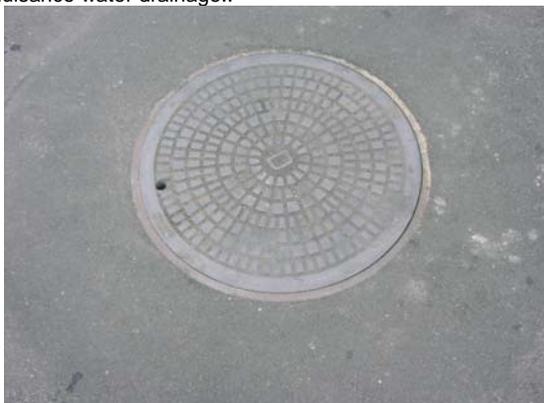
Fueling Station Oil Stop Valve -- 06/10/09

The area drain under the canopy is connected to an oil stop valve in case of an accidental spill and nuisance water drainage.

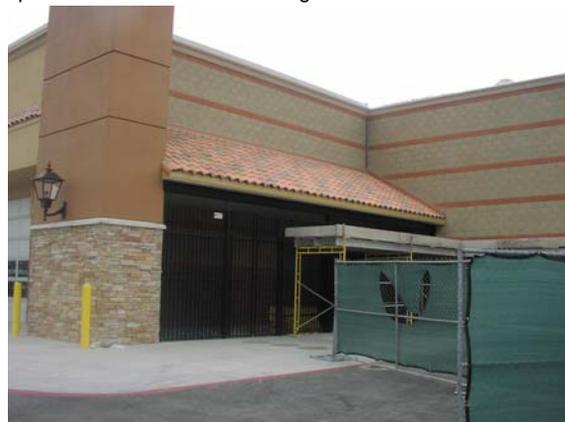
Outdoor Storage Area -- 04/23/09

The outdoor tire and battery storage area is protected by a roof, and surface runoff flows drain away from this area

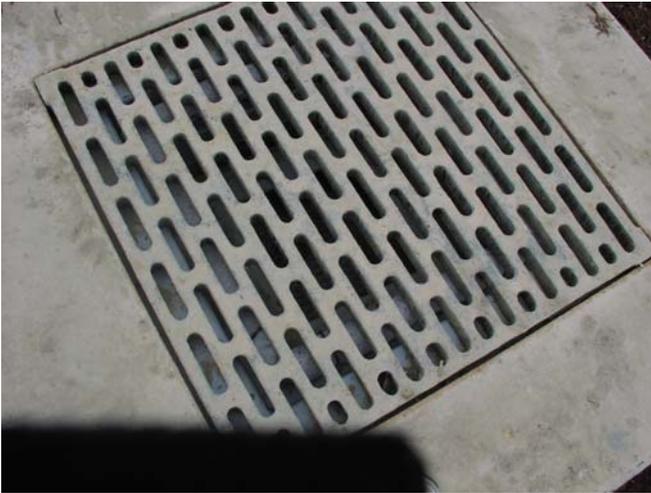
Inlet Insert 04/23/09

The storm drain inlet insert was installed to remove trash, debris, and oils

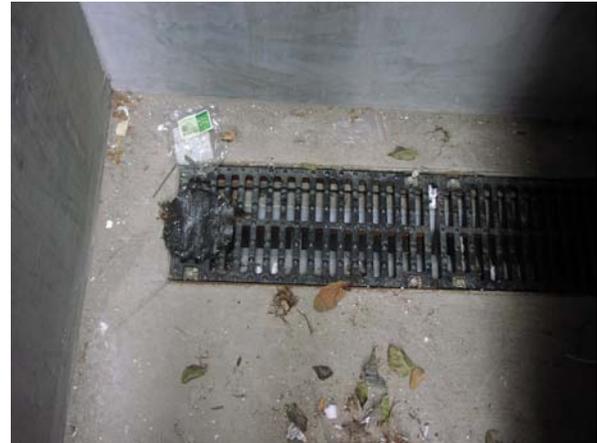
Truck Well – Inlet Insert 04/23/09

The truck well drain inlet insert was installed to remove trash, debris, and oils
