North Coast Regional Water Quality Control Board

**CAL EMA Spill Notification #13-2165
and Complaint Inspection Report
Steven Kistler Property
Kistler Vineyards
Sonoma County
WDID No. 1B13125CNSO**

Subject: April 11, 15, 18, and 29, 2013 Inspection and follow up of Salmon
Creek incident

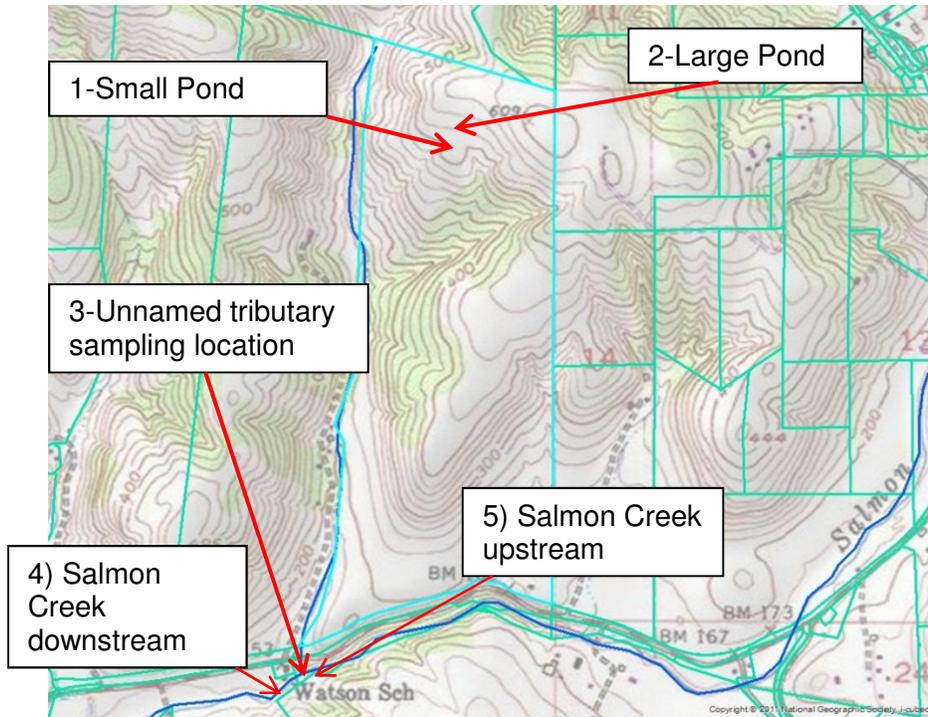
Image 2- Sonoma County APN 026-120-006, owned by Steve Kistler, highlighted in light blue above. Approximate sampling locations for samples taken on April 11, 2013, are identified by sample number and location.

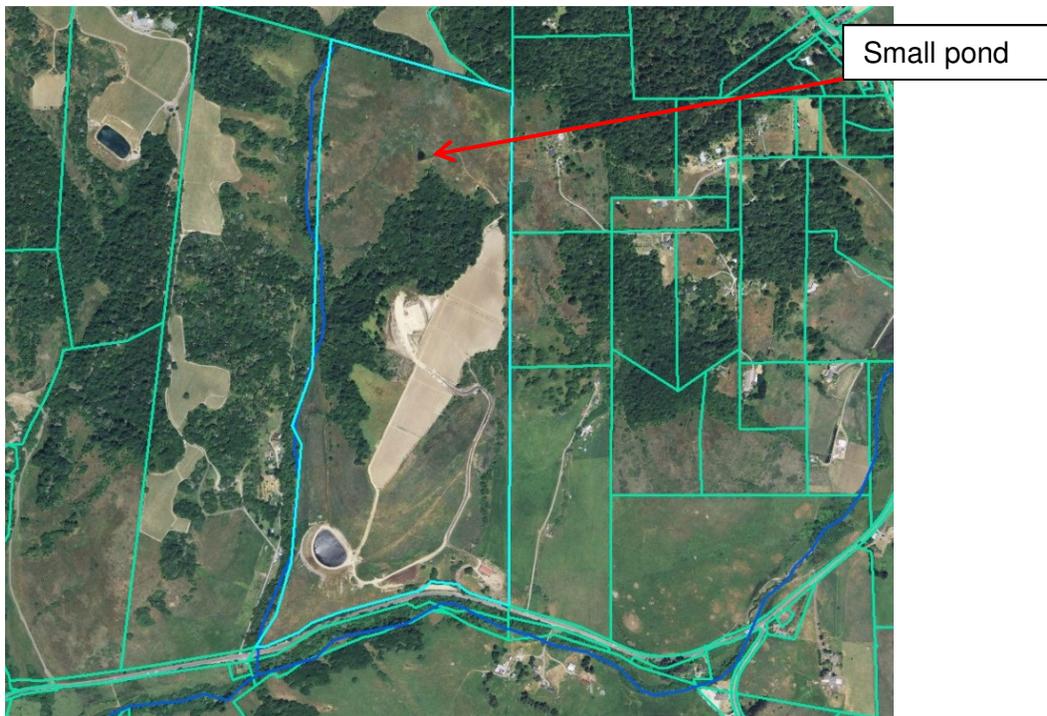
Image 3- 2012 National Aerial Imagery Program air photo- the parcel in blue above is the Kistler parcel. The small pond is visible in the image, the large pond has not yet been constructed.

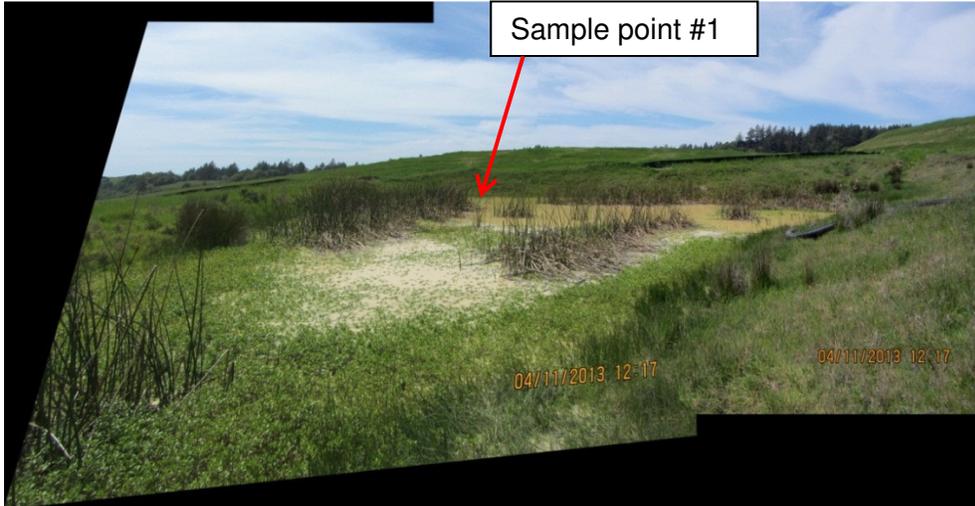
Image 5- Sampling point #1 small pond on the Kistler property

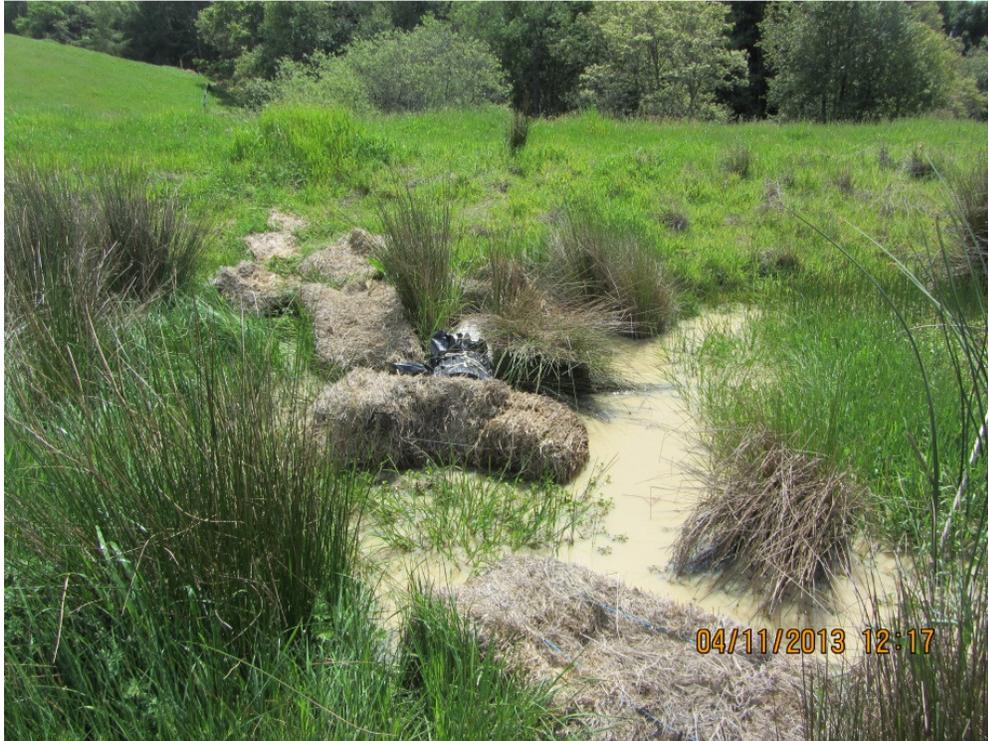
Image 6- Small pond spillway plugged with haybales

Mr. Molinar said he stopped pumping when Mr. Kistler told him the water was not good to pump out anymore. When he finished pumping out the pond Mr. Kistler had him install hay bales in front of the small pond outlet pipe to keep the water from flowing out to the creek below. Mr. Kistler told him that they would pump out the rest of the water onto the fields around the pond. Mr. Molinar showed us the hay bales, which were visible as a plug in front of the small pond outflow pipe.

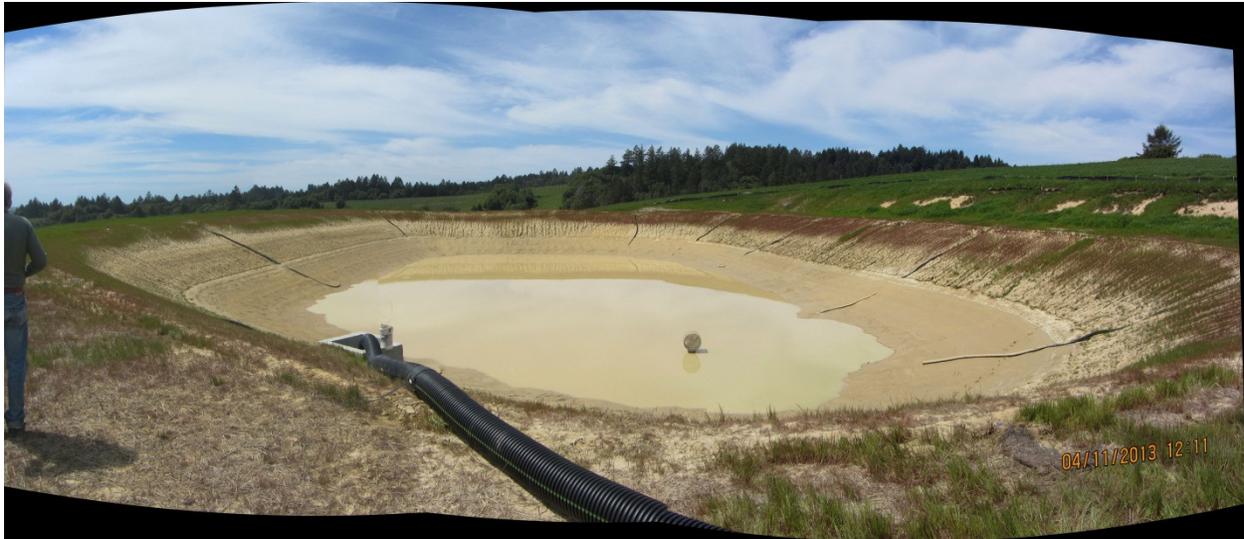
Image 7-, Stitched image of the large pond on the Kistler Property (Note the pond elevation prior to draining is visible as the pond bank without surface erosion or vegetation encroachment).

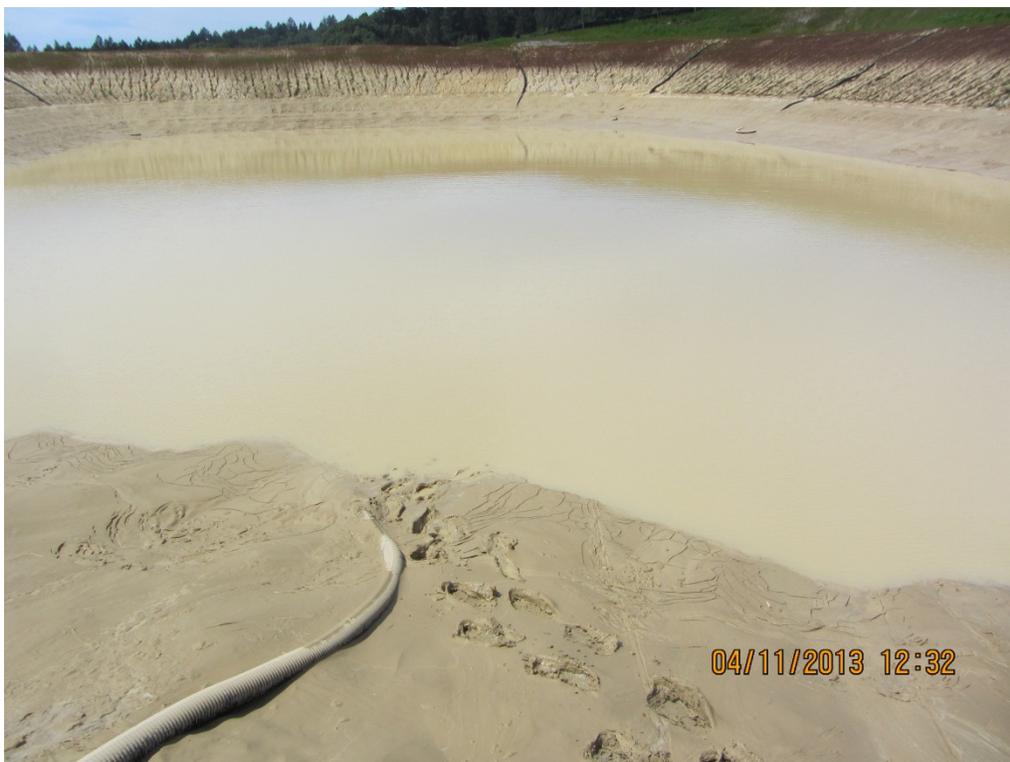
Image 8- Large pond- Sampling point #2 access and egress point shown by my footprints.

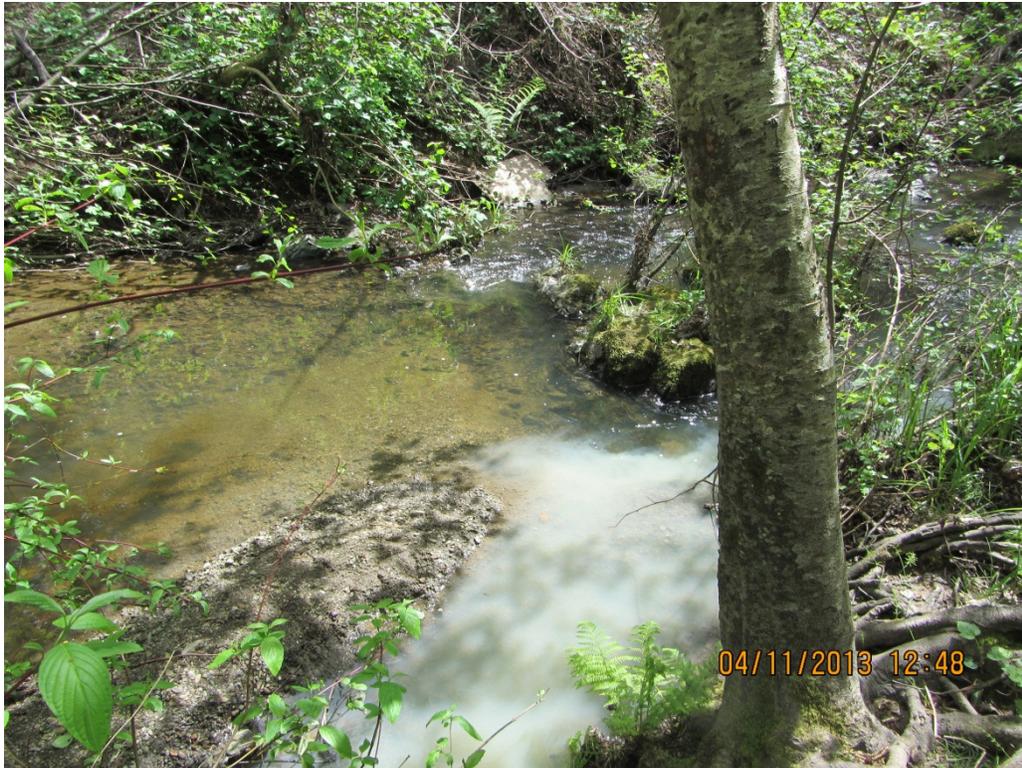
Image 9- Salmon Creek at the confluence with the unnamed tributary adjacent to Watson School

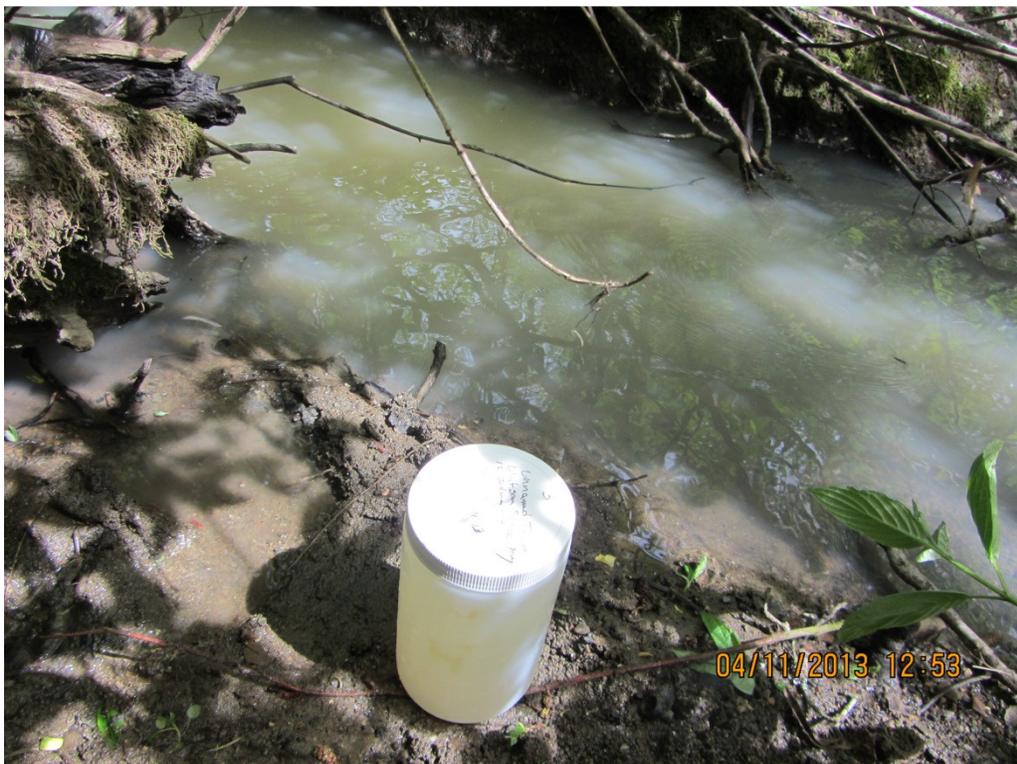
Image 10- Unnamed tributary stream adjacent to Watson School at the location where I collected Sample #3.

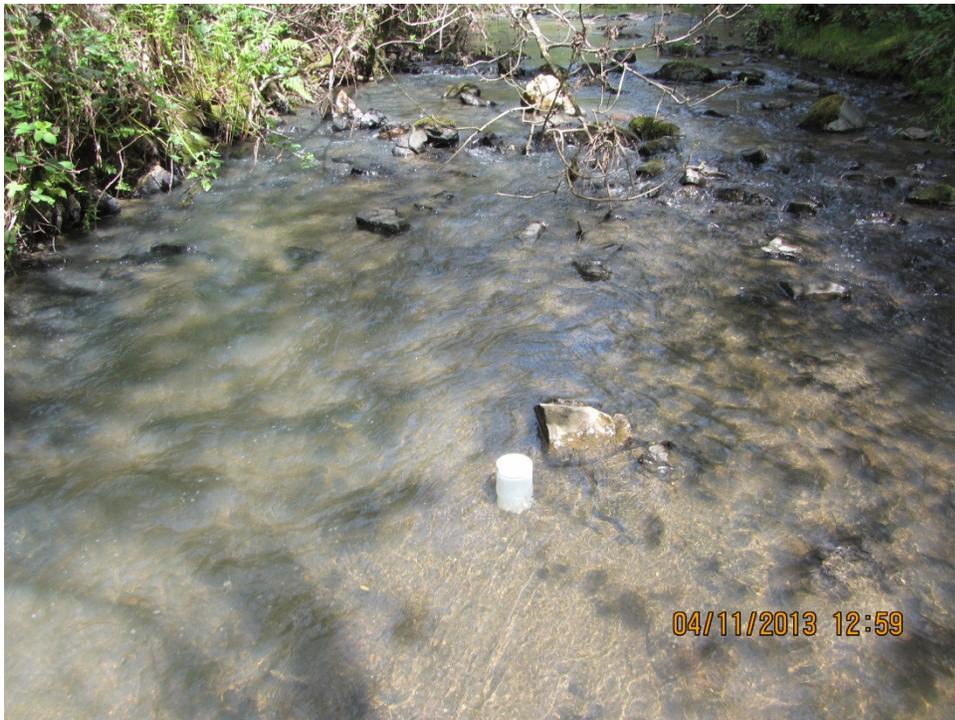
Image 11- Salmon Creek 90 feet downstream from unnamed tributary confluence with Salmon Creek, Sample location #4

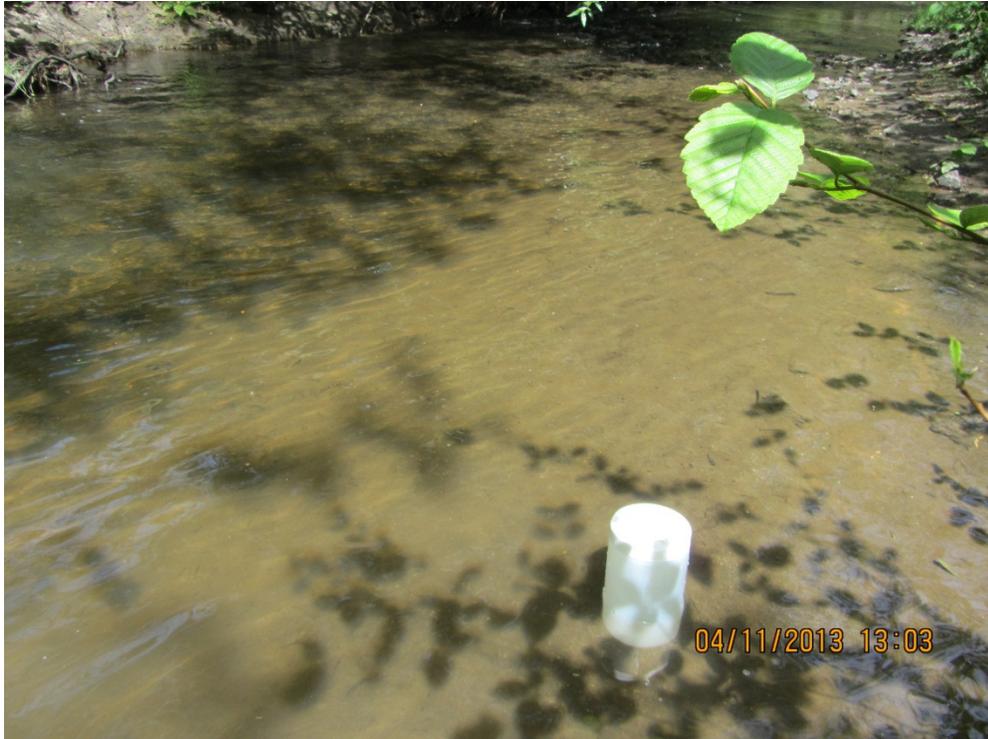
Image 12- Salmon Creek upstream of unnamed tributary confluence, sample location #5

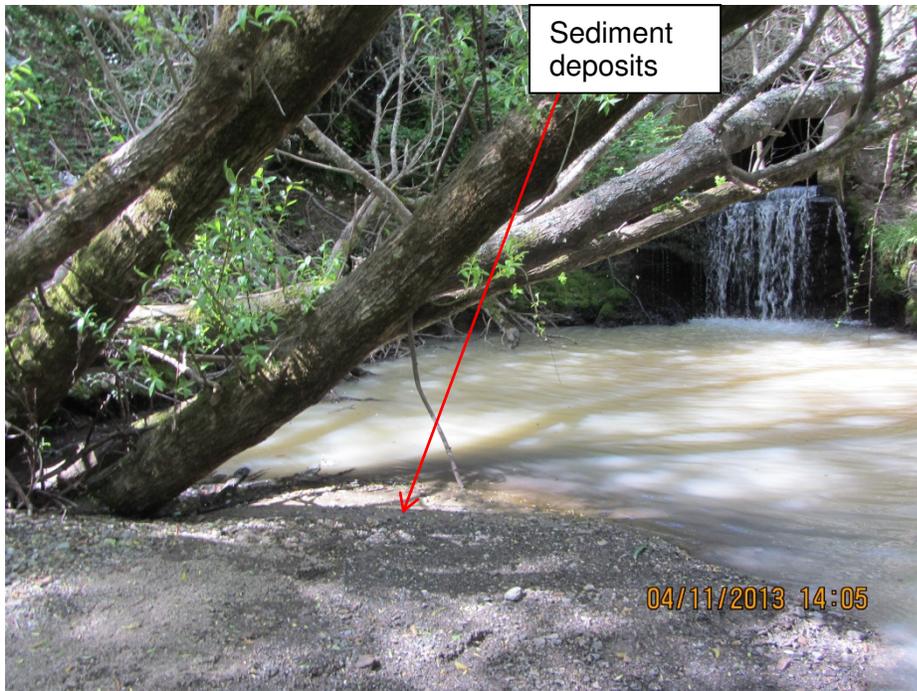
Image 13- Unnamed tributary to Salmon Creek below Bodega Hwy culvert crossing.

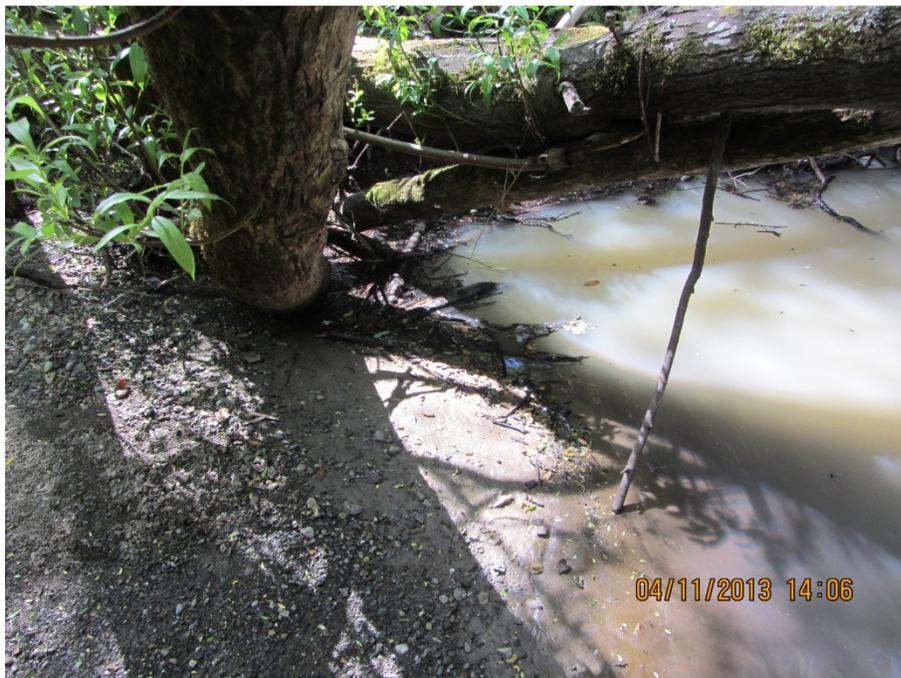
Image 14- Same location, a sediment deposit close up. At the time I took the photo, I observed that the water appeared to be receding from a higher flow level.

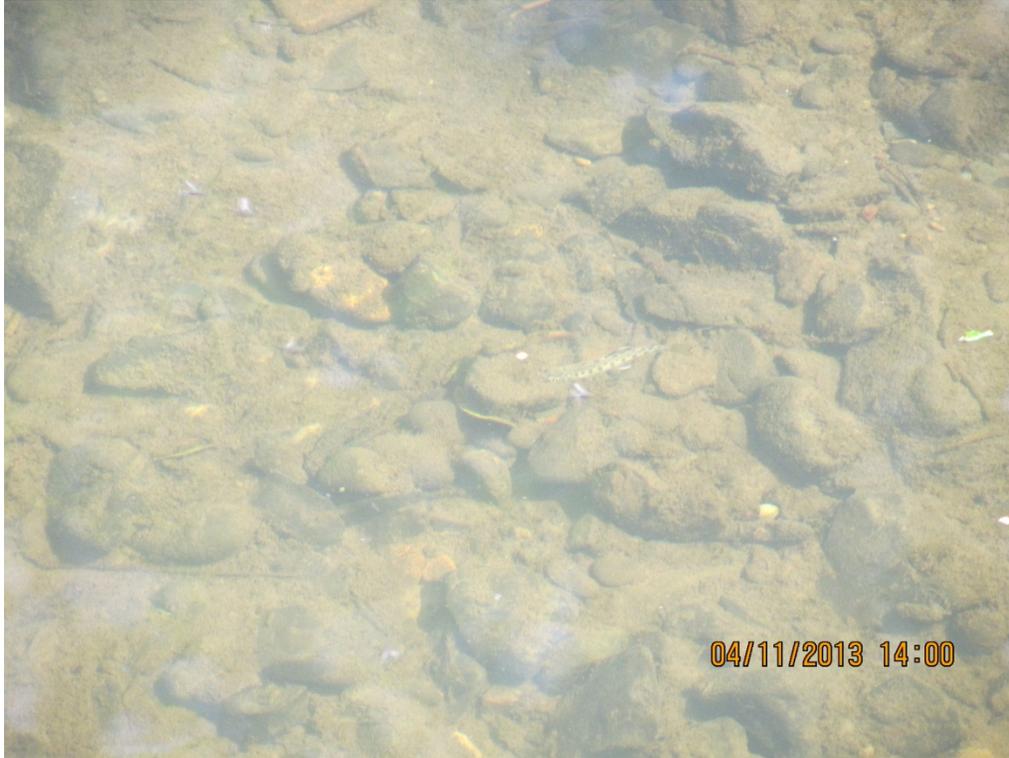
Image 15- Salmon Creek downstream of confluence with the unnamed tributary note the steelhead trout in the photo, and compare this photo with image 16.

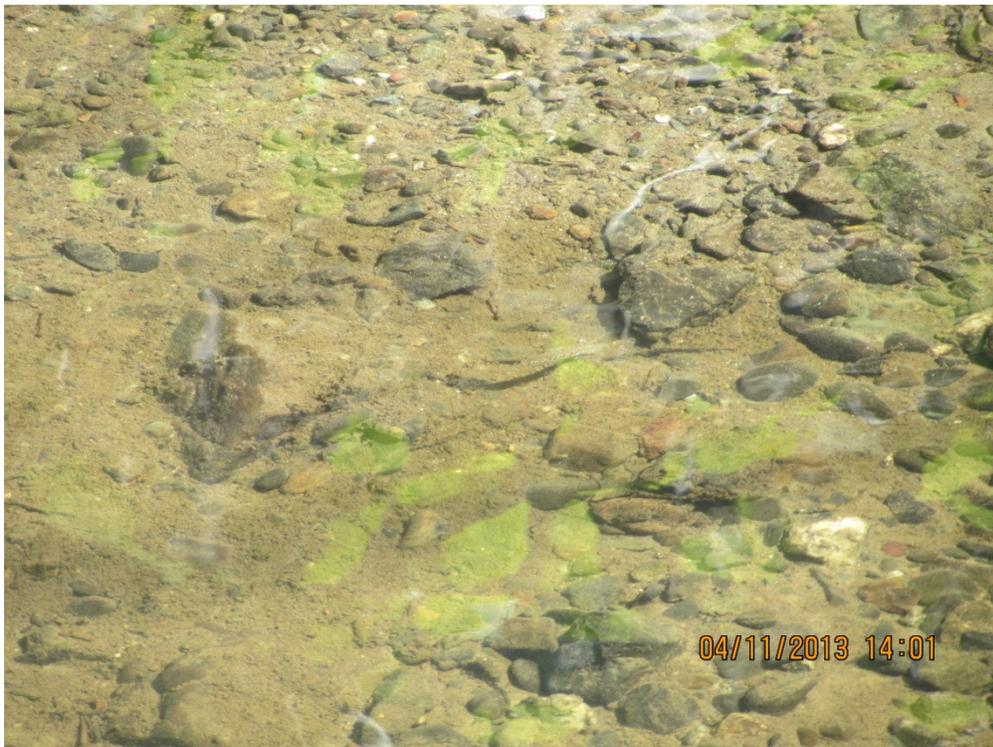
Image 16- Salmon Creek upstream of the unnamed tributary

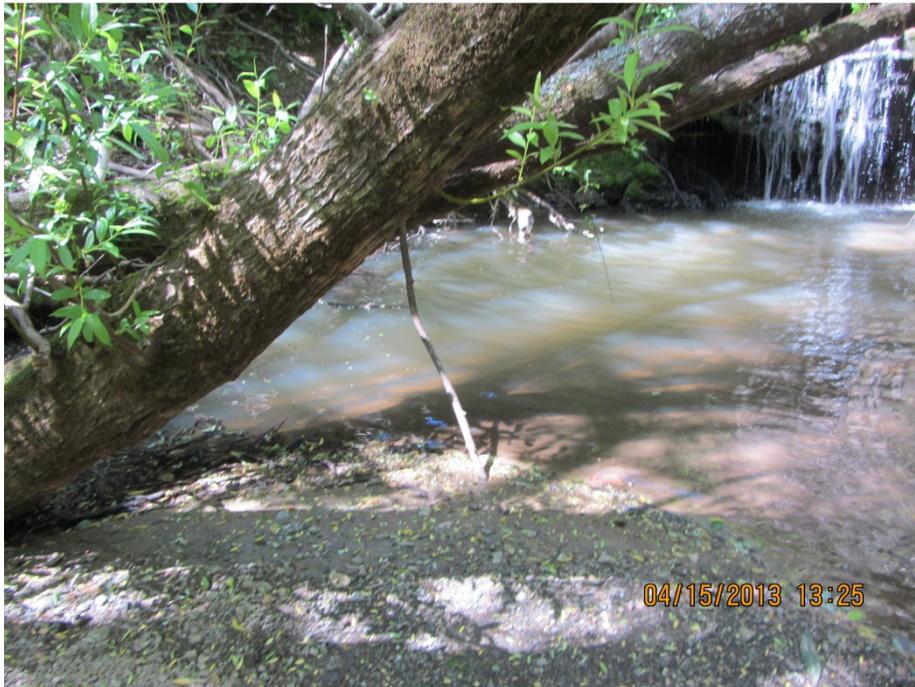
Image 17- Unnamed tributary below Bodega Highway culvert crossing (note when compared with images 13 and 14 above, the water level appears to have receded further, and the water is still turbid as compared with background).

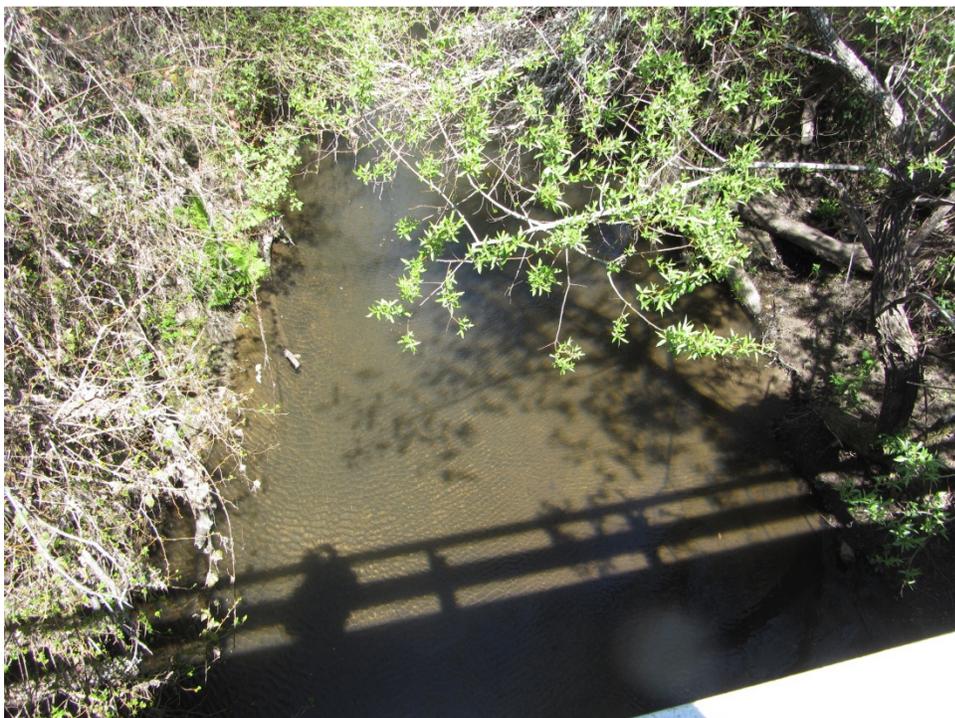
Image 18- Salmon Creek at Salmon Creek Road bridge- water in Salmon Creek has noticeably cleared up in comparison to the water shown in image 15.

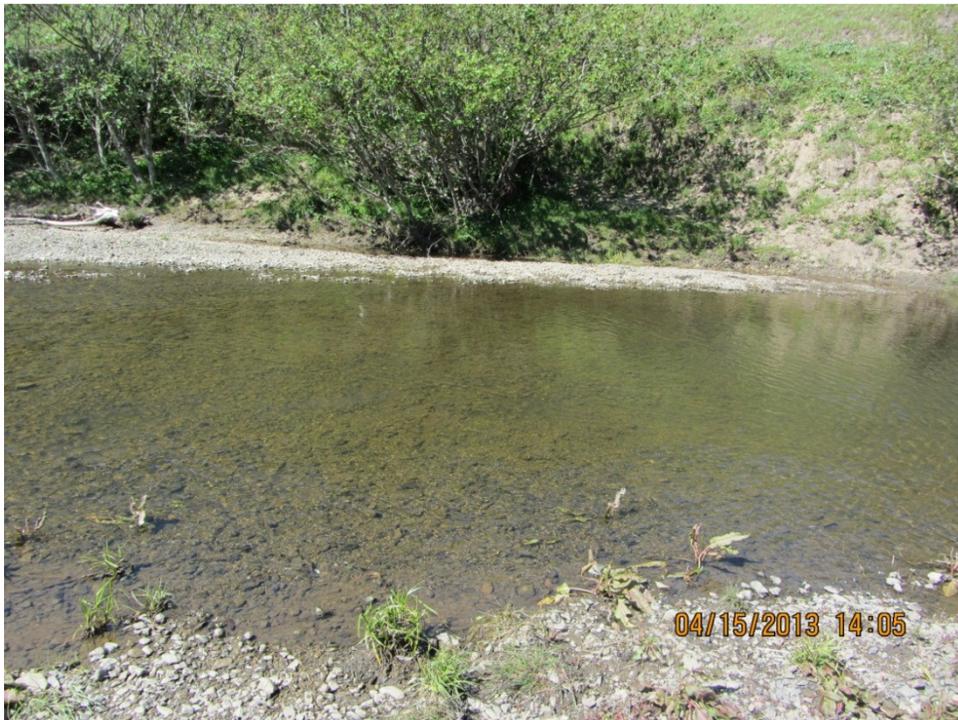
Image 19- Salmon Creek at Bodega Bay PUD intake location. Attachment B includes photos provided by Emmet O'Grady showing this location was very turbid on April 12, 2013.

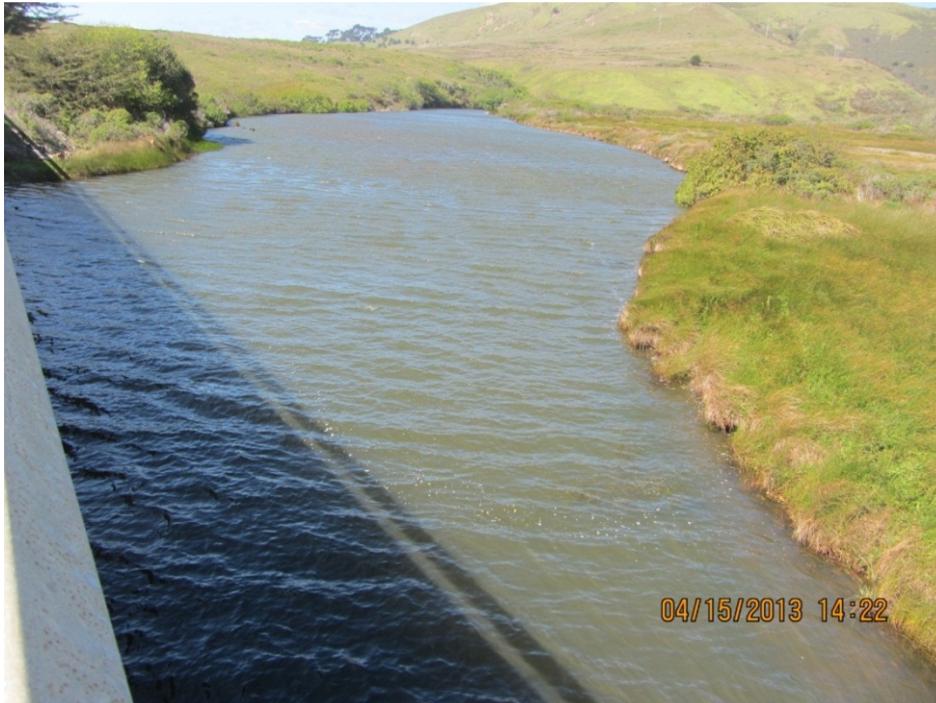
Image 20- Salmon Creek estuary at Highway 1 bridge, the turbid water is noticeable, and the duration may be tidally influenced in this location.

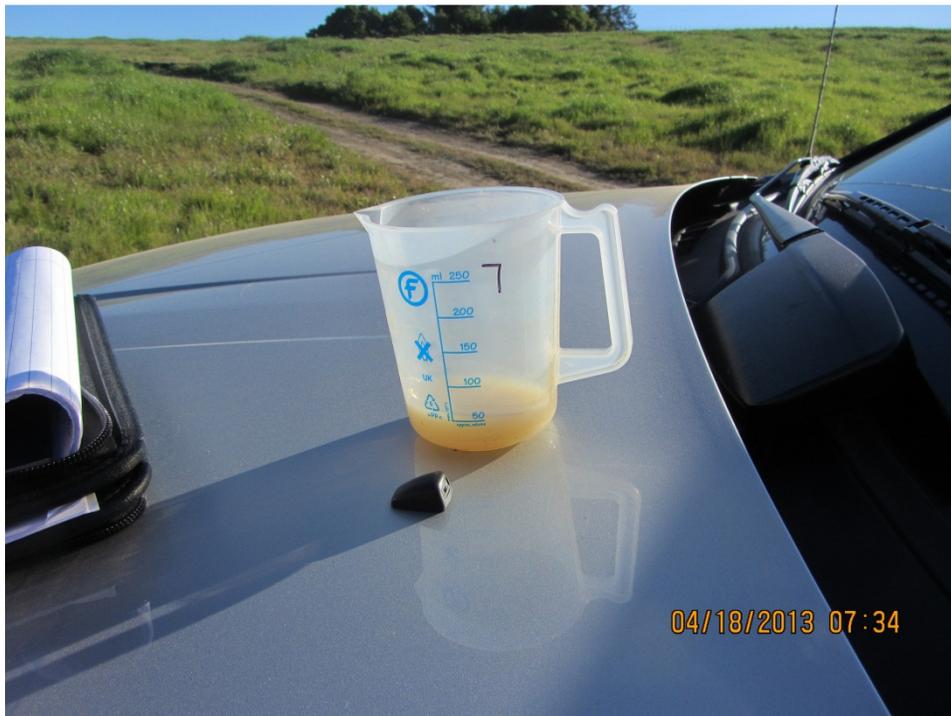
Image 21- Cup used by Mr. Molinar and Mr. Kistler to check the water to see if it was OK.

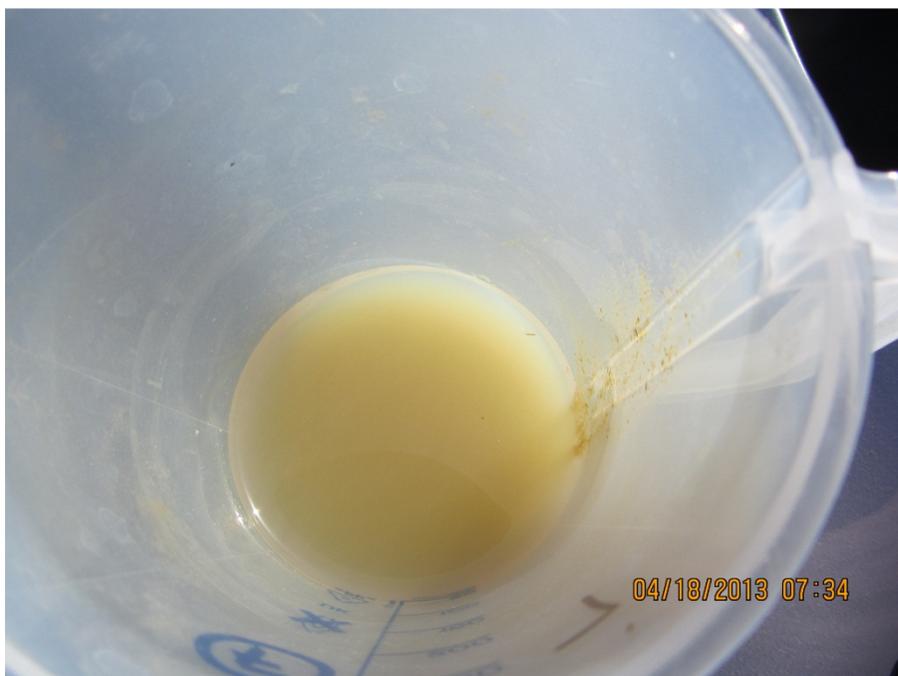
Image 22- Residual water in cup reportedly left after the last test collected by Mr. Molinar and Mr. Kistler on April 10, 2013.

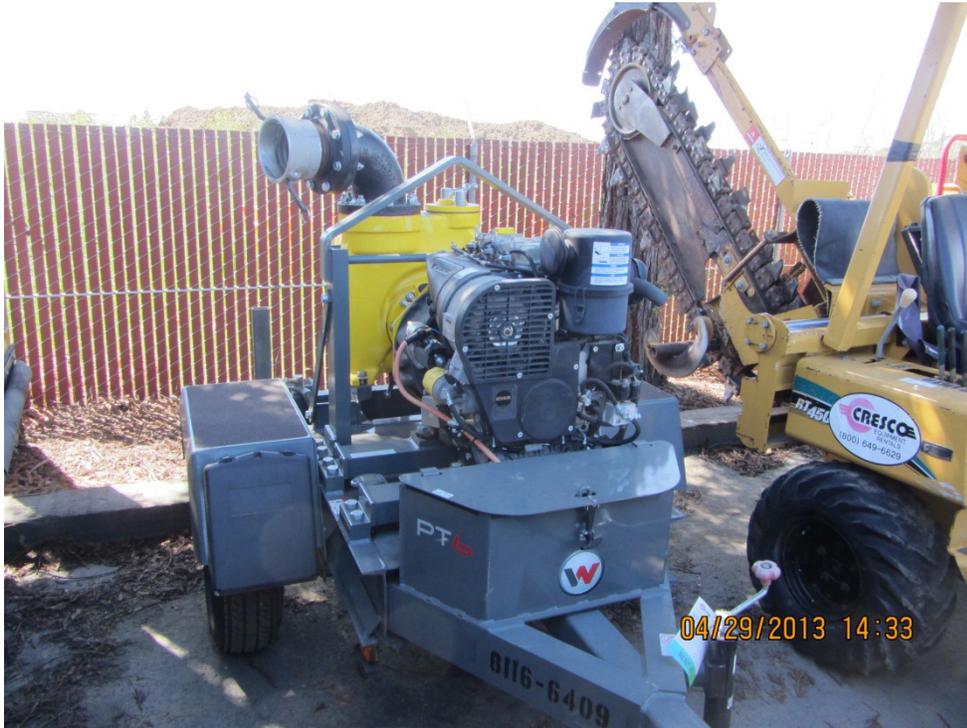
Image 23- Wacker PT6LT 6 inch pump on Cresco lot.
