City of Santa Rosa Offset Credit Proposal for Pepperwood Preserve BMPs

Credit Proposal Summary

**Pepperwood Preserve/
Upper Mark West Creek
Erosion Inventory and Assessment
Sonoma County, California**

PWA Report No. 08081301
March 2008

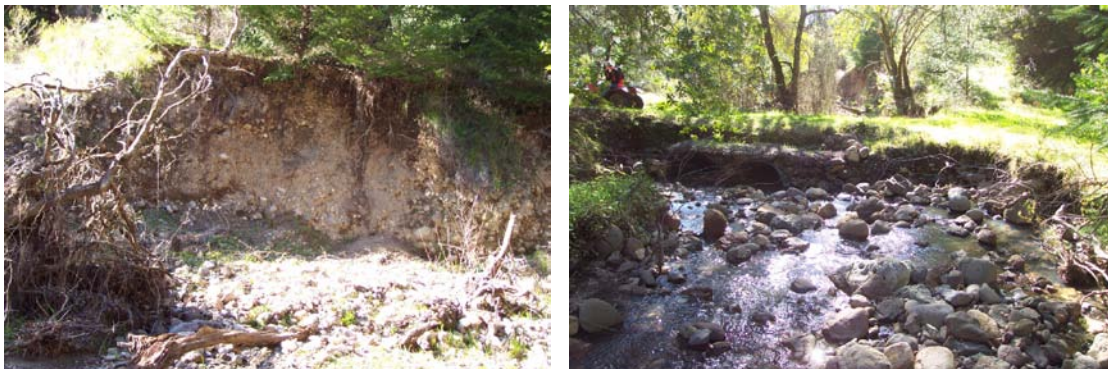
Figure 1. Example of an eroding bank of a headwater stream in the Pepperwood Preserve (left) and poorly designed stream culvert systems (right).

The erosion sites at Pepperwood Preserve are road and ditch systems that are hydrologically connected to the stream channels discharging to Mark West Creek and eventually the Laguna de Santa Rosa. These systems are either threatened to erode, or actually eroding as the result of poor stream crossing designs, the presence of springs, and/or inadequate storm flow drainage facilities. Figure 1 illustrates the type of sites being addressed.
