Subject: Enrollment of THP 1-06-202 HUM (Unit 8) in the Elk River WWDR, "Tier II"

THP No. 1-06-202 HUM (Bridgehead) Unit # 8

**THP: Bridgehead    THP 06-202    Unit # 8    January 16, 2009**

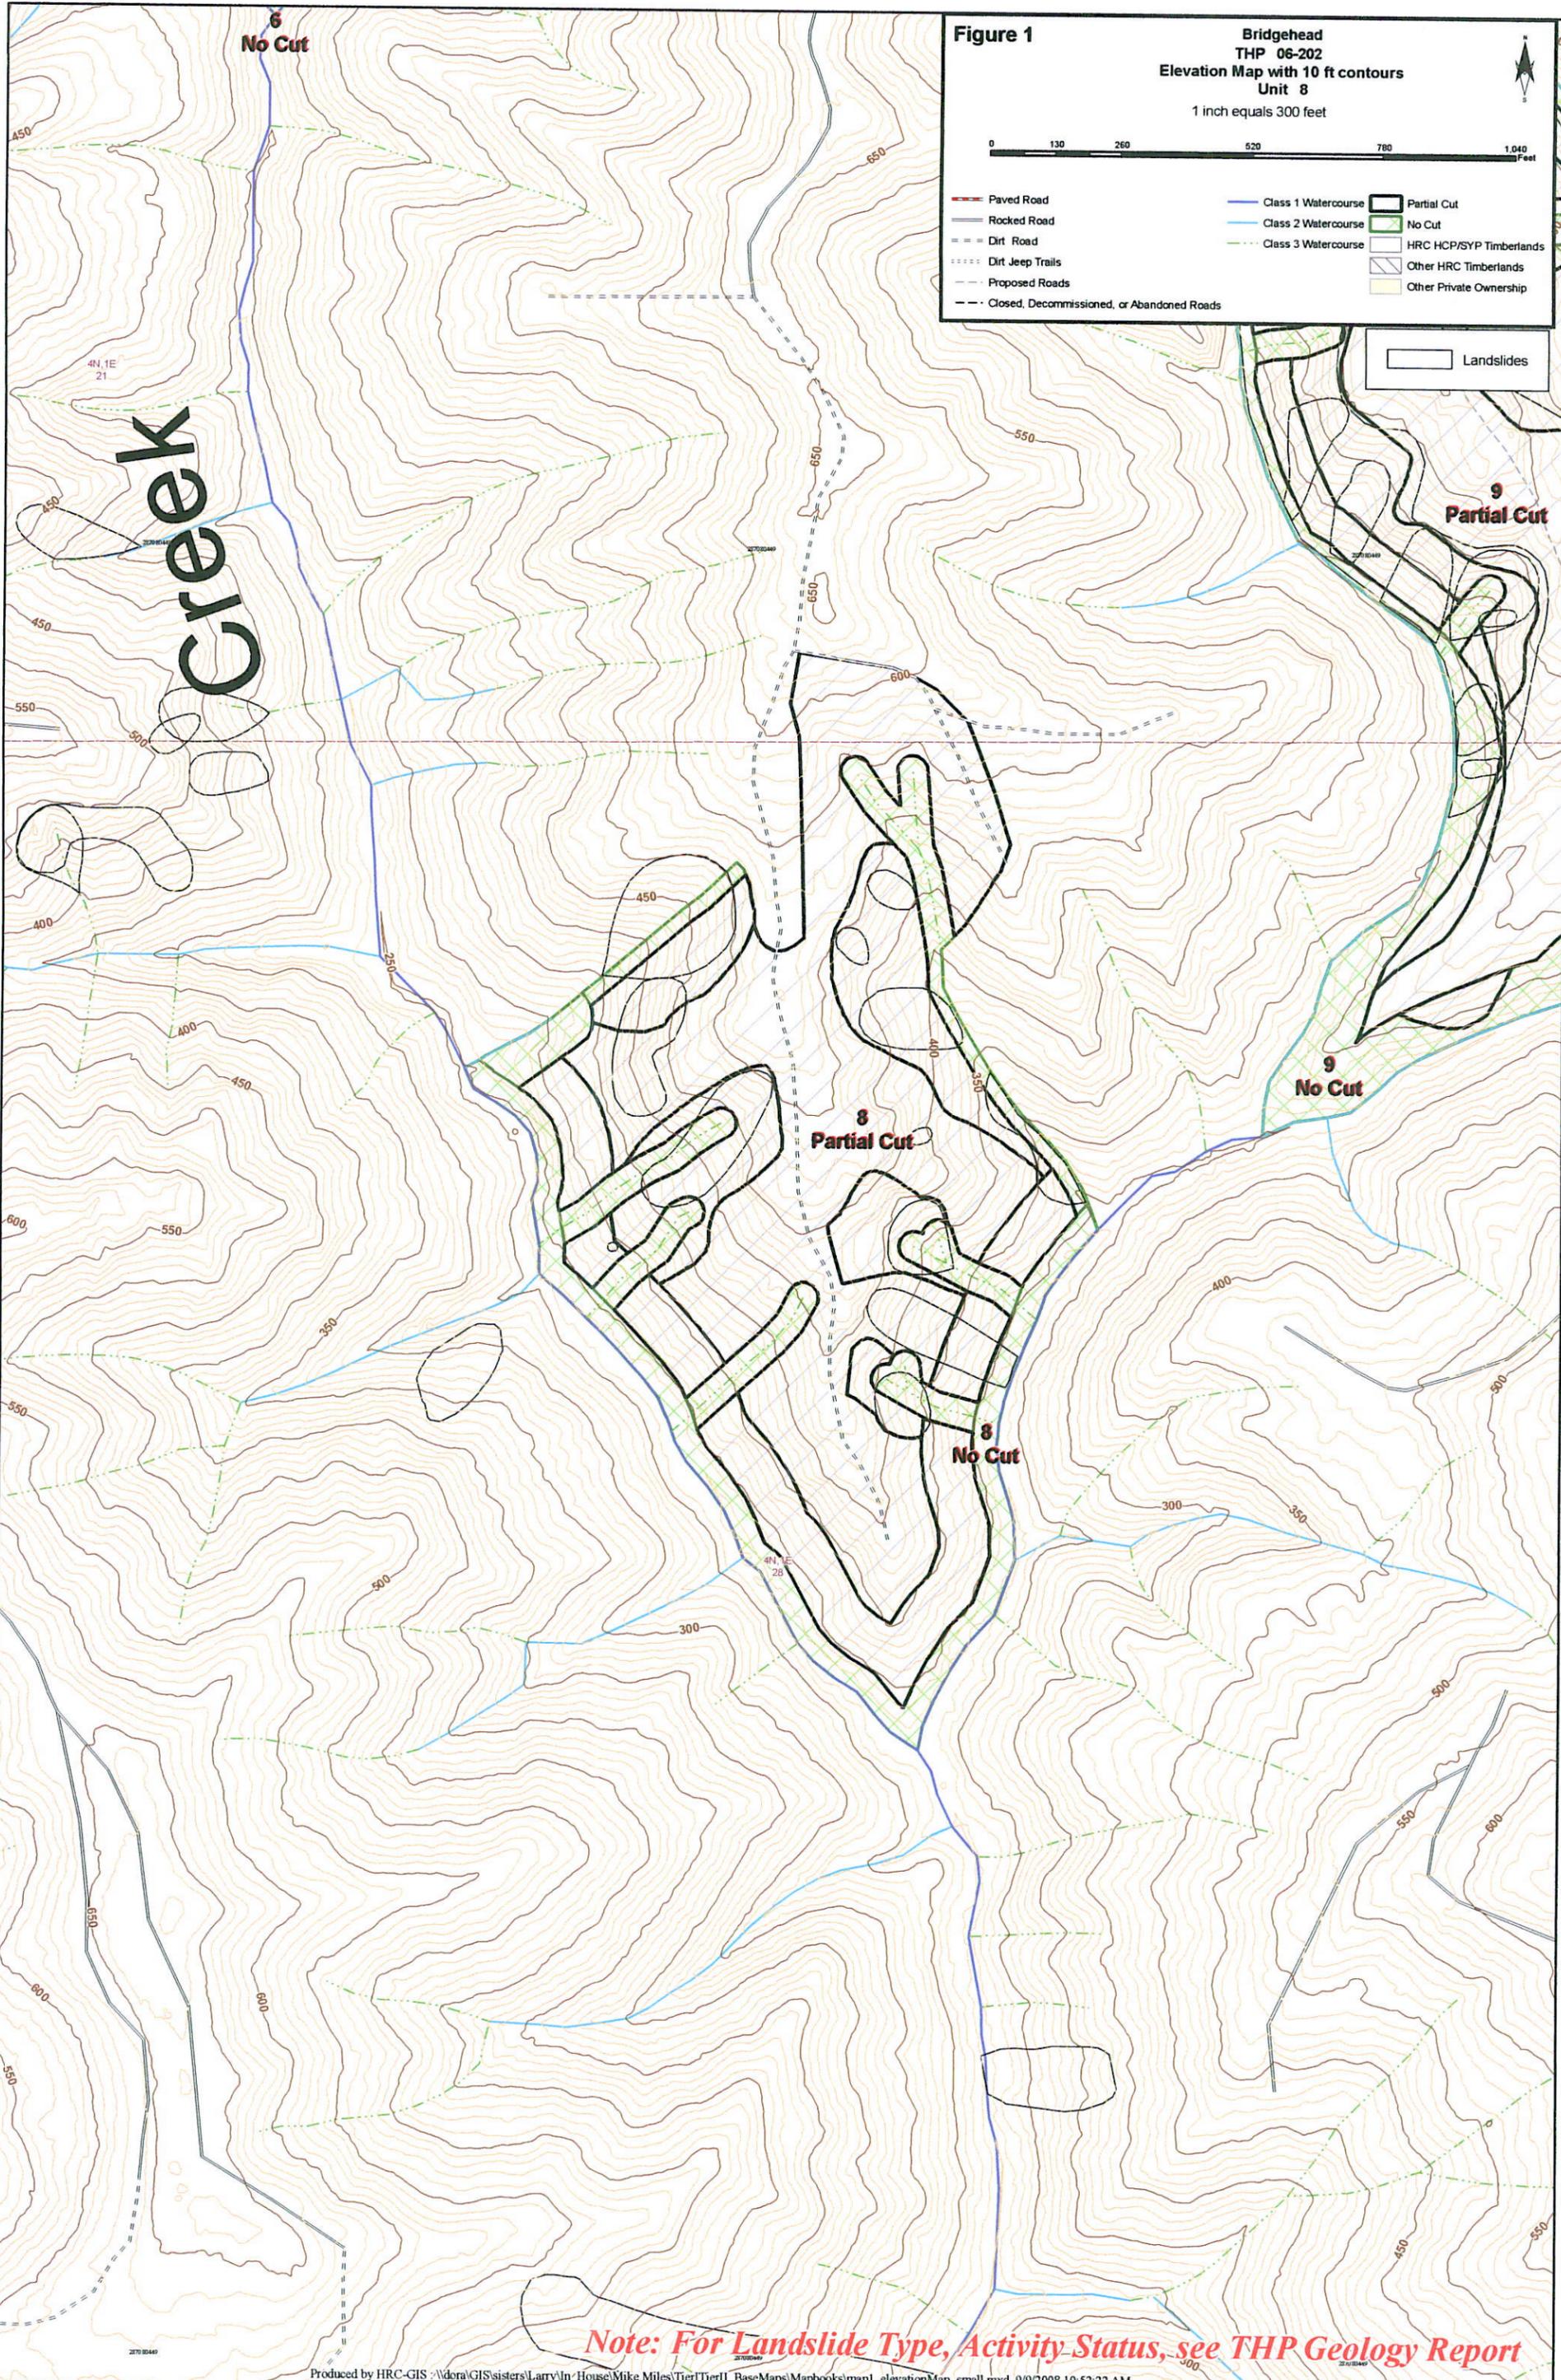
**Figure 1**

**Bridgehead  
THP 06-202  
Elevation Map with 10 ft contours  
Unit 8**

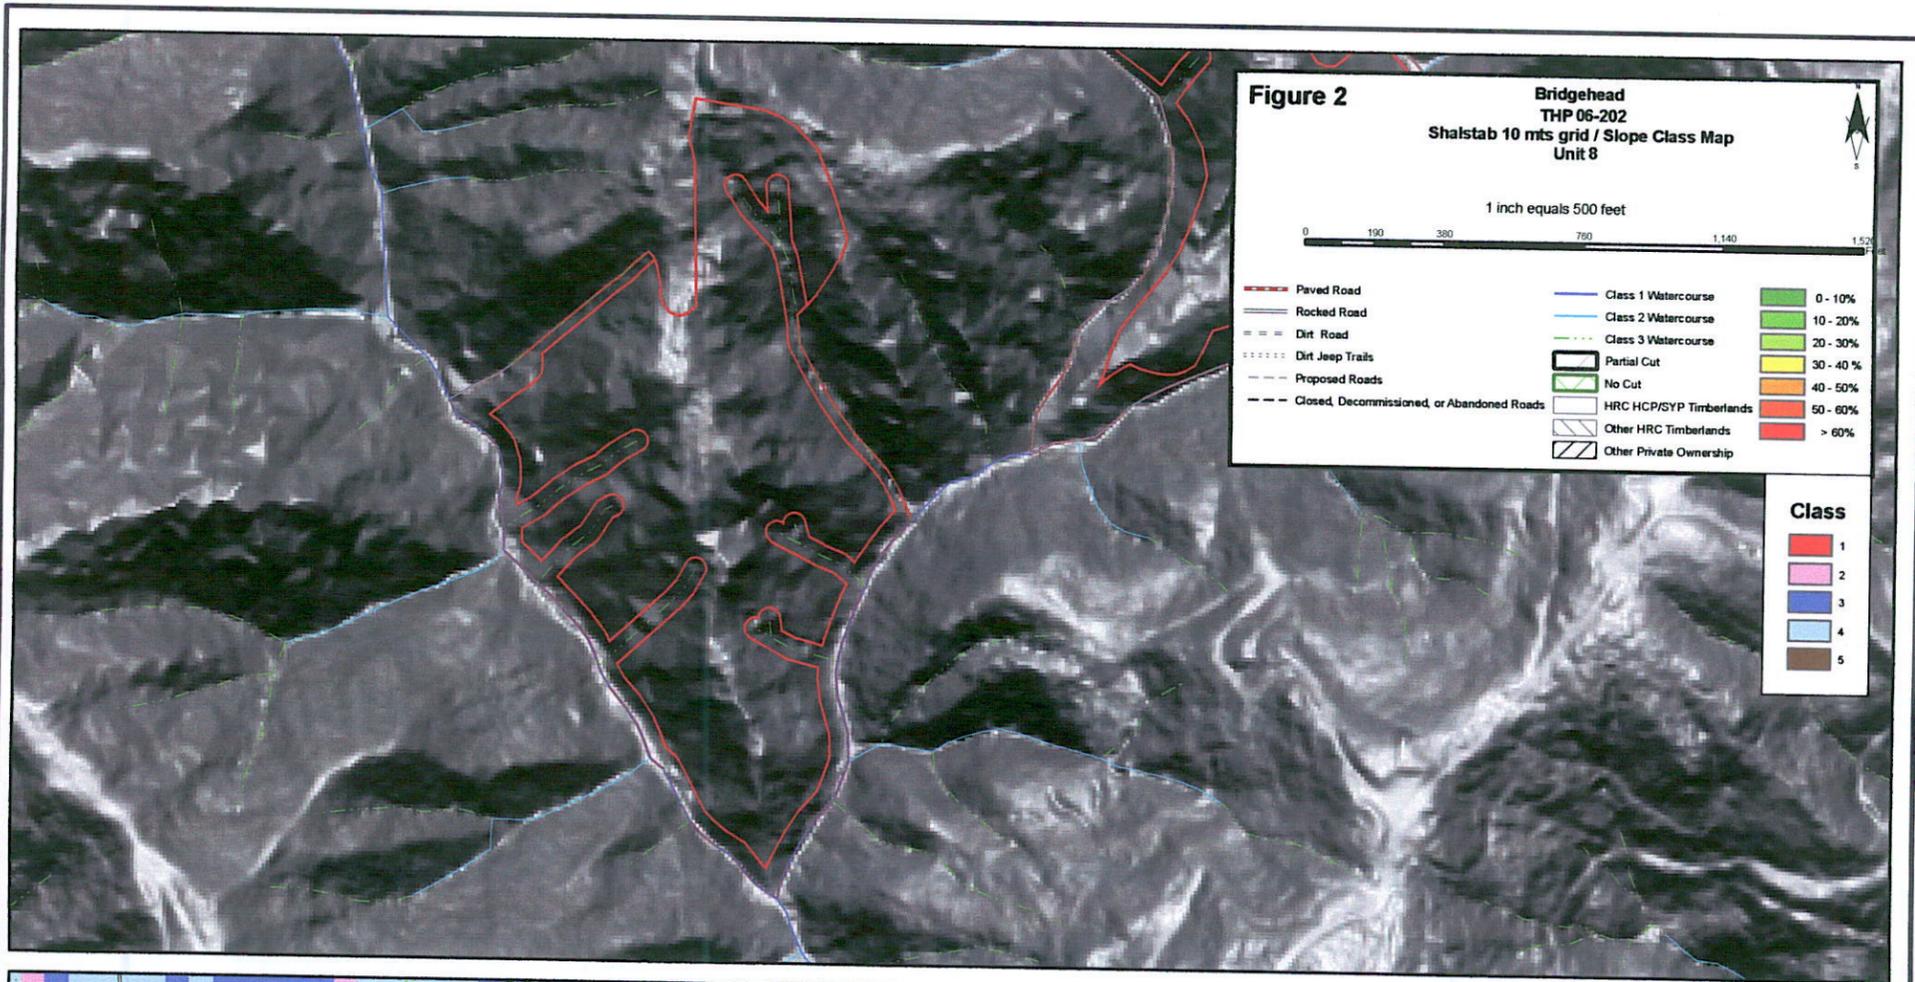
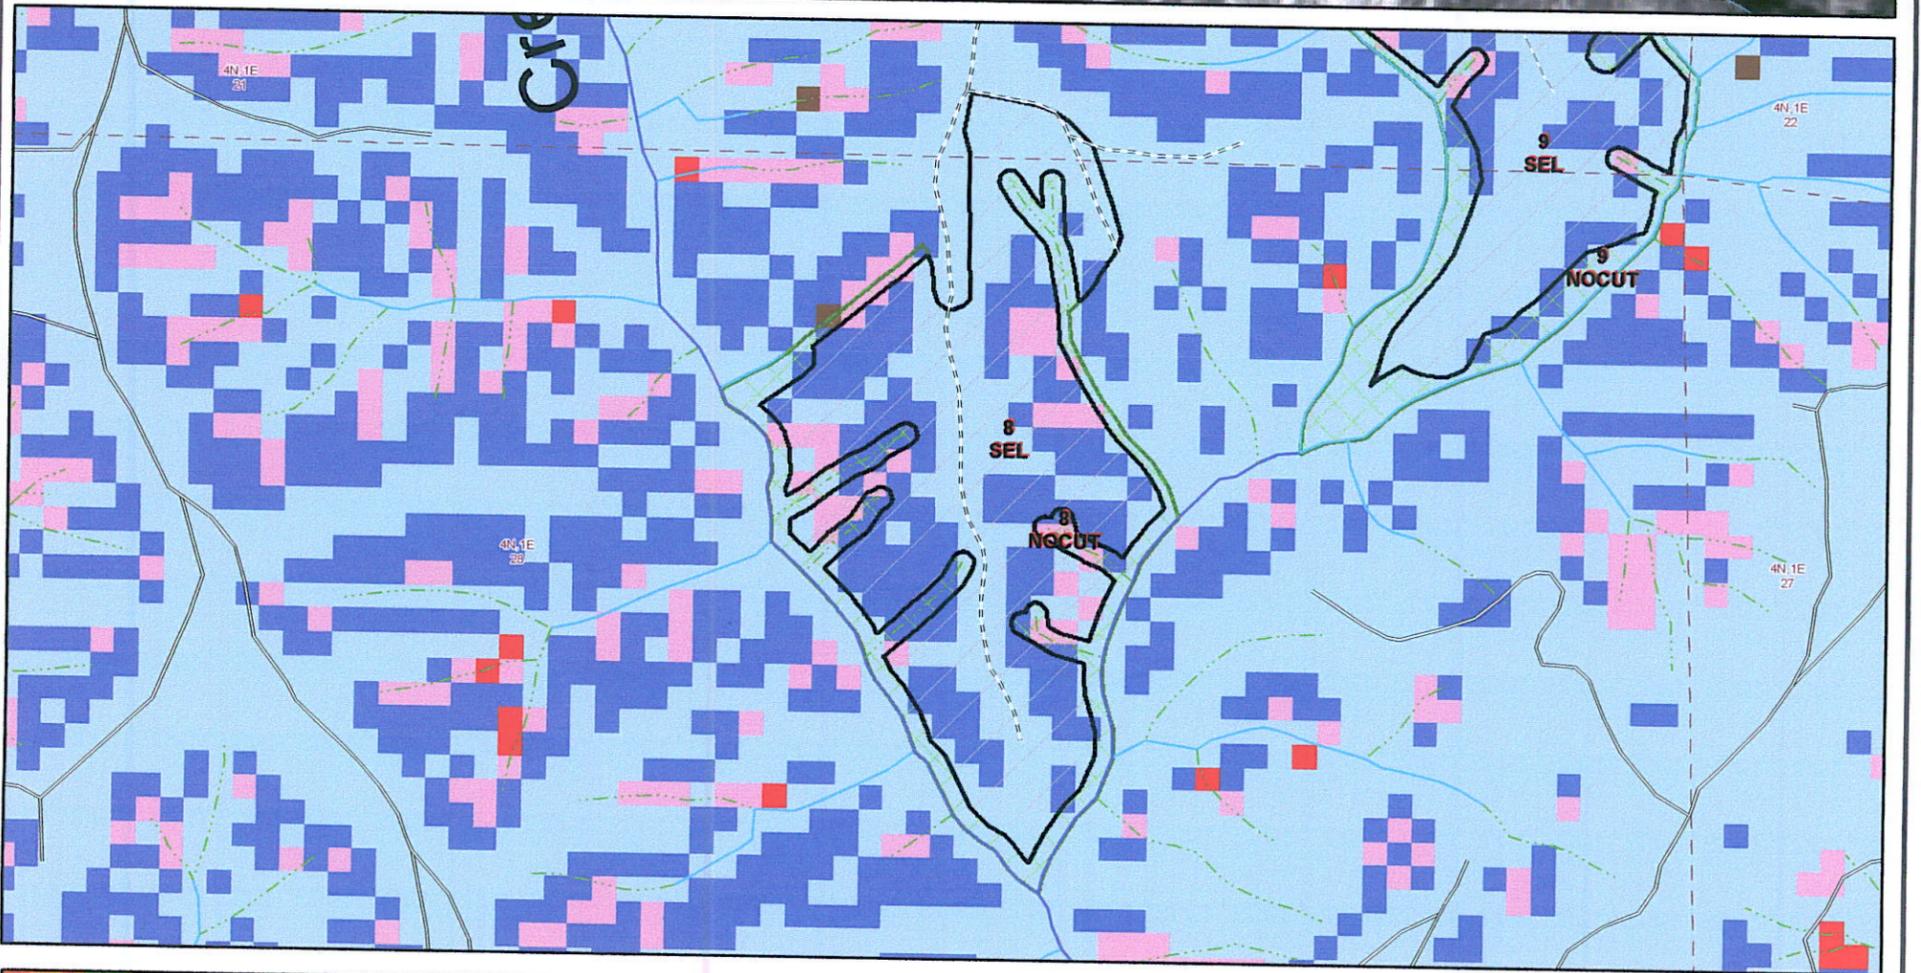
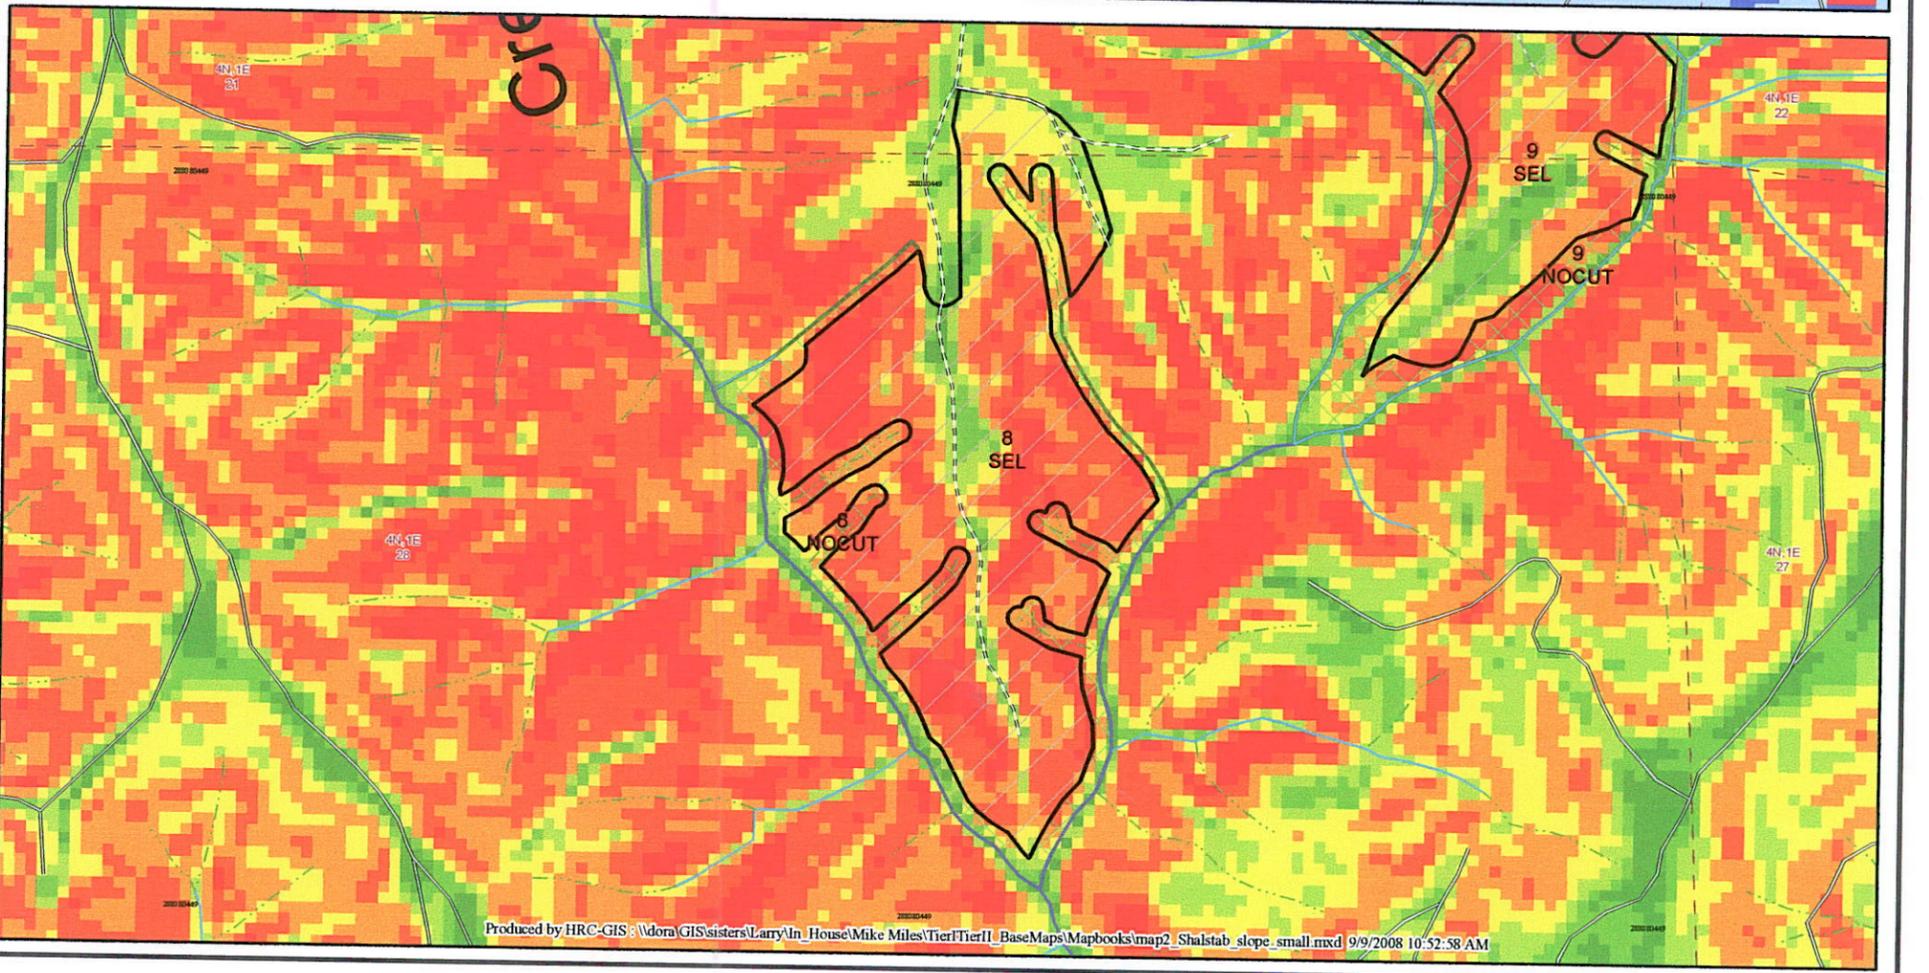
Review of Figure 2 (Hillslope Shade) shows no correlation between surface morphology and deep seated mass wasting. The slopes appear uniformly weathered with typically linear, moderately incised Class III watercourse channels and apparently unaltered basal Class I and Class II channel orientation. The prominent watercourses appear well entrenched and include relatively short flanking slopes.

A) General Observations	B) Harvest Related Impacts and Hillslope Sensitivity
<p>However, several areas exceeding 50% inclination appear relatively stable. Areas of elevated SHALSTAB (Value 2) coincide with streamside slopes. The areas of elevated SHALSTAB have limited pixels located within RMZ protection or within potentially unstable areas identified by a geologist. Protection was afforded the areas of elevated SHALSTAB during THP development. The downslope Class I watercourses are buffered with a 50-foot no harvest RMZ and 50% canopy retention from 50 to 150 feet. The canopy closure requirement has been met and exceeded with the retention of 120 sq. ft of basal area. Our review of the SHALSTAB areas revealed steeply inclined swales, abundant 2<sup>nd</sup> growth timber and evidence of landsliding such as scarps, hummocks, and colluvial deposits.</p> <p>Mass Wasting Potential (MWP) modeled for the unit is regionally moderate to low. The model identifies moderate mass wasting potential on mid slope elevations between the Class I watercourses and the small ridge central to the unit. Low mass wasting potential is located on the flanking slopes of watercourse and along the central ridge. There appears to be a degree of correlation, in this unit, between the moderate mass wasting potential modeled and potentially unstable slopes identified during field evaluation.</p> <p>Nine landslides were identified during the field review of this unit. Their individual characterization is included in the THP geology report. The Typical mitigation for the unstable areas was 100 sq. ft. per acre retention where delivery potential was determined significantly low. No harvest for the areas where delivery potential was considered high.</p> <p>The stand is predominantly redwood with infrequent fir trees. The original harvest was a ground based clearcut yarded either to the downslope watercourse or the ridge top. This plan proposes the harvest</p>	<p>are not proposed in this plan.</p> <p>This level of partial harvest should result in a minimal impact to the slopes. The target species is redwood that grows predominantly as sprouts from old growth stumps. Canopy closure and root strength will be insignificantly reduced post harvest.</p>

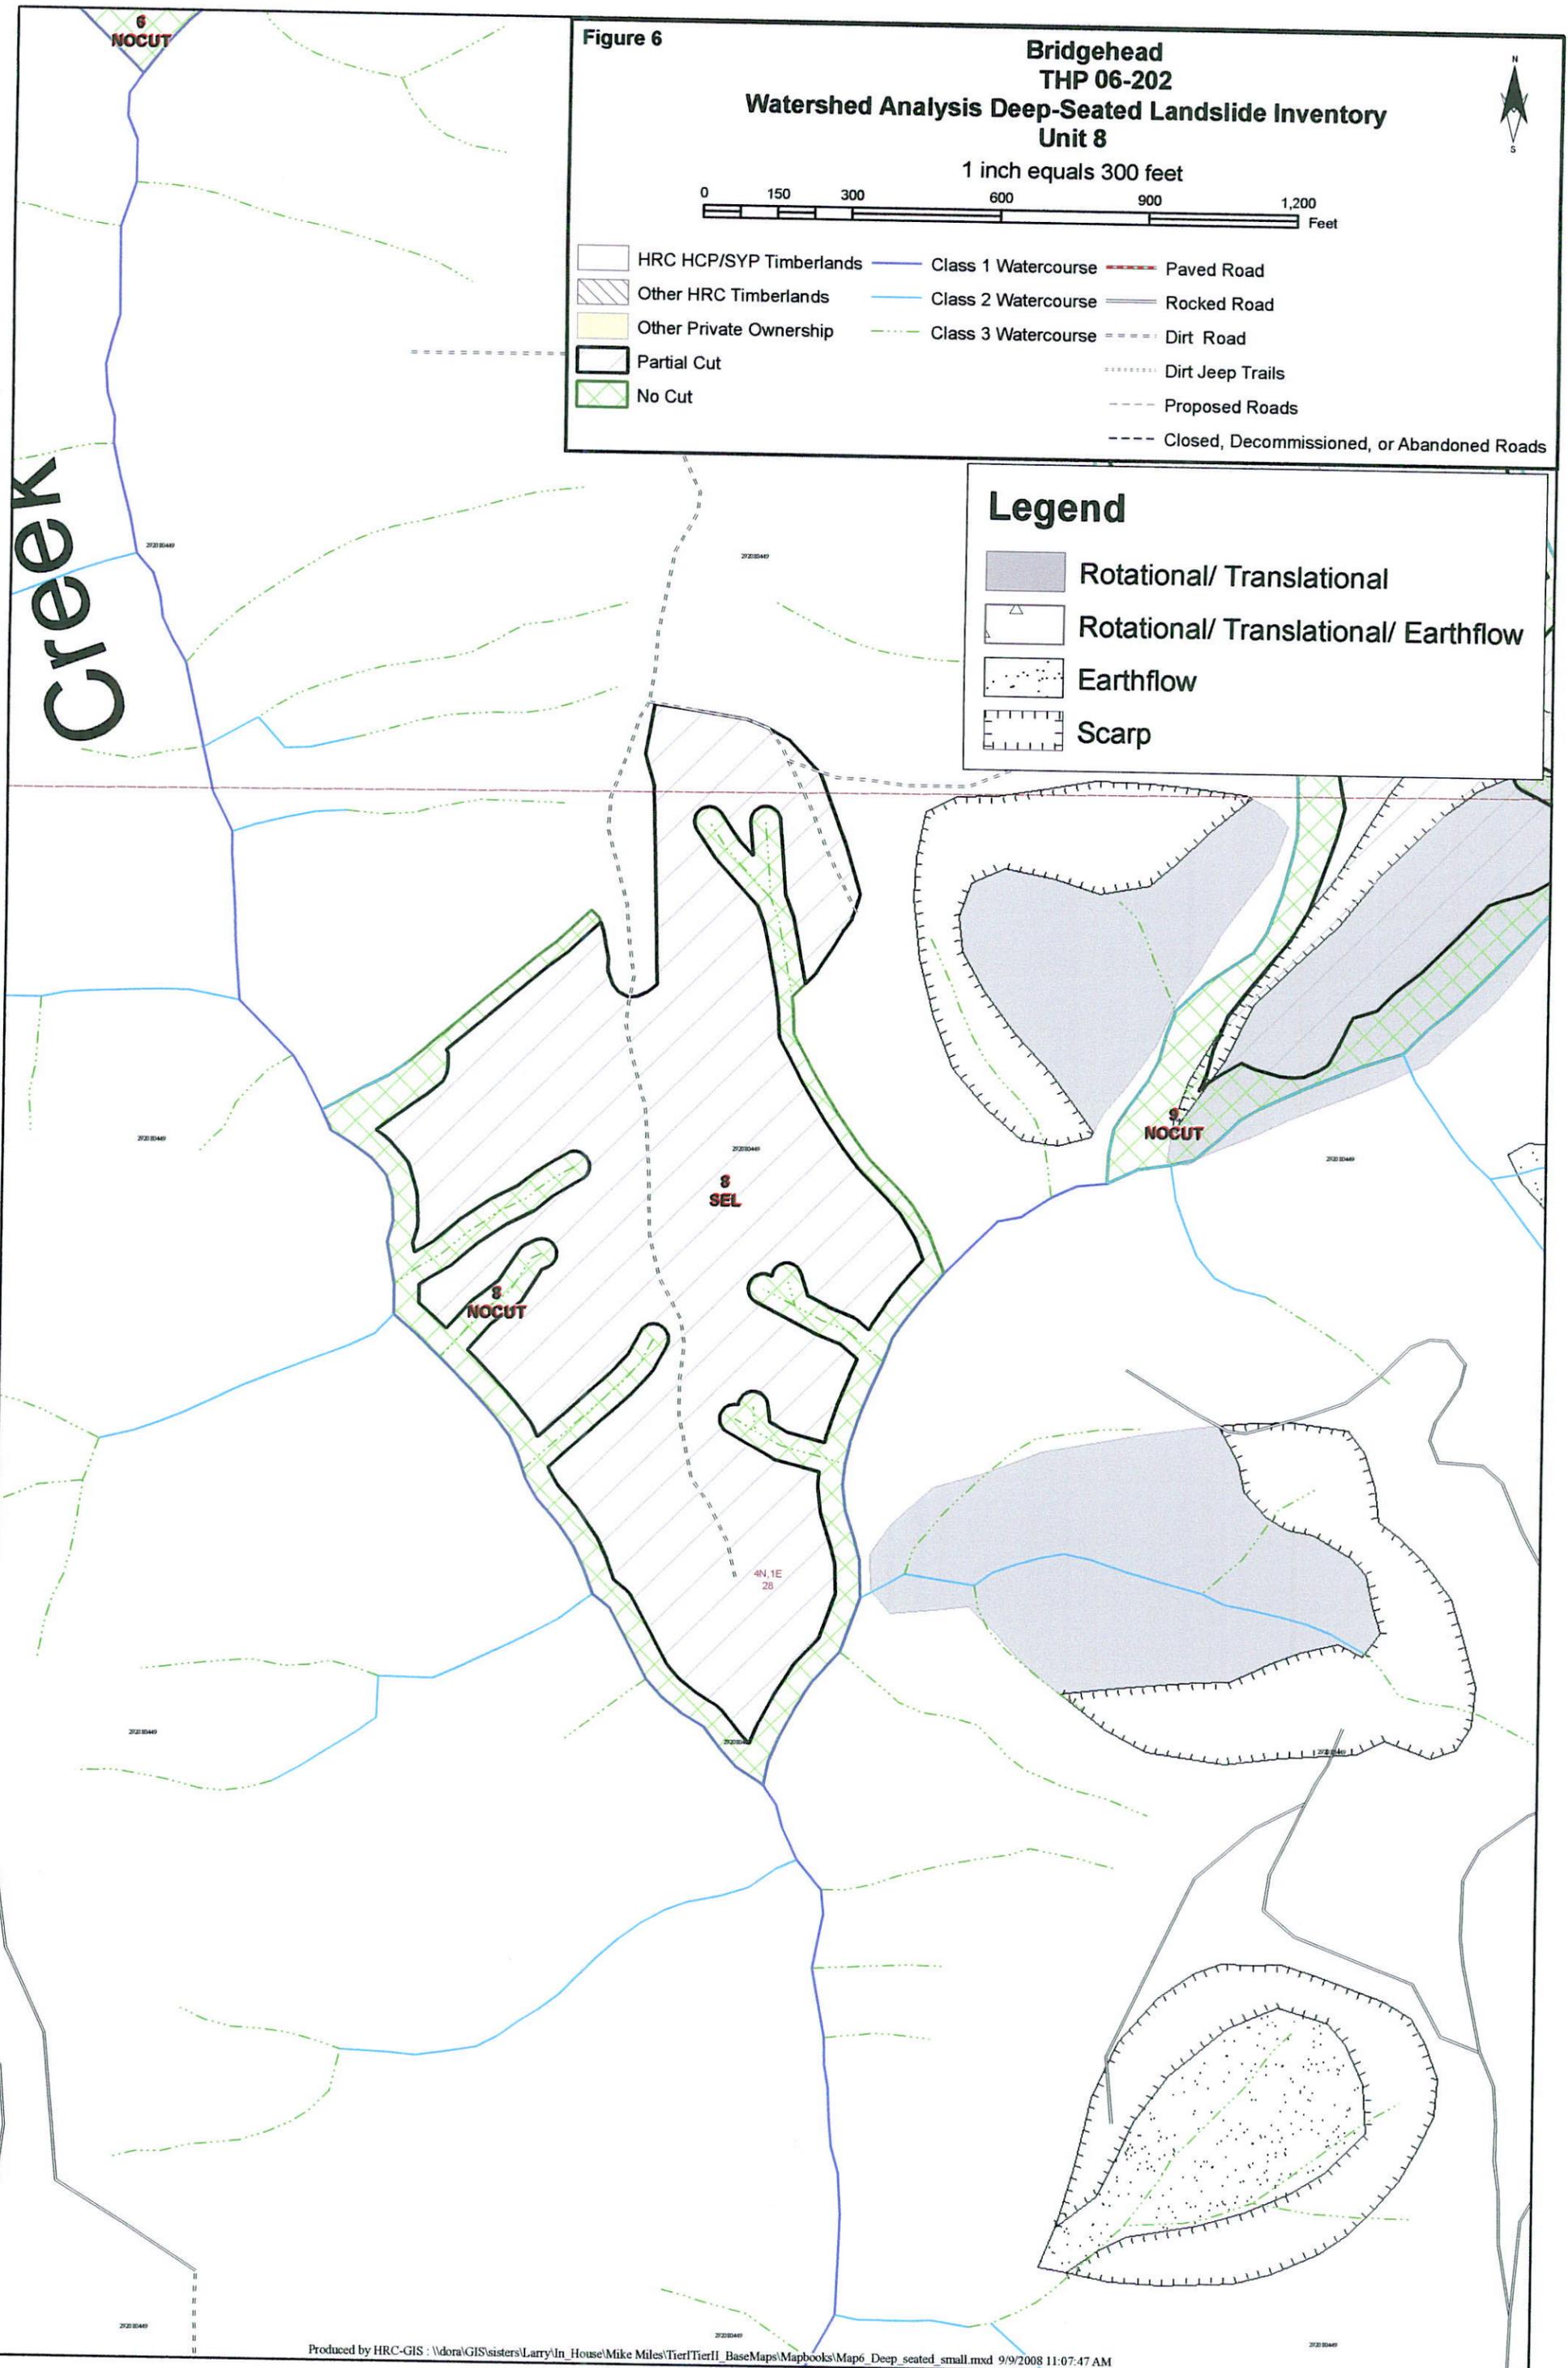
Figure 6

**Bridgehead  
THP 06-202  
Watershed Analysis Deep-Seated Landslide Inventory  
Unit 8**

No deep-seated landslides are mapped in the unit from Watershed Analysis mapping (Figure 6).

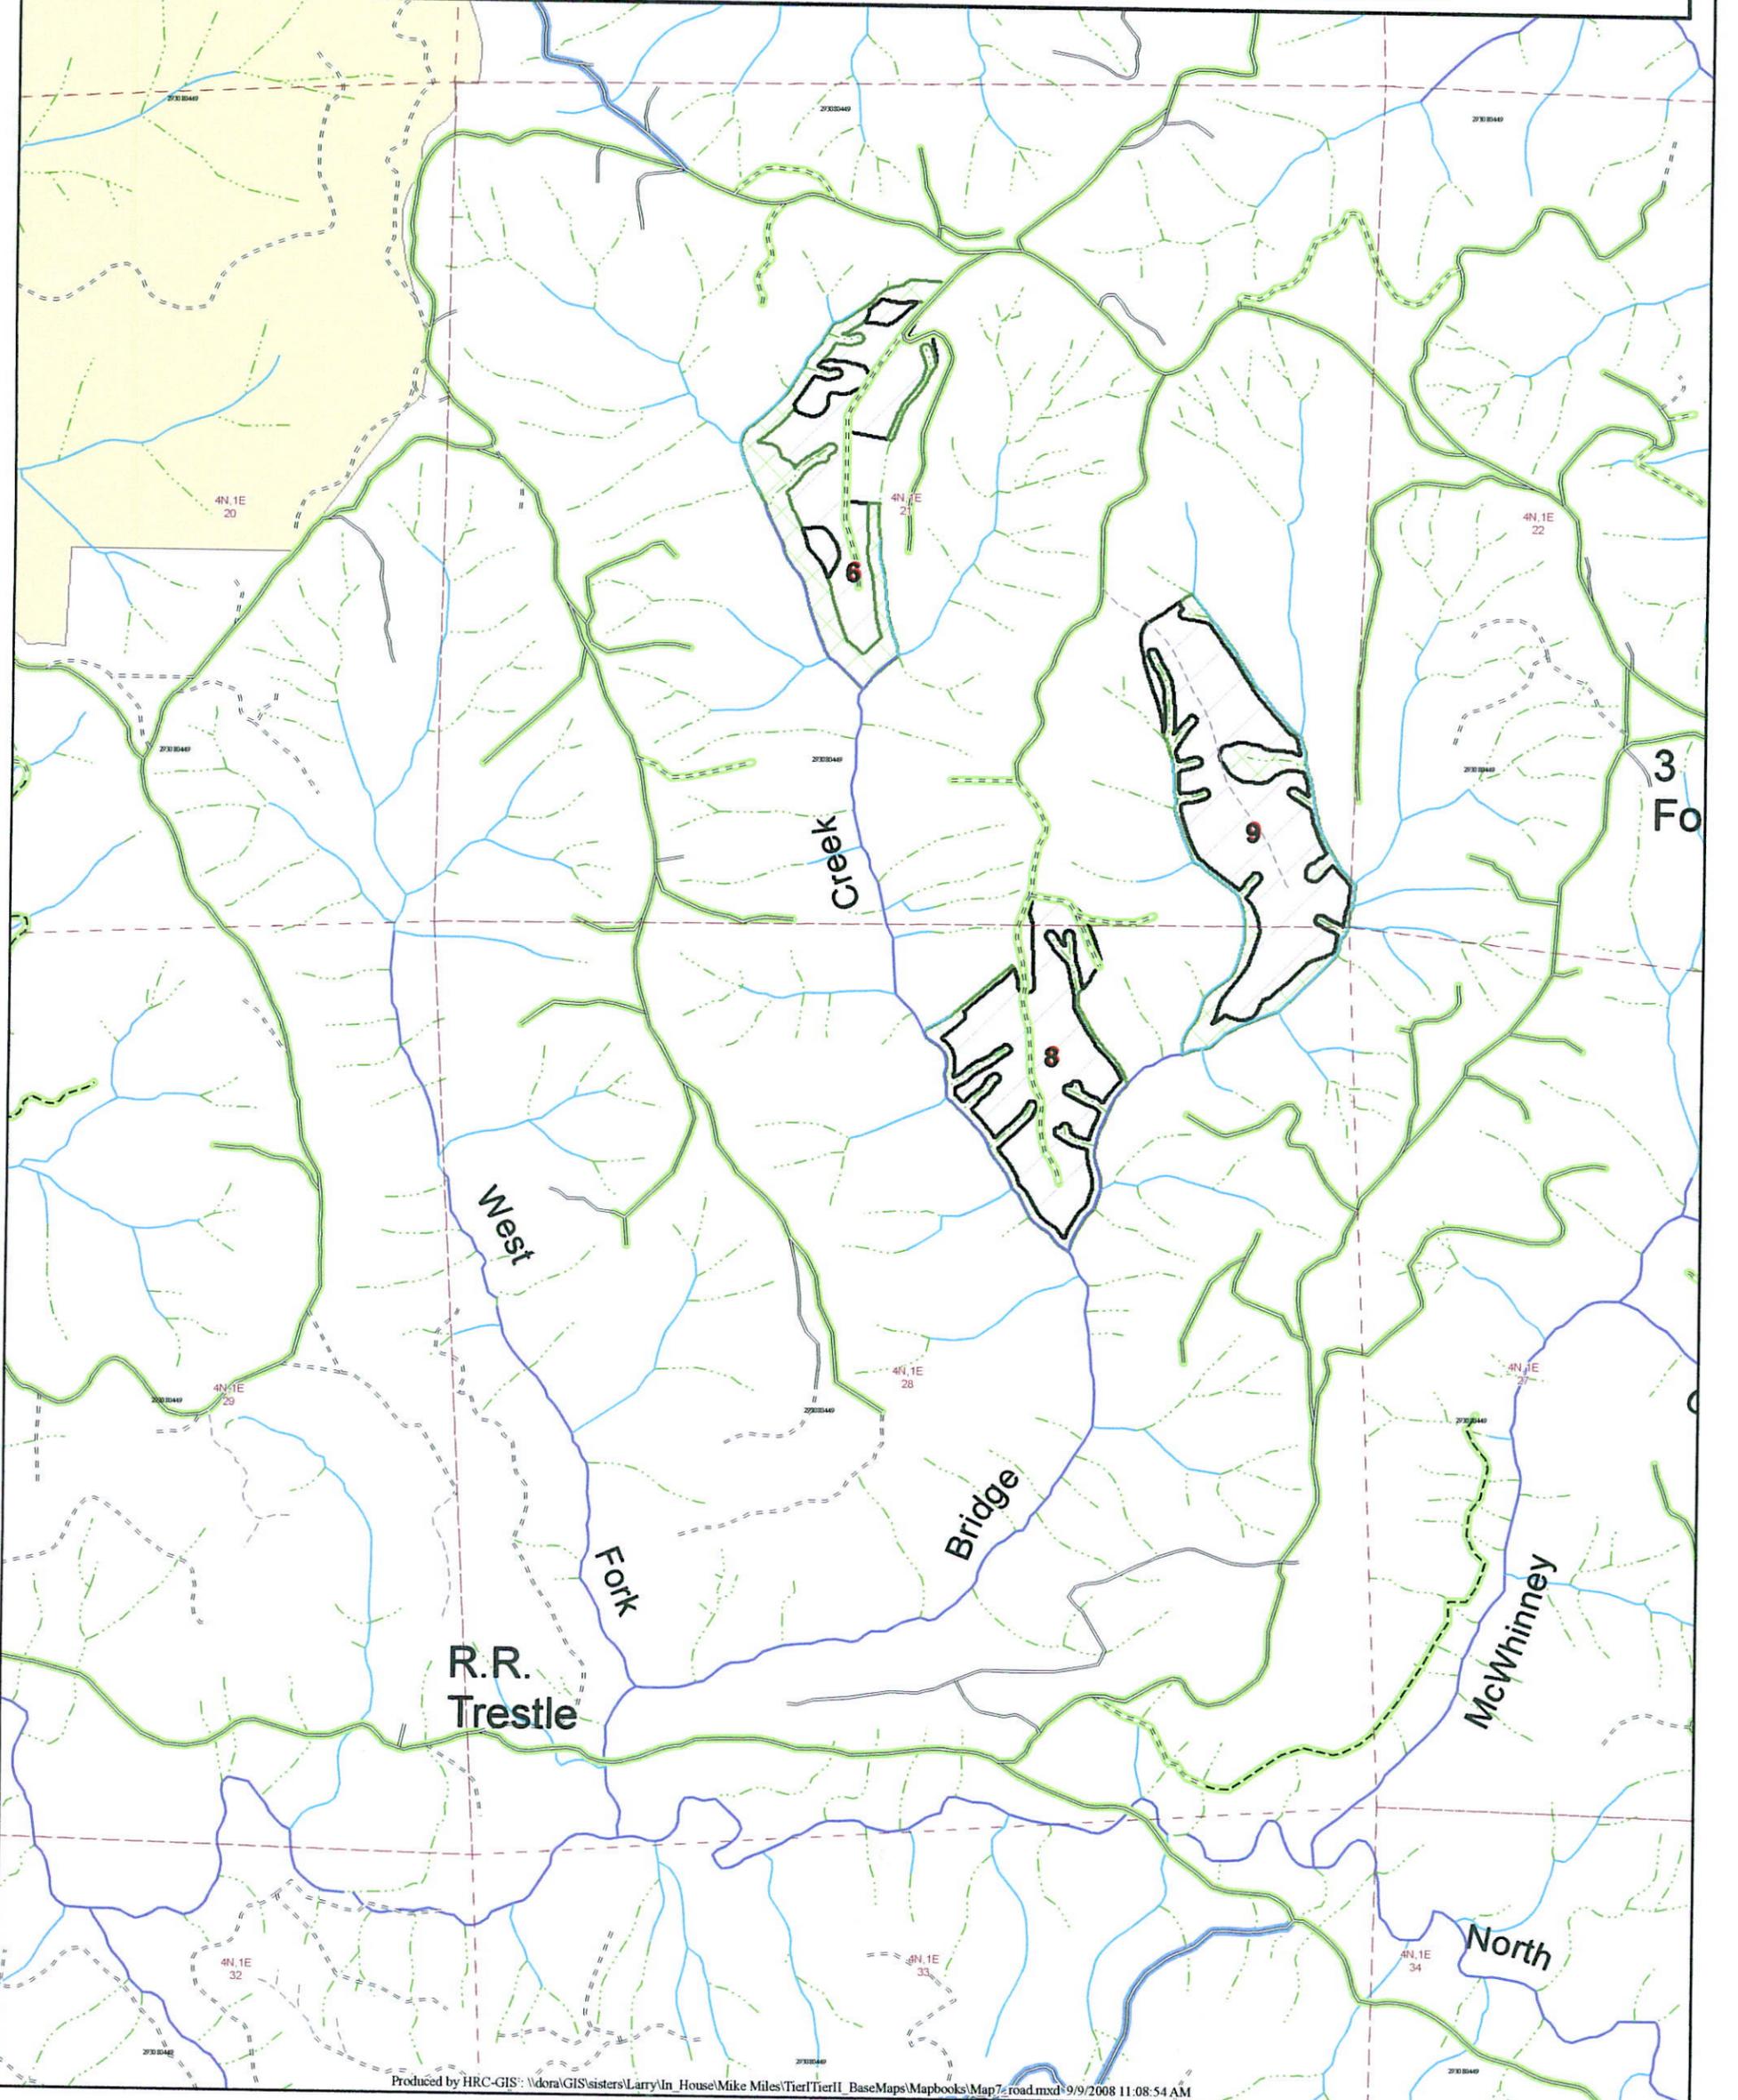
Figure 7

### Bridgehead THP 06-202 Road Map
