Subject: Enrollment of THP 1-05-176 HUM (Unit 2) in the Freshwater Creek WWDR, "Tier II"

THP No. 1-05-176 HUM (Little Fresh) Unit # 2

THP: Little Fresh THP 05-176 Unit # 2 March 3, 2009

Erosion Control Plan (ECP) for
the “Little Fresh” THP

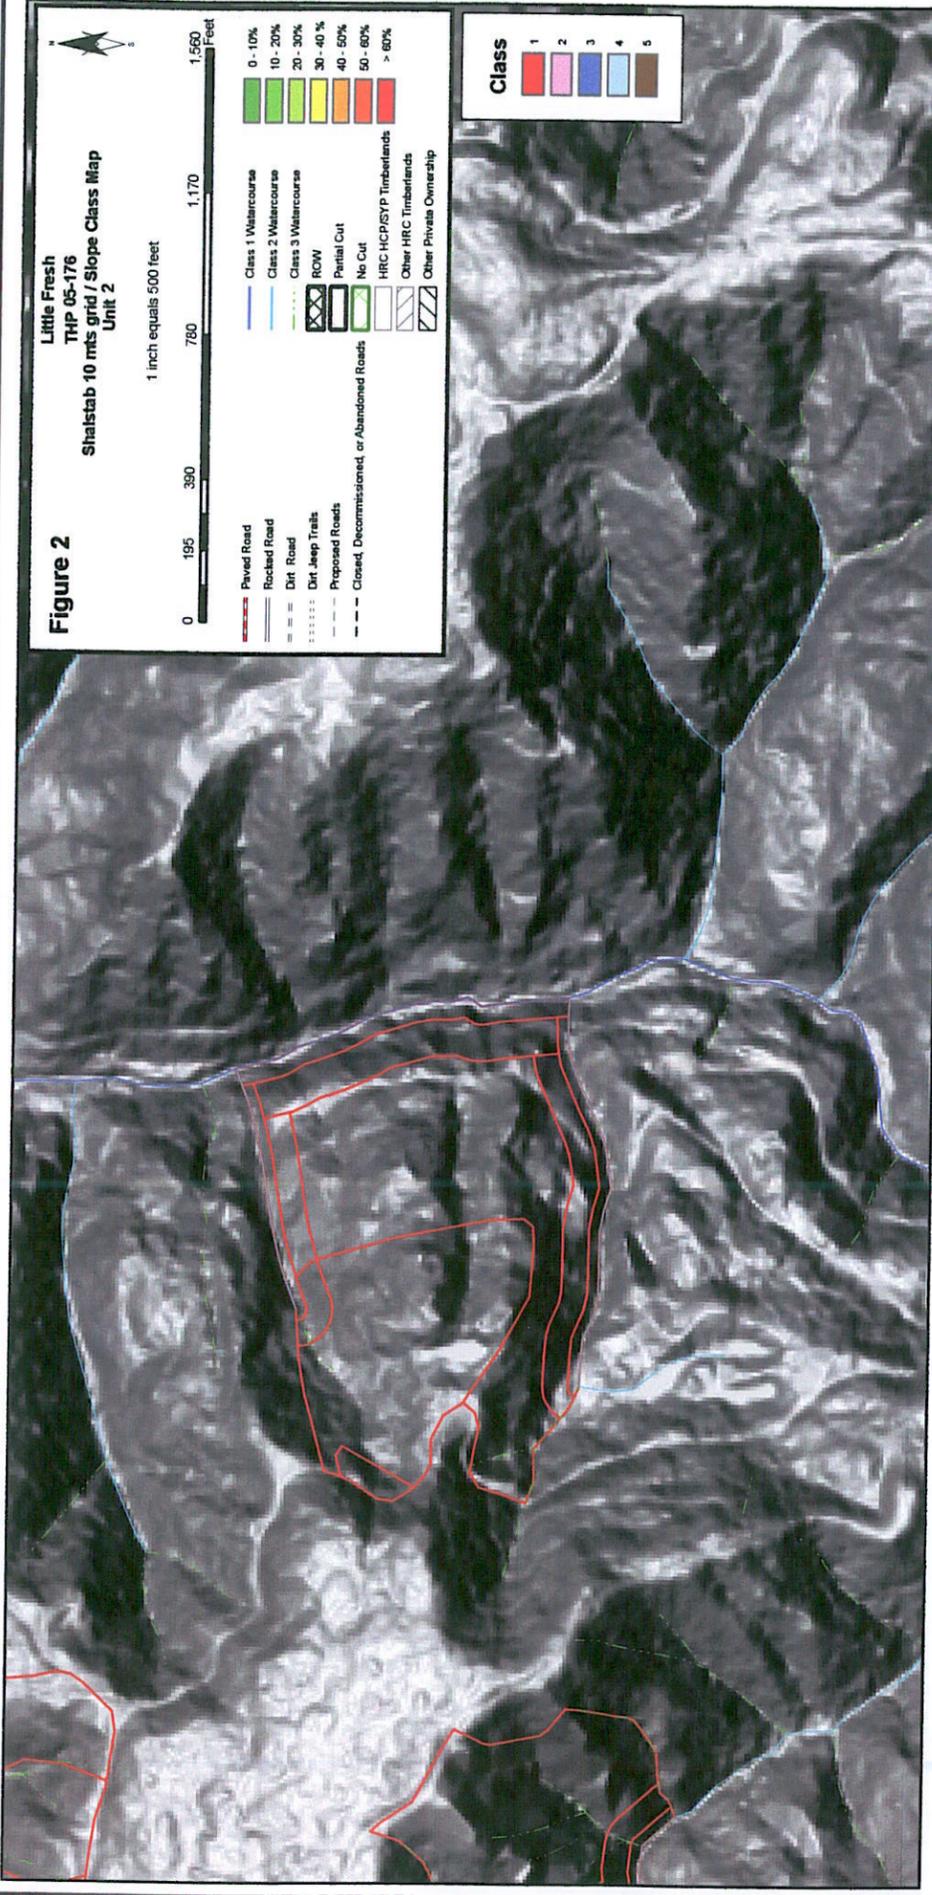
Figure 3

Little Fresh
THP 05-176
CGS Map Unit 2

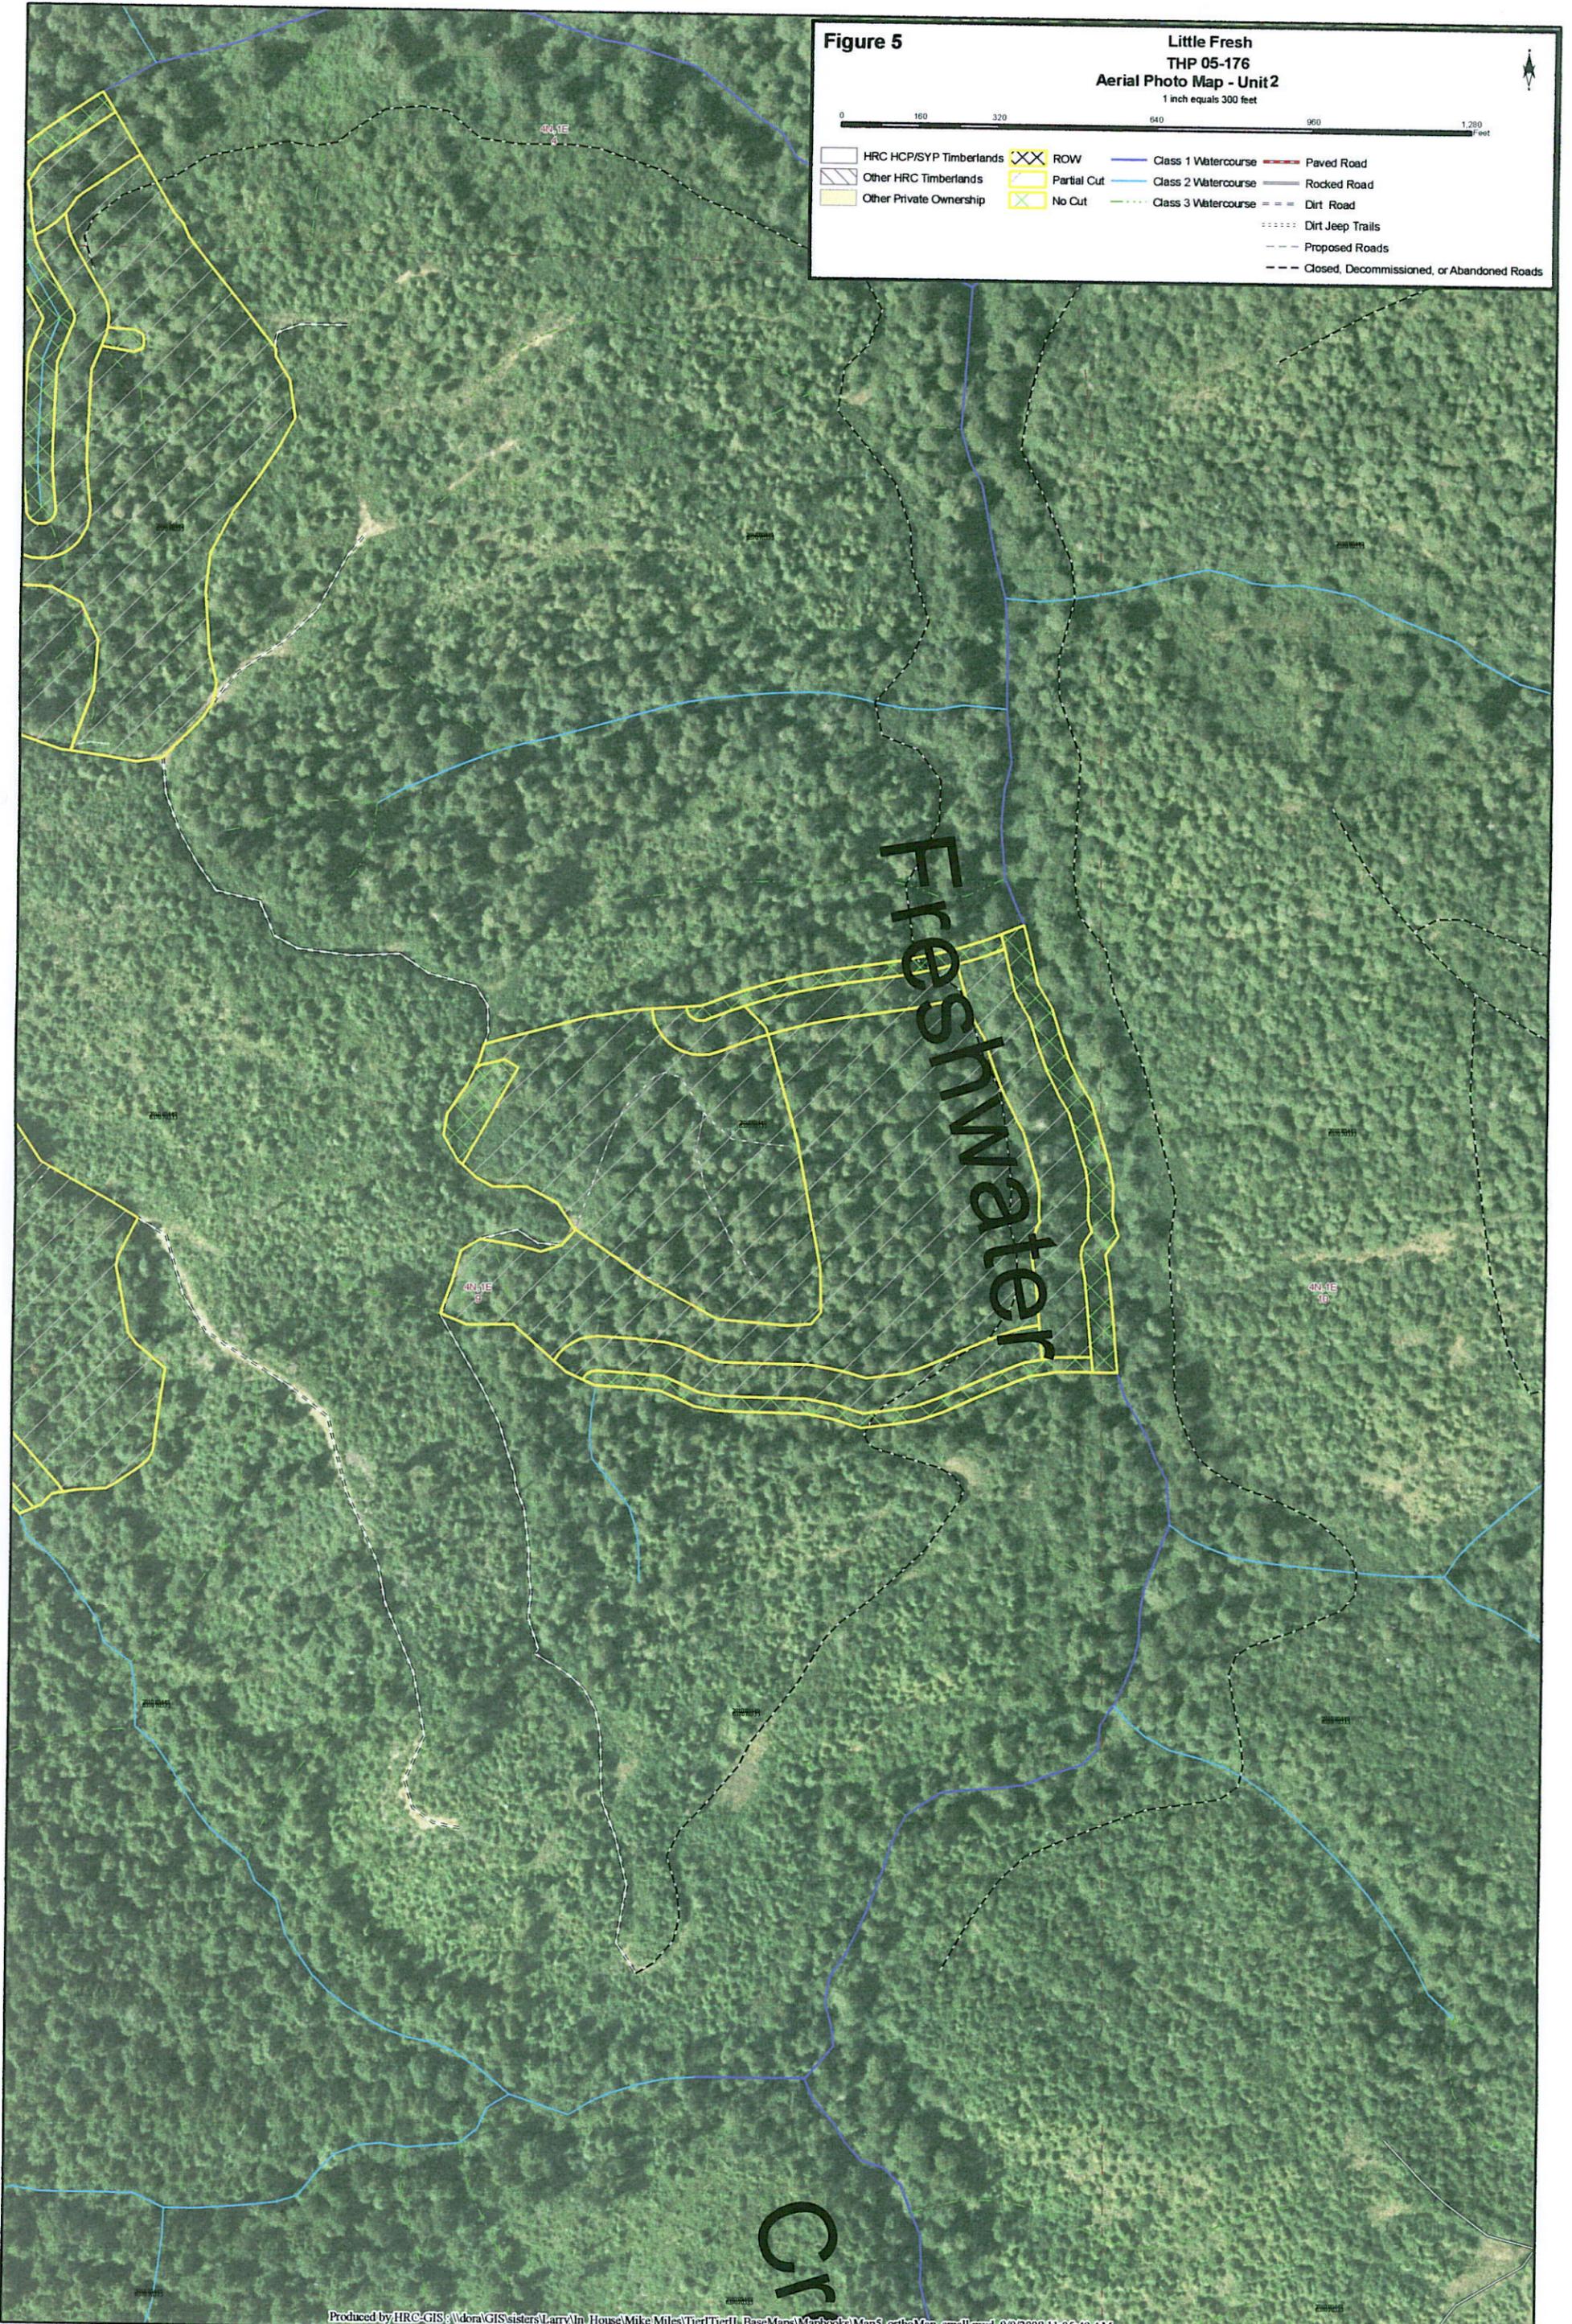
Figure 6

A low to moderate deep-seated landslide is mapped in the unit from Watershed Analysis mapping (Figure 6). The Watershed Analysis mapping correlates well with CGS (1999) mapping of the dormant translational/rotational landslide.

- Crown of Deep-Seated Landslides
- Hazard for Reactivation or Acceleration of Movement**
REACT_HAZARD
- N/A (landslides in grassland areas)
 - Very Low
 - Low
 - Low to Moderate
 - Moderate
 - High
