Subject: Enrollment of THP 1-05-176 HUM (Unit 5) in the Freshwater Creek WWDR, "Tier II"

THP: Little Fresh THP 05-176 Unit # 5 6-23-09

Erosion Control Plan (ECP) for
the “Little Fresh” THP

1-05-176HUM

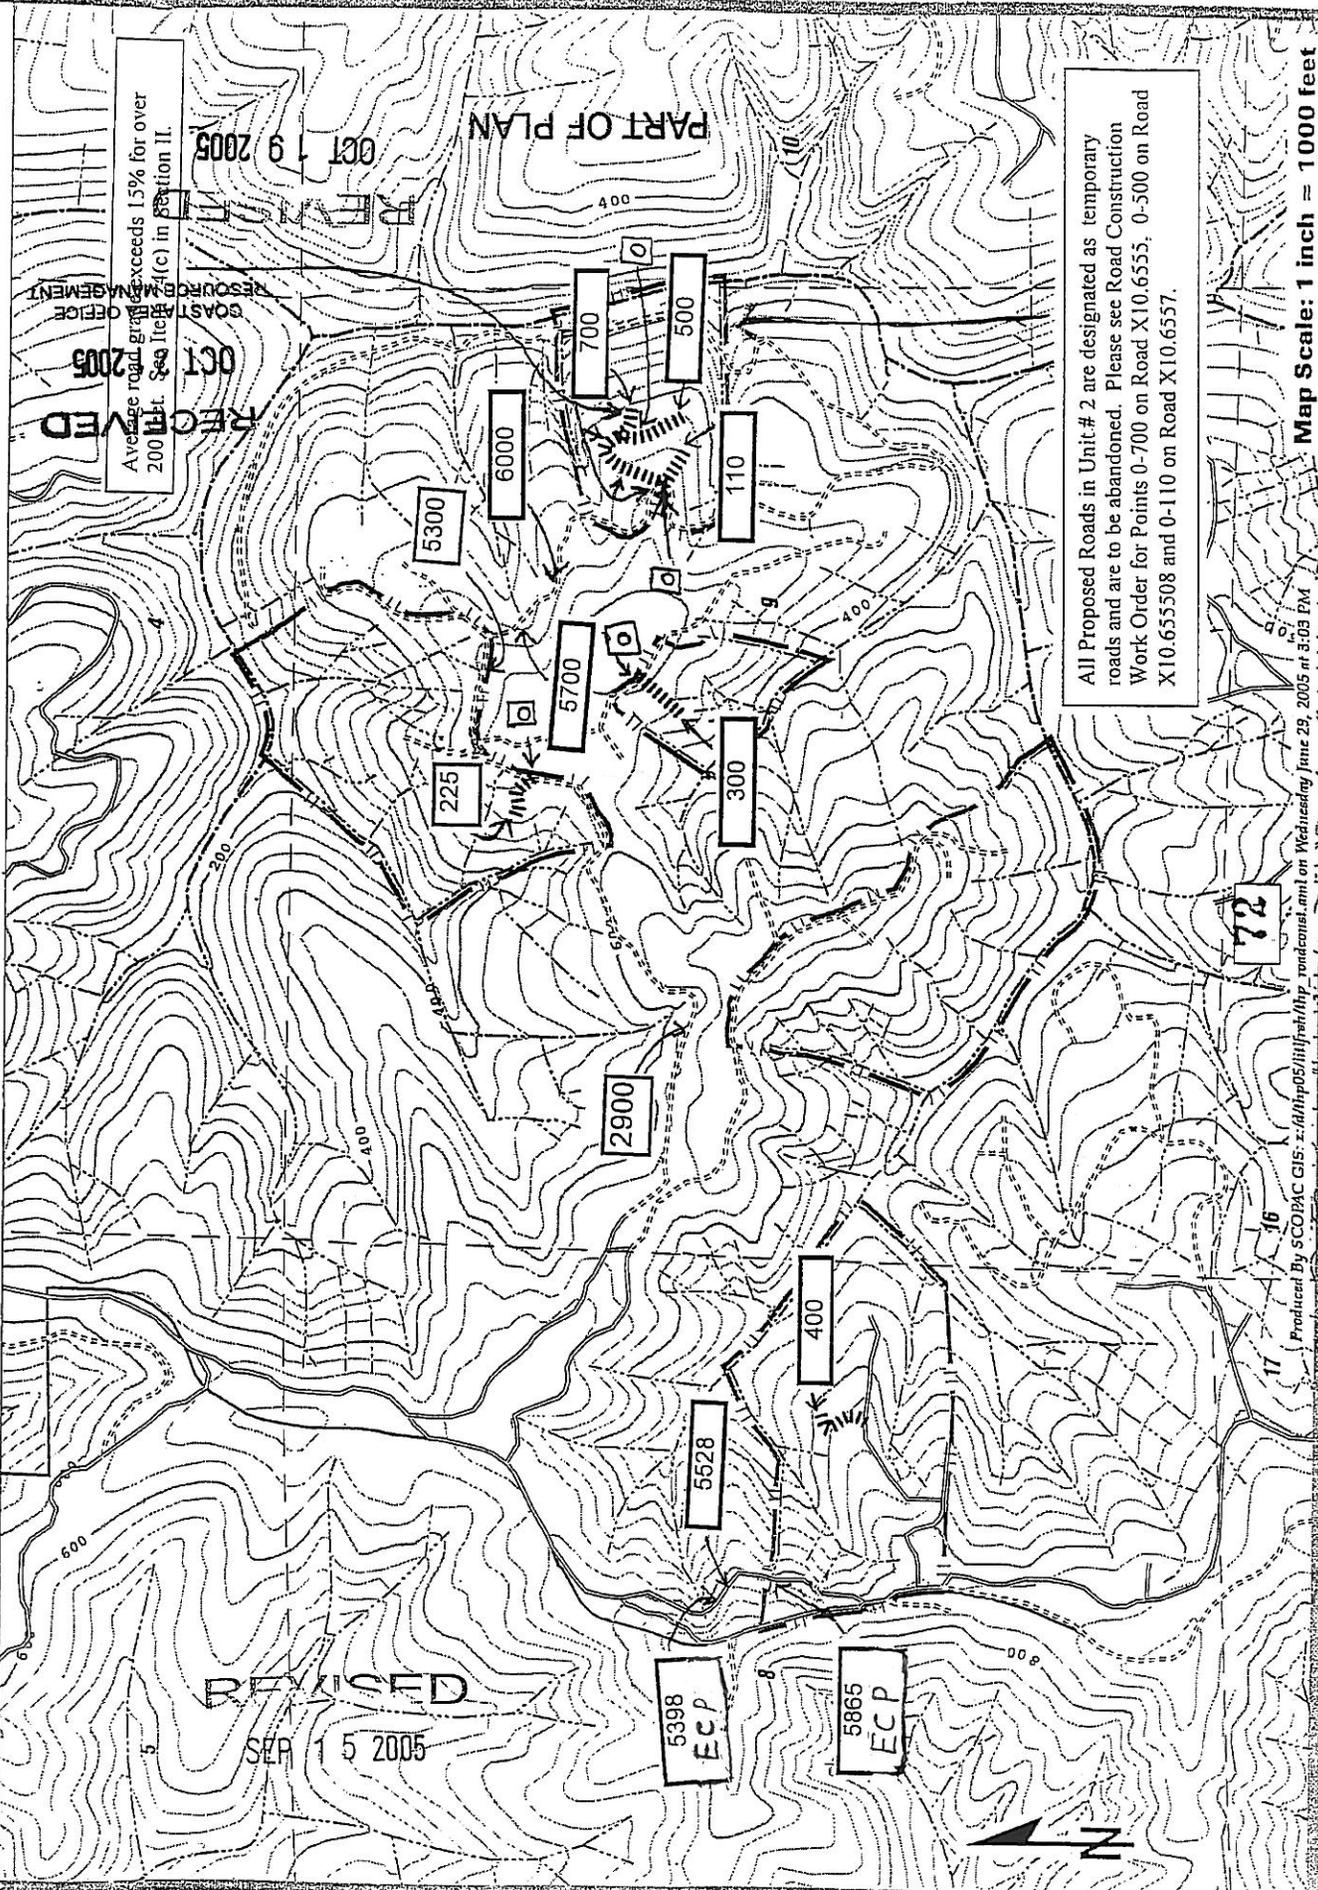
All Proposed Roads in Unit # 2 are designated as temporary roads and are to be abandoned. Please see Road Construction Work Order for Points 0-700 on Road X10.6555, 0-500 on Road X10.655508 and 0-110 on Road X10.6557.

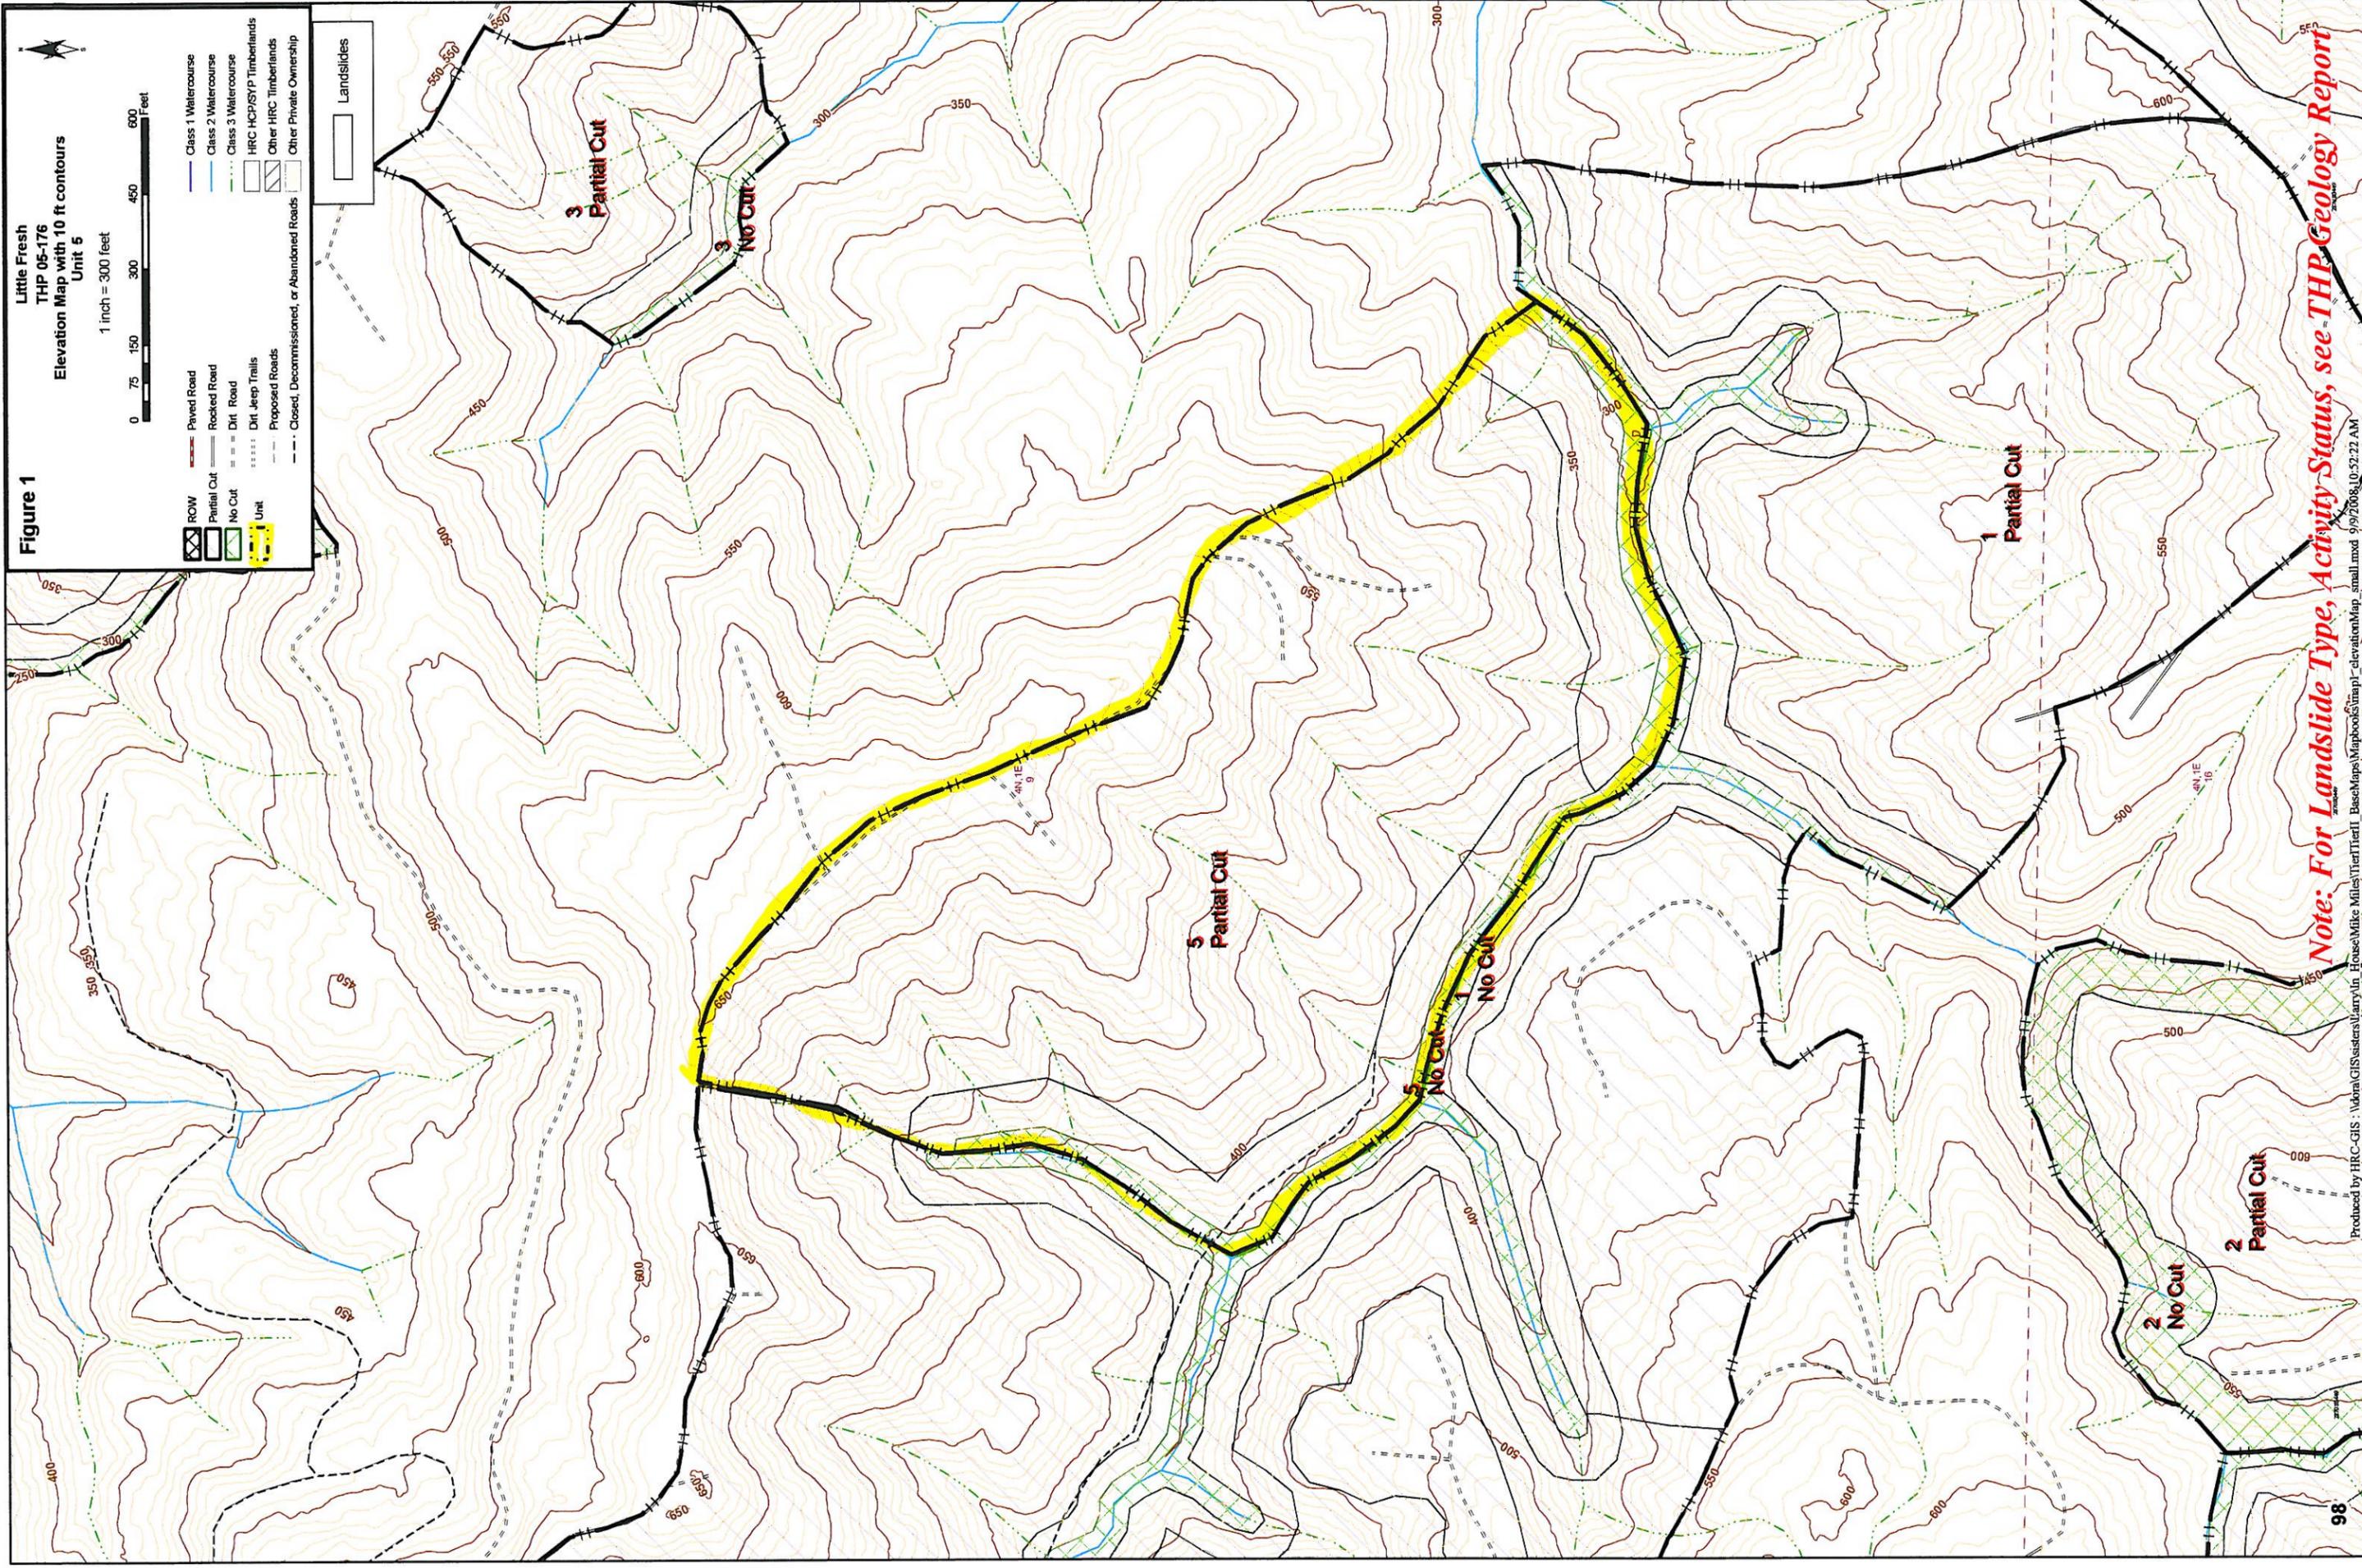
Note: For Landslide Type, Activity Status, see THP Geology Report

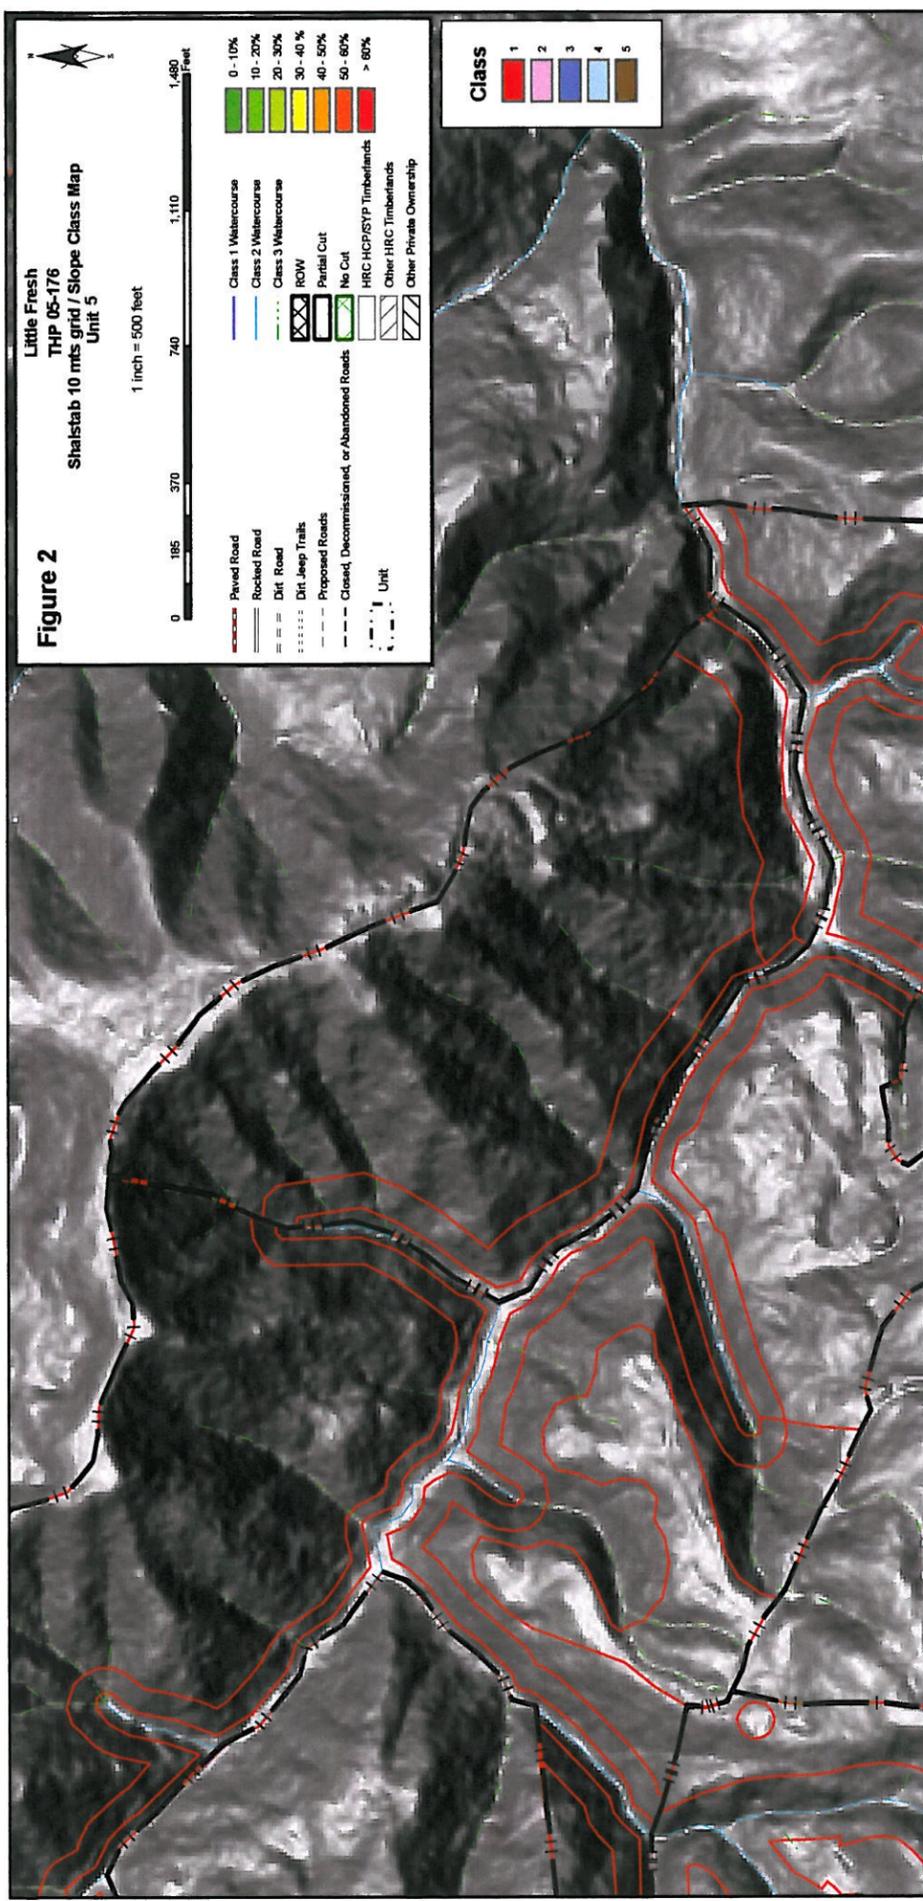
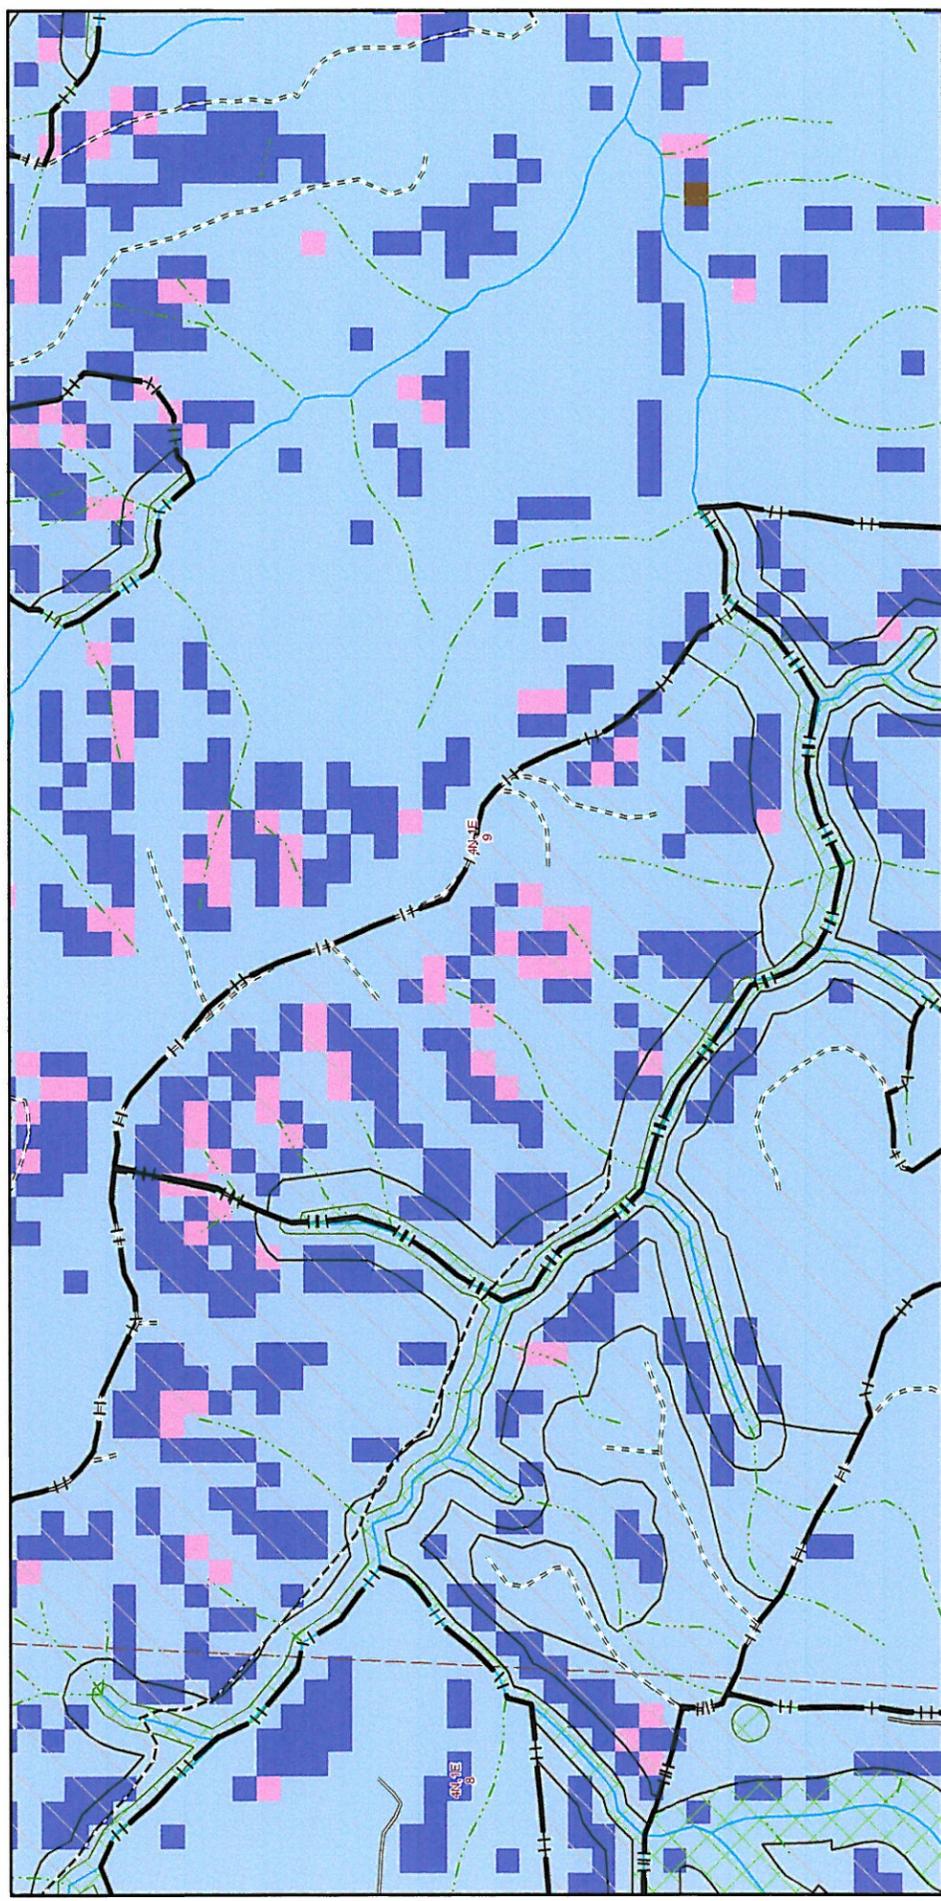
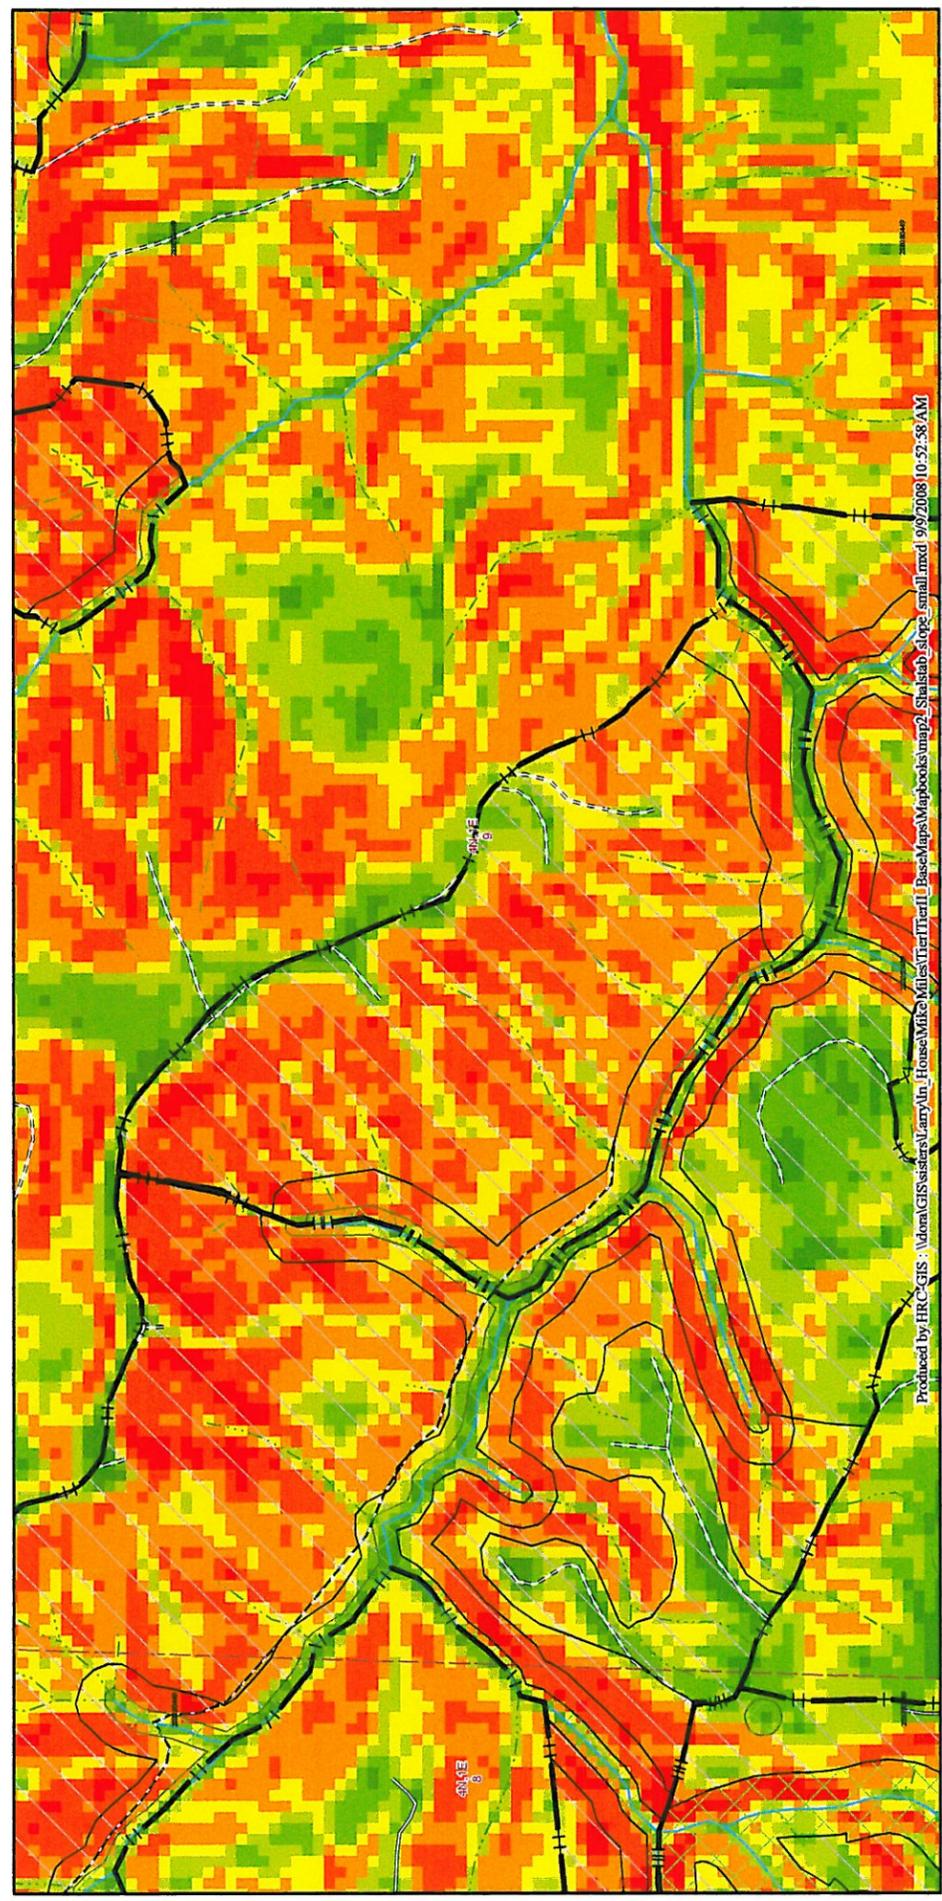
In similar context, the debris slide slopes mapped on Figure 3 represent a potential source area due to steep inclination. No failures were observed on the slope to confirm the areas as debris slide slopes.

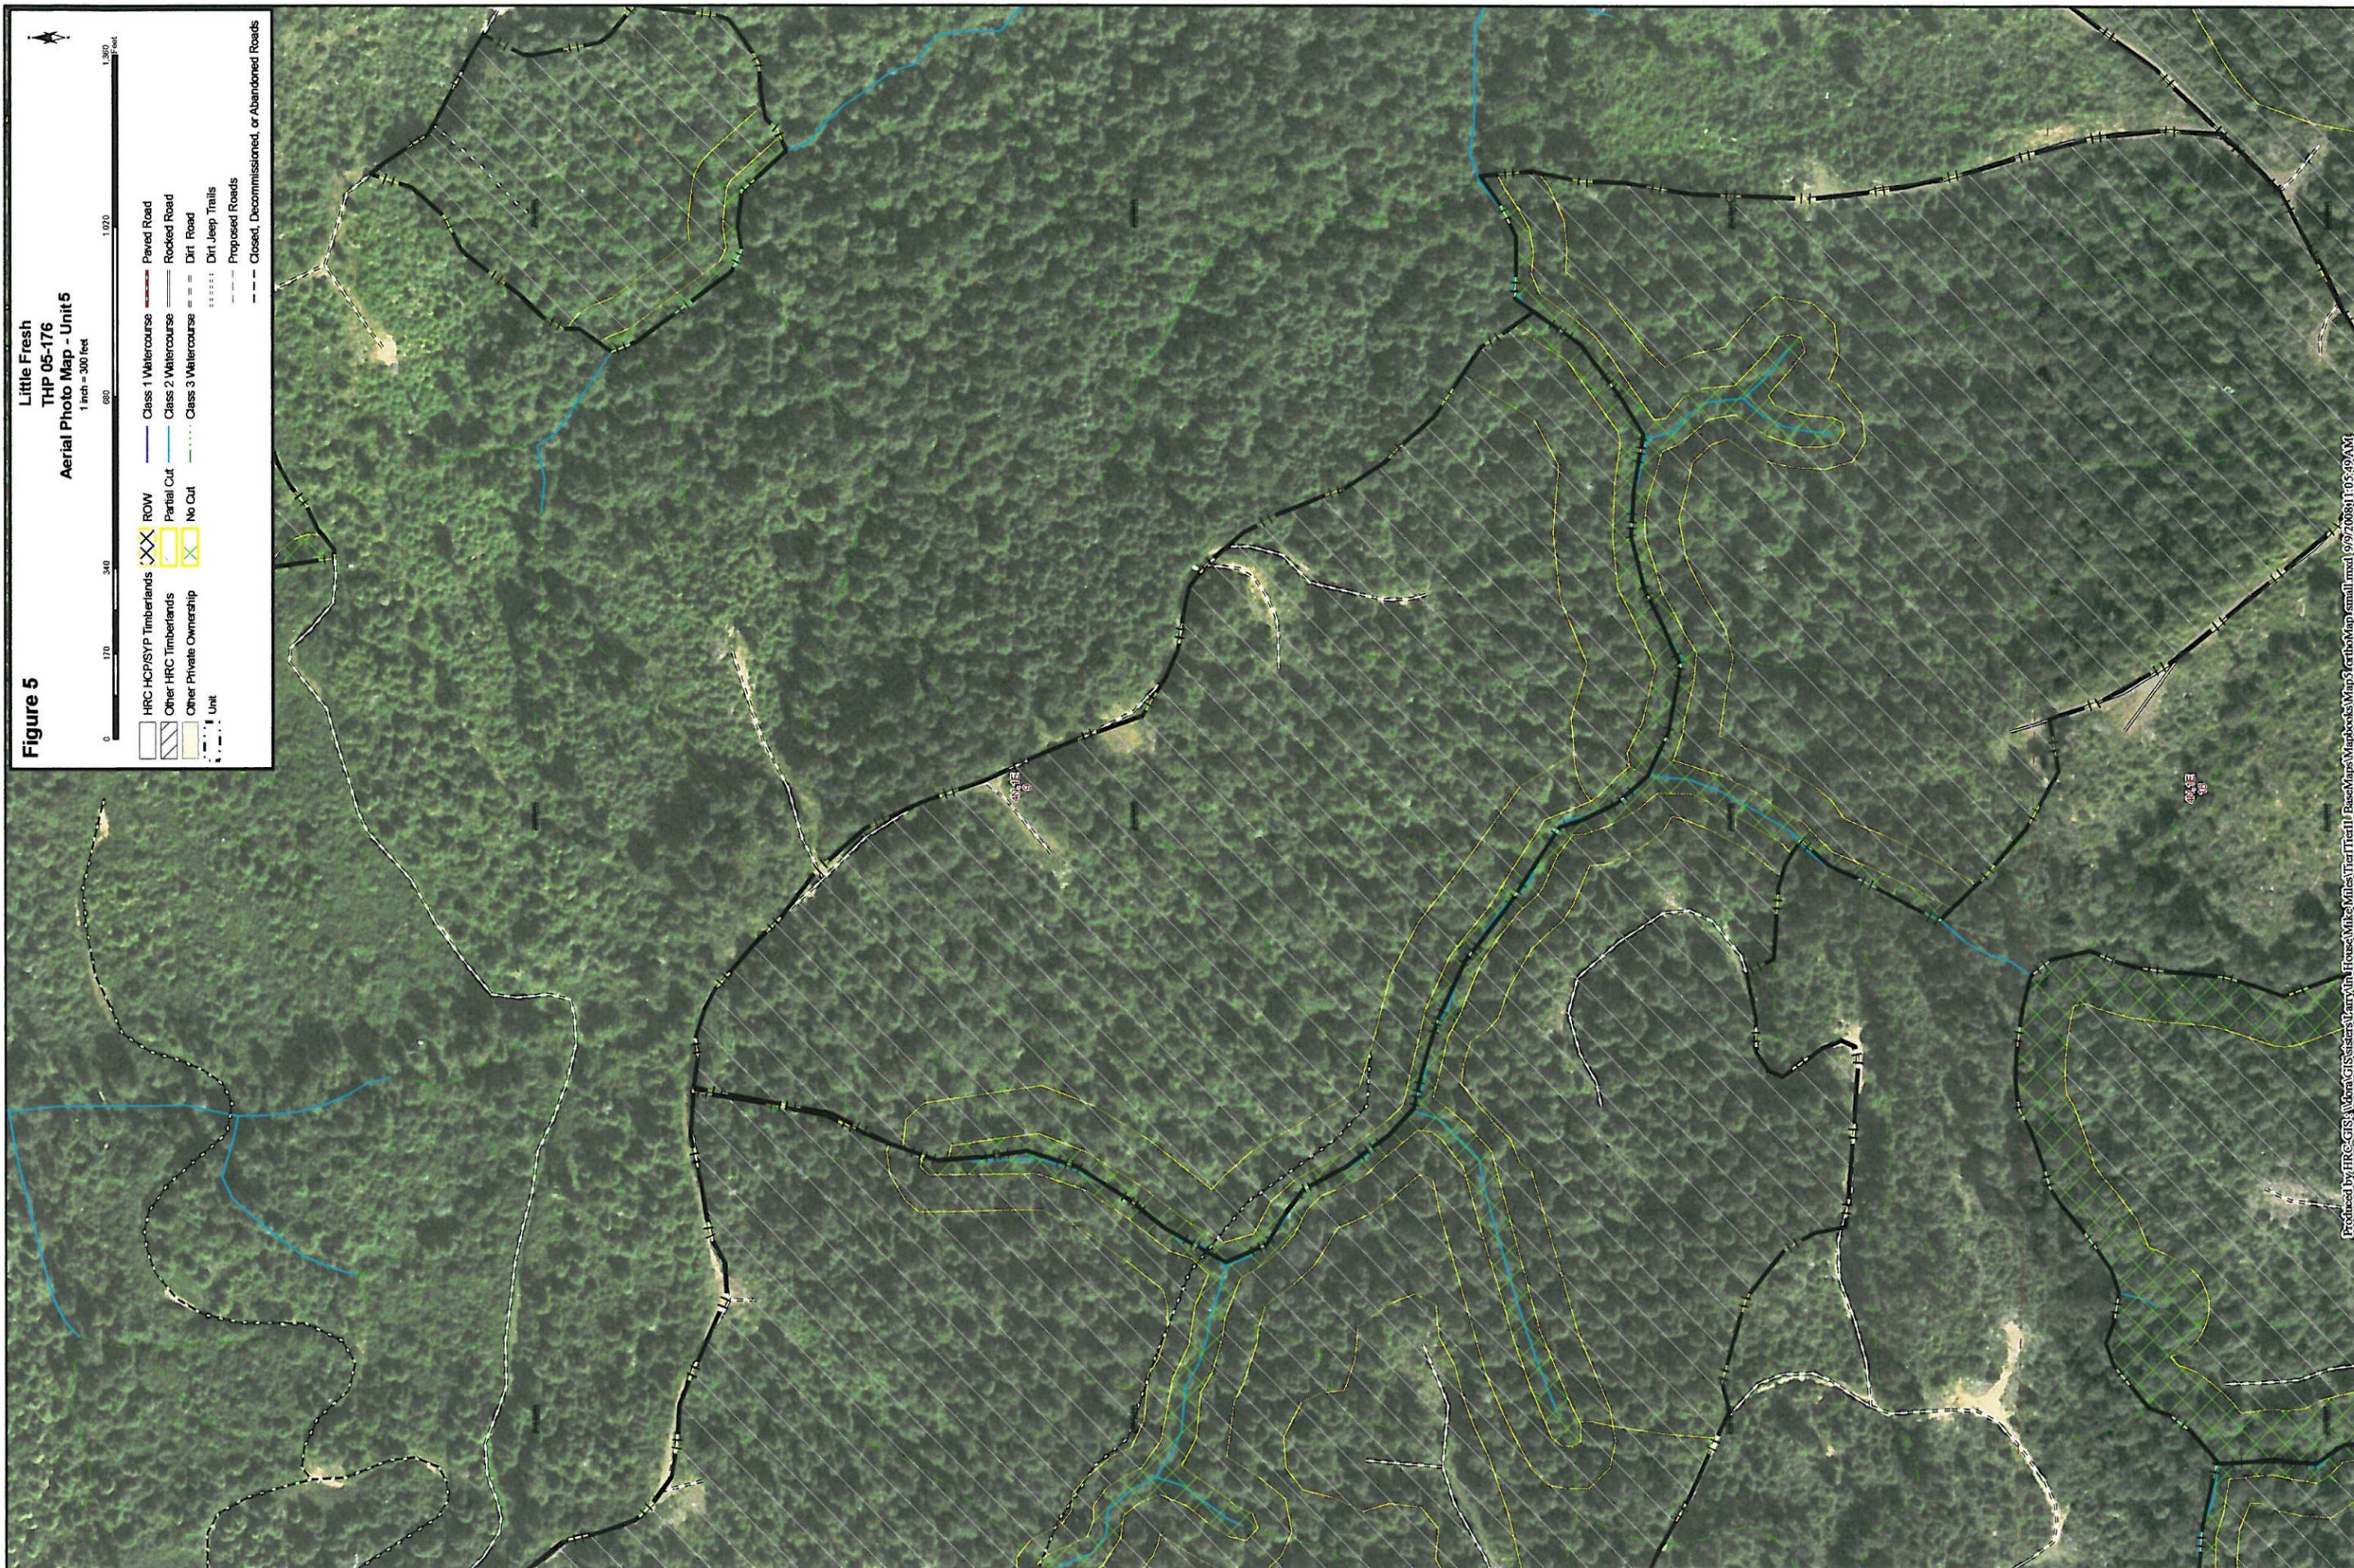
One small deep-seated landslide is mapped within the unit from Figure 6. The landslide is assessed with a moderate hazard for reactivation. The scarp for the mapped landslide extends almost to the ridgetop and is well incised with numerous watercourses.

The deep-seated landslide mapped on Figure 6 is dormant mature. The slide has remained stable long enough for three watercourses to prominently erode uniform watercourse channels.
