Subject: Enrollment of THP 1-08-048 HUM (Unit 1) in the Freshwater Creek WWDR, "Tier II"

THP No. 1-08-048 HUM (Little 34) Unit # 1

THP: Little 34 THP 08-048 Unit # 1 6-22-09

Erosion Control Plan (ECP) for the “Little 34” THP 1-08-048HUM

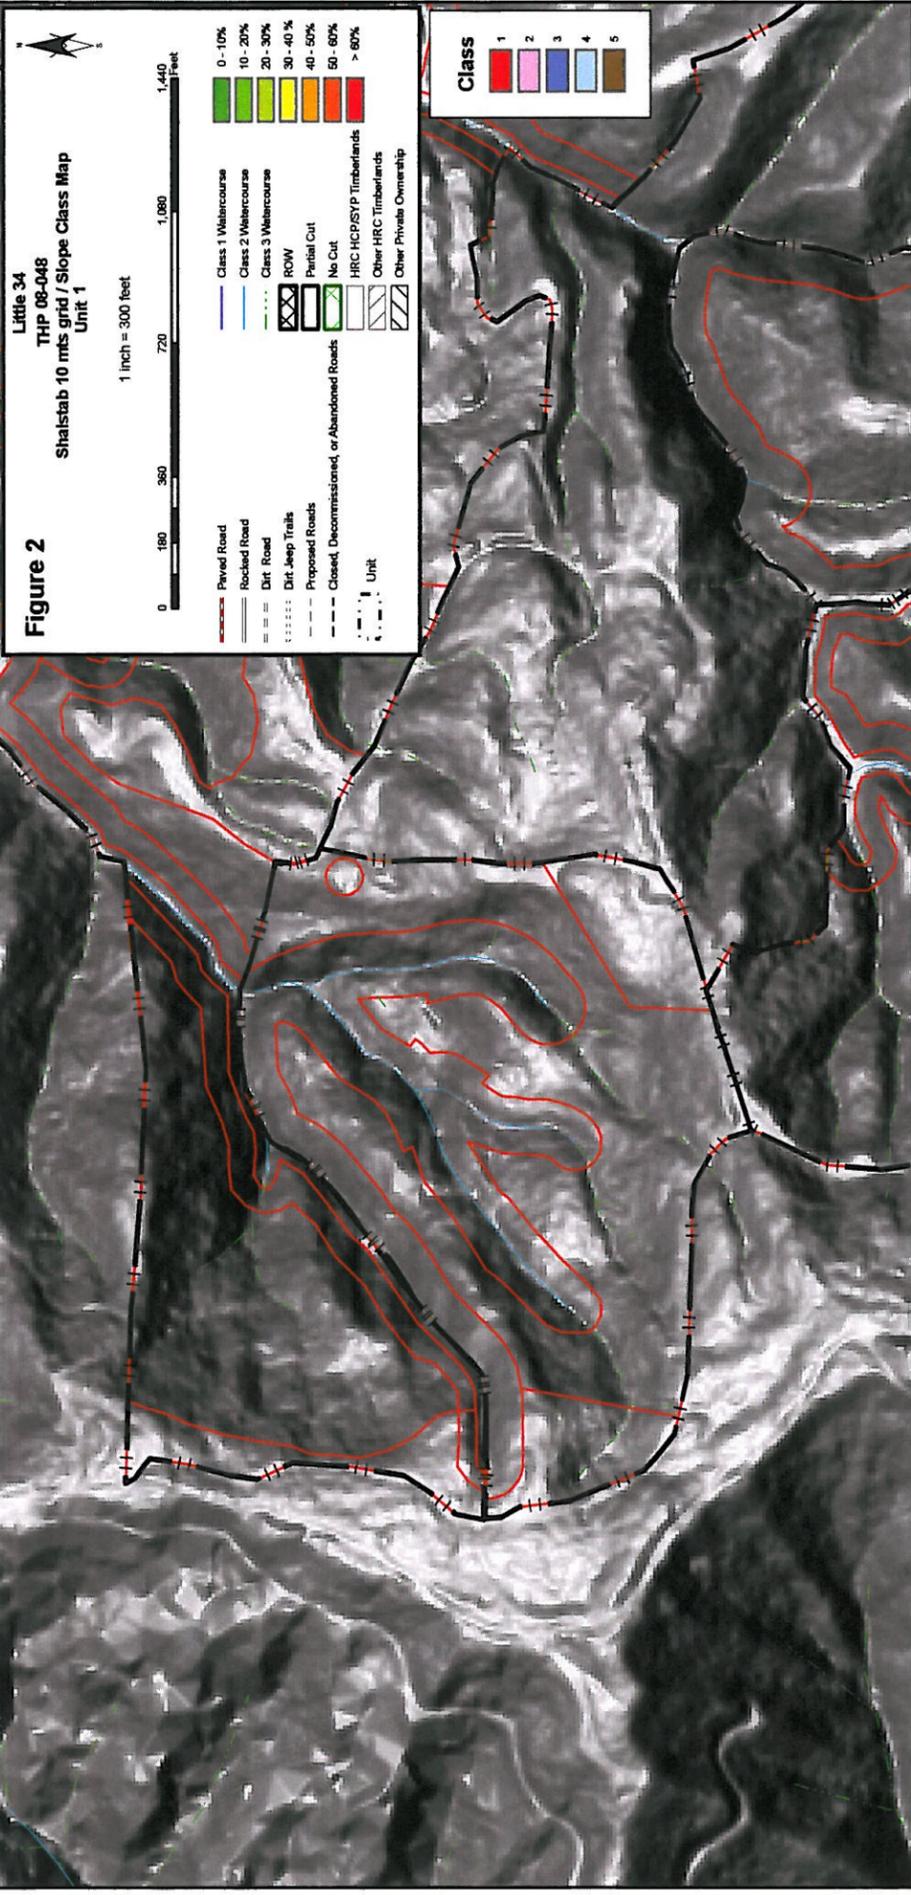
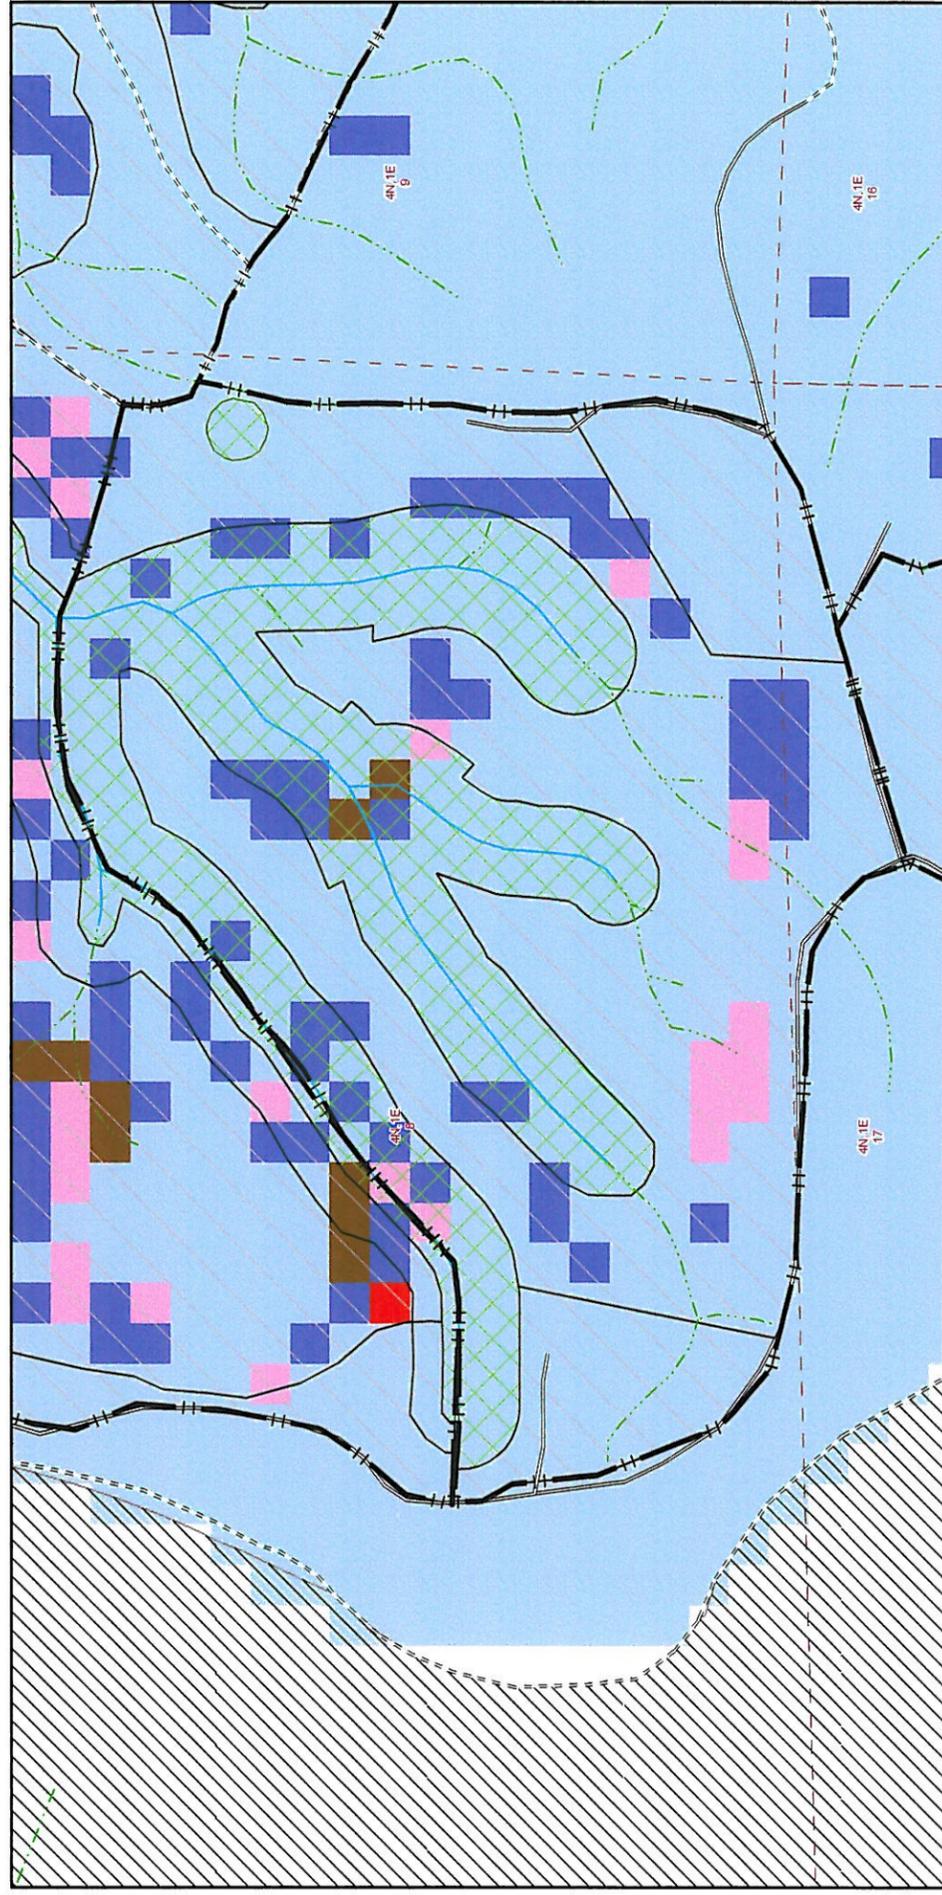
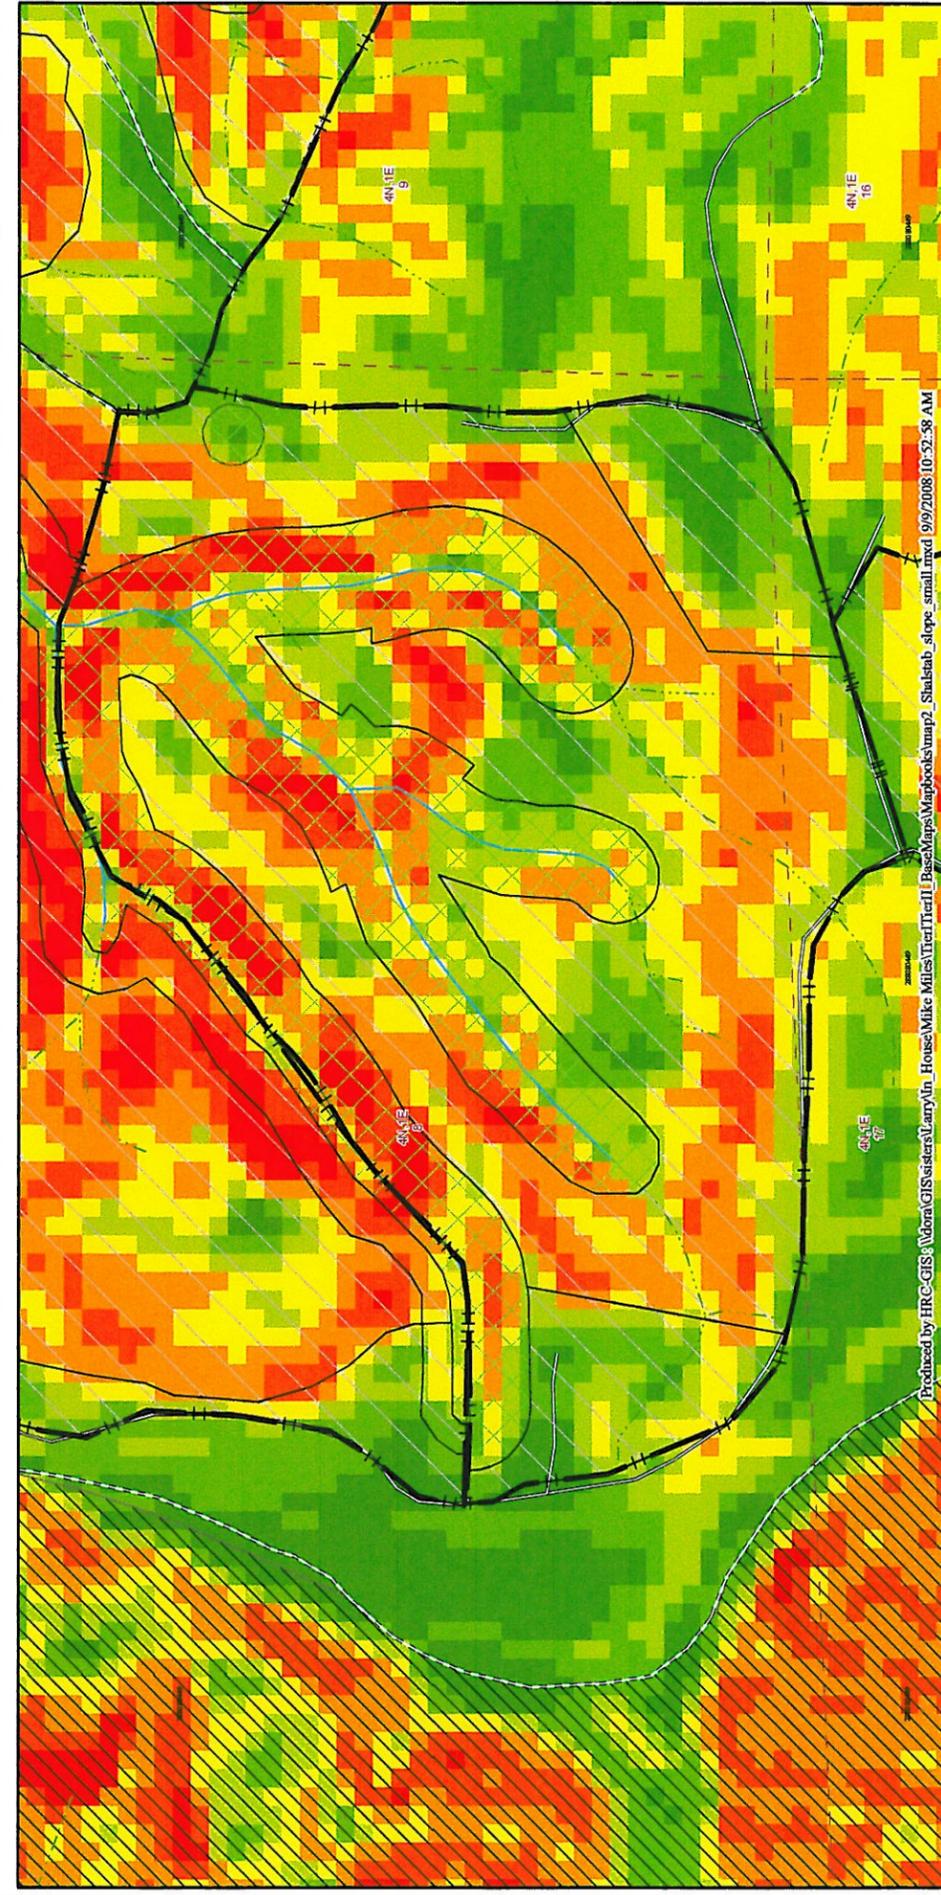
Review of Figure 2 (Hillslope Shade) shows the irregular surface morphology characterized by the topographic map. The morphology is smooth and rather uniform with all of the watercourse Classes well incised. The recognition of the Figure 3 and Figure 6 large dormant mass wasting is not obvious however remains a plausible explanation for the unique surface morphology within the unit. Should the failures exist, they are very old.

Areas of elevated SHALSTAB (Value 2) are located in the northwestern Class II (in a no harvest area), central to the unit (one pixel straddled by no harvest RMZ), and in three locations along the ridgetop. Two of these areas are located within Class III watercourses. The remaining area is one pixel in size and located upslope of a Class II RMZ. Our review of the SHALSTAB areas revealed steeply inclined swales, evenly distributed, in situ old growth stumps and abundant 2nd growth timber.

Little 34
THP 08-048
Shalsab 10 mts grid / Slope Class Map
Unit 1

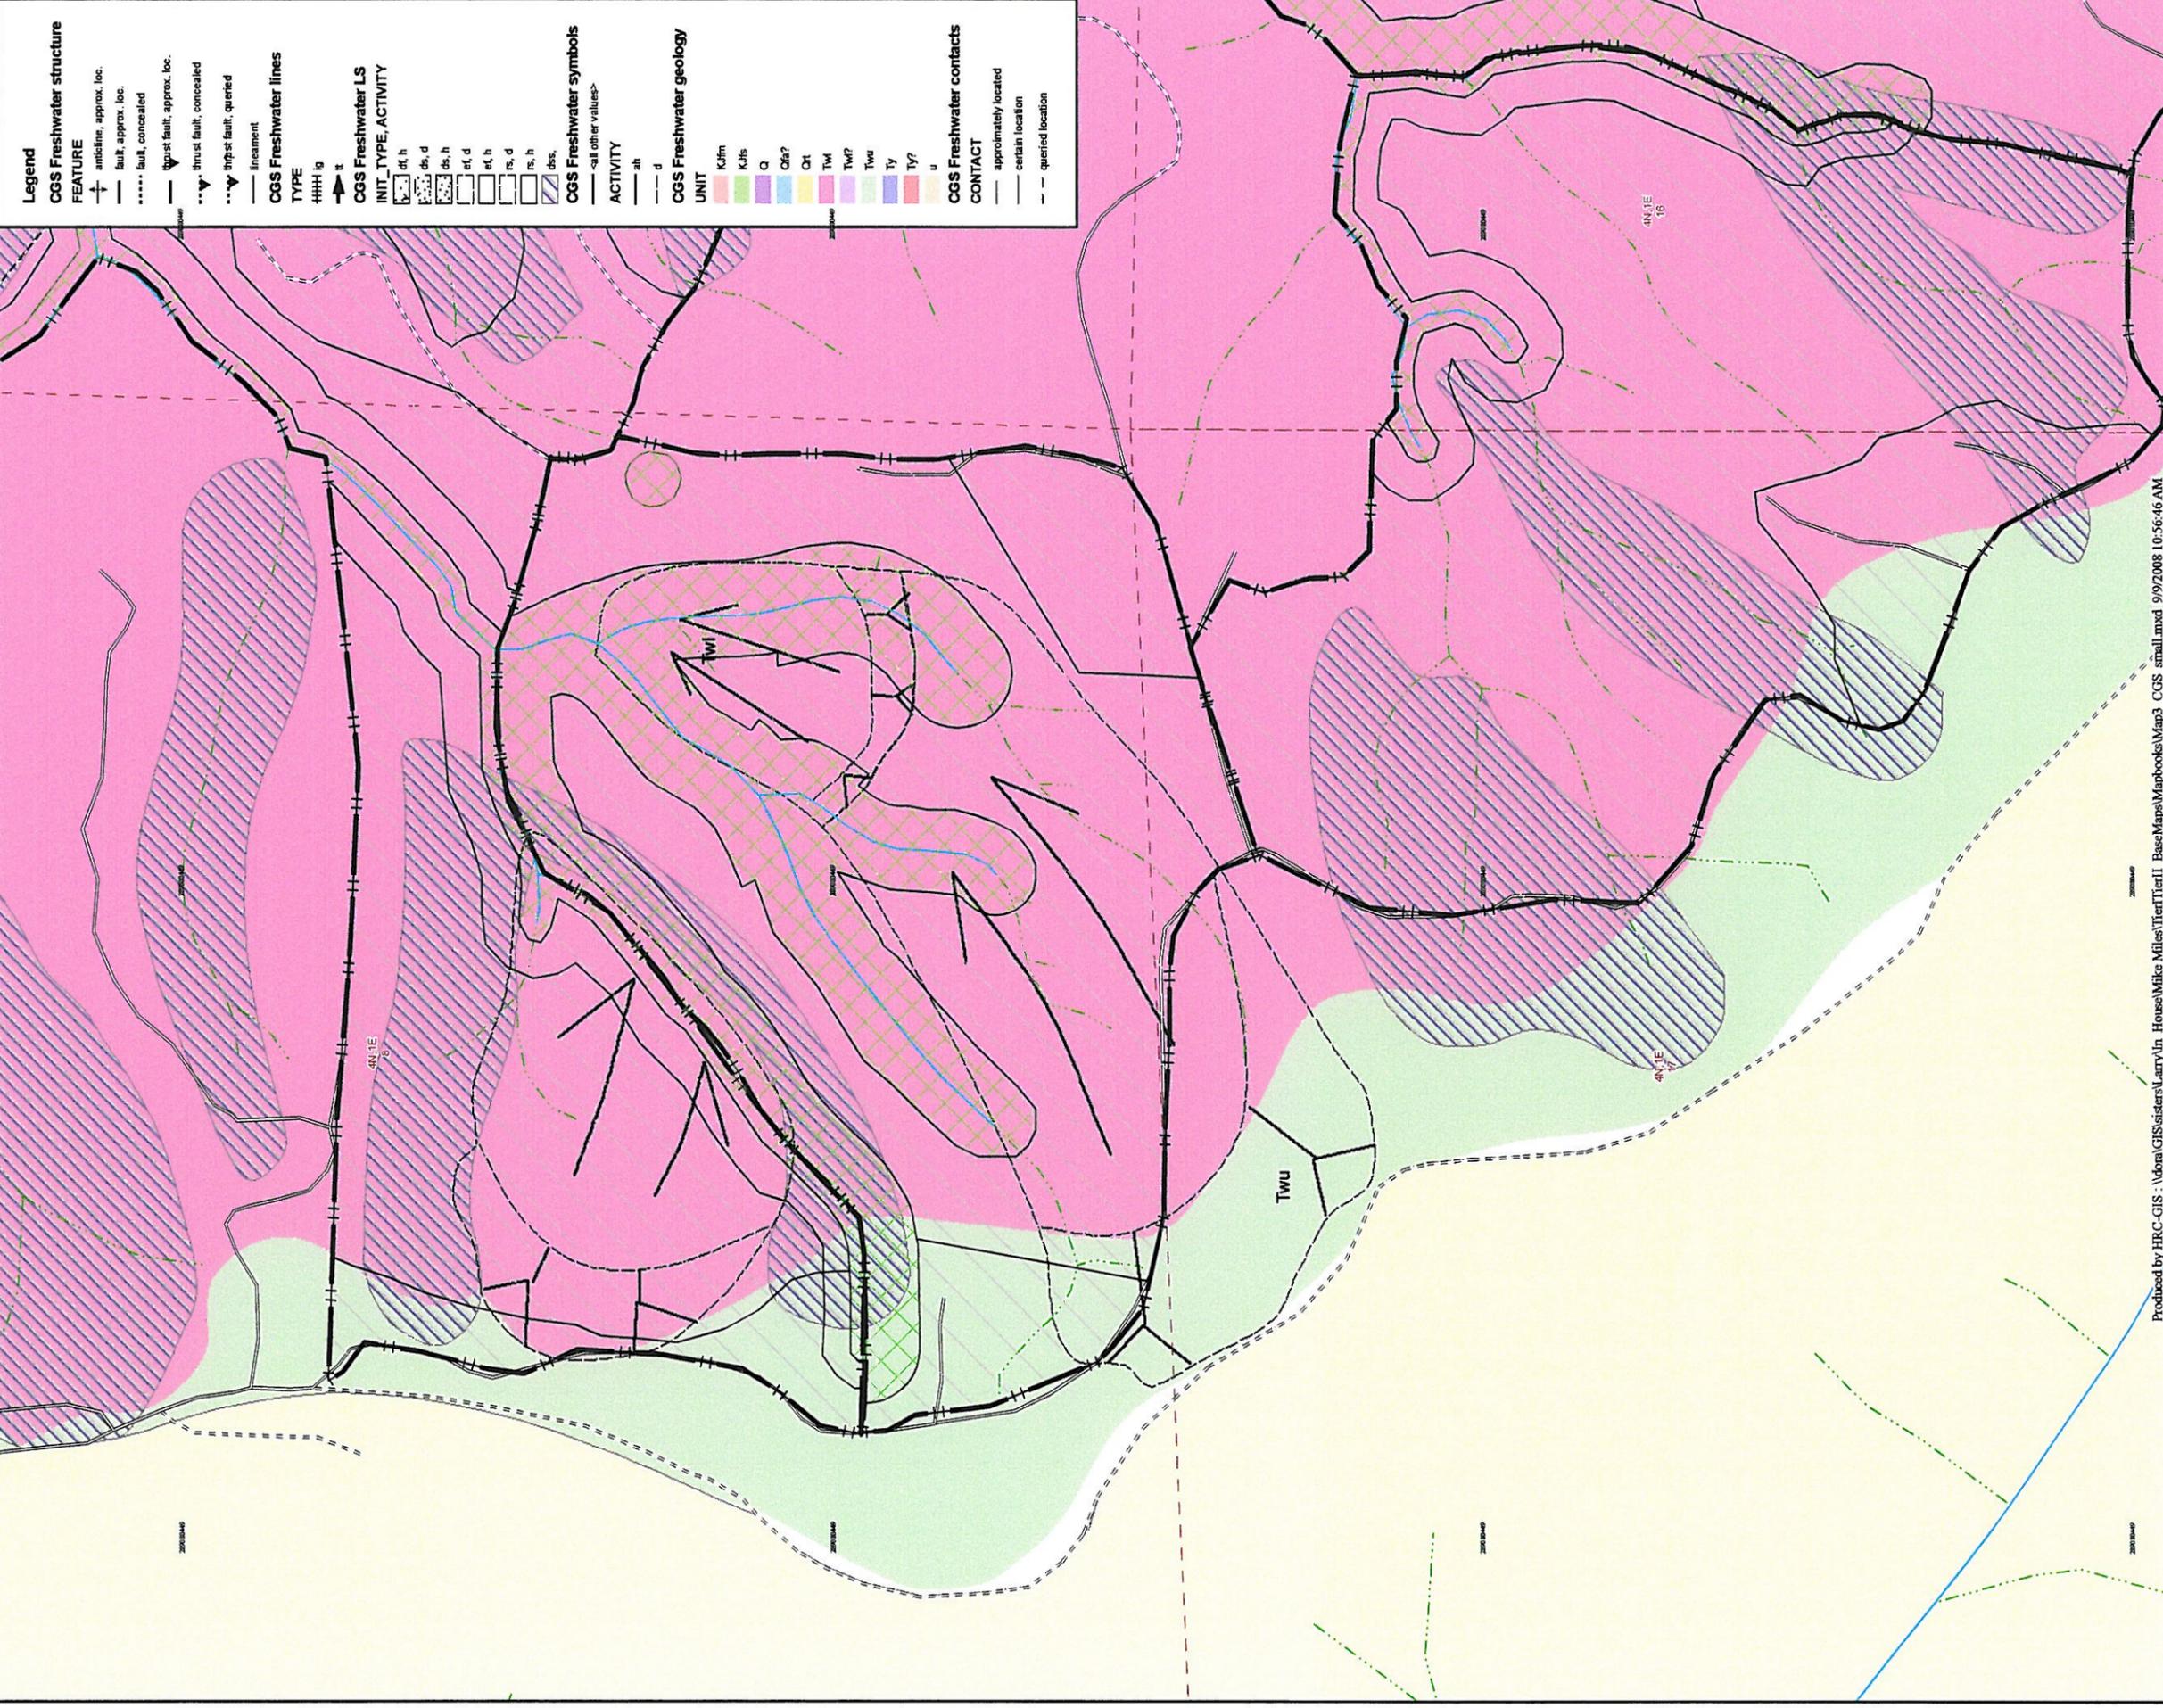
The harvest unit occupies a northeast trending sub-basin characterized by irregular but smooth topography. The irregular morphology includes sections of planar slopes interrupted by broad, watercourse incised benches. The unit includes four arms of a forking Class II watercourse. All of the forks transition to Class III status in the uppermost elevations and further fork. Figure 3 shows the unit to be predominantly underlain by sediments consistent with the Lower Group of the Wildcat. A few locations within the unit are mapped to be underlain by the upper Wildcat Group sediments. These rocks are comprised of moderate to well consolidated silts, sands, and clays, with infrequent gravels. The upper Wildcat Group sediments may include the Hookton Formation, a younger estuarine deposit of silts and clays. CGS (1999) mapping of potential unstable areas is limited to debris slide slopes / source areas along the northern harvest unit boundary Class II watercourse and one nested dormant rock slide. The majority of the source are located upslope and outside of the unit.

Debris slide slopes mapped (Figure 3) within the unit correlates with the steeply inclined flanking slopes to the northern harvest unit boundary Class II watercourse (including one area of value 2 SHALSTAB). The steep slopes in this area are all located within the no harvest Class II RMZ. It appears that these areas were mapped as potential source areas since no actual debris slides were identified during THP layout and approval.

Little 34
THP 08-048
CGS Map Unit 1

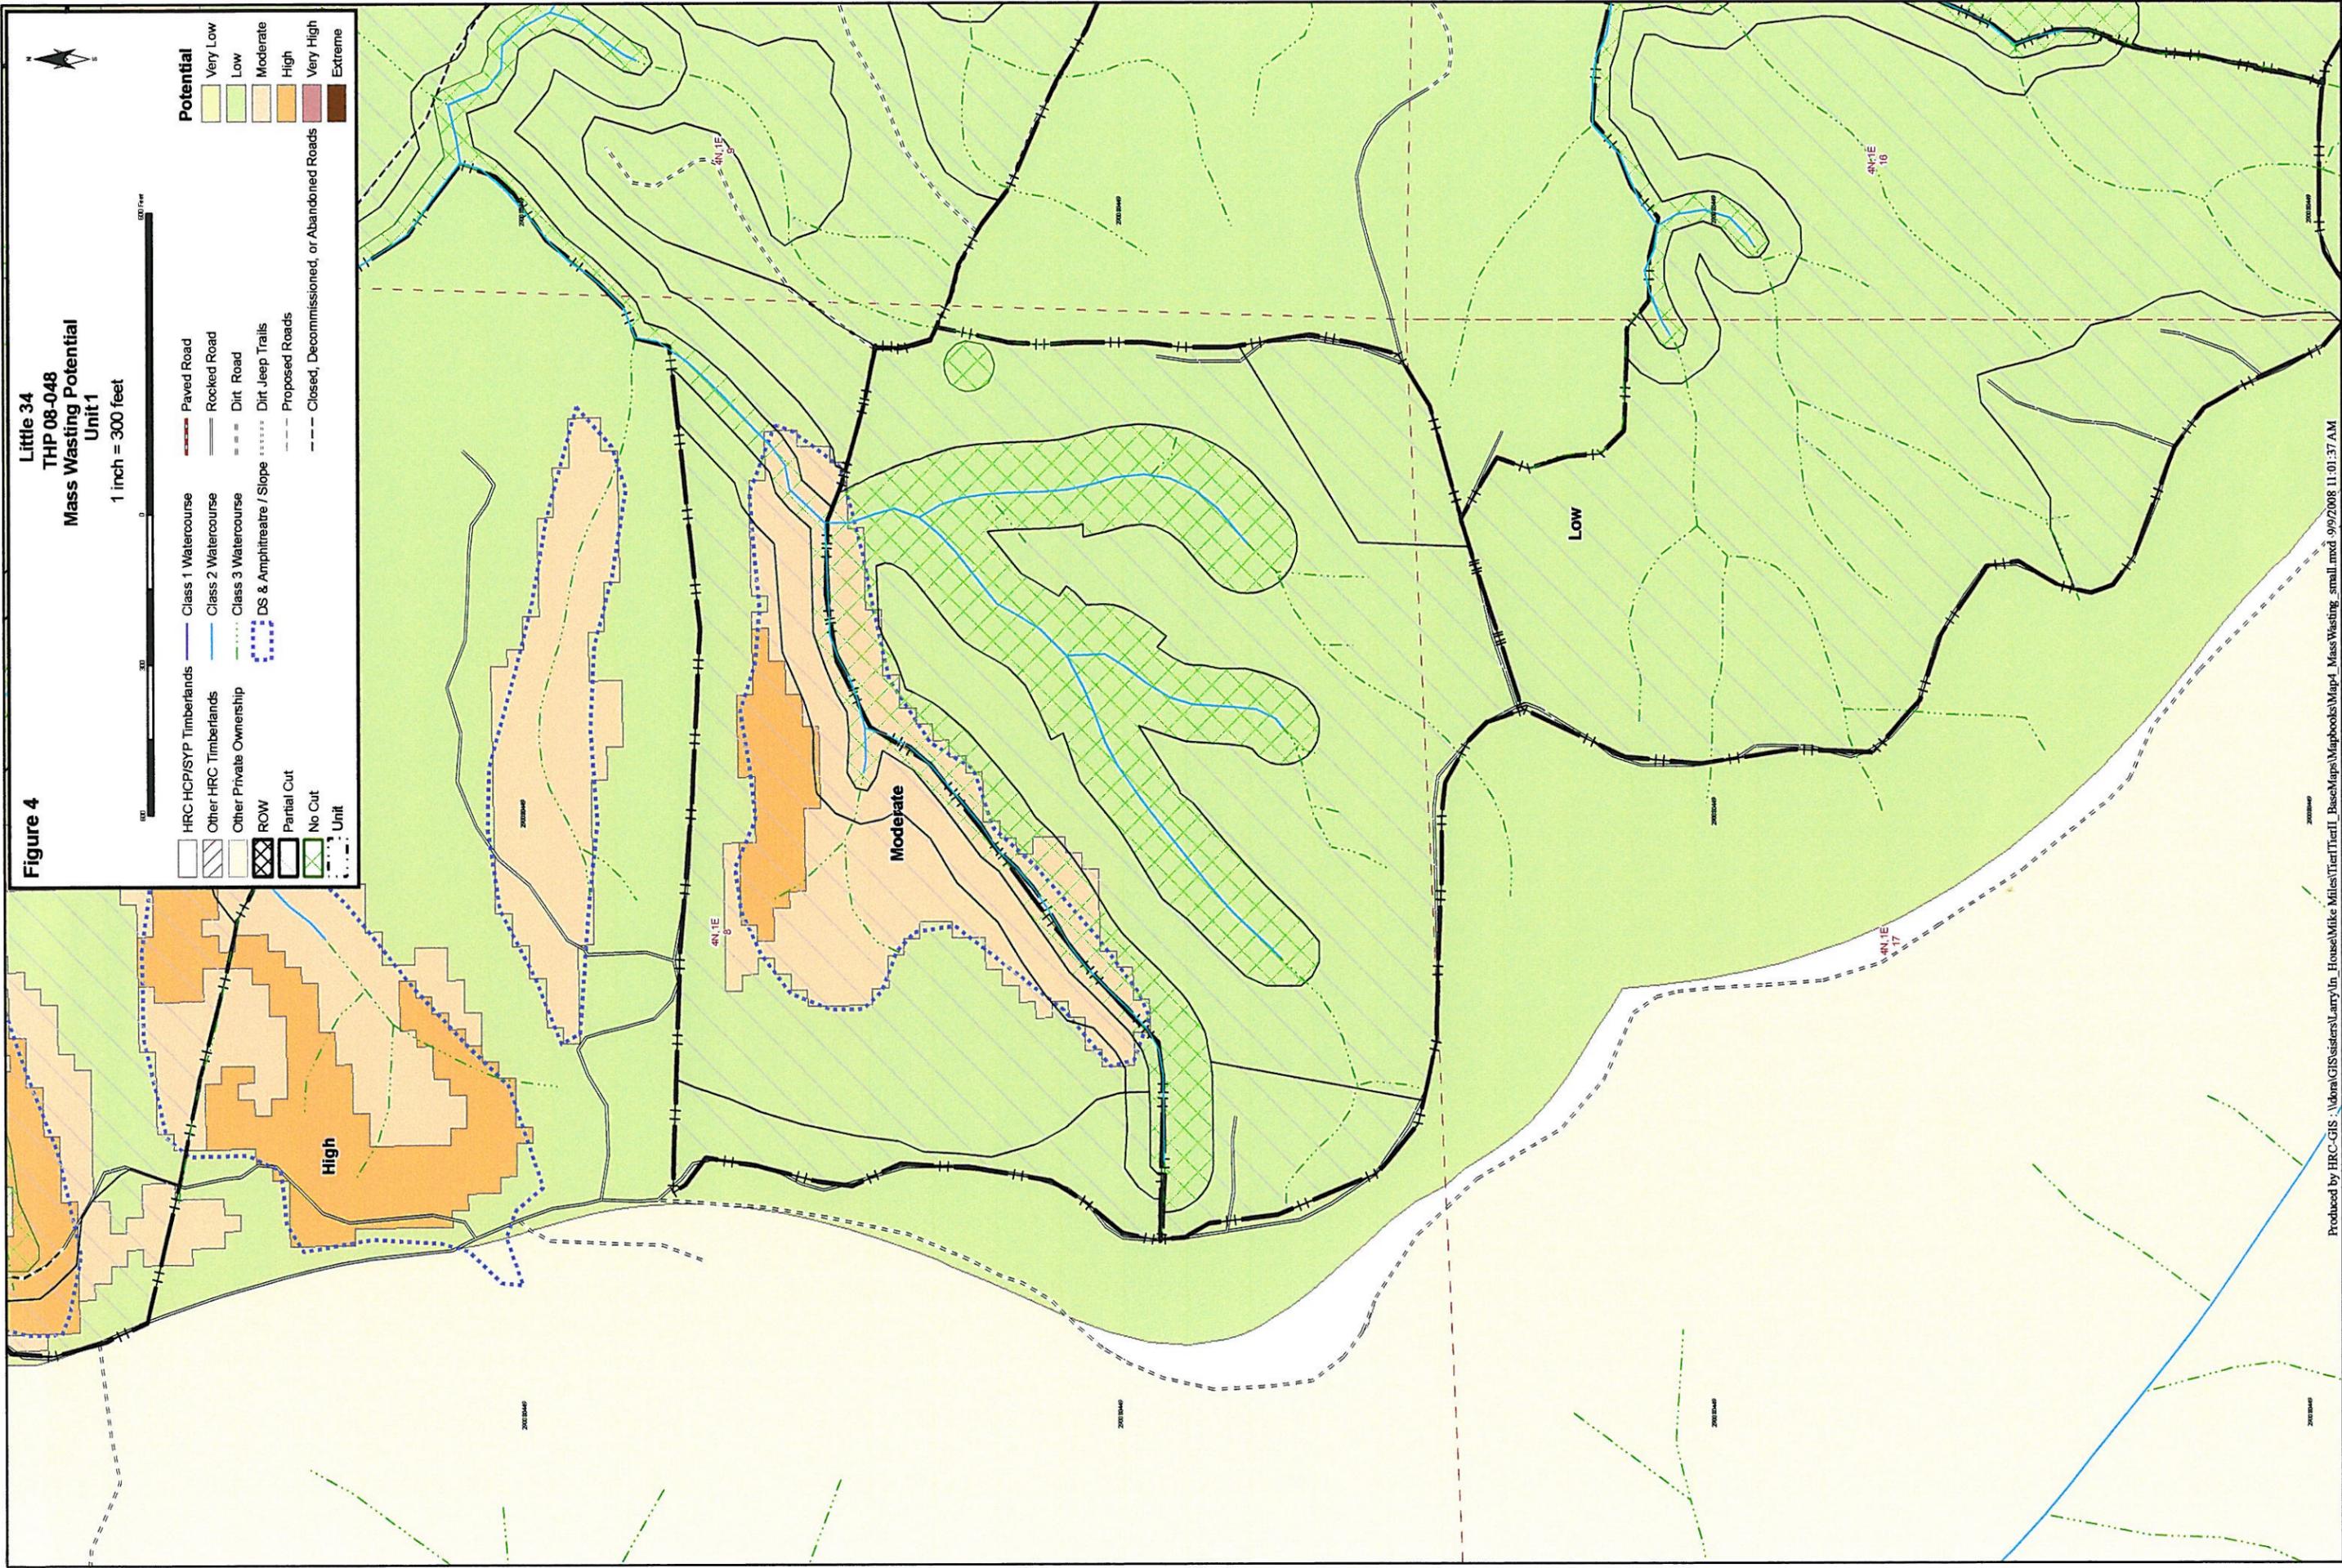
Figure 4

Mass Wasting Potential (MWP) modeled for the unit (Figure 4) is regionally low. The channel of the northern boundary Class II watercourse is modeled with moderate hazard.

Little 34
THP 08-048
Mass Wasting Potential
Unit 1

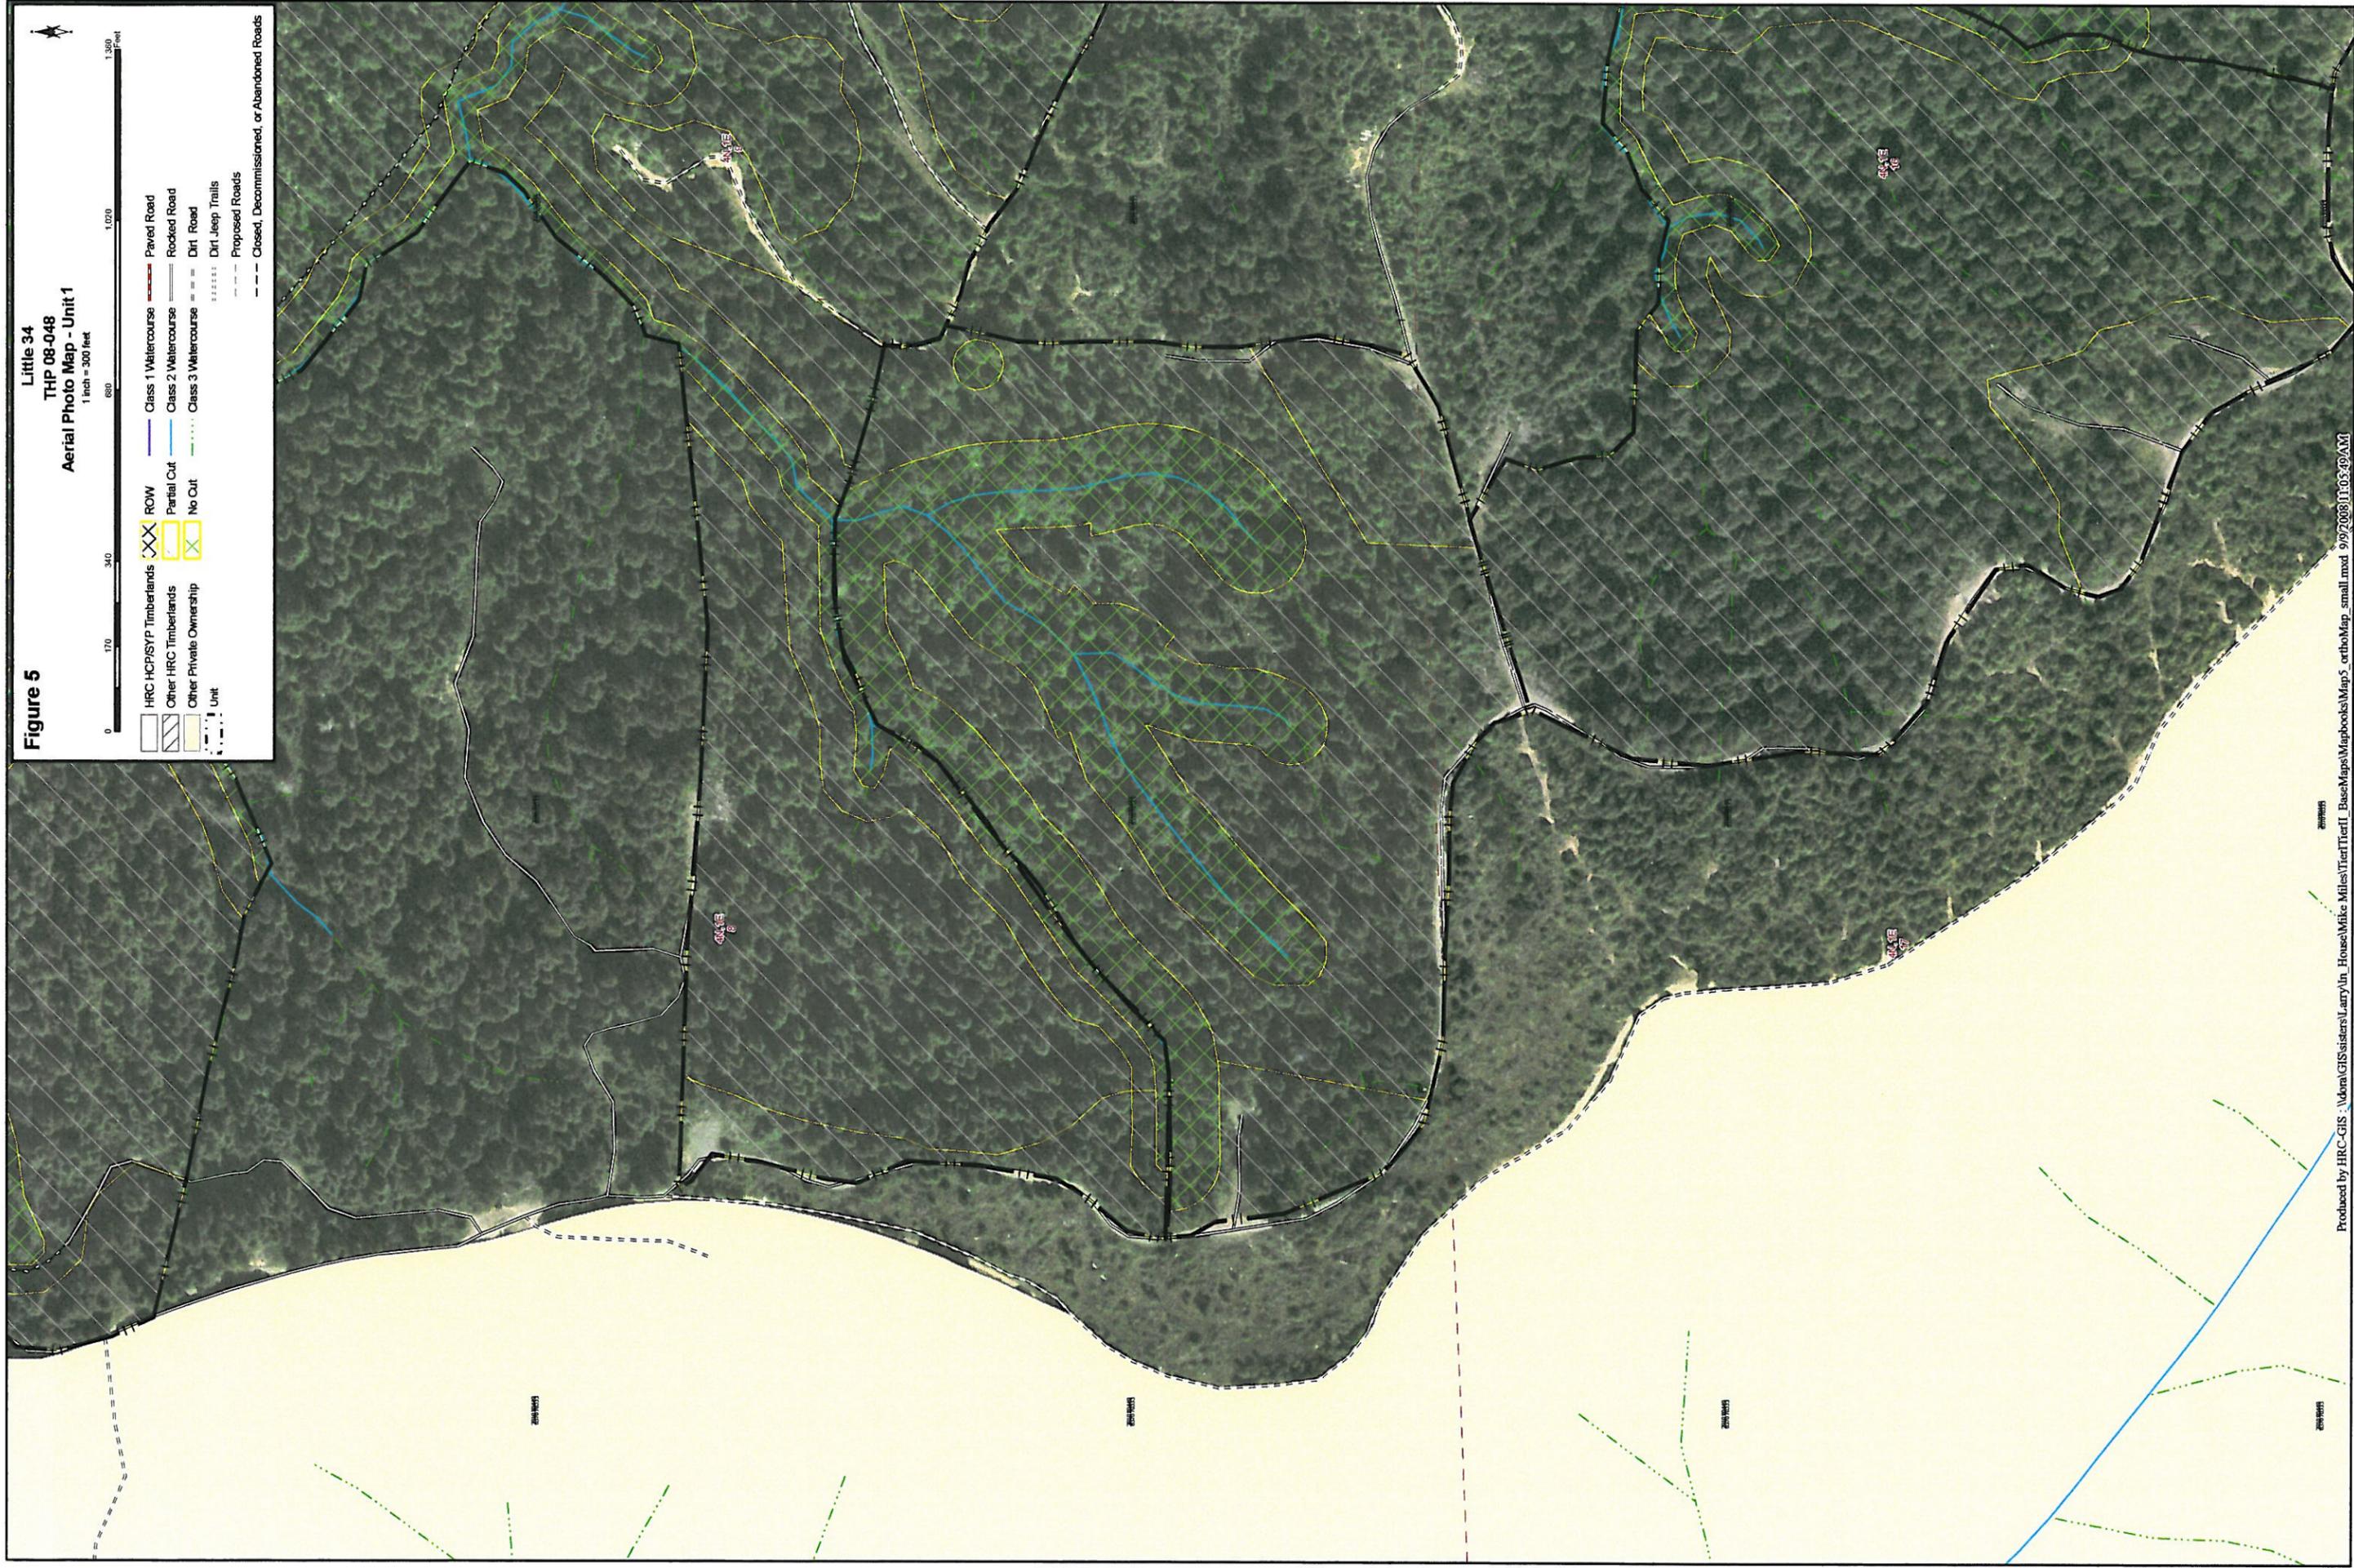
Figure 5

Little 34
THP 08-048
Aerial Photo Map - Unit 1

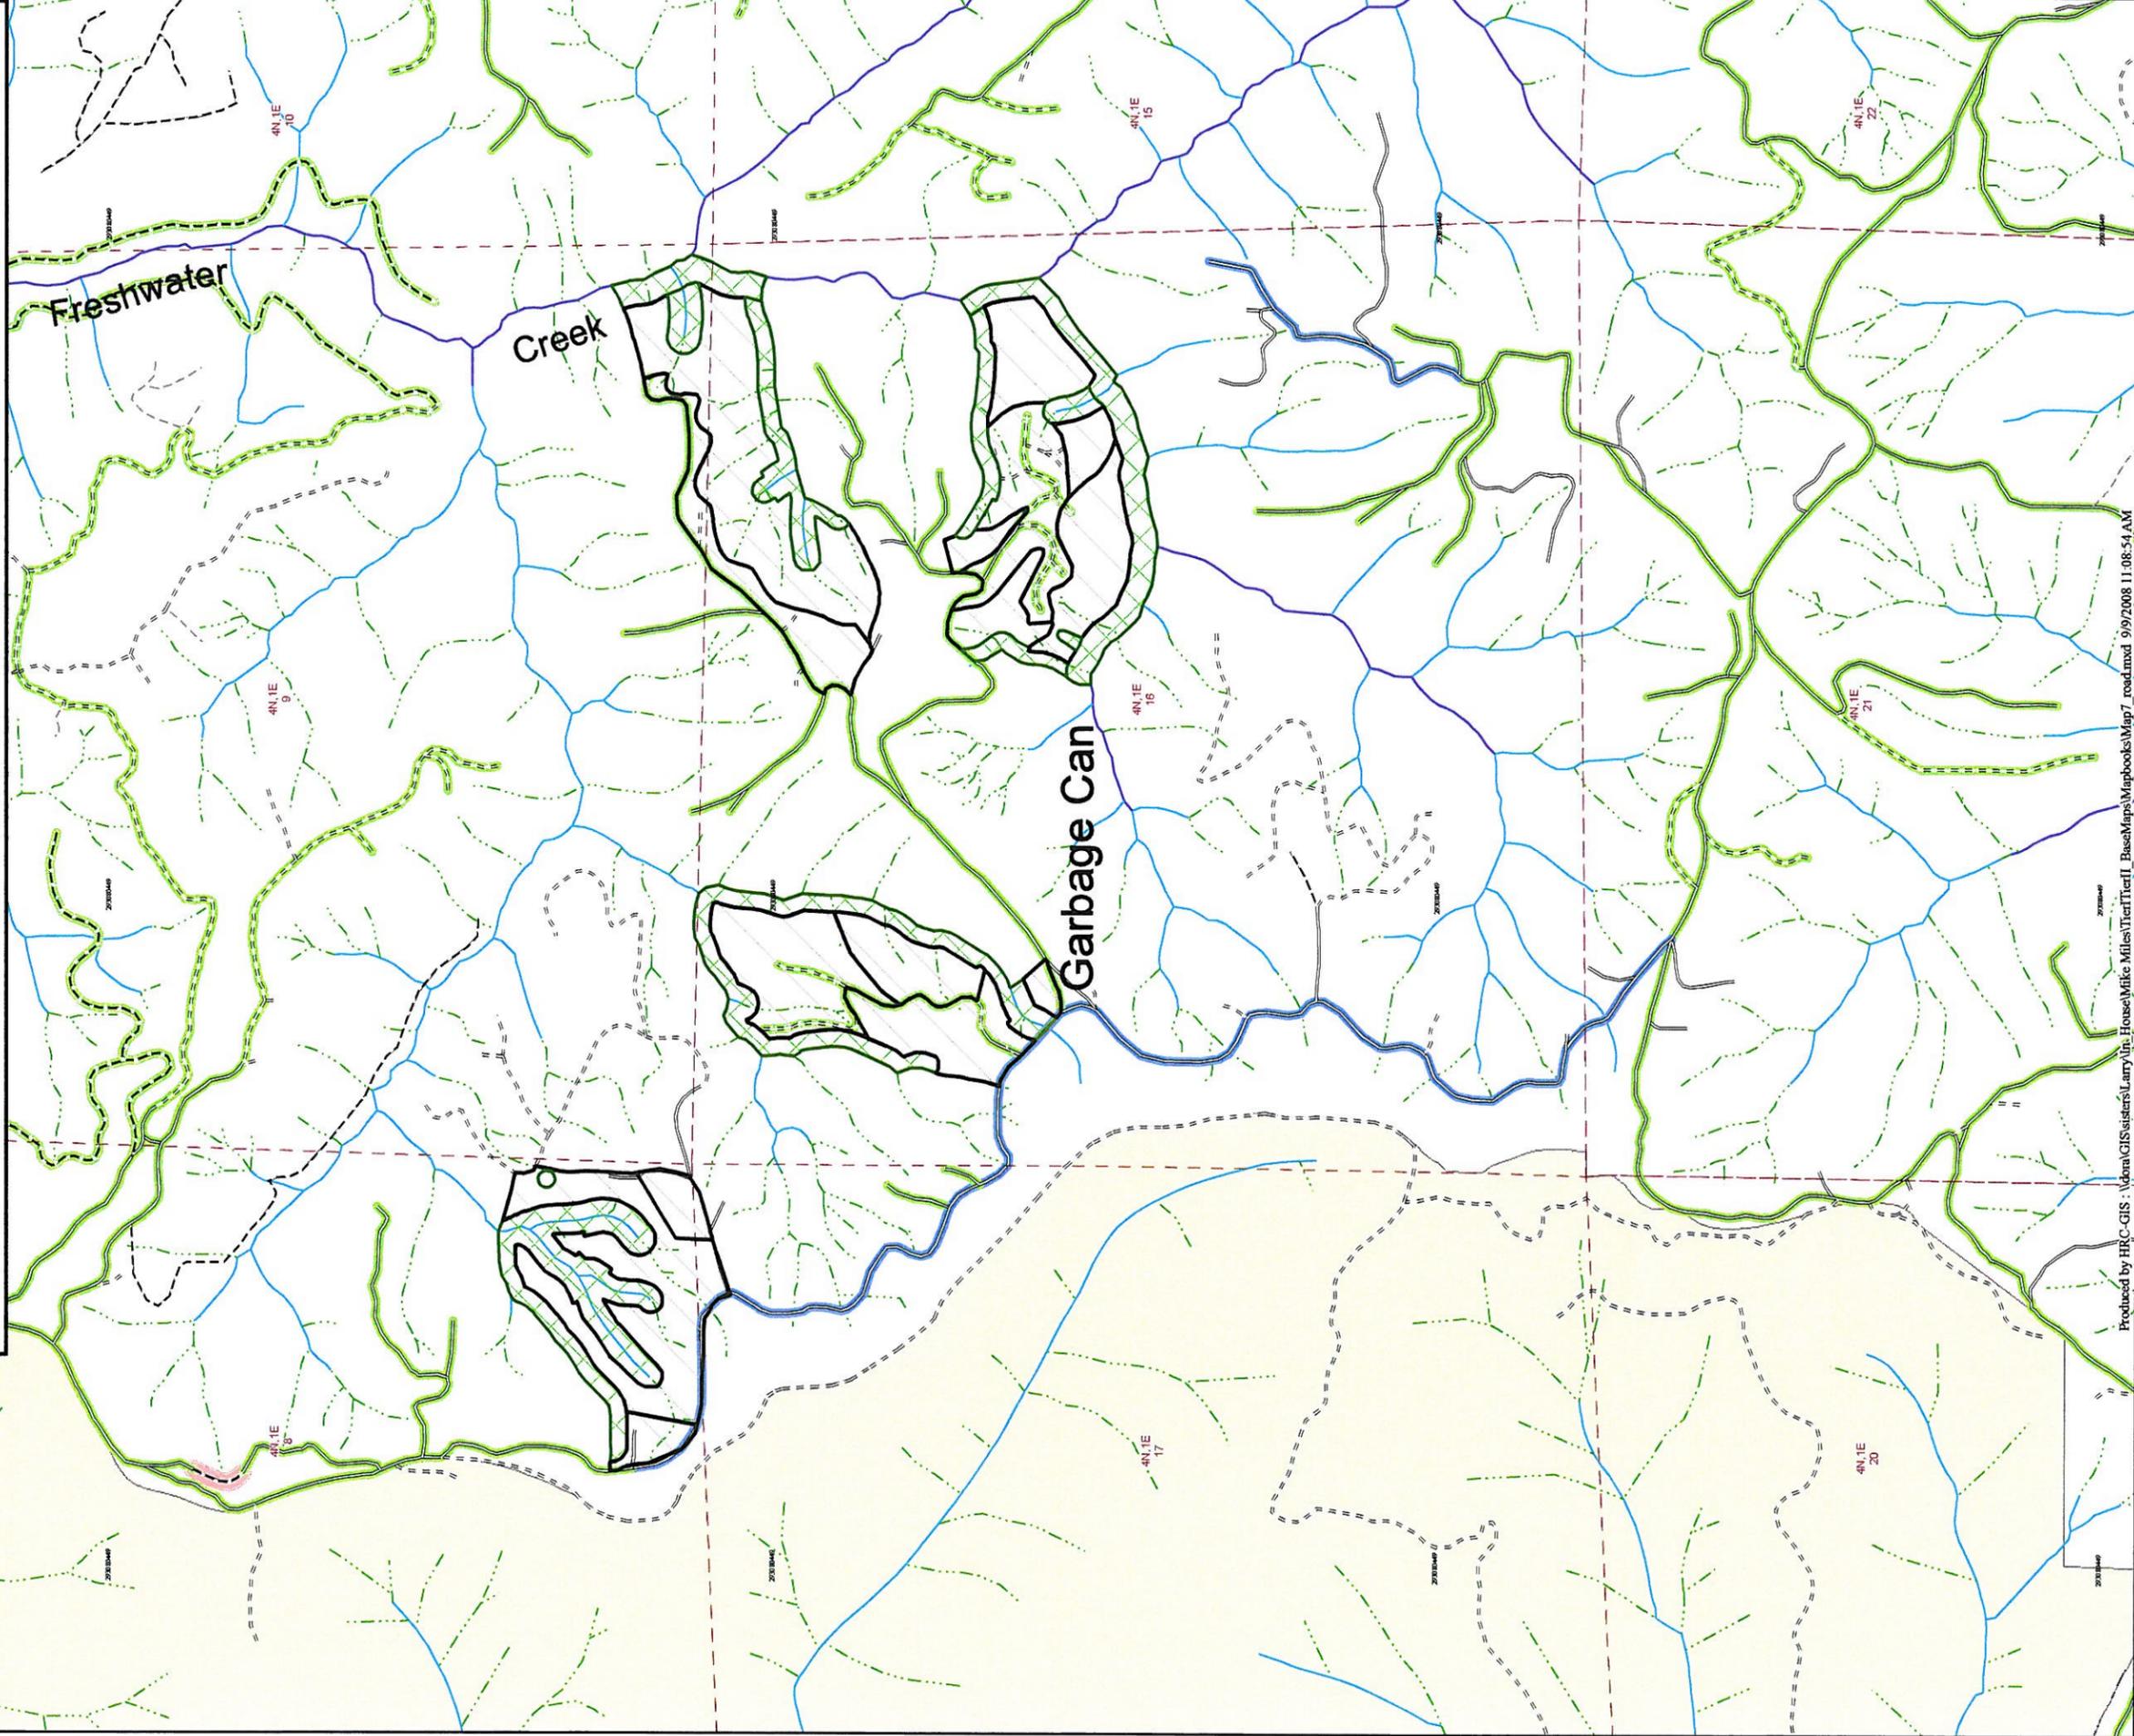
Figure 7

Little 34
THP 08-048
Road Map
