Subject: Enrollment of THP 1-08-048 HUM (Unit 3) in the Freshwater Creek WWDR, "Tier II"

**THP: Little 34    THP 08-048    Unit # 3                    3-10-09**

## Erosion Control Plan (ECP) for the “Little 34” THP 1-08-048HUM

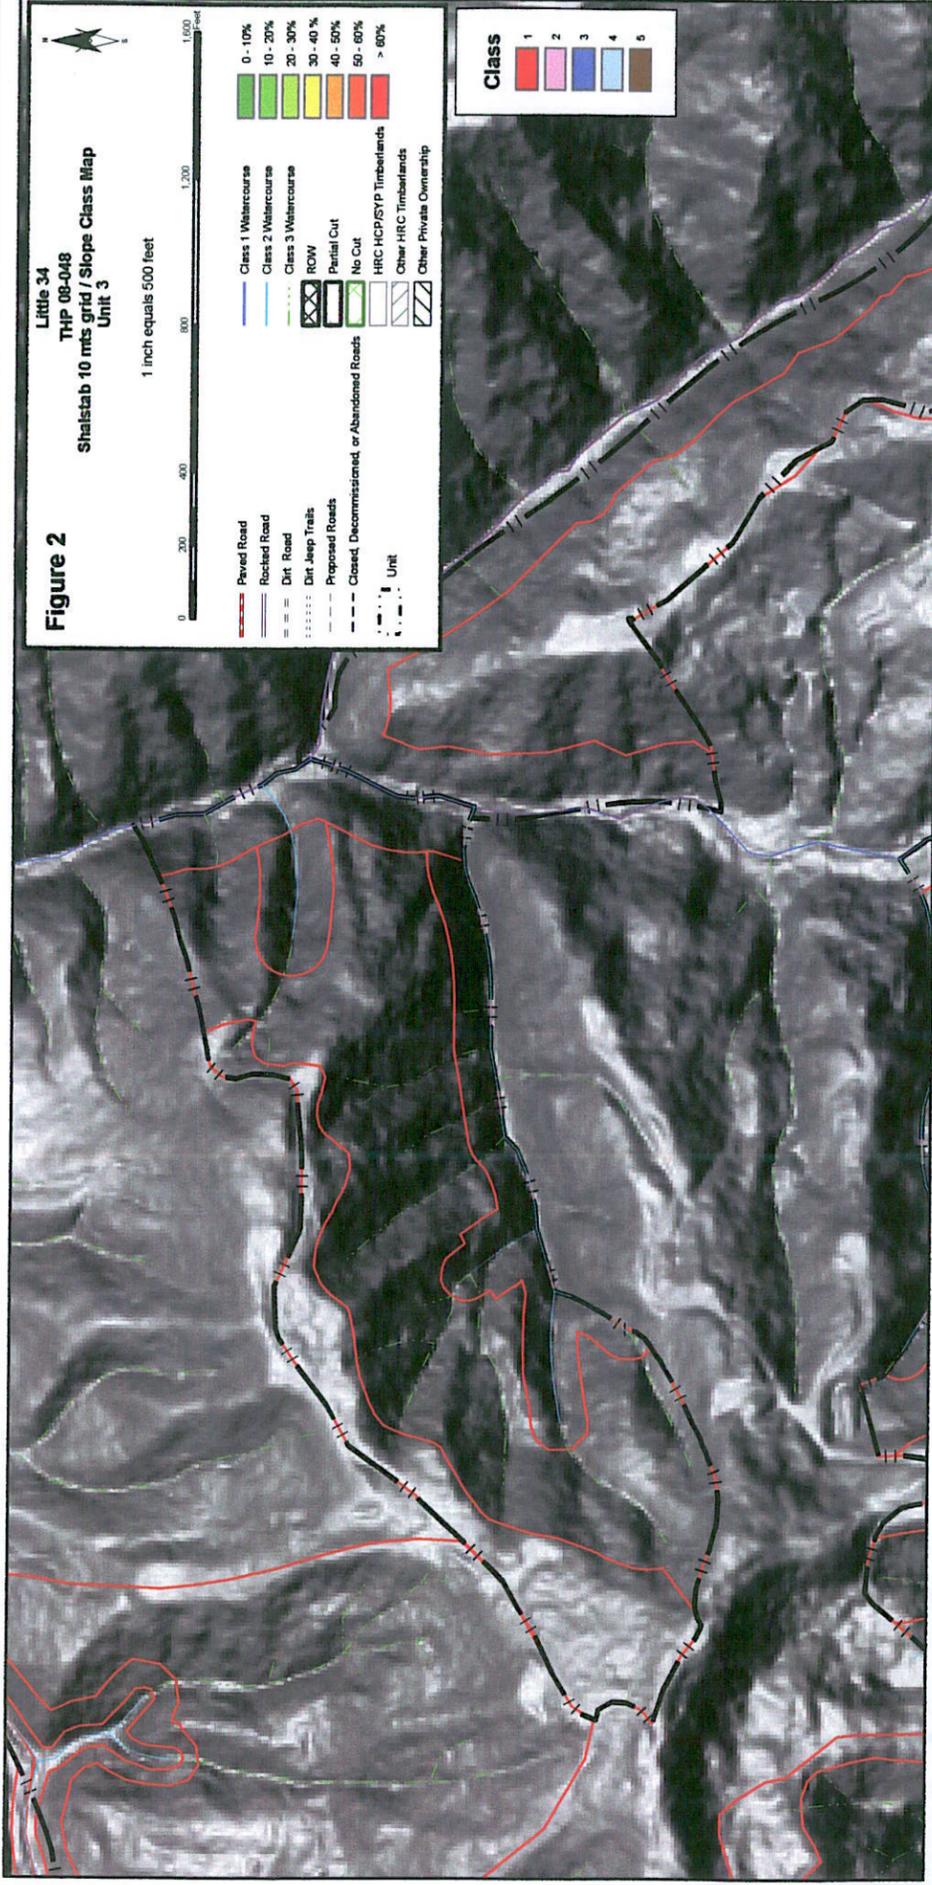
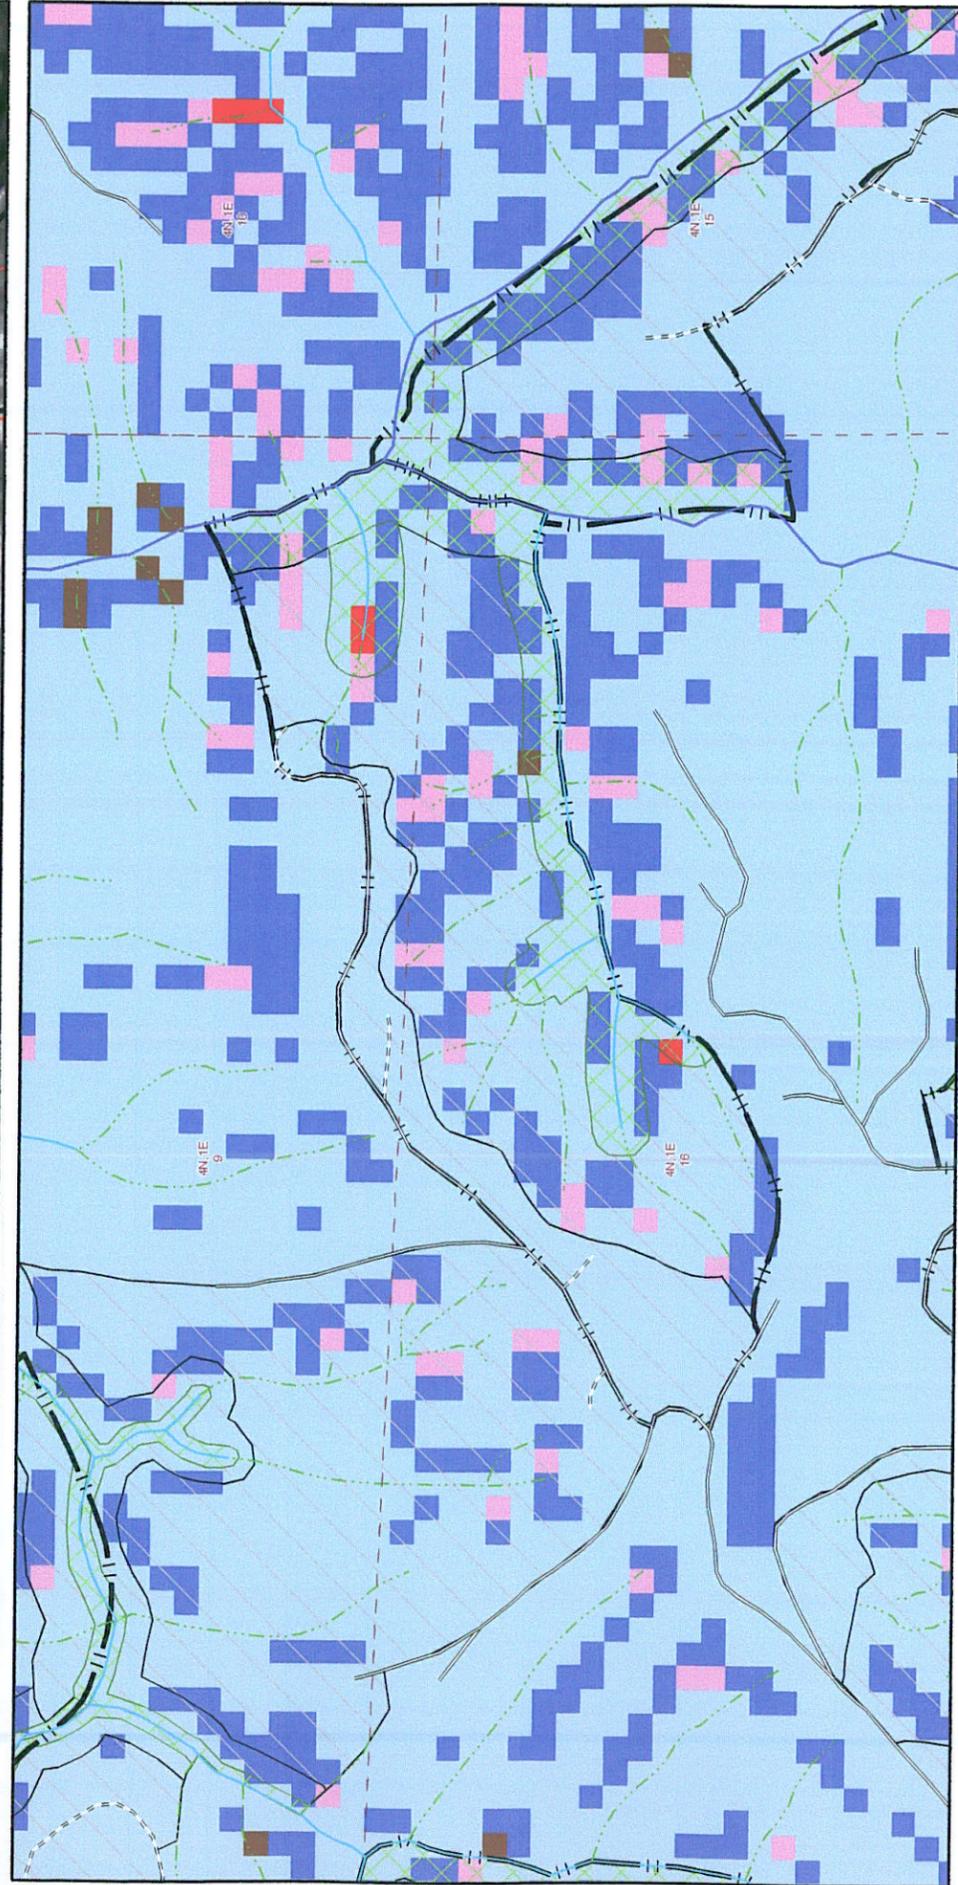
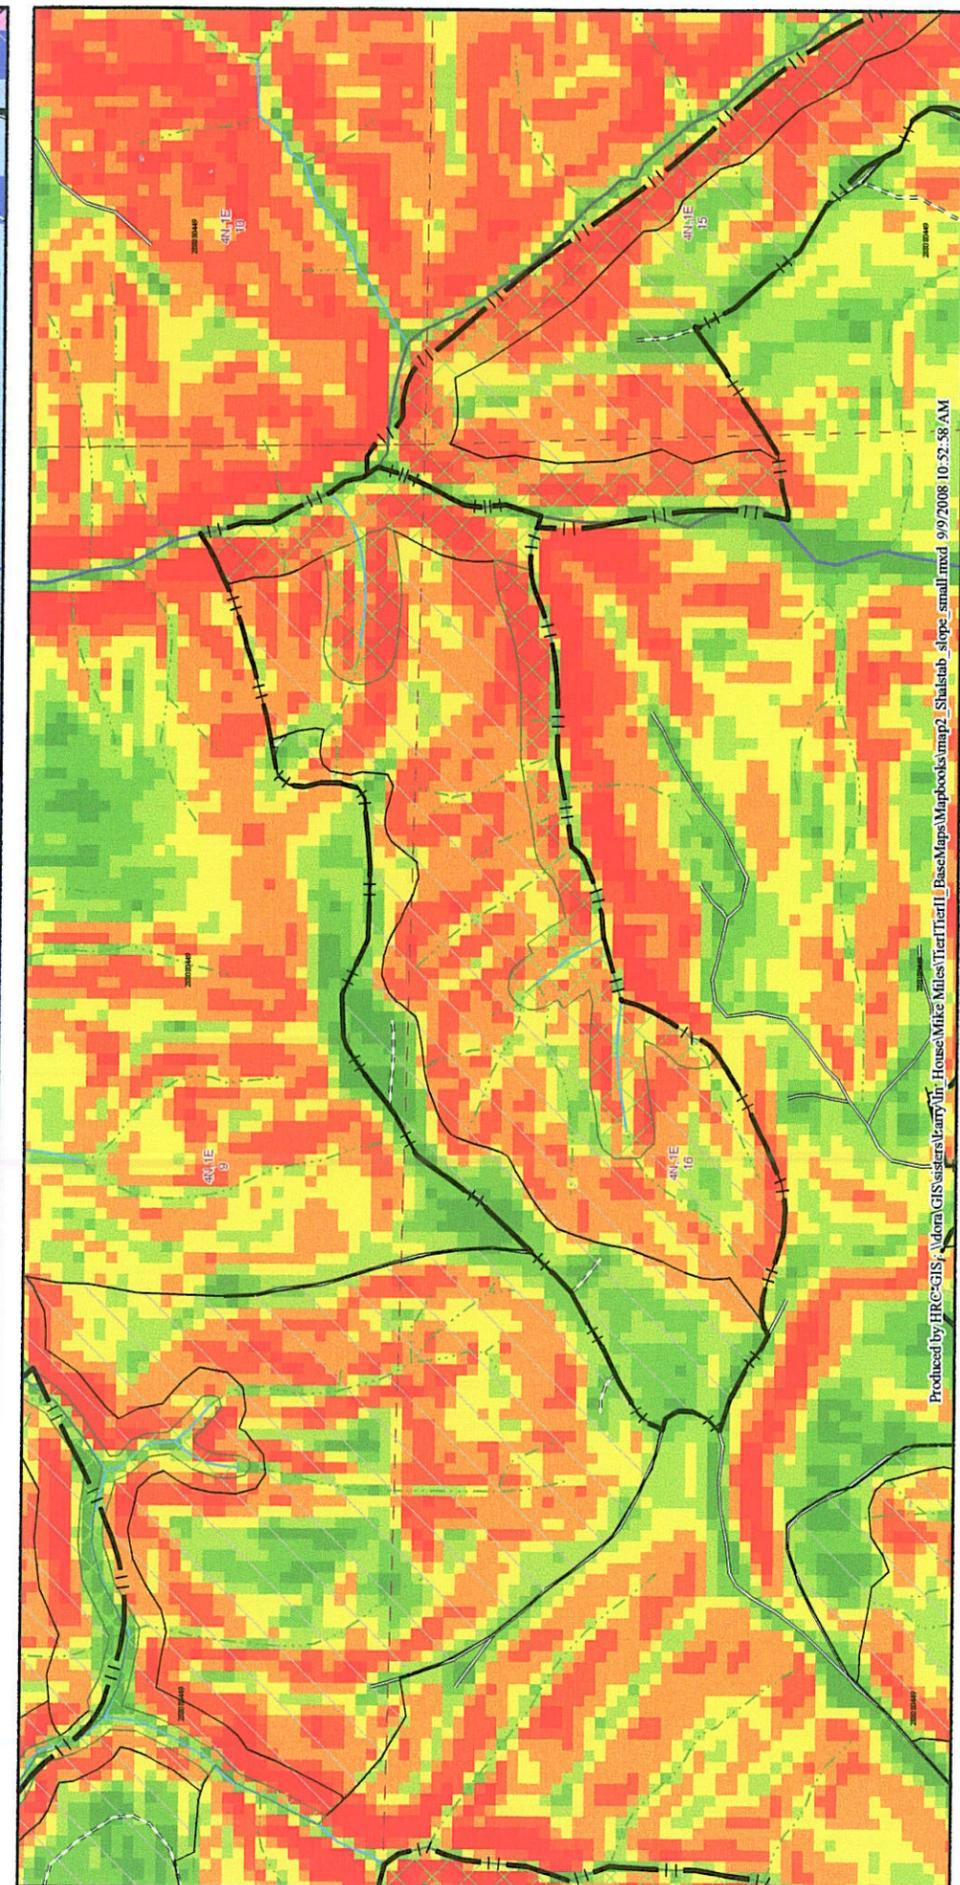
Review of Figure 2 (Hillslope Shade) shows no correlation between surface morphology and deep seated mass wasting. The Hillslope Shade maps show moderately steep convergent slopes (swales) that are most prominent where Class II and Class III watercourses have been mapped. The Class I watercourse appears well entrenched with a consistent low gradient channel.

Areas of elevated SHALSTAB (Value 2) are concentrated within and adjacent the Class III watercourse. No potentially unstable areas were identified in association with the elevated SHALSTAB during THP development. Three pixels of elevated SHALSTAB value 1 are located within the Class II RMZ expanded harvest exclusion zones. The downslope Class I watercourse is buffered with an expanded harvest exclusion zone that is 150 feet upslope of the watercourse. Our review of the SHALSTAB areas revealed steeply inclined swales, evenly distributed, in situ old growth stumps and abundant 2<sup>nd</sup> growth timber.

Little 34  
THP 08-048  
Shalstab 10 mts grid / Slope Class Map  
Unit 3

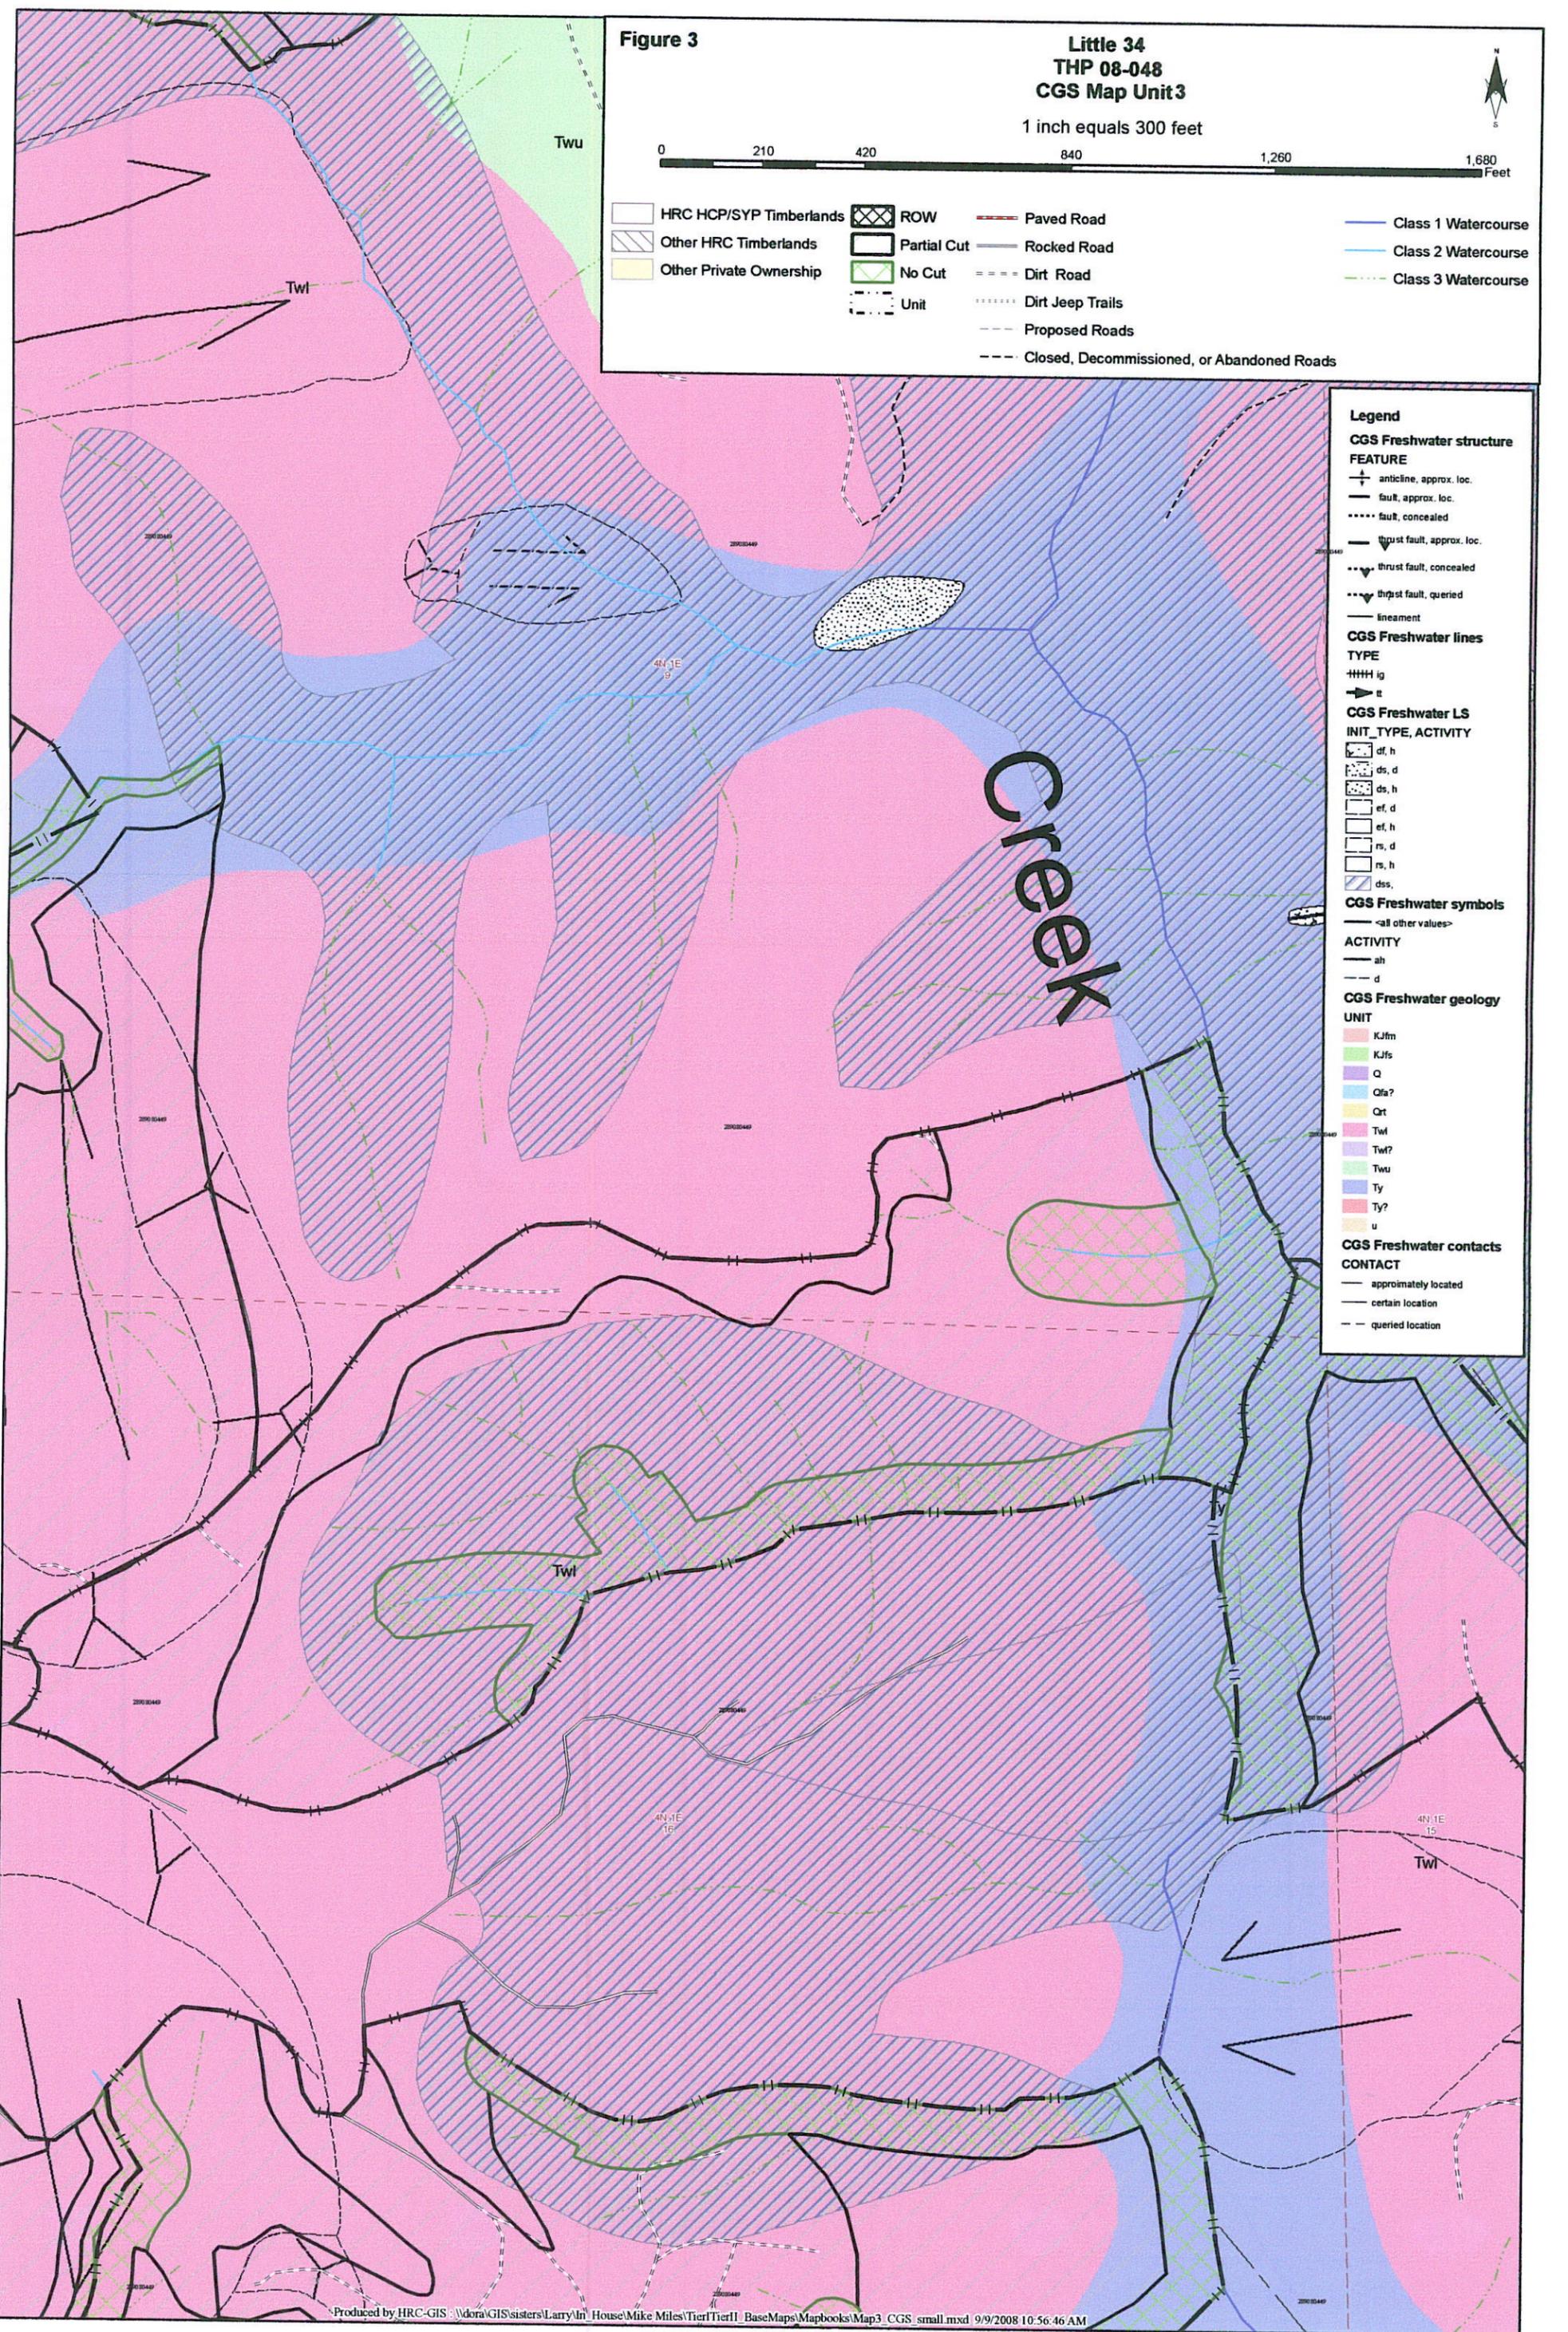
Figure 3

Debris slide slopes mapped (Figure 3) within the unit correlates well with the watercourses. It appears that these areas were mapped as potential source areas since no actual debris slides were identified during THP layout and approval.

Little 34  
THP 08-048  
CGS Map Unit 3

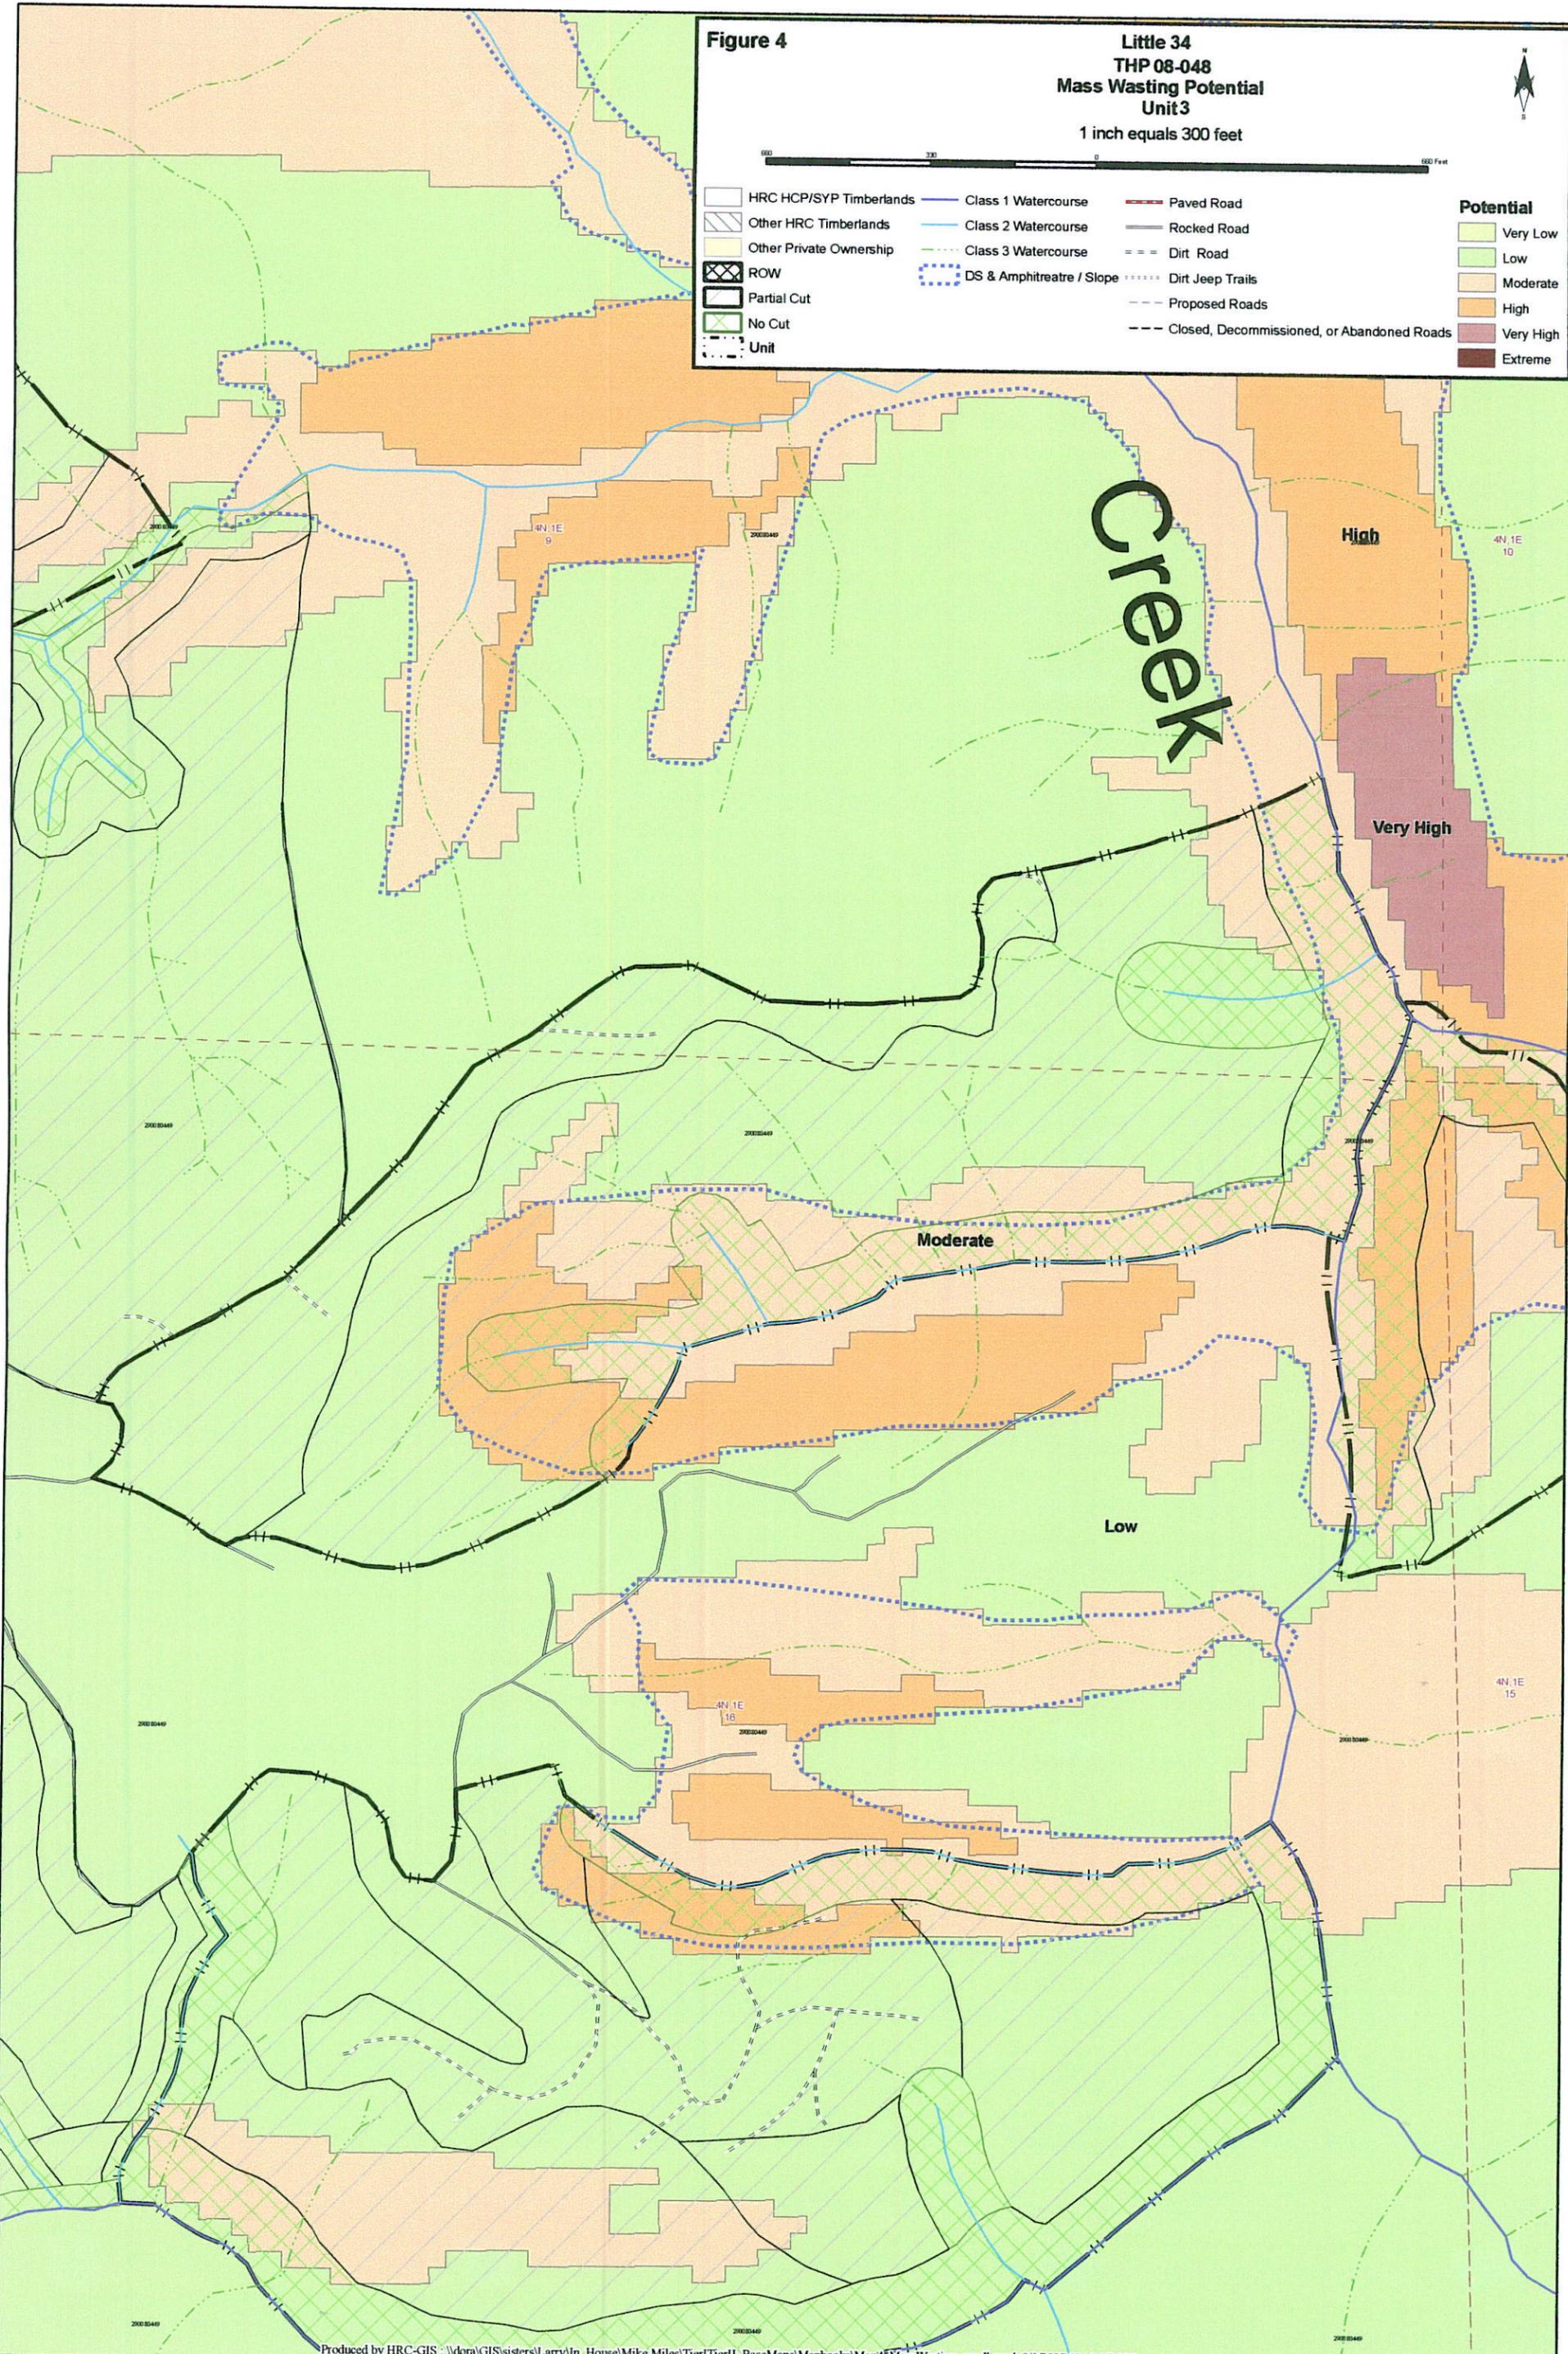
Figure 4

Mass Wasting Potential (MWP) modeled for the unit (Figure 4) is regionally low. Within the unit moderate and high MWP has been modeled adjacent the southern harvest unit boundary Class II watercourse. The areas matching high MWP are in response to the inclusion within the model the values for the Figure 3 mapped debris slide slopes.

Little 34  
THP 08-048  
Mass Wasting Potential  
Unit 3

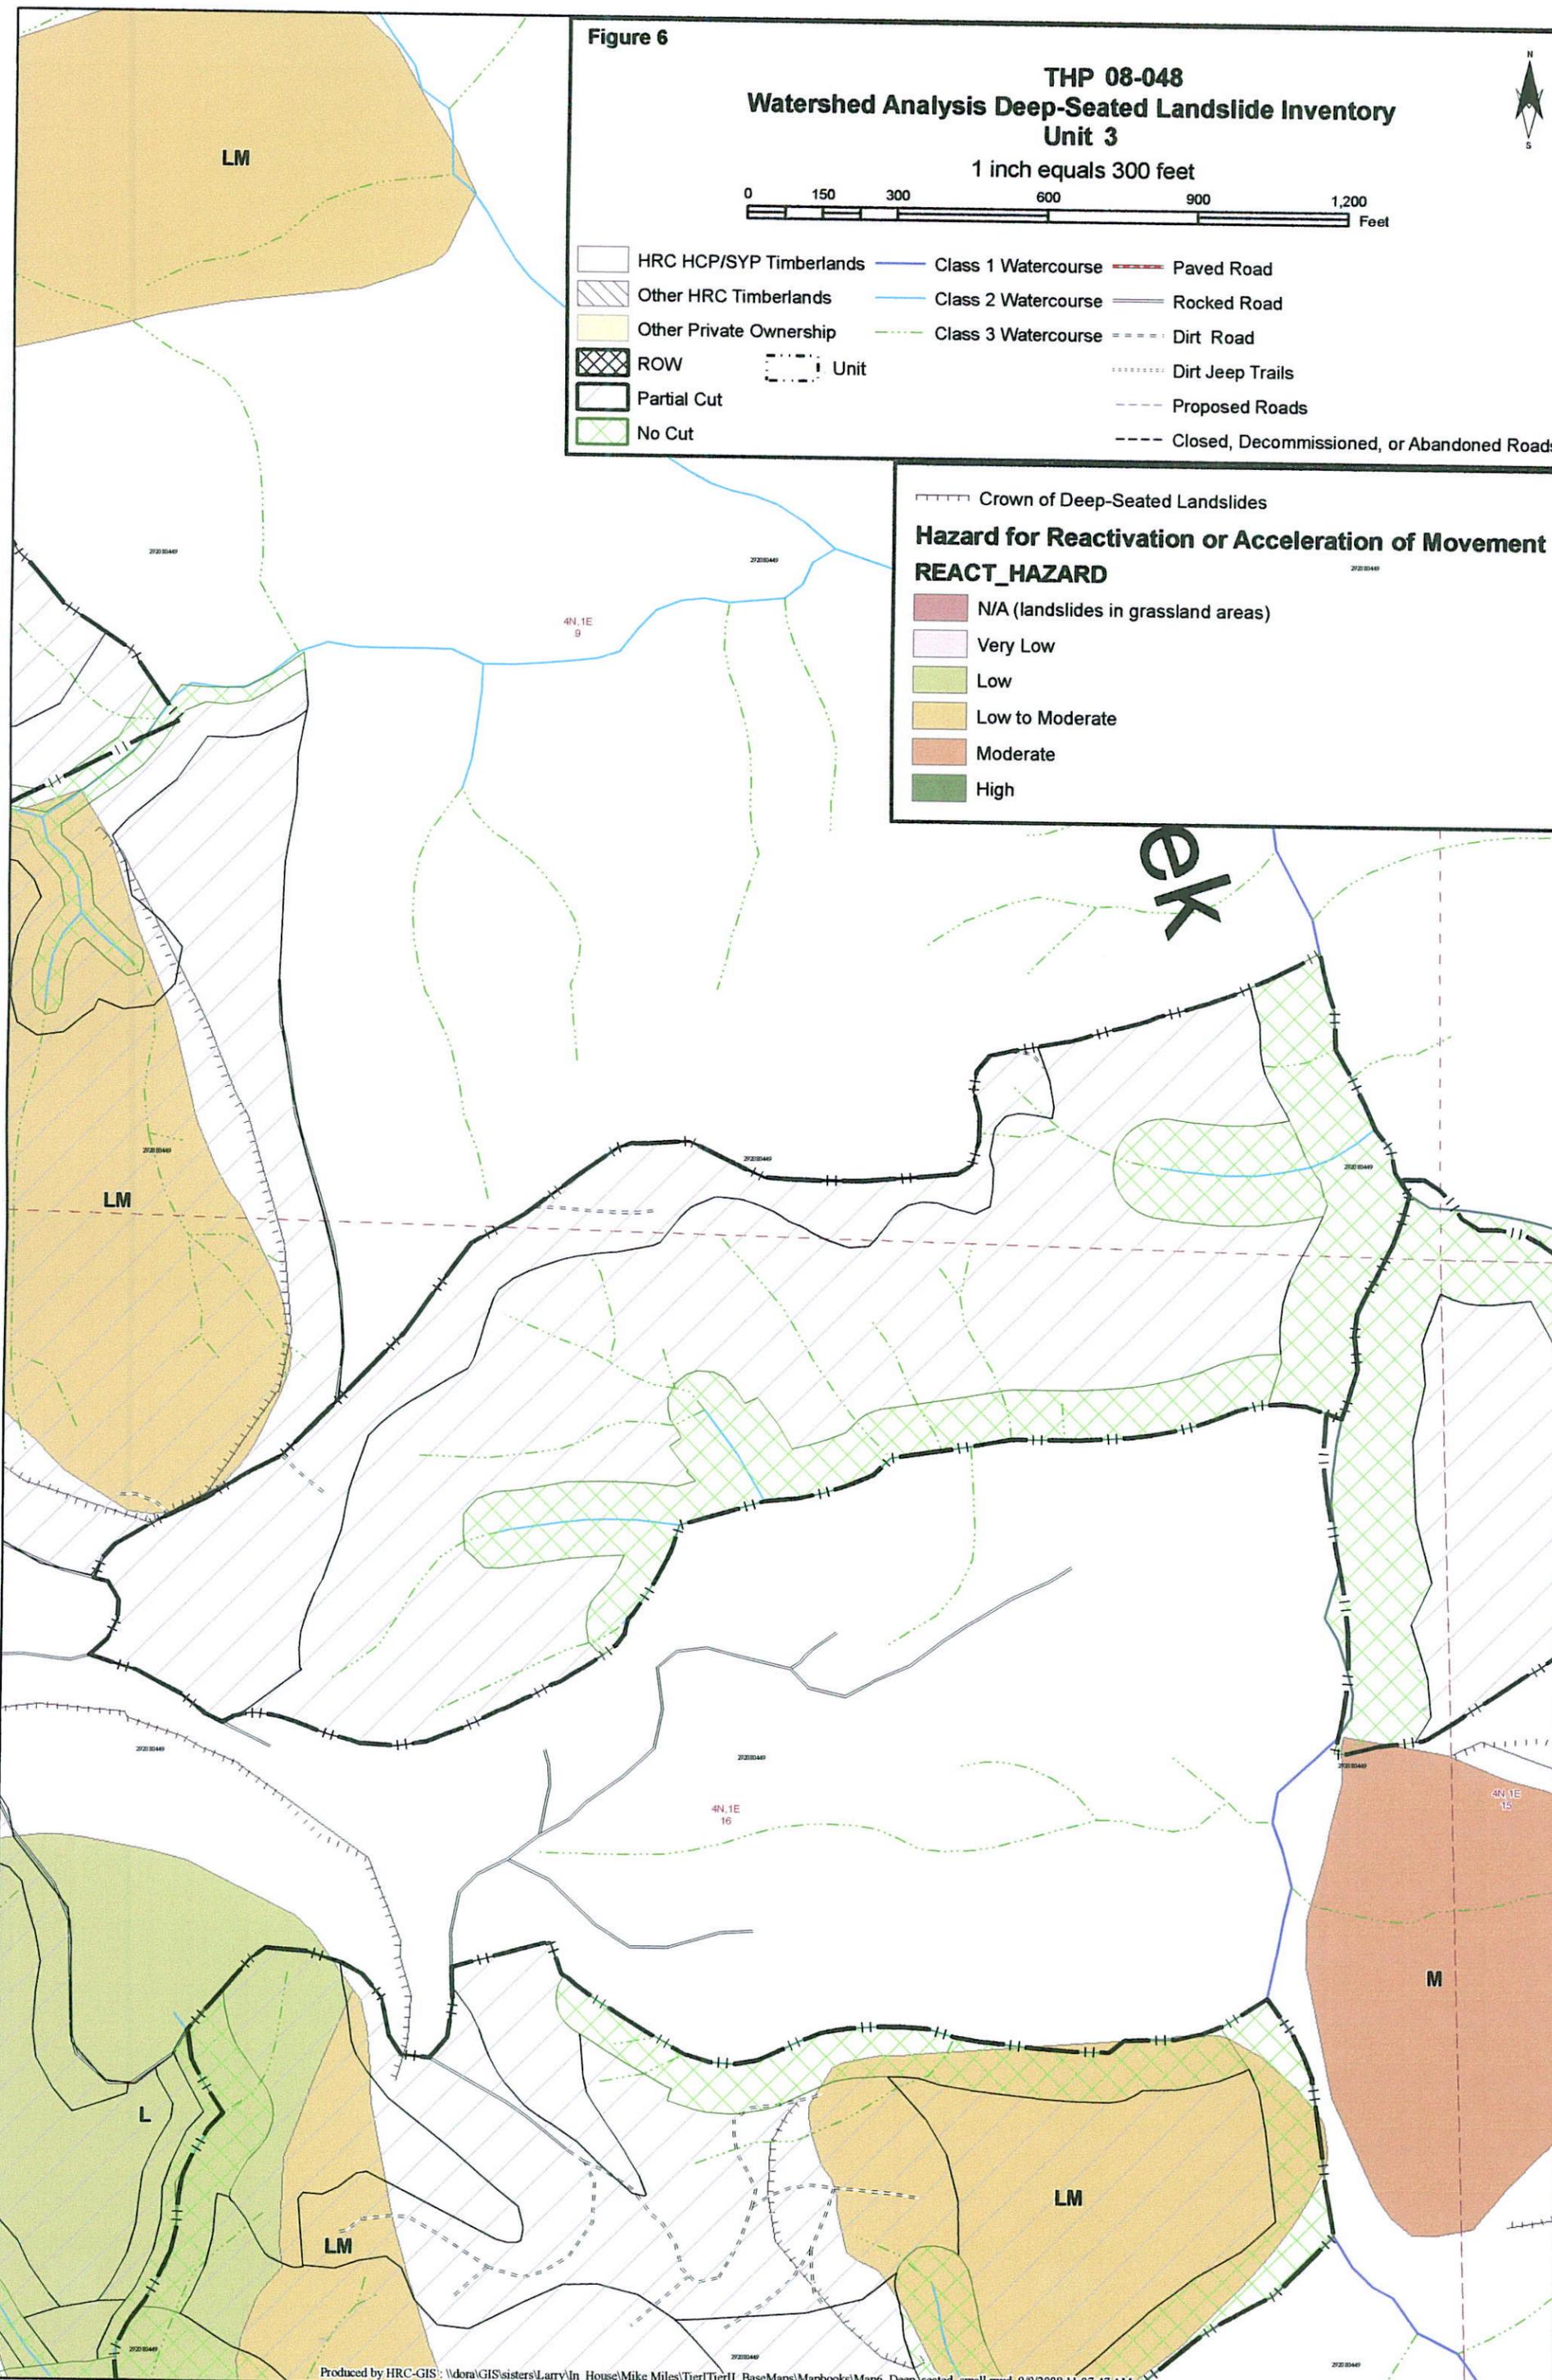
Figure 6

No areas associated with deep-seated landsliding are mapped in the unit from Watershed Analysis (Figure 6).

# THP 08-048 Watershed Analysis Deep-Seated Landslide Inventory Unit 3

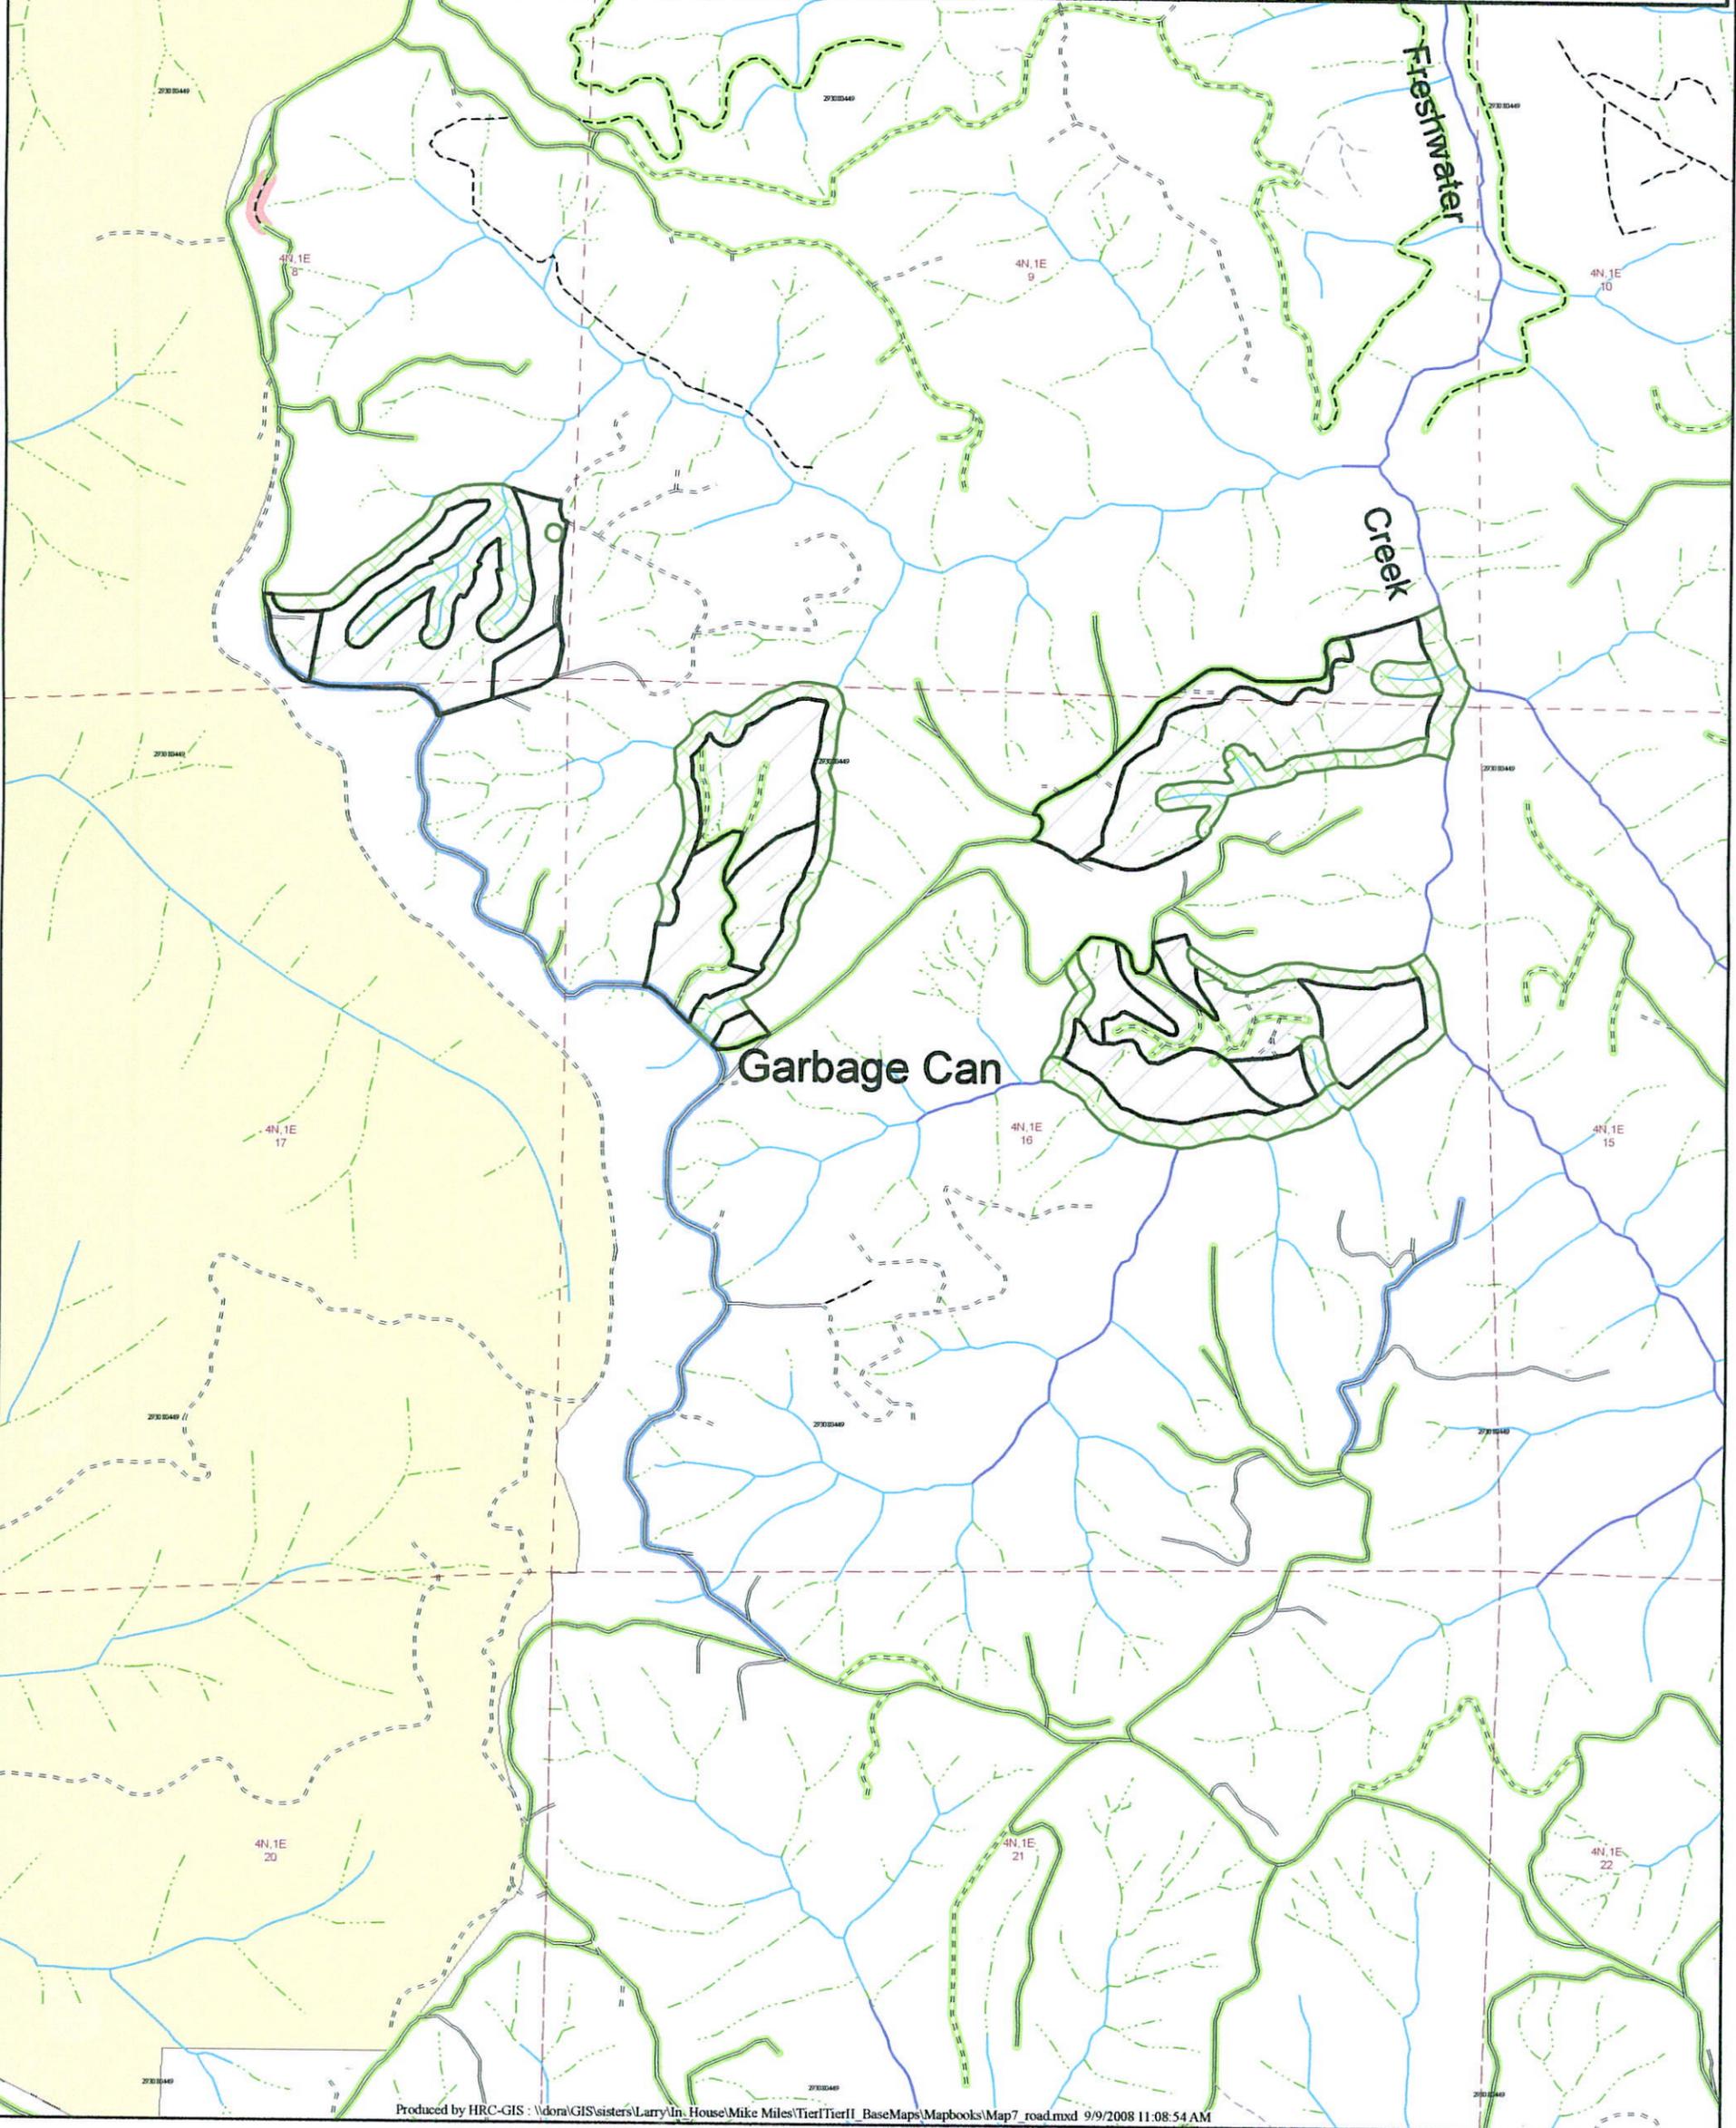
Figure 7

Little 34  
THP 08-048  
Road Map
