Subject: Enrollment of THP 1-09-100 HUM (Unit 1 and 2) in the Freshwater Creek WWDR, "Tier II"

THP No. 1-09-100 HUM (Little Little) Unit # 1 and 2

THP: Little Little THP 09-100 Units # 1 and 2 March 30, 2010

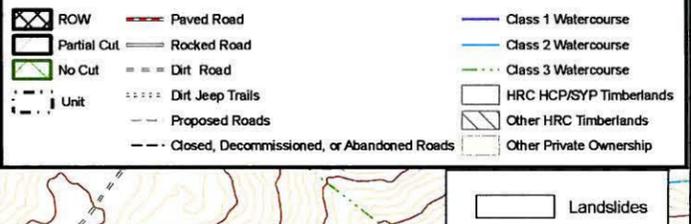
Figure 1

Little Little
THP 09-100
Elevation Map with 10 ft contours
Unit 1

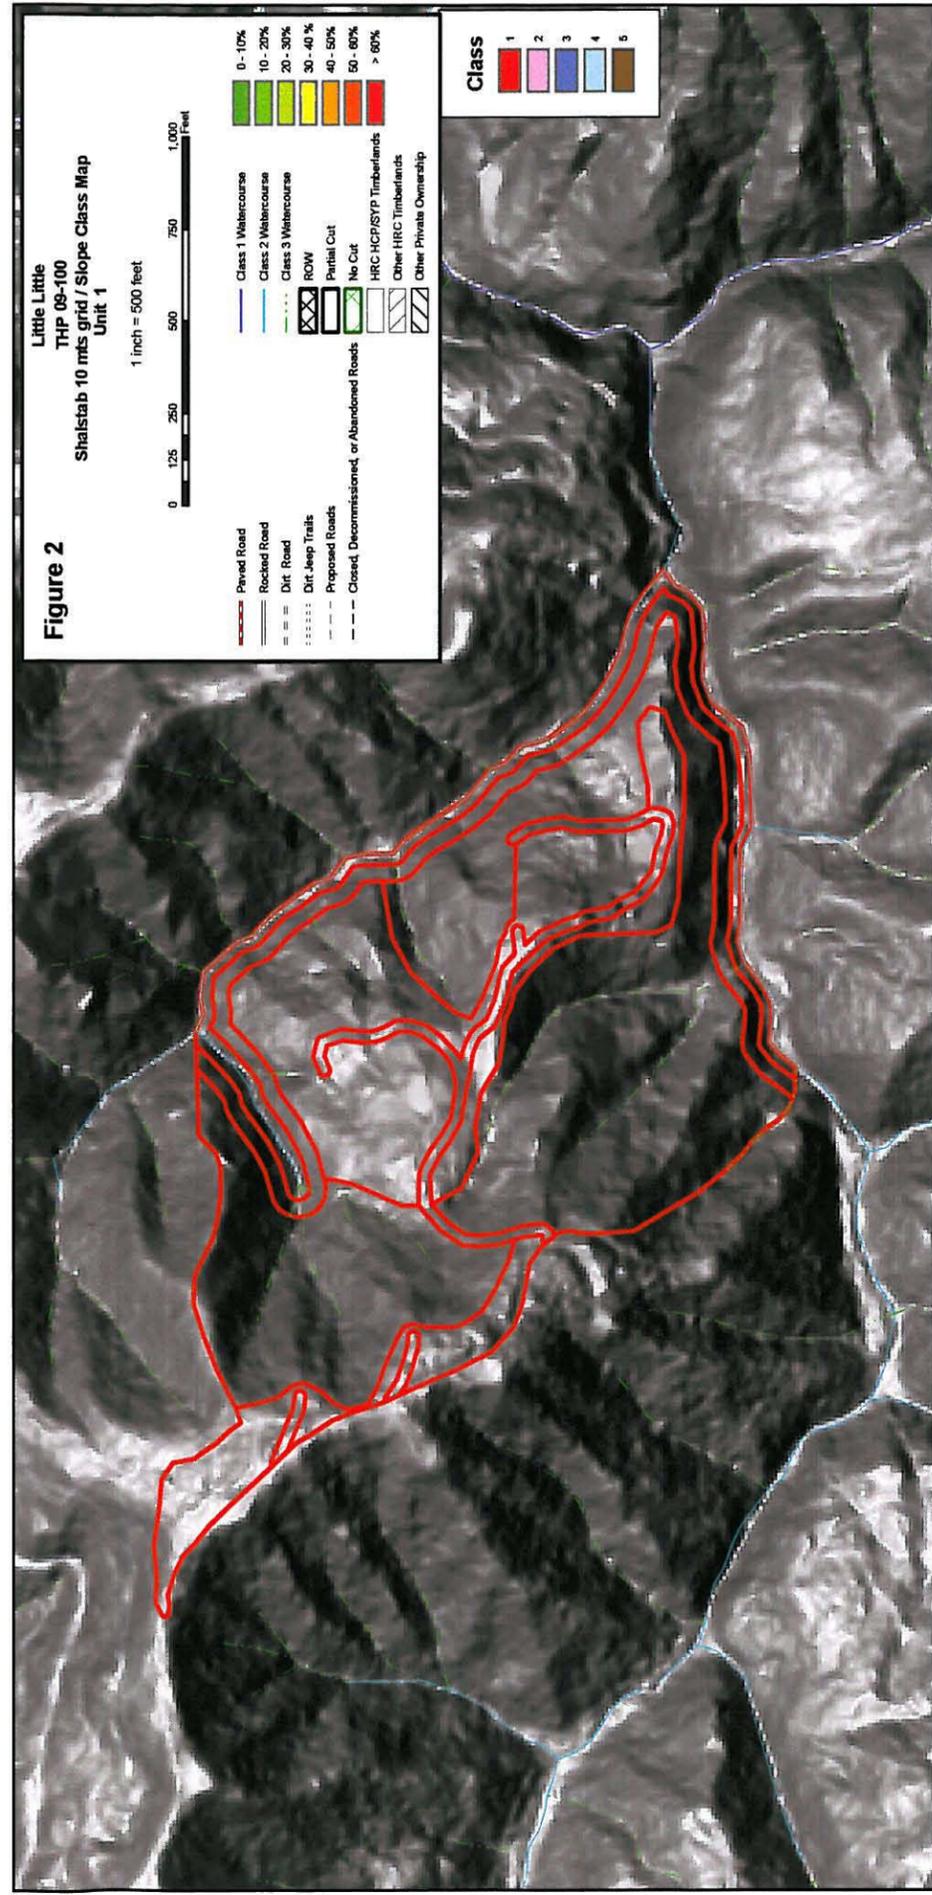
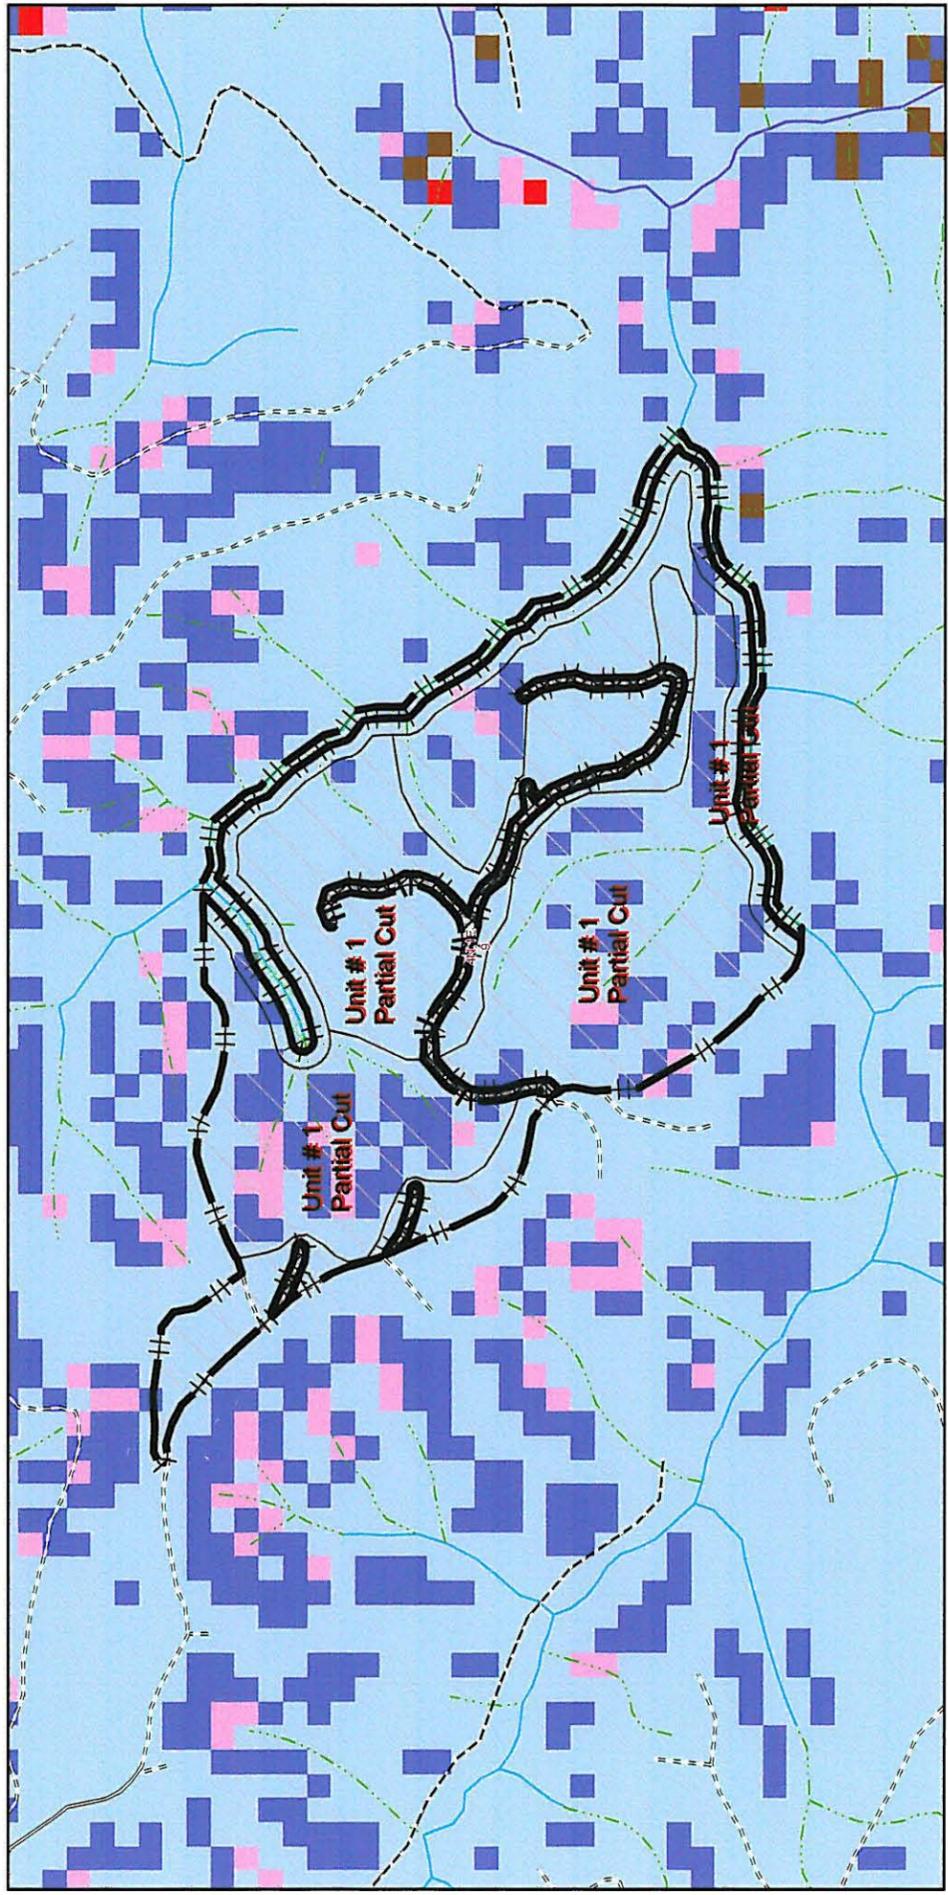
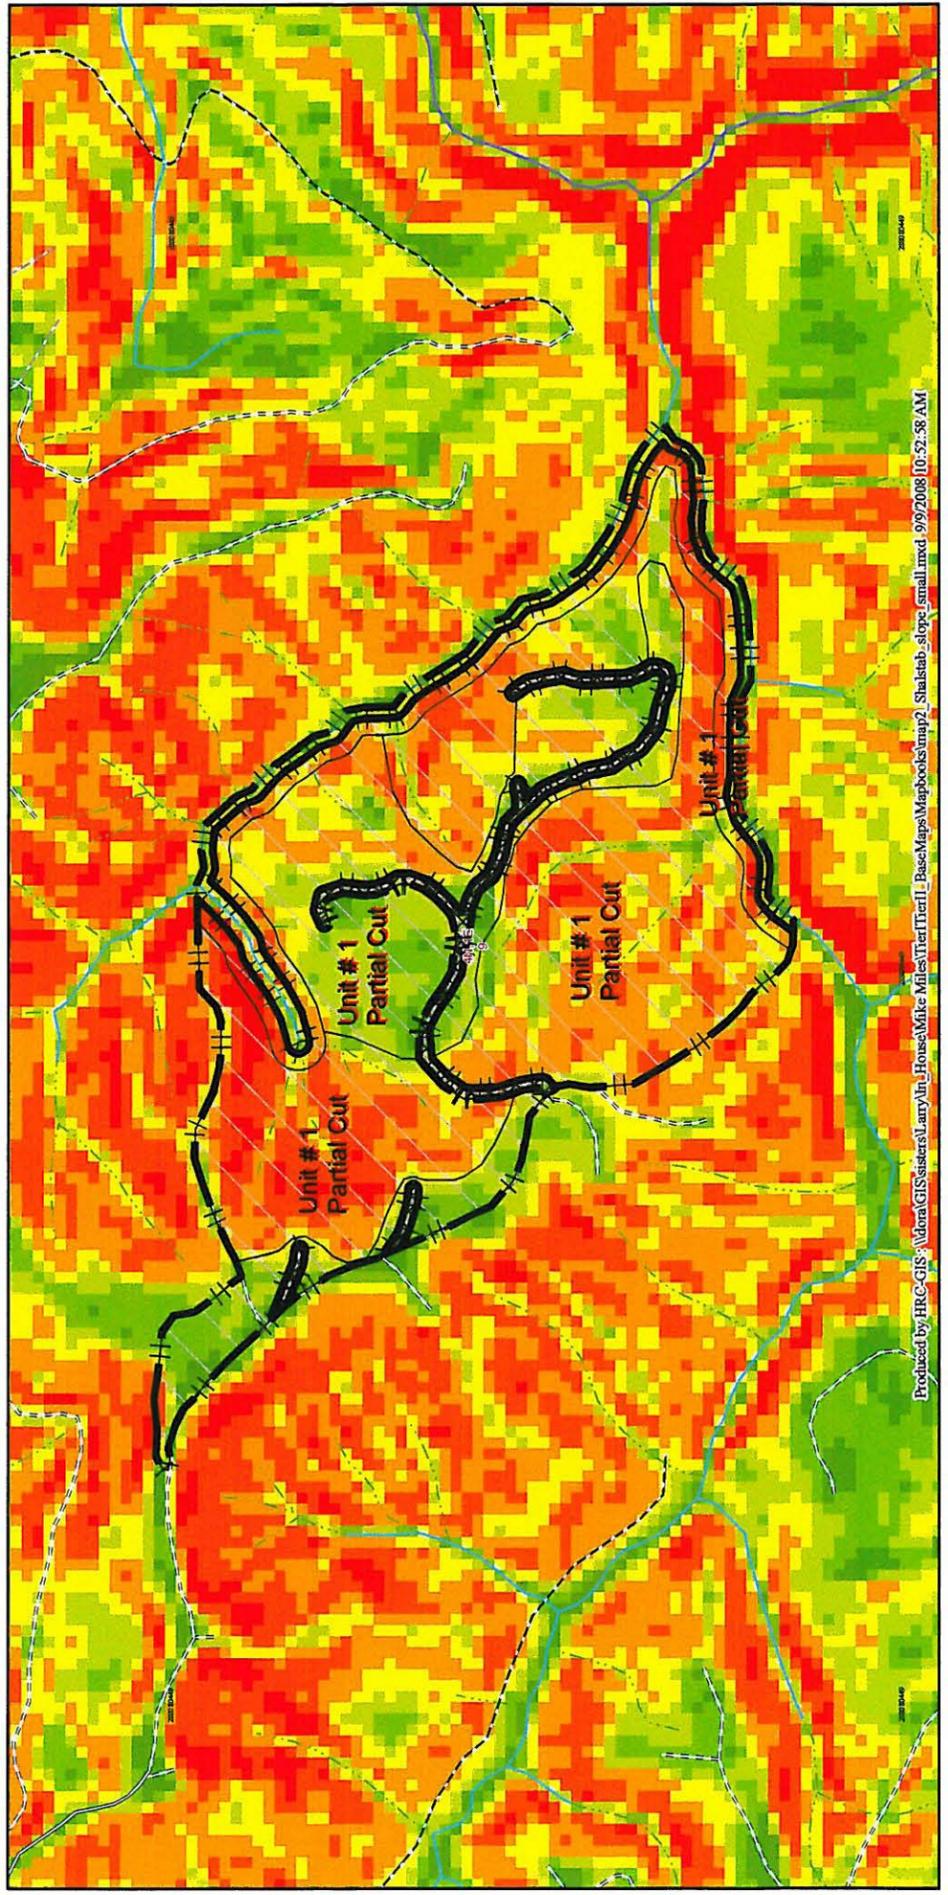
Little Little
TRIP 09-100
Shalstab 10 mrs grid / Slope Class Map
Unit 1

Review of Figure 2 (Hillslope Shade) shows moderate correlation between surface morphology and the head scarp of the mapped deep seated landslide in Unit 1. In both units the Hillslope Shade maps show moderate to steep convergent slopes (swales) that are most prominent where Class II and Class III watercourses have been mapped. The Class II watercourses appear well entrenched with a consistent low gradient channel.

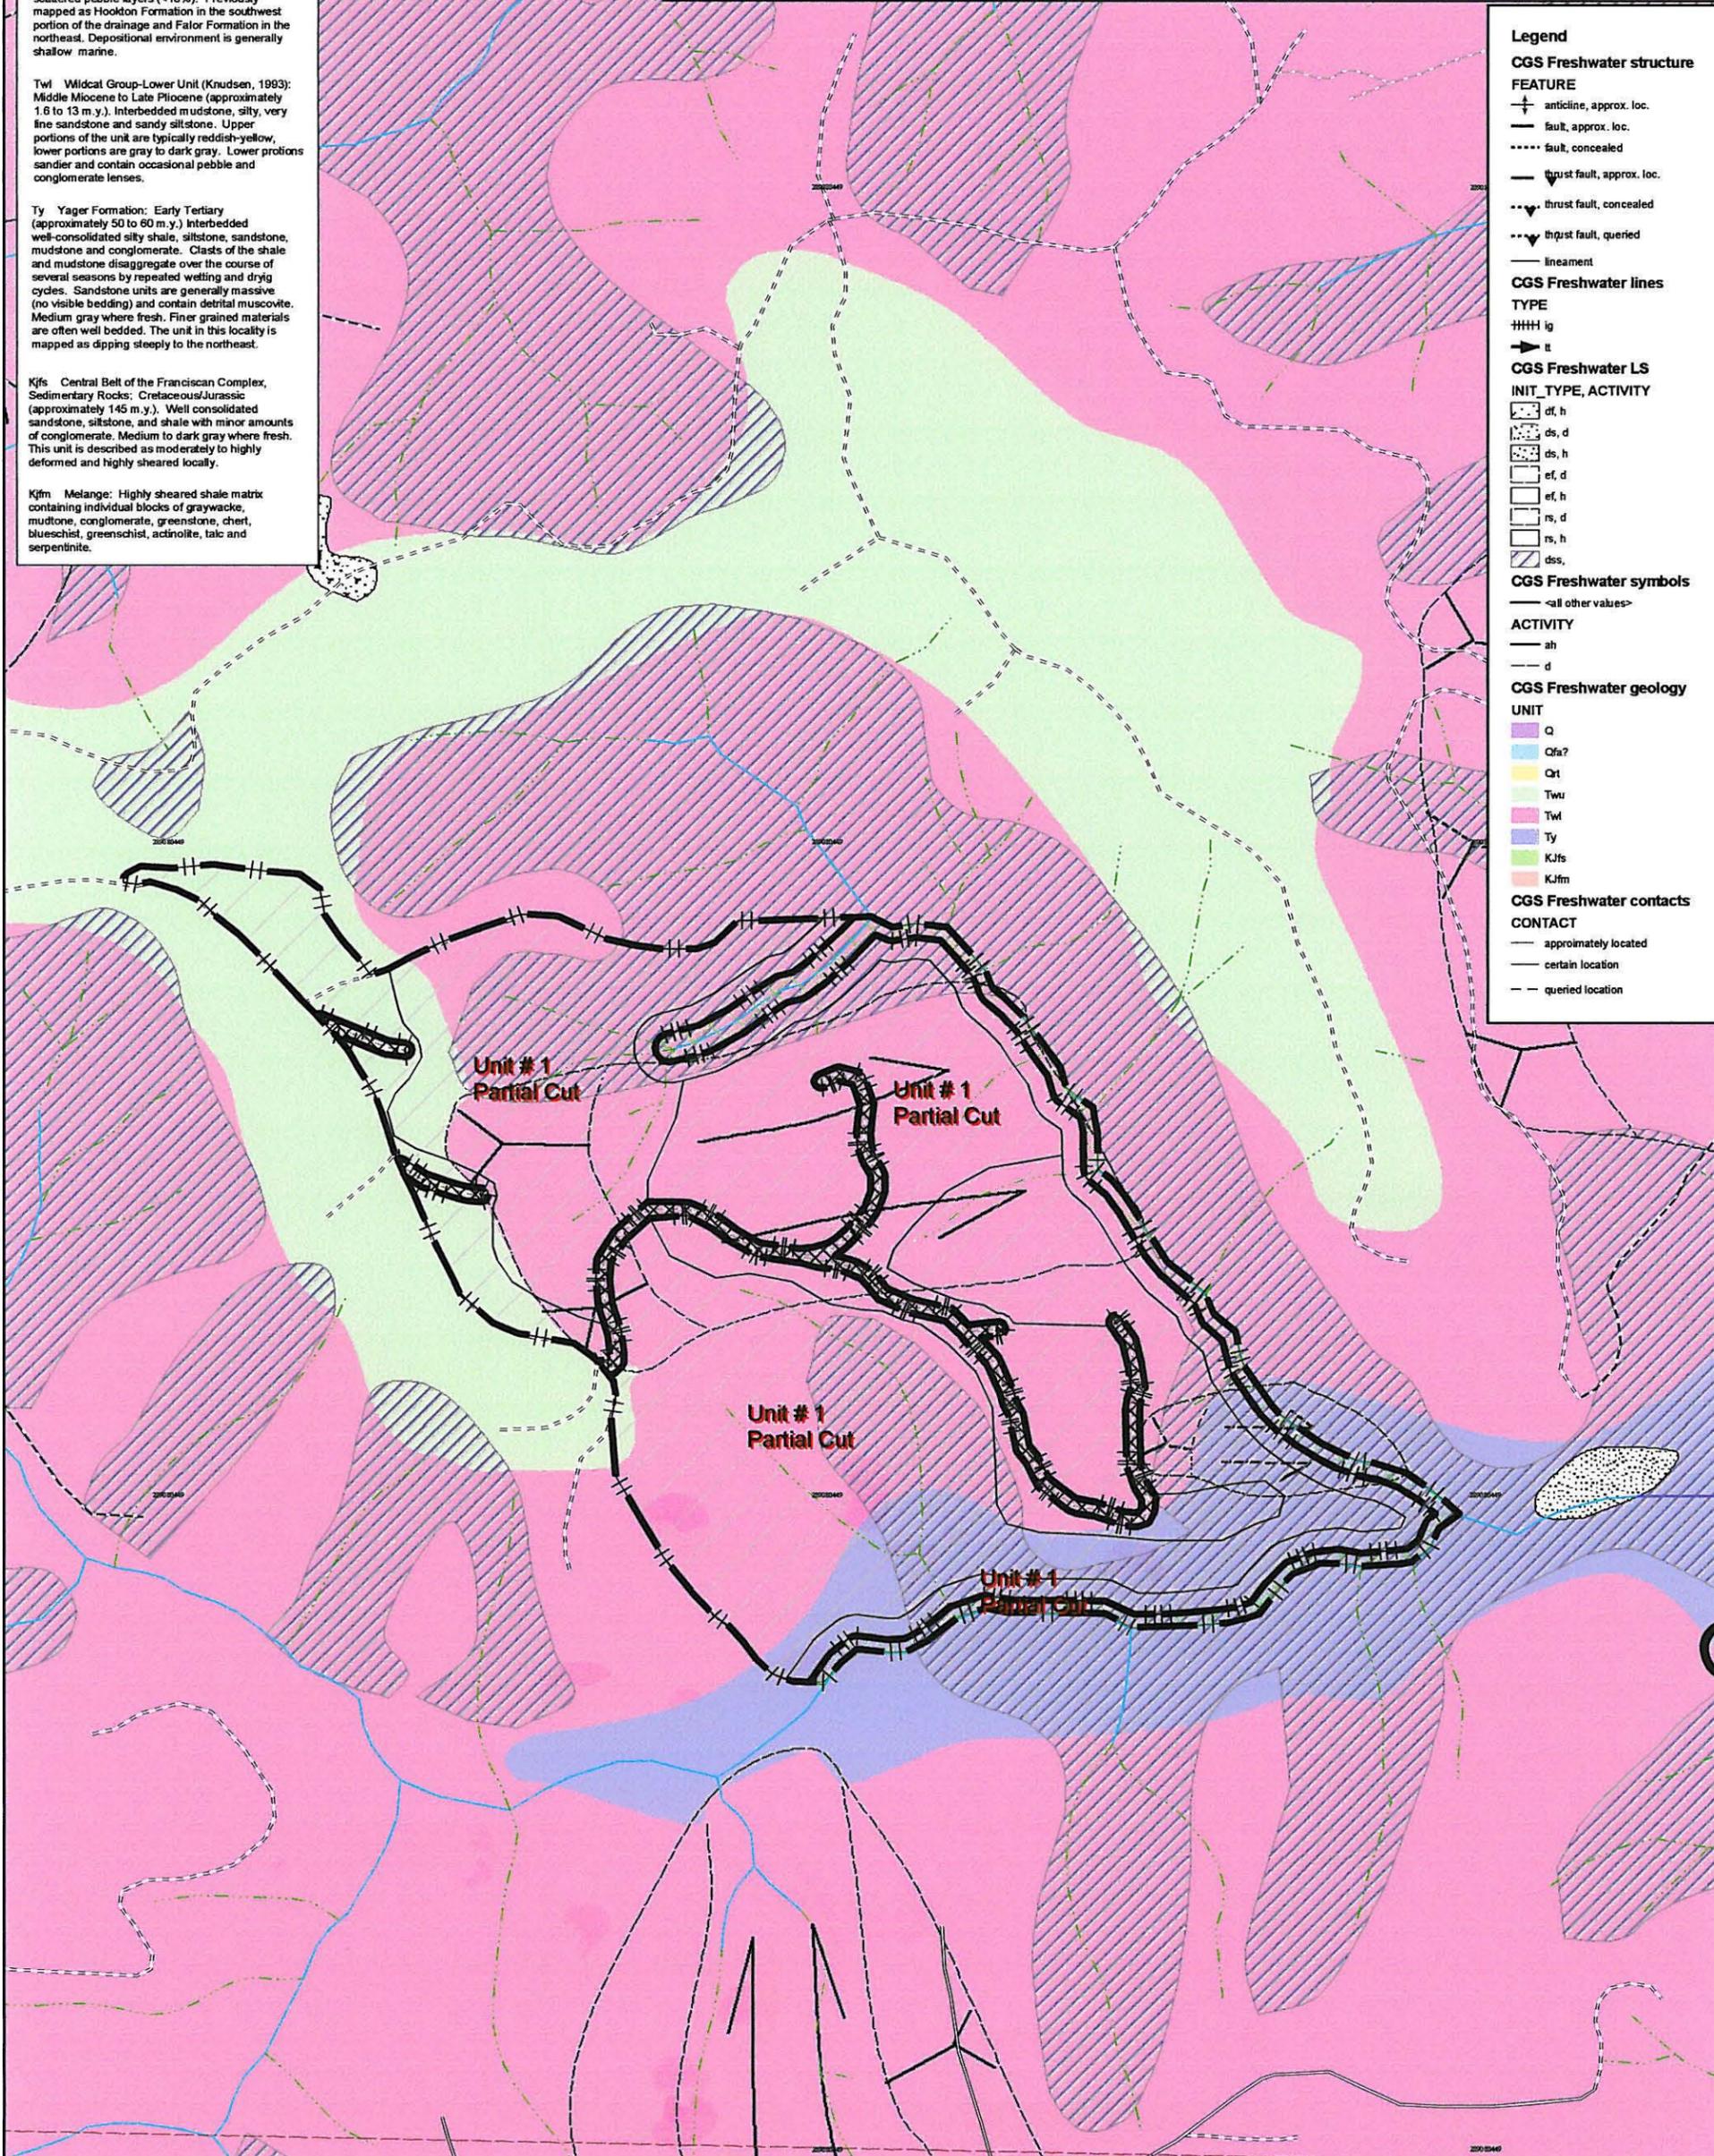
Figure 3

Little Little
THP 09-100
CGS Map Unit 1

Debris slide slopes mapped (Figure 3) within the unit generally correlates well with watercourses. It appears that these areas were mapped as potential source areas since few actual debris slides were identified during THP layout and approval.

Debris slide slopes mapped (Figure 3) within the unit generally correlate with the watercourses. It appears that these areas were mapped as potential source areas since few actual debris slides were identified during THP layout and approval.

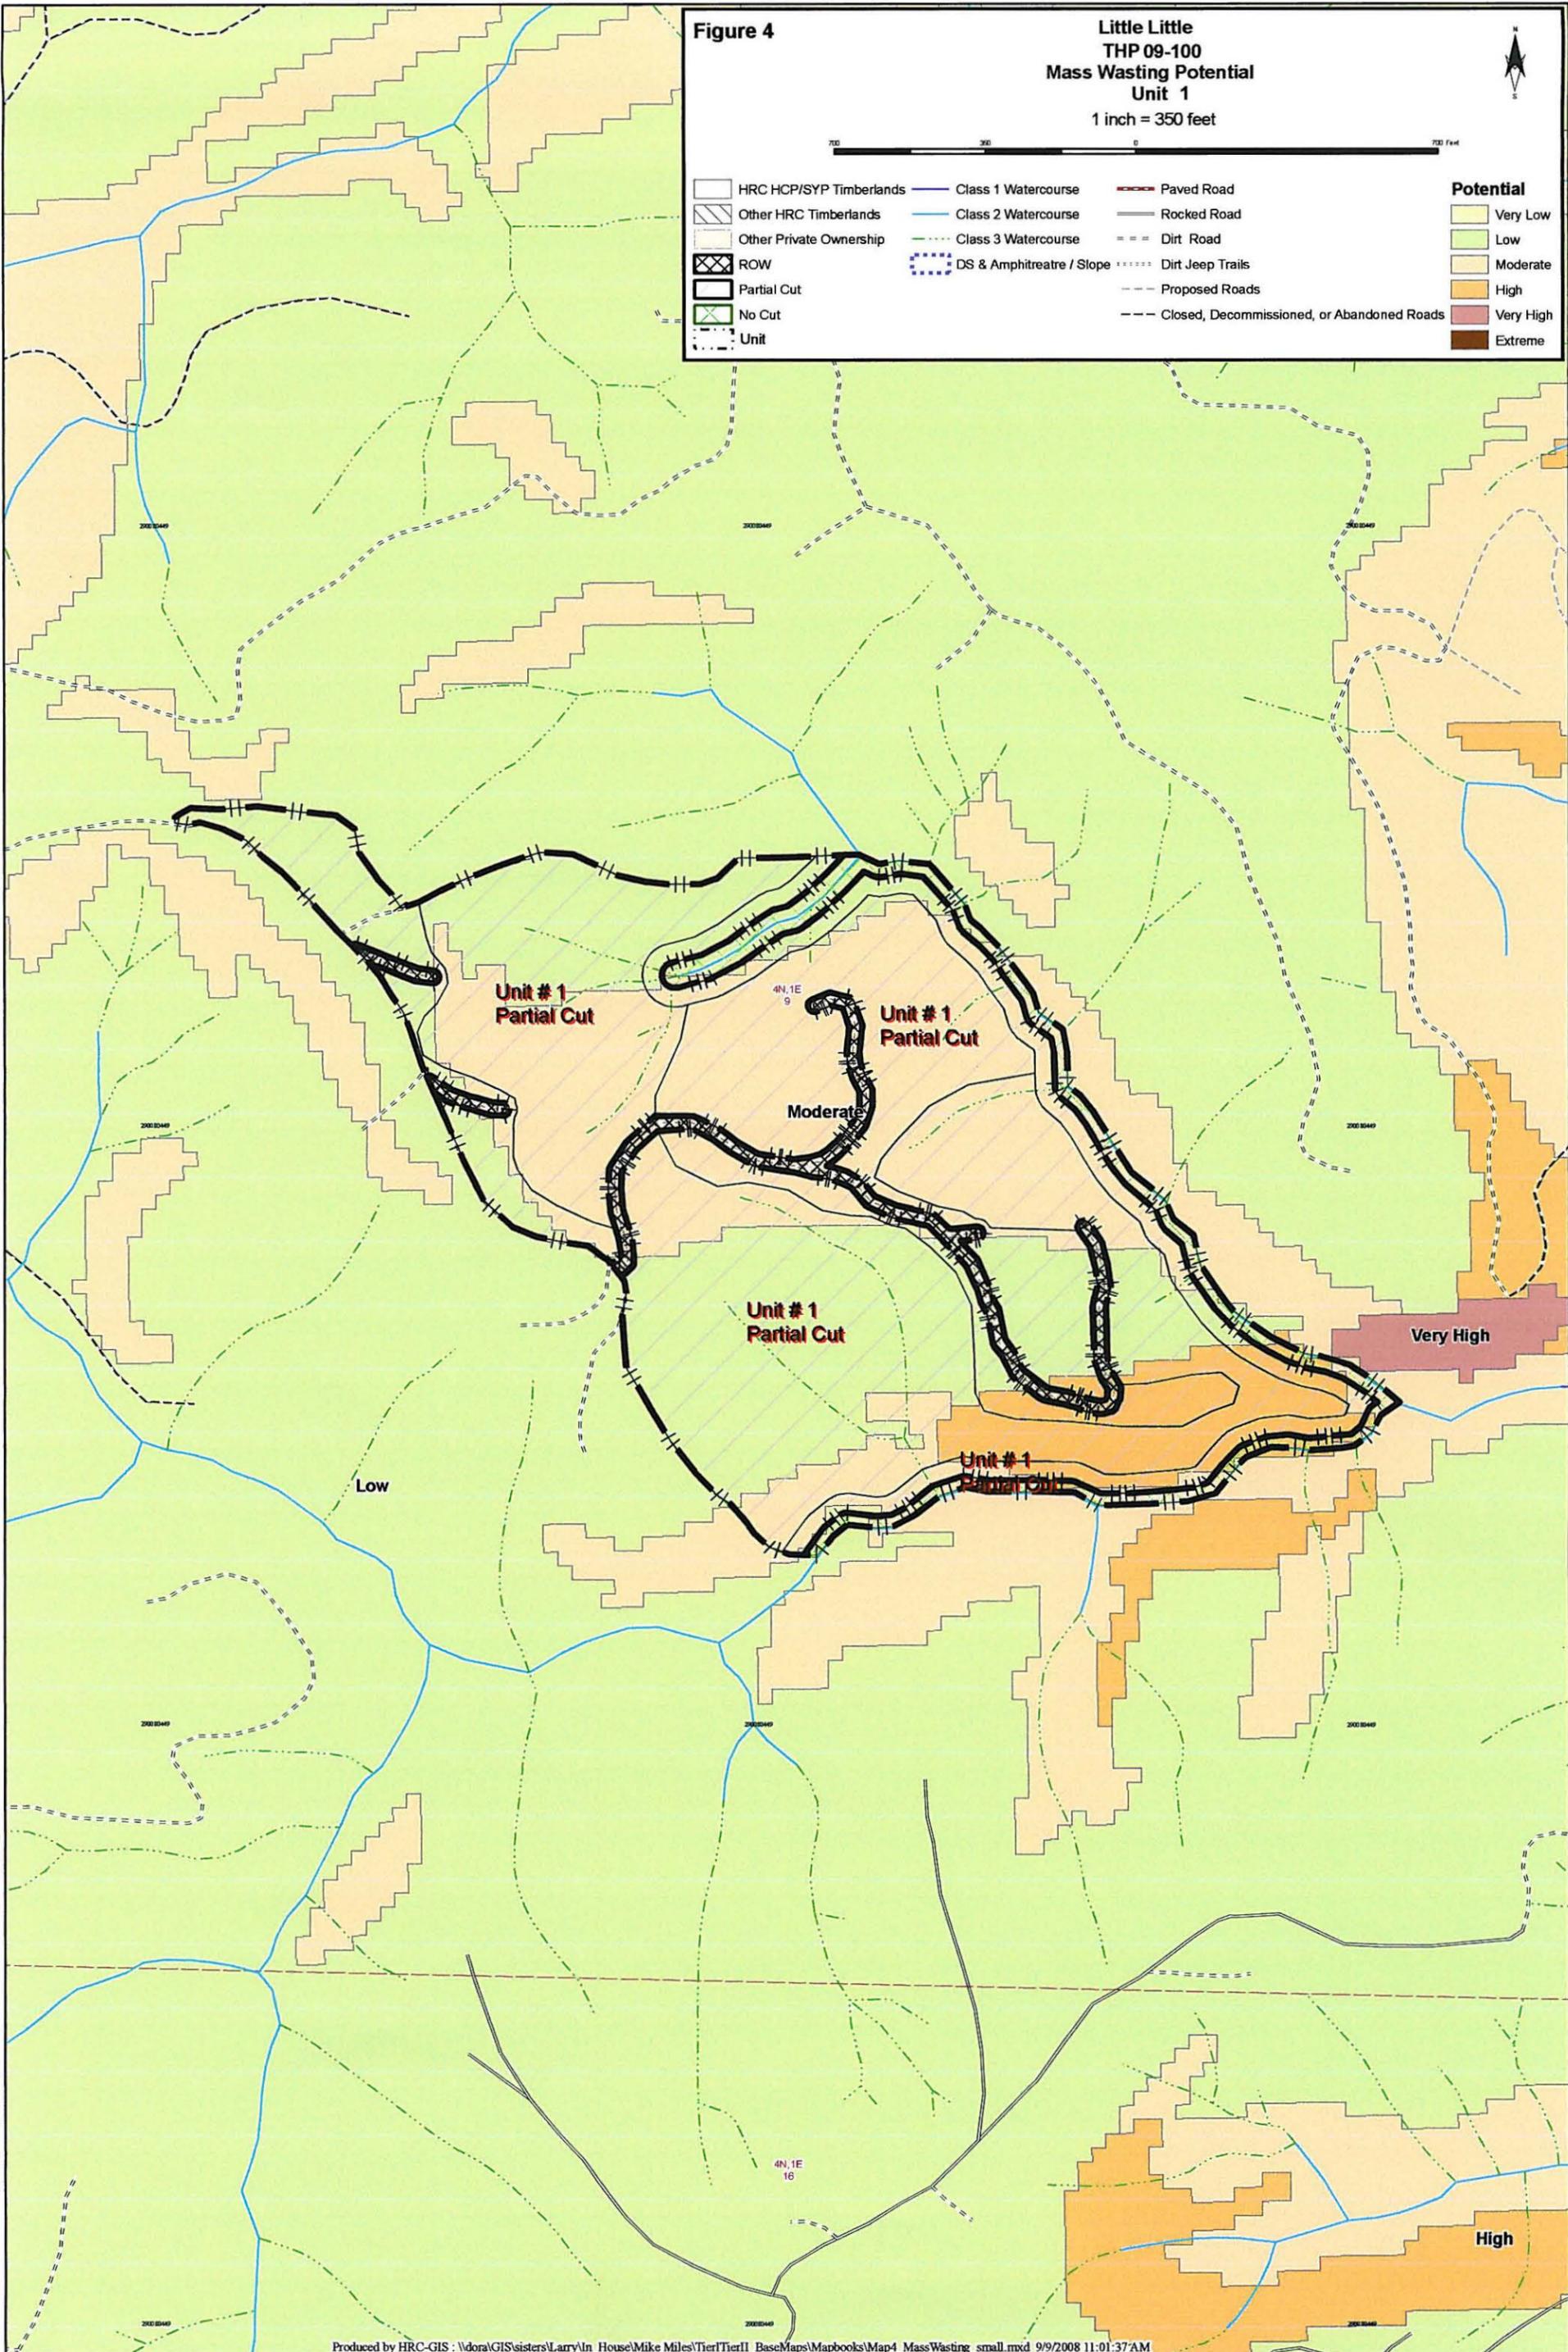
Figure 4

Little Little
THP 09-100
Mass Wasting Potential
Unit 1

Mass Wasting Potential (MWP) modeled for the unit (Figure 4) is regionally low. Within the unit moderate and high MWP has been modeled adjacent the Class II watercourses. The area matching high MWP is in response to the inclusion within the model the values for the Figure 3 mapped Yager Terrane bedrock underlying mapped debris slide slopes. Moderate MWP mapped within the unit correlates well with the dormant deep-seated landslide in the northern portion of the unit.

Mass Wasting Potential (MWP) modeled for the unit (Figure 4) is regionally low. Within the unit moderate and high MWP has been modeled adjacent the Class II watercourses. The areas matching high MWP are in response to the inclusion within the model the values for the Figure 3 mapped debris slide slopes underlain by Yager Terrane bedrock.

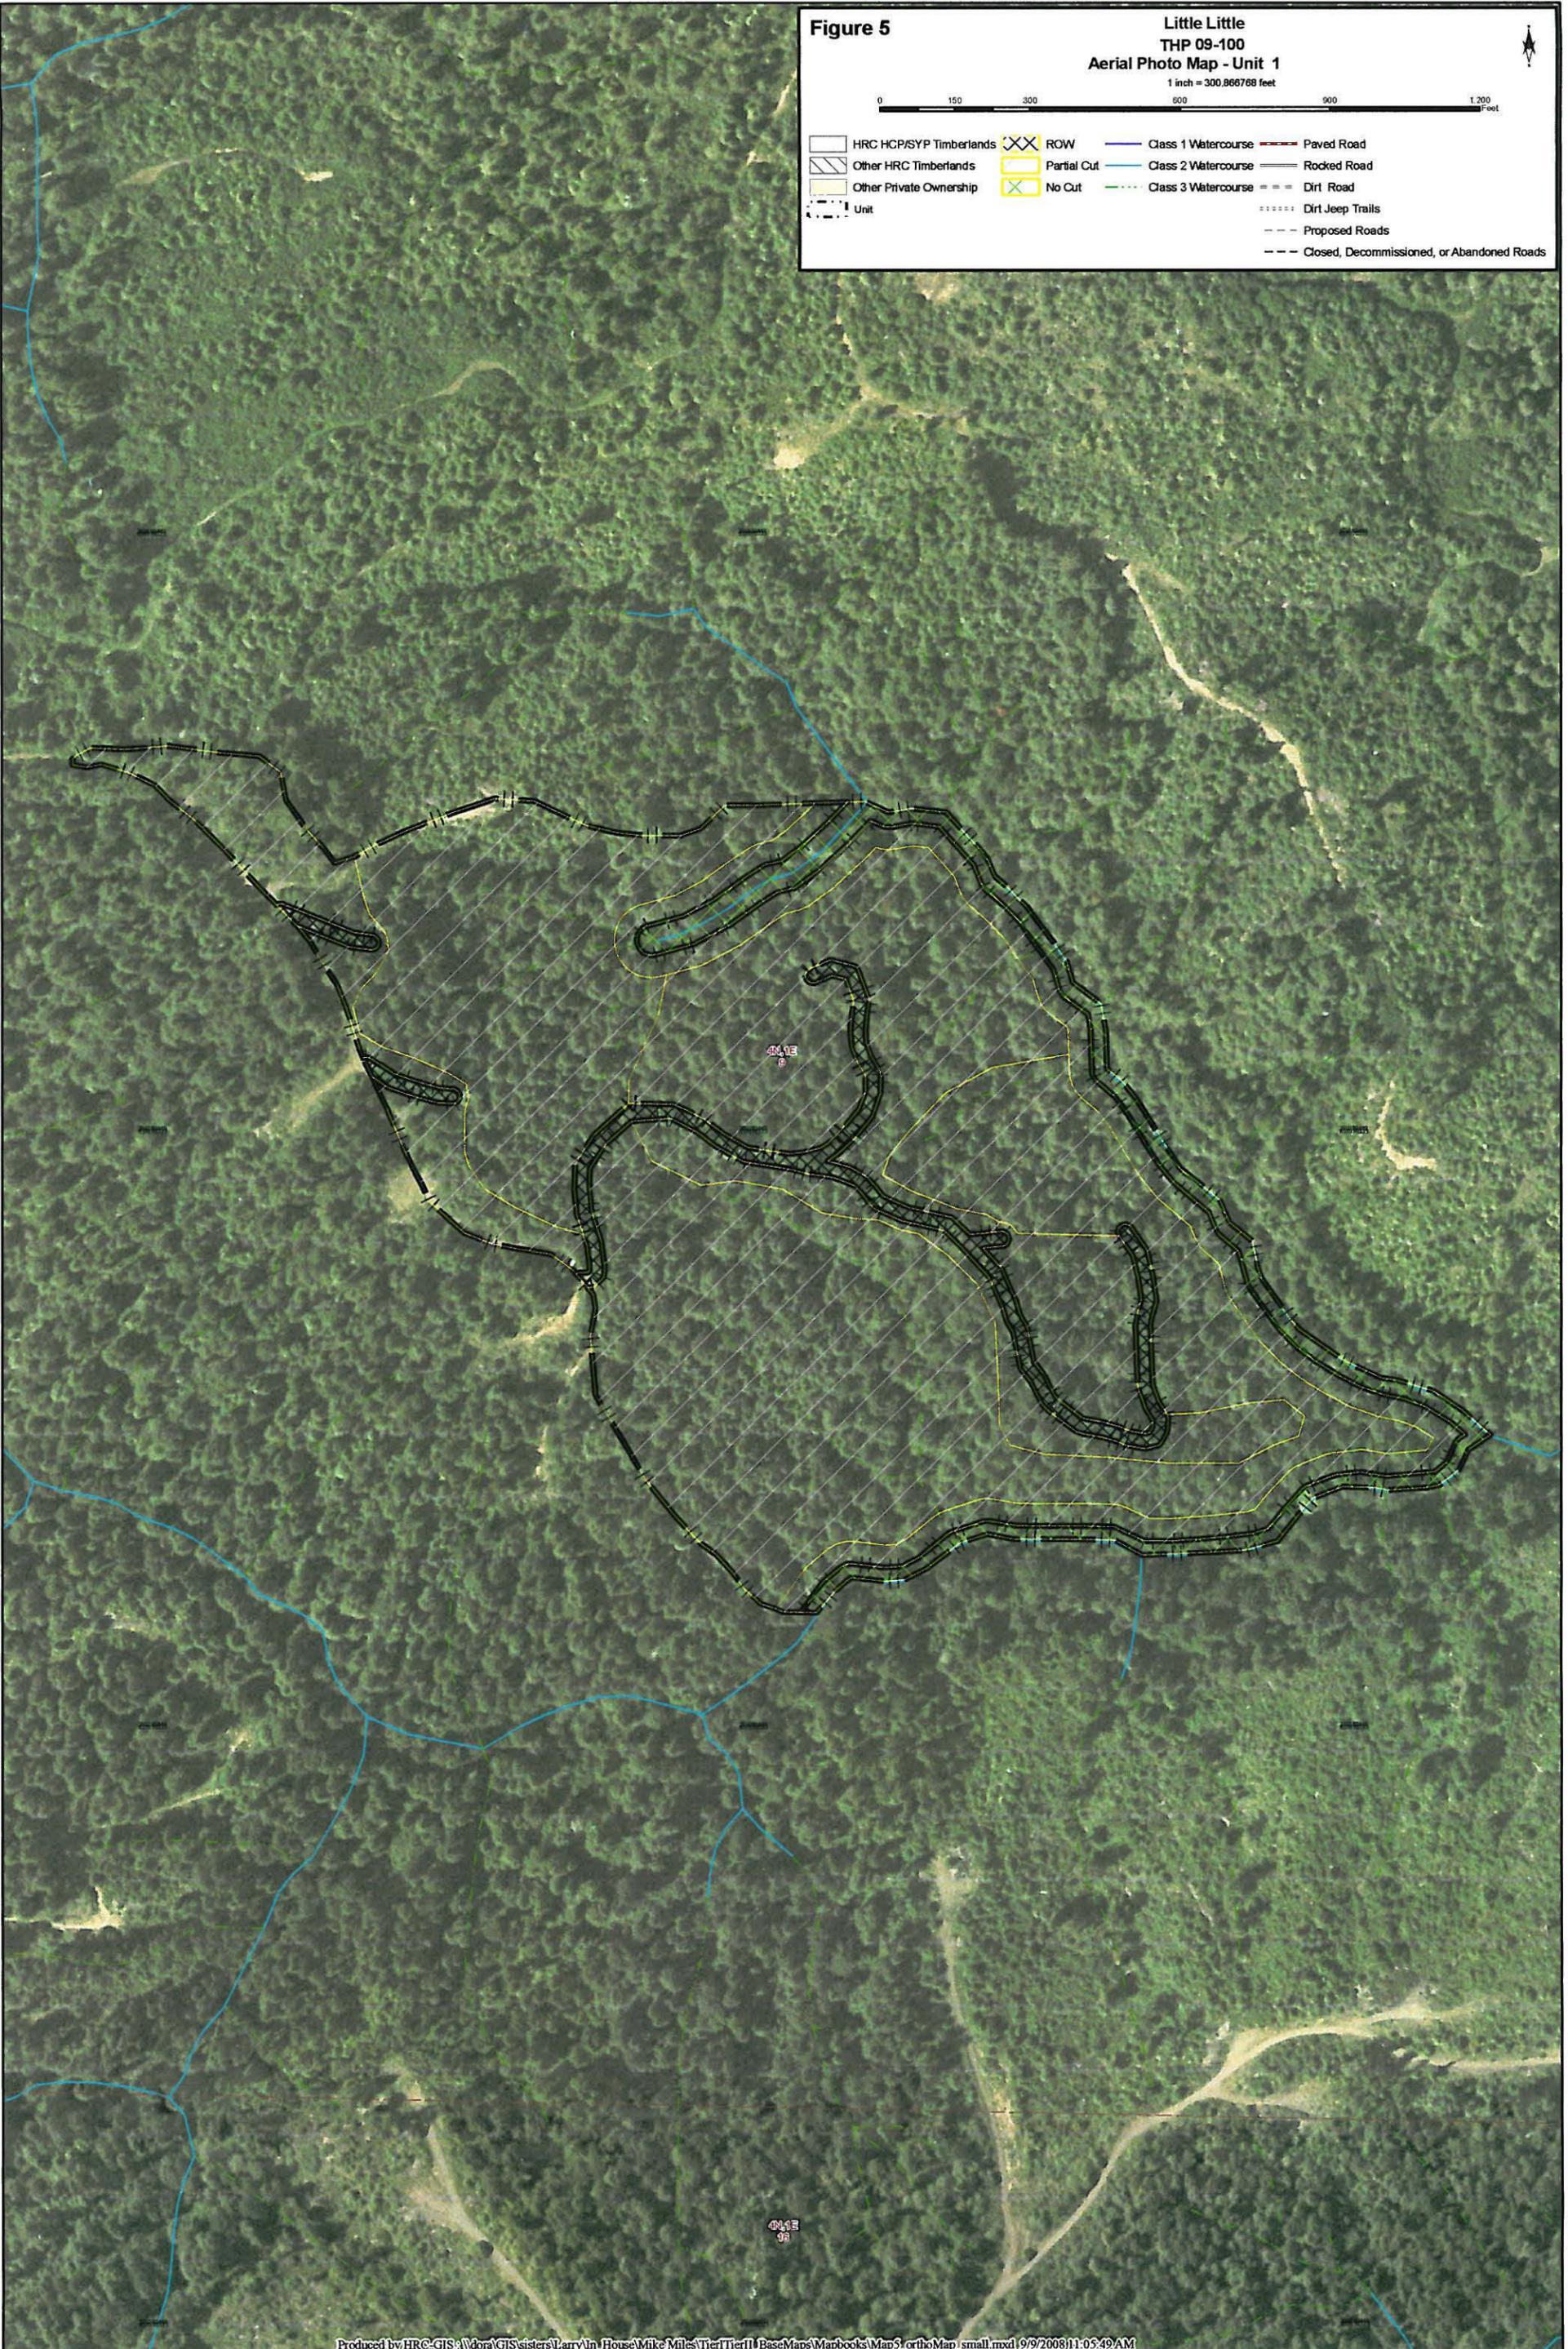
Figure 6

Mapping from Watershed Analysis (Figure 6) identifies low to moderate hazard for reactivation that correlates with CGS (1999) mapping of the deep-seated ridge to creek dormant translational/rotational landslide in Unit 1. Watershed Analysis (Figure 6) does not model any hazards within Unit 2.

Little Little THP 09-100 Watershed Analysis Deep-Seated Landslide Inventory Unit 1

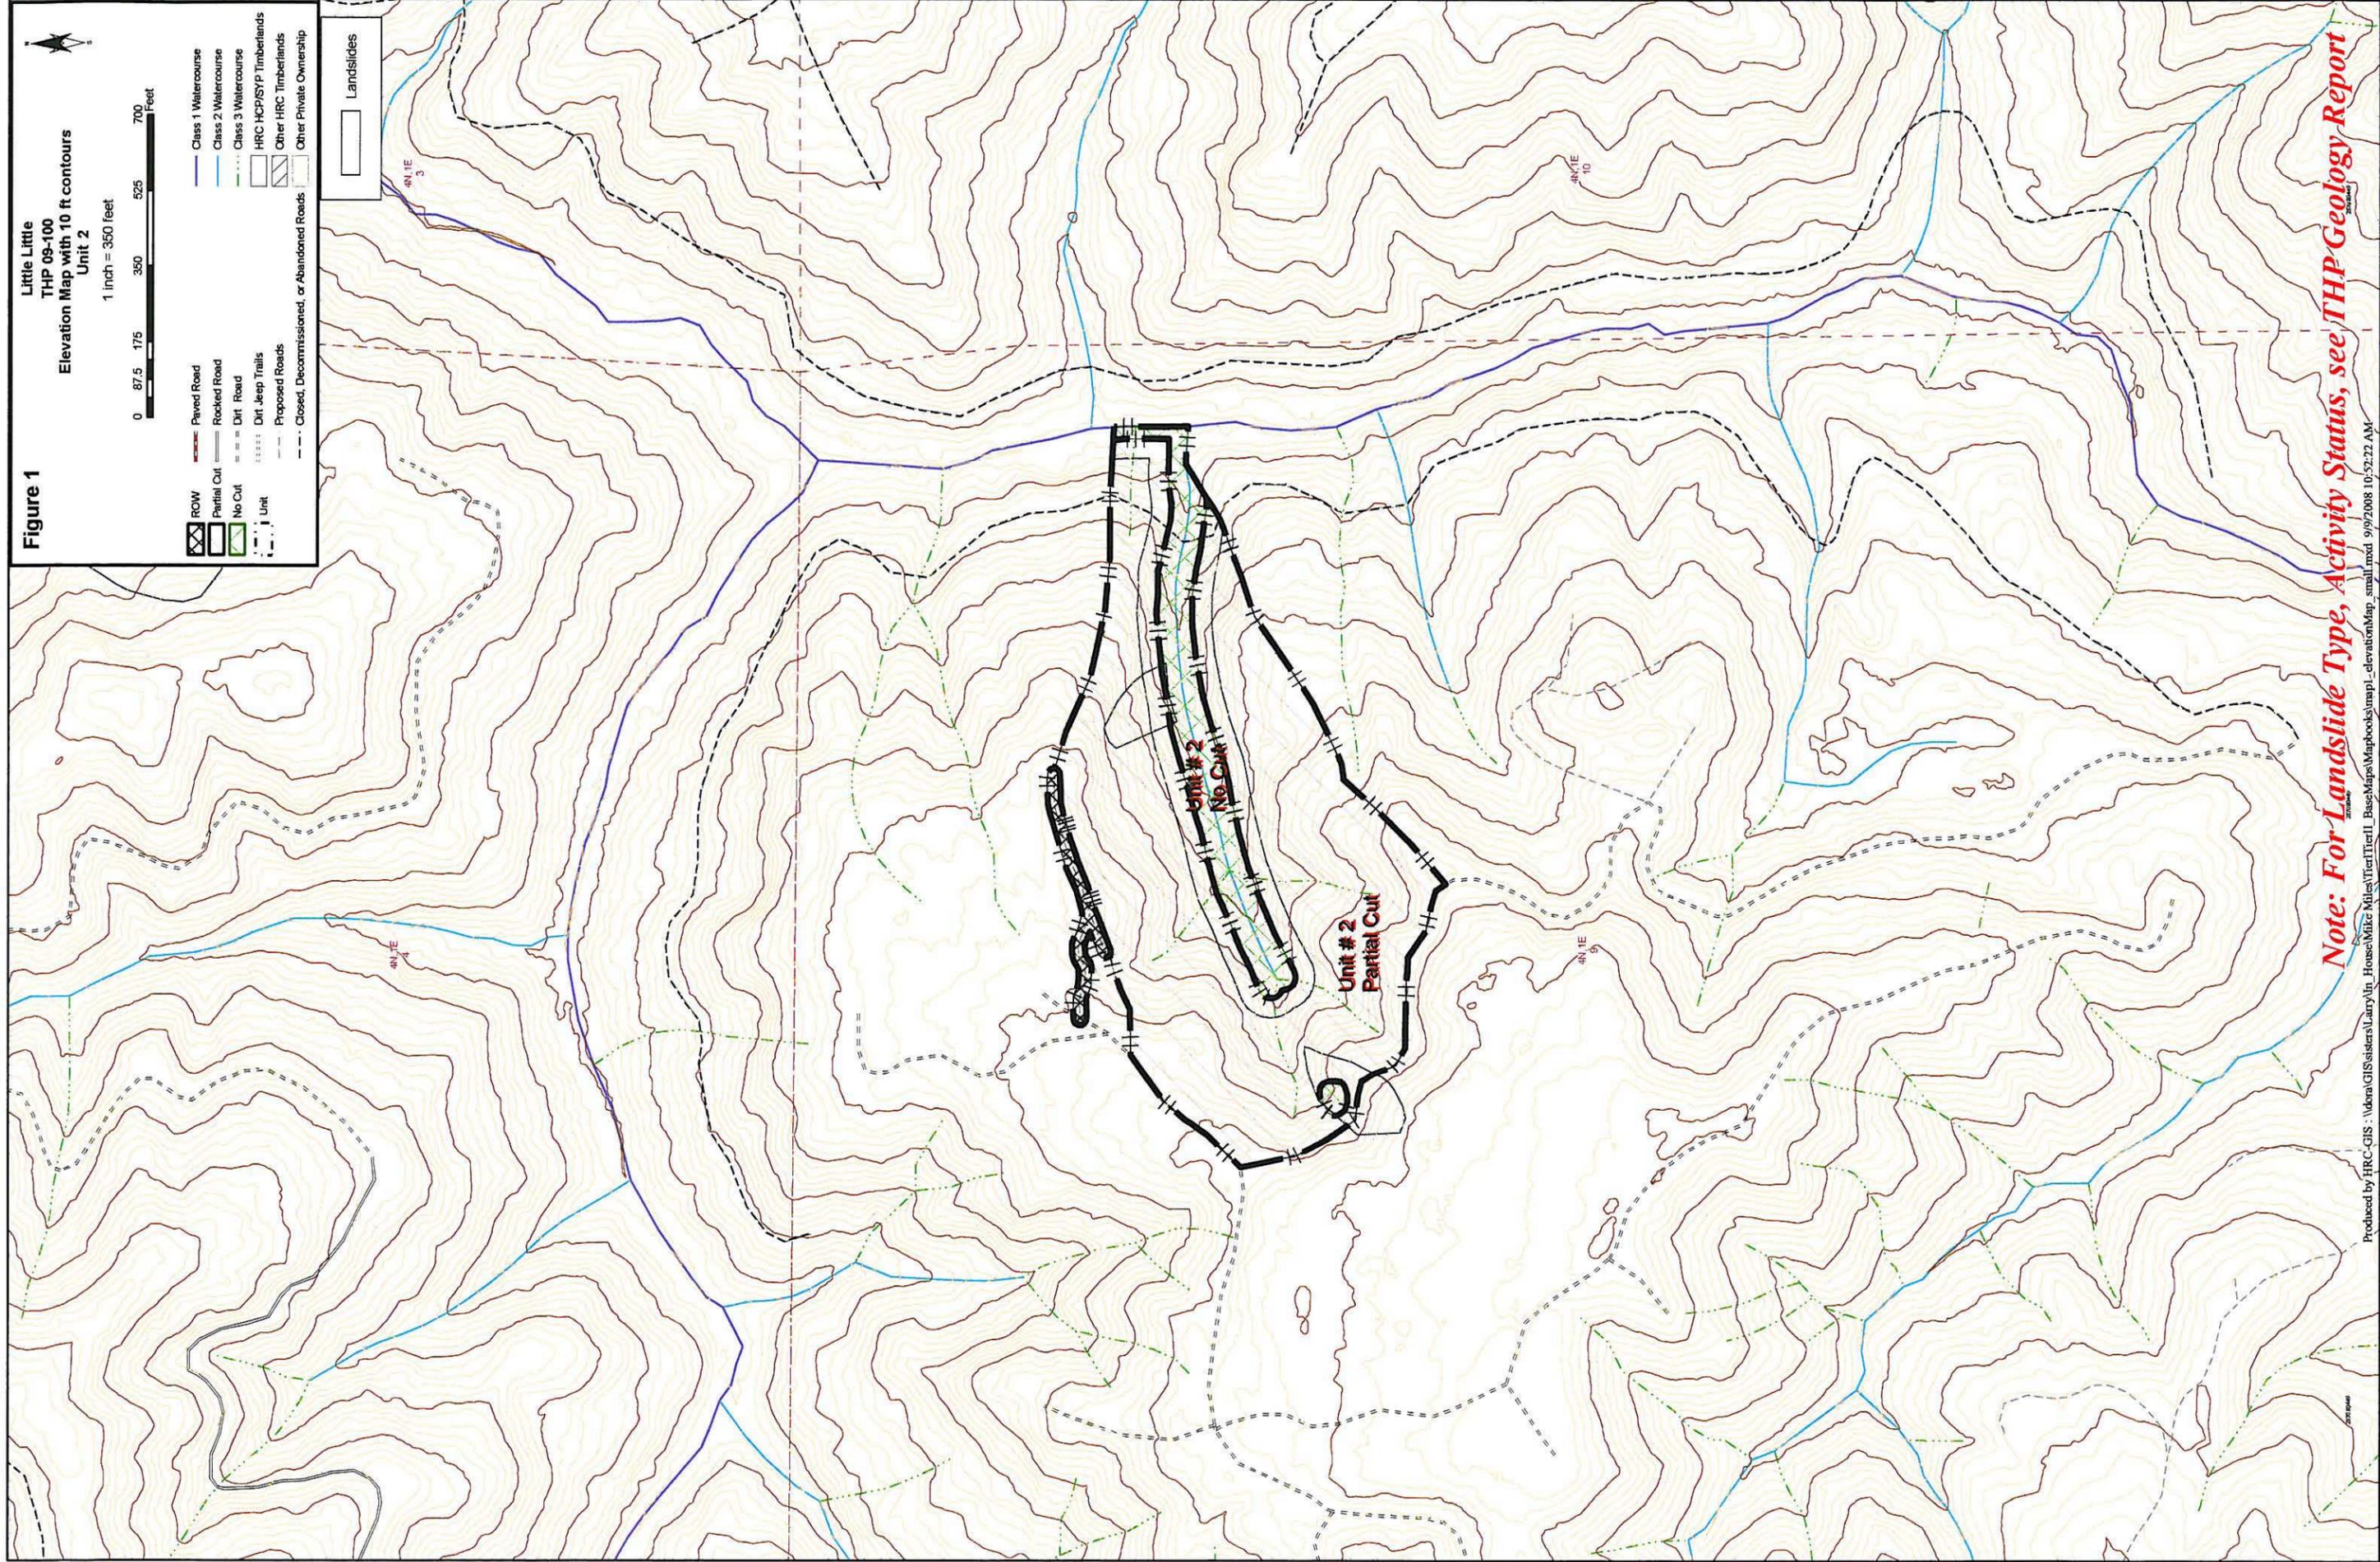
Figure 1

Little Little
THP 09-100
Elevation Map with 10 ft contours
Unit 2
