Subject: Enrollment of THP 1-09-100 HUM (Unit 1 and 2) in the Freshwater Creek WWDR, "Tier II"

THP No. 1-09-100 HUM (Little Little) Unit # 1 and 2

THP: Little Little THP 09-100 Units # 1 and 2 March 30, 2010

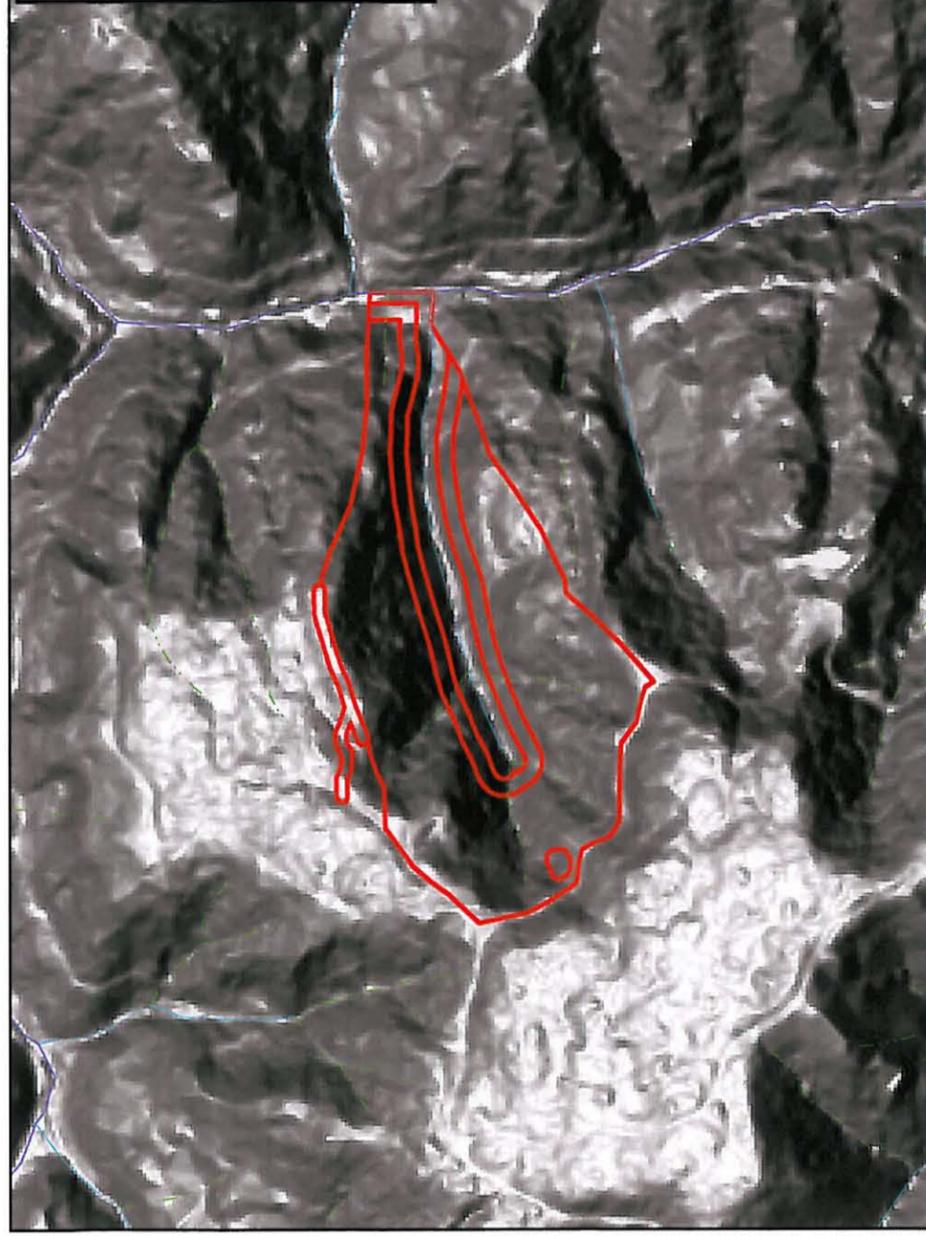
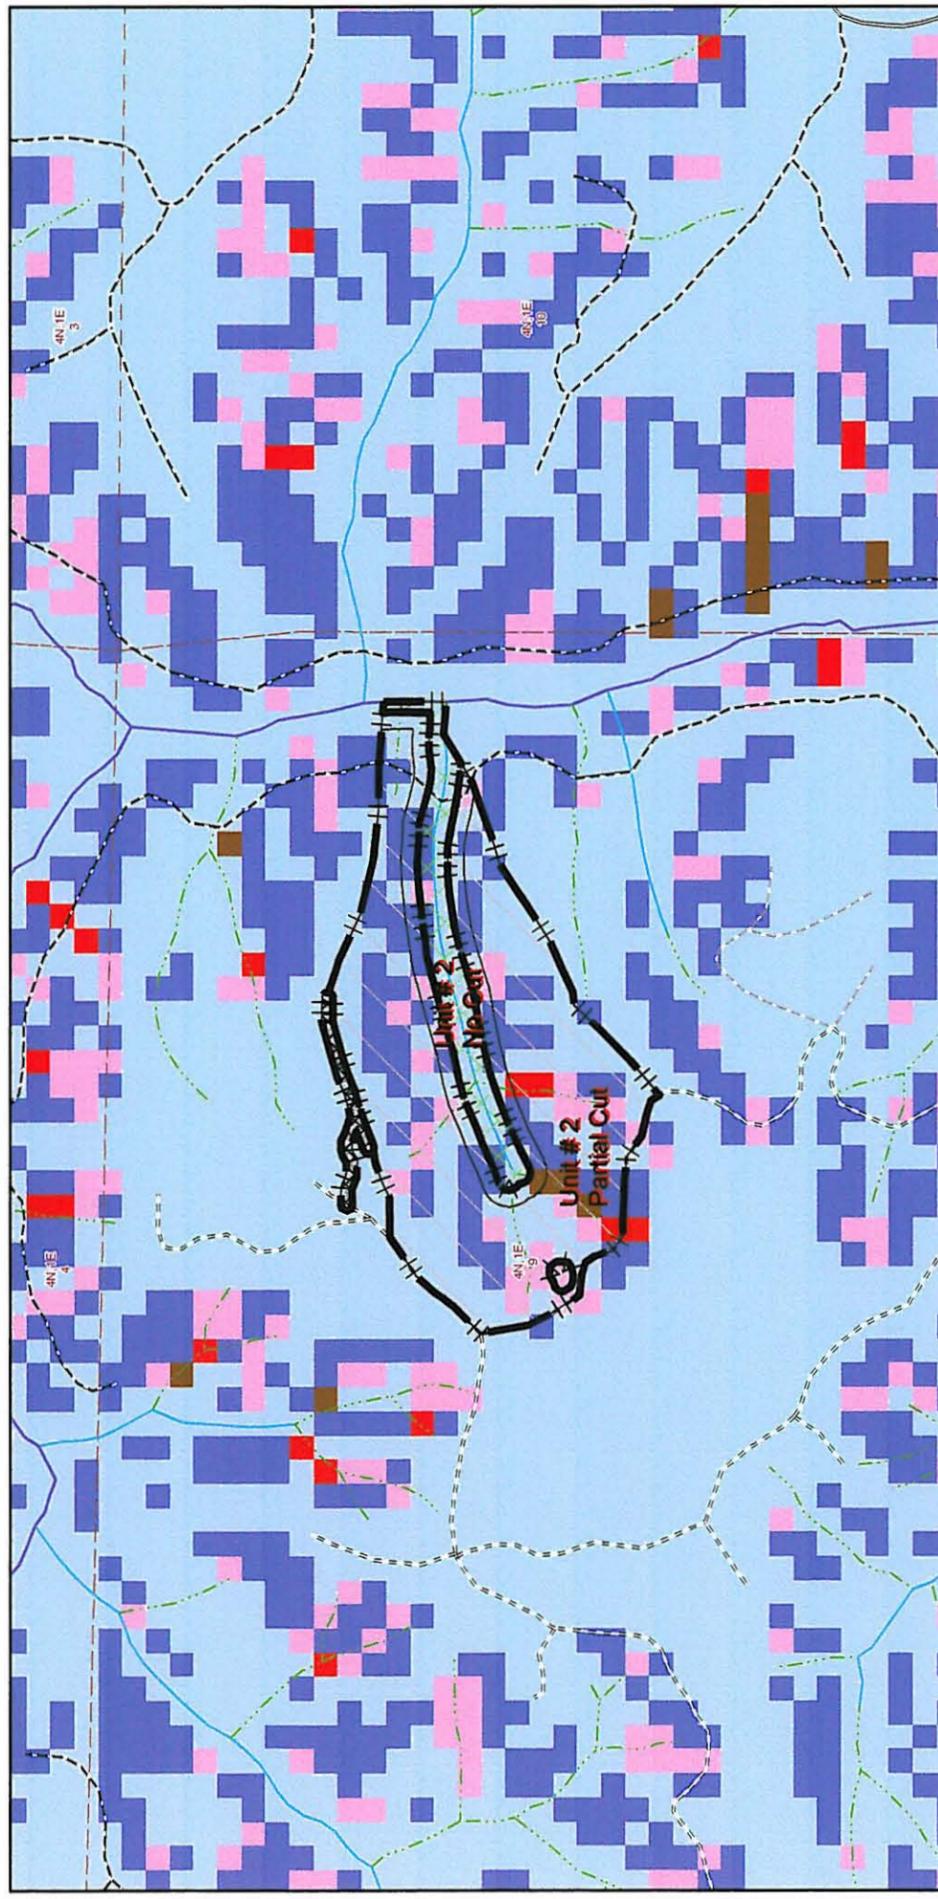
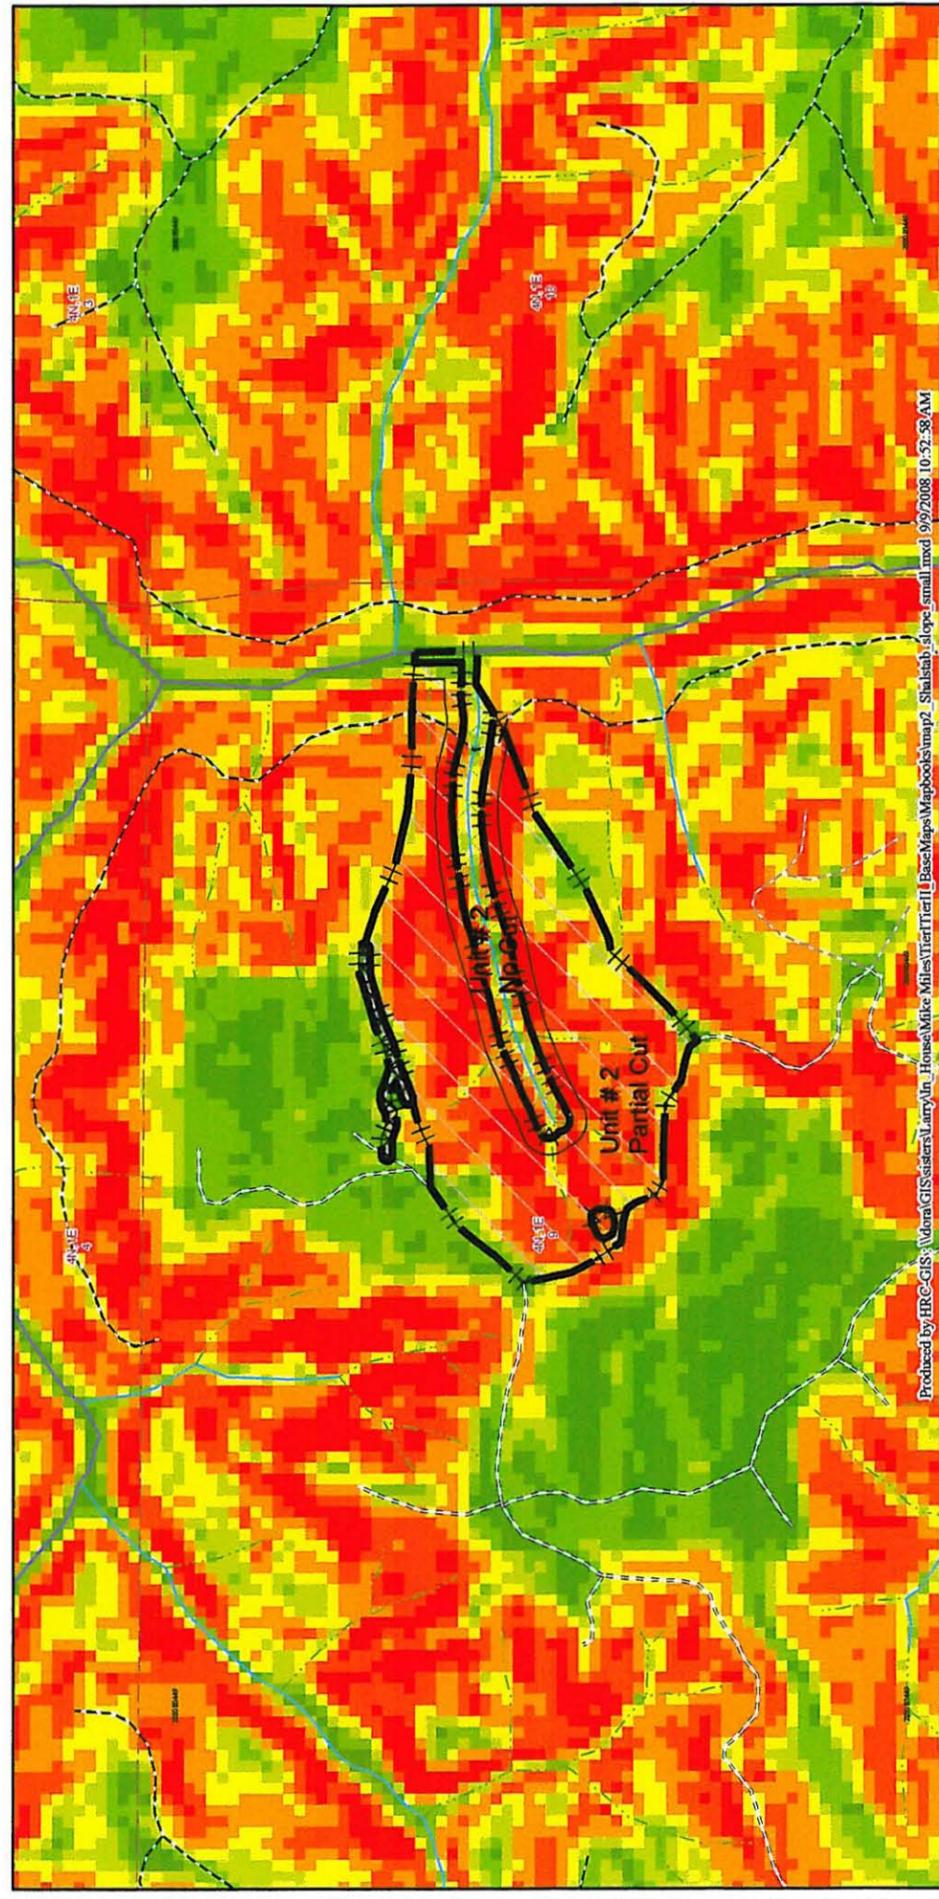
Figure 2

Little Little
THP 09-100
Shalstab 10 mts grid / Slope Class Map
Unit 2

SHALSTAB modeling (Figure 2) shows moderately convergent and steeply inclined slopes throughout the polygon. Three pixels of SHALSTAB value 1 are modeled in southern and western portion of the plan. Numerous value 2 pixels correlate with the swales containing Class II and Class III watercourses. One unstable area was identified in the western most portion of the unit. A cluster of SHALSTAB value two pixels correlates with our mapping the unstable area identified as a shallow debris slide.

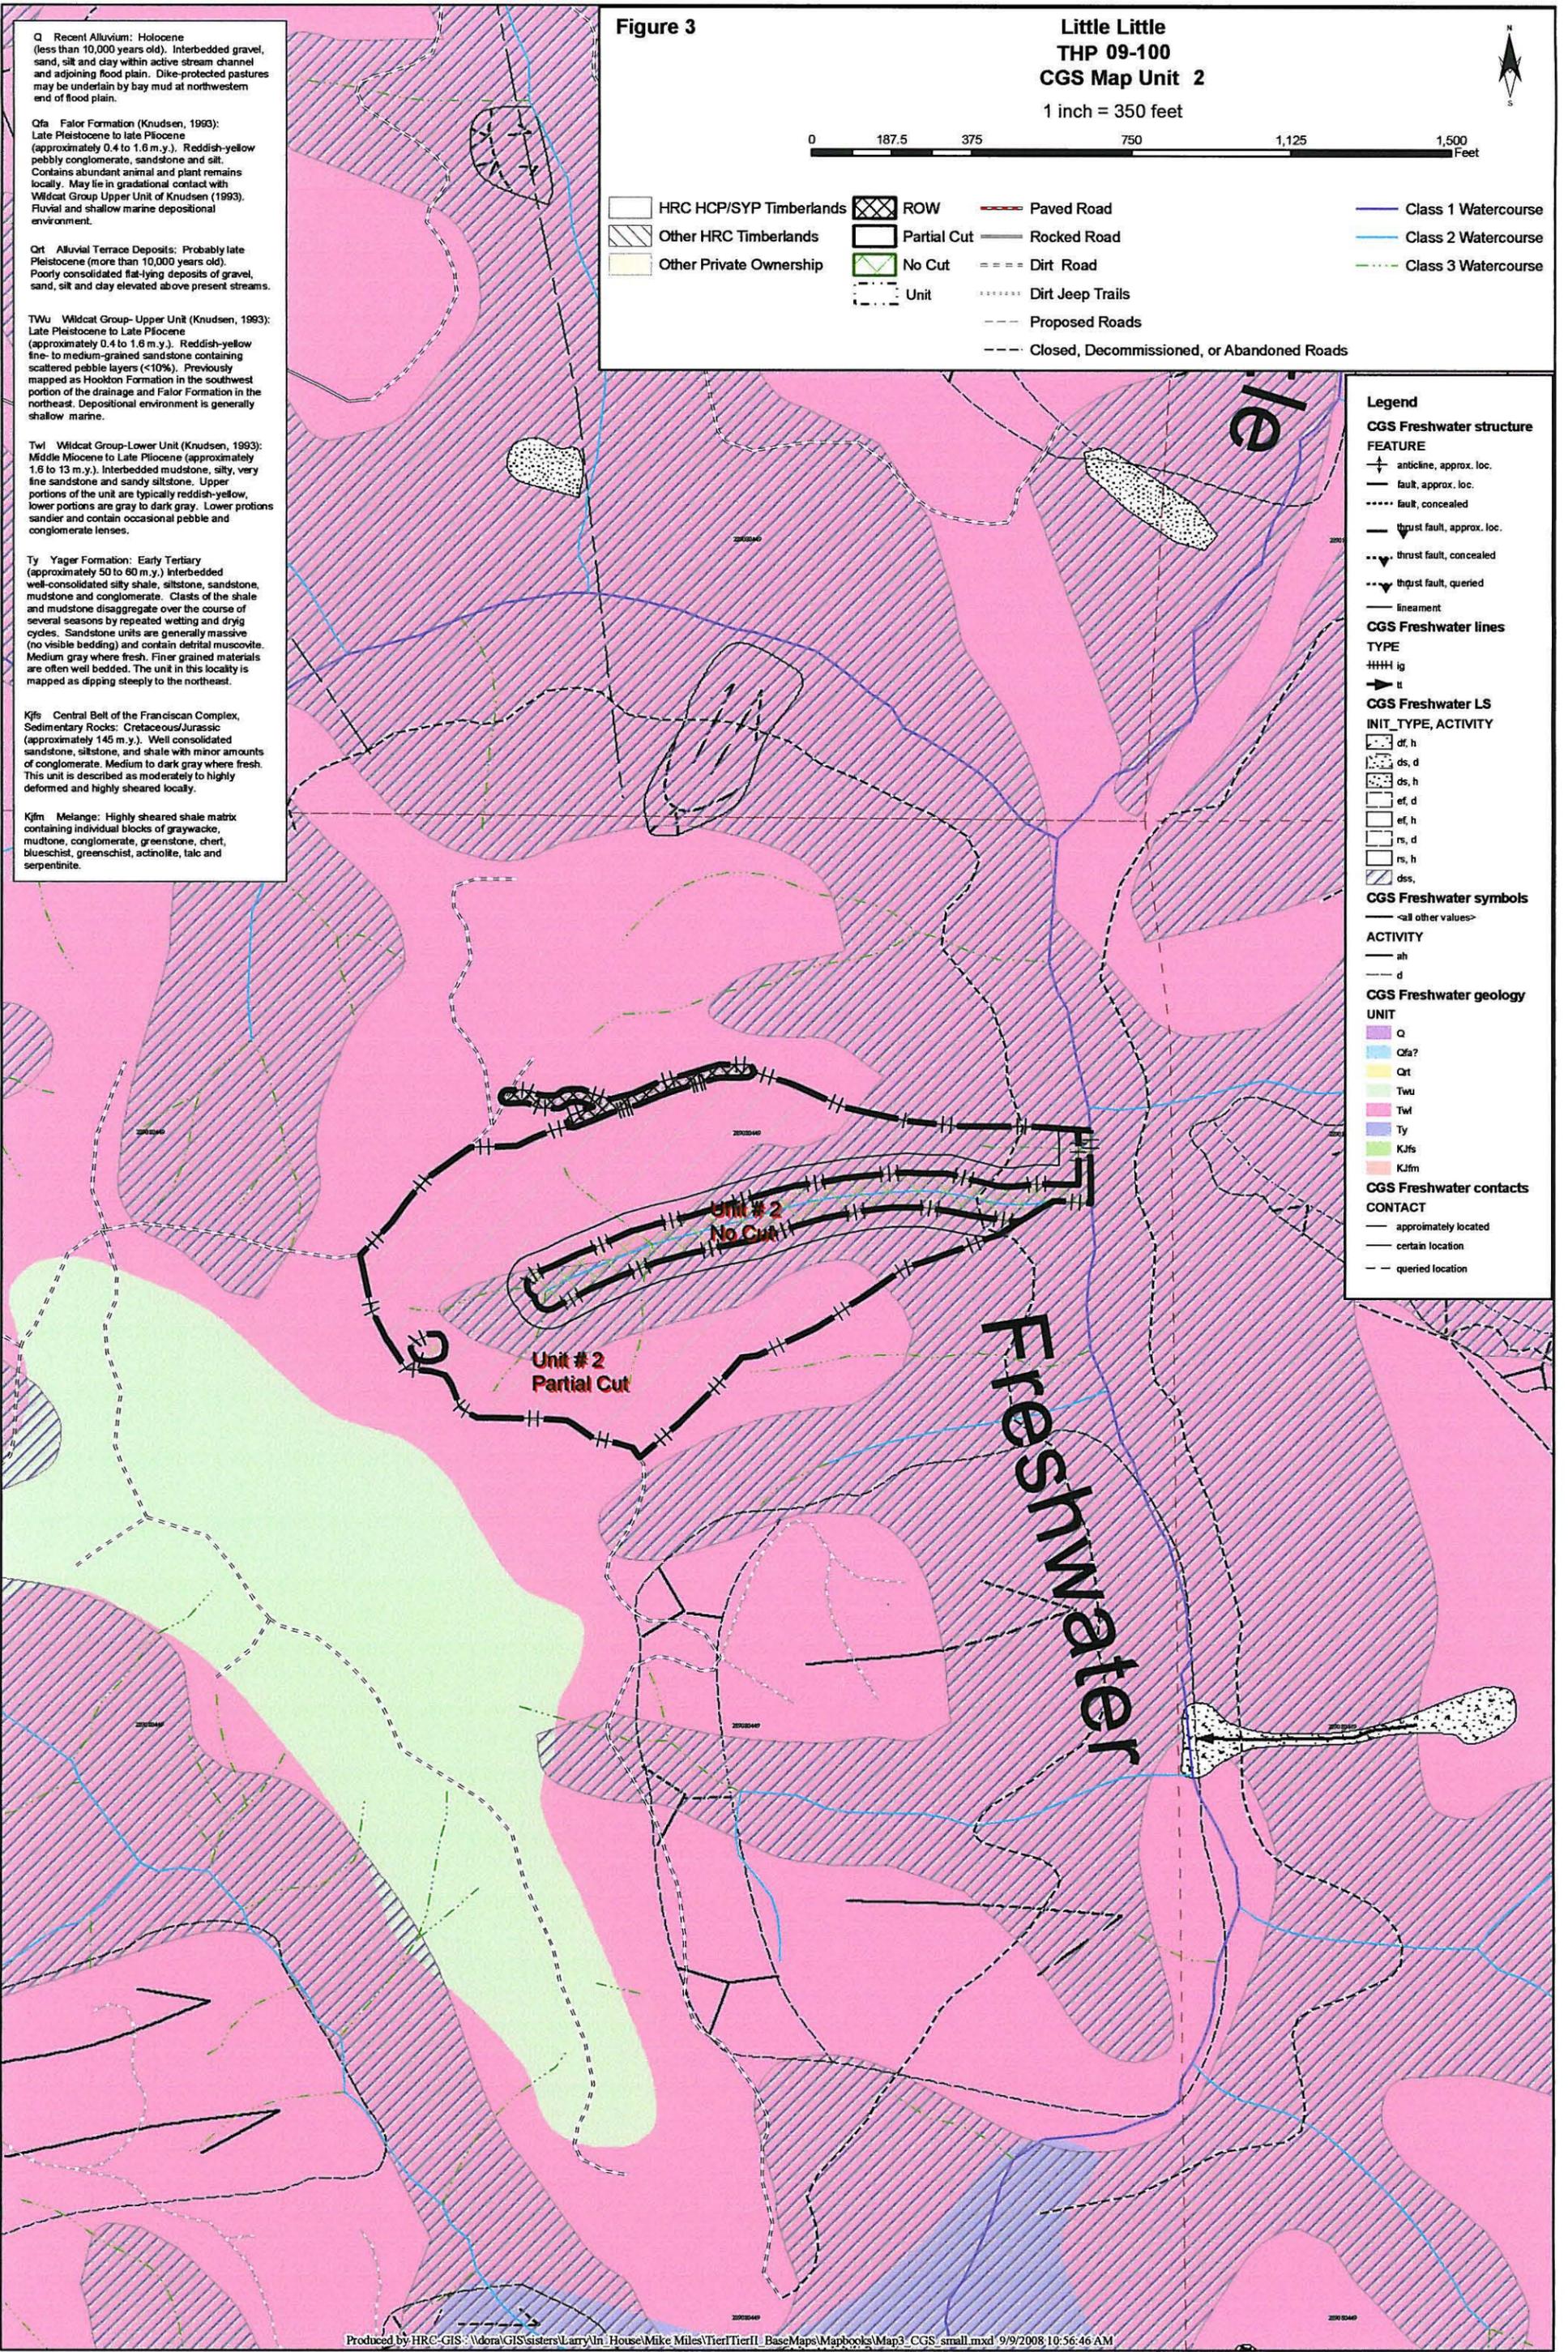
Figure 3

Little Little
THP 09-100
CGS Map Unit 2

Kjfm Melange: Highly sheared shale matrix containing individual blocks of graywacke, mudstone, conglomerate, greenstone, chert, blueschist, greenschist, actinolite, talc and serpentinite.

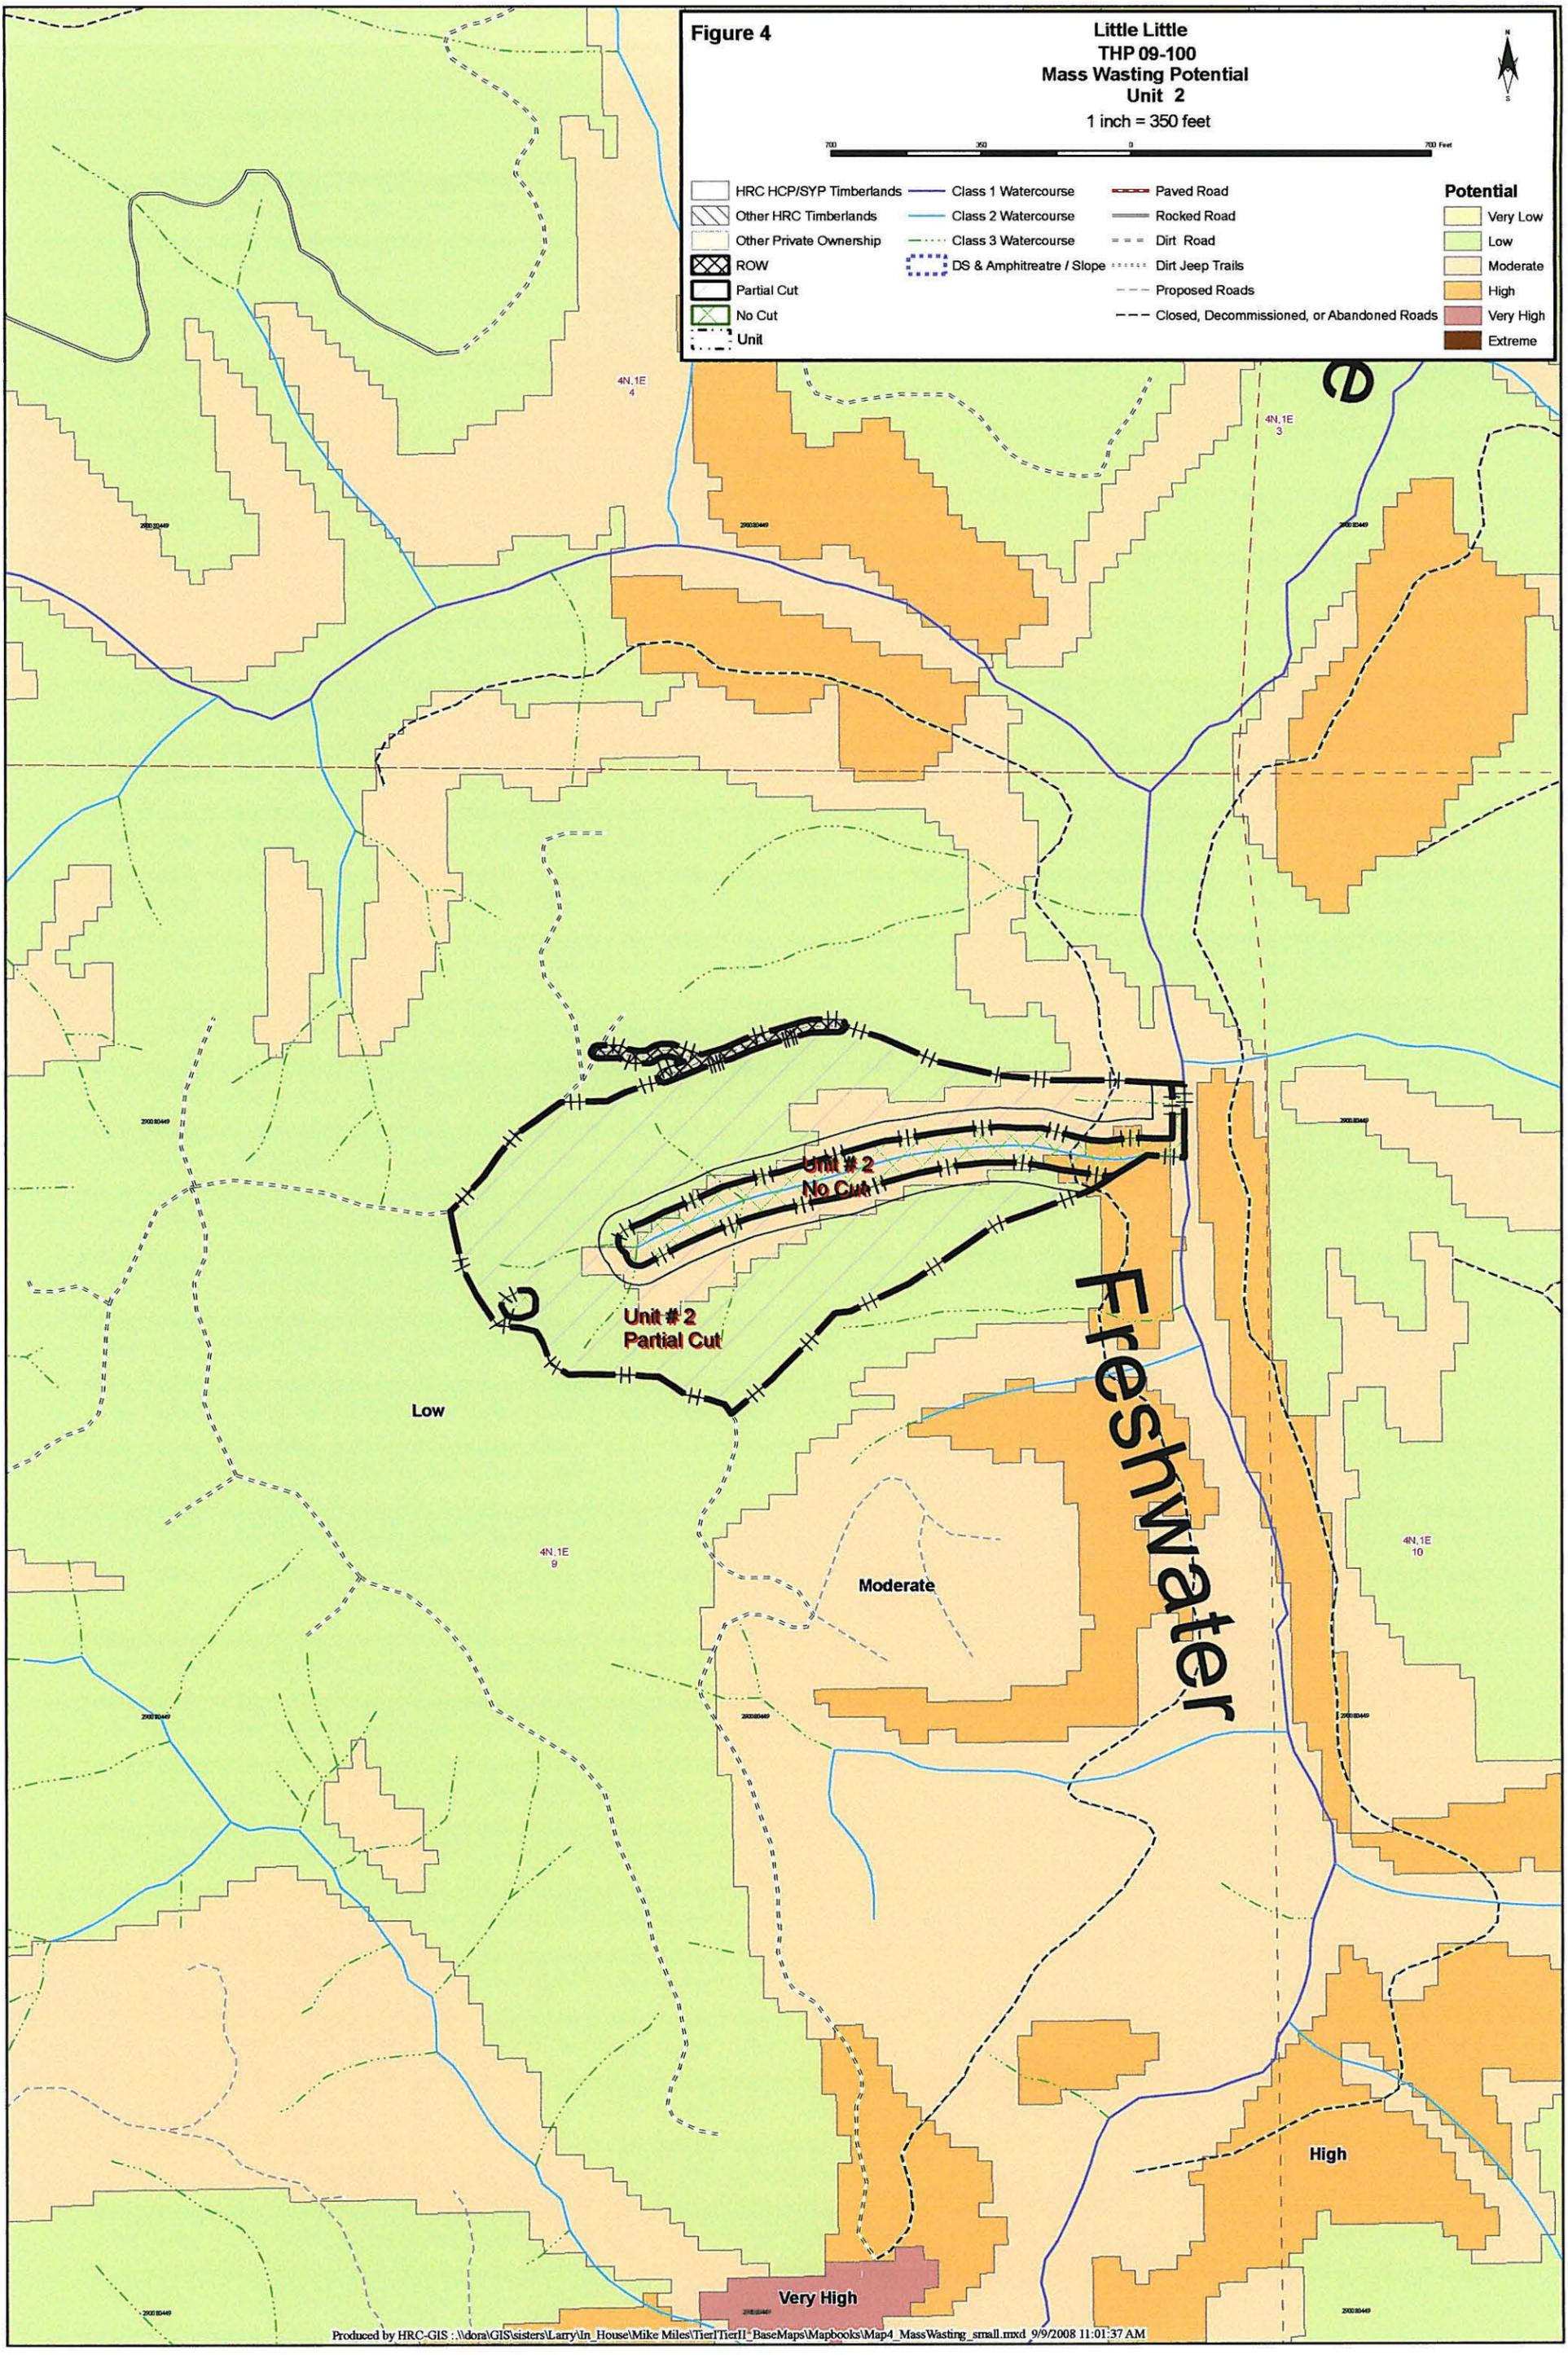
Figure 4

Little Little
THP 09-100
Mass Wasting Potential
Unit 2

Mass Wasting Potential (MWP) modeling for the unit is low to moderate. The majority of the moderate MWP is within the Class II RMZ. A small area of high MWP is modeled in the eastern portion of the unit adjacent Little Freshwater Creek. The high MWP correlates with steep slopes adjacent the Class II watercourse and Little Freshwater Creek (Class I watercourse). High MWP within the unit is mostly inside the Class II harvest exclusion zone and completely within the outer band of the Class II RMZ.

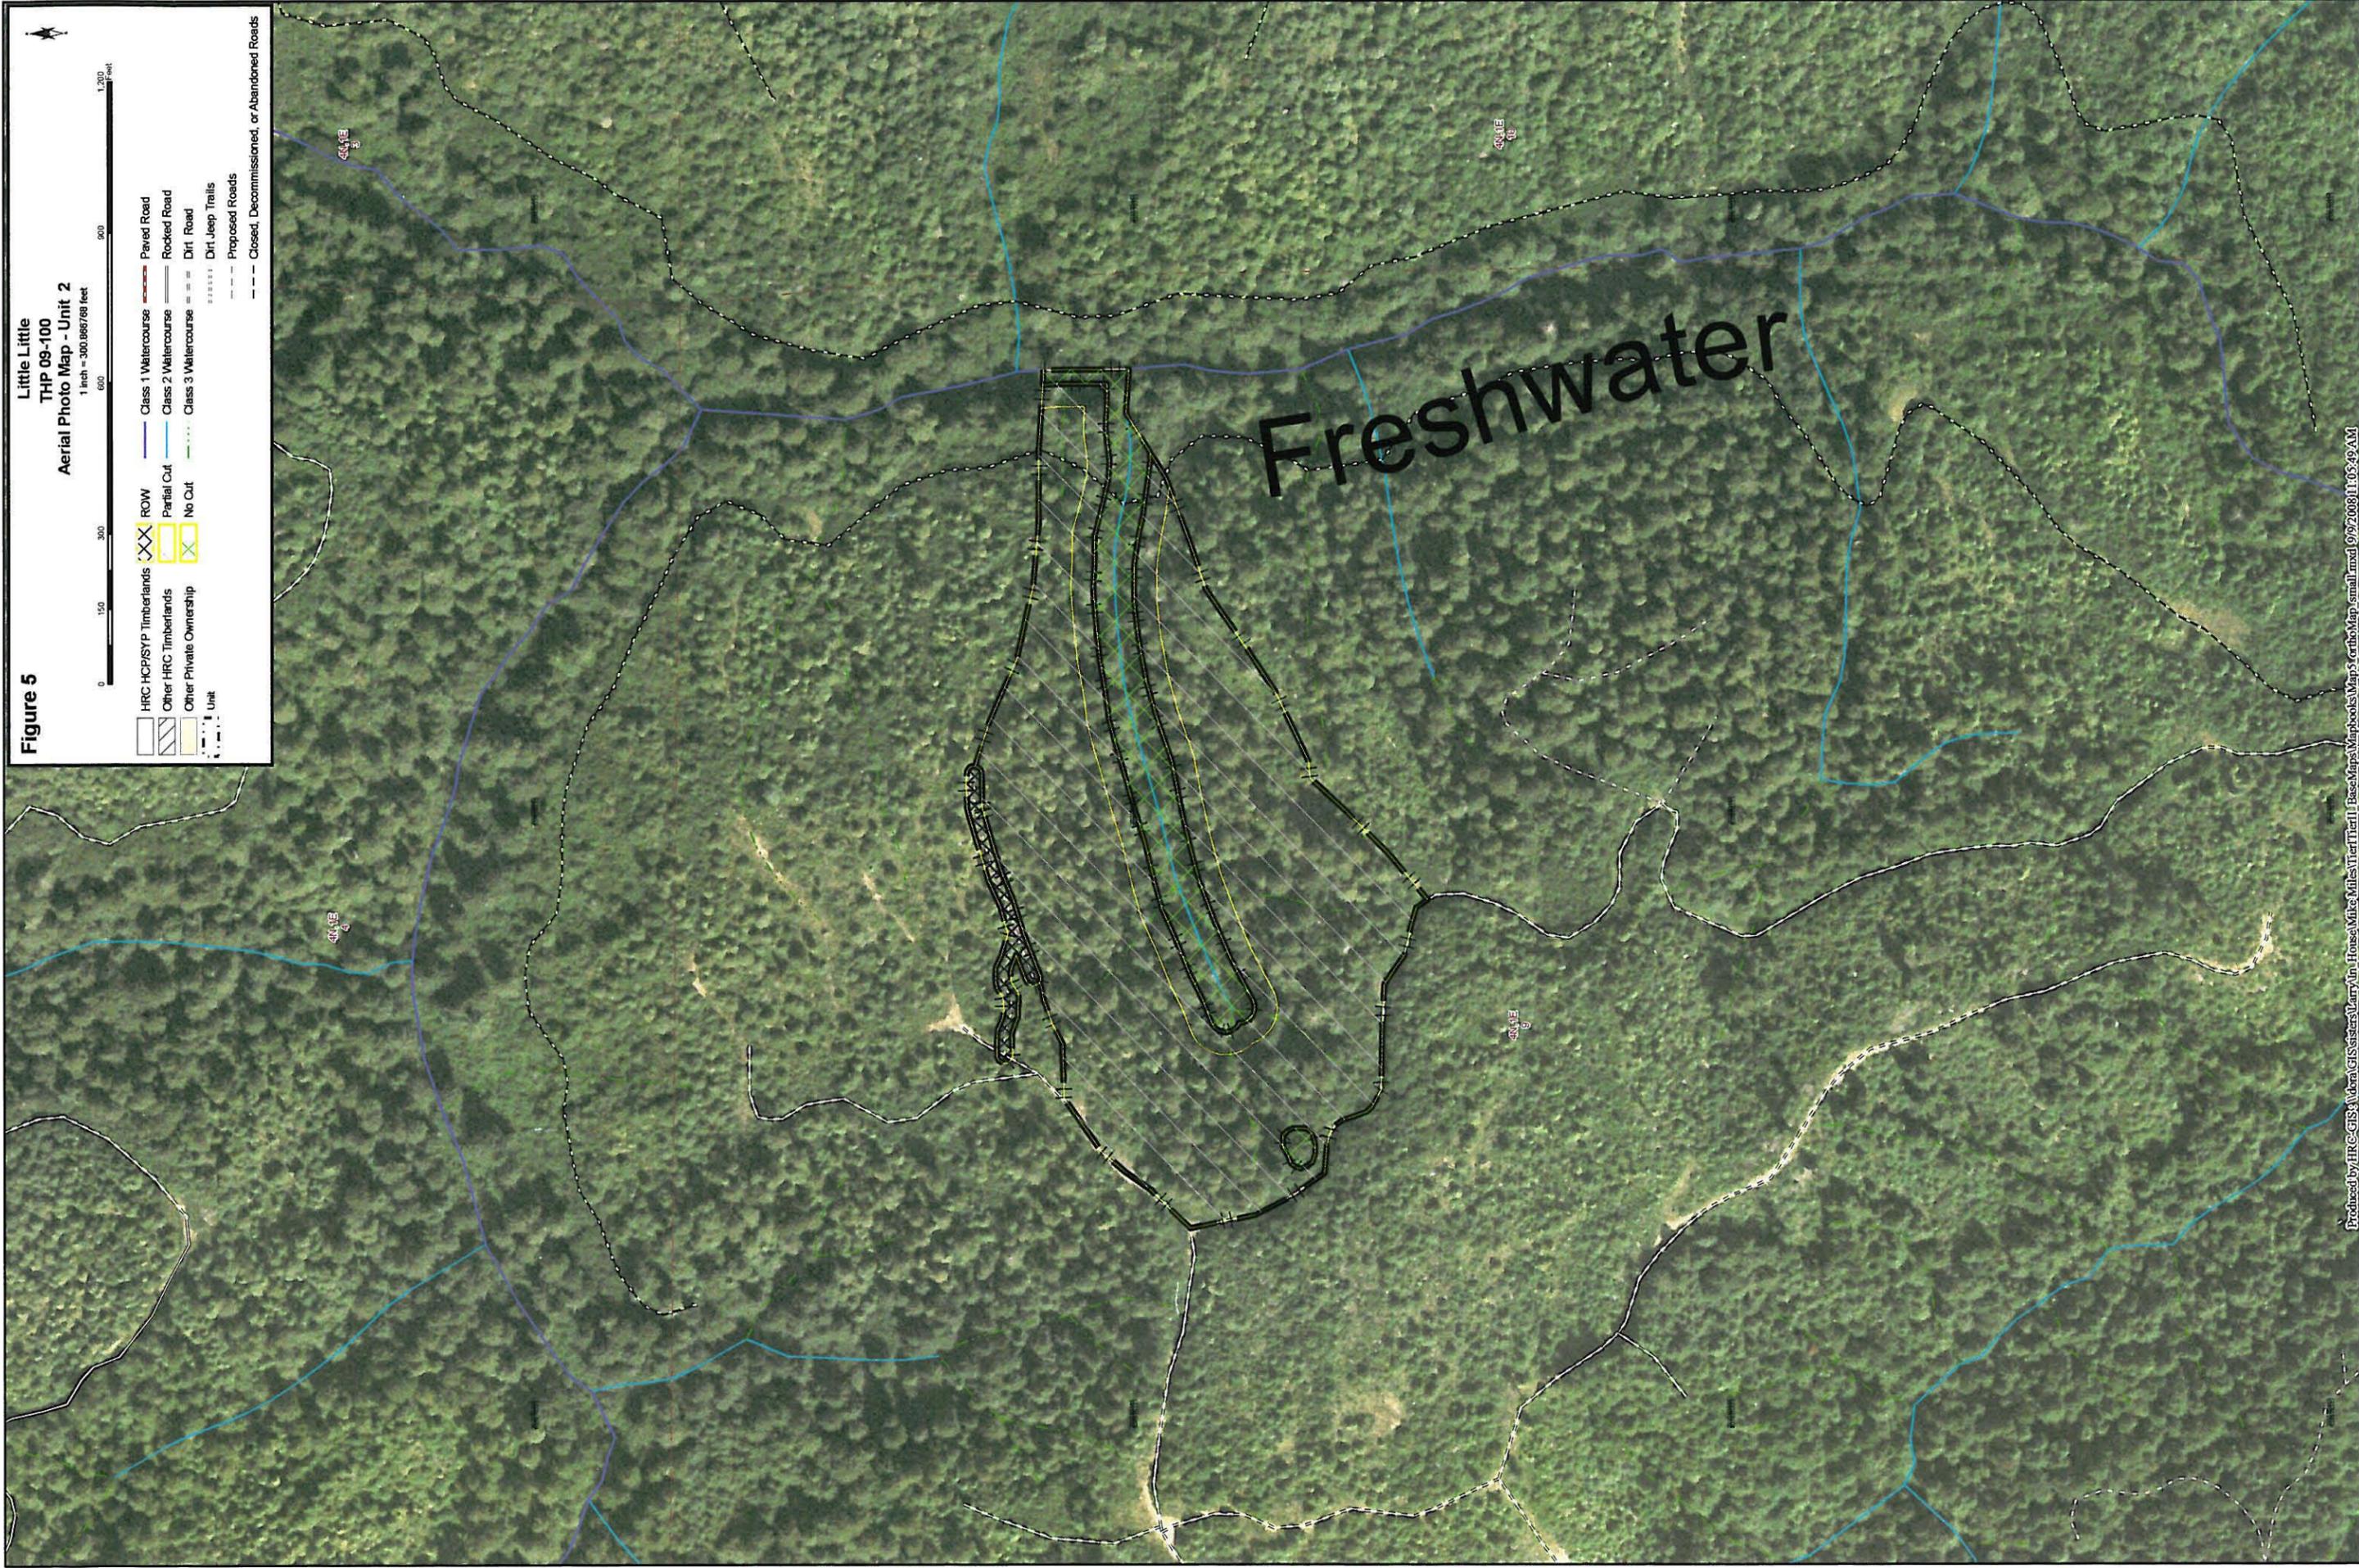
Figure 6

Watershed Analysis Deep-Seated Landslide Inventory (Figure 6) did not identify deep-seated landslides within the proposed unit.

Little Little THP 09-100 Watershed Analysis Deep-Seated Landslide Inventory Unit 2

Mapping from Watershed Analysis (Figure 6) identifies low to moderate hazard for reactivation that correlates with CGS (1999) mapping of the deep-seated ridge to creek dormant translational/rotational landslide in Unit 1. Watershed Analysis (Figure 6) does not model any hazards within Unit 2.
