**Humboldt
Redwood™**

Subject: Enrollment of portions of THP 1-12-084 HUM in the Freshwater Creek WWDR,
"Tier II"

Next Becks Thing THP

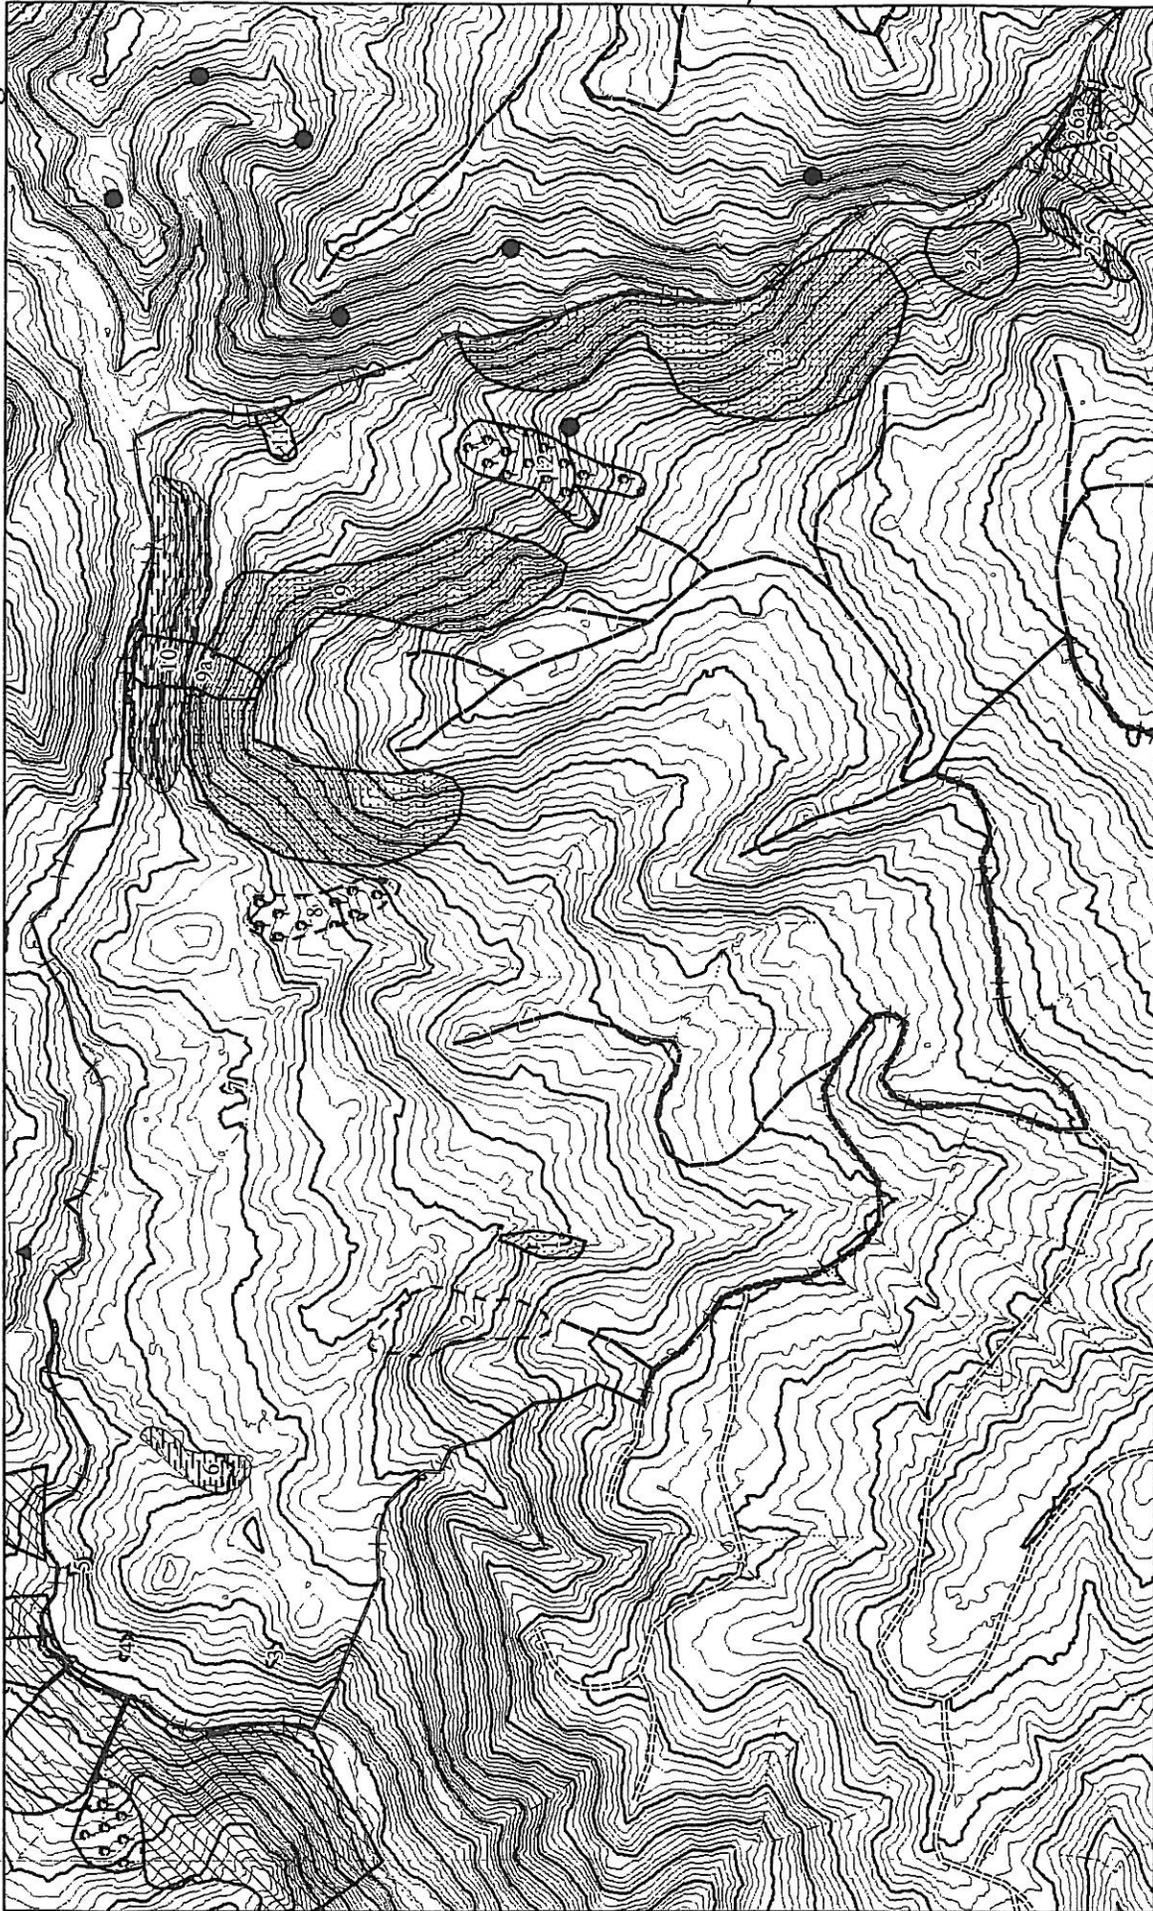
Figure 3a: Mass Wasting Location map, northern

Debris slide slope 9 (Figure 3a) is inclined between 75 and 90 percent on west, north, and east facing slopes. The north facing slope leads towards an inner gorge slope (10) upslope of a Class I watercourse. A train grade crosses the down slope extent of debris slide slope and likely contributed to instability at the site. A large debris slide (9a) initiated upslope of the train grade and evacuated a portion of the grade. The train grade is intact adjacent 9a with minor cut slope failures that deposit on the existing grade. Timber on landform 9 is dominated by fir trees that are widely spaced slightly swept and tilted. Robust vegetation is present on the majority of the slope beneath the over story canopy. Debris slide 9a and inner gorge 10 have been flagged with no cut and are not proposed for harvest. No group openings and 120 square feet of basal area per acre is proposed for the north facing slope on landform 9. The west and east facing slopes of landform 9 do not lead directly towards a watercourse.

Landslide 7 (Figure 3a) is a very small, recently active earthflow that initiated within the fill prism of the train grade adjacent Freshwater Creek. The landslide is 70 feet long, 30 feet wide, and 2 feet deep. No sediment delivery was observed as the landslide parallels a Class II watercourse. The landslide is within the Class II RMZ so no group openings will occur. No merchantable timber is present on the body and green tree retention ("L" trees) has been marked adjacent the perimeter of the landslide. The proposed harvest activities are not likely to significantly alter existing stability conditions at this location.

Landslide 12 (Figure 3a) is an active suspended to dormant historic earthflow located in the northeastern portion of the proposed THP. We observed swept second growth timber and rotated old growth stumps on the body of the landslide. One old growth stump is split with approximately 15 feet of lateral offset between the two halves. The head scarp and lateral margins are not clearly defined by prominent scarps. The extent of the landslide was determined by the transition to undeformed old growth stumps and straight growing second growth timber. A sharp break in slope is present in the lower body of the landslide where slope inclinations increase and lead towards a swale containing a Class III watercourse. It appears reduced lateral support caused by the break in slope is a driving mechanism for the upslope slide mass. The Forester proposes no group openings and 120 square feet of basal area retention per acre.

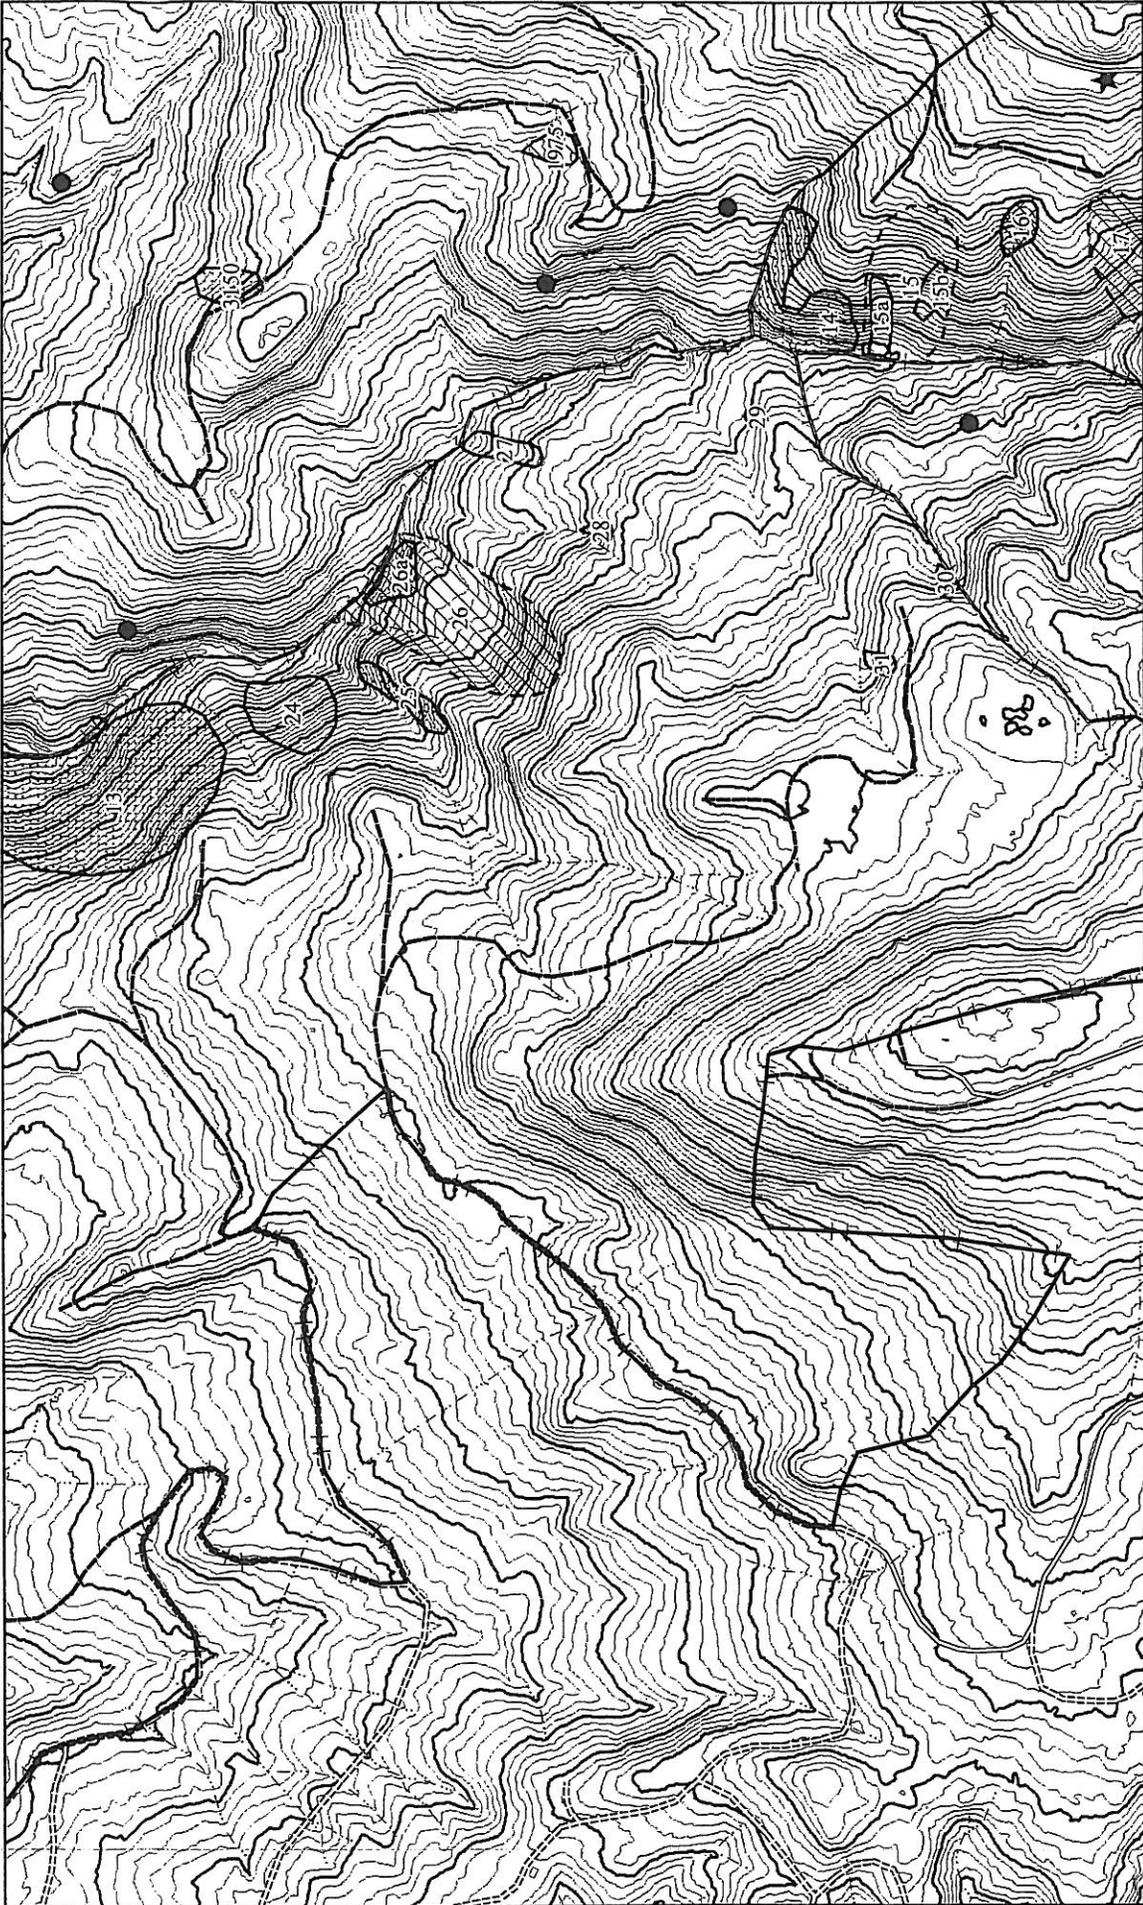
Figure 3b: Mass Wasting Location map, central

We observed one headwall swale, as defined by the HCP, present within the proposed harvest plan. This landform has been cataloged as **16** and appears on Figures 3b, 3c and 3d. This landform has been encompassed in NO CUT flagging and will not be harvested on.

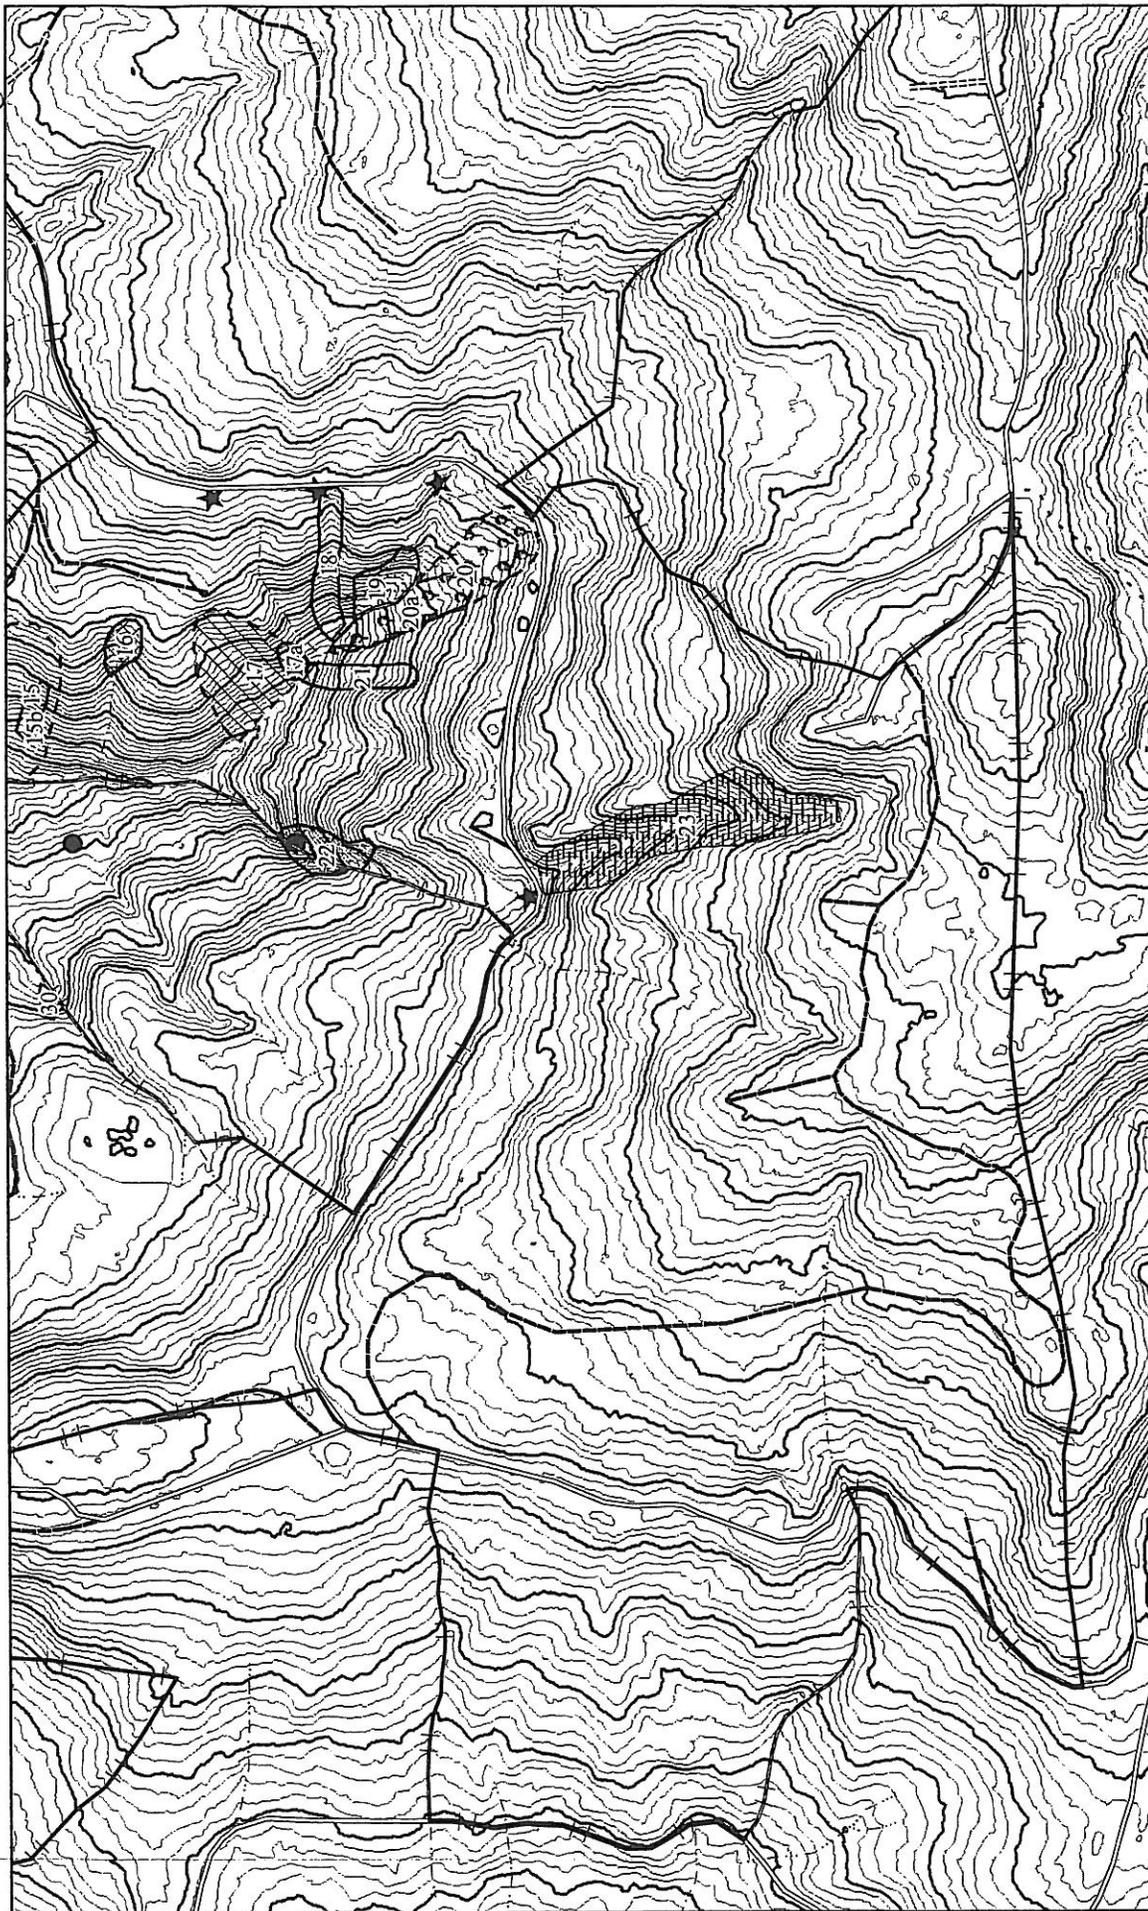
Figure 3c: Mass Wasting Location map, southwestern

Landform 19 (Figure 3c) is an area of steeply inclined streamside slopes. We observed raveling of gravely soils and exposures of highly fractured, well consolidated meta-sandstone. This slope does not support a robust stand of mature second growth timber. The RMZ flagging has been expanded upslope to encompass this landform. The Forester informed us no trees would be marked for harvest at this location.

Landslide 20a (Figure 3c) is an active suspended to dormant historic earthflow located down slope of Road 15. We observed hummocky slope morphology, swept second growth timber, and numerous rotated old growth stumps. A class II watercourse is present within the slide body. Watercourse morphology is erratic and poorly developed. Subdued earthflow morphology is present upslope of 20a and shown on the Mass Wasting Location Map (Figure 3c) as landslide 20. The right lateral margin of 20a is non-distinct and likely located within a Class II watercourse channel. The left lateral margin is well defined, approximately 4-6 feet tall, and near vertical. The RMZ for the Class II watercourse encompasses the landslide. The Forester informed us no trees are marked for harvest within landslide 20a.
