Elk River Restoration Summit

February 8 and 9, 2012
Eureka, CA

Adona White, PE
Basin Planning
North Coast Regional Water Quality Control Board

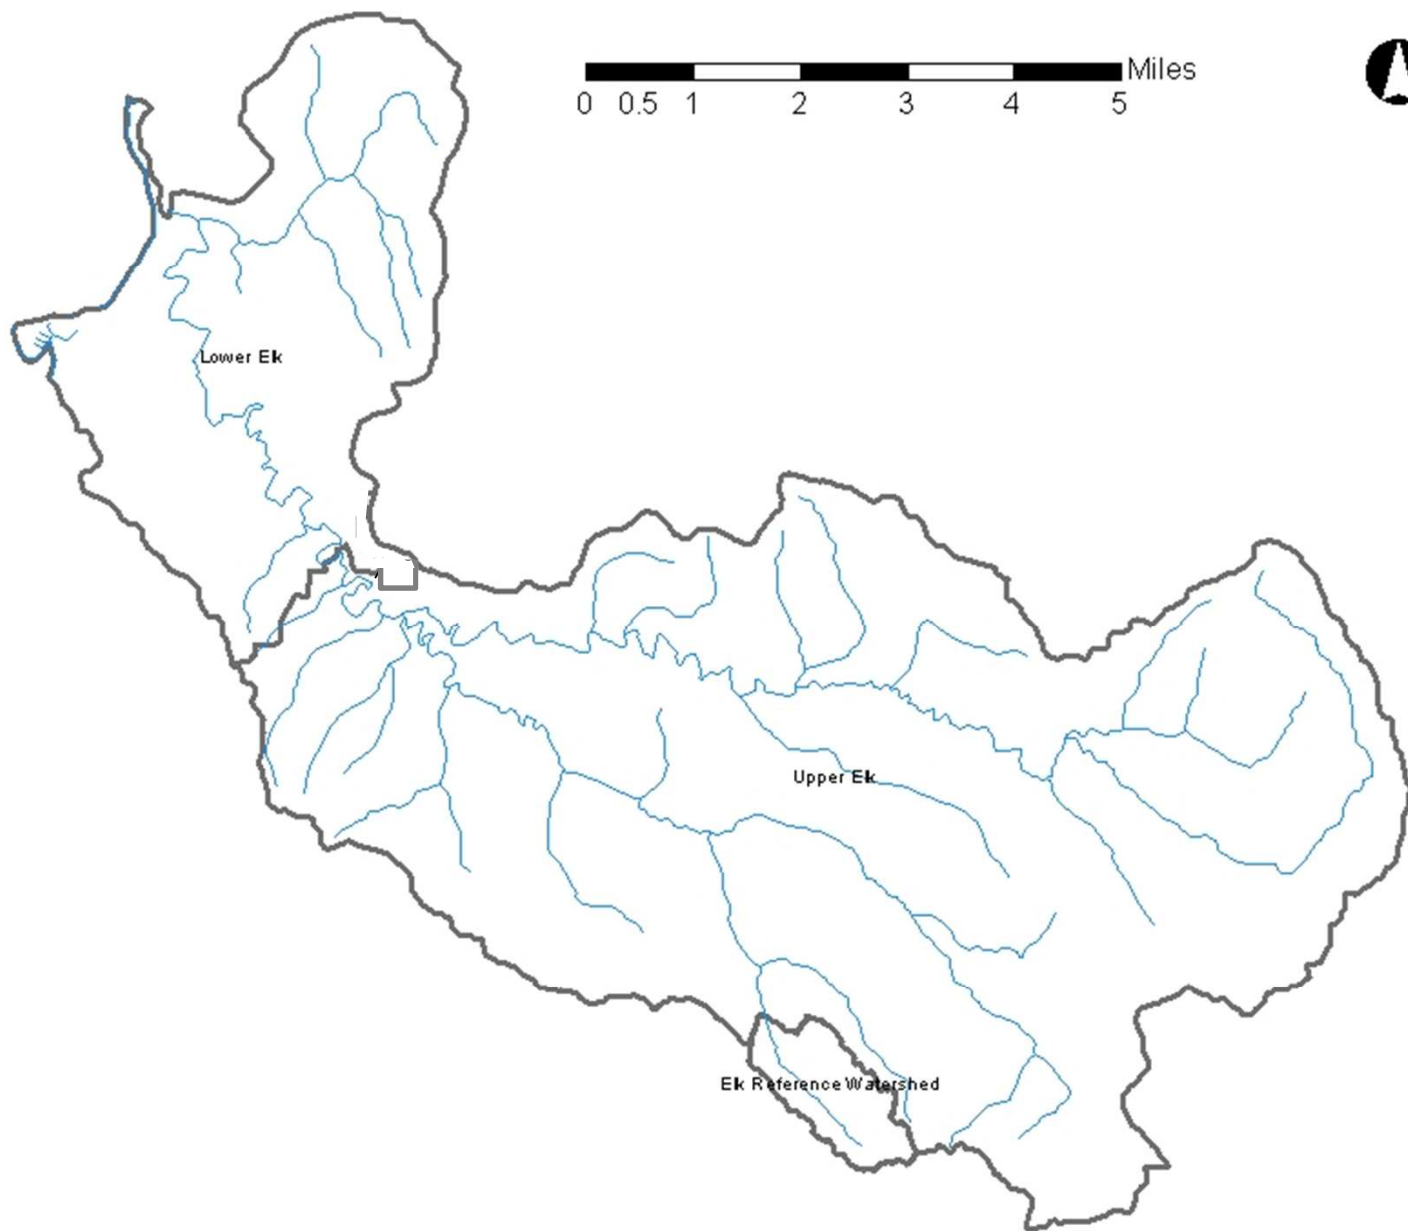
Elk River Landuse

97% of North and South Forks in HRC,
GDRC & BLM ownership

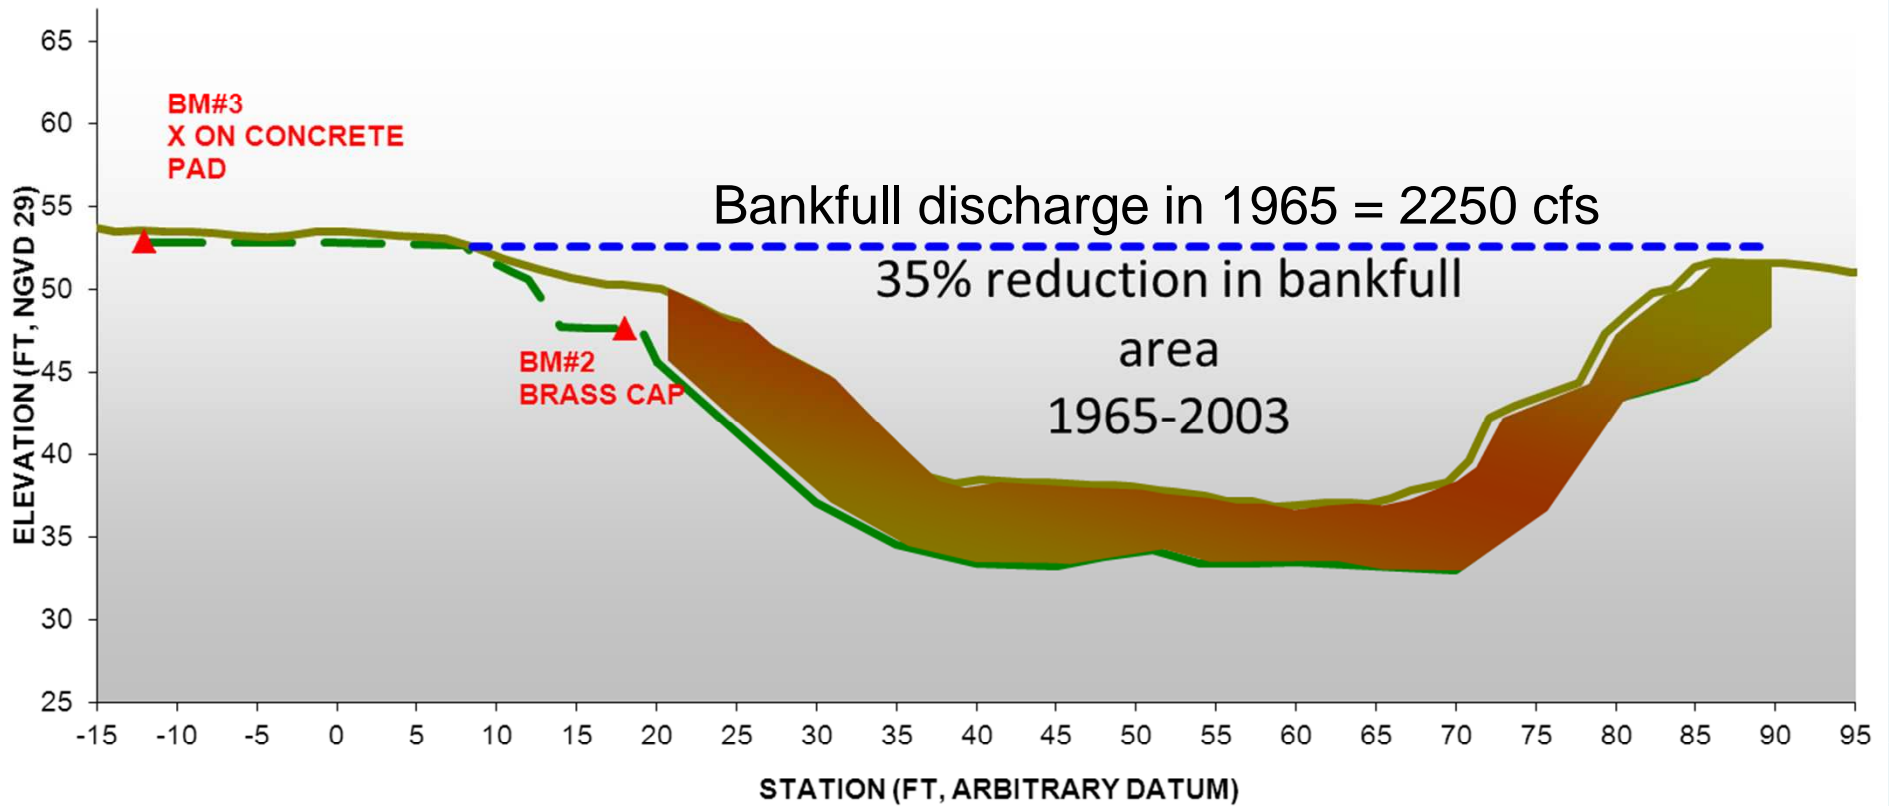
Comparison with historic conditions:
USGS gaged Upper Mainstem (1958-1967)
PL reoccupied site beginning in 1998

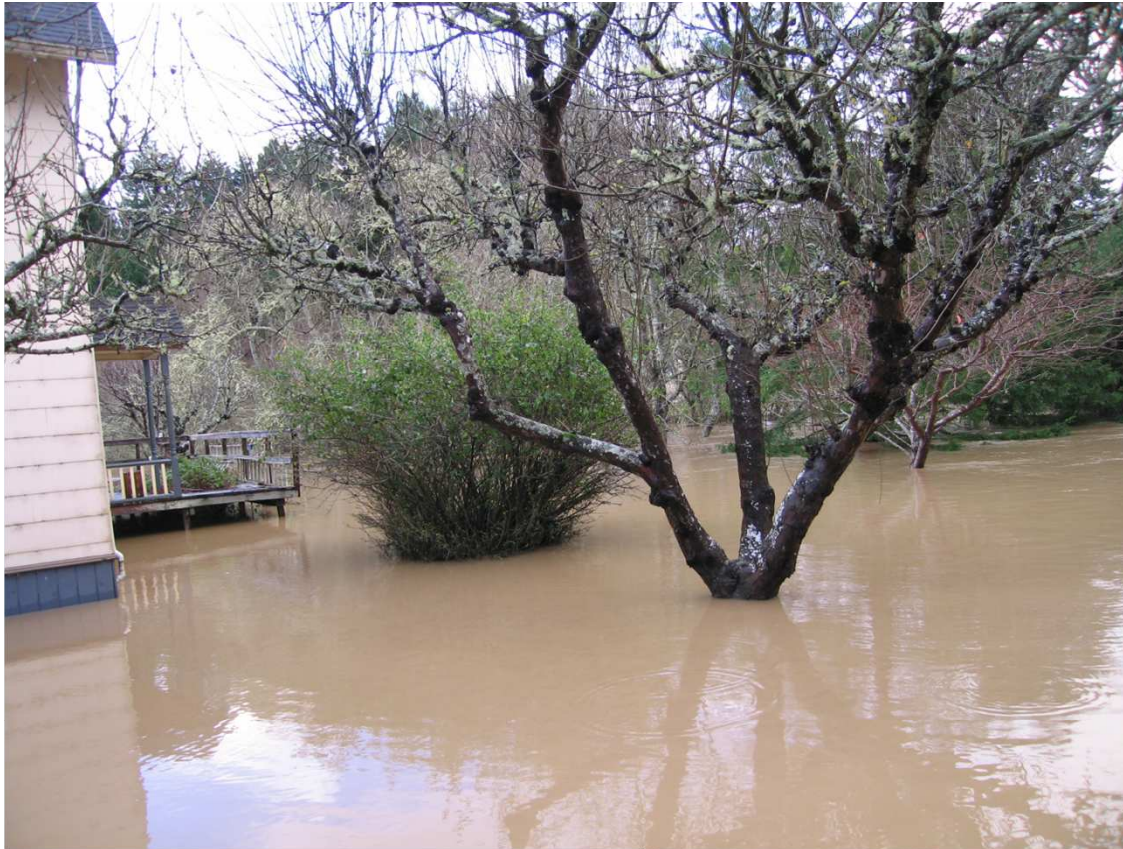
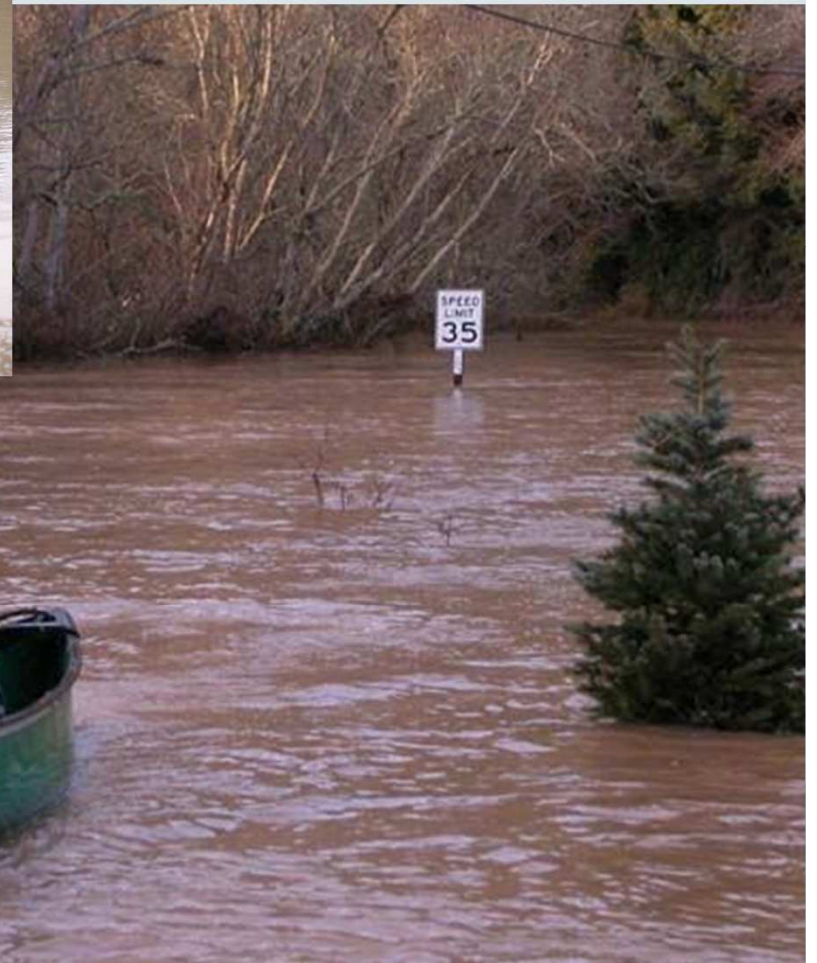
Nuisance Flooding Conditions

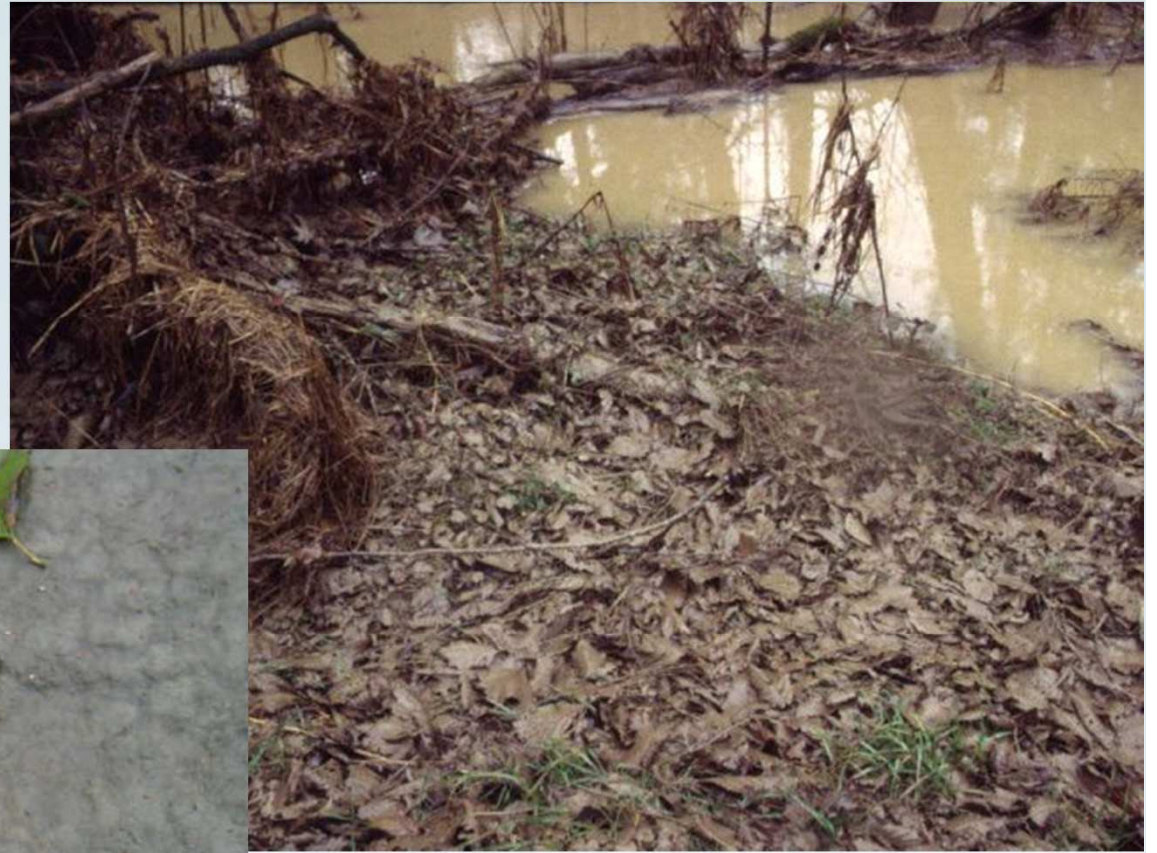
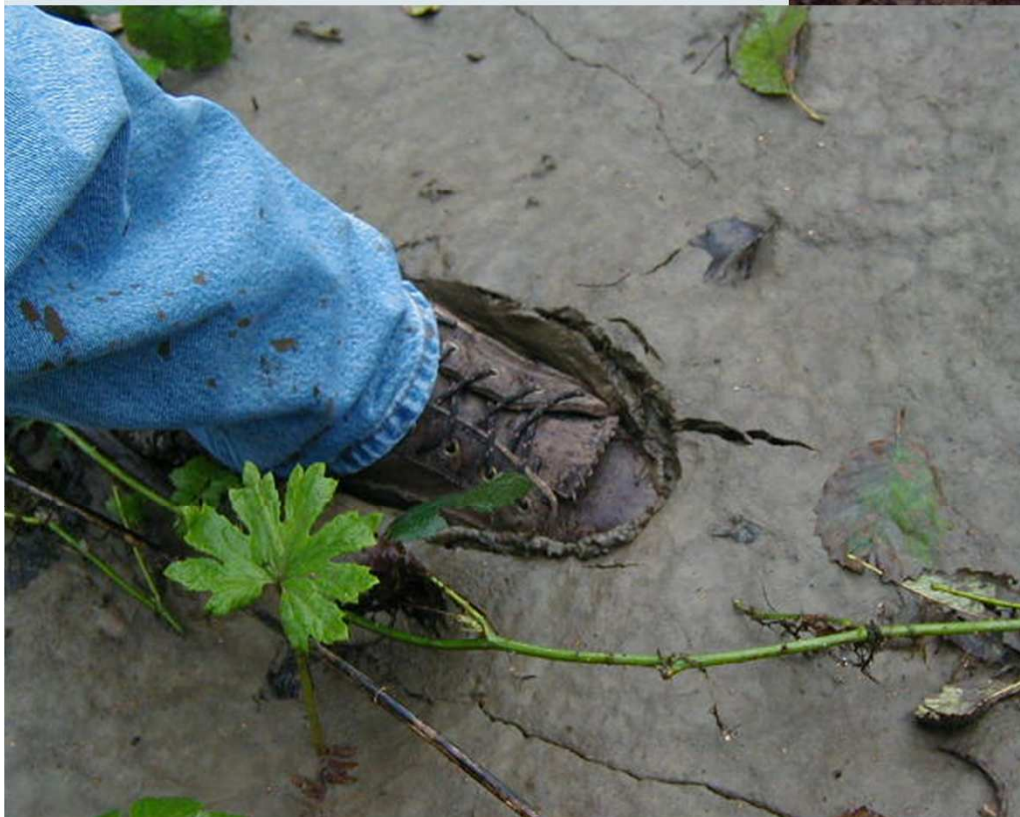
Sediment loads and ongoing deposition
